FINAL
ANNUAL MONITORING REPORT
YEAR 5 (2014)

VICKI'S THICKET RIPARIAN BUFFER MITIGATION SITE
CRAVEN COUNTY, NORTH CAROLINA
(EEP Contract No. 002283, EEP ID No. 94015)
[DWQ Reference No. 10-0652]

MONITORING PLAN VIEW
 VICKI'S THICKET
 RIPARIAN BUFFER MITIGATION SITE
 Craven County, North Carolina

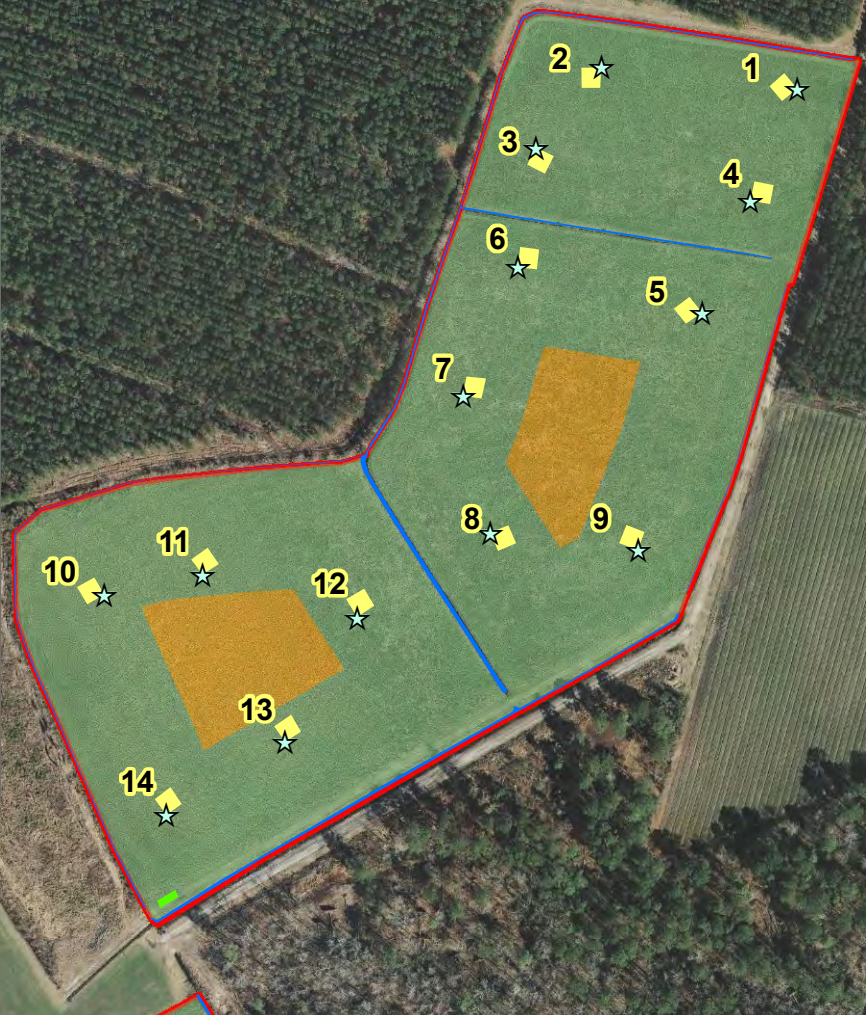
FIGURE
2

Vicki's Thicket
28.63 Nutrient Offset Restoration Credits

- Easement = 31.35 acres
- Nutrient Offset Restoration = 28.63 acres (1,247,210 sq. ft)
- Planted No Credit Areas = 2.27 acres
- Surface Water Within Easement = 0.45 acre
- Vegetation Plots
- ☆ Vegetation Plot Origins
- Area to be Replanted in 2014/2015

Vegetation within a small area of the old farm path has not done well; therefore, 20-3 gallon containerized trees will be planted within this area (denoted in green on Figure 2, Appendix A) in late 2014/early 2015.

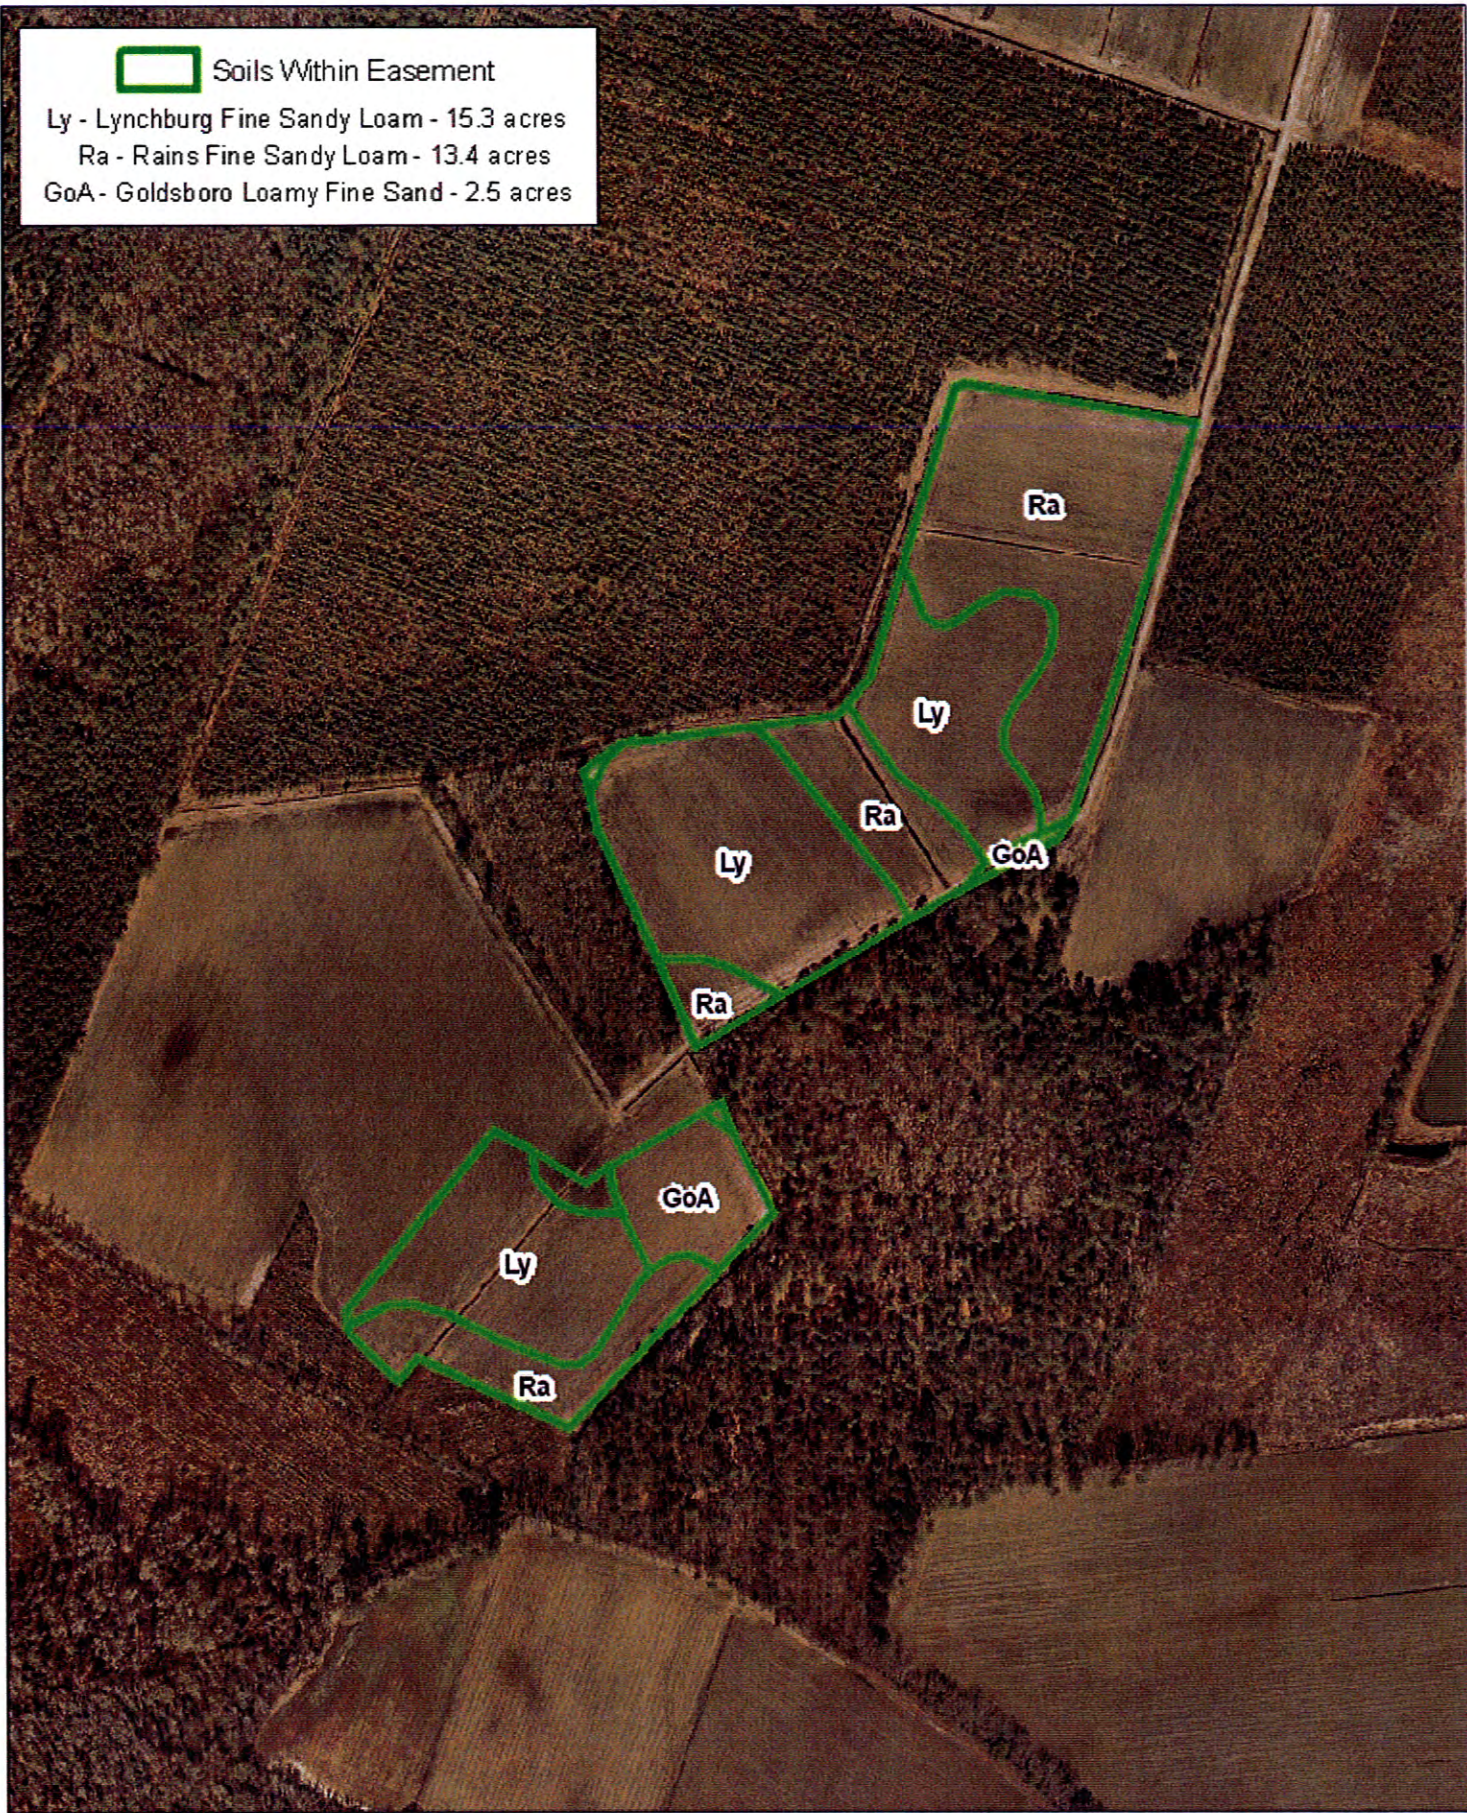
Figure 3:
Soils

Soils Within Easement

Ly - Lynchburg Fine Sandy Loam - 15.3 acres

Ra - Rains Fine Sandy Loam - 13.4 acres

GoA - Goldsboro Loamy Fine Sand - 2.5 acres

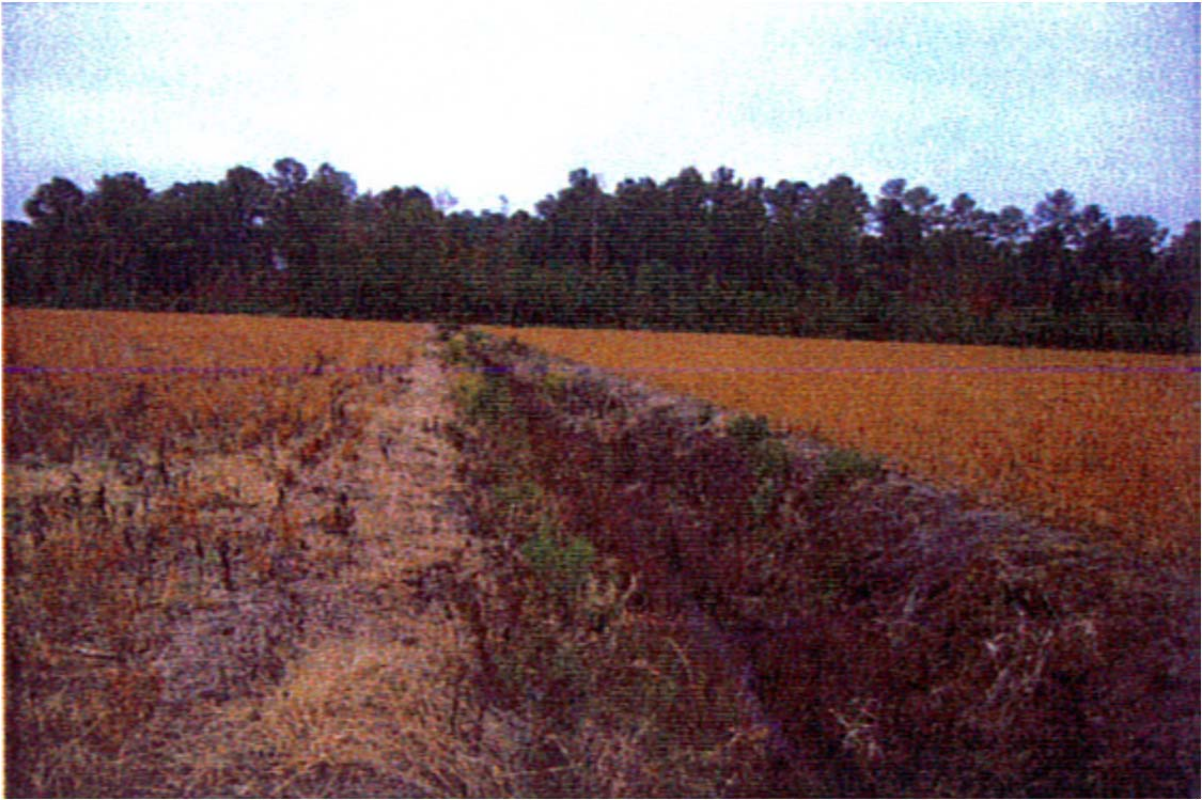
**Preconstruction Photograph
Vicki's Thicket
Taken 2008**

Prior to construction, the Site was characterized by ditched agricultural land used for row crop production. Land use practices including the maintenance and removal of vegetation, regular plowing, and use of agricultural chemicals had resulted in degraded water quality.
