MITIGATION PLAN

VILE CREEK MITIGATION SITE

Alleghany County, NC
DEQ Contract No. 5999
DMS ID No. 96582

New River Basin
HUC 0505001

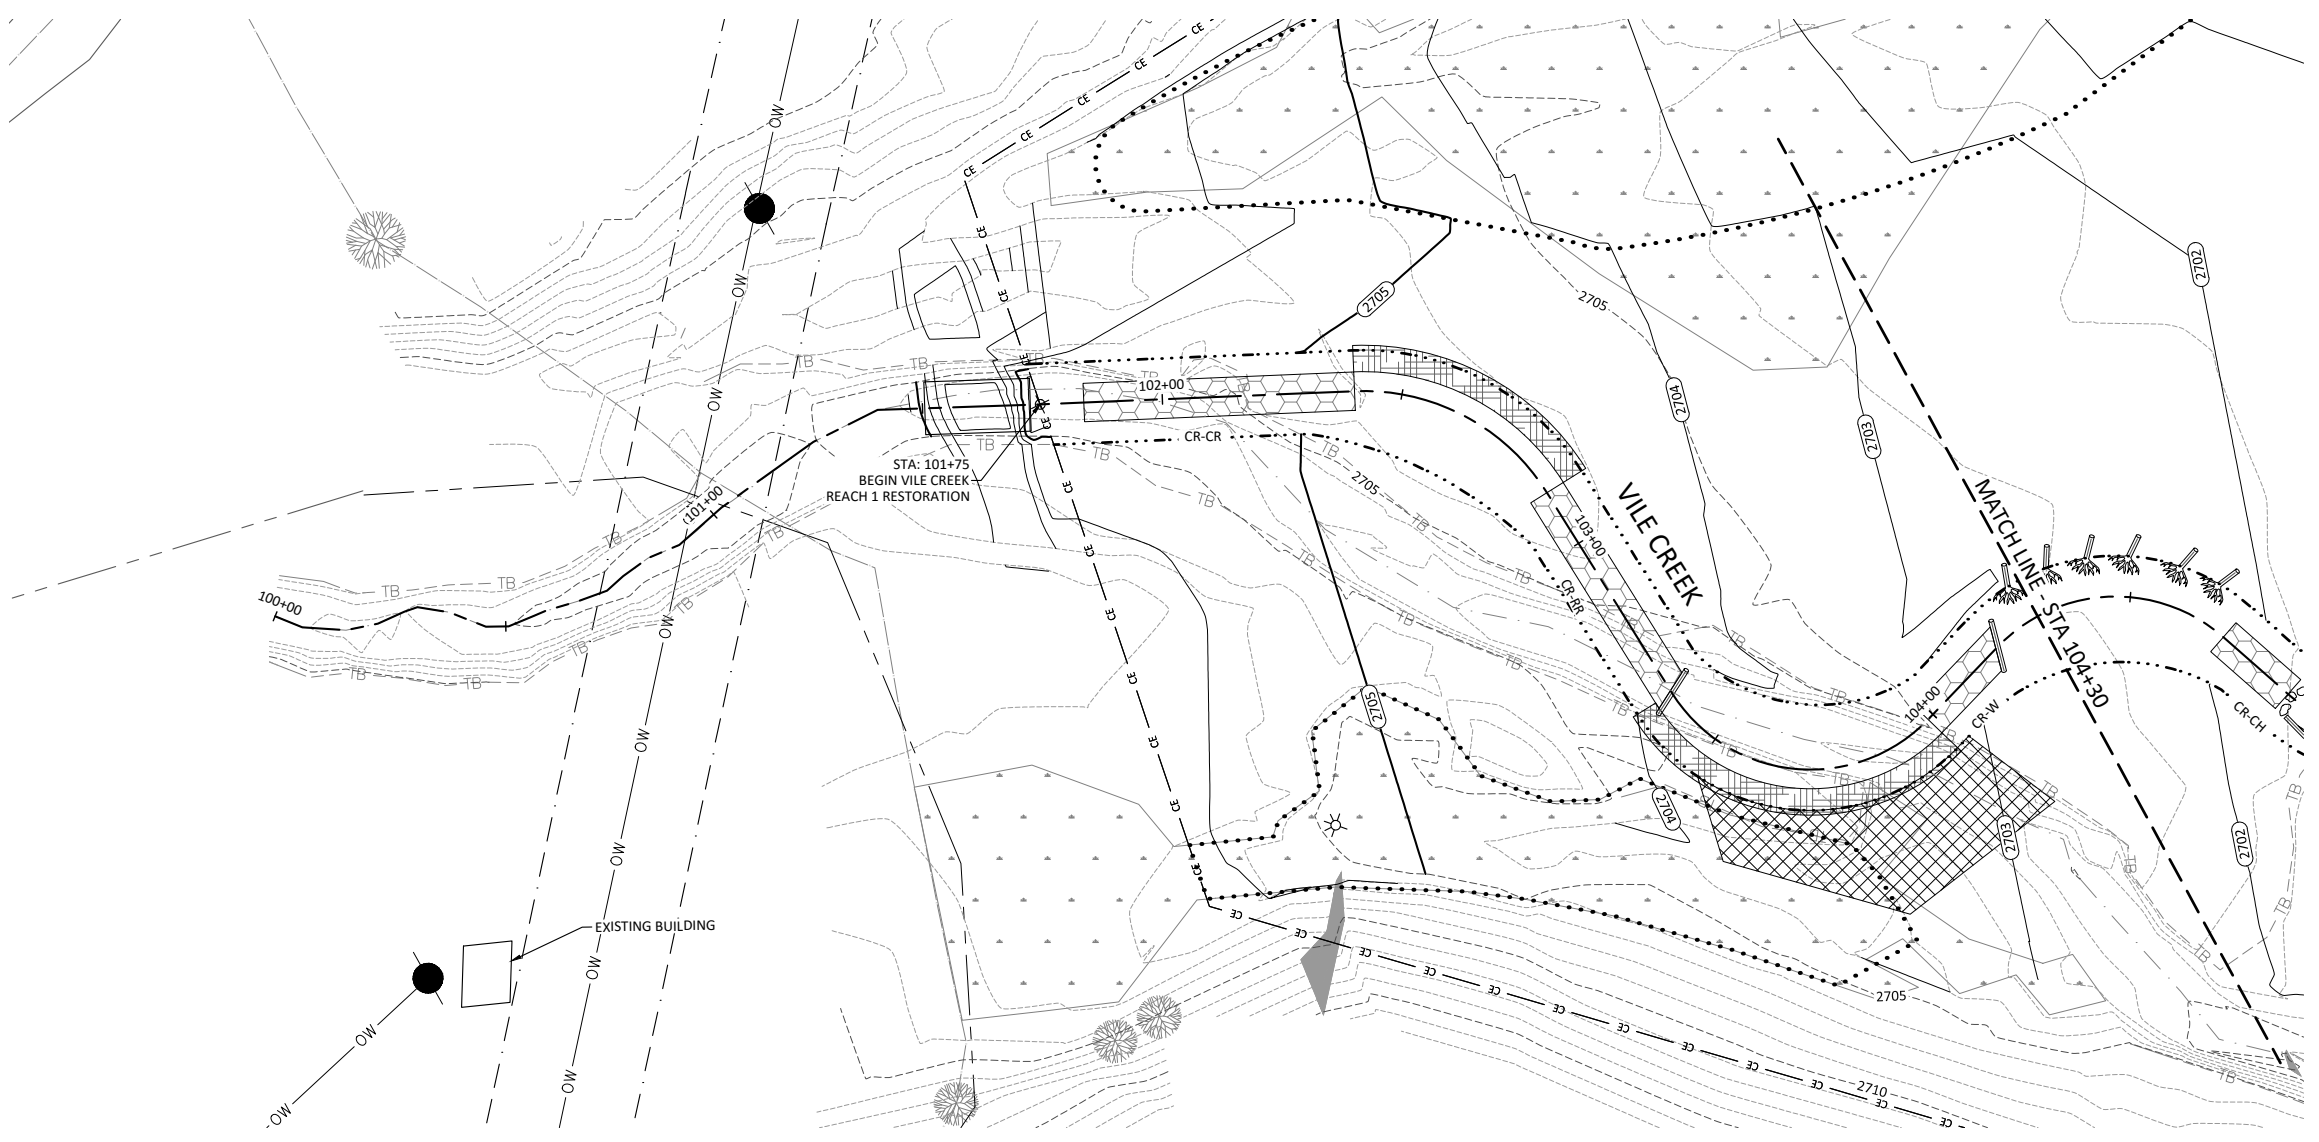
Vile Creek Mitigation Site
Allegheny County, North Carolina
 Vile Creek Reach 1
 Stream Plan and Profile

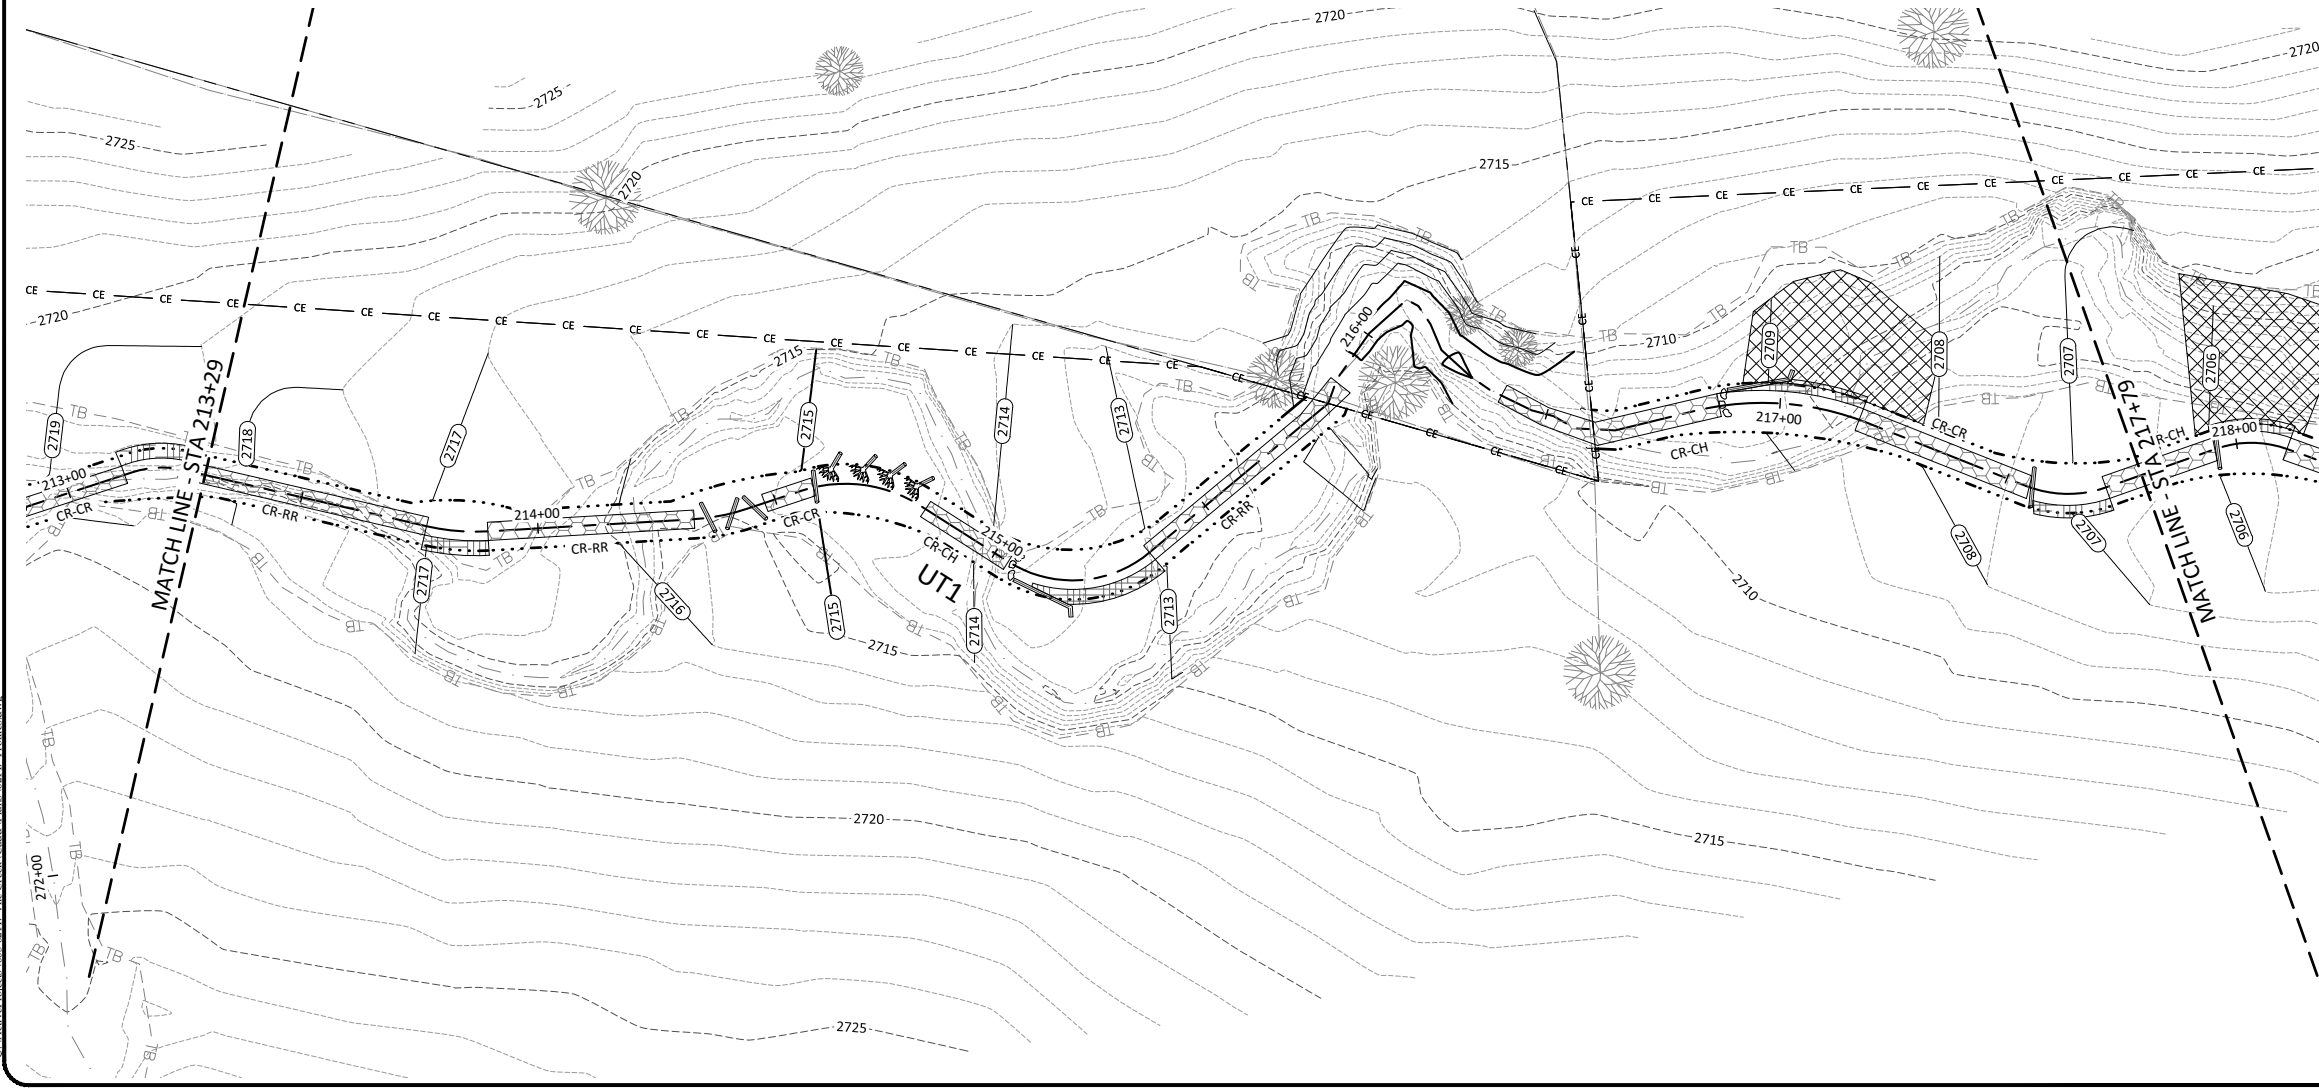
Vile Creek Mitigation Site
Allegheny County, North Carolina
 UT1 Reach 2
 Stream Plan and Profile
