**YEAR 3 (2014) ANNUAL MONITORING REPORT**  
**WALL RIPARIAN BUFFER MITIGATION SITE**

RANDOLPH COUNTY, NORTH CAROLINA  
EEP PROJECT ID: 95007

DATA COLLECTED AUGUST 2014  
CONSTRUCTION COMPLETED MARCH 2012  
**MONITORING REPORT SUBMITTED OCTOBER 2014**

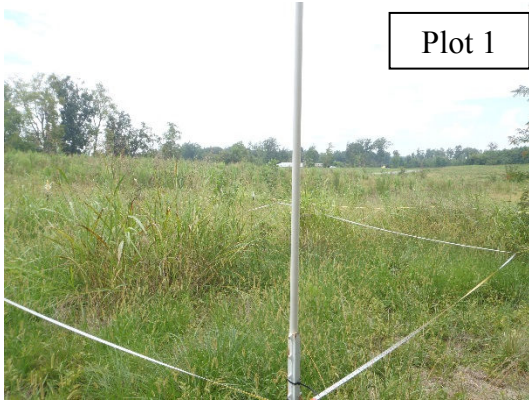
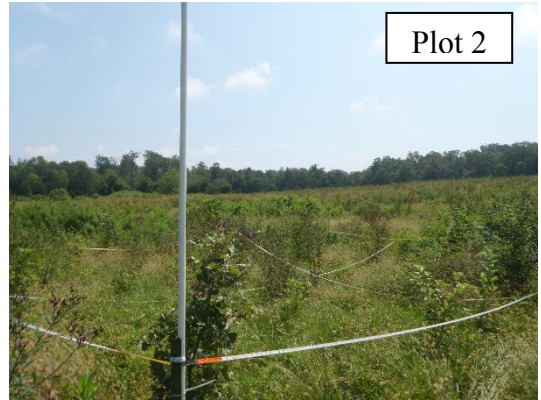
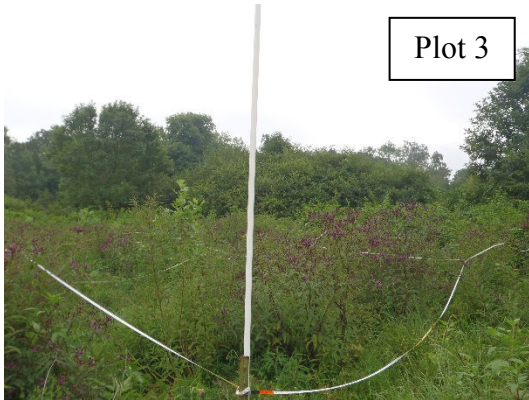
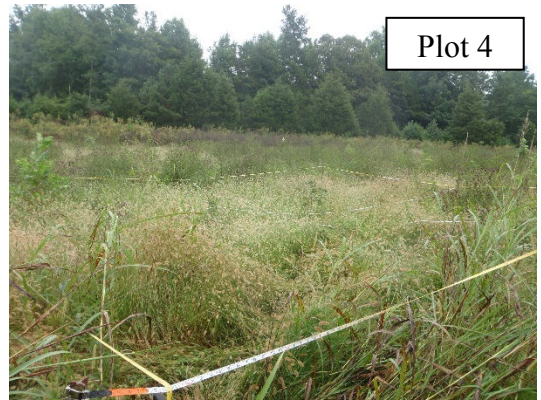
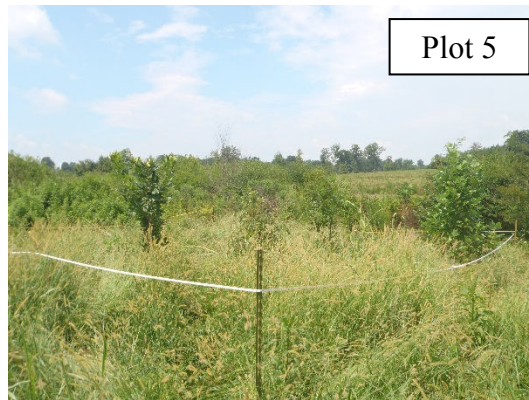
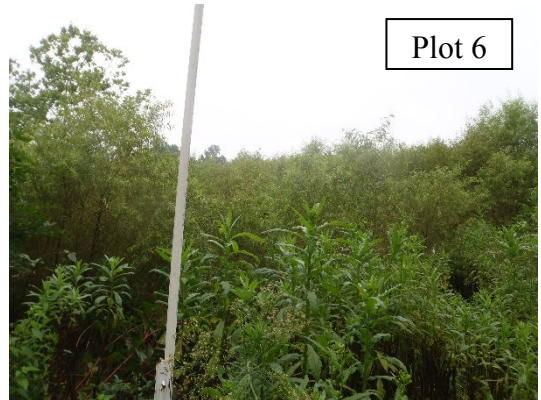
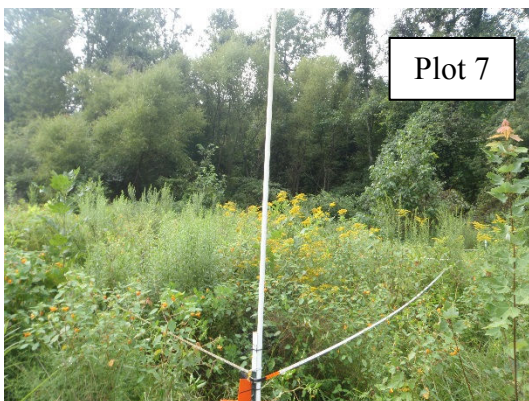
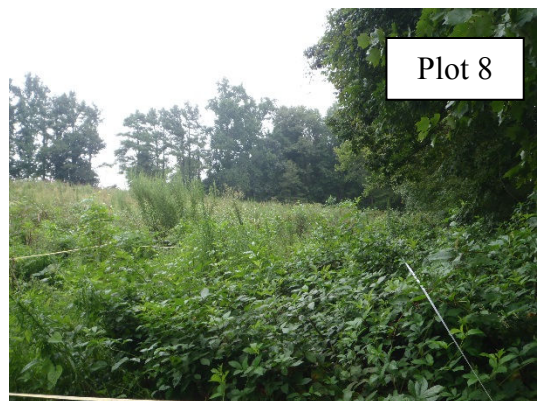
**Wall Buffer**  
**2014 (Year 3) Vegetation Monitoring Photographs**  
**Taken August 2014**

Vegetation sampling across the Site was above the required average density with 769 planted stems per acre surviving. In addition, each individual plot was above success criteria based on planted stems alone.

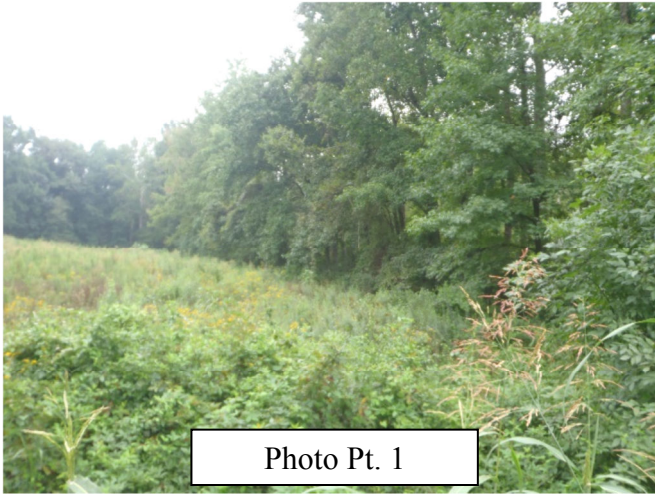
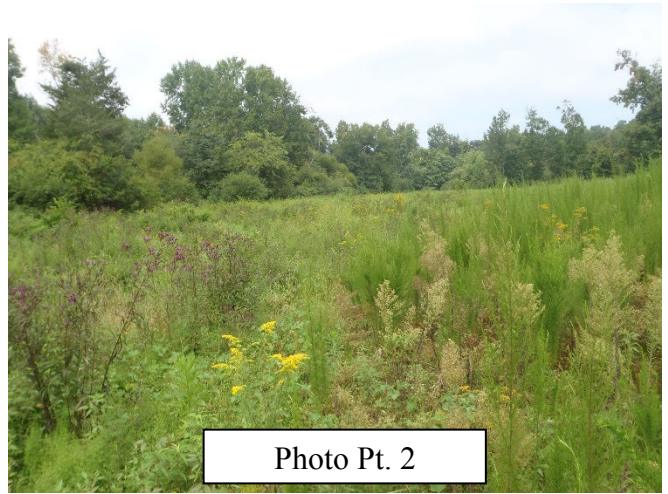
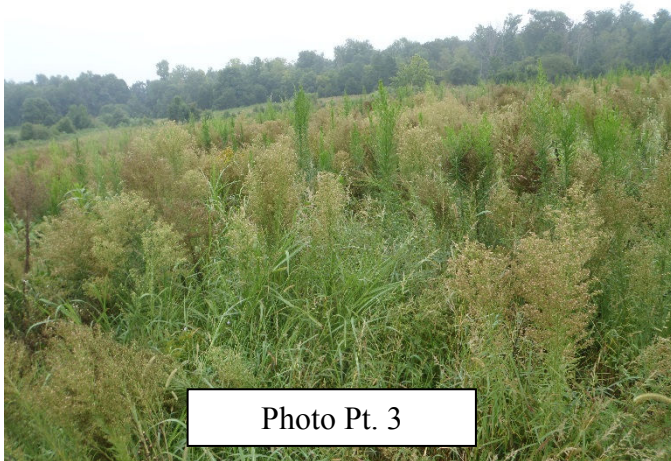
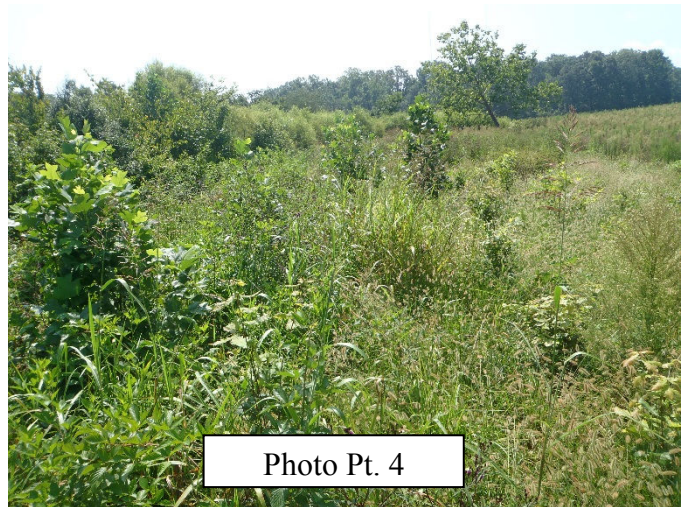
**Wall Buffer  
2014 (Year 3) Photo Point Photographs  
Taken August 2014**

Objective	Buffer Restoration Activity
Removing a pond impounding a reach of UT3 and UT4.	Pond removal occurred in April 2012 – see permanent photo point #4 on Figure 2 (Appendix B).
Removing a section of paved road at the upper reach of UT5.	Paved road removal occurred in April 2012 and planting of the area occurred in early 2013.
Removing invasive species along the upper reach of UT2.	Invasive species removal and monitoring will be ongoing throughout the monitoring period, with the first treatment in early 2013.
Installing shallow marsh wetland treatment areas on two ephemeral ditches entering the Site from Wall Brothers Road.	Shallow marsh wetland treatment areas were installed in April 2012 including log outfalls, planting with erosion control seed, and planting native forest vegetation.
Restoring approximately 9.8 acres of riparian buffer by planting with native forest vegetation.	Site revegetation occurred in March 2012, with supplemental planting of disturbed areas occurred in early 2013 (Appendix C).
