**YEAR 5 (2016) ANNUAL MONITORING REPORT**

**WALL RIPARIAN BUFFER MITIGATION SITE**

RANDOLPH COUNTY, NORTH CAROLINA  
DMS PROJECT ID: 95007

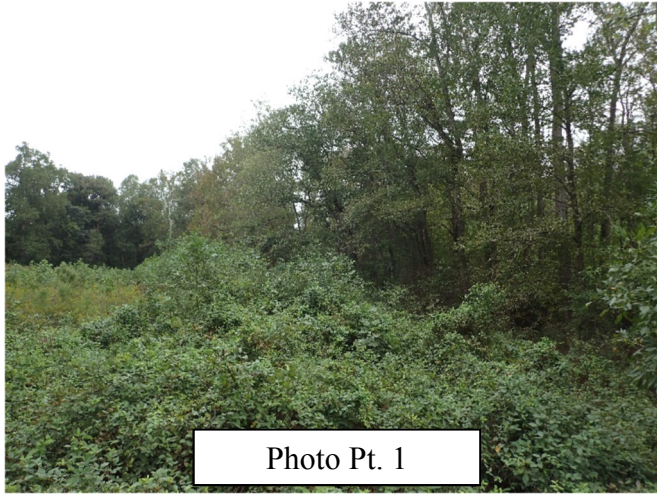
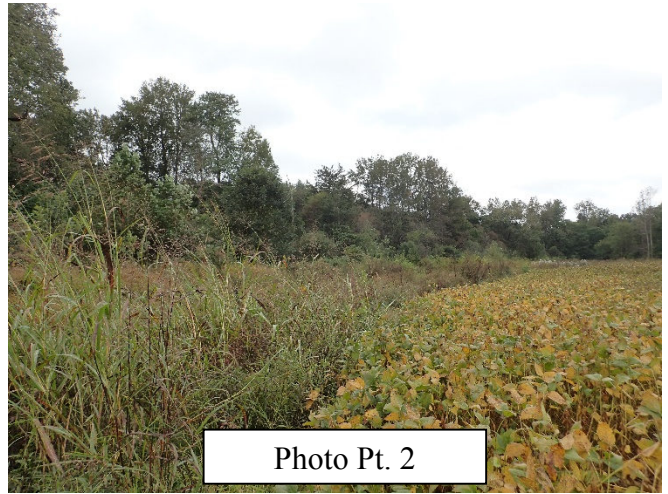
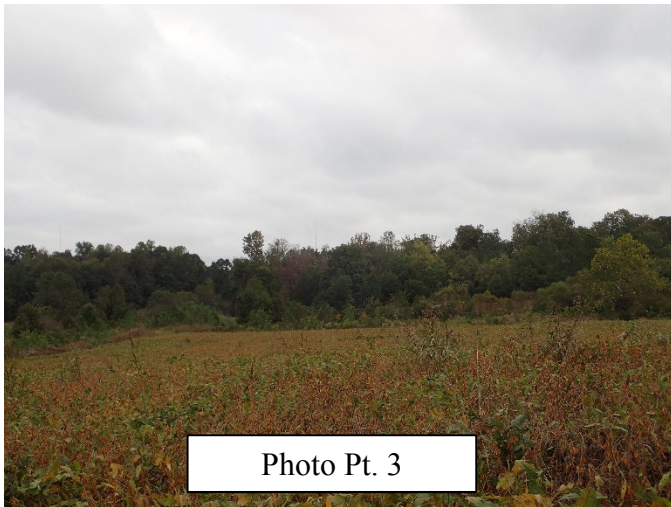
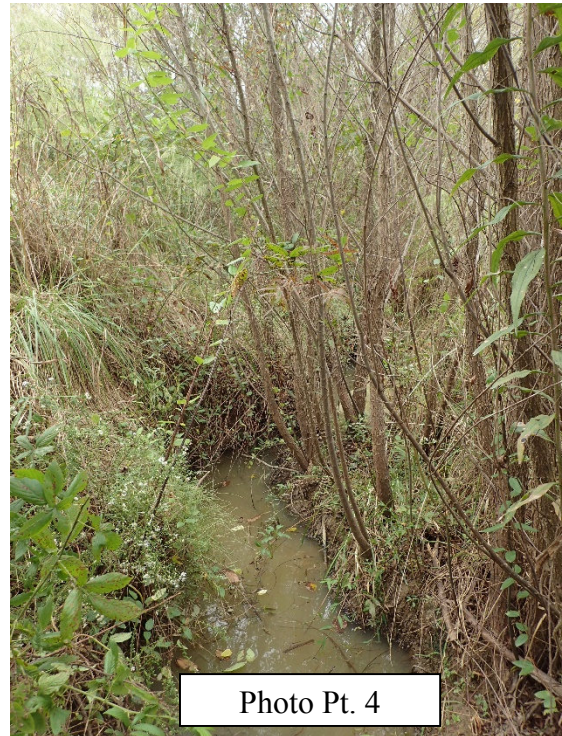
**Wall Buffer  
2016 (Year 5) Photo Point Photographs  
Taken October 2016**

Objective	Buffer Restoration Activity
Removing a pond impounding a reach of UT3 and UT4.	Pond removal occurred in April 2012 – see permanent photo point #4 on Figure 2 (Appendix B).
Removing a section of paved road at the upper reach of UT5.	Paved road removal occurred in April 2012 and planting of the area occurred in early 2013.
Removing invasive species along the upper reach of UT2.	Invasive species removal and monitoring will be ongoing throughout the monitoring period, with the first treatment in early 2013 and a site-wide treatment of fescue in the spring of 2014.
Installing shallow marsh wetland treatment areas on two ephemeral ditches entering the Site from Wall Brothers Road.	Shallow marsh wetland treatment areas were installed in April 2012 including log outfalls, planting with erosion control seed, and planting native forest vegetation.
Restoring riparian buffer by planting with native forest vegetation.	Site revegetation occurred in March 2012, with supplemental planting of disturbed areas in early 2013 (Appendix C).

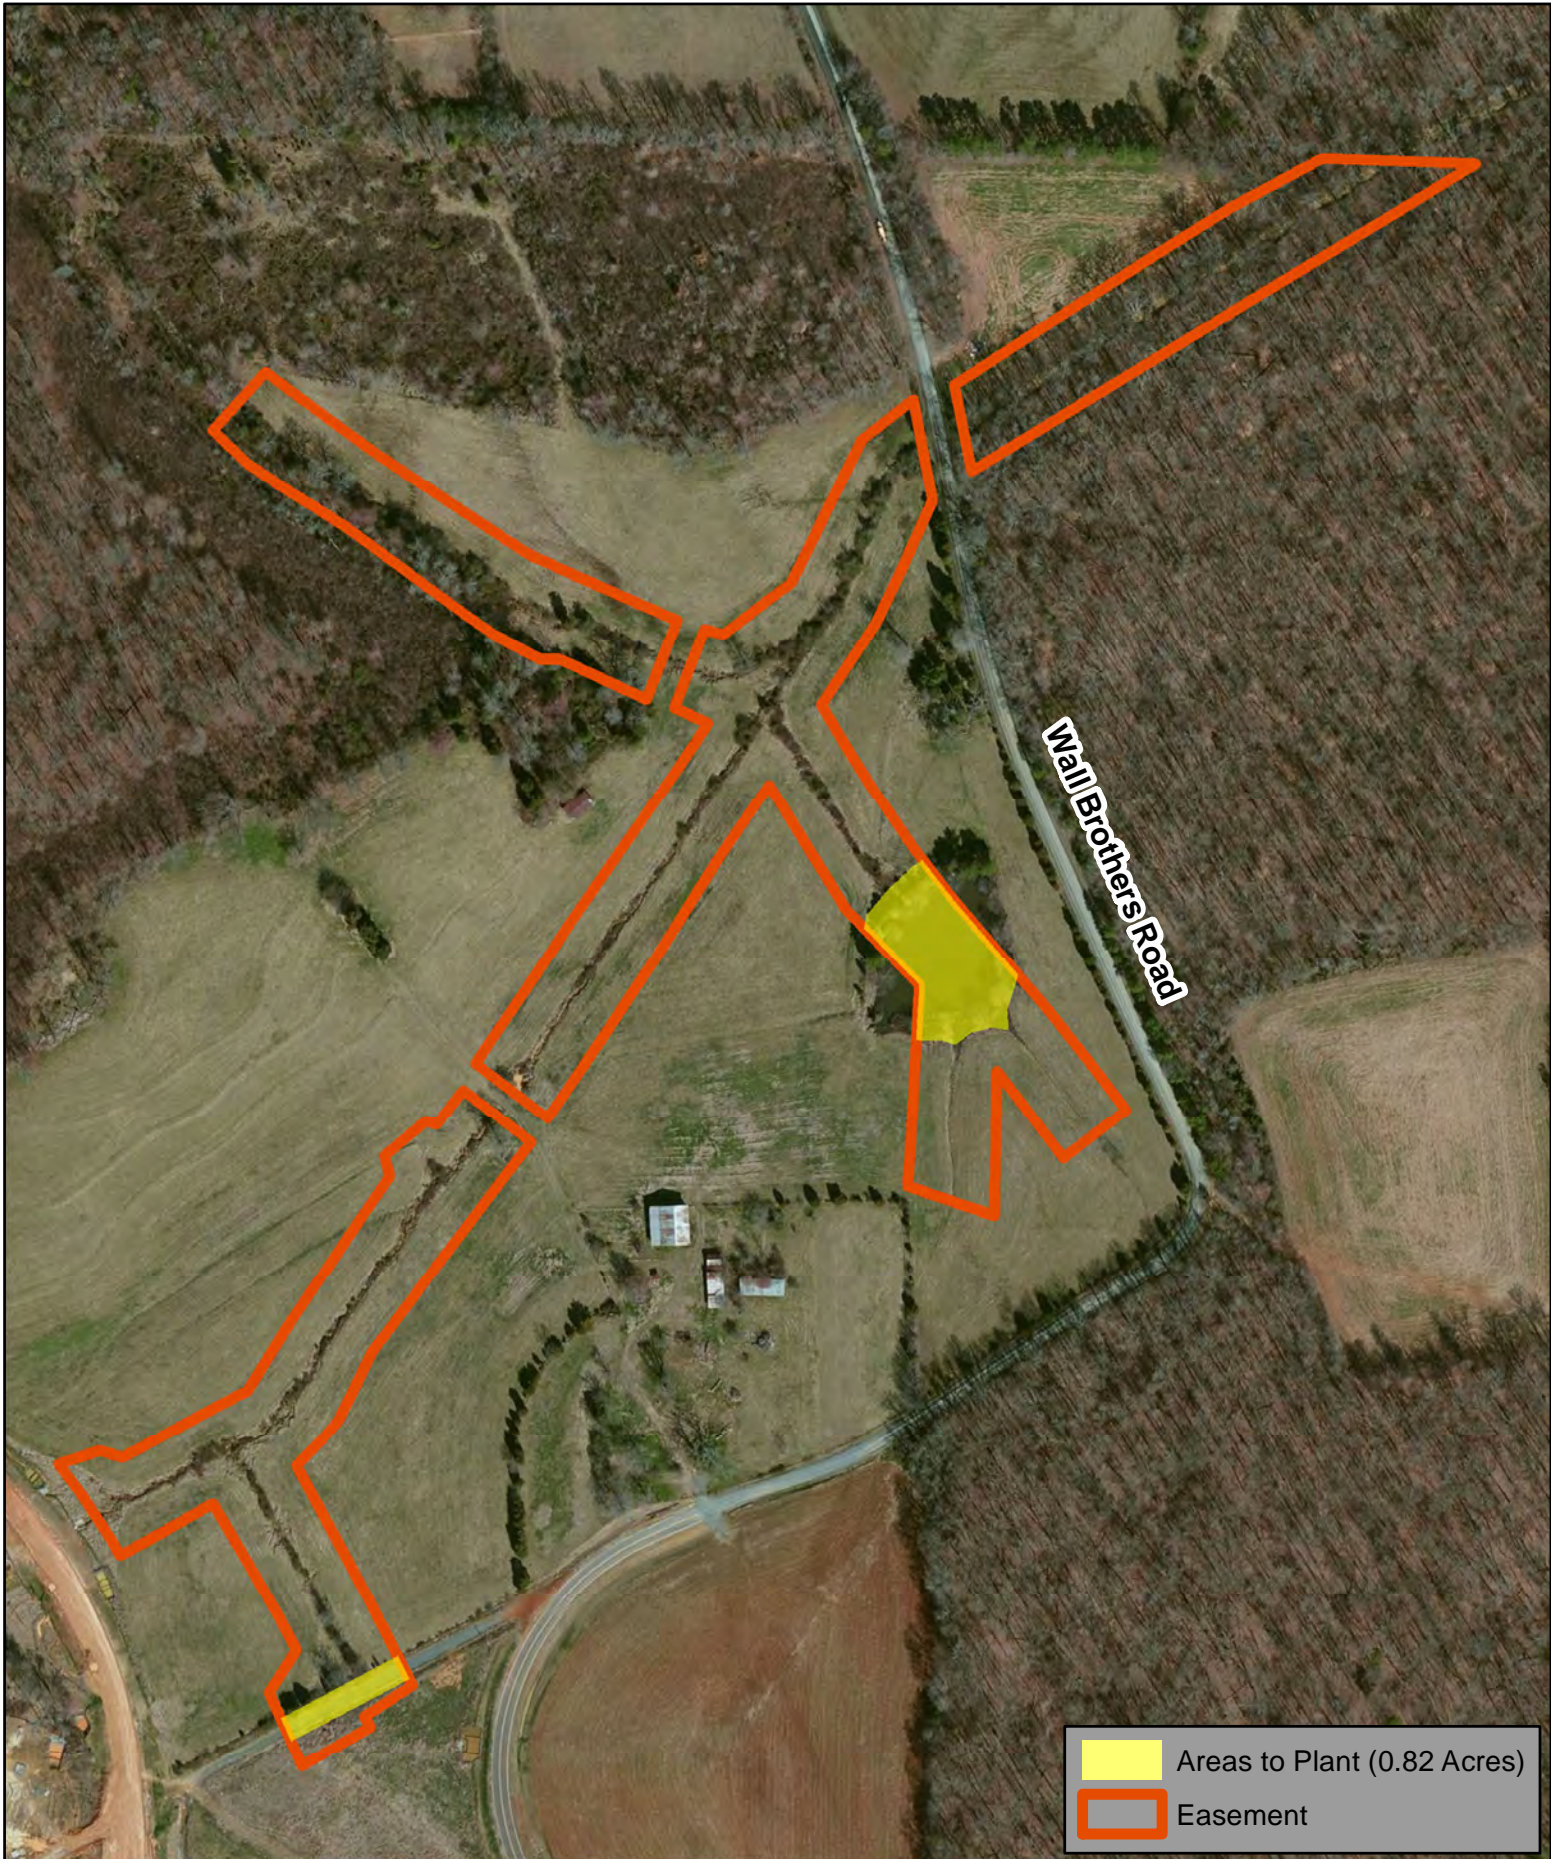
**Figure 1:**  
Construction Status

I wanted to provide you with an update regarding the status of construction and planting at the Wall Riparian Buffer Mitigation Project in Randolph County. Due to the late closing date on the property (April 11<sup>th</sup>), we opted to plant the site in March and then due the construction following closing. On March 22<sup>nd</sup>, Carolina Silvics planted the entire site except for two small areas totaling 0.8 acres. During the week of April 23<sup>rd</sup>, Axiom Green Build worked in these two areas to remove a) short section of gravel road along with a concrete culvert and b) a small earthen dam. Attached is a figure showing both the area planted and the area of construction.

As a result of doing the construction after the planting season had passed, the two areas totaling 0.8 acres still need to be planted. I had hoped to do this immediately following construction but due to the unseasonably warm weather it simply would not be successful. If agreeable to you, I would like to use this year's growing season for the first year of monitoring with the stipulation that during the winter of 2012/2013 we will plant the 0.8 acre area with 1-gallon containerized trees (as opposed to bare root seedlings).

Areas to Plant (0.82 Acres)

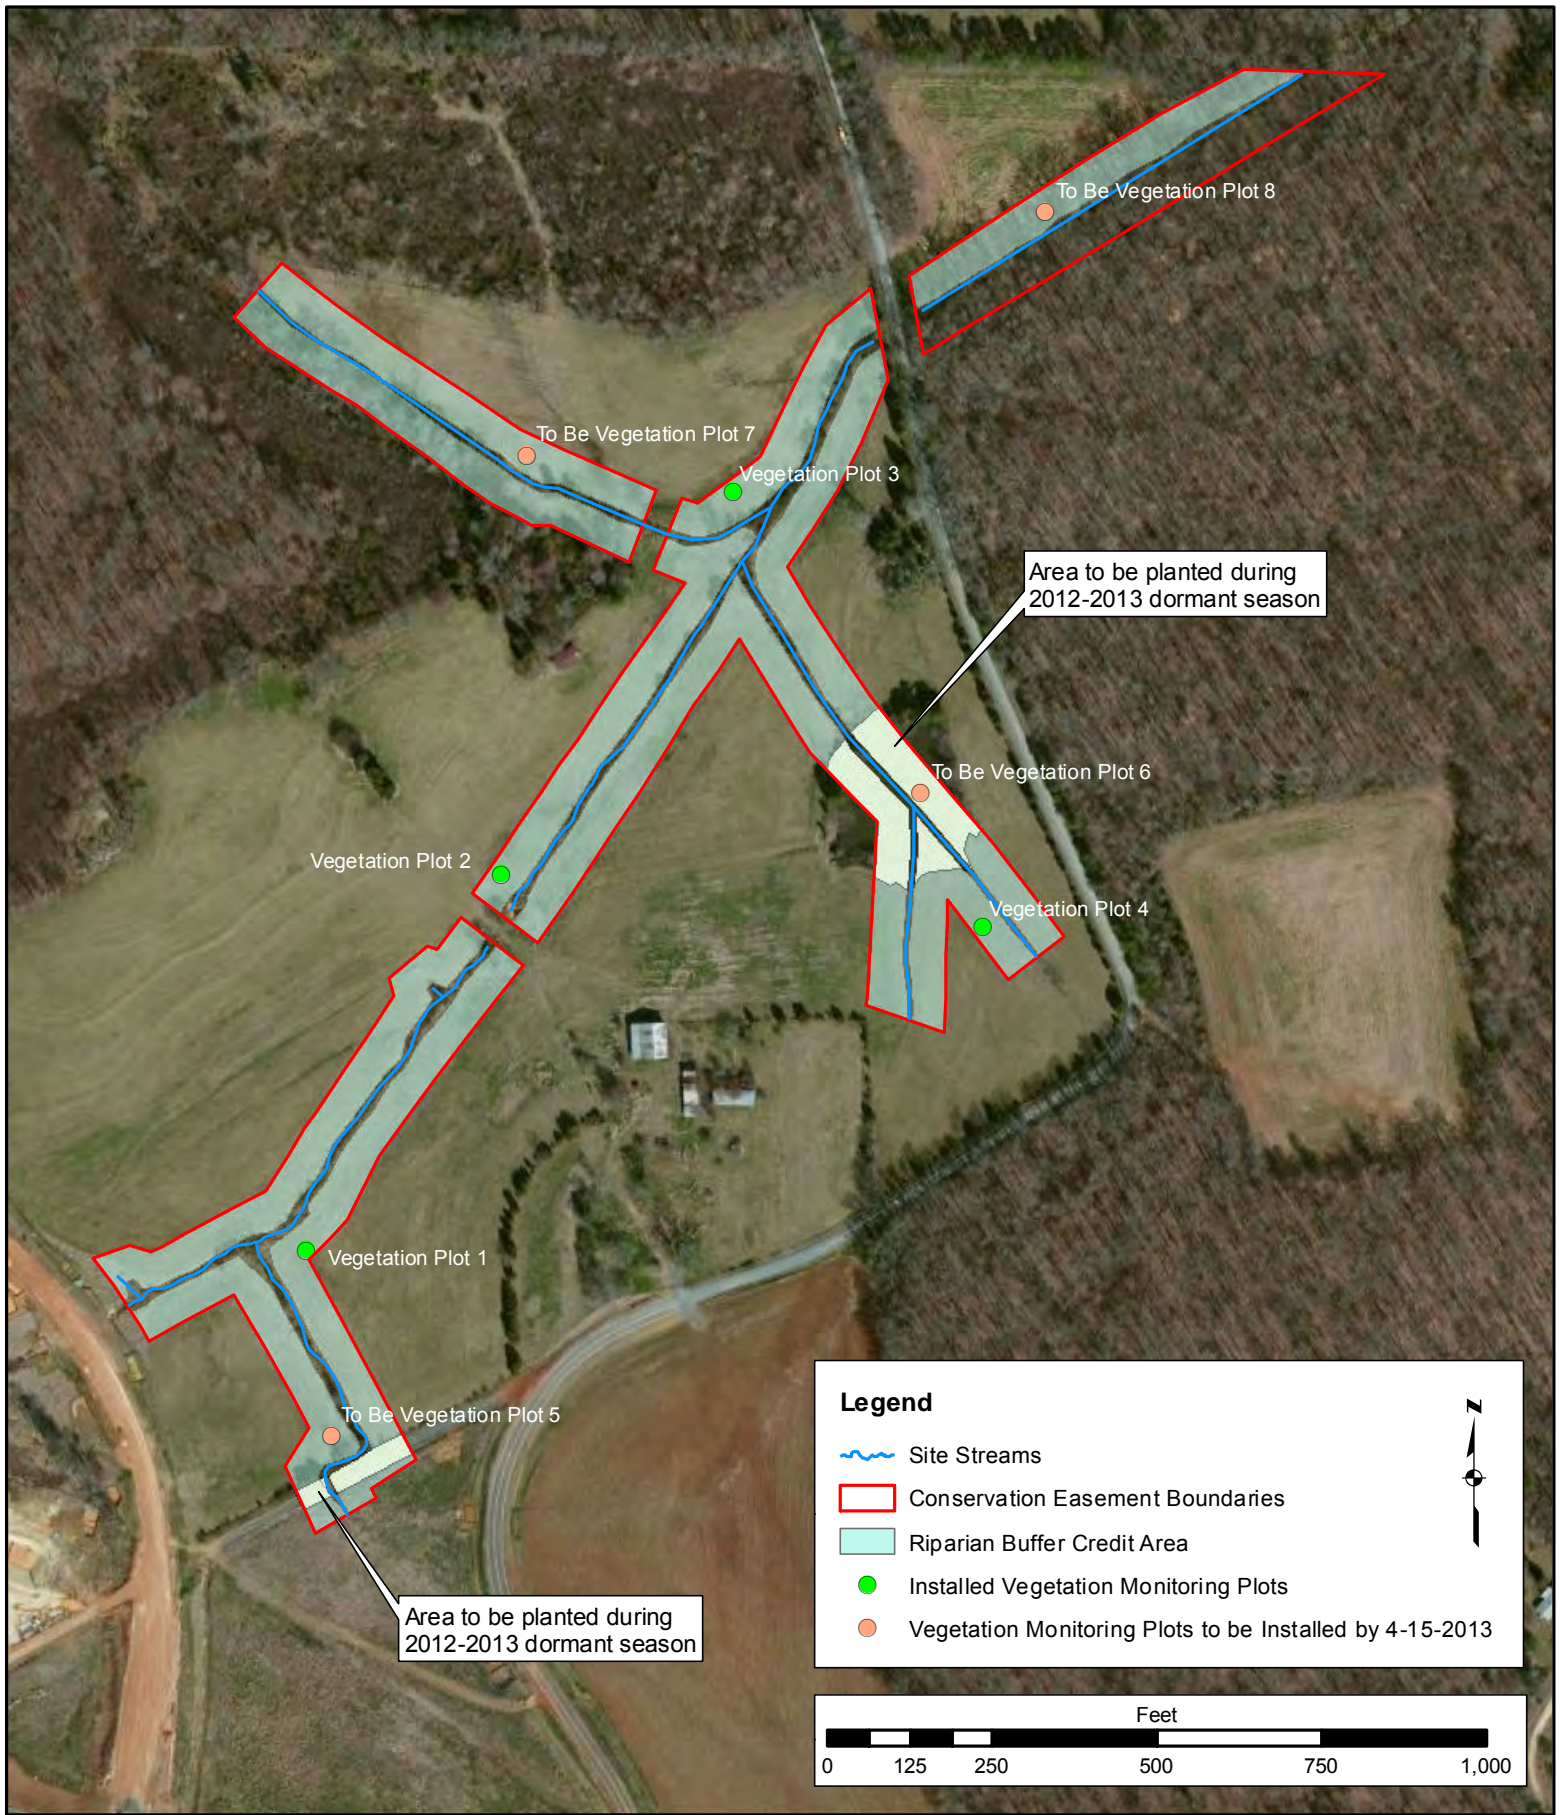
**Location of Additional Vegetation Monitoring Plots**

Restoration Systems is recommending this timeline because an additional .80 acres of the Site must be planted during the 2012 – 2013 dormant season. It is planned that one of the four additional monitoring plots will be located in the soon to be planted area. Baseline vegetation data will be conducted simultaneously with the installation of the additional plots and will be included within the 2013, year 2, annual monitoring report. RS understands the addition of these monitoring plots will not prolong the vegetation monitoring of the Site, so long as all current and additional monitoring plots achieve the success criteria outlined in the Mitigation Plan. Installation of the additional monitoring plots will follow CVS protocol and will measure 10 by 10 meters. Please see the attached figure depicting the approximate location of these additional monitoring plots, as well as the areas to be planted during the 2012 – 2013 dormant season.

Figure indicates where the physical location of all monitoring devices.
