**ANNUAL MONITORING REPORT
YEAR 2 (2006)**

**WALNUT CREEK BUFFER RESTORATION SITE
WAYNE COUNTY, NORTH CAROLINA**

**WALNUT CREEK MITIGATION SITE
ANNUAL MONITORING REPORT
YEAR 2 (2006)
WAYNE COUNTY, NORTH CAROLINA**

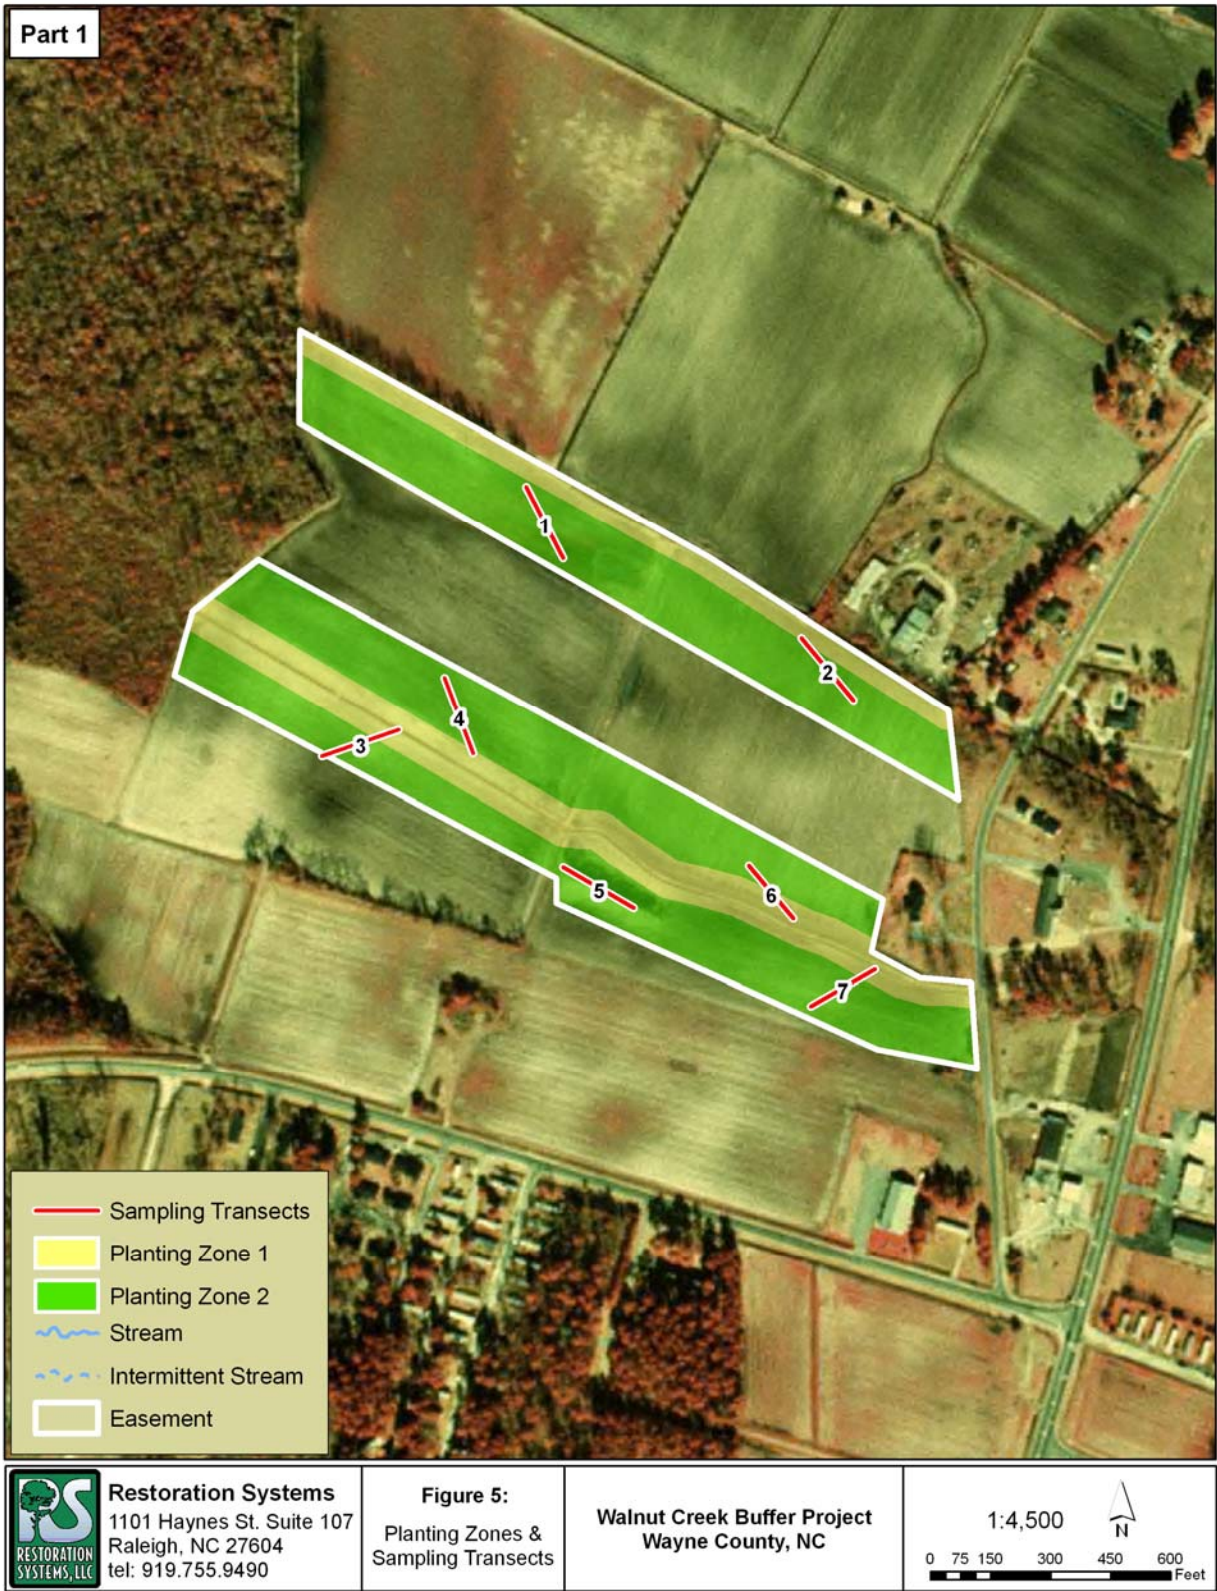
Figure 5. Location of Sampling Transects in Part 1

Monitoring procedures for vegetation were designed in accordance with *Guidelines for Riparian Buffer Restoration* (EEP 2004) and the *North Carolina Administrative Code* (NCAC 2000). A general discussion of the plant community restoration monitoring program is provided. Monitoring of restoration efforts will be performed for a minimum of five years or until success criteria are fulfilled. The locations of monitoring plots are depicted in Figures 5 and 6.

Eight sample transects were established within planted areas of the Site shortly after planting. Transects 1-7 (Part 1) are 200 feet in length and 12 feet in width (0.055 acre). Transect 8 is 160 feet long and 7.5 feet wide (0.055 acre). The shorter length of Transect 8 is due to size constraints in Part 2 of the Site. In each sample plot, vegetation parameters monitored include species composition and species density. Visual estimates of the abundance of herbaceous species were also noted. Photographs of the vegetation plots are included in Appendix A.

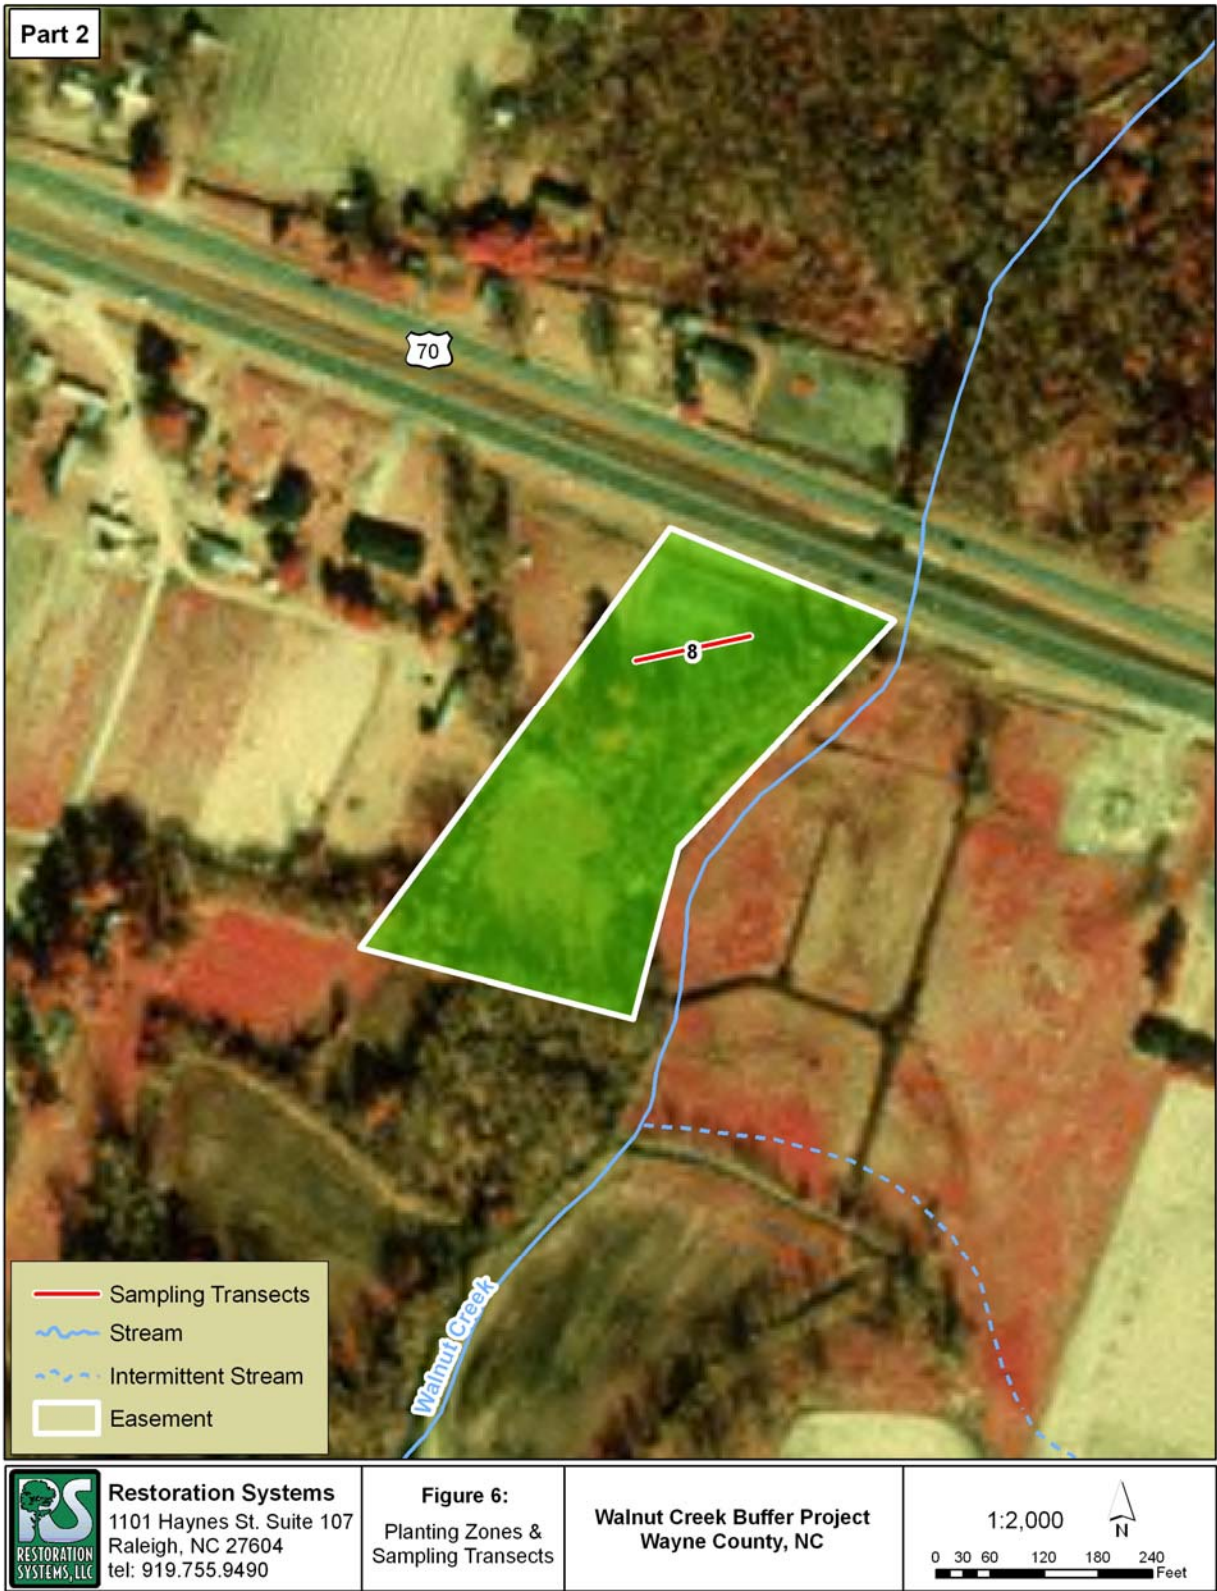
Figure 6. Location of Sampling Transects in Part 2
