# **ANNUAL MONITORING REPORT YEAR 3 (2007)**

**(Contract Number D04009-2)**

## **WALNUT CREEK BUFFER RESTORATION SITE WAYNE COUNTY, NORTH CAROLINA**

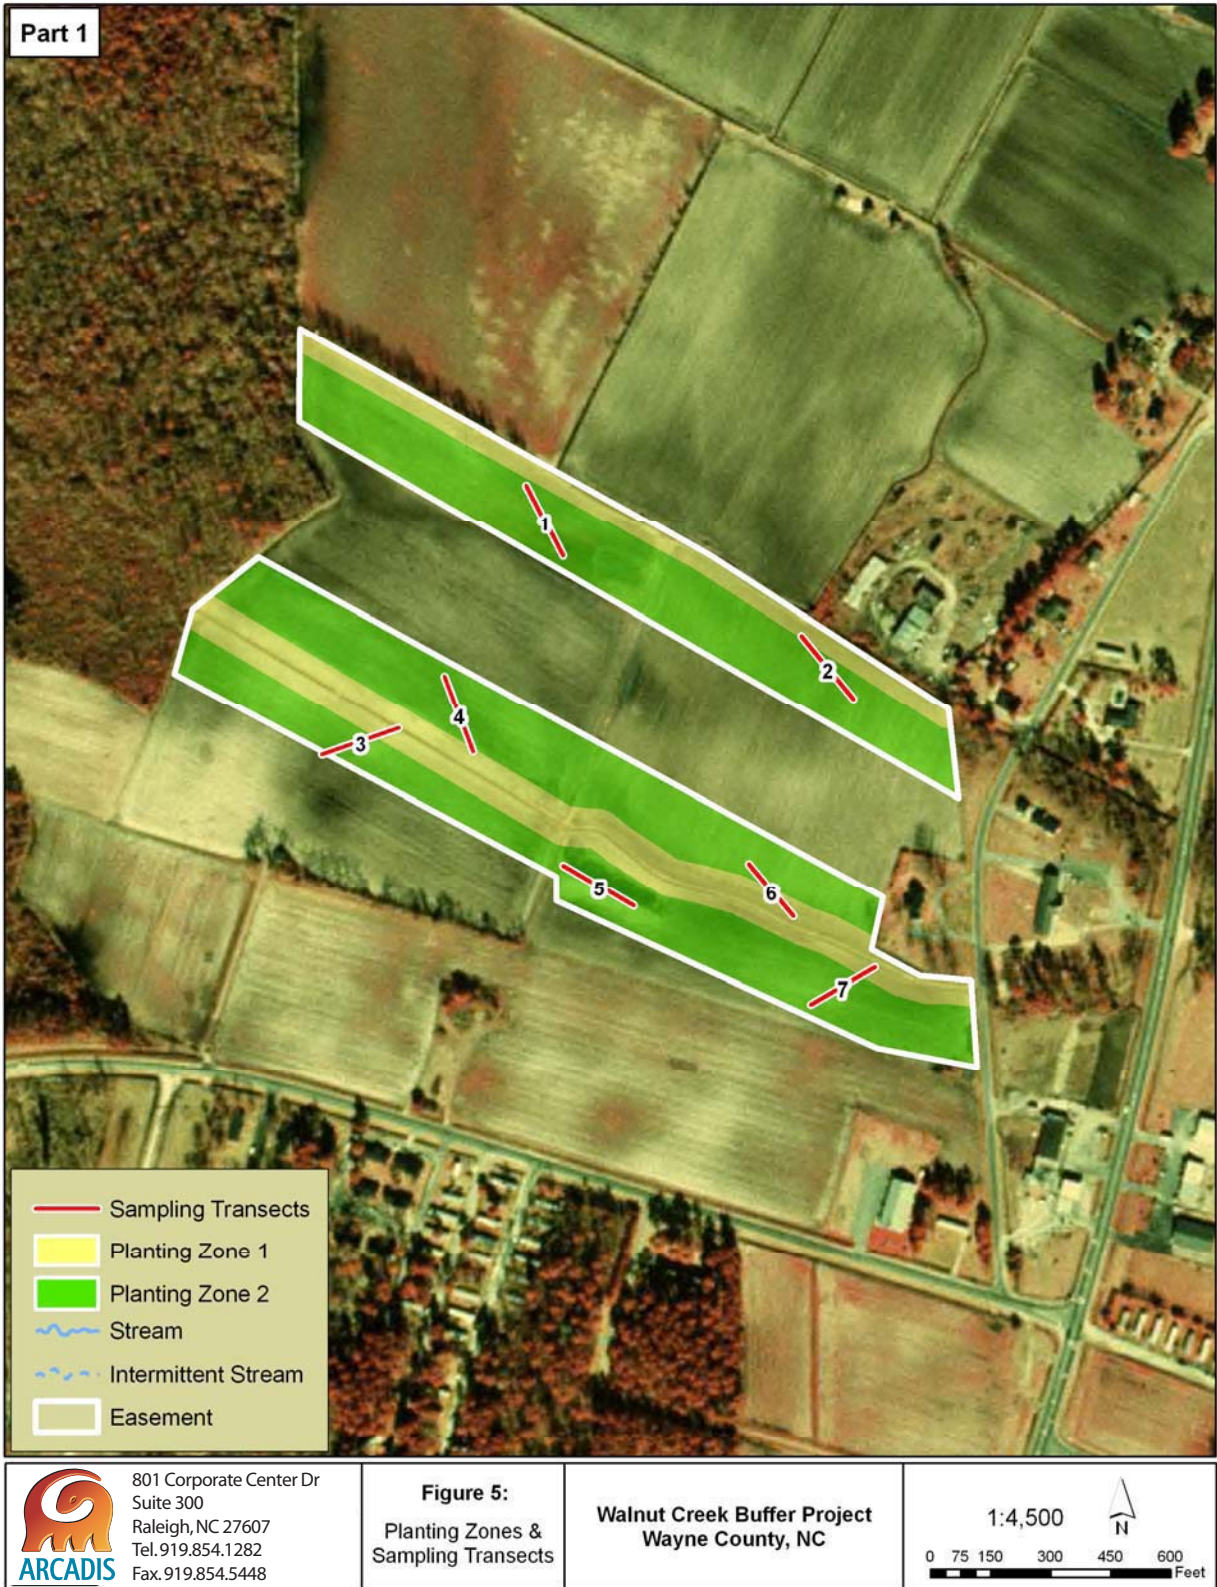
**Figure 5. Location of Sampling Transects in Part 1**

Eight sample transects were established within planted areas of the Site shortly after planting. Transects 1-7 (Part 1) are 200 feet in length and 12 feet in width (0.055 acre). Transect 8 is 160 feet long and 7.5 feet wide (0.055 acre). The shorter length of Transect 8 is due to size constraints in Part 2 of the Site. In each sample plot, vegetation parameters monitored include species composition and species density. Visual estimates of the abundance of herbaceous species were also noted. Photographs of the vegetation plots are included in Appendix A.

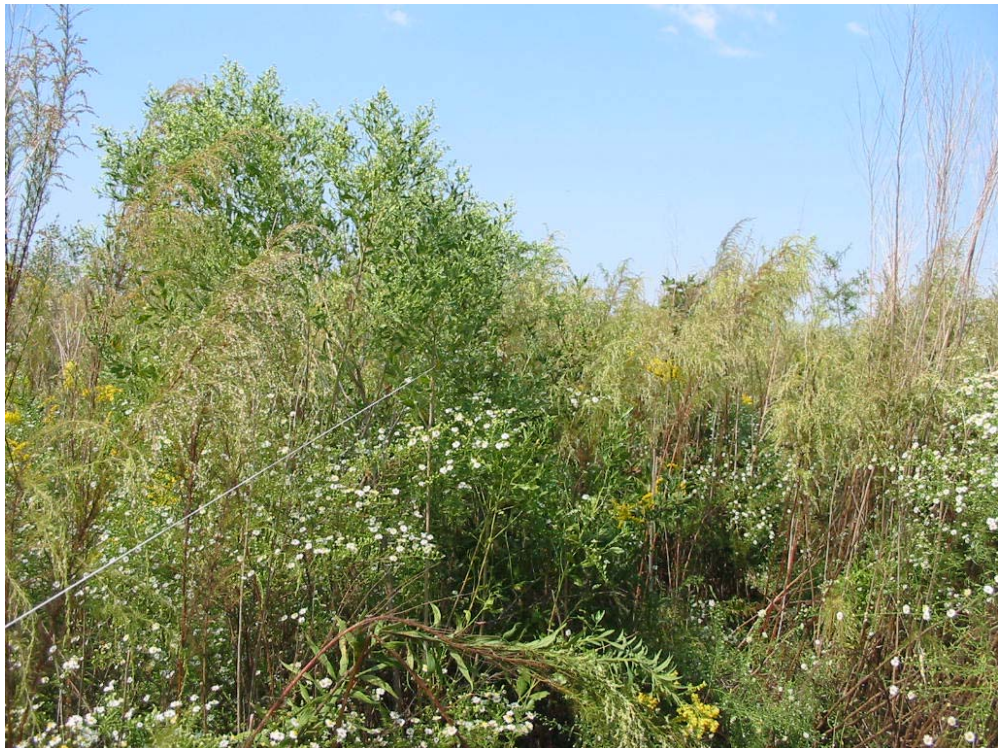
**Transect 6**

Transects 1-7 supported only limited numbers of non-planted stems. The most numerous colonizing species was Groundsel tree, with a maximum of 28 stems noted in Transect 6.

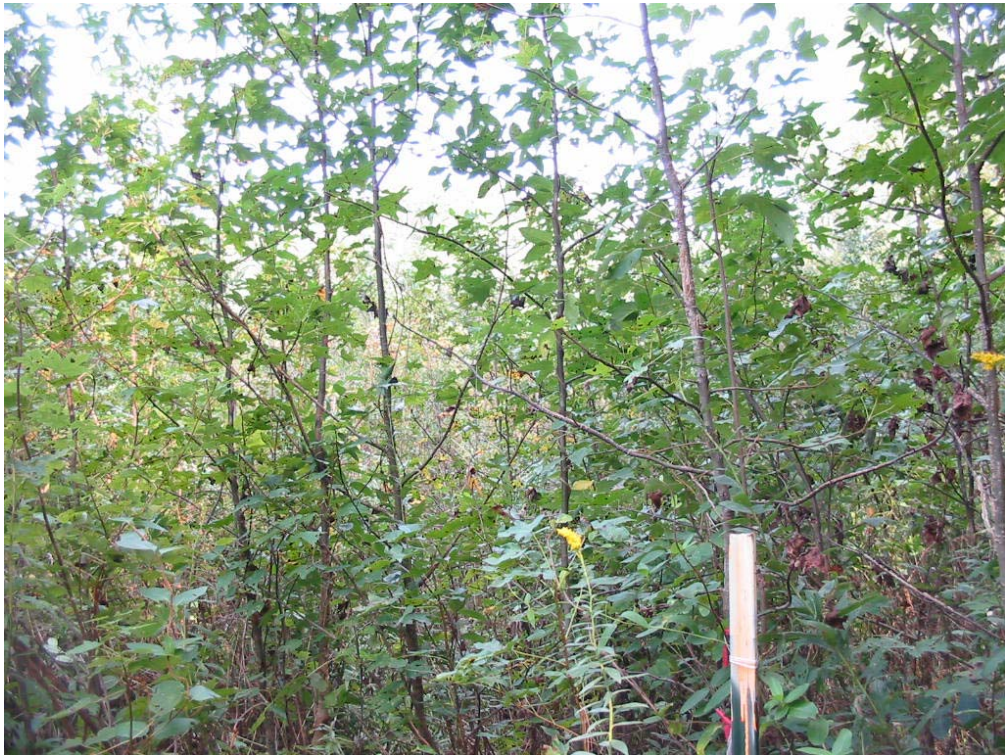
**Transect 8**

Part 2 of the Site supported numerous sprouting Sweet-gum stems as well as common rush (*Juncus effusus*), Japanese honeysuckle (*Lonicera japonica*), and blackberry (*Rubus* sp.).
