**ANNUAL MONITORING REPORT
YEAR 4 (2008)
WALNUT CREEK BUFFER RESTORATION SITE
WAYNE COUNTY, NORTH CAROLINA
(Contract Number D04009-2)**

September 2008

**WALNUT CREEK BUFFER RESTORATION SITE
ANNUAL MONITORING REPORT
YEAR 4 (2008)
WAYNE COUNTY, NORTH CAROLINA**

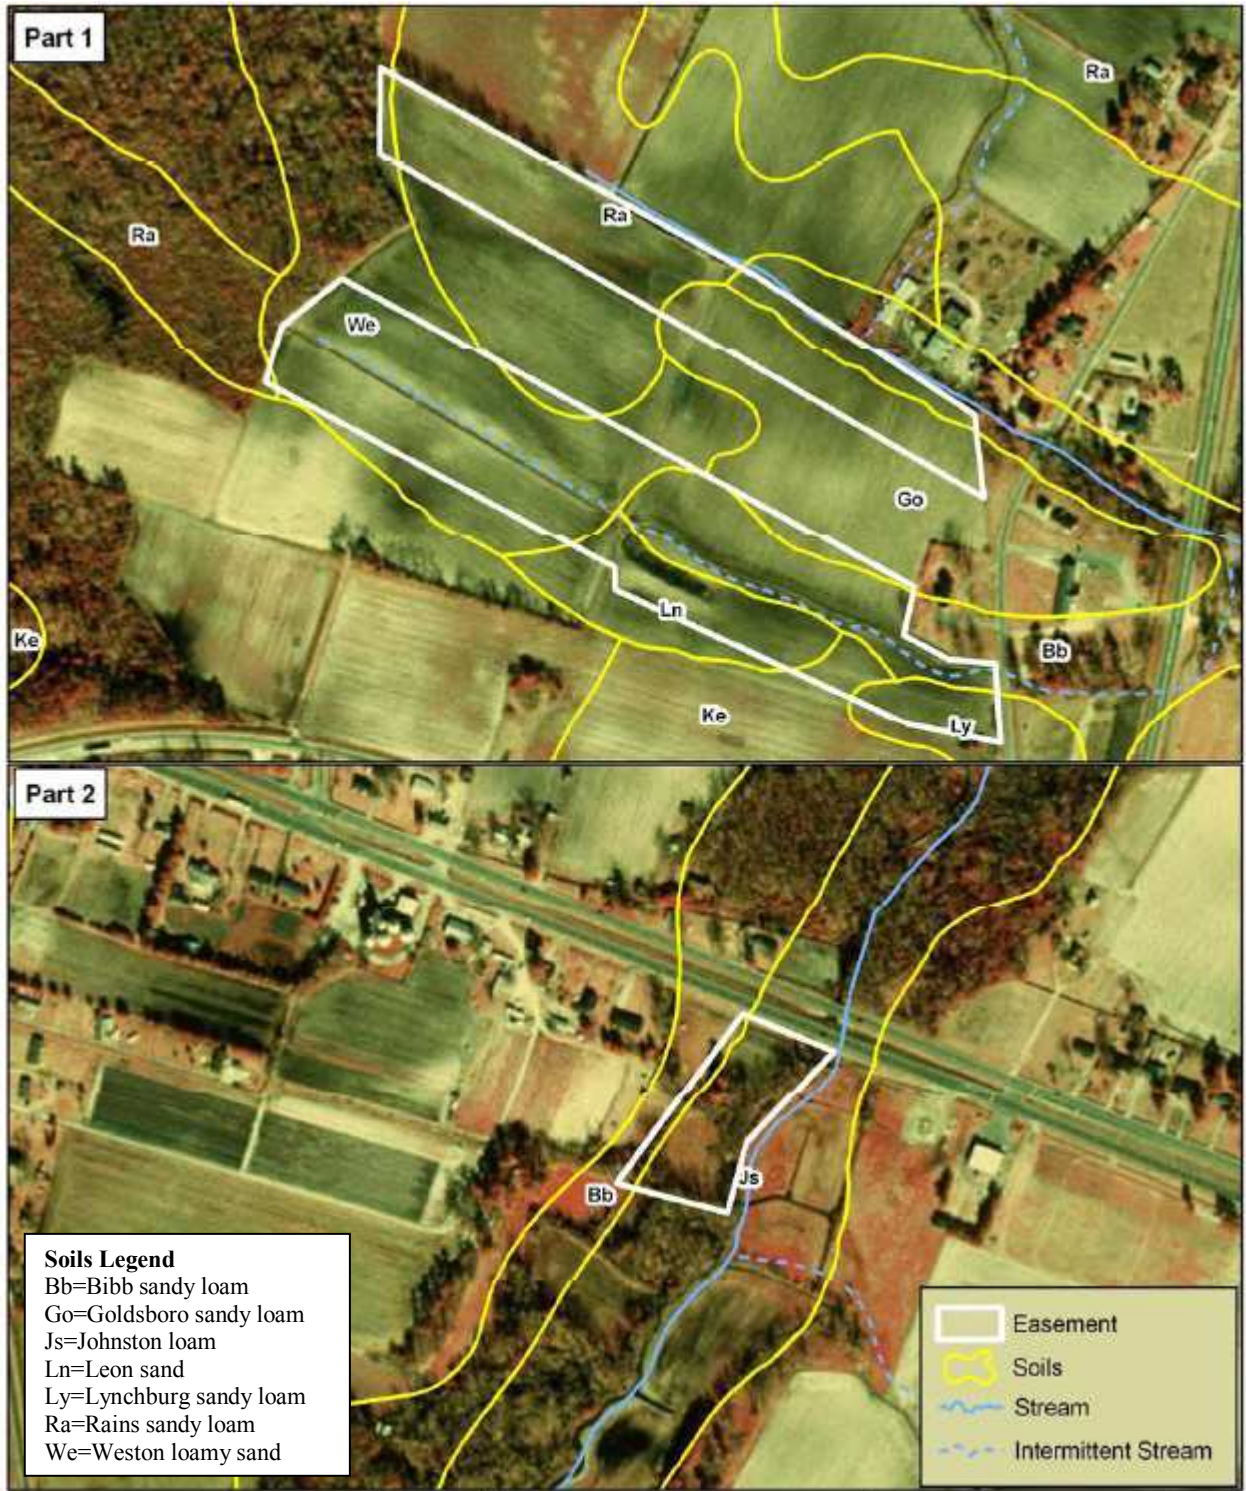
Figure 4. Soils
Walnut Creek
Buffer Restoration Site
Wayne County
Year 4 (2008) Annual Monitoring

Restoration Systems, LLC (Restoration Systems) has completed riparian buffer restoration at the Walnut Creek Buffer Restoration Site (hereafter referred to as the "Site") to assist the North Carolina Ecosystem Enhancement Program (EEP) in fulfilling restoration goals in the region. The Site is located in the western portion of Cataloging Unit 03020202 (Hydrologic Unit 03020202010040) of the Neuse River Basin, approximately one mile east of Goldsboro, in Wayne County (Figures 1 and 2). The Site conservation easement encompasses 27.9 acres immediately adjacent to Walnut Creek and an unnamed tributary to Walnut Creek within subbasin 03-04-02 of the Neuse River Basin (Figure 3). Site soils are comprised primarily of poorly drained wet flat soil series such as Bibb, Johnston, Rains, and Weston (Figure 4).

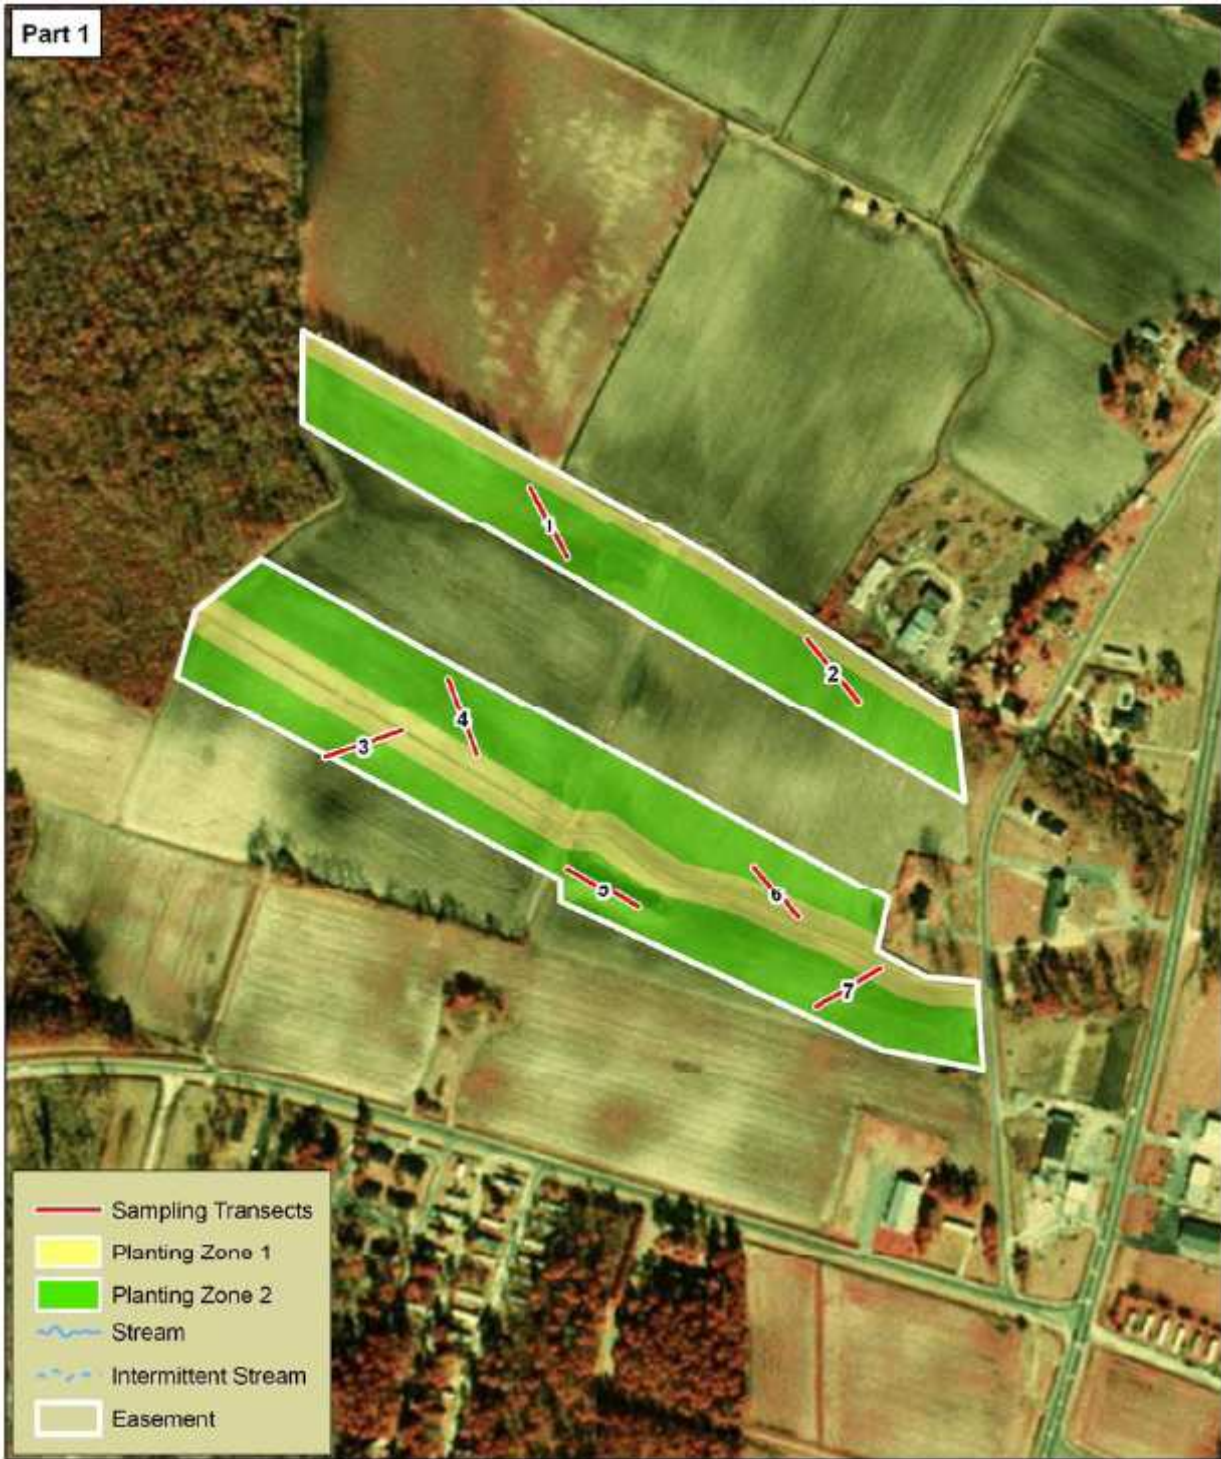
**Figure 5. Planting Zones and Sampling
Transects in Part 1
Walnut Creek
Buffer Restoration Site
Wayne County
Year 4 (2008) Annual Monitoring**

Eight sample transects were installed within planted areas of the Site shortly after planting. Transects 1-7 (Part 1) are 200 feet in length by 12 feet in width (0.055 acre). Transect 8 is 160 feet in length and 7.5 feet in width (0.0275 acre). In each sample plot, vegetation parameters monitoring include species composition and density. Visual estimates of the percent cover of herbaceous species were also noted. Photographs of the vegetation plots are included in Appendix A.

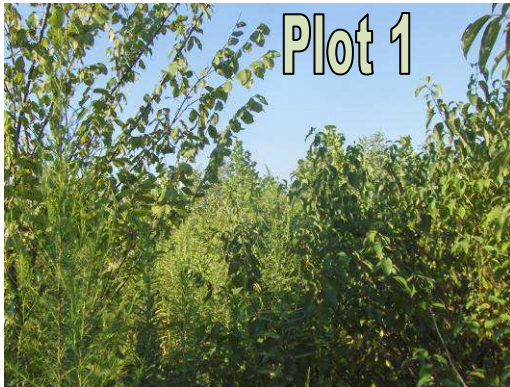
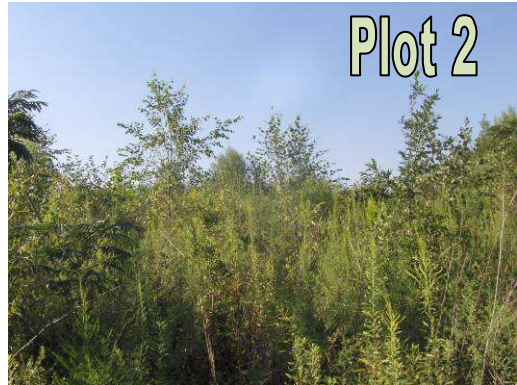
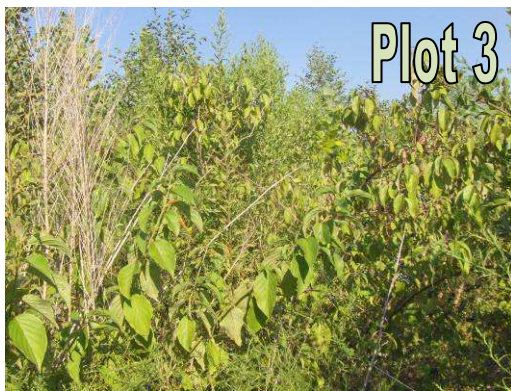
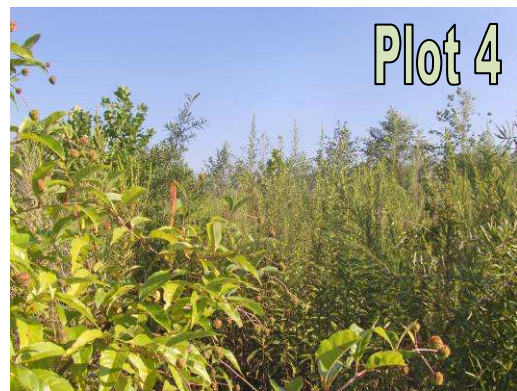
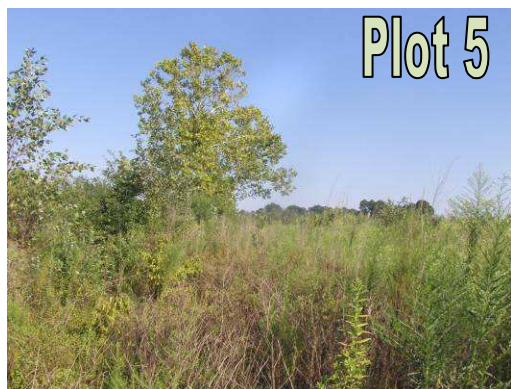
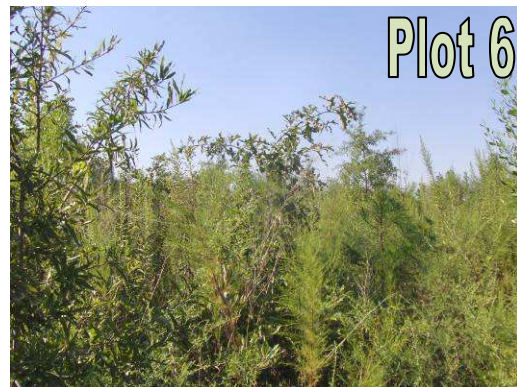
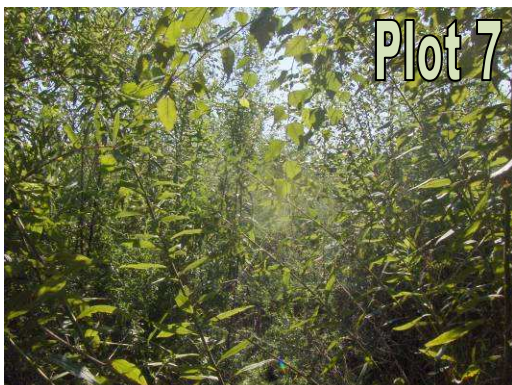
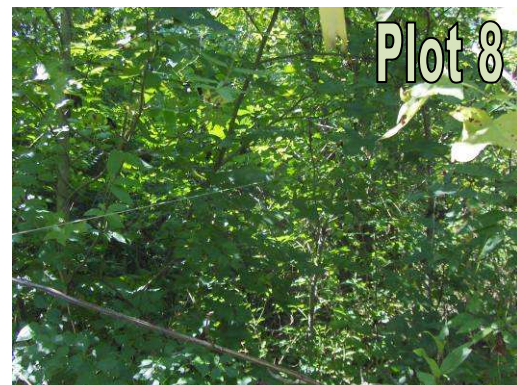
**Walnut Creek Buffer Restoration Site Year 4 (2008) Annual Monitoring
Vegetation Plot Pictures Taken September 2008**

Quantitative sampling of vegetation was conducted in July 2008. Results are provided in Table 3. Vegetation success criteria for year 4 (320 stems per acre) were exceeded for the 2008 annual monitoring year with 2892 tree stems per acre across the Site. Each individual vegetation plot met success criteria and had a species diversity consisting of 9 to 19 species per plot.

Transects 1-7 were dominated by planted species most notably American sycamore (*Platanus occidentalis*), silky dogwood (*Cornus amomum*), and river birch (*Betula nigra*). Transect 8 was dominated by natural recruits consisting of red maple (*Acer rubrum*) and sweetgum (*Liquidambar styraciflua*) from an adjacent forest.
