**ANNUAL MONITORING REPORT
YEAR 5 (2009)
WALNUT CREEK BUFFER RESTORATION SITE
WAYNE COUNTY, NORTH CAROLINA
(Contract Number D04009-2)**

**WALNUT CREEK BUFFER RESTORATION SITE
ANNUAL MONITORING REPORT
YEAR 5 (2009)
WAYNE COUNTY, NORTH CAROLINA**

**Walnut Creek Buffer Restoration Site Year 5 (2009) Annual Monitoring
Vegetation Plot Pictures Taken June 2009**

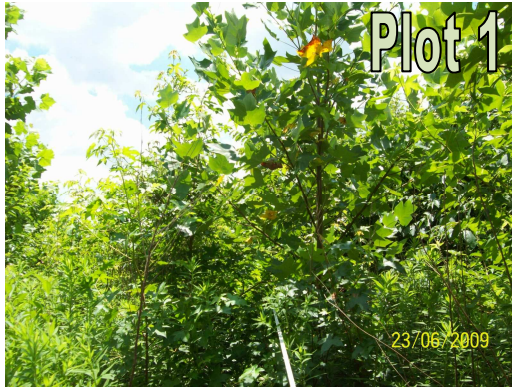
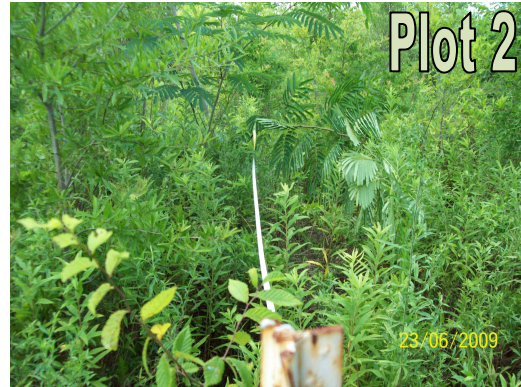
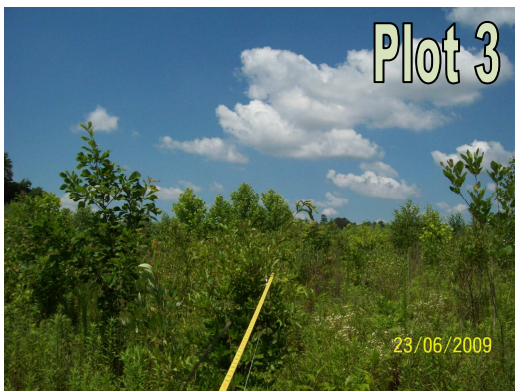
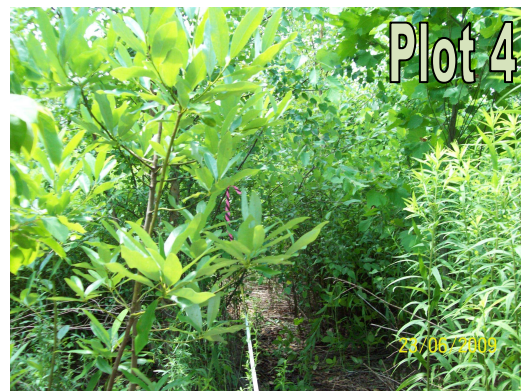
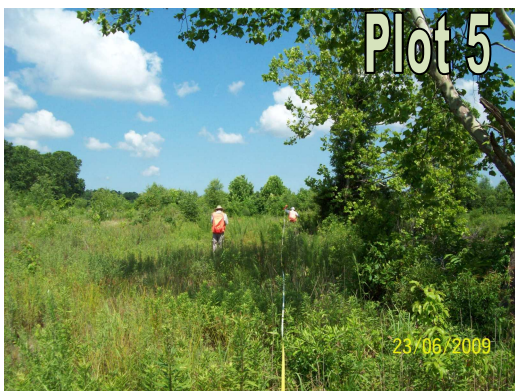
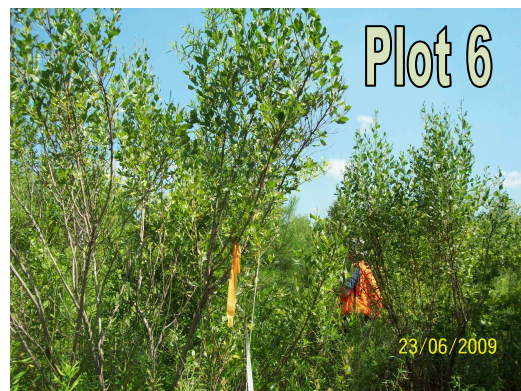
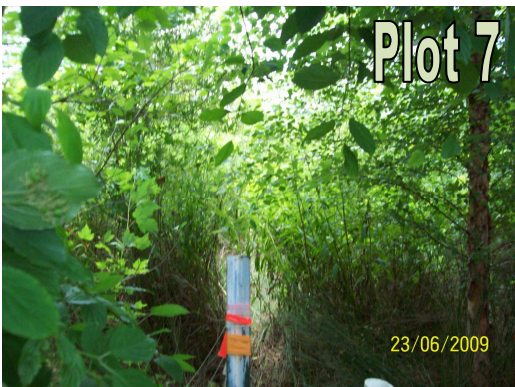
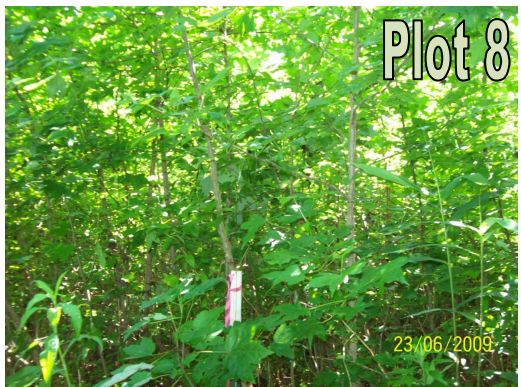
Quantitative sampling of vegetation was conducted in June 2009. Results are provided in Table 3. Vegetation success criteria for year 5 (320 stems per acre) were exceeded for the 2009 annual monitoring year with 3149 tree stems per acre across the Site. Each individual vegetation plot met success criteria and had a species diversity consisting of 8 to 19 species per plot.

Transects 1-7 were dominated by planted species most notably American sycamore (*Platanus occidentalis*), silky dogwood (*Cornus amomum*), and river birch (*Betula nigra*). Transect 8 was dominated by natural recruits consisting of red maple (*Acer rubrum*) and sweetgum (*Liquidambar styraciflua*) from an adjacent forest.
