WELLS CREEK #2 -- NCEEP Project #92688
2013 Monitoring Report: MY-3
Alamance County NC – CAPE FEAR 03030002

Final Report Submitted **November 18, 2013** to:

WELLS CREEK #2 -- NCEEP Project #92688
2013 MONITORING REPORT – YEAR 3

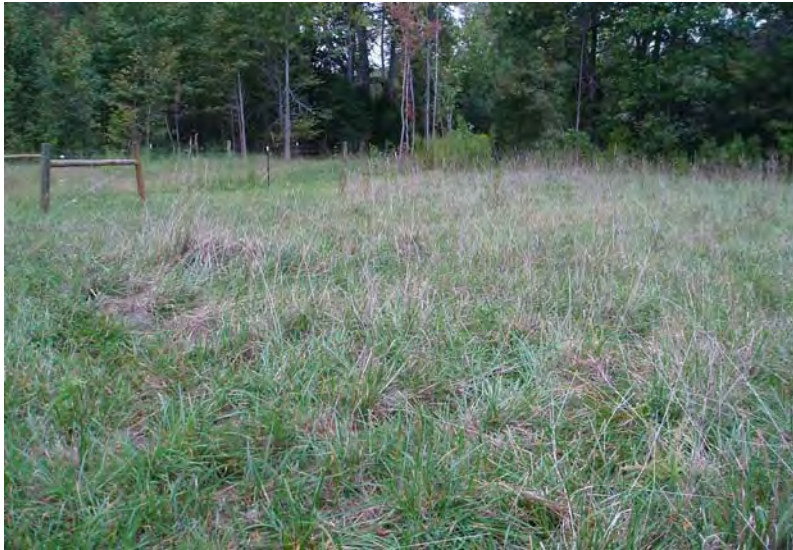
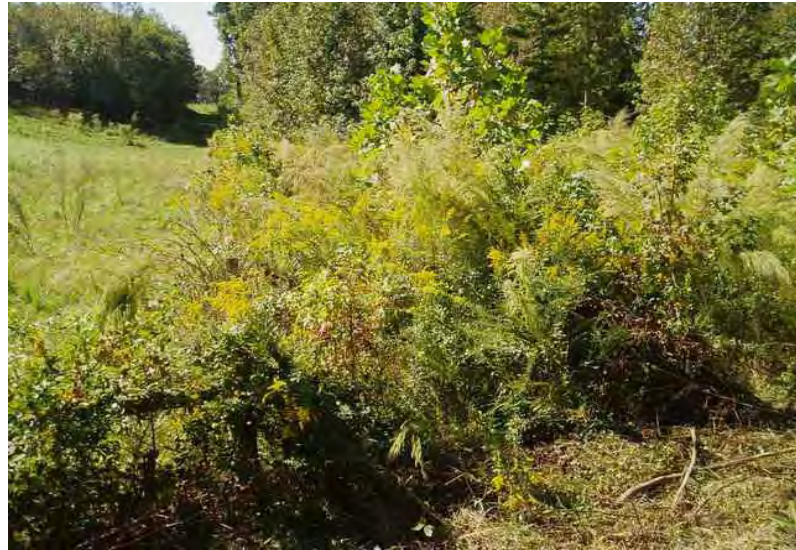
PP #1 – Looking S from Carl Noah Rd, E of Wells Cr (09/16/09)

PP #1 – Looking S from Carl Noah Rd, E of Wells Cr (10/02/13)

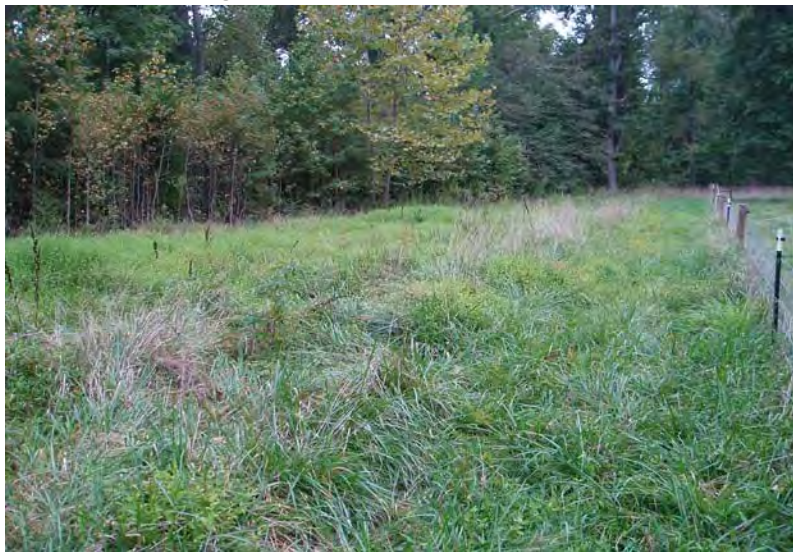
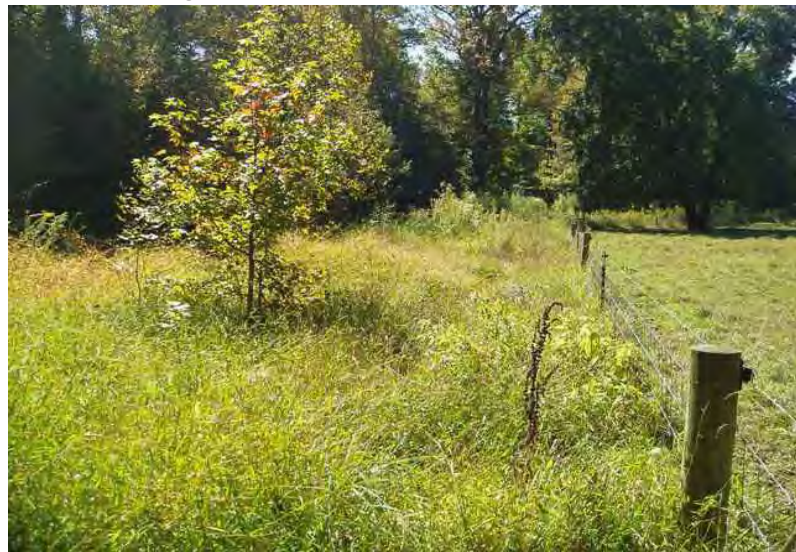
PP #2 – Looking S along easement, W of Wells Cr (09/16/09)

PP #2 – Looking S along easement, W of Wells Cr (10/02/13)

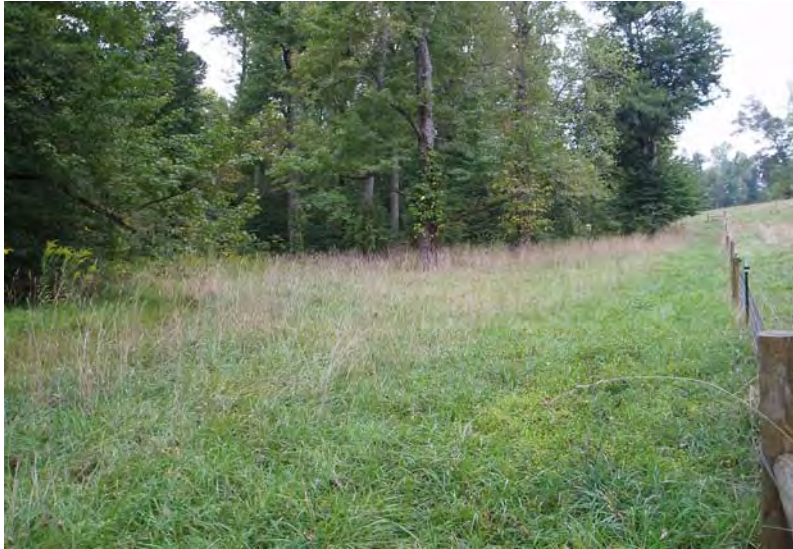
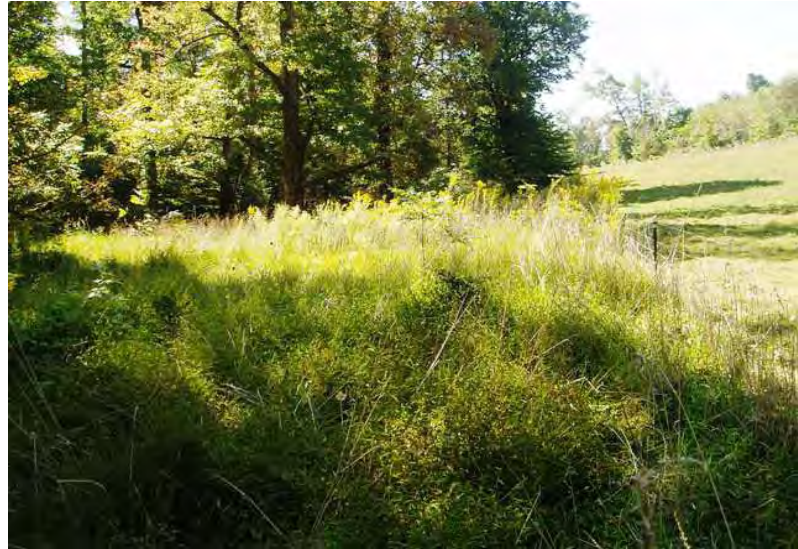
PP #3 – Looking SW along easement, W of Wells Cr (09/16/09)

PP #3 – Looking SW along easement, W of Wells Cr (10/02/13)

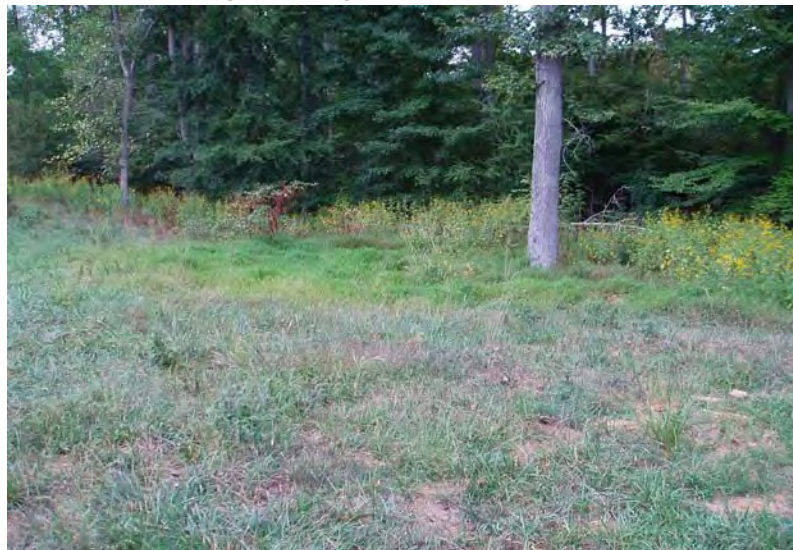
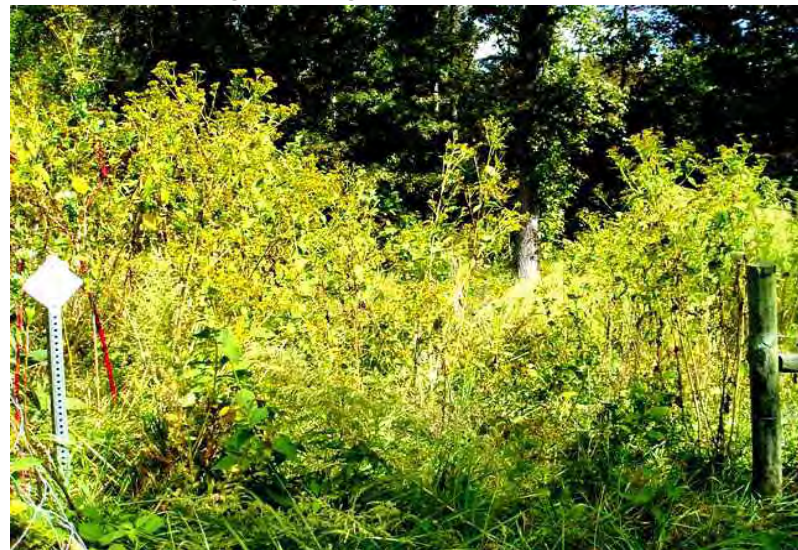
PP #4 – Looking East from easement toward Wells Cr (09/16/09)

PP #4 – Looking East from easement toward Wells Cr (10/02/13)

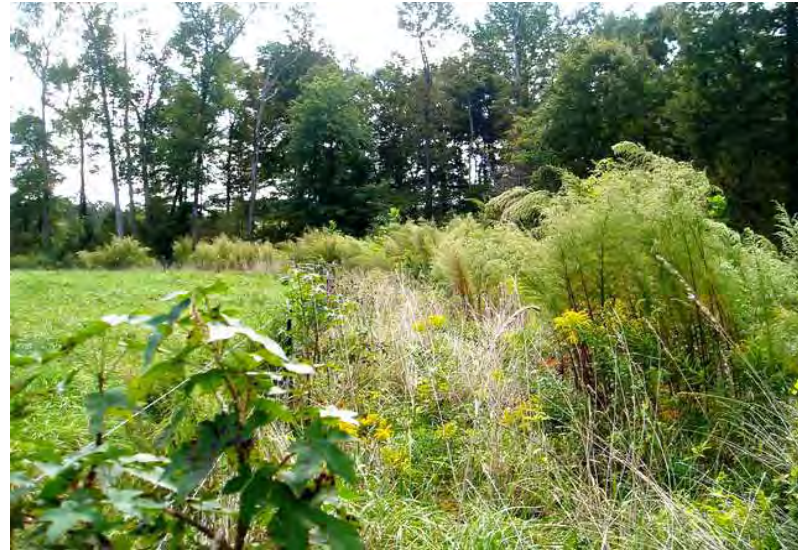
PP #5 – Looking south along easement, E of Wells Cr (09/16/09)

PP #5 – Looking south along easement, E of Wells Cr (10/02/13)

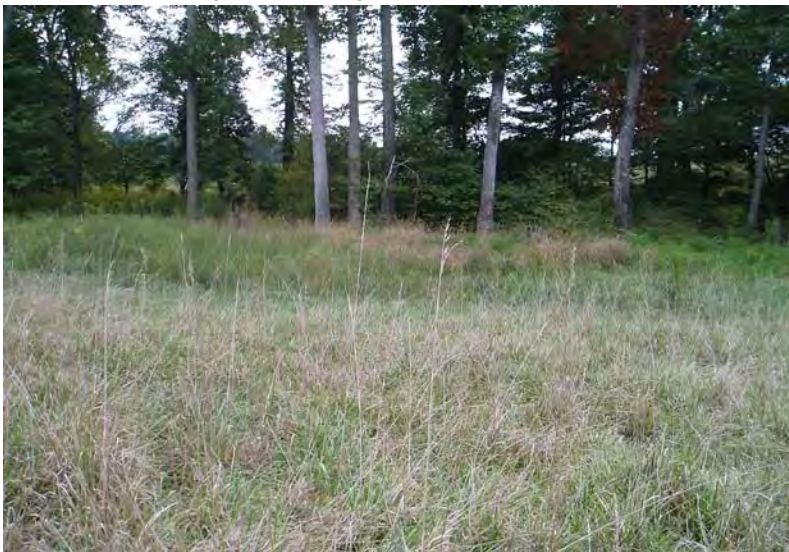
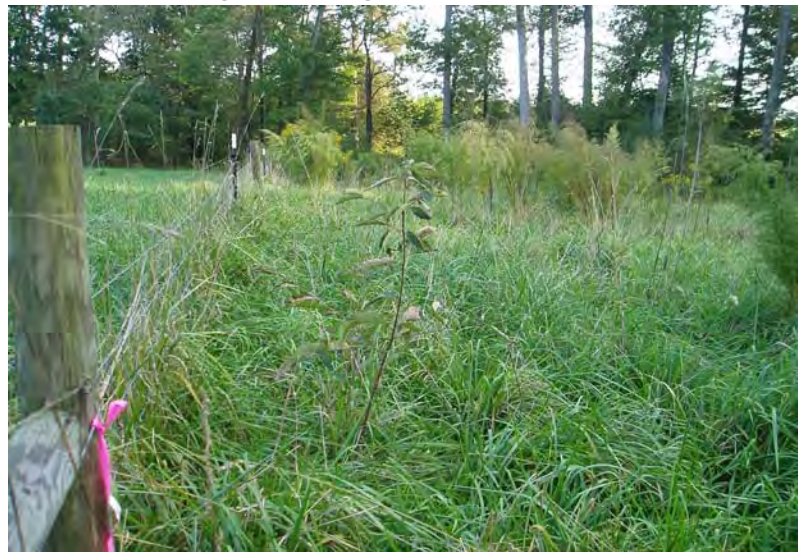
PP #6 – Looking south from easement toward Wells Cr (09/16/09)

PP #6 – Looking south from easement toward Wells Cr (10/12/13)

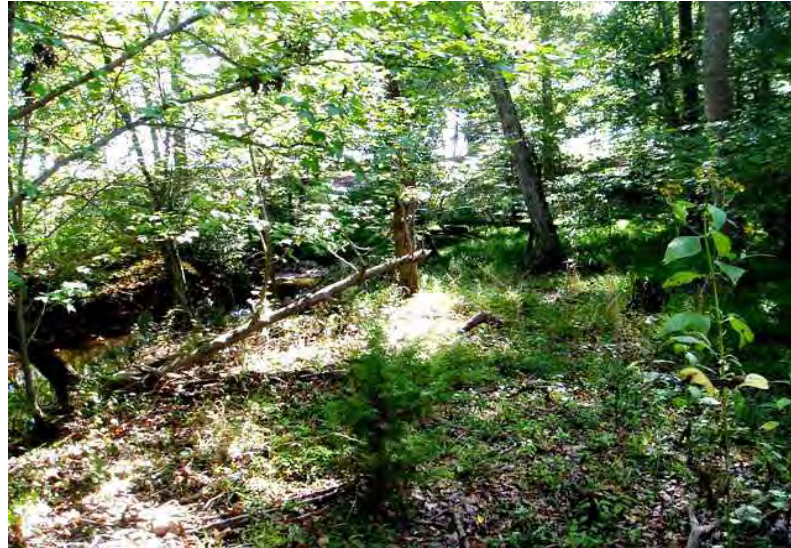
PP #7 – Looking South beside RBK Wells Cr (09/16/09)

PP #7 – Looking South beside RBK Wells Cr (10/12/13)

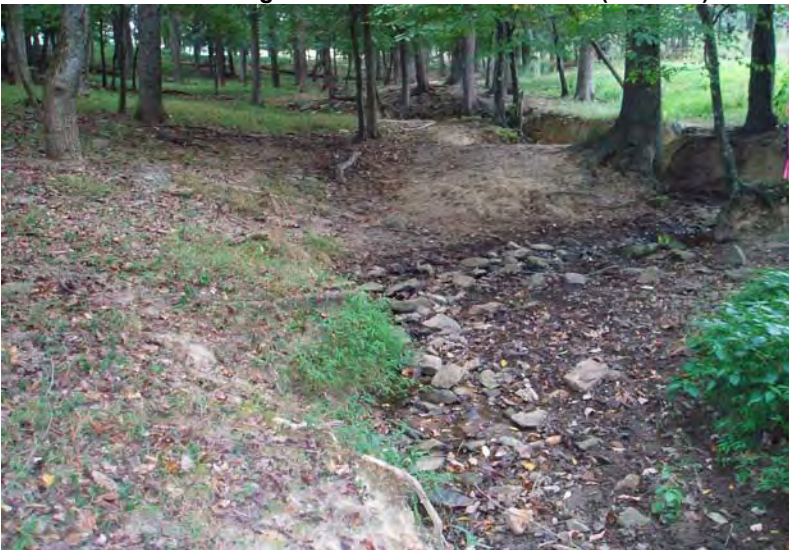
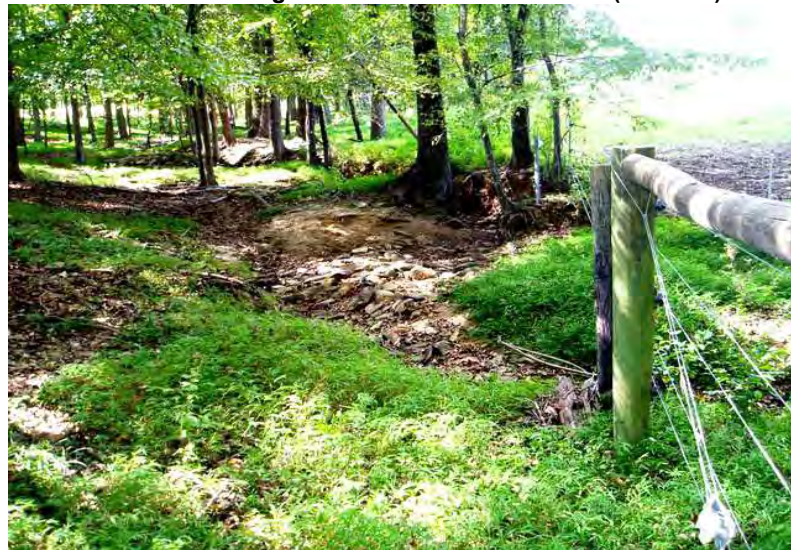
Based on the permanent photopoints and overall visual assessment in 2013, there are no new areas of channel instability in the project area. The lower portion of UT3 near its confluence with Wells Creek (near photopoint 8) remains incised with steep and sparsely wooded banks, similar to its pre-project condition. The livestock exclusion fence is close to the north (left) bank of UT3, which limits the potential for woody vegetation recovery along this bank segment.

PP #8 – Looking up UT3 from lower end (09/16/09)

PP #8 – Looking up UT3 from lower end (10/02/13)

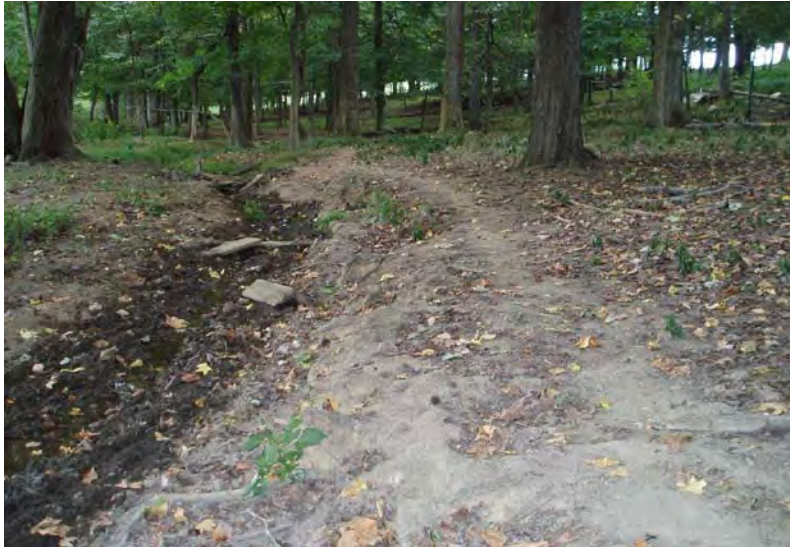
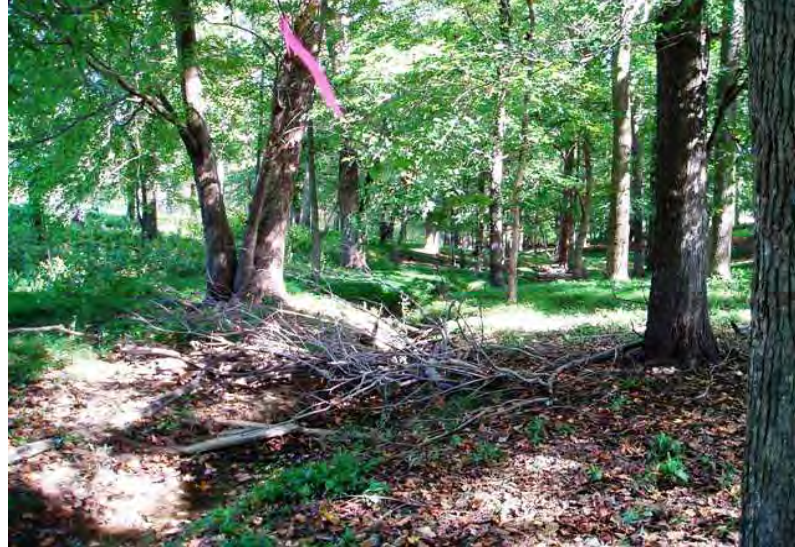
Wells Creek UT3: The September 2011 monitoring report noted livestock encroachment (hog wallows and paths) in areas along tributary UT3 (Enhancement Reach) that hogs had used prior to fencing, and which were still accessible to small hogs that could get under the fence. The hogs were subsequently removed from the adjacent pastures, which are now used for cattle only. During the spring 2013 assessment we noted cattle hoof prints and dung (apparently a few months old) just inside the fence south of UT3, but no detectable cattle damage to trees or shrubs within the easement. No break in the fence or obvious point of entry was found. Three dead calves had been left inside the fence to decay, near the lower end of UT3 about 50 feet from the stream bank. In October 2013 there was no further evidence of livestock encroachment, no new carcasses placed in the easement, and the easement fence remains intact.

PP #9 – Looking downstream (east) along UT3 (09/16/09)

PP #9 – Looking downstream (east) along UT3 (10/02/13)

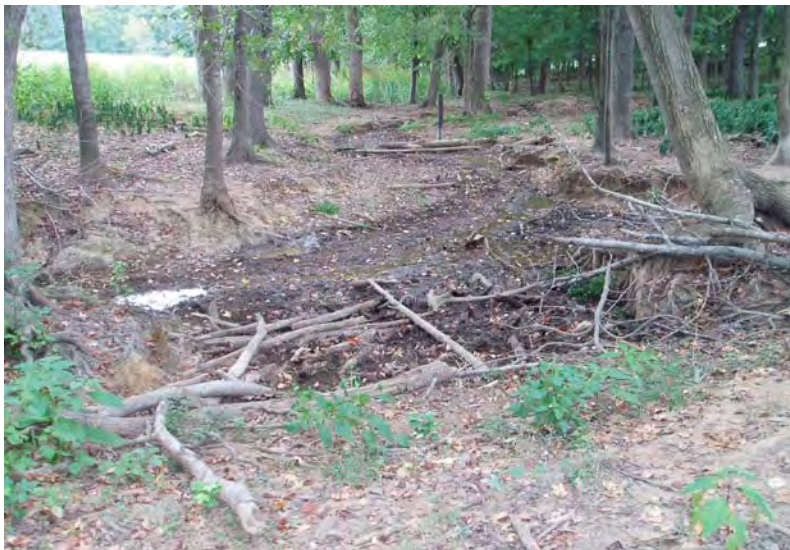
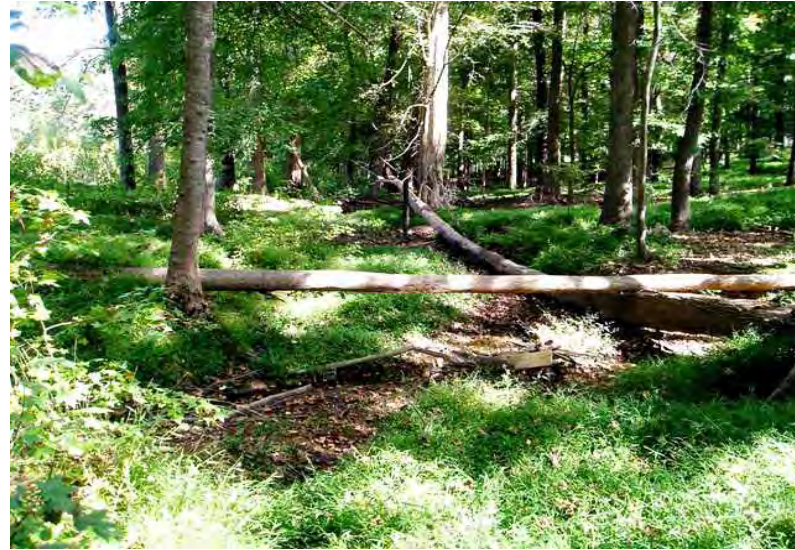
PP #10 – Looking across trampled banks, upper UT3 (09/16/09)

PP #10 – Looking across trampled banks, upper UT3 (10/02/13)

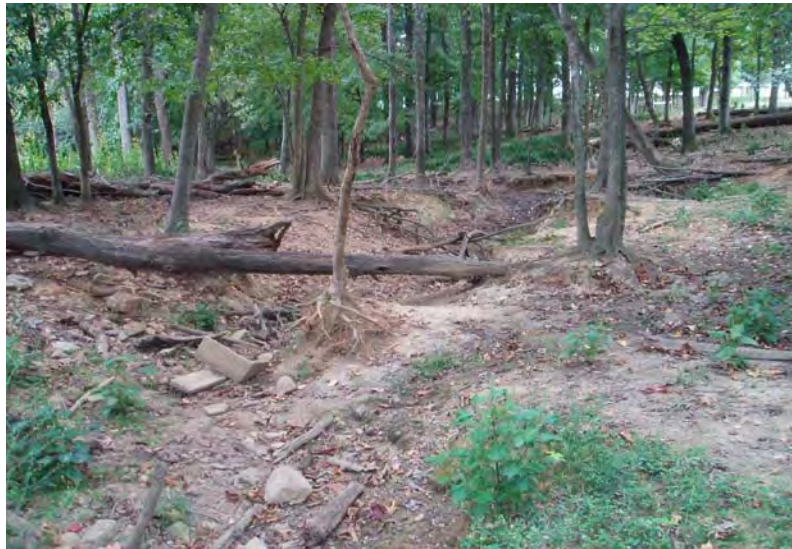
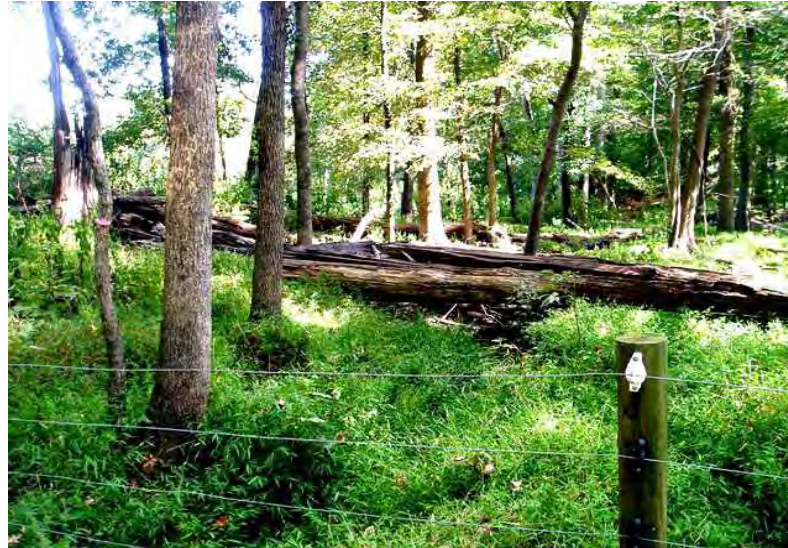
PP #11 – Looking downstream from UT3 Head (09/16/09)

PP #11 – Looking downstream from UT3 Head (10/02/13)

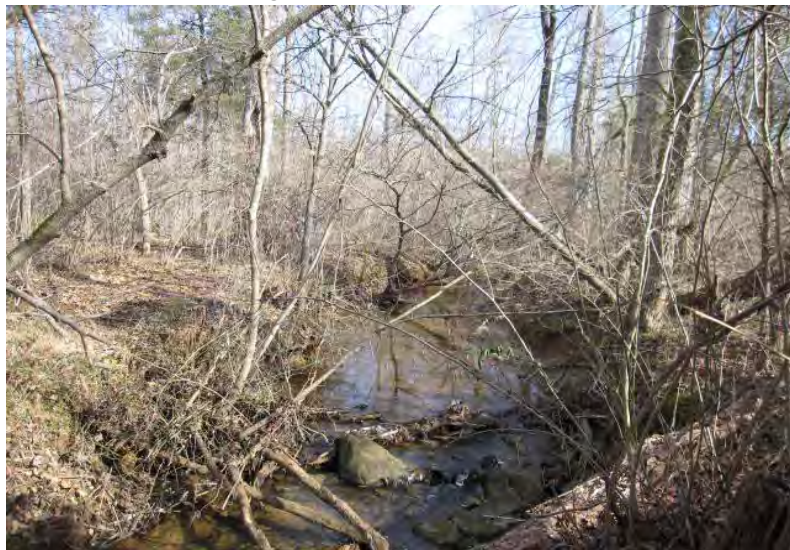
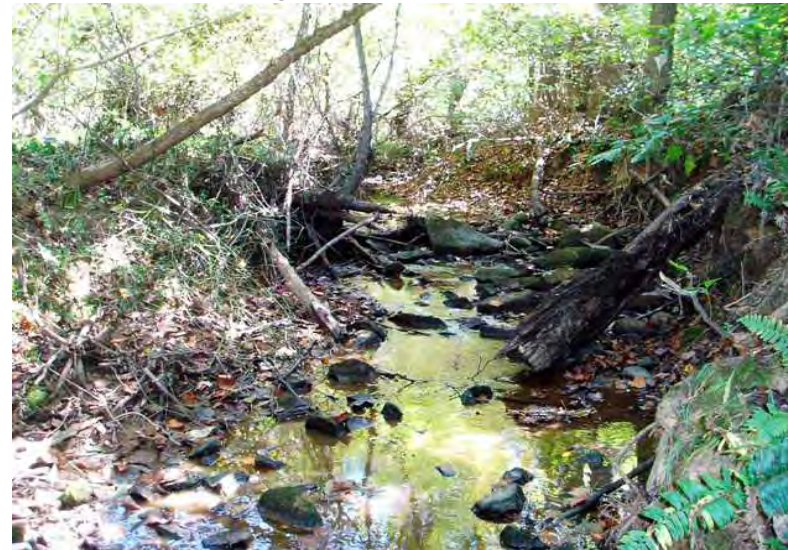
PP #12 – Wells Cr north of Carl Noah Rd, looking upstr (01/03/10)

PP #12 – Wells Cr north of Carl Noah Rd, looking upstr (10/02/13)

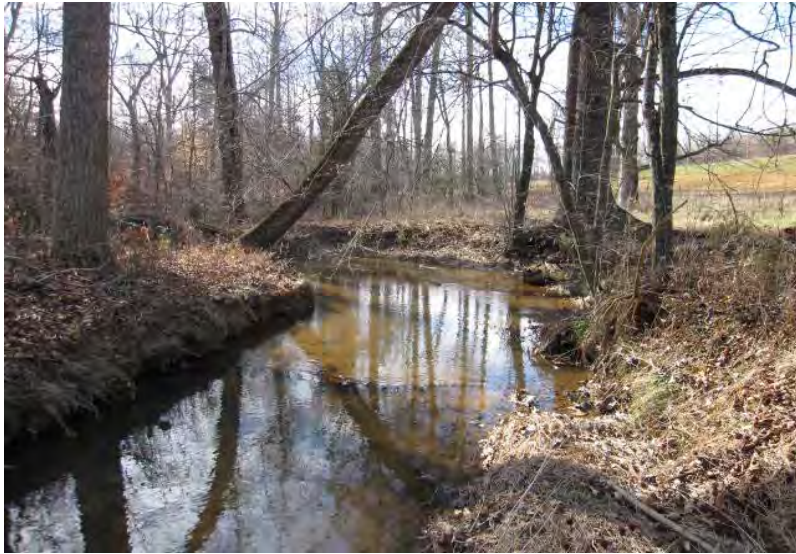
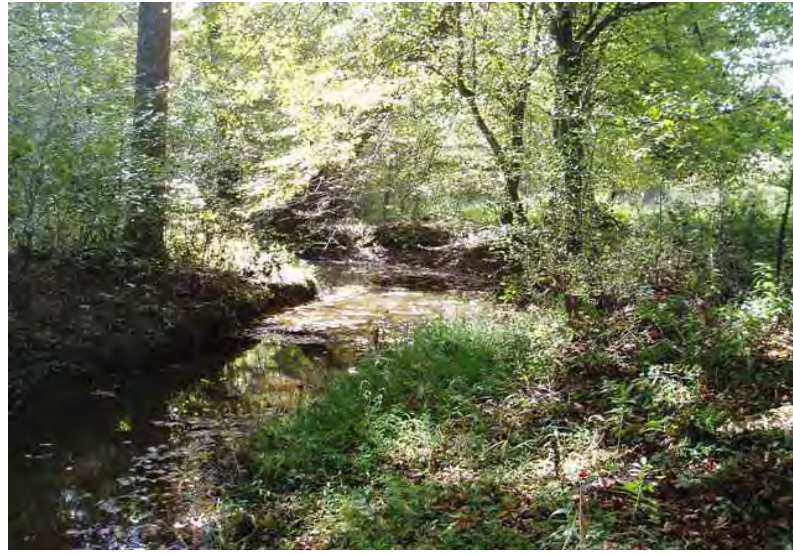
Wells Creek Main Stem: At the two cattle crossings on the Wells Creek Enhancement Reach, south of Carl Noah Rd, the fencing wire is disengaged from the fence posts in some areas, as noted in the 2012 and spring 2013 reports. Cattle were present in the adjacent pasture, but were excluded from the conservation easement by a temporary portable electric fence. No livestock encroachment or damage inside the conservation area along the main stem of Wells Creek was evident. The segment north of Carl Noah Rd has no fencing and no adjacent pasture.

PP #13 – Wells Creek South of Carl Noah Road (01/03/10)

PP #13 – Wells Creek South of Carl Noah Road (10/02/13)

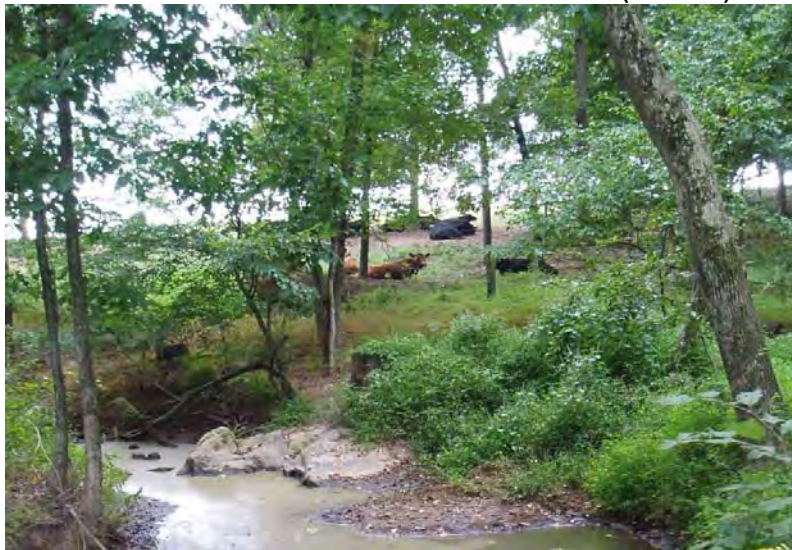
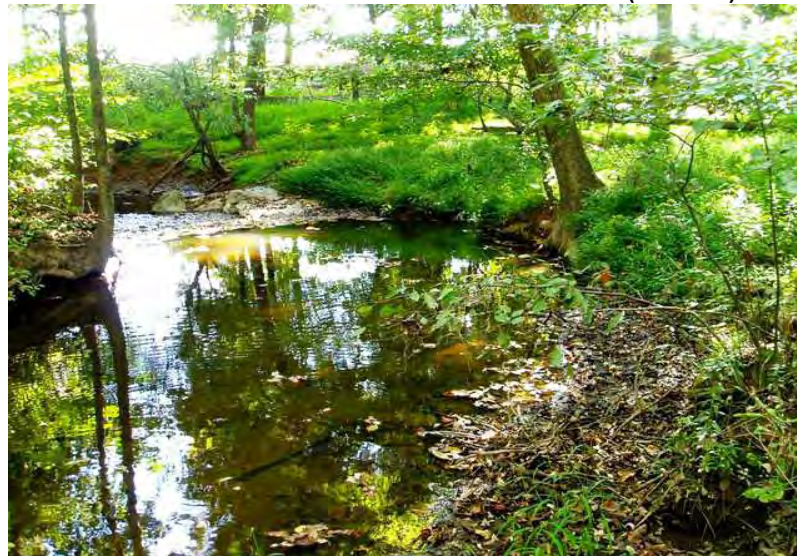
PP #14 – Confluence of Wells Creek and UT3 (09/16/09)

PP #14 – Confluence of Wells Creek and UT3 (10/02/13)

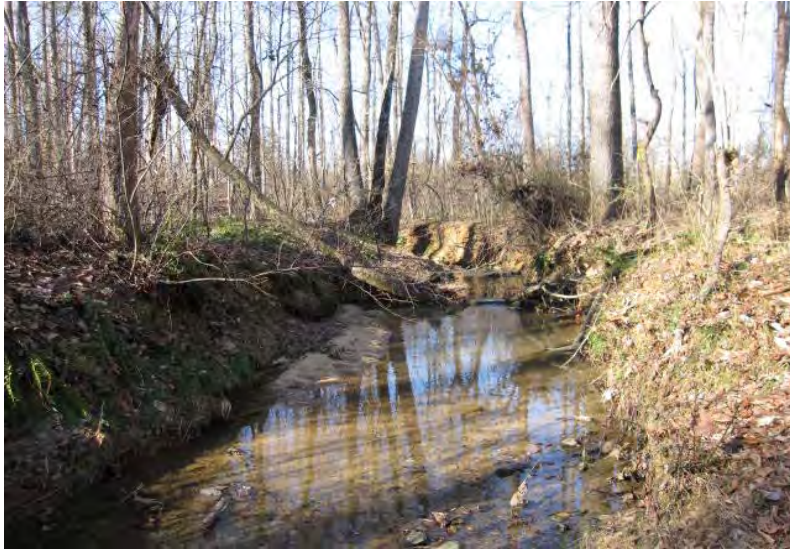
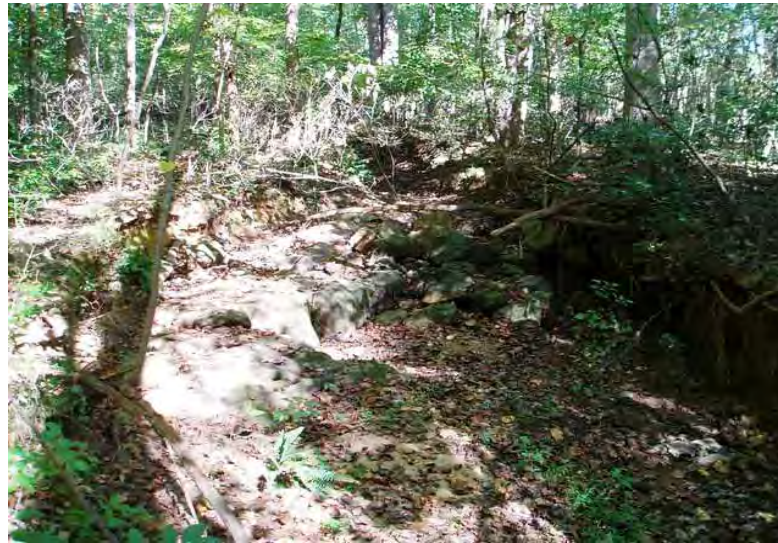
PP #15 – UT#1 Preservation Reach (01/03/10)

PP #15 – UT#1 Preservation Reach (10/02/13)

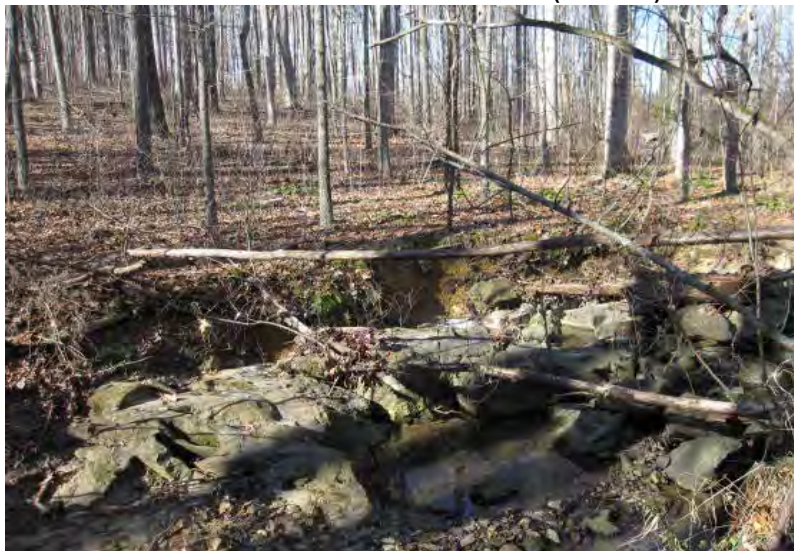
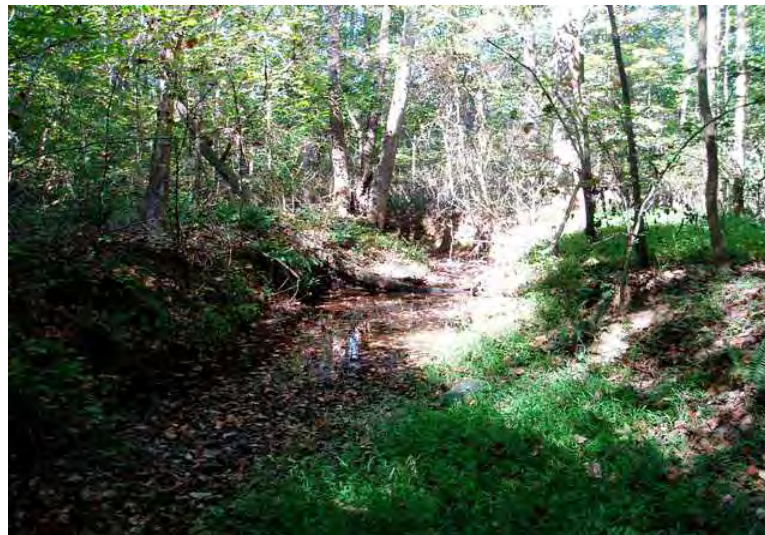
PP #16 – UT1 Preservation Reach (01/03/10)

PP #16 – UT1 Preservation Reach (10/02/13)

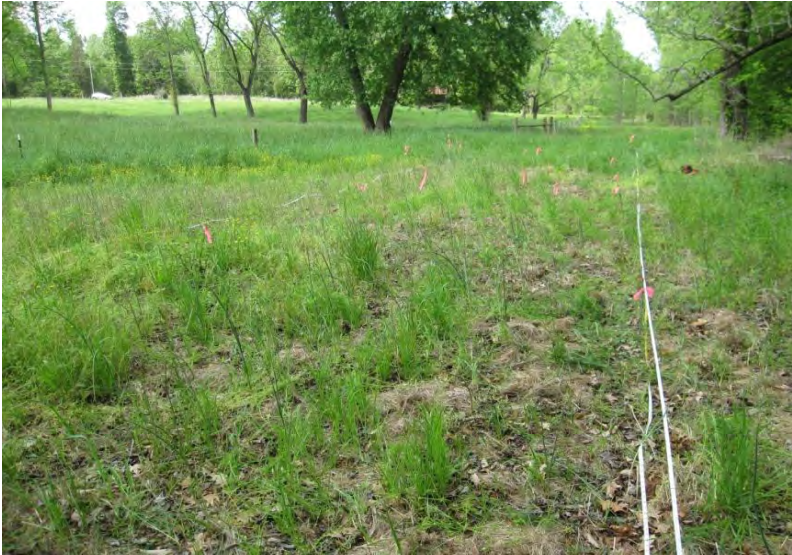
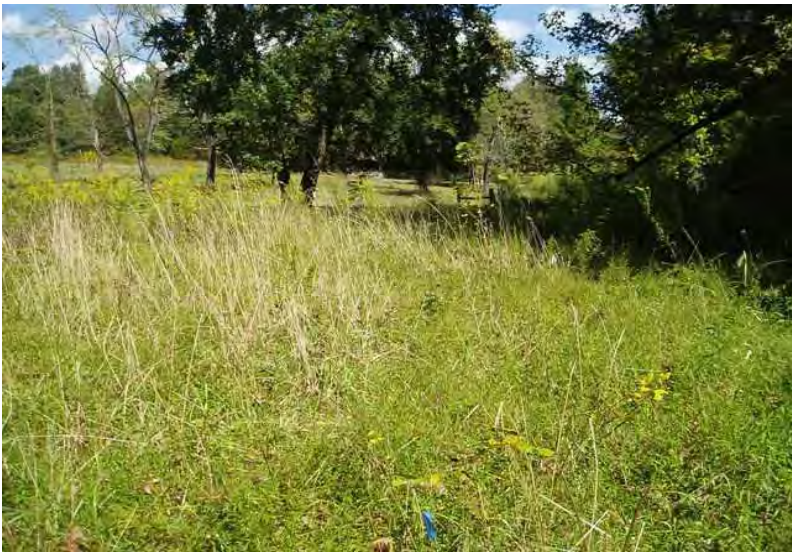
and 12 live planted woody stems in 2013, with an average density of 546 planted stems per acre, a decrease of 7% from 2012. Both plots exceed the MY3 planted stem density success criterion of 320 stems per acre for stream enhancement. Native volunteer woody seedlings are abundant in both plots, and average density of planted plus native volunteer stems was 1760 stems per acre in 2013.

VP 1 (April 27, 2011)

VP 1 (October 02, 2013)

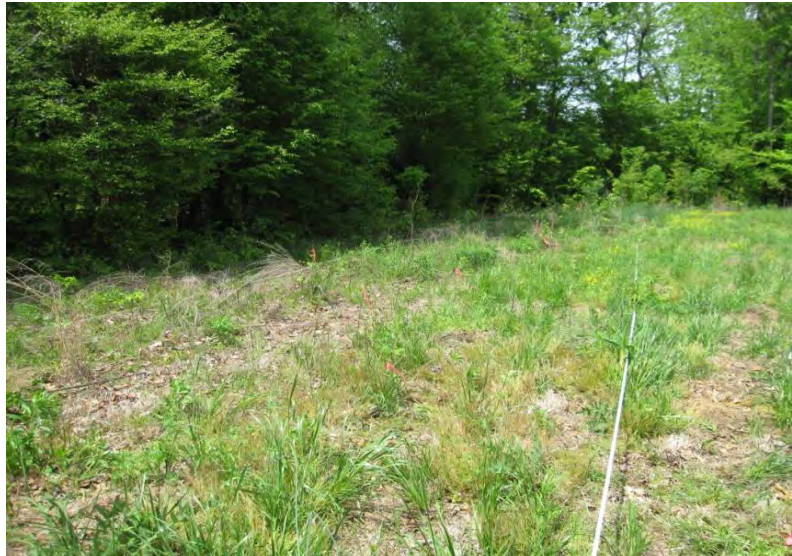
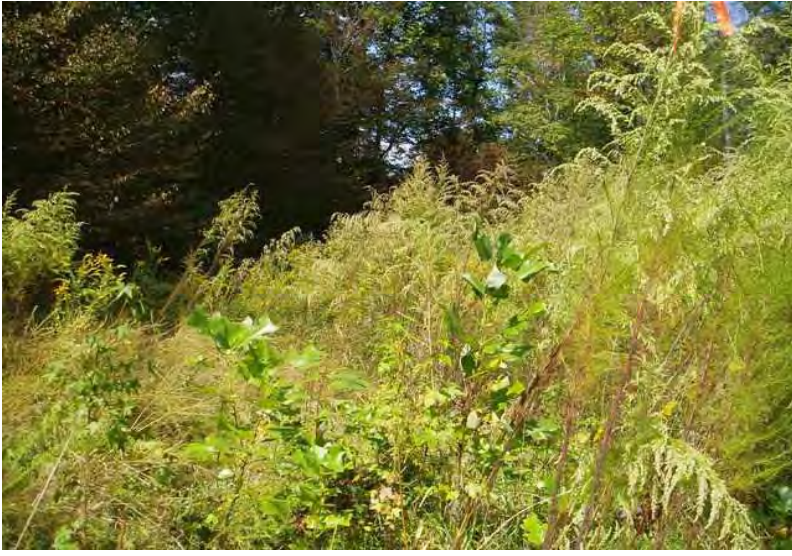
VP 2 (April 27, 2011)

VP 2 (October 02, 2013)
