MY2 Monitoring Report

White Mitigation Project
Randolph County, NC
Cape Fear River Basin

NCDMS Project No. 100112
NCDMS Contract No. 7860
NC DWR Project No. 2019-0884
RFP No. 16-007703

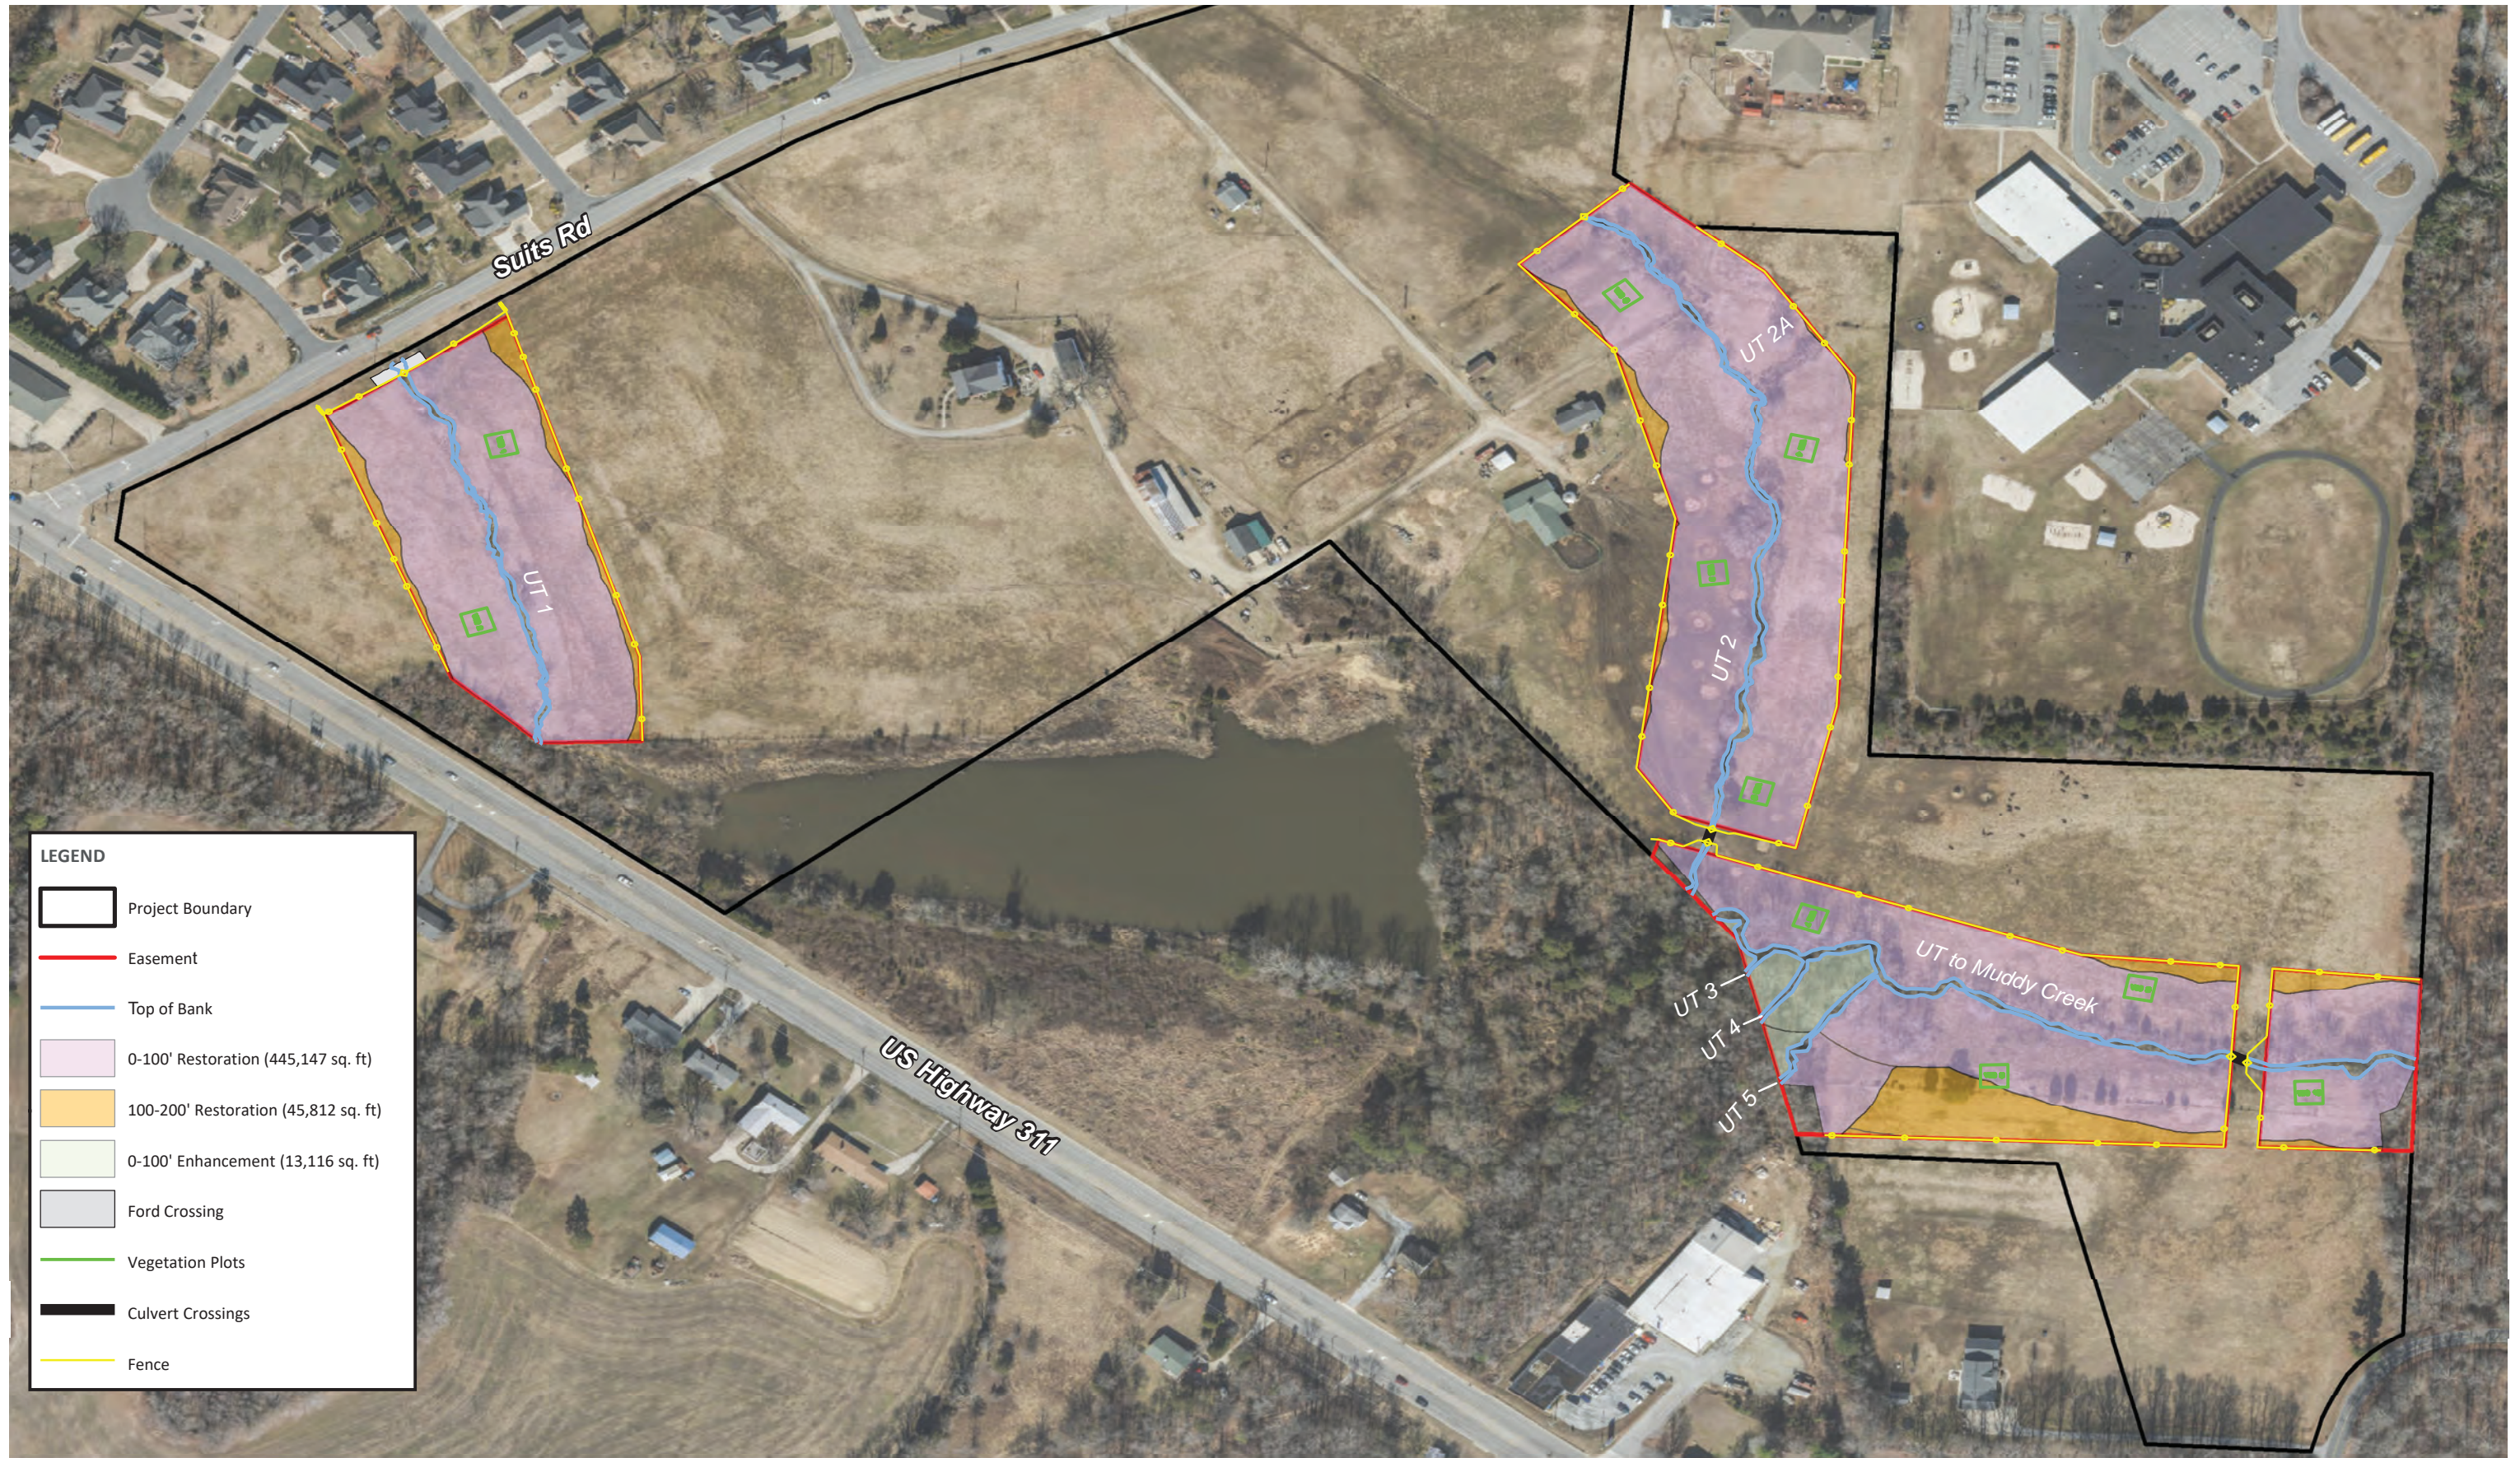
FIGURE 3. ASSET MAP
WHITE MITIGATION SITE
 RANDOLPH COUNTY, NORTH CAROLINA

- Project Boundary
- Easement
- Top of Bank
- 0-100' Restoration (445,147 sq. ft.)
- 100-200' Restoration (45,812 sq. ft.)
- 0-100' Enhancement (13,116 sq. ft.)
- Ford Crossing
- Vegetation Plots
- Culvert Crossings
- Fence

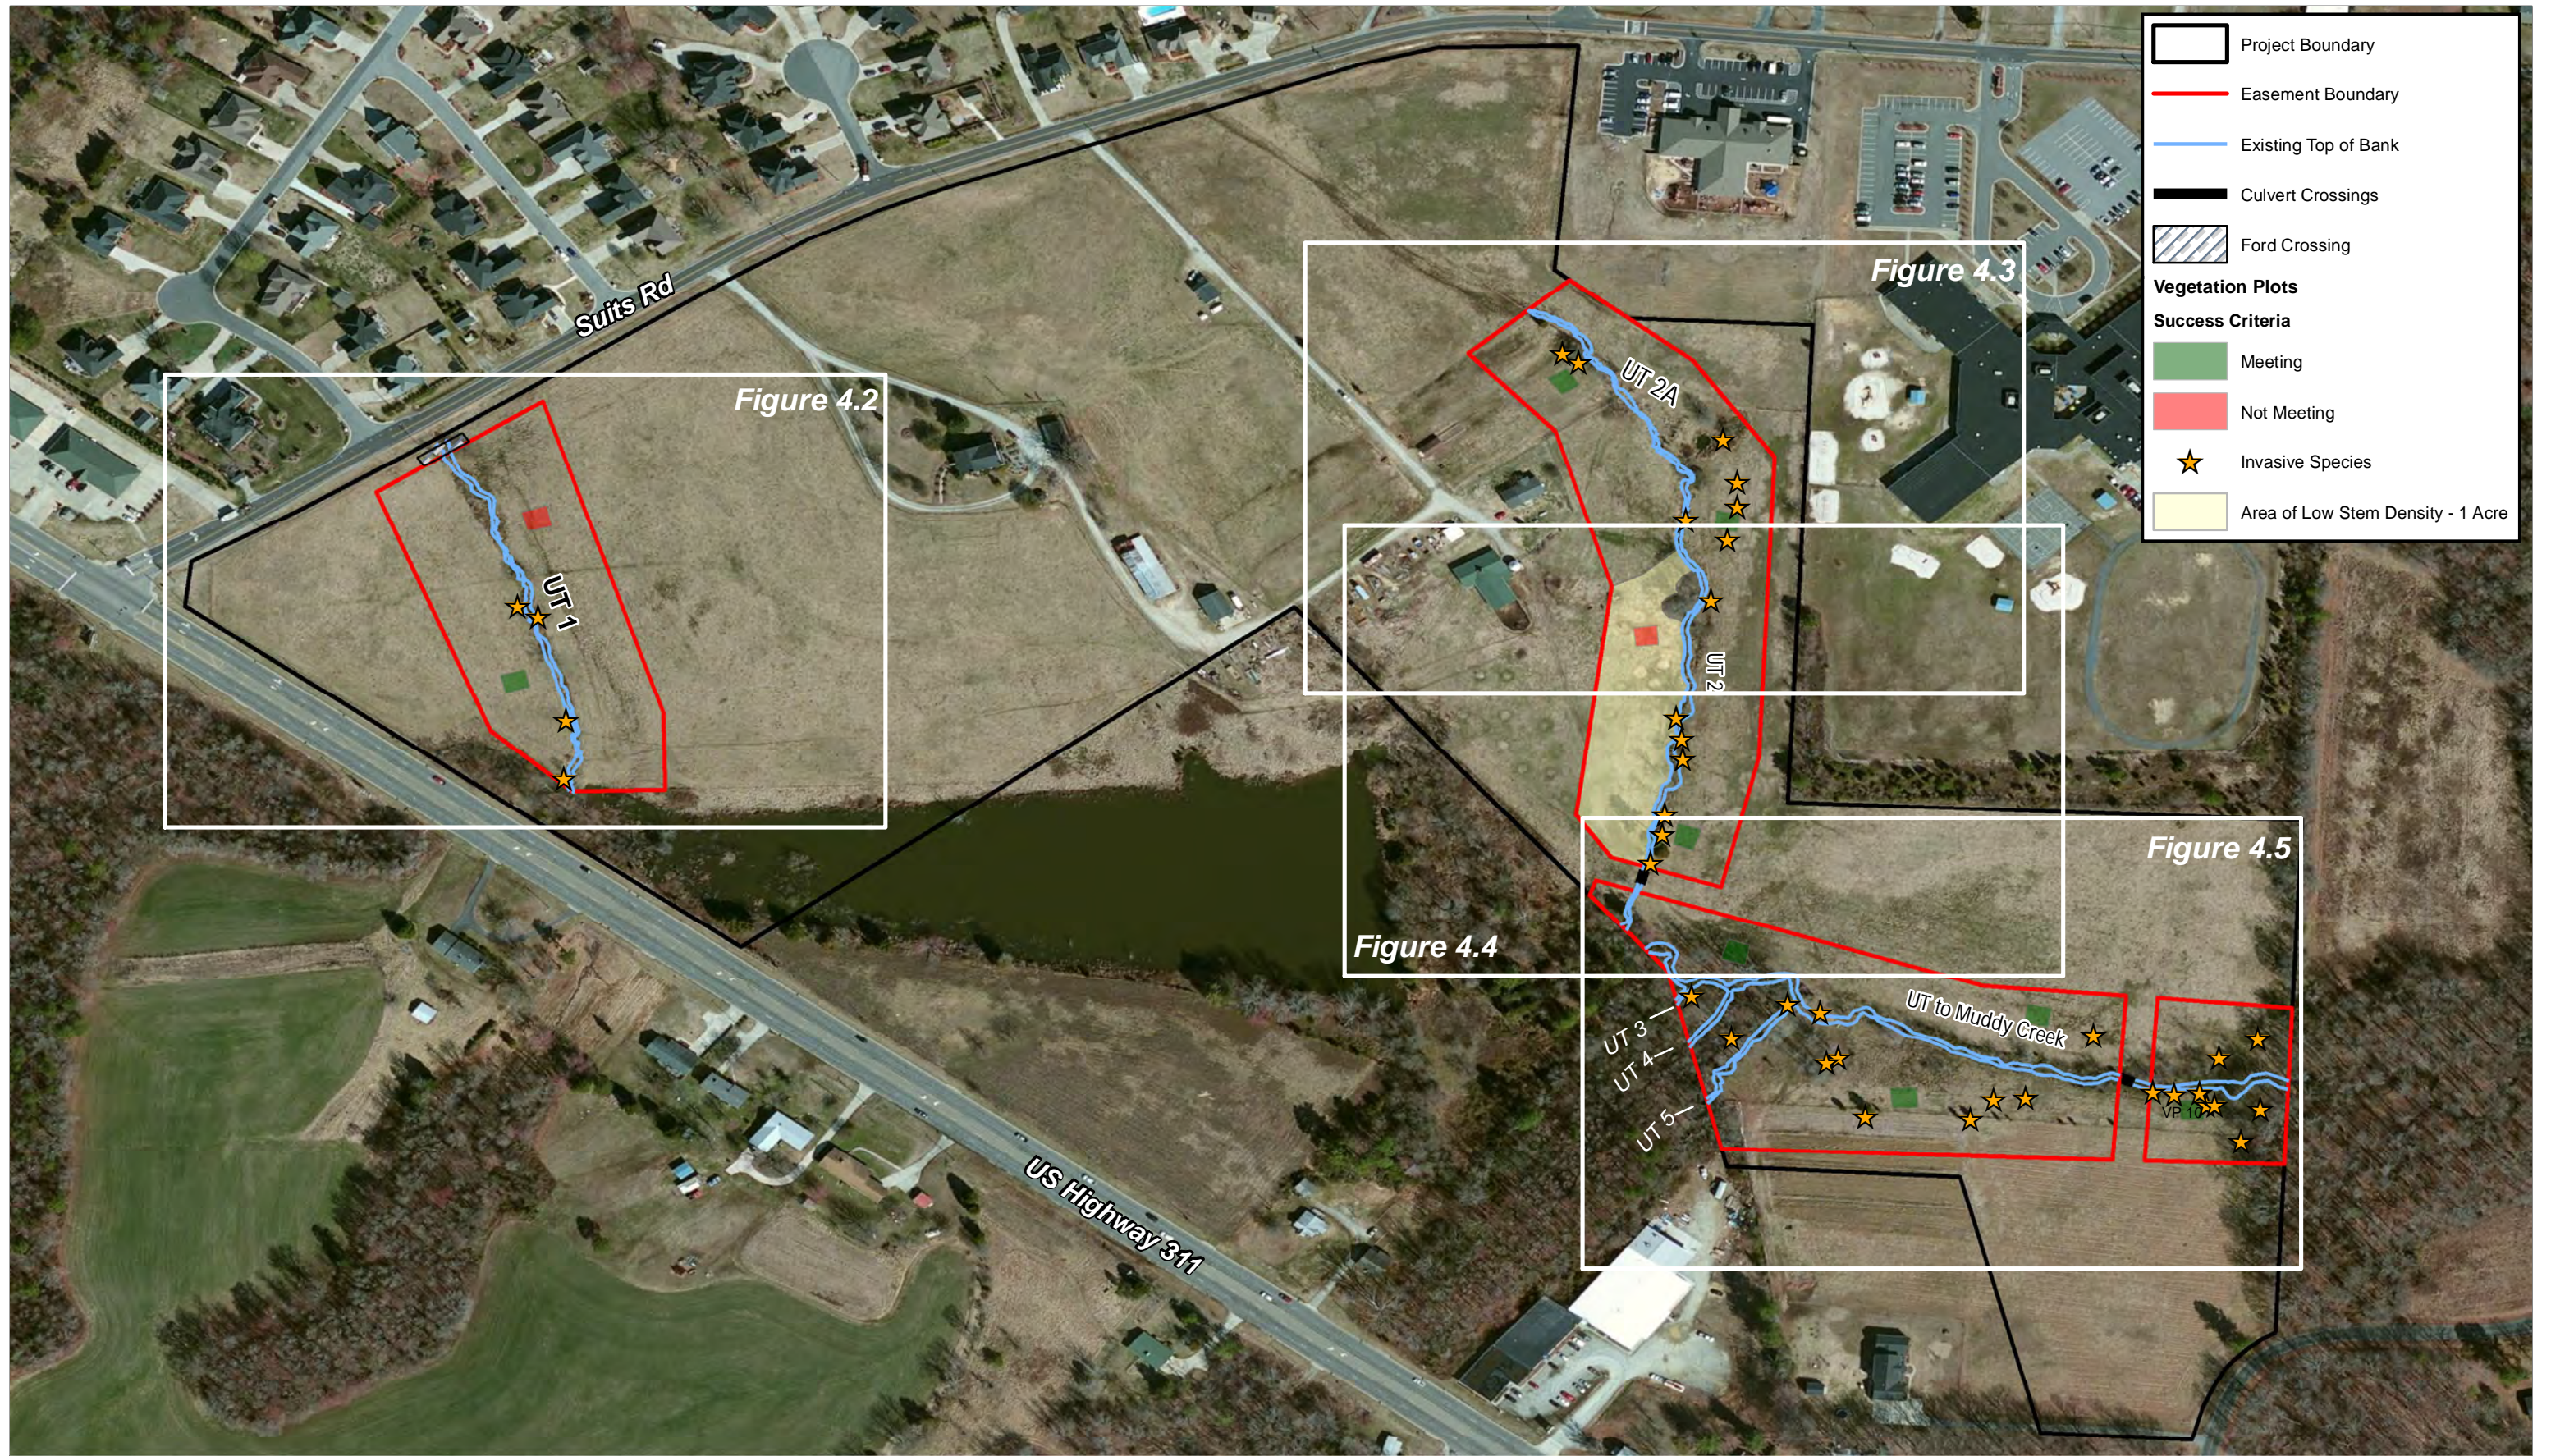
Project Boundary
	Easement Boundary
	Existing Top of Bank
	Culvert Crossings
	Ford Crossing
Vegetation Plots	
Success Criteria	
	Meeting
	Not Meeting
	Invasive Species
	Area of Low Stem Density - 1 Acre

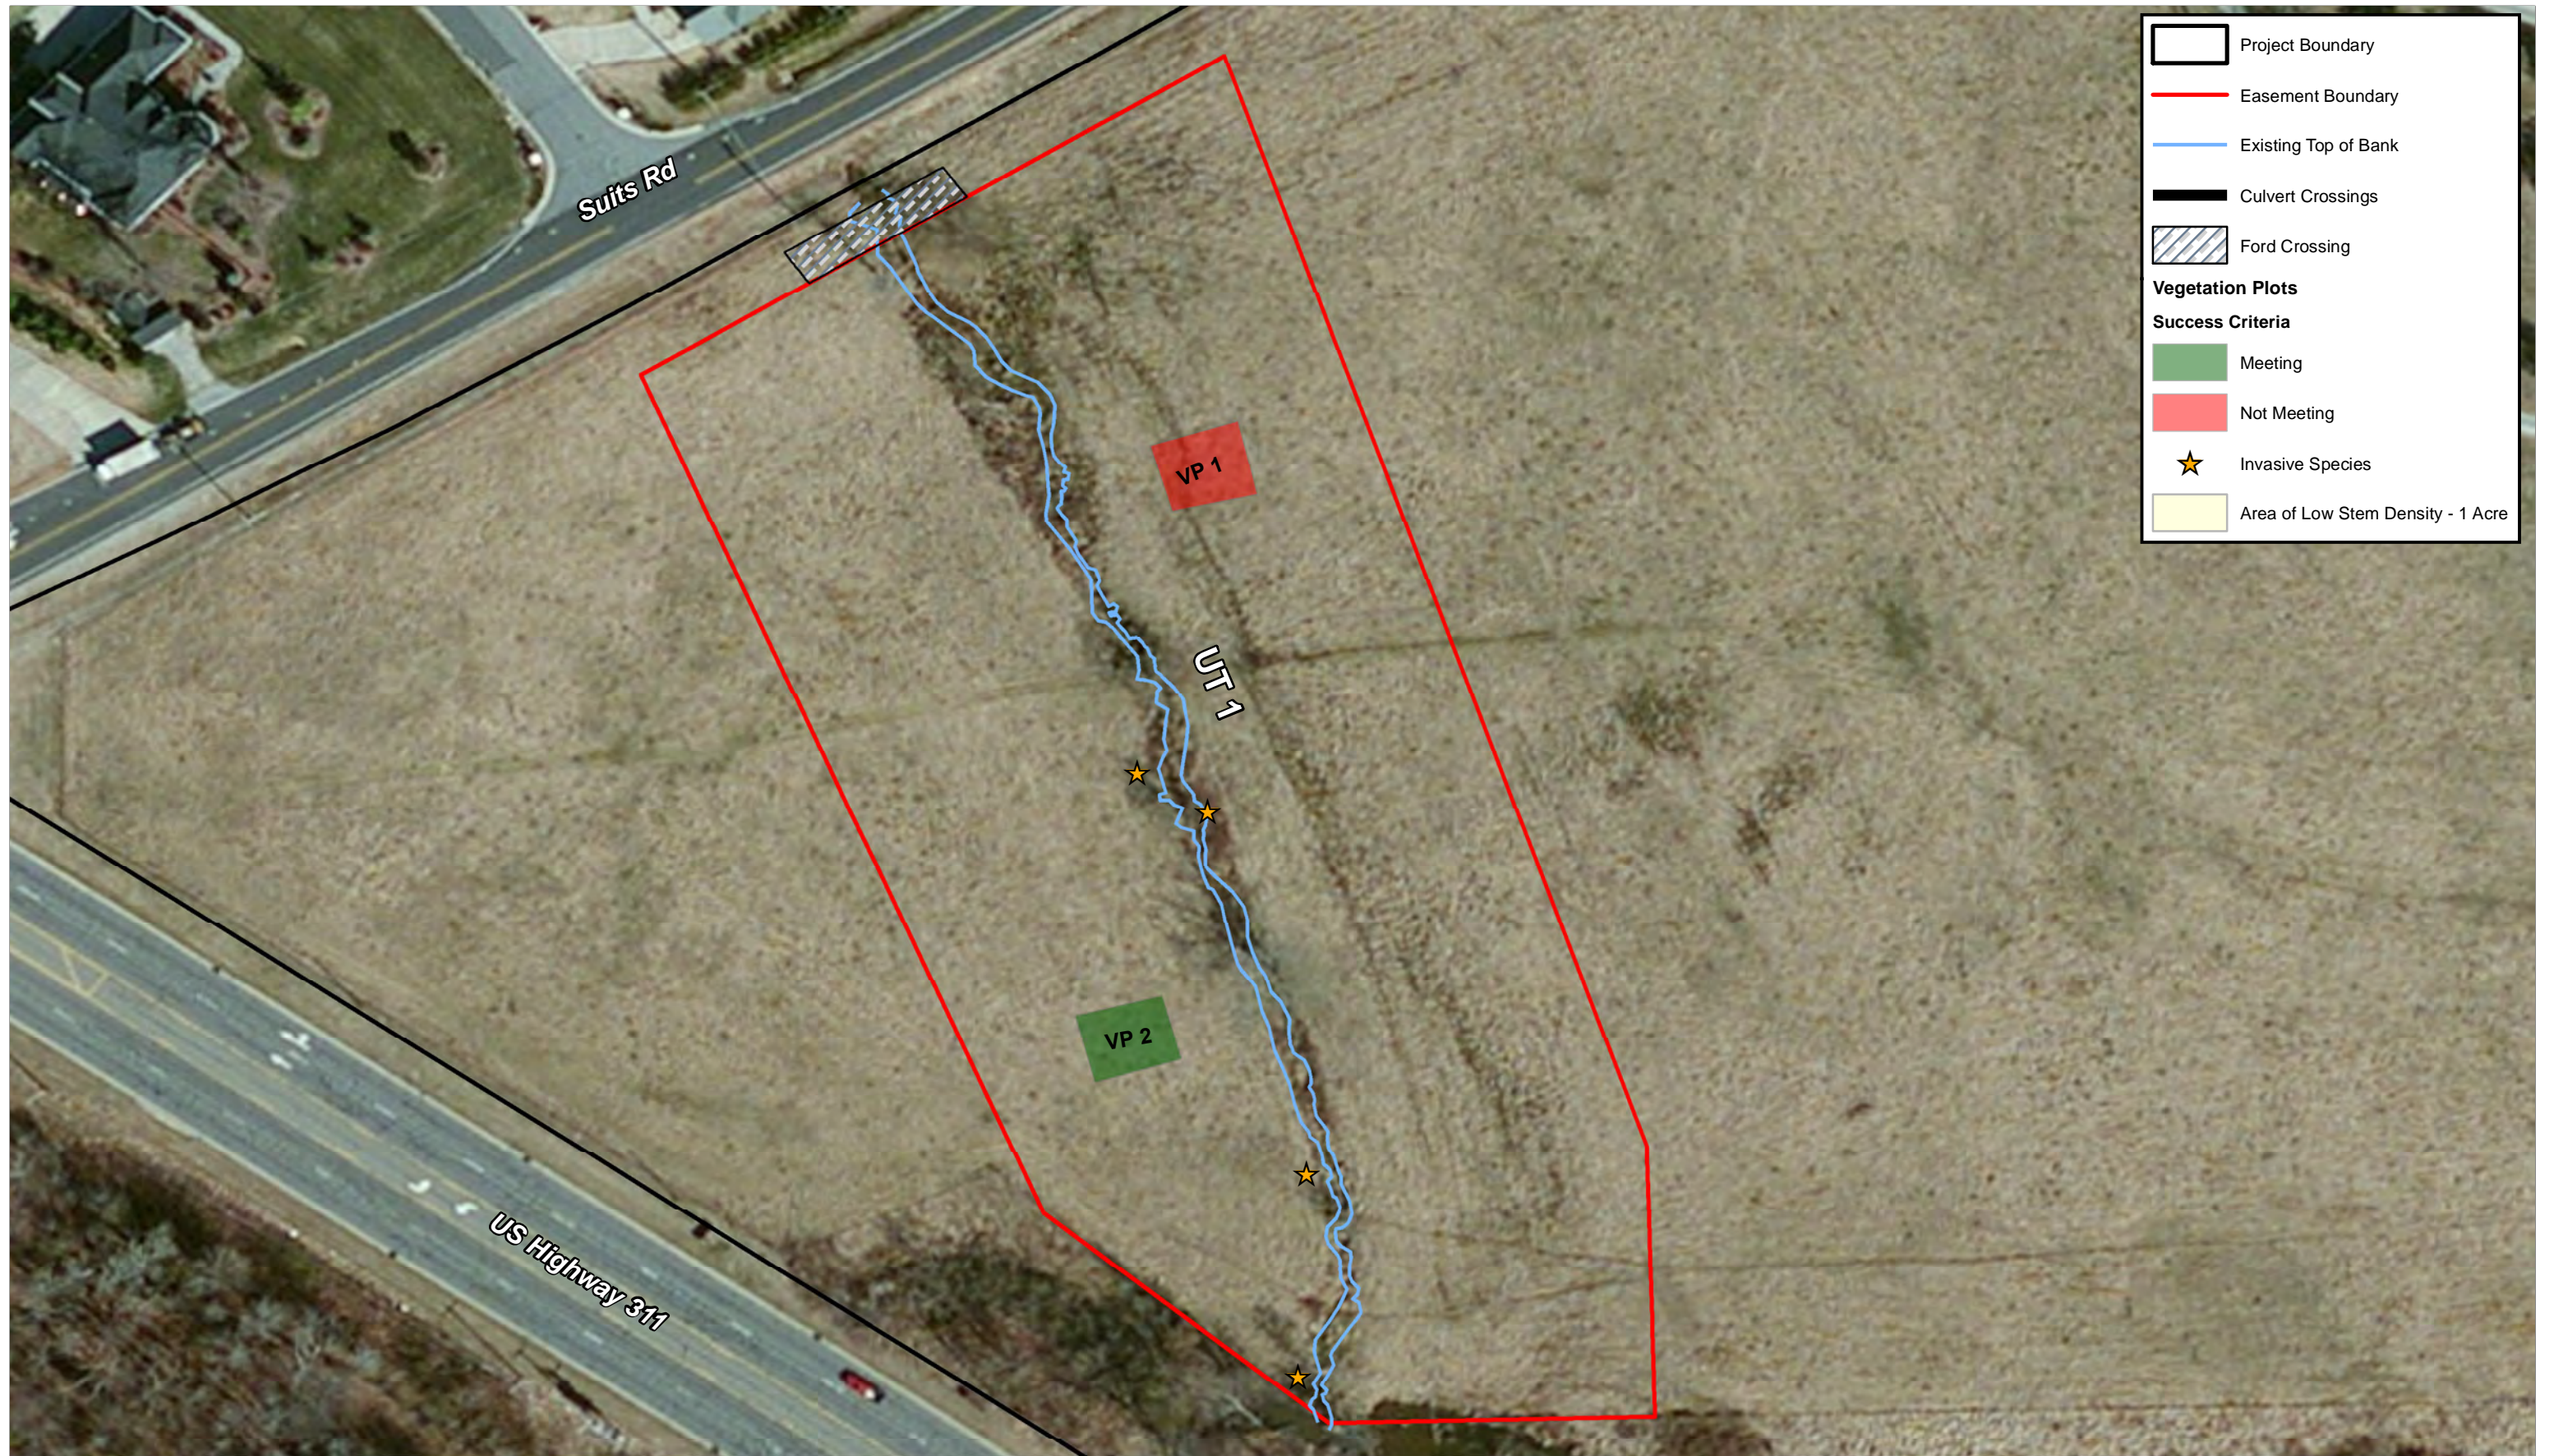
FIGURE 4.2

Project Boundary
	Easement Boundary
	Existing Top of Bank
	Culvert Crossings
	Ford Crossing
Vegetation Plots	
Success Criteria	
	Meeting
	Not Meeting
	Invasive Species
	Area of Low Stem Density - 1 Acre

Several areas of Chinese privet (*Ligustrum sinense*) and multiflora rose (*Rosa multiflora*) were treated in April 2021 (MY1). While the areas previously treated are dead, 38 new areas of invasive growth were discovered during vegetation monitoring in September 2021 and May 2022, and are depicted in Figures 4.1-4.5. It is important to note that the Site had dense growth of Chinese privet along the banks and floodplain of UT MC, UT 3, UT 4, and UT 5 that were treated and removed during construction. Much of the new growth is a result of stump coppicing and sprouting from a prevalent seed bank. New areas of invasive species growth were treated in May and July 2022. Further details of invasive species management procedures can be found in Section 2.3 of this document.

Dense herbaceous vegetation observed along the right bank of UT2 near VP5 has choked out planted stems. This area is depicted in the Current Condition Plan Review (Figure 4.1-4.5). It is anticipated that approximately 1 acre of area will be replanted at a density of 360 stems per acre (Figure 6) in March 2023. Table 7 outlines species and quantities chosen for the replant based on the approved planting plan in the Mitigation Plan. Prior to replanting this area, the dense herbaceous layer of vegetation may be mowed to allow planted stems time to establish.

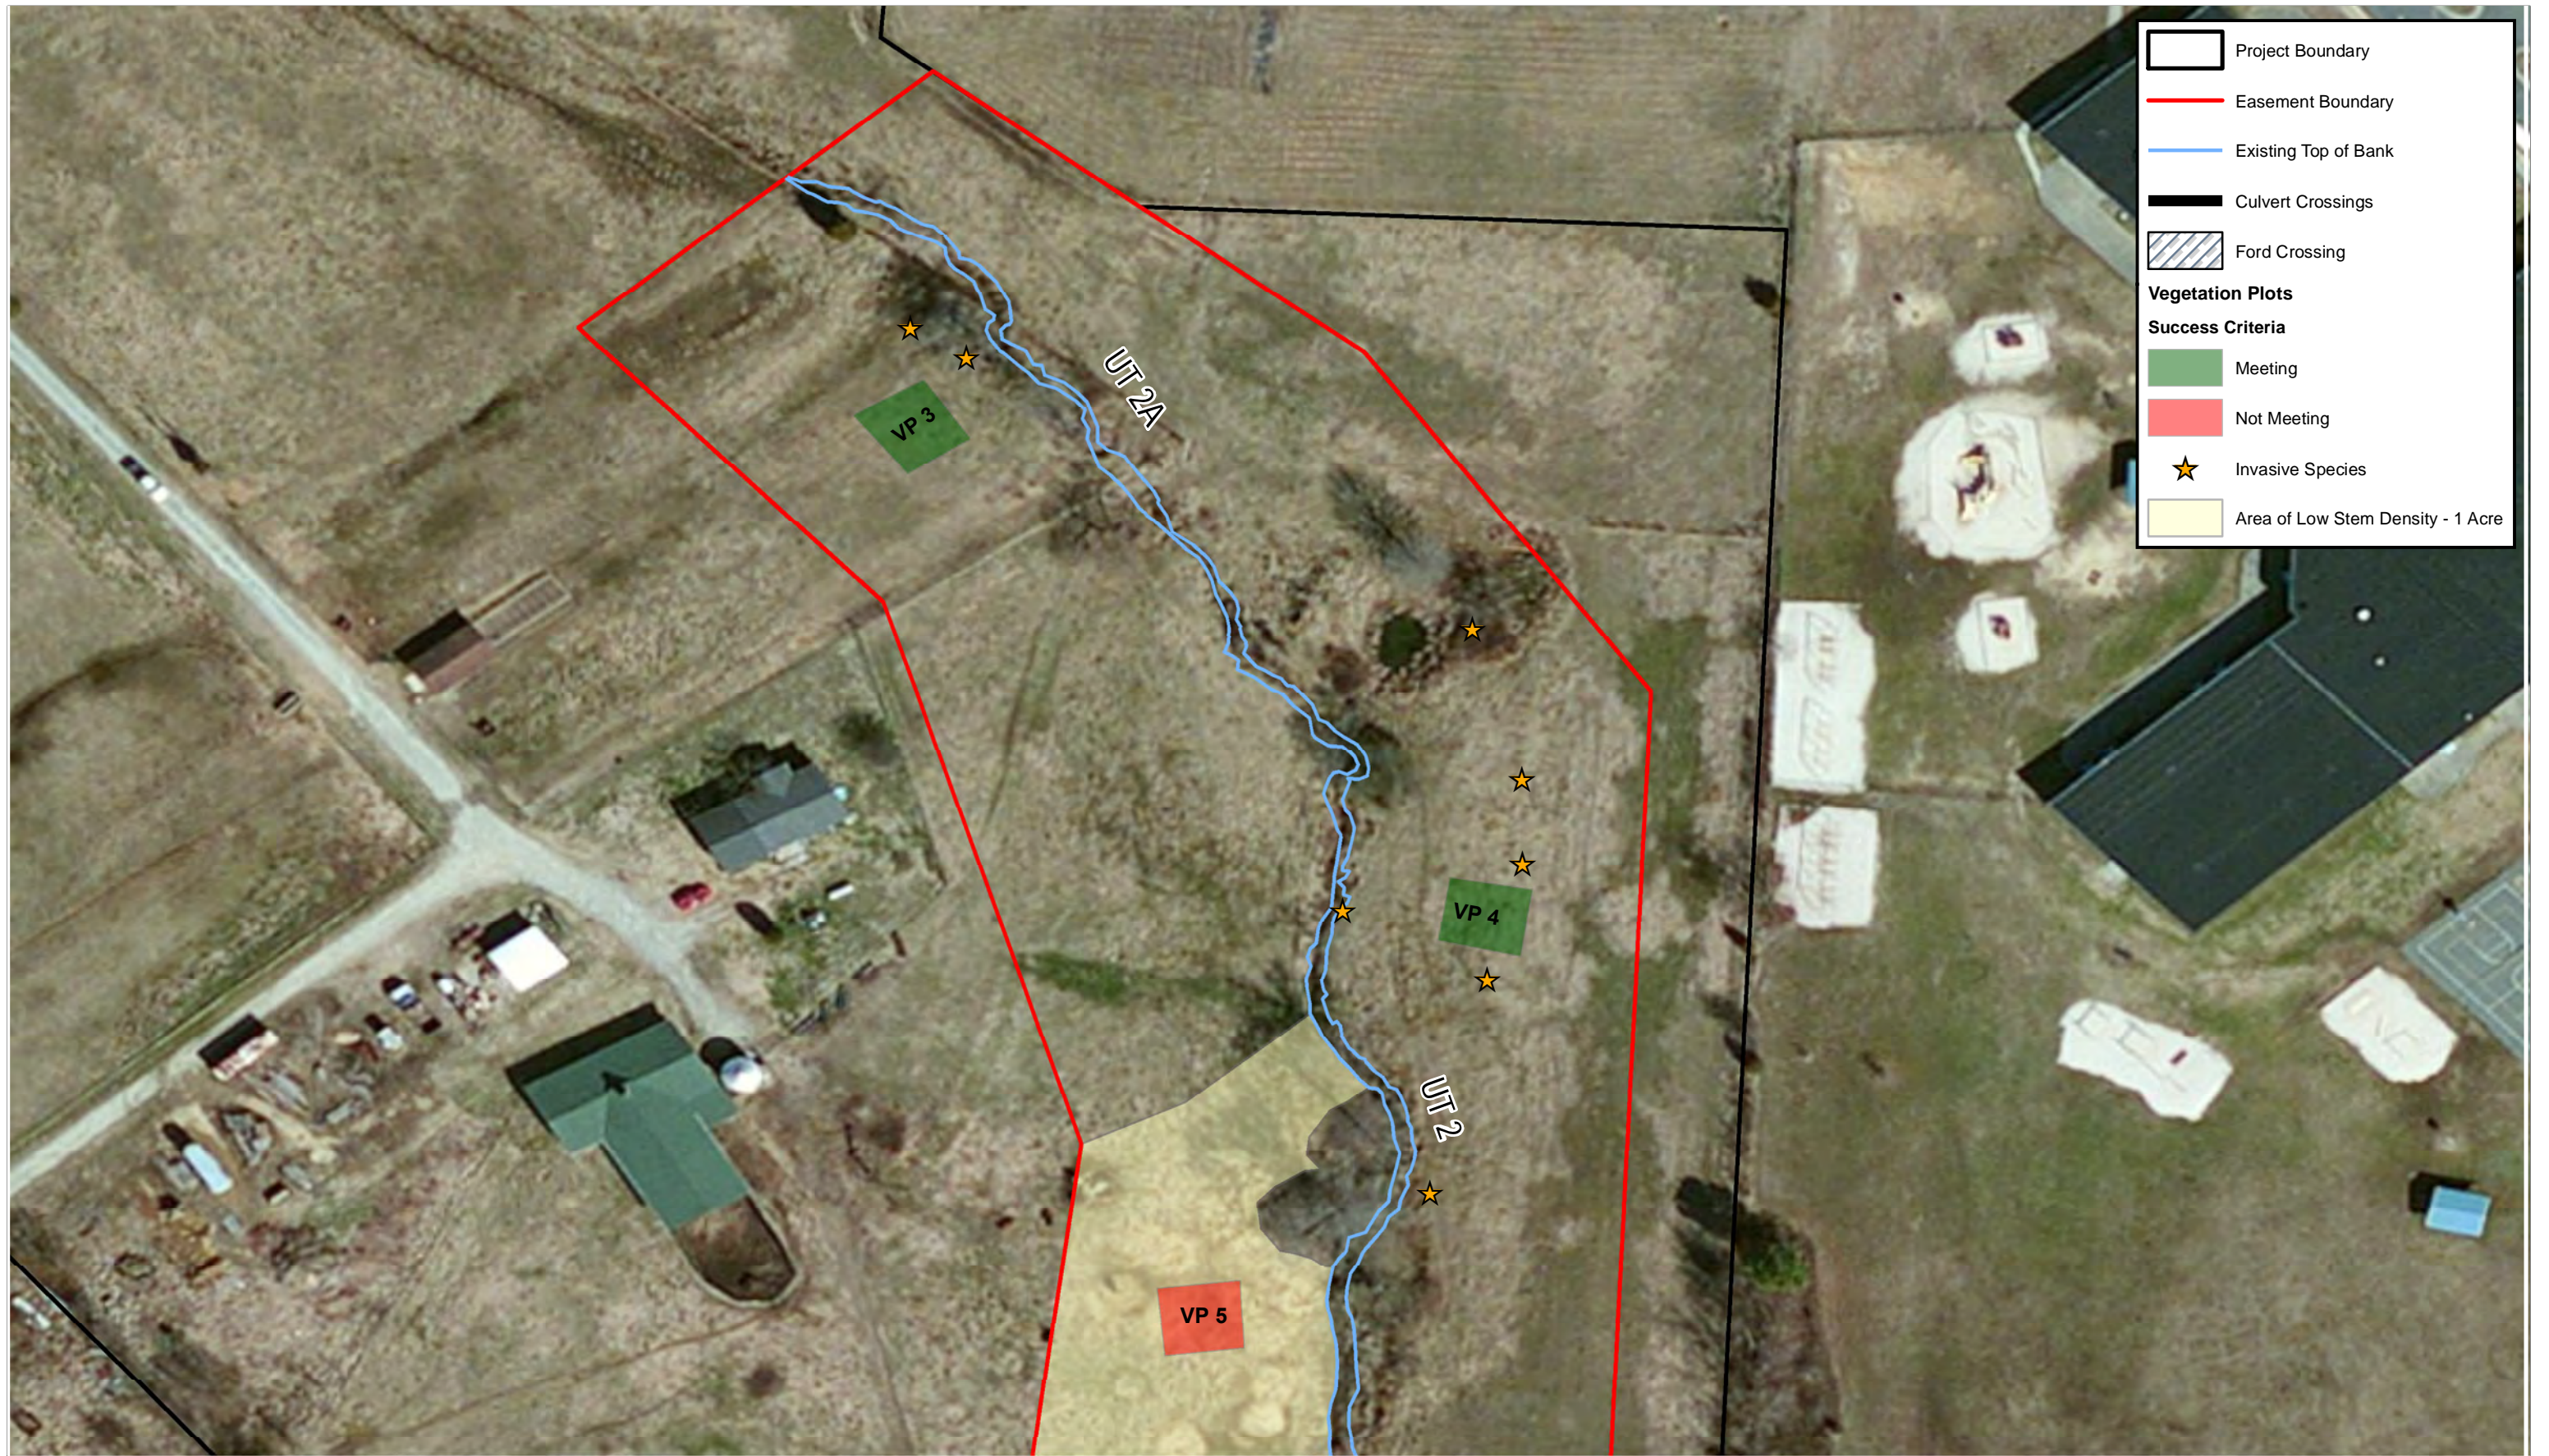
FIGURE 4.3

Project Boundary
	Easement Boundary
	Existing Top of Bank
	Culvert Crossings
	Ford Crossing
Vegetation Plots	
Success Criteria	
	Meeting
	Not Meeting
	Invasive Species
	Area of Low Stem Density - 1 Acre

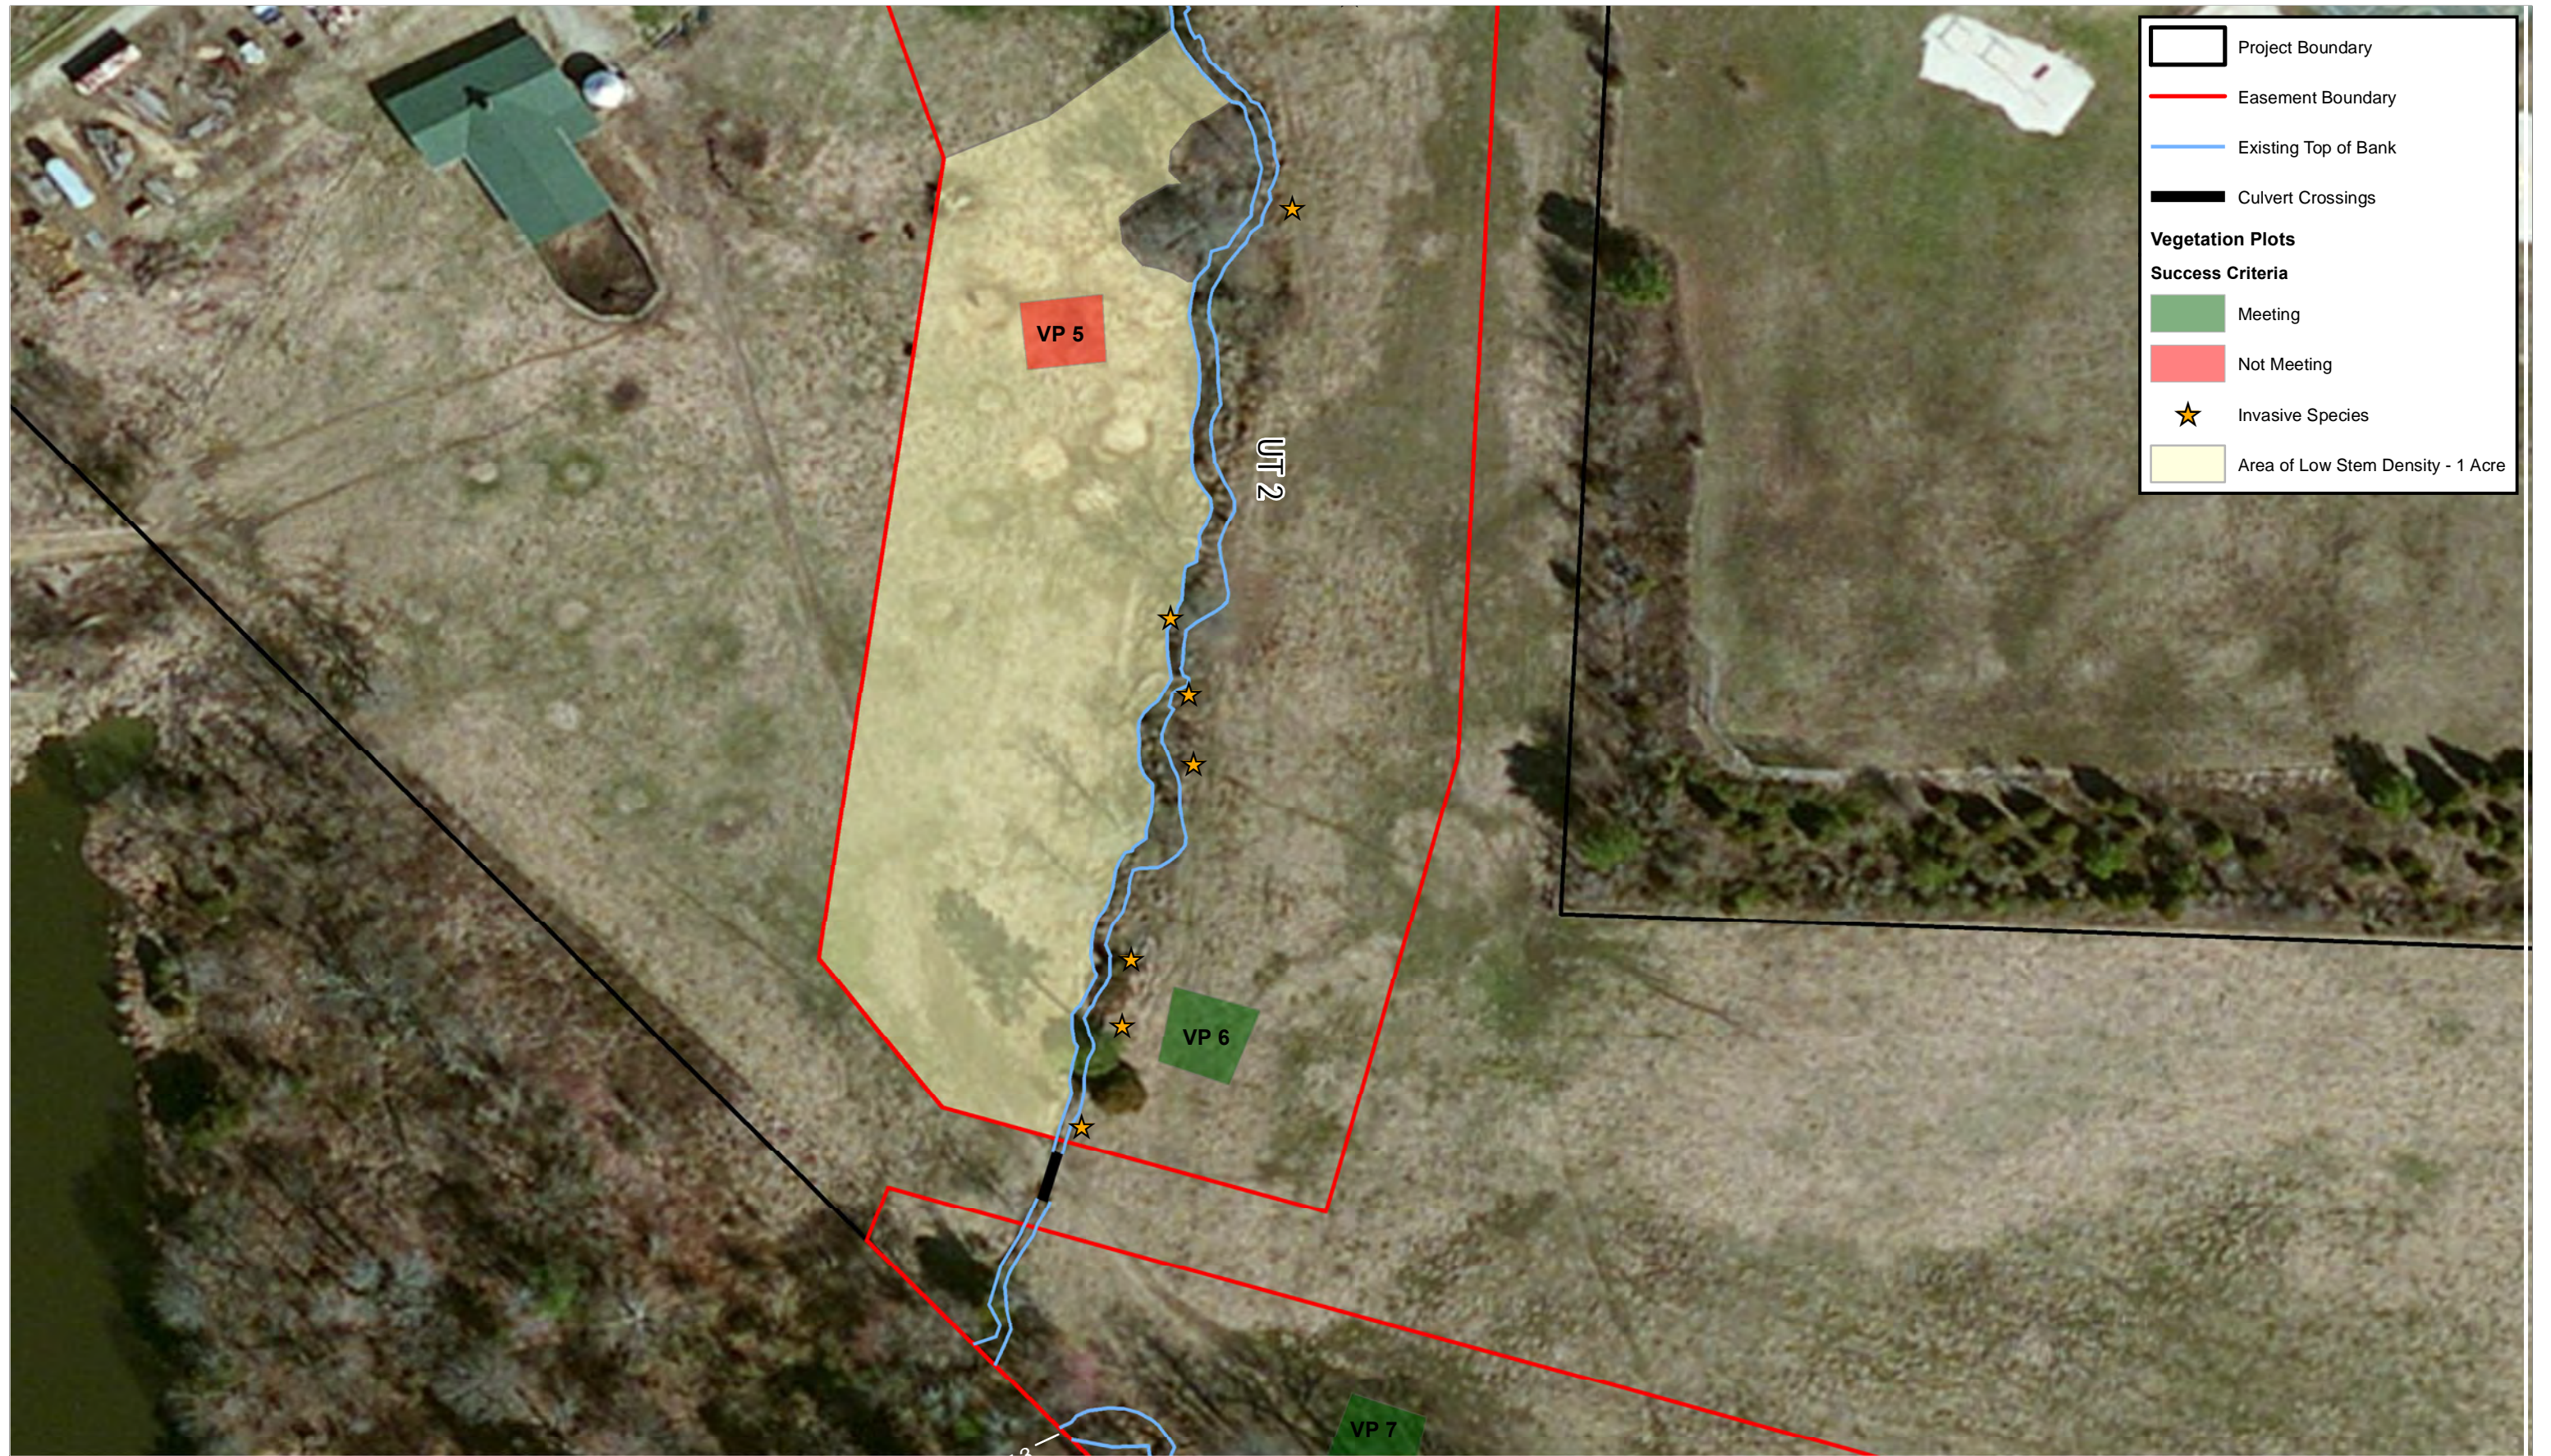
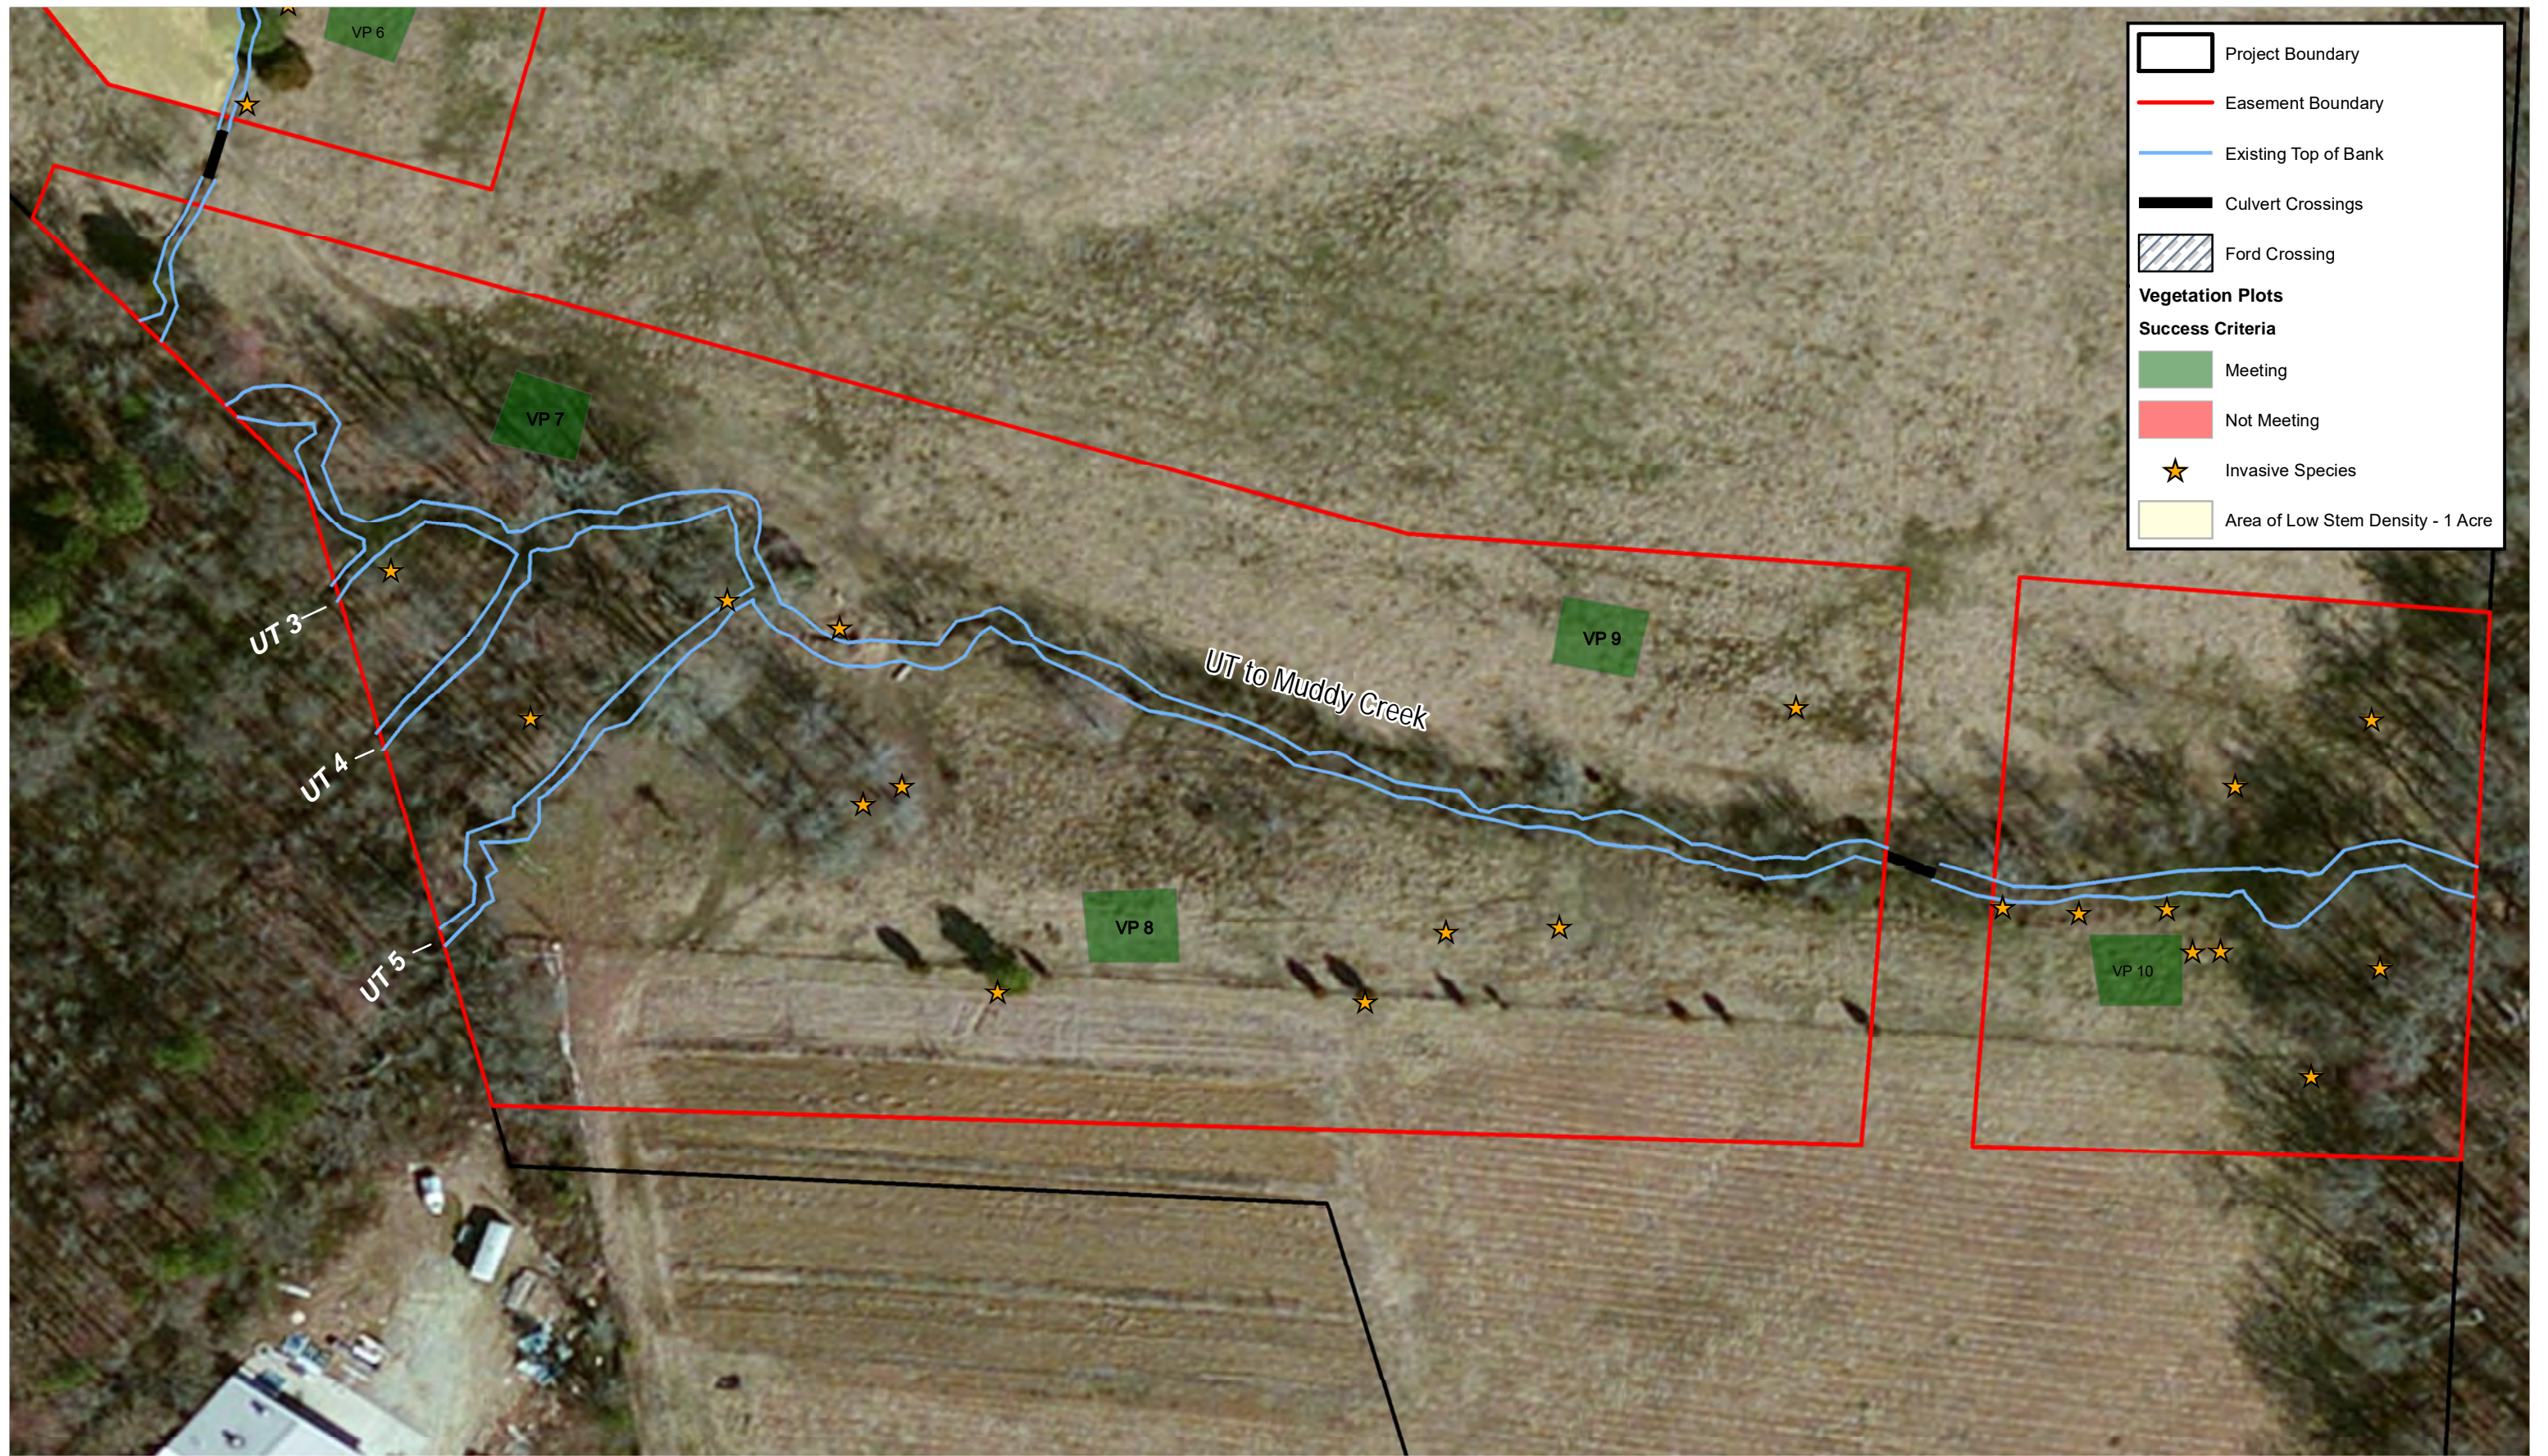
CCPV MAP YEAR 2
 WHITE BUFFER MITIGATION SITE
 RANDOLPH COUNTY, NORTH CAROLINA
