MY2 Monitoring Report

White Mitigation Project
Randolph County, NC
Cape Fear River Basin

NCDMS Project No. 100112
NCDMS Contract No. 7860
NC DWR Project No. 2019-0884
RFP No. 16-007703

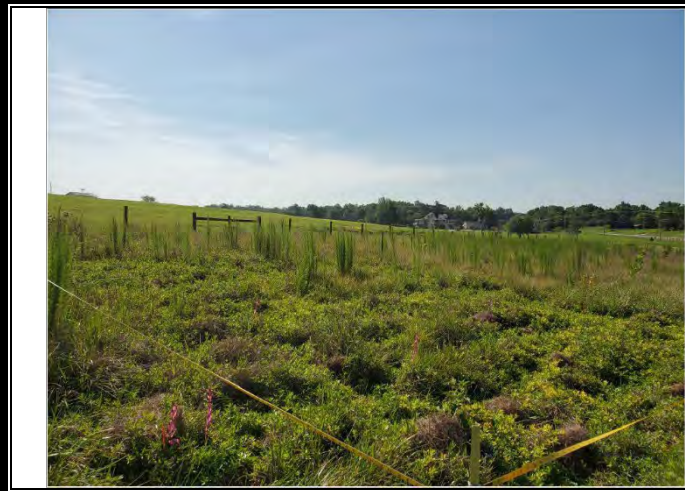
Vegetation Plot 1 is demonstrating a planted stem density of 161 stems per acre after 2 years of monitoring. With the inclusion of volunteer stems the plot still fails to meet success criteria with only 242 stems per acre. It is unknown what is causing the high mortality of planted stems within the vegetation plot. Visual observations at the time of monitoring suggests that the stem density of VP1 is not indicative of planted stem survival in the surrounding area and the plot will be reassessed during MY3 monitoring.

Figure 5.1 Vegetation Plot 1 (07/28/2022)

Section 2.2: Suggest surveying a random vegetation plot(s) in the areas surrounding VP1 in MY3 to support visual assessment of stem survival outside VP1.

RE: A Random vegetation plot will be surveyed in the area near VP1 and included in the MY3 report if it fails to meet density criteria in MY3.

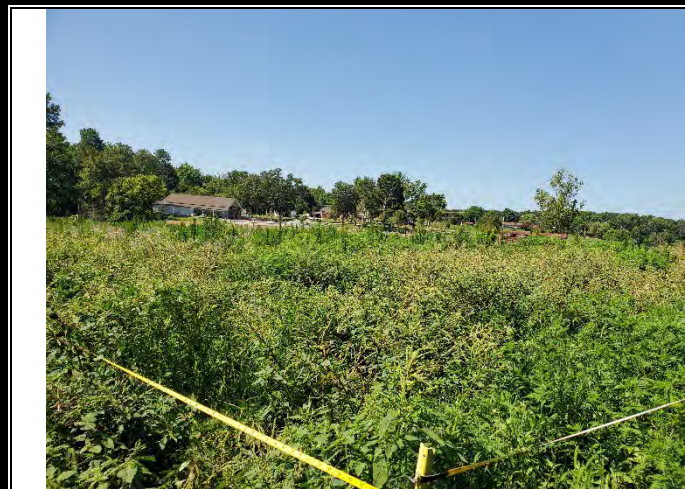
Vegetation plot 5 has failed to meet criteria for the second year in a row due to dense herbaceous growth. Knotweed (*Polygonum* spp.) and spiny pigweed (*Amaranthus spinosus*) have taken the place of fescue, stifling bare-root plantings in and around VP5. VP5 had a stem density of 81 stems per acre, with only two bare-root plantings surviving in the plot; others were either dead or unable to be located due to the dense vegetative growth.

Figure 5.5 Vegetation Plot 5 (07/28/2022)

Dense herbaceous vegetation observed along the right bank of UT2 near VP5 has choked out planted stems. This area is depicted in the Current Condition Plan Review (Figure 4.1-4.5). It is anticipated that approximately 1 acre of area will be replanted at a density of 360 stems per acre (Figure 6) in March 2023. Table 7 outlines species and quantities chosen for the replant based on the approved planting plan in the Mitigation Plan. Prior to replanting this area, the dense herbaceous layer of vegetation may be mowed to allow planted stems time to establish.

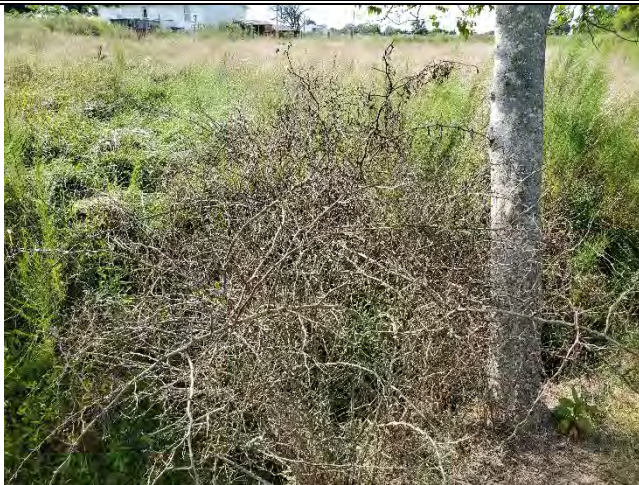
Several areas of Chinese privet (*Ligustrum sinense*) and multiflora rose (*Rosa multiflora*) were treated in April 2021 (MY1). While the areas previously treated are dead, 38 new areas of invasive growth were discovered during vegetation monitoring in September 2021 and May 2022, and are depicted in Figures 4.1-4.5. It is important to note that the Site had dense growth of Chinese privet along the banks and floodplain of UT MC, UT 3, UT 4, and UT 5 that were treated and removed during construction. Much of the new growth is a result of stump coppicing and sprouting from a prevalent seed bank. New areas of invasive species growth were treated in May and July 2022. Further details of invasive species management procedures can be found in Section 2.3 of this document.

Figure 5.11 Treated Multiflora rose UT2
(07/28/2022)

Approximately 38 instances of invasive species, mainly Chinese privet and multiflora rose, were spot treated using a 6% solution of aquatic glyphosate. Treatments were made during May 2022 and July 2022. Invasive species will be monitored and treated as needed in subsequent monitoring years.

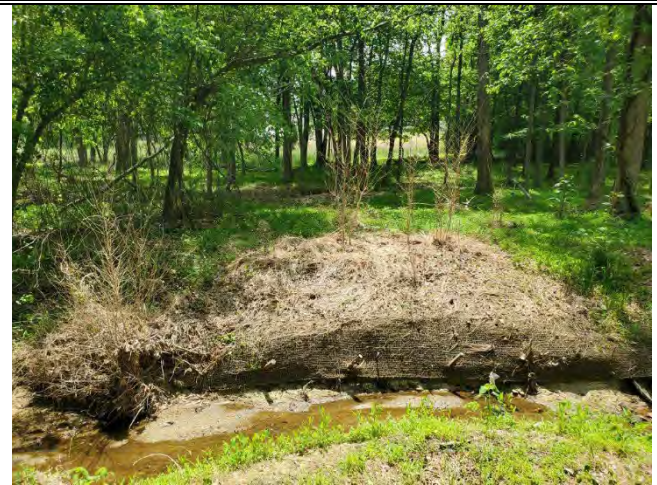
The 1,830 feet of repaired stream bank has remained stable over the past year of monitoring. Livestakes and bare-root plantings along the majority stabilized streambanks have increased in vigor over the past monitoring year. One bare area measuring 20 feet in length was observed during the spring invasive species treatment at the confluence of UT 3 and UT MC. While the stream bank remains stable, livestock will need to be reestablished in the subsequent monitoring year.

Figure 5.12 Lack of vegetation along bank at confluence
of UT3 and UT to Muddy Creek (07/28/2022)

Livestakes will be clipped from black willow (*Salix nigra*) and tag alder (*Alnus serrulata*) on site and reestablished in the bare area observed between UT 3 and UT MC.

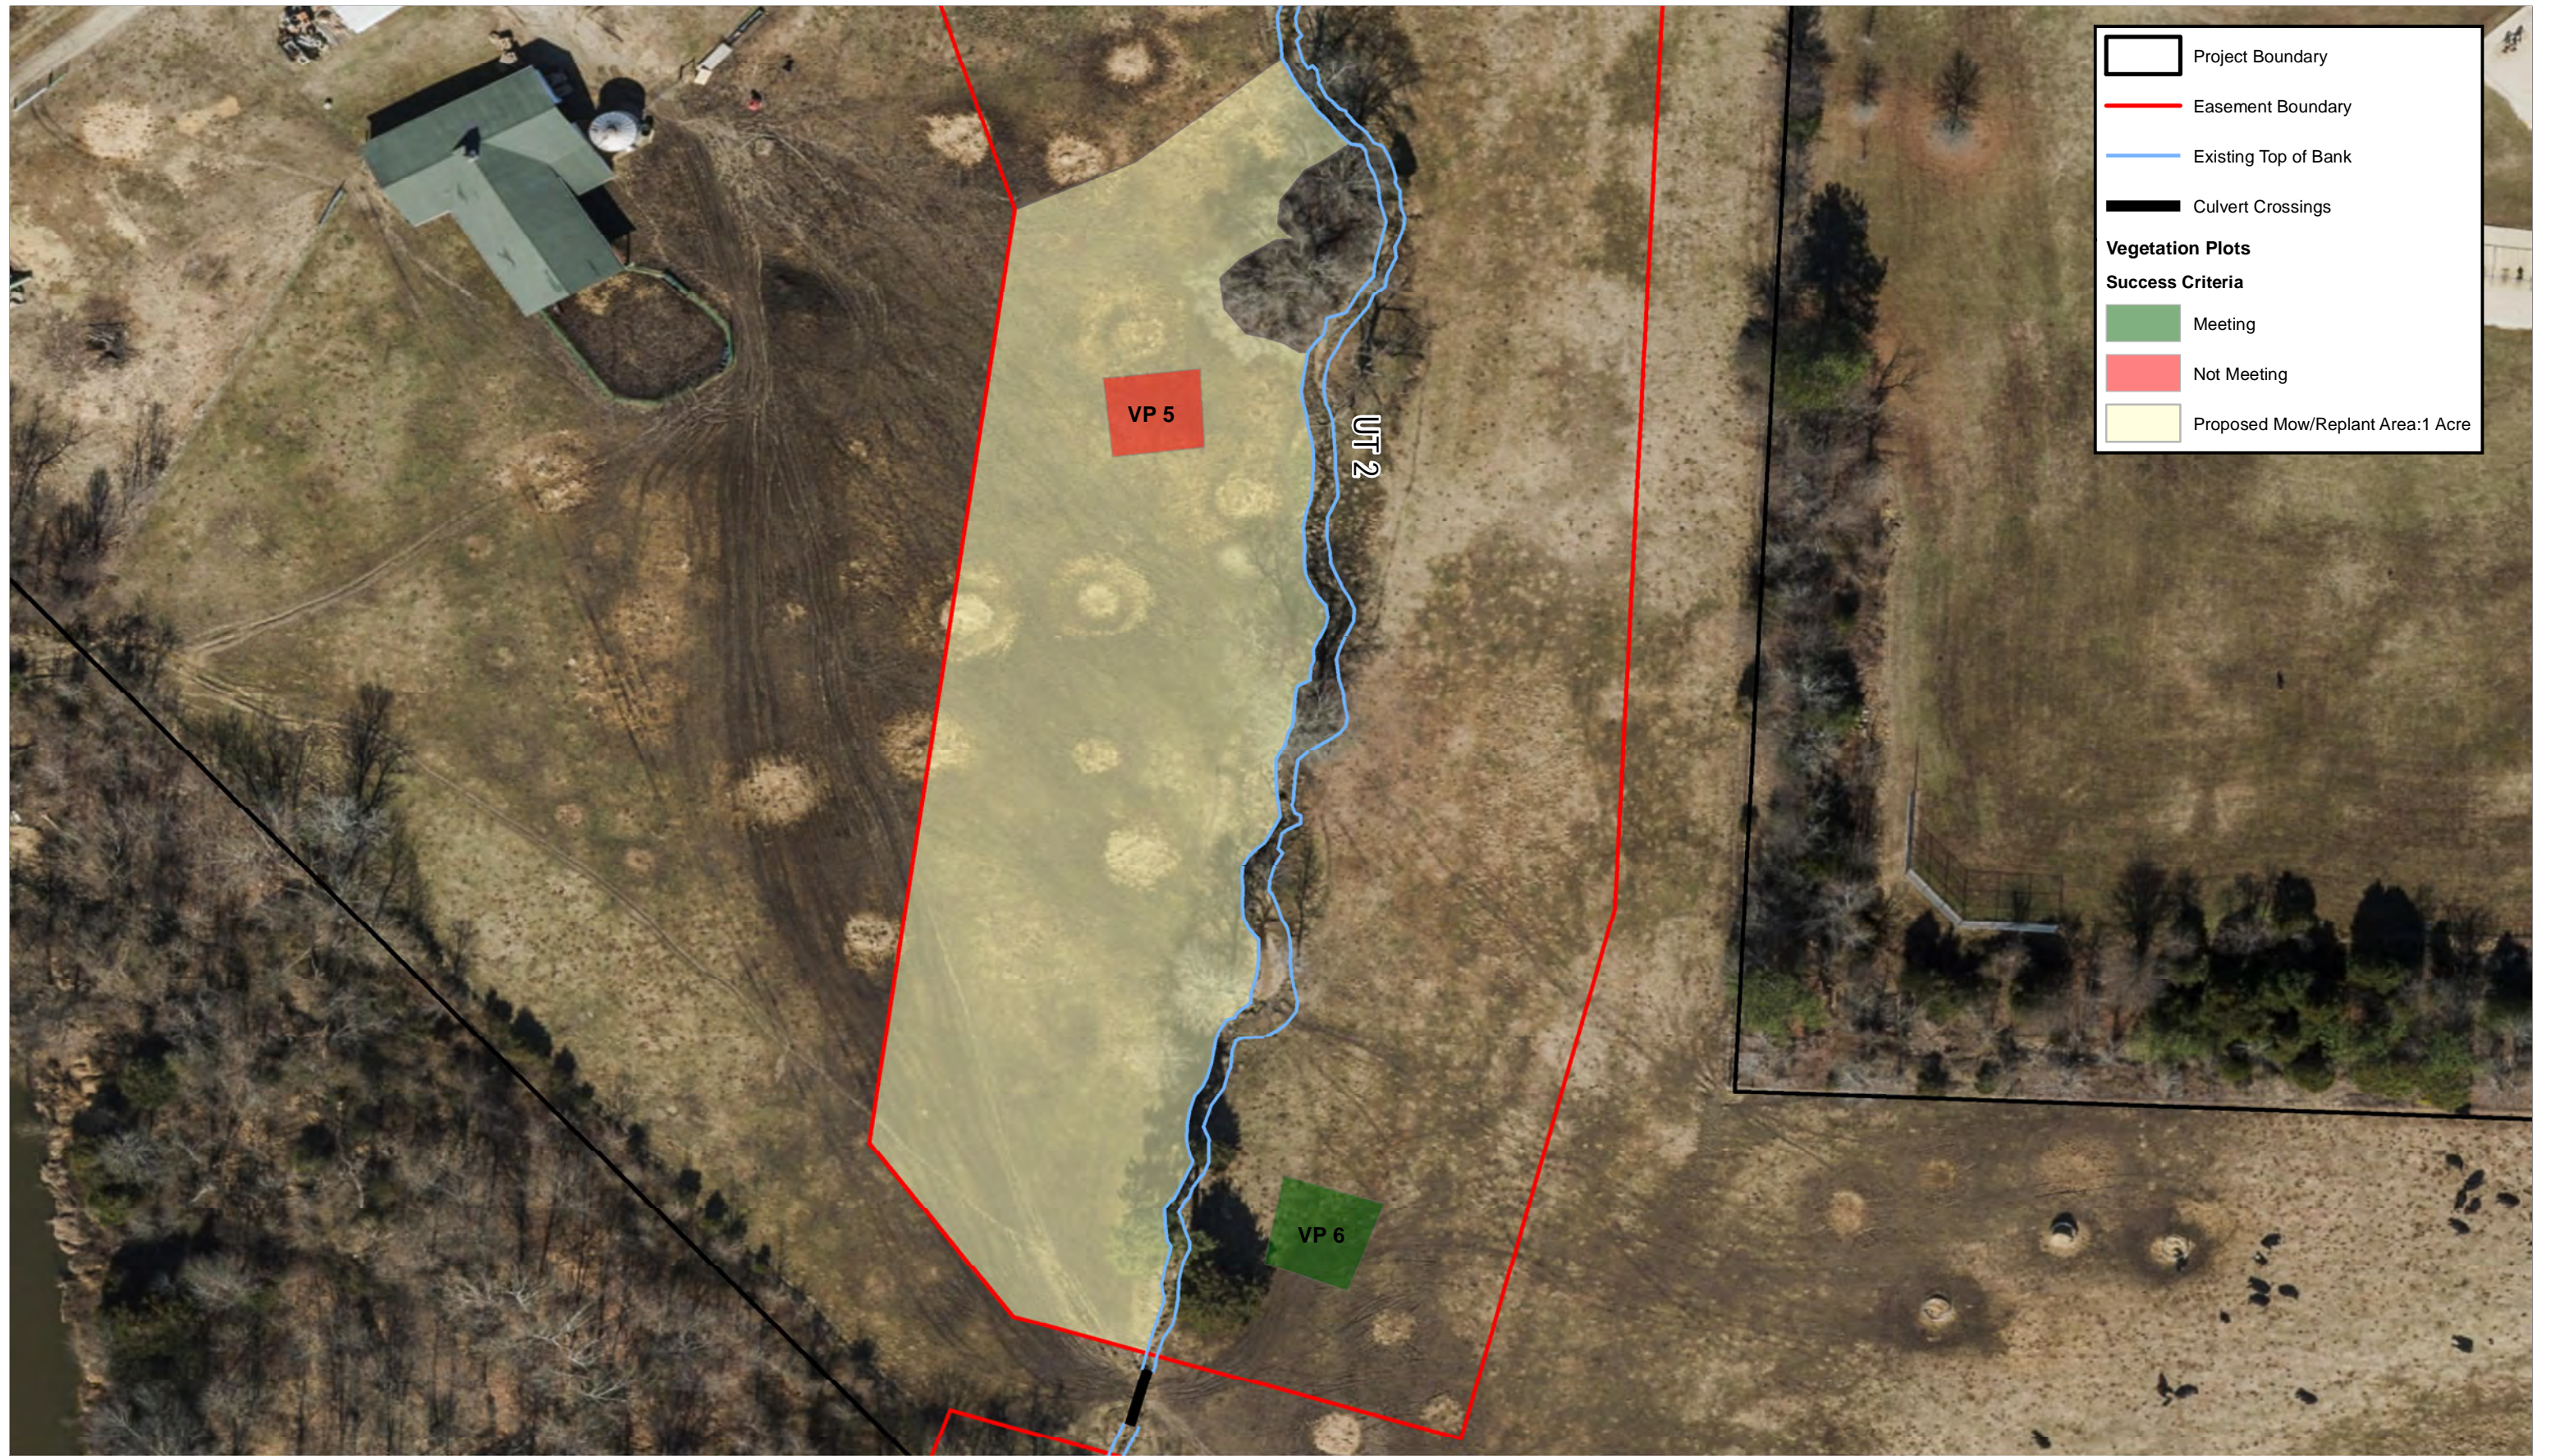
PROPOSED REPLANT AREA MAP
 WHITE BUFFER MITIGATION SITE
 RANDOLPH COUNTY, NORTH CAROLINA

Proposed Mow/Replant Area: 1 Acre
