MY3 Monitoring Report

White Mitigation Project
Randolph County, NC
Cape Fear River Basin

NCDMS Project No. 100112
NCDMS Contract No. 7860
NC DWR Project No. 2019-0884
RFP No. 16-007703

Construction Completed: 2021
Data Collected: August 23, 2023
Report Submitted: January 19, 2024

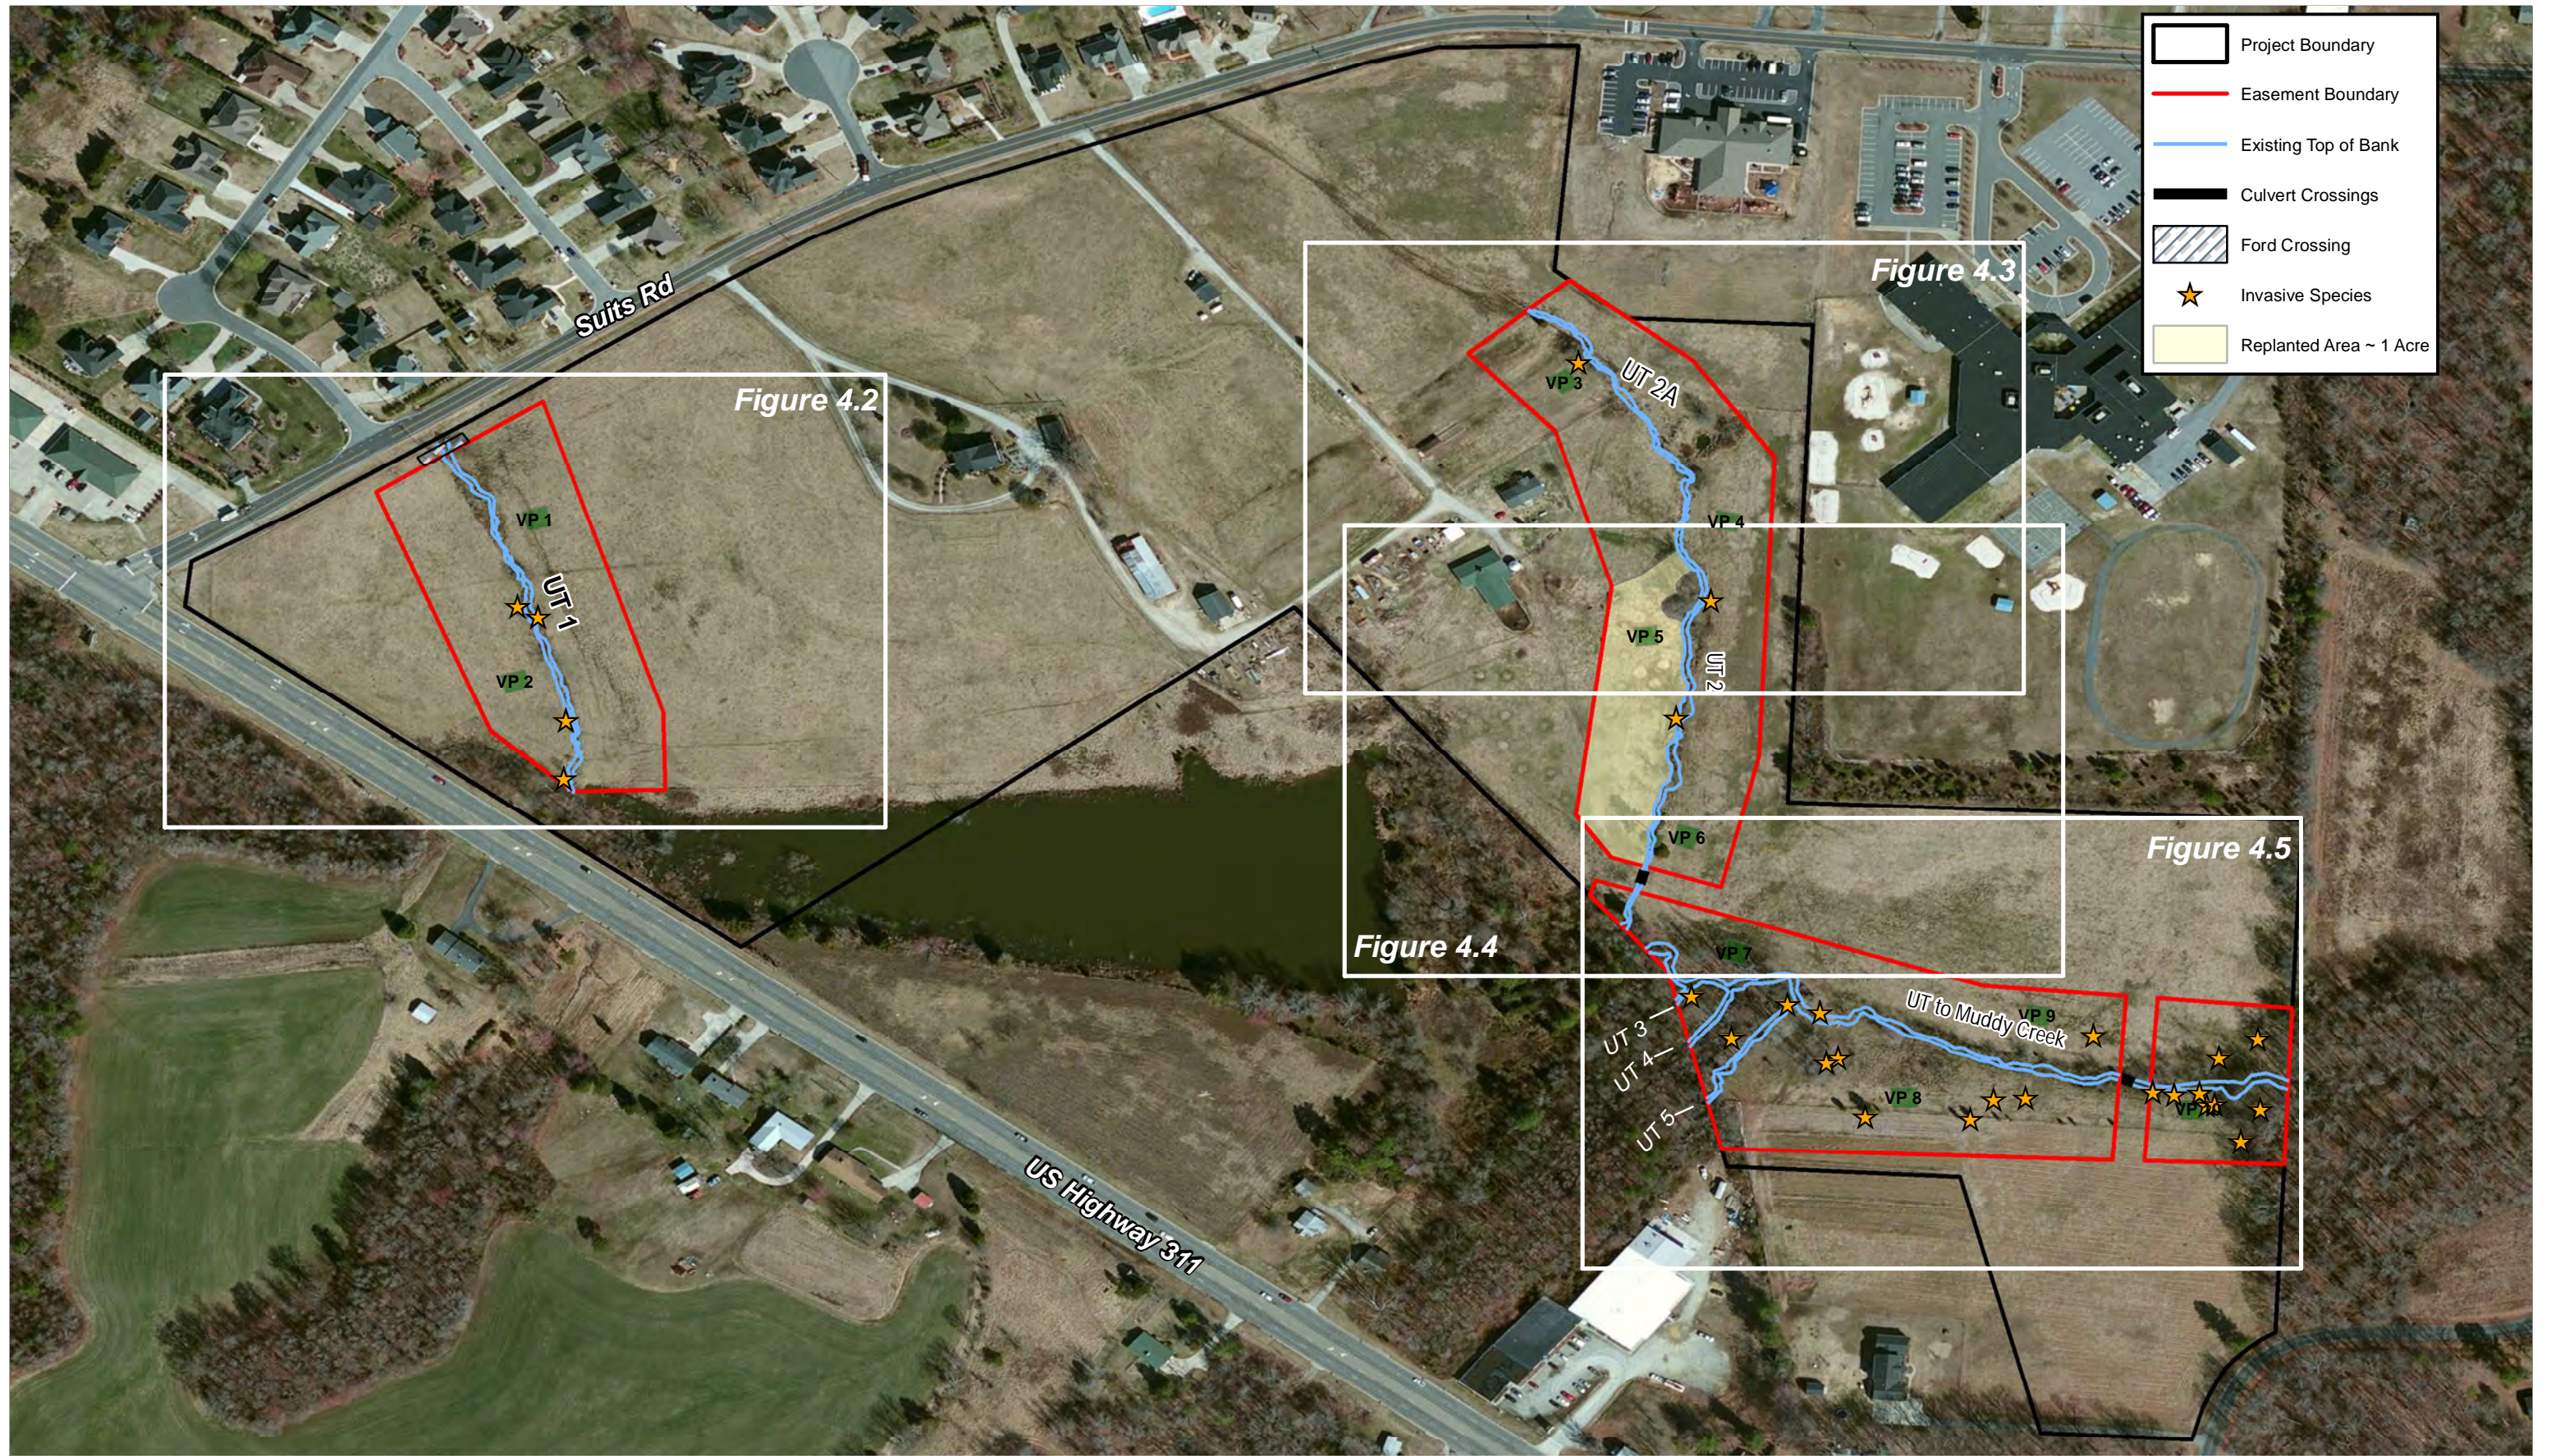
- Project Boundary
- Easement Boundary
- Existing Top of Bank
- Culvert Crossings
- Ford Crossing
- ★ Invasive Species
- Replanted Area ~ 1 Acre

Some areas of invasives that were treated in MY2 persisted into MY3. sporadic individuals of invasive species, mainly Chinese privet and multiflora rose, were spot treated using a 6% solution of aquatic glyphosate in August 2023. Areas treated in MY3 are depicted in the CCPV (Figures 4.1-4.5 [Appendix A]). It is important to note that the Site had dense growth of Chinese privet along the banks and floodplains of UT MC, UT 3, UT 4, and UT 5 that were treated and removed during construction. Much of the new and/or returning growth is a result of stump coppicing and sprouting from a prevalent seed bank. Invasive species will continue to be monitored and treated as needed in subsequent monitoring years.

Dense herbaceous vegetation observed along the right bank of UT2 near VP5 choked out planted stems in MY2 and was subsequently mowed and replanted on March 7, 2023. This area is depicted in the CCPV (Figure 4.1-4.5). Approximately 1 acre was replanted at a density of 360 stems per acre (Figure 6).

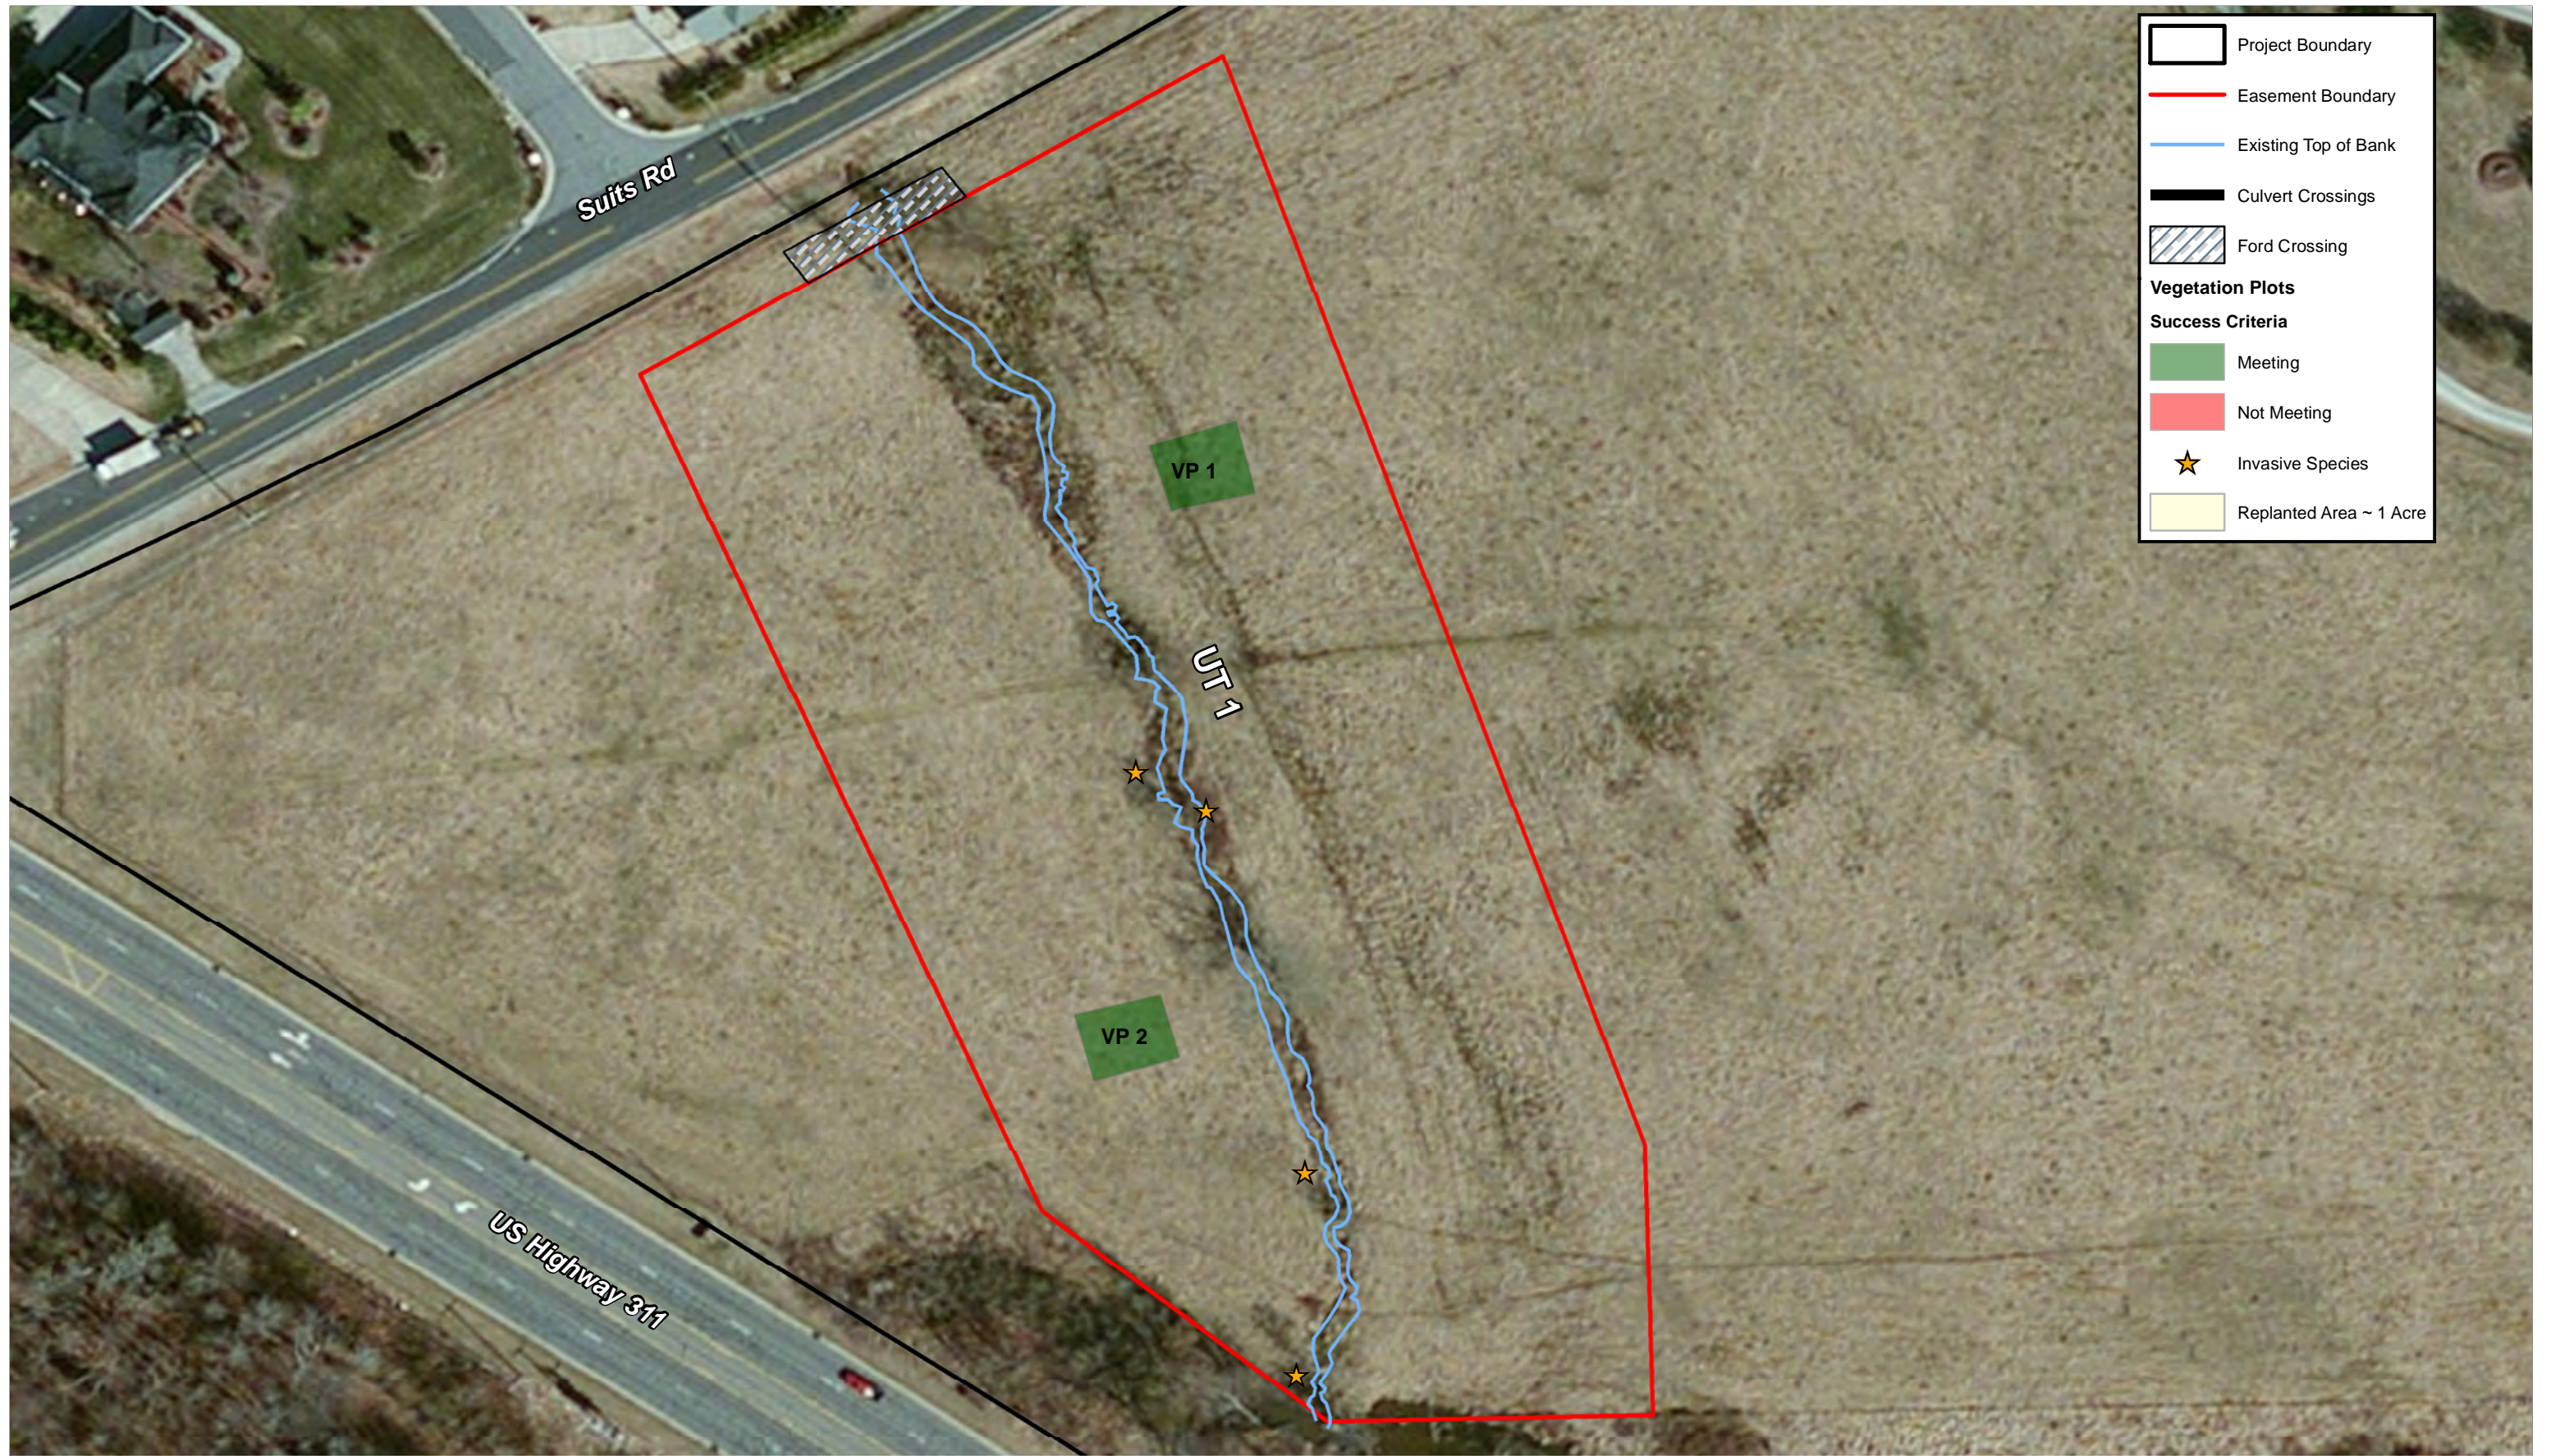
FIGURE 4.2

Project Boundary
	Easement Boundary
	Existing Top of Bank
	Culvert Crossings
	Ford Crossing
Vegetation Plots	
Success Criteria	
	Meeting
	Not Meeting
	Invasive Species
	Replanted Area ~ 1 Acre

In MY2, dense herbaceous vegetation observed along the right bank of UT2 near VP5 choked out planted stems. After consulting with DMS, approximately 1 acre near VP5 was mowed on March 6, 2023 and replanted on March 7, 2023 at a density of 360 stems per acre. The replanted area is depicted in the CCPV (Figure 4.4). Table 7 outlines species and quantities planted based on the approved planting plan in the Mitigation Plan and can be found in Appendix D Adaptive Management Replant Plan.

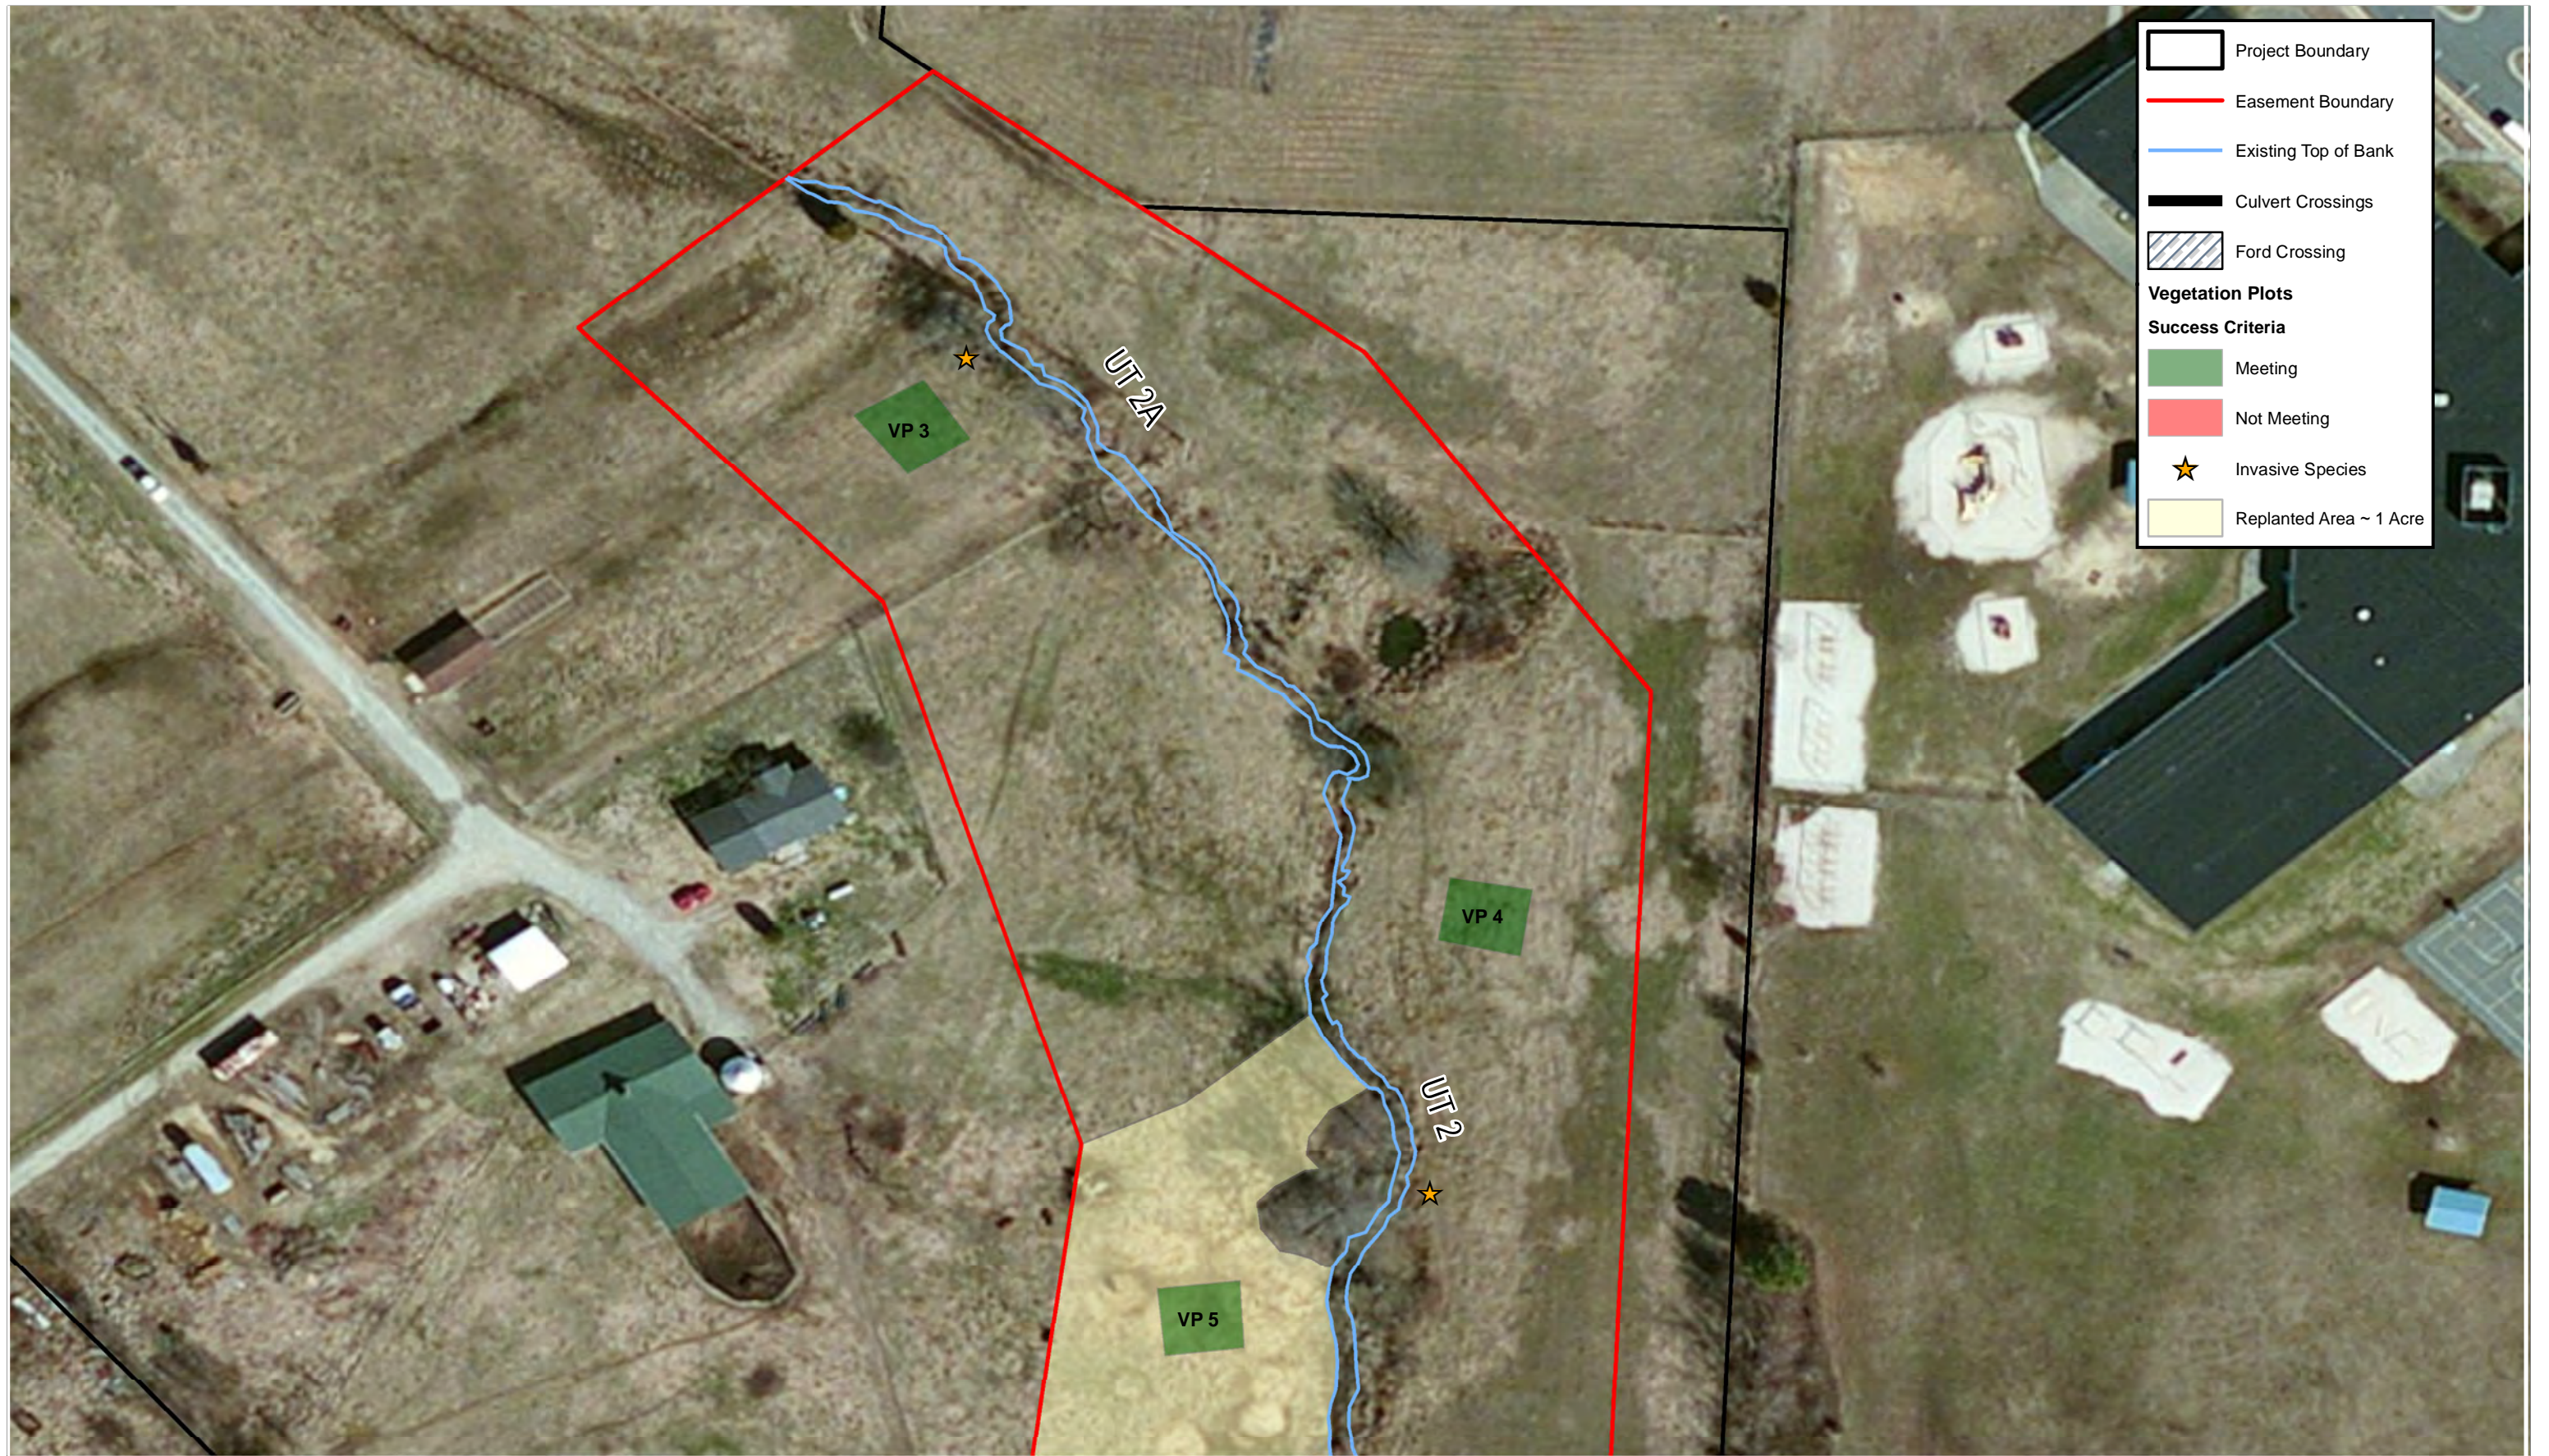
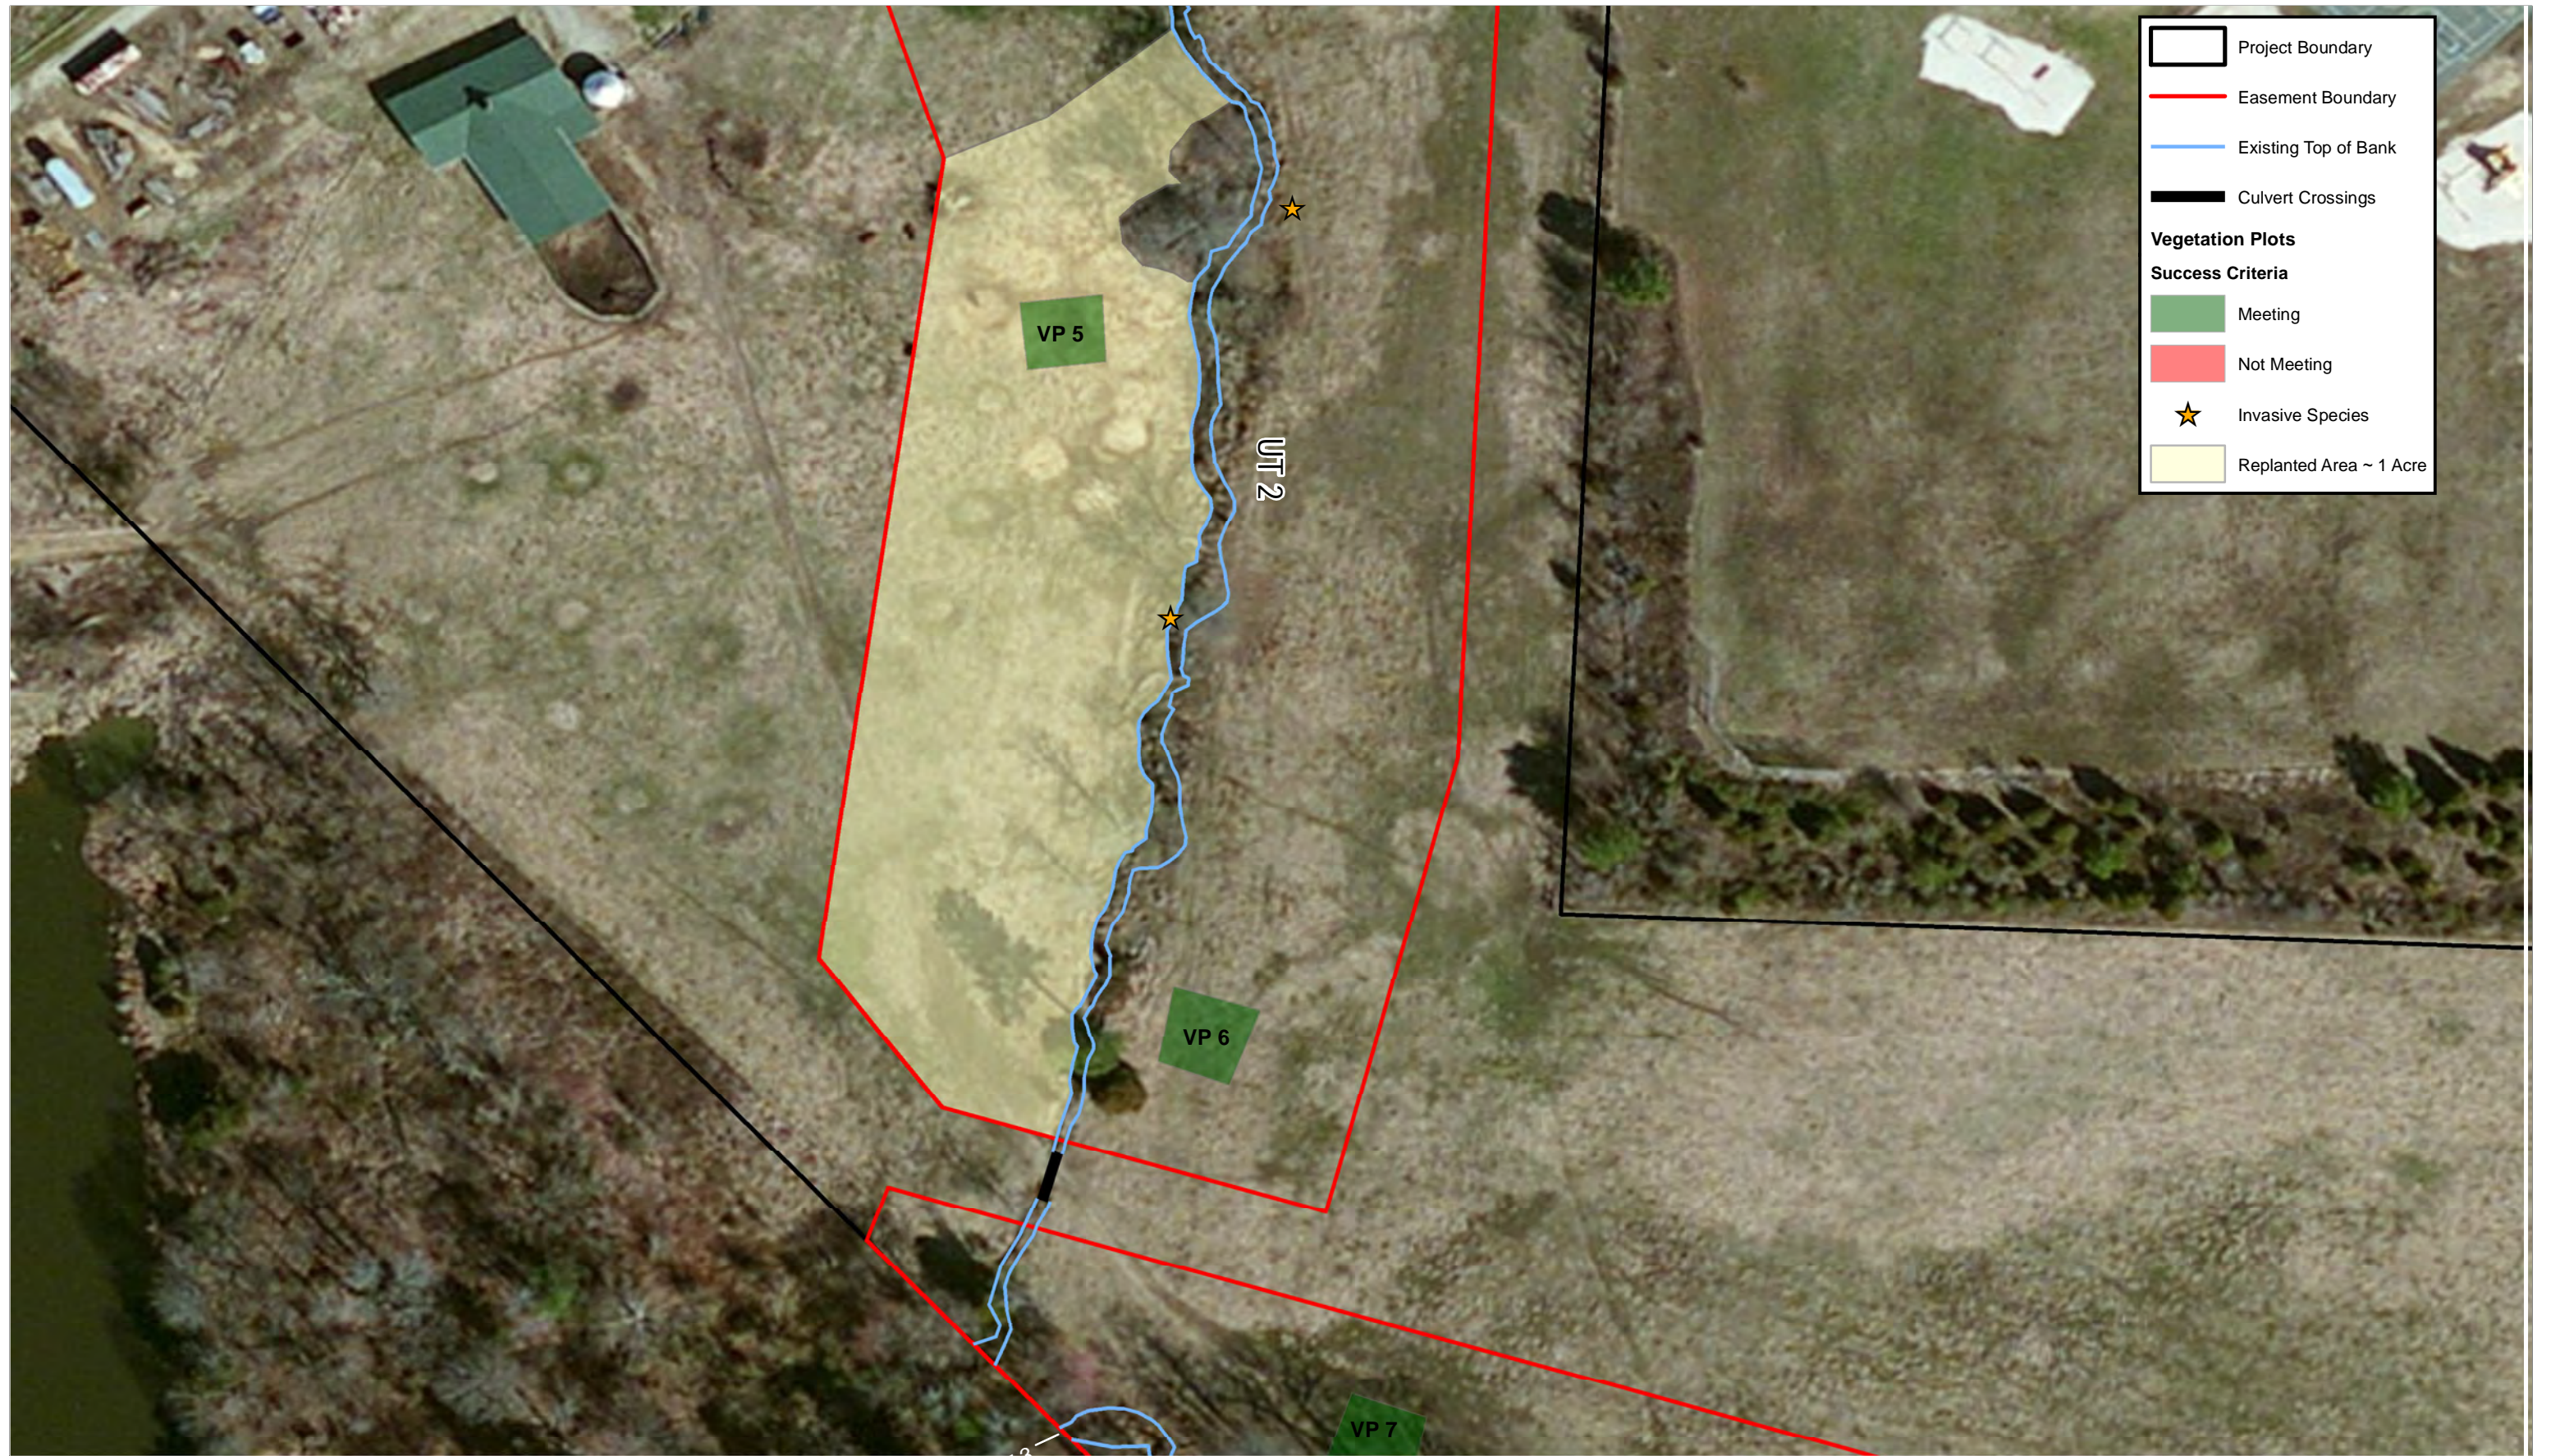
CCPV MAP YEAR 3
 WHITE BUFFER MITIGATION SITE
 RANDOLPH COUNTY, NORTH CAROLINA

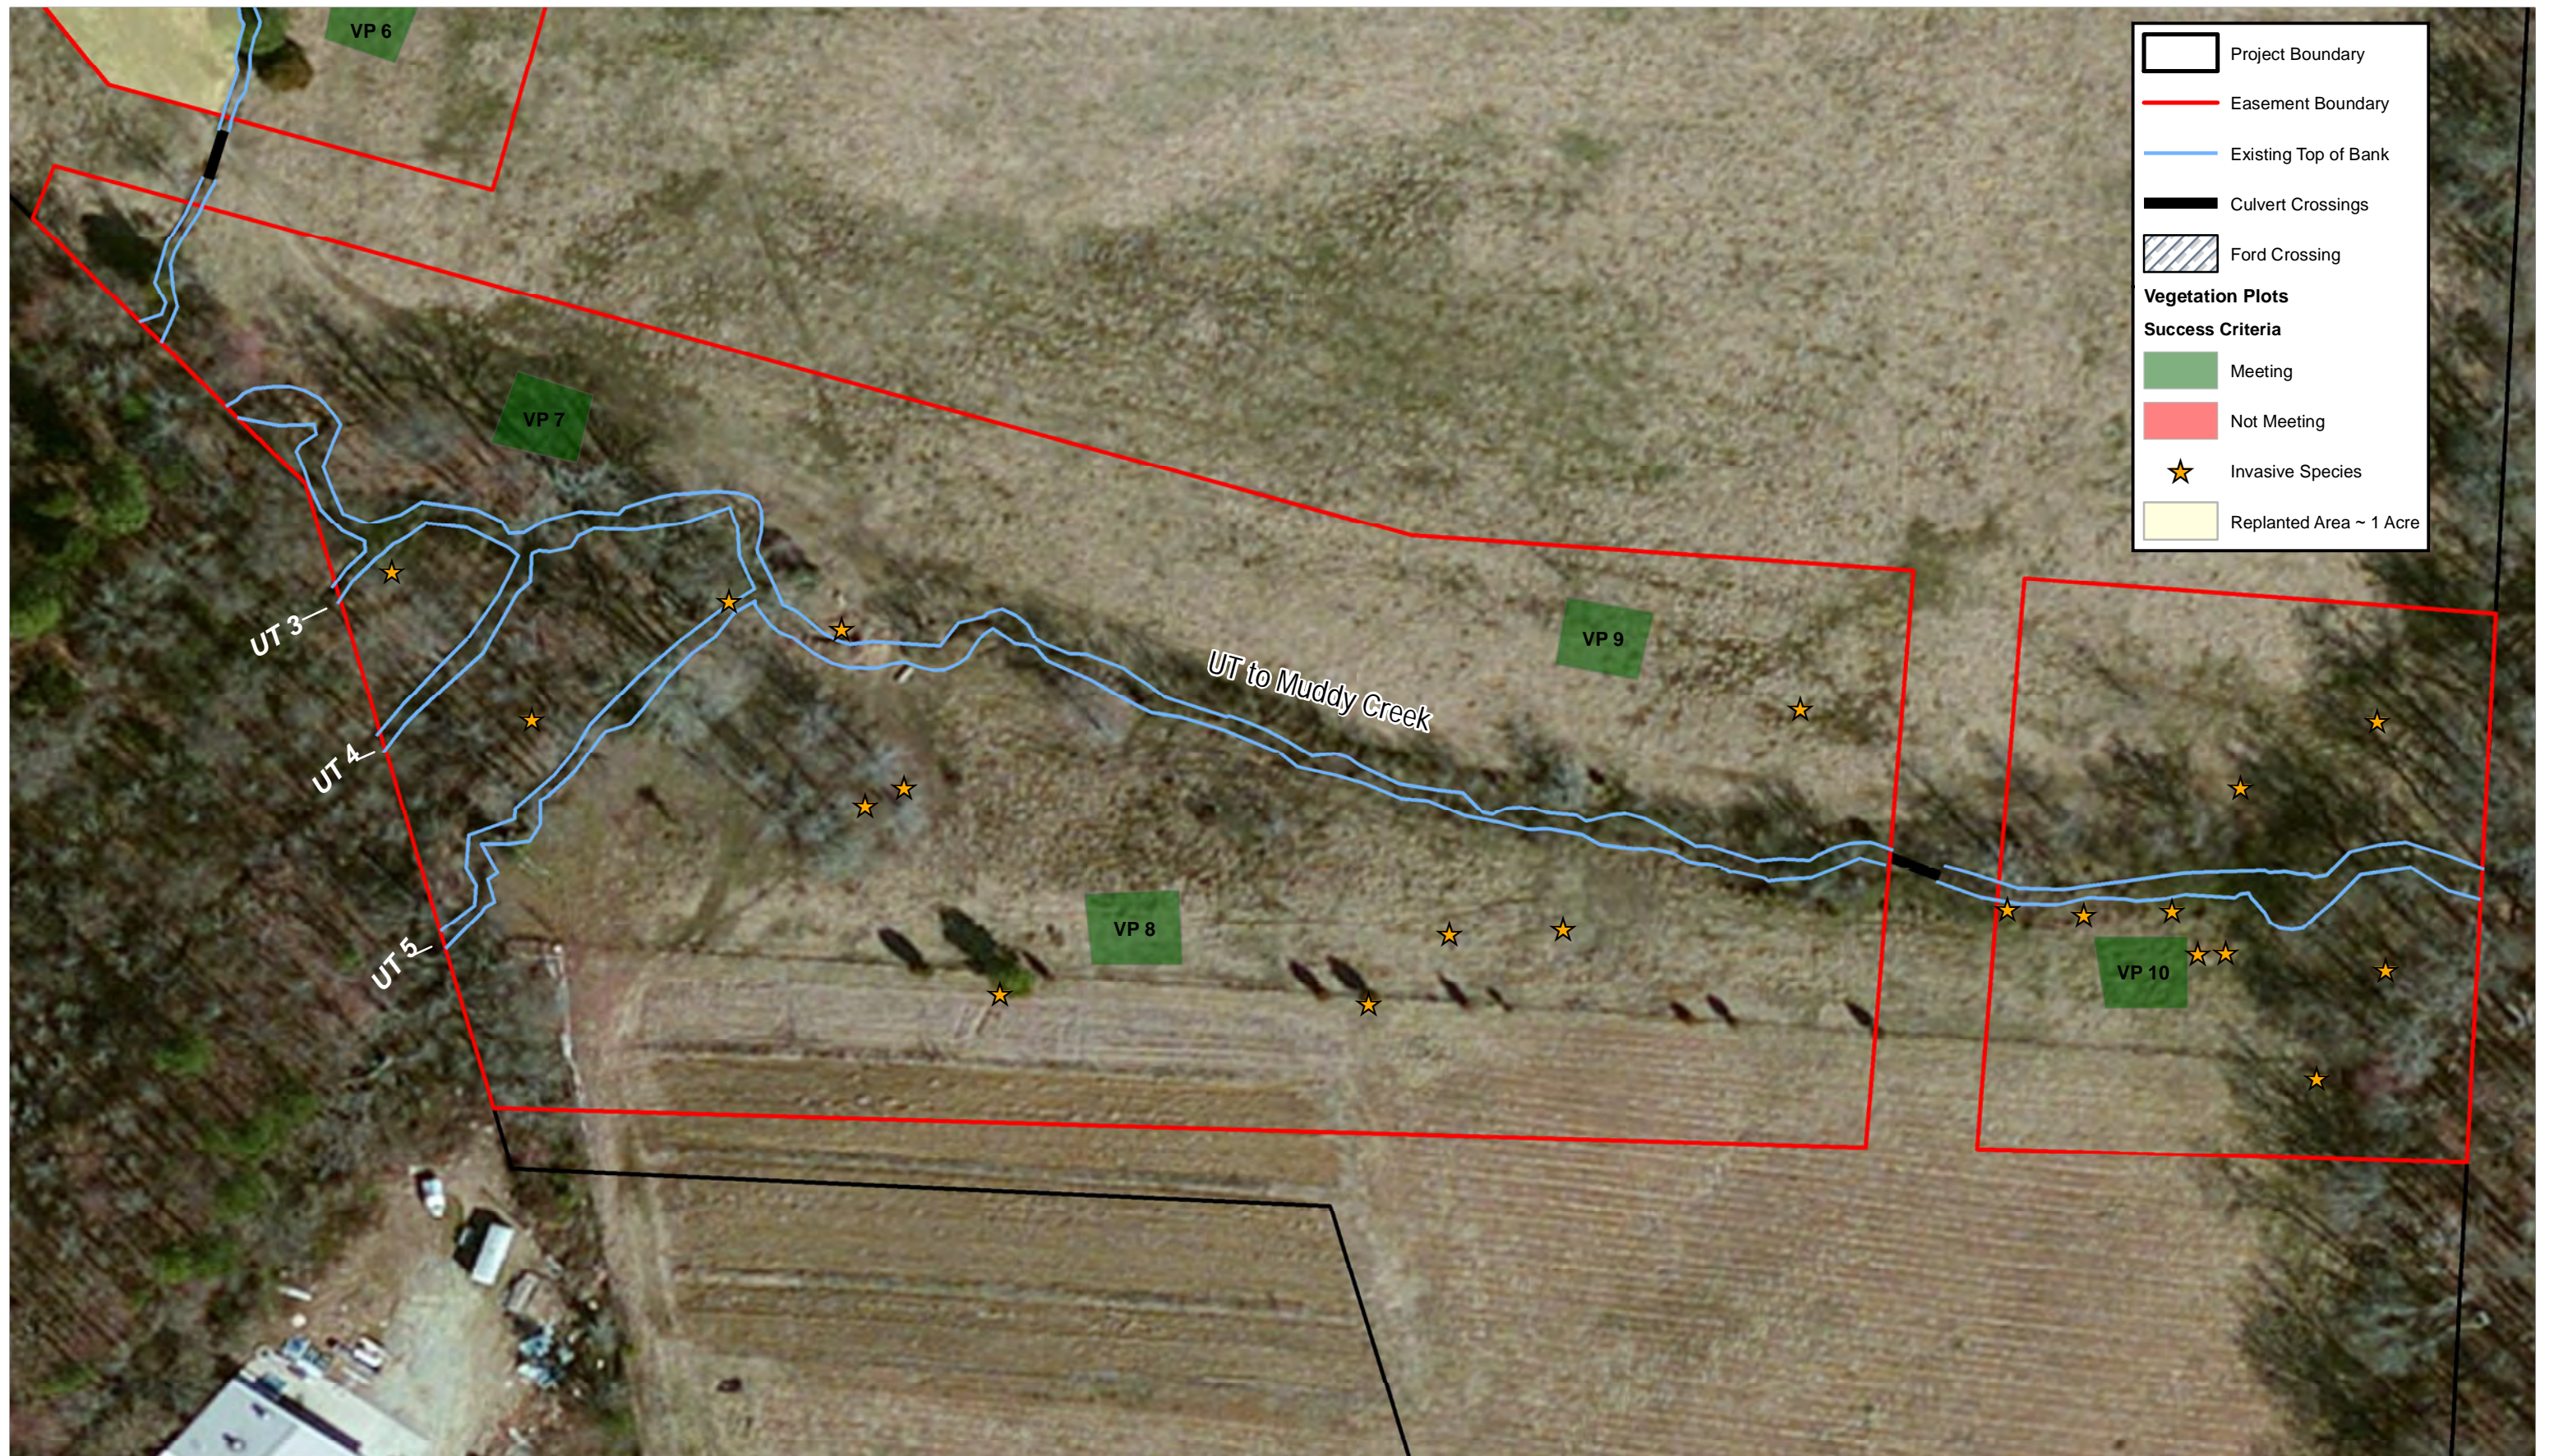
FIGURE 4.5

Project Boundary
	Easement Boundary
	Existing Top of Bank
	Culvert Crossings
	Ford Crossing
Vegetation Plots	
Success Criteria	
	Meeting
	Not Meeting
	Invasive Species
	Replanted Area ~ 1 Acre

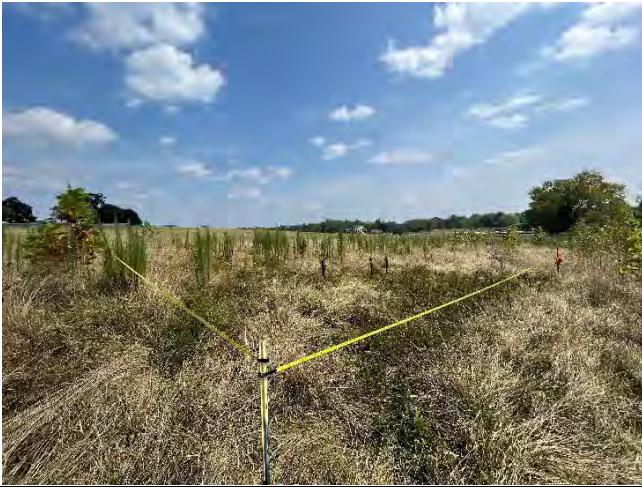
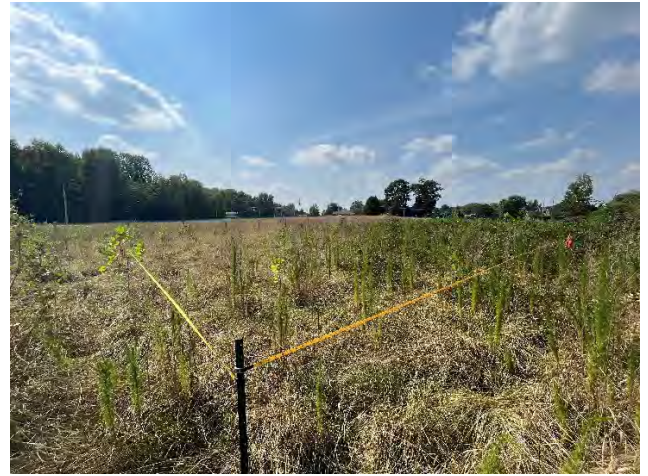
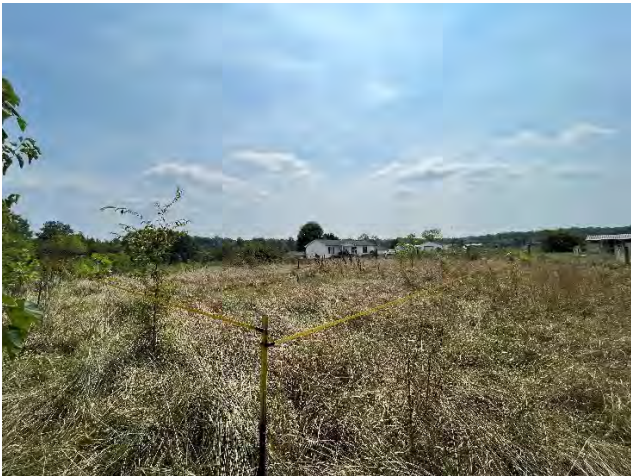
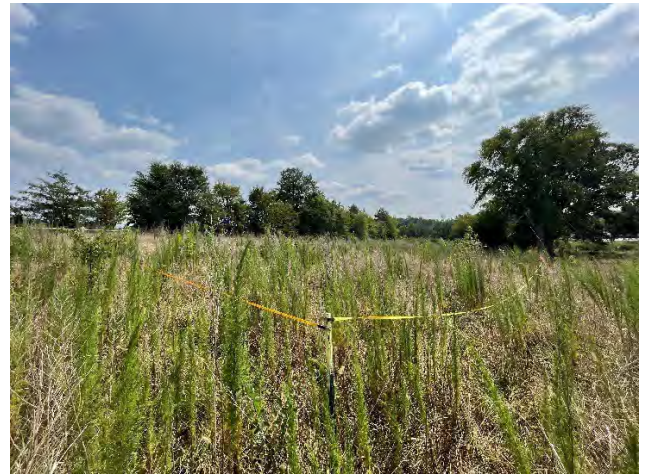
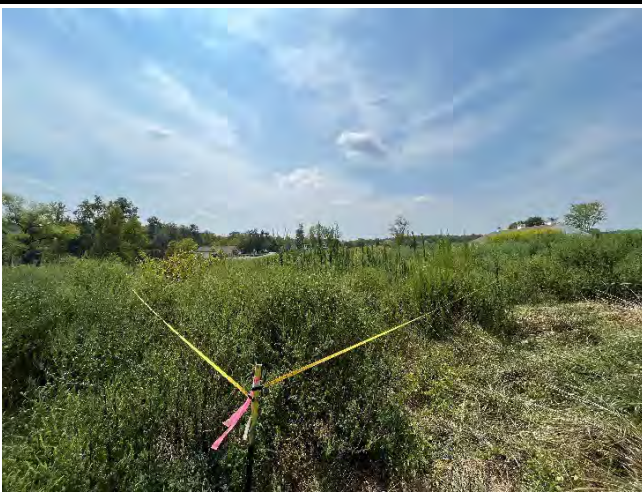
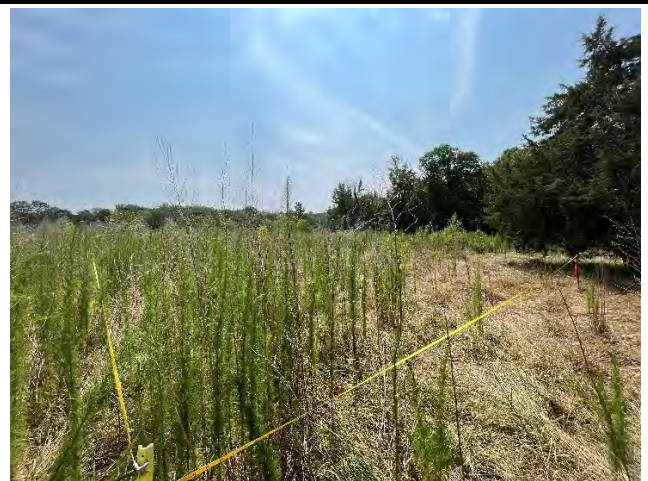
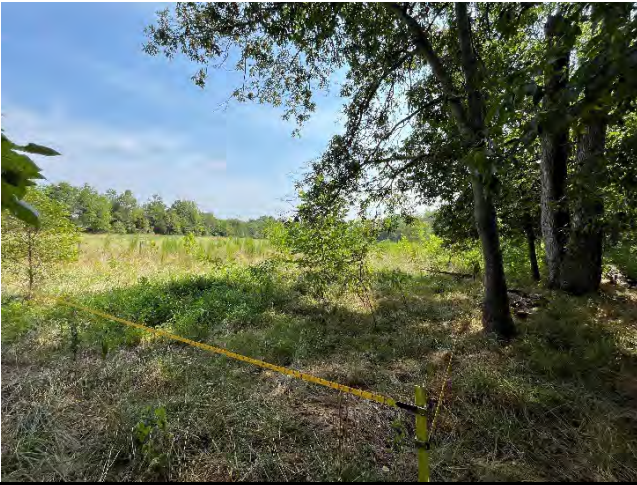
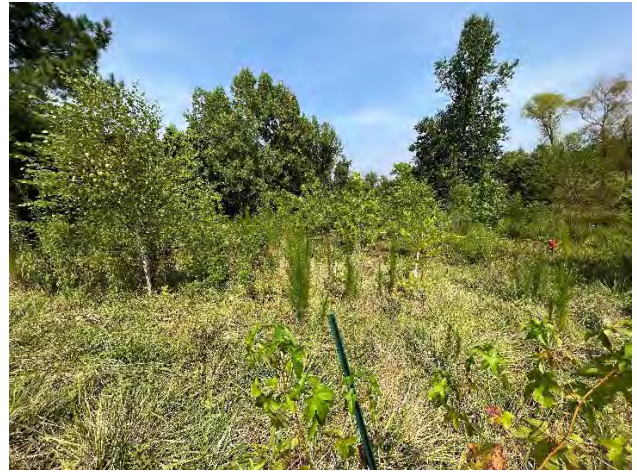
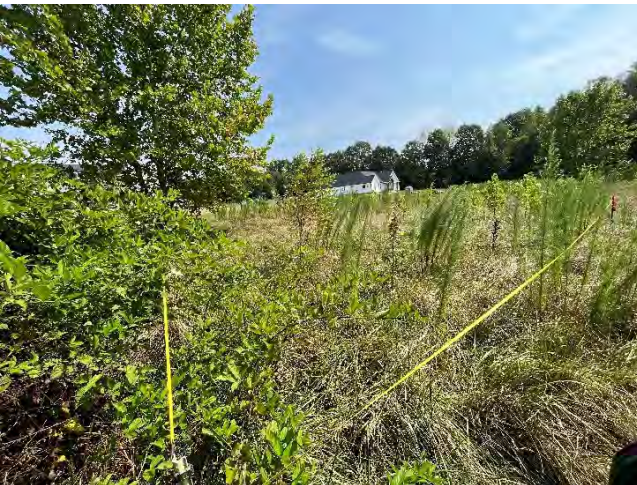
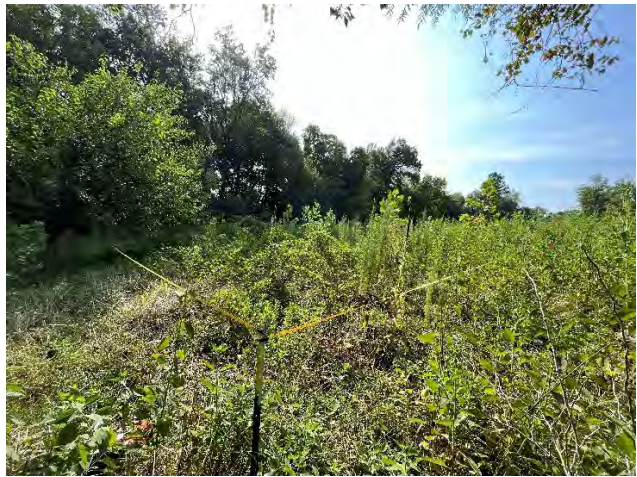
Figures 5.1 - 5.12 Vegetation Plots and Site Photographs

All vegetation plots are meeting or exceeding success criteria outlined in the Mitigation Plan of 260 stems per acre, averaging 364 stems per acre across the Site. Raw data from the CVS tool is included in Table 6 (Appendix B). Individual stem height data is also included in Appendix B
