WHITELACE CREEK STREAM AND WETLAND ENHANCEMENT
AND BUFFER RESTORATION SITE
2011 MONITORING REPORT (YEAR 6 OF 6)

Lenoir County, North Carolina
EEP Project No. 420
Constructed 2005

Status of Plan: Final
Submission Date: November 2011

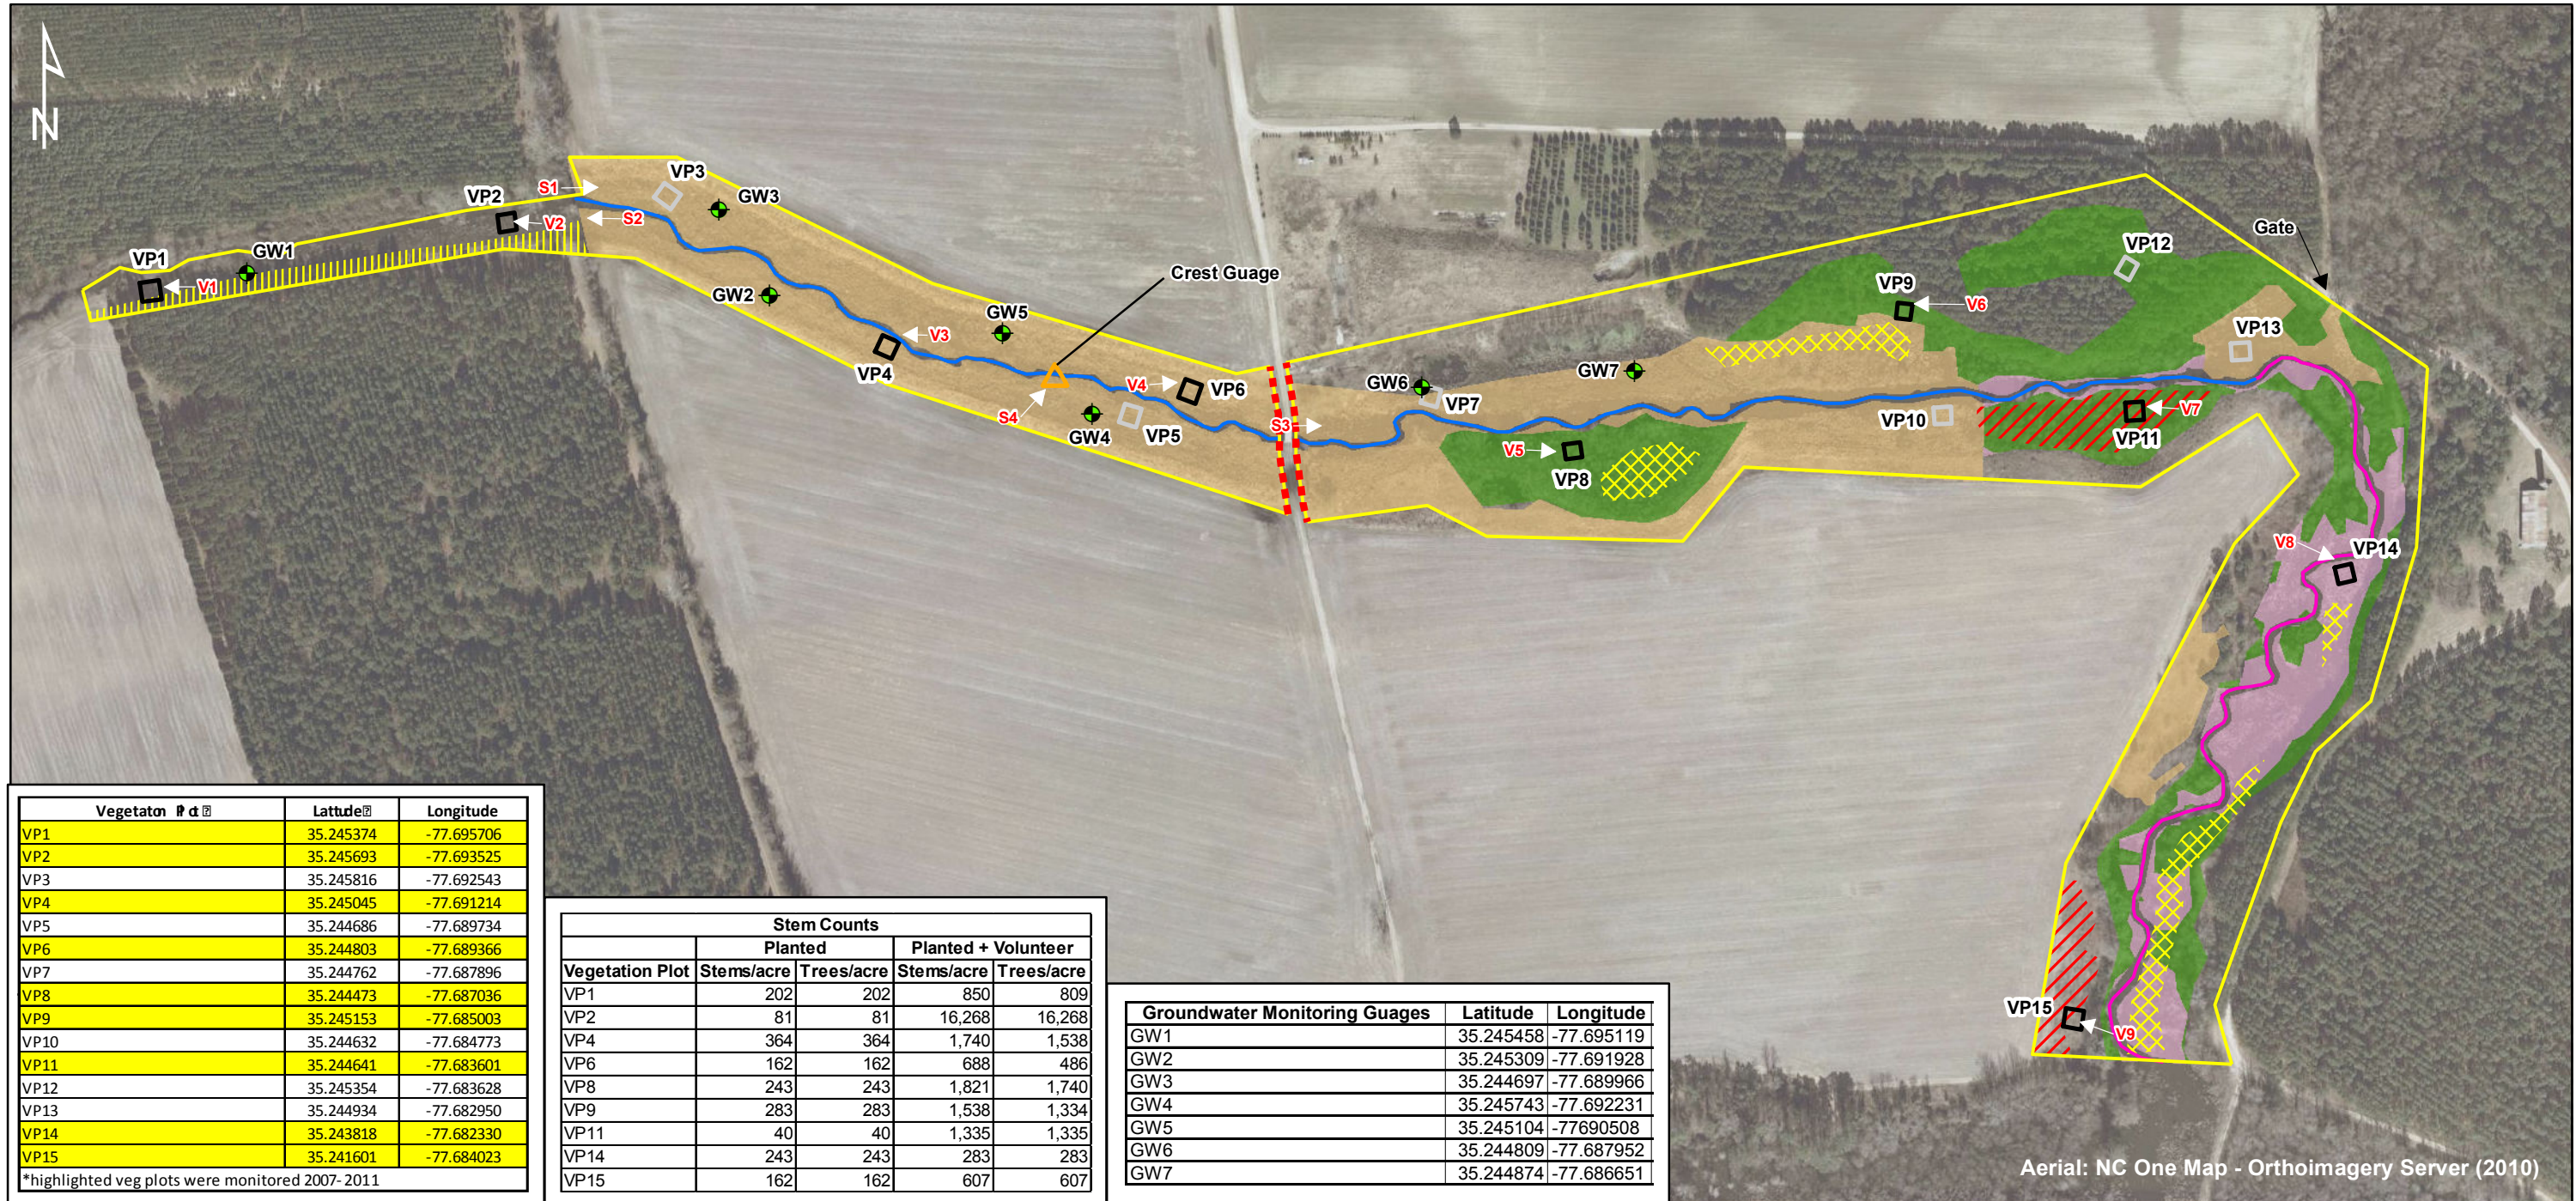
Figure 2 - Current Condition Plan View Map MY6
 Whitelace Creek Stream and Wetland Enhancement
 and Buffer Restoration, EEP #420
 Lenoir County, North Carolina
 November 2011

- Stream Enhancement I (3,293 lf)
 - Stream Enhancement II (1,889 lf)
 - Wetland Enhancement (2.77 ac)
 - Wetland Preservation (8.01 ac)
 - Buffer Restoration (565,734 sq ft)
- Vegetation Plots**
- Not Monitored (6)
 - Monitored (9)
 - Photo Points (V=Veg, S=Stream)
- Monitoring Gauges**
- Successful for MY6 (7)

- Crest Gauge
- Conservation Easement
- Major Vegetation Problem Areas**
- Weak
- Minor Vegetation Problem Areas**
- Lespedeza
- Typha
- Possible Encroachment

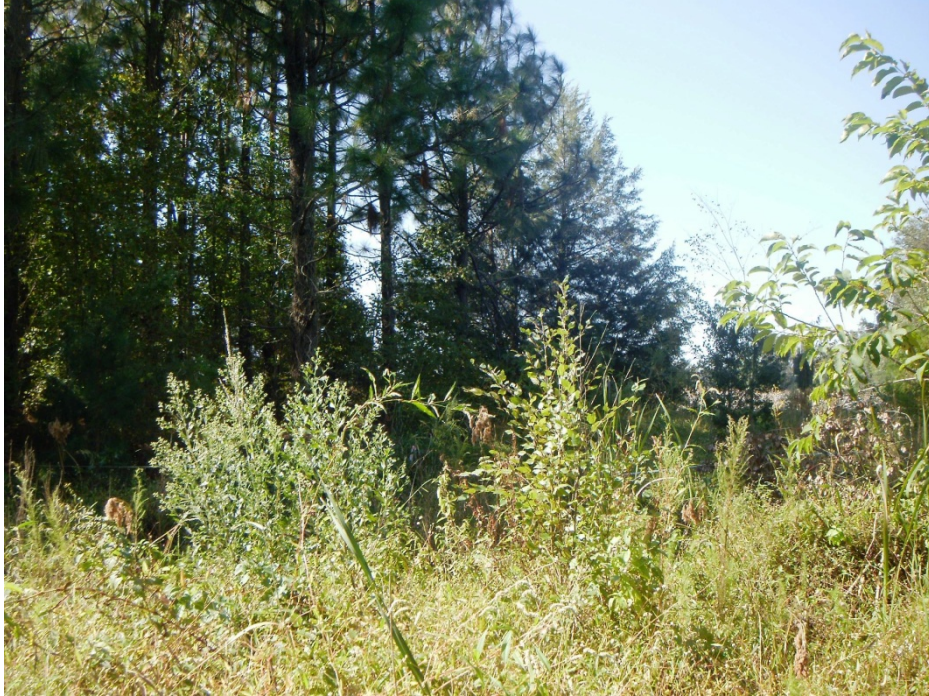
Photo Station 1: Vegetation Plot 1 (10/05/11)

flooding, and deer browsing affected many of the planted trees in vegetation plots. It should be noted that vigorous woody volunteer recruitment (especially *Betula nigra*) is present in the upper section of the reach near Vegetation Plots 1 and 2.

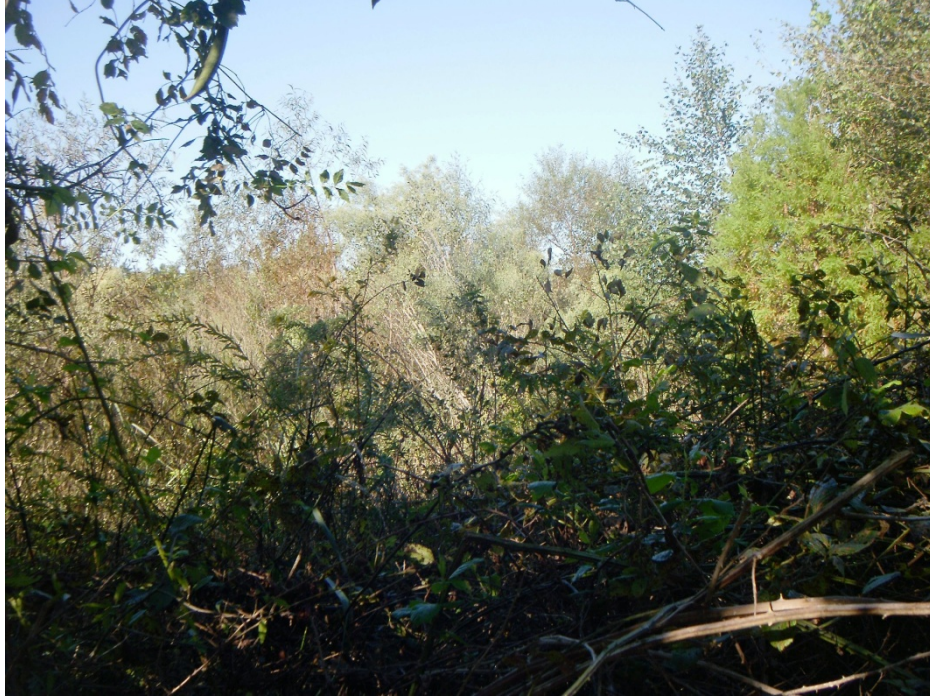
Photo Station 3: Vegetation Plot 4 (10/05/11)

The Year 6 vegetative monitoring was performed on October 5, 2011, using the Carolina Vegetation Survey Level 2 methodology on 9 of the original 15 plots, as requested by NCEEP. Refer to Table 7 and the Current Condition Plan View (CCPV) Map in the appendices for the vegetation results. Monitoring revealed that only 2 of the 9 plots (22%) met the 5-year vegetative success criteria of 260 planted stems or greater per acre for streams and wetlands. When volunteer stems are included, all of the vegetation plots meet or exceed the required density of 260 stems or greater per acre, with the average vegetation density across the site being 2,788 stems per acre (planted and volunteer). Located within the Neuse River Basin, this project was instituted prior to October 11, 2007 and is therefore eligible for riparian buffer restoration credit up to 200 feet from the top of bank of all perennial and intermittent waterways within the conservation easement. As such, applicable vegetation plots have been assessed for the vegetation success criteria for buffers (320 planted trees or greater per acre). Vegetation Plots 4 and 6 lie within the riparian buffer restoration areas of the project site (refer to the CCPV Map). Only Vegetation Plot 4 is currently meeting the vegetation success criteria of 320 planted trees or greater per acre. When volunteer trees are also included, both Vegetation Plot 4 and Vegetation Plot 6 meet or exceed the required density of 320 trees or greater per acre.

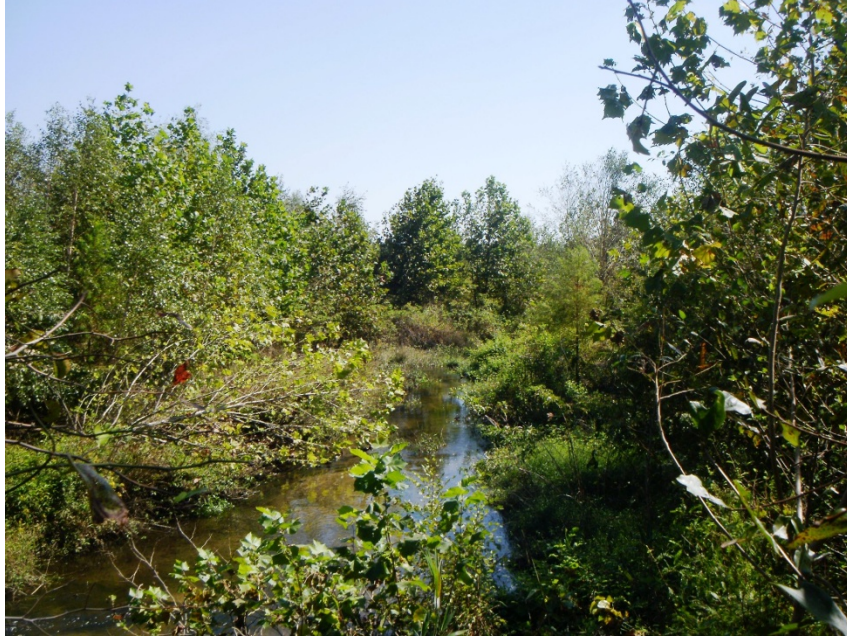
As in previous years, a general assessment of stream stability was conducted. Results were the same as in the past in that the stream is stable and is well connected to the floodplain. Stream channels bars are still present which could lead to lateral migration and bank instability; however, migration and instability were not observed during current monitoring.

Photo Station 1 (S1) – Overview of Project (looking downstream from Sta.10+00 (10/05/11))

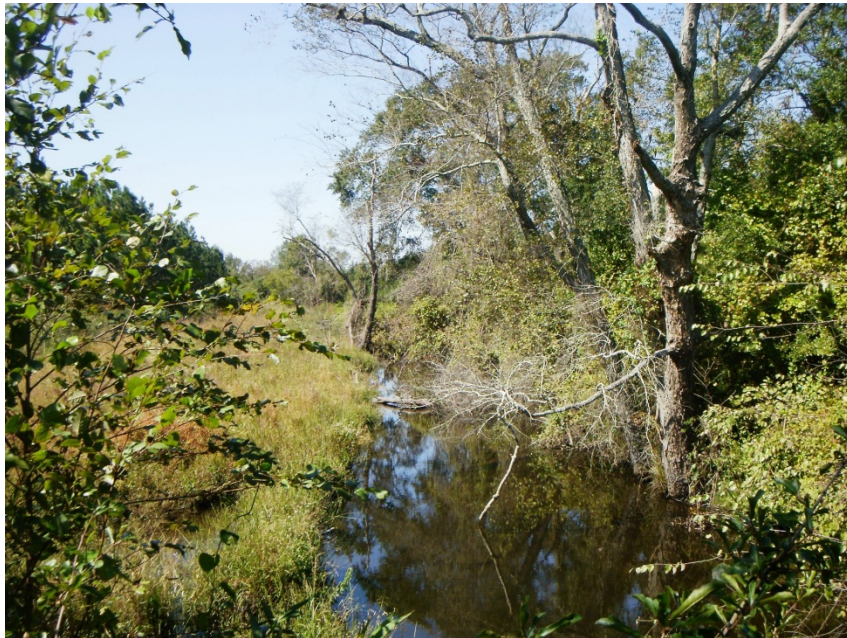
Photo Station 2 (S2) - Overview of upstream portion of reach (looking upstream from Sta.10+00 (10/05/11))

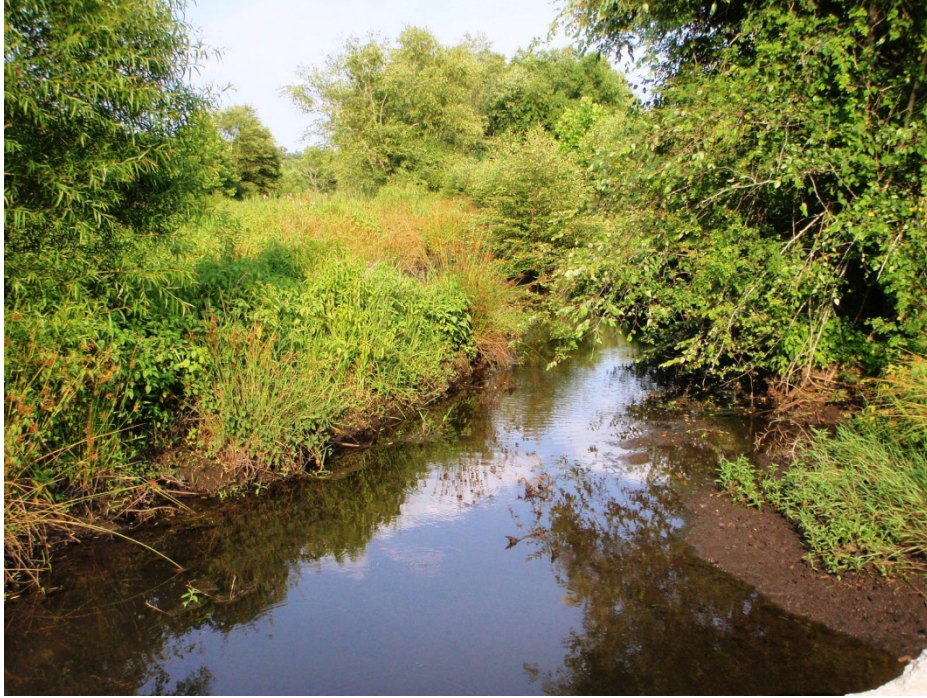
Photo Station 3 (S3) – Looking downstream from bridge (06/15/11)

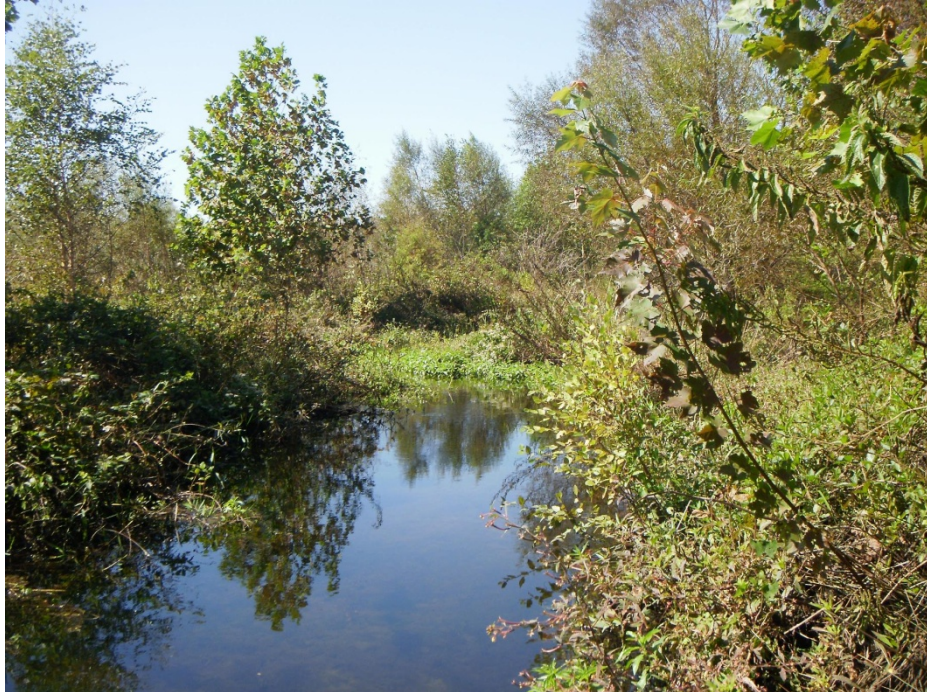
Photo Station 4 (S4) – Looking upstream from crest gauge (10/05/11)
