ANNUAL REPORT FOR 2003

**White Oak Creek
Johnston County
Project No. 6.408014T
TIP No. R-2000 WM**

Prepared By:
Office of Natural Environment & Roadside Environmental Unit
North Carolina Department of Transportation
December 2003

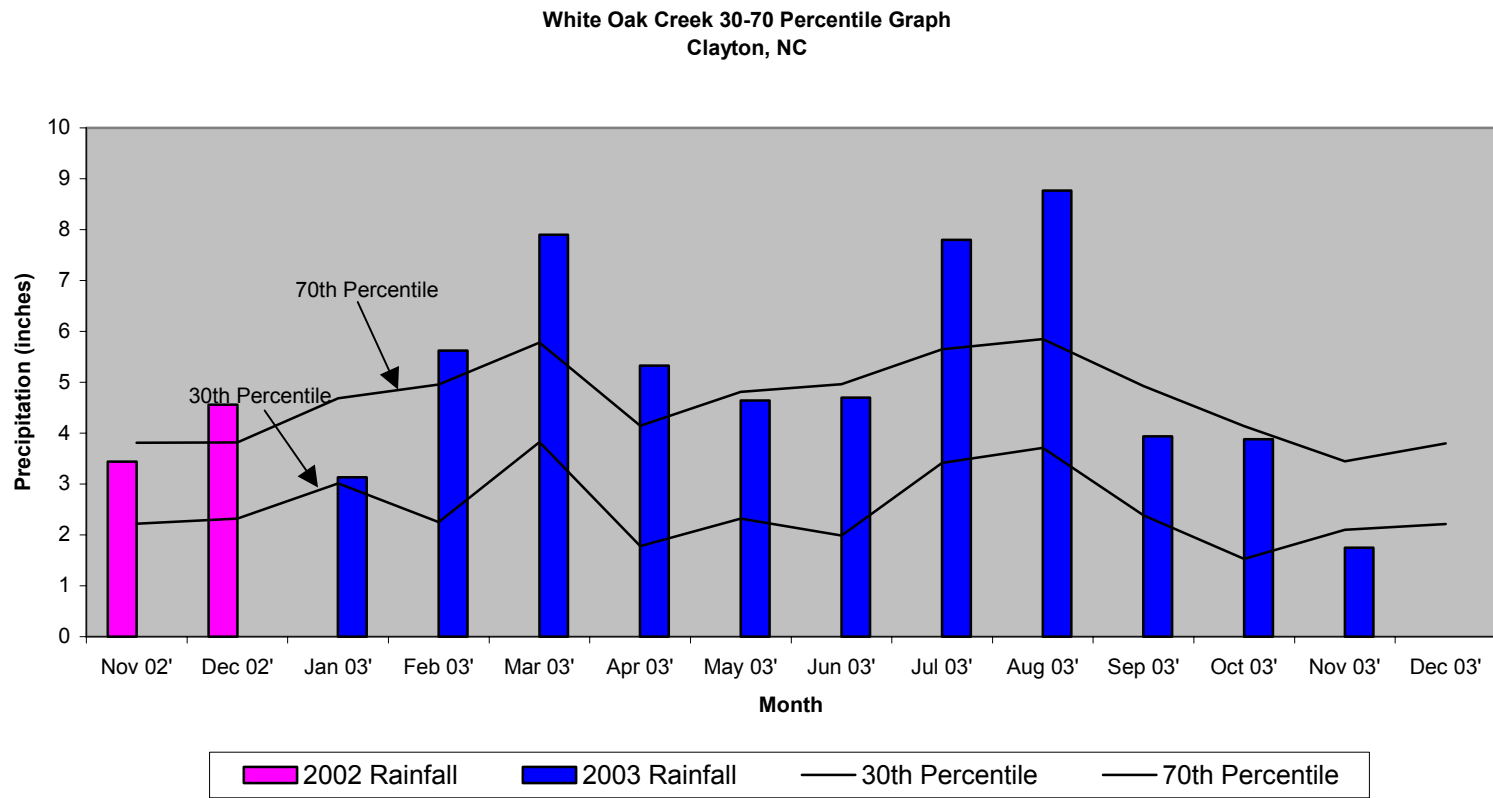
Figure 4: 30-70 Percentile Graph

Figure 4 represents an evaluation of the local climate in comparison with historical data in order to determine whether 2003 was “average” in terms of rainfall. The two lines represent the 30th and 70th percentiles of monthly precipitation for Clayton. The bars are the monthly rainfall totals for parts of 2002 and 2003. The onsite rain gauge experienced a gauge malfunction, therefore the rain gauge from the Clayton weather station was used for the following dates: January 1 - May 4 and July 9 - November 26. The State Climate Office collected the historical and monthly rainfall data.

For the 2003-year, the month of November recorded below average rainfall. The months of November (02'), January, May, June, September, and October all recorded average rainfall for the site. December (02'), February, March, April, July, and August all recorded above average rainfall. Overall, 2003 experienced average to above average rainfall.
