ANNUAL REPORT FOR 2004

**White Oak Creek
Johnston County
Project No. 6.408014T
TIP No. R-2000 WM**

Prepared By:
Office of Natural Environment & Roadside Environmental Unit
North Carolina Department of Transportation
December 2004

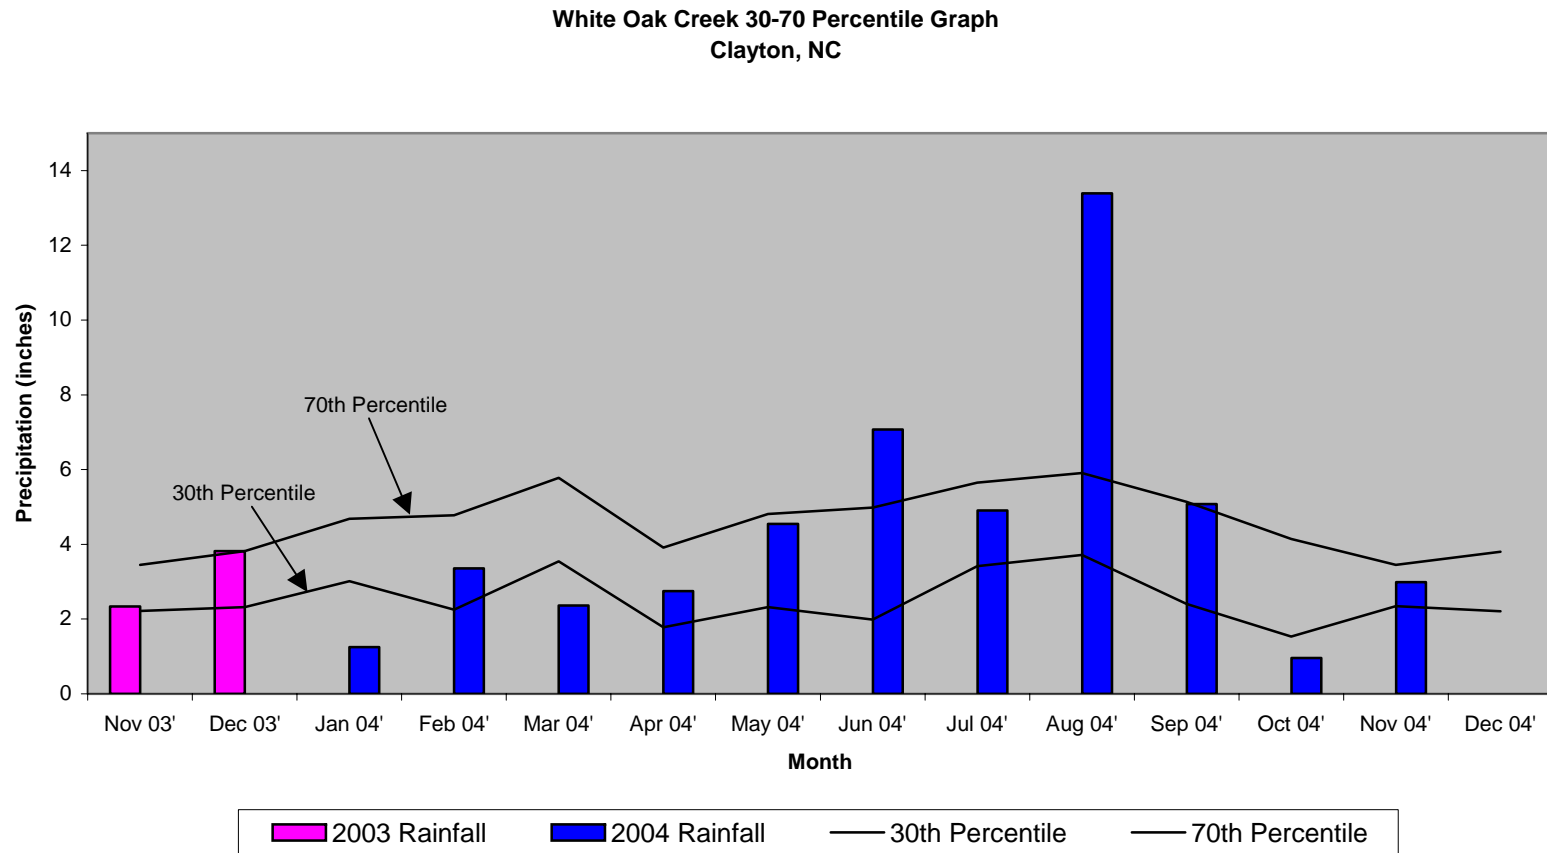
Figure 4: 30-70 Percentile Graph

Figure 4 represents an evaluation of the local climate in comparison with historical data in order to determine whether 2004 was “average” in terms of rainfall. The two lines represent the 30th and 70th percentiles of monthly precipitation for Clayton. The bars are the monthly rainfall totals for parts of 2003 and 2004. The onsite rain gauge experienced a gauge malfunction, therefore the rain gauge from the Clayton weather station was used for the following dates: January 1 - May 4 and July 9 - November 26. The State Climate Office collected the historical and monthly rainfall data.

For the 2004-year, the month of January, March, and October recorded below average rainfall. The months of November (03’), December (03’), February, April, May, July, and November all recorded average rainfall for the site. June, August, and September all recorded above average rainfall. Overall, 2004 experienced an average rainfall year.
