WHITE OAK CREEK MITIGATION SITE

2005 Annual Monitoring Report (Year 4)

Johnson County
EEP Project No. 417
Design Firm: Rummel, Klepper & Kahl, LLP

February 2006

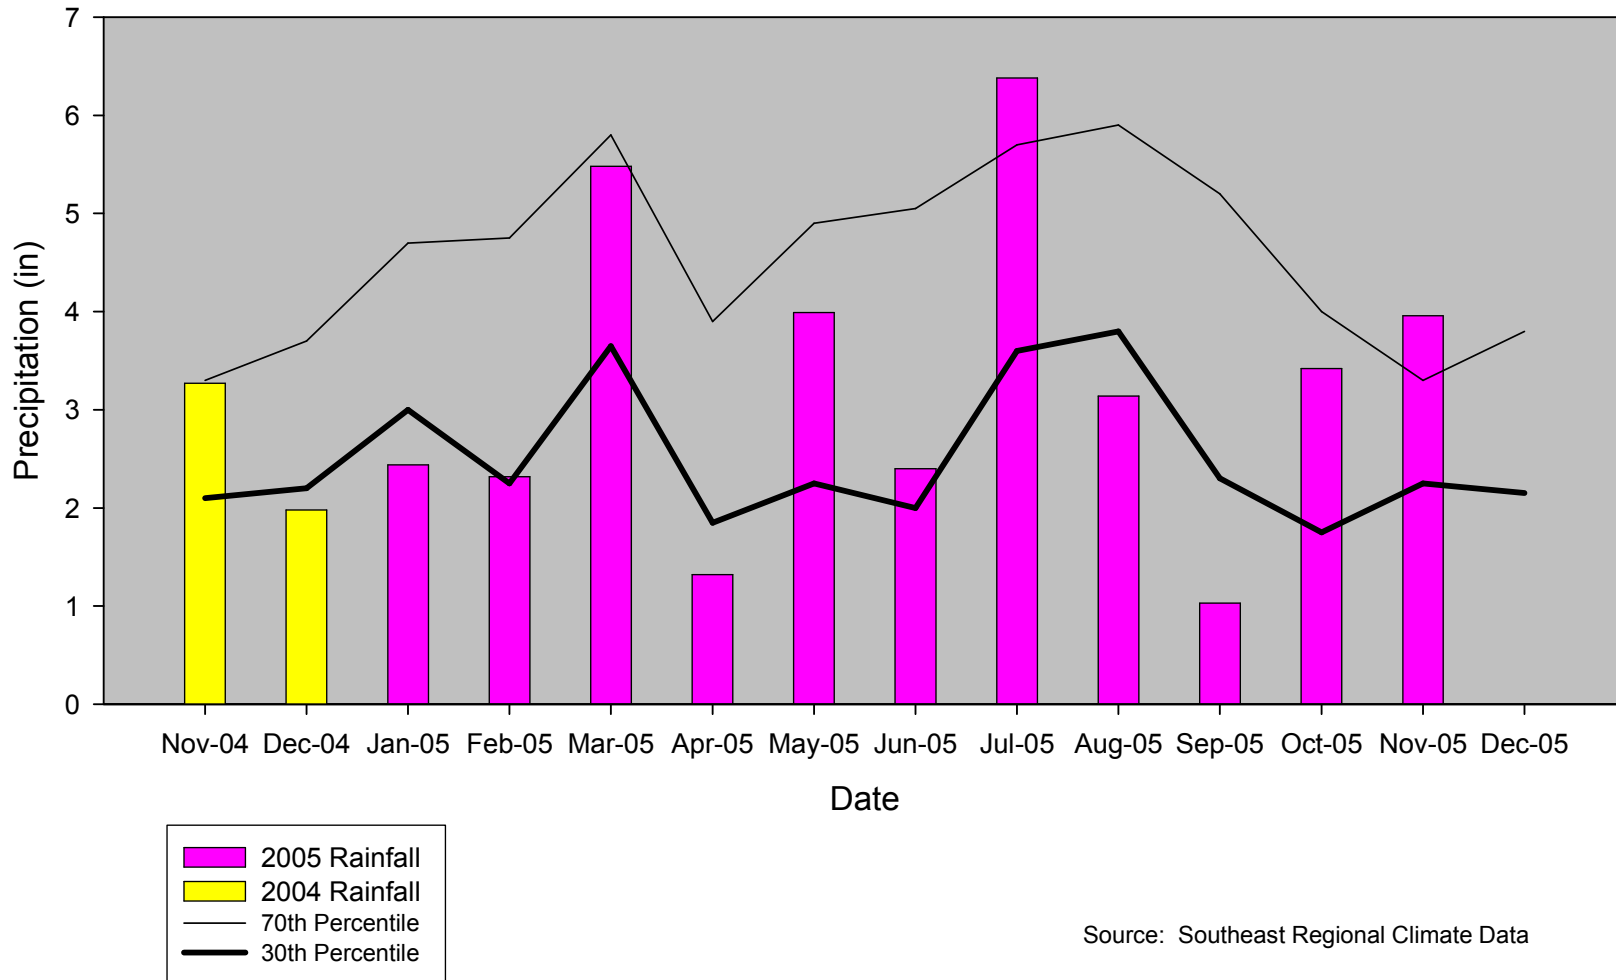
**Figure 3. Monthly Rainfall and 30-70 Percentile Graph for Clayton, NC
White Oak Creek Mitigation Site**

Figure 3 (Appendix A) provides an evaluation of the local climate in comparison with historical data in order to determine whether 2005 was a year with “average” rainfall. The bars are the monthly rainfall totals for the 2005 hydrologic year collected from the on-site rain gauge. Also represented on the figure are the 30th and 70th percentiles of monthly precipitation for the Clayton weather station. The historical data and monthly data were collected by the Southeast Regional Climate Data.

Months with below average rainfall include: January, April, August, and September. The months of February, March, May, June, October, and November experienced average rainfall. July received above average rainfall. Through the end of November, the region has experienced a rain deficit of approximately eight inches. A normal yearly rainfall in the area is approximately 45.7 inches.

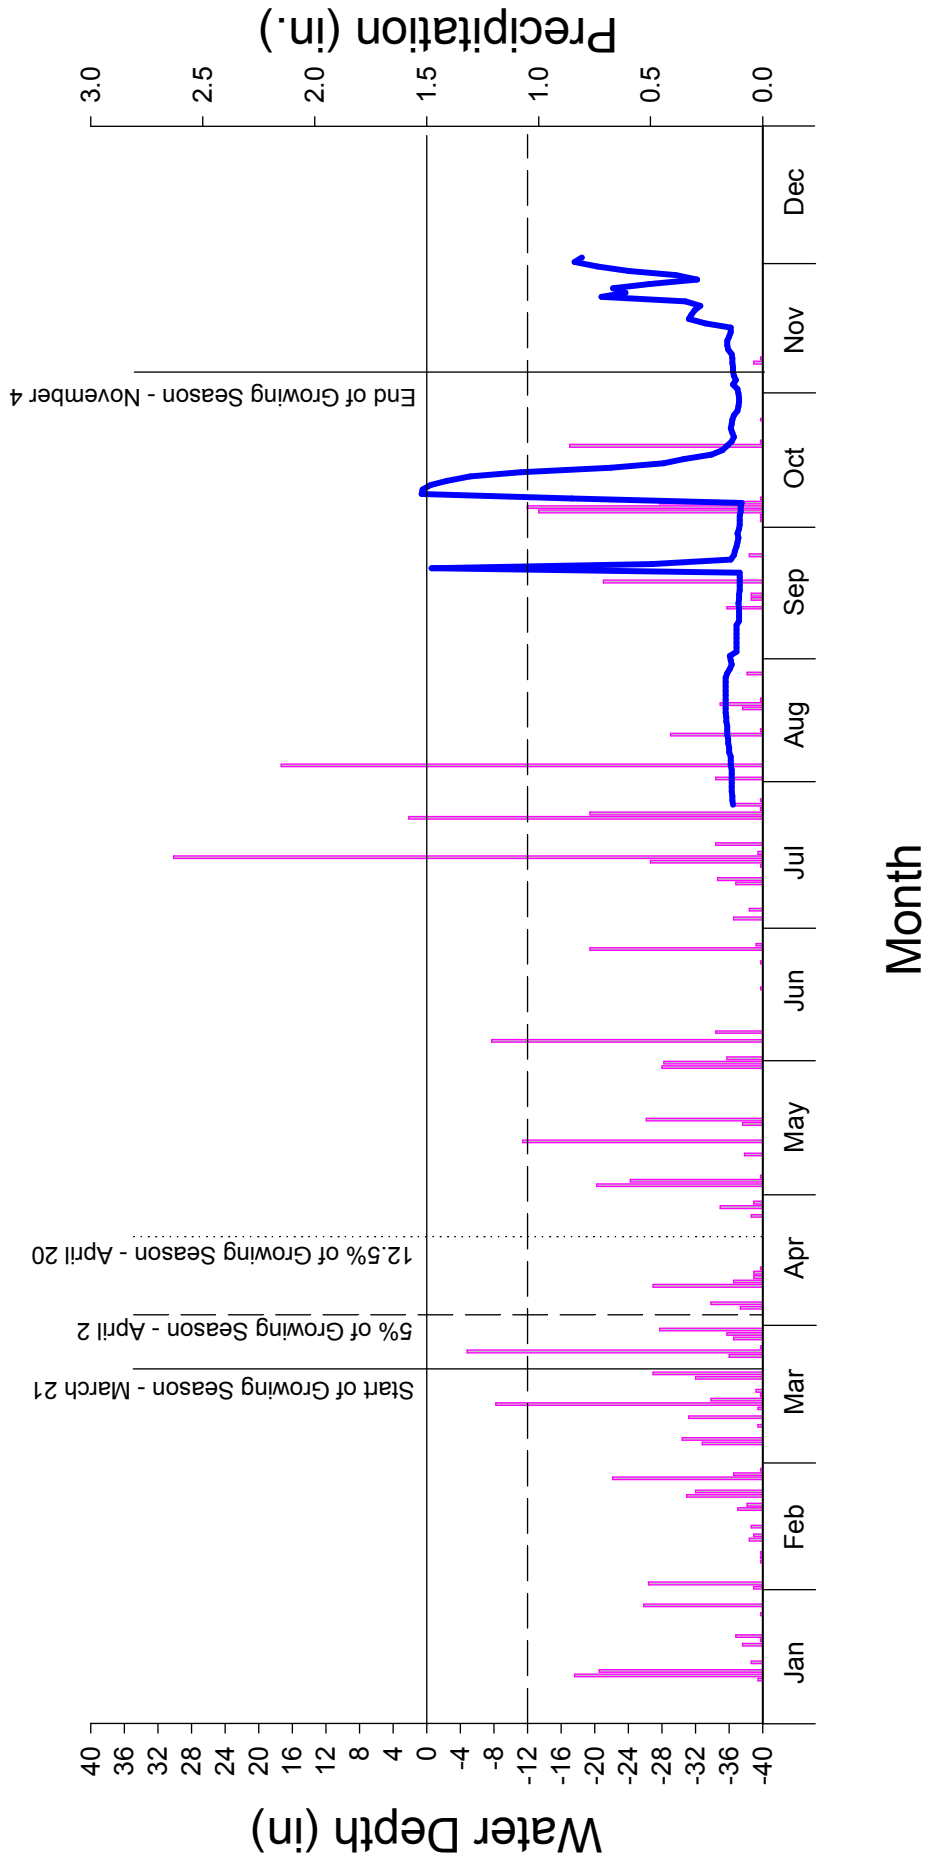
White Oak Creek 2005 Monitoring Gauge 3 - 8E529FC

*Prior to July 2005 gauge was not functioning due to low battery charge. Batteries were replaced during first site visit in late July.

¹ Gauges 3, 20, and 30 were non-functional for much of the growing season due to low battery charge. Batteries were replaced on July 29th, 2005 during the initial site visit.

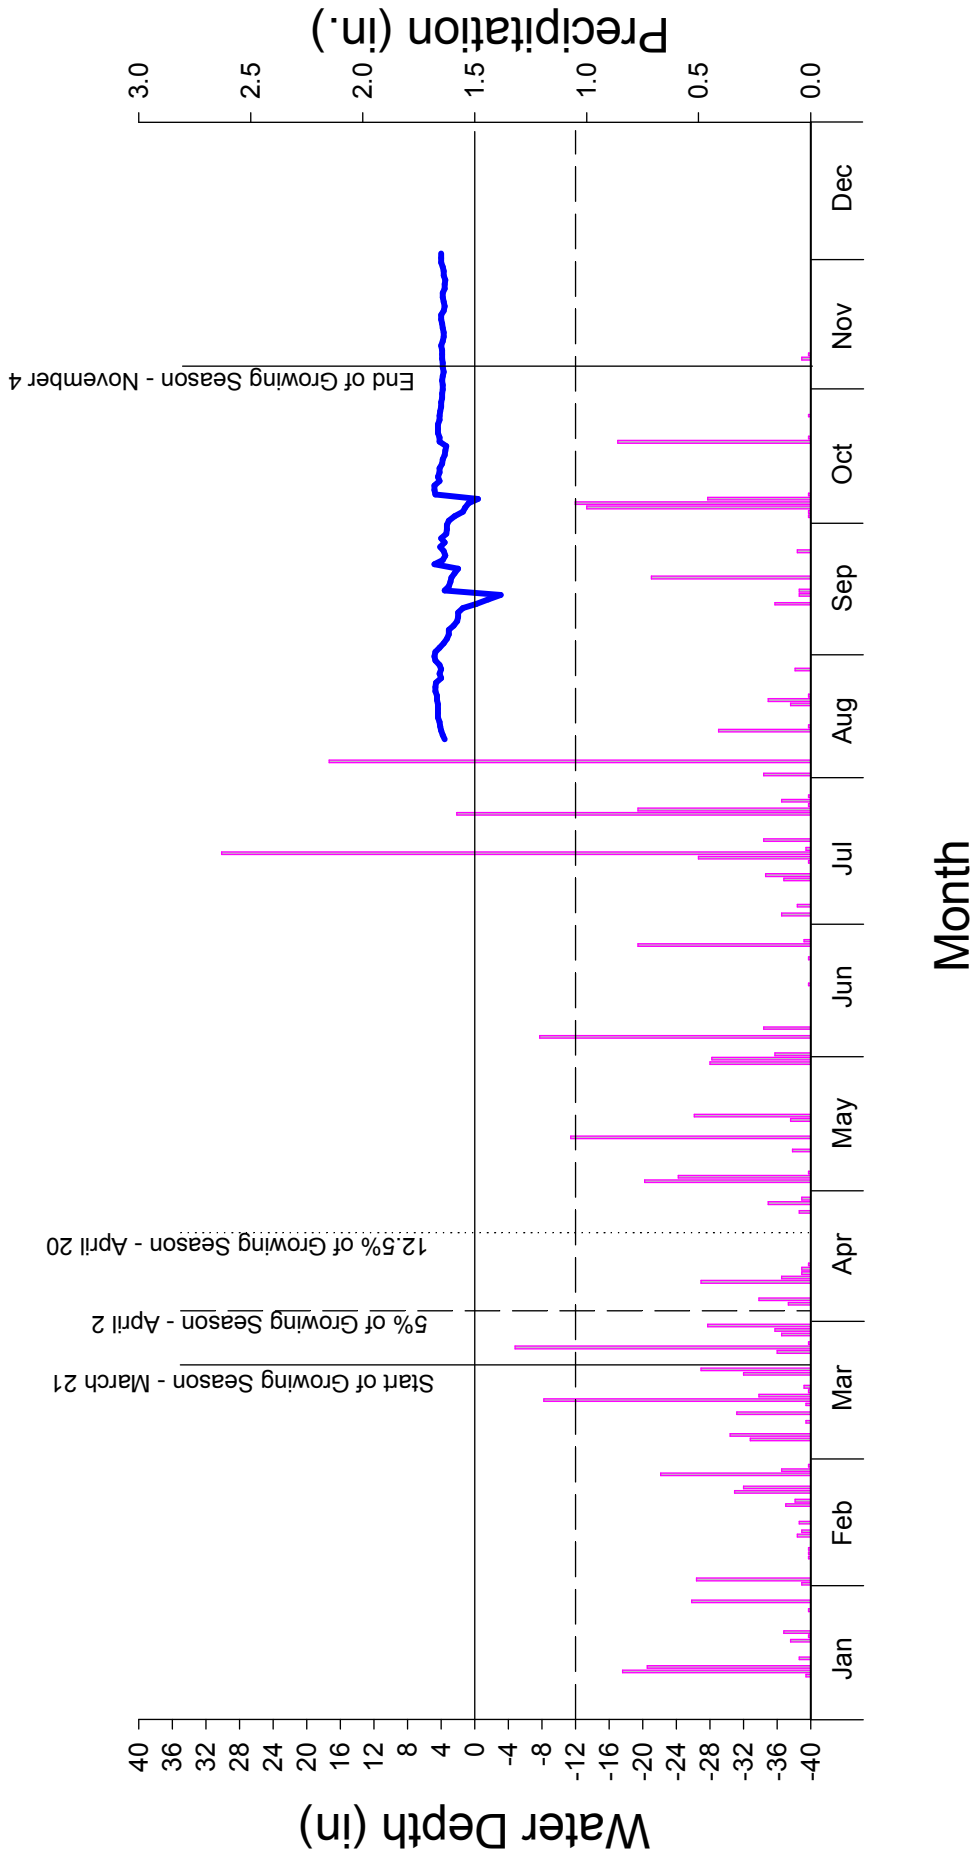
White Oak Creek 2005 Monitoring Gauge 4 - B651405

*Gauge was found to be non-functioning during first site visit in July 2005. Gauge was replaced in August 2005.

² Gauges 4, 5, 16, 25, 26, and 29 were non-functional for much of the growing season. They were replaced with new gauges on August 11th, 2005.

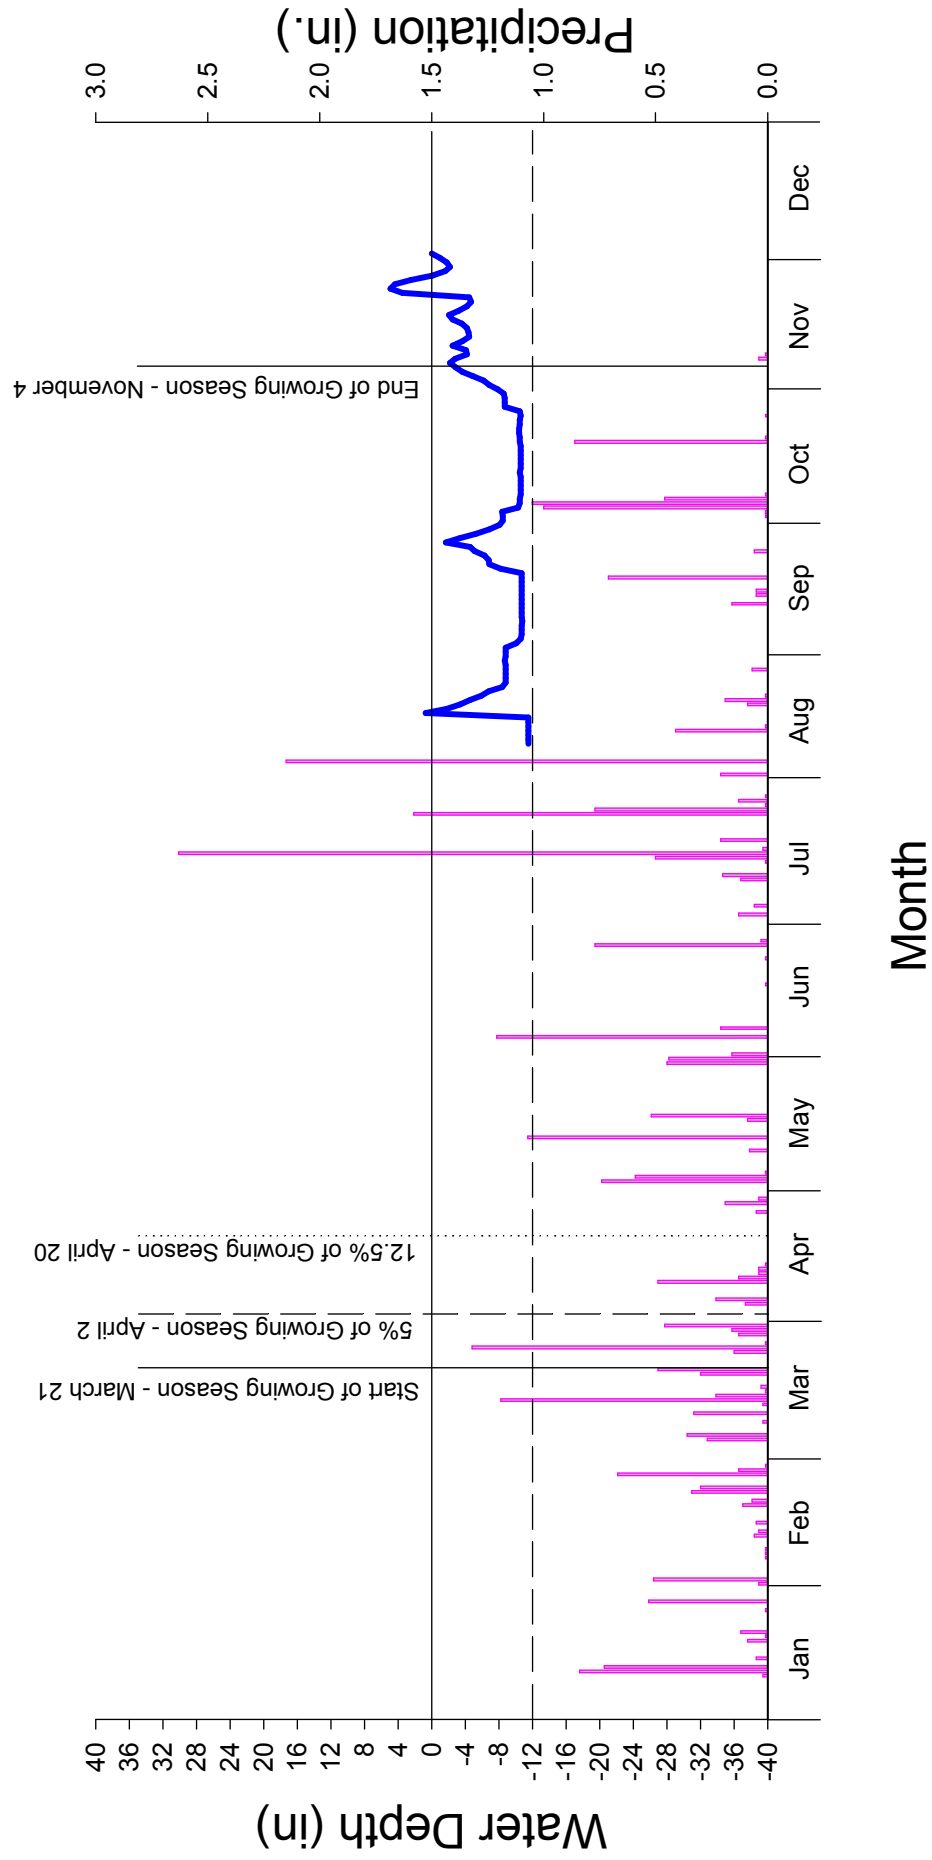
White Oak Creek 2005 Monitoring Gauge 5 - B65131A

*Gauge was found to be non-functioning during first site visit in July 2005. Gauge was replaced in August 2005.

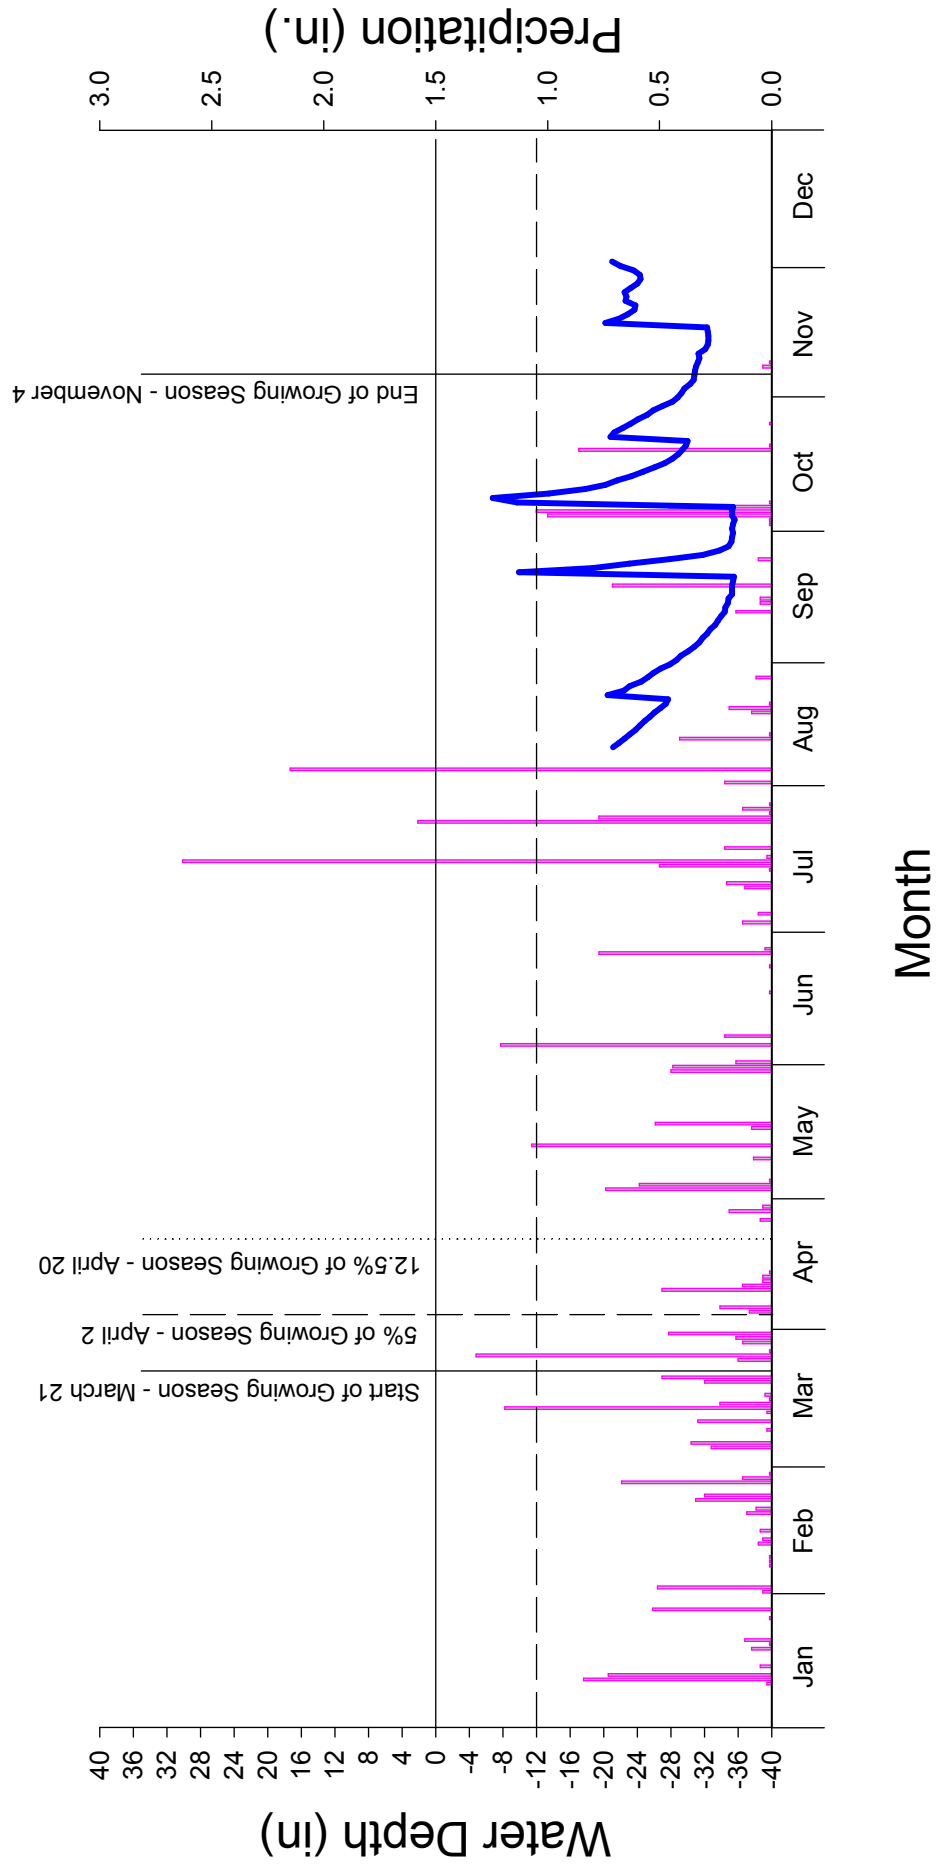
White Oak Creek 2005 Monitoring Gauge 12 - B65222F

*Gauge was found to be non-functioning during first site visit in July 2005. Gauge was replaced in August 2005.

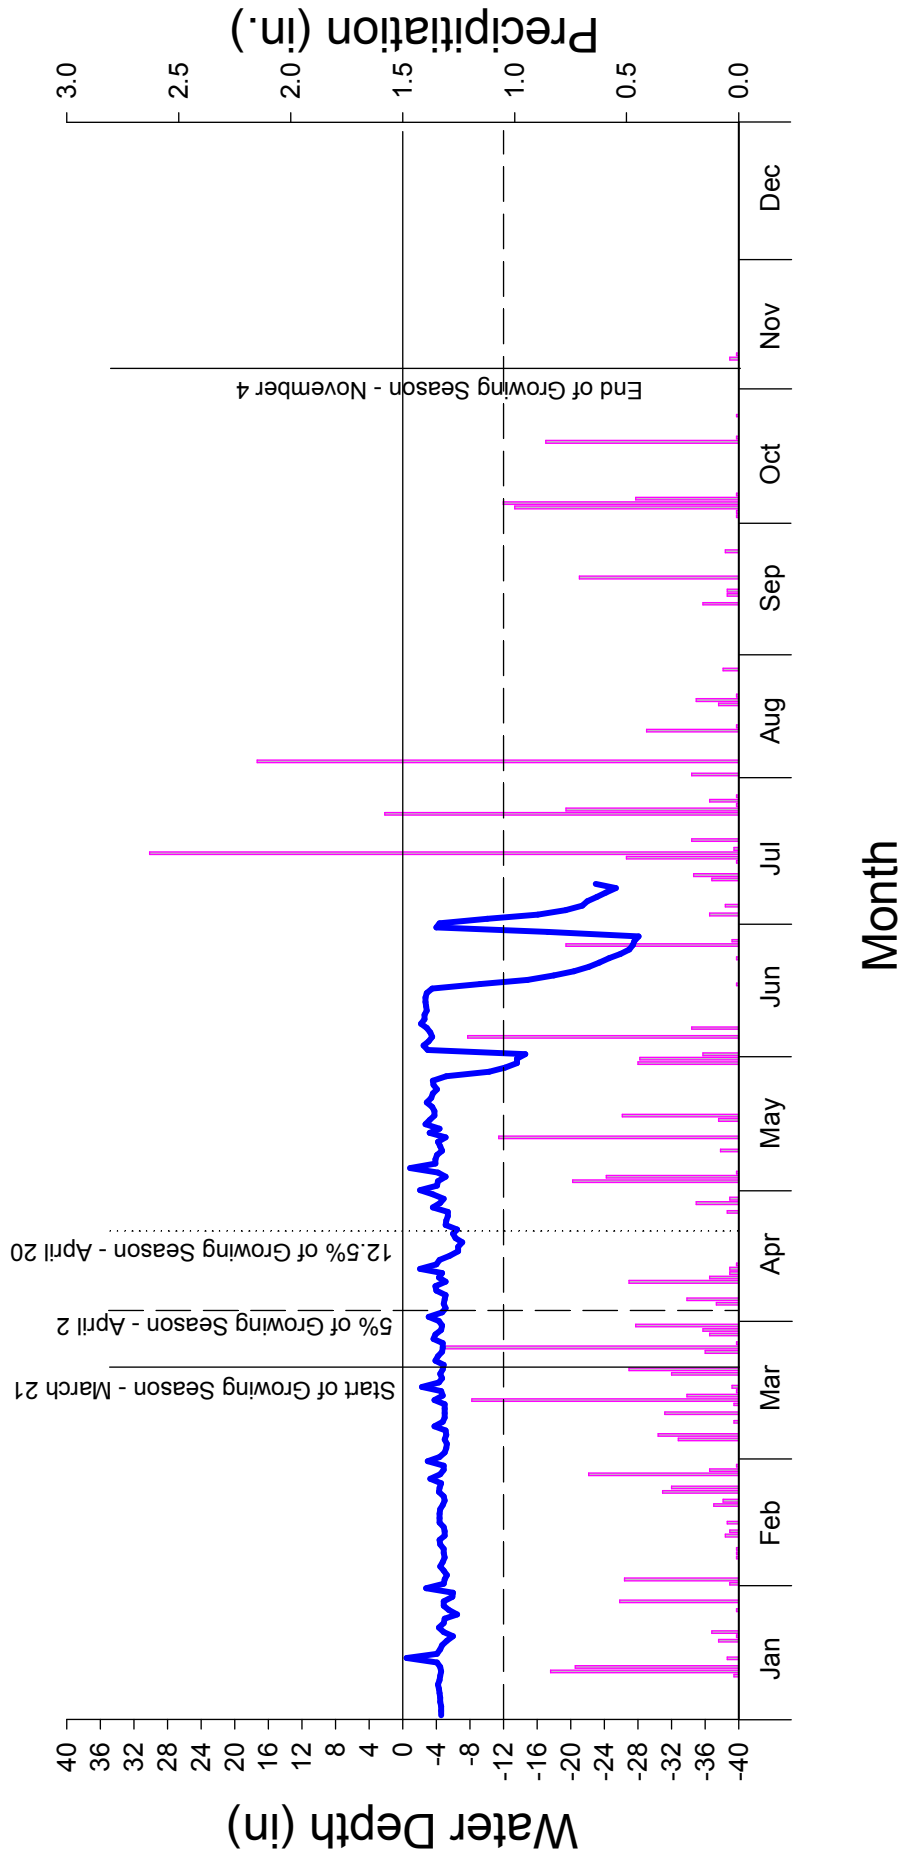
Monitoring Gauge 14 - 9D7ECE7

*Gauge was found to be non-functioning during first site visit in July 2005. Prior attained data was retrievable, although attempts to repair the gauge failed. Gauge will be replaced prior to 2006 growing season.

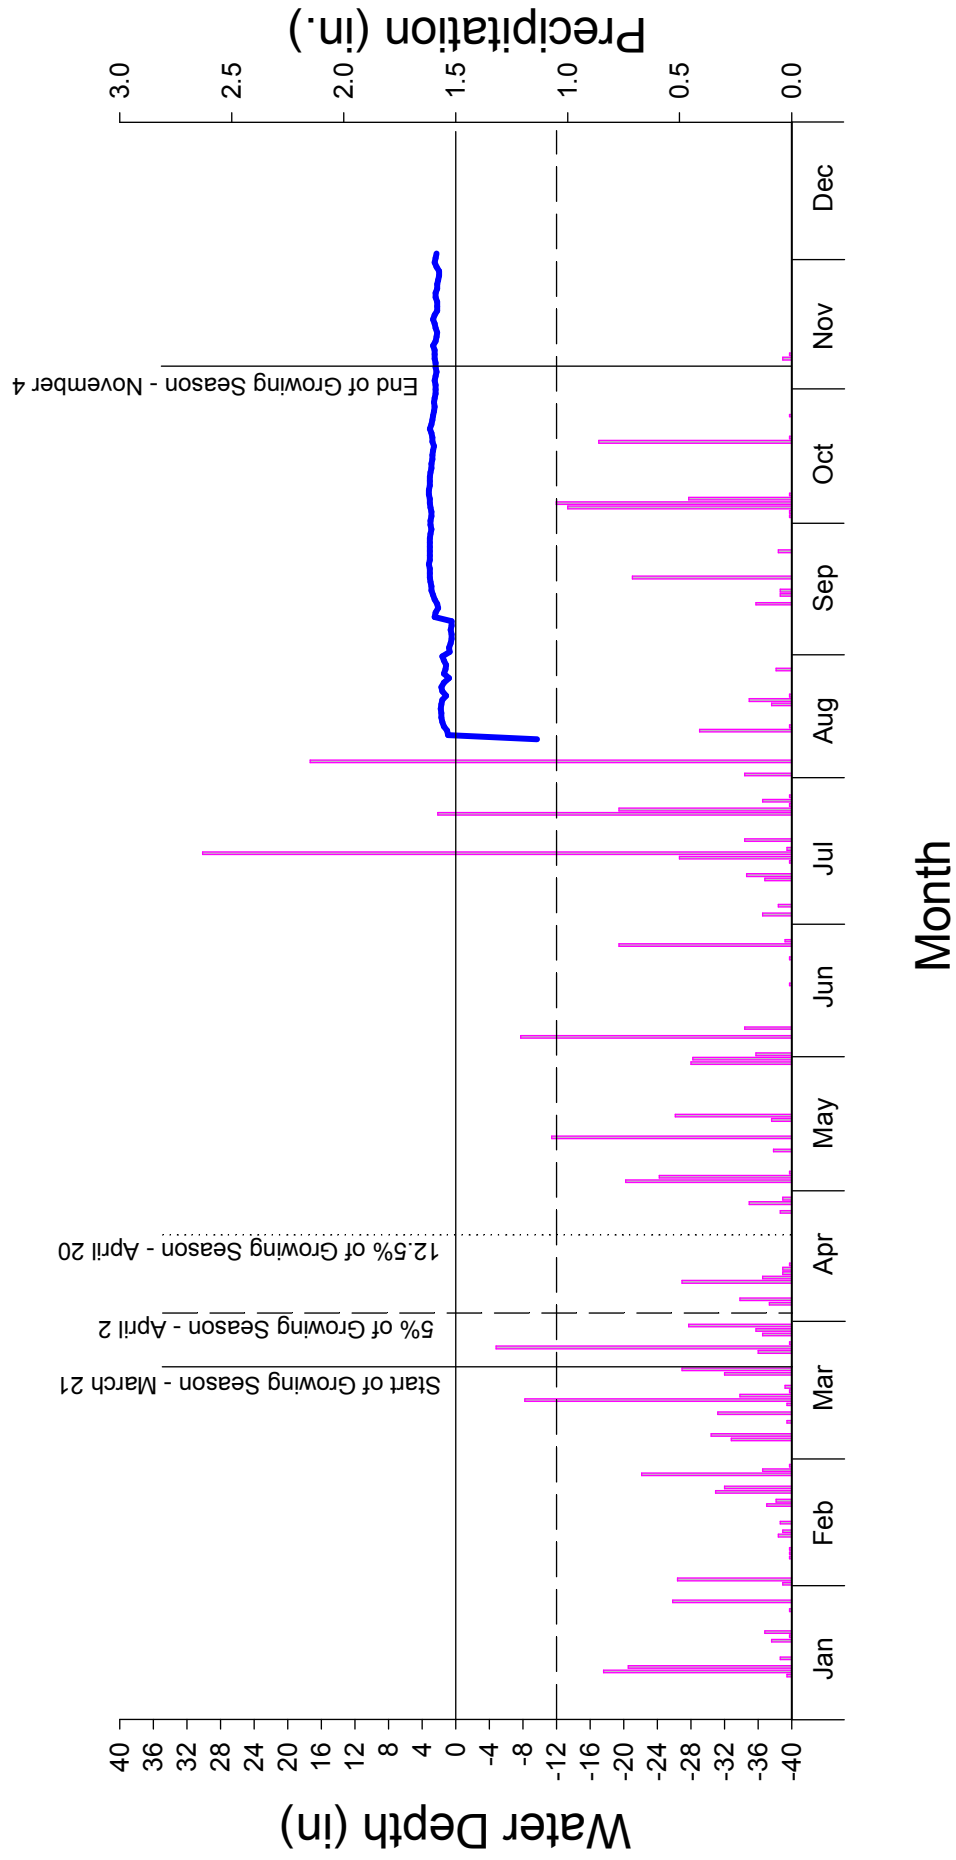
White Oak Creek 2005 Monitoring Gauge 16 - B6513D9

*Gauge was found to be non-functioning during first site visit in July 2005. Gauge was replaced in August 2005.

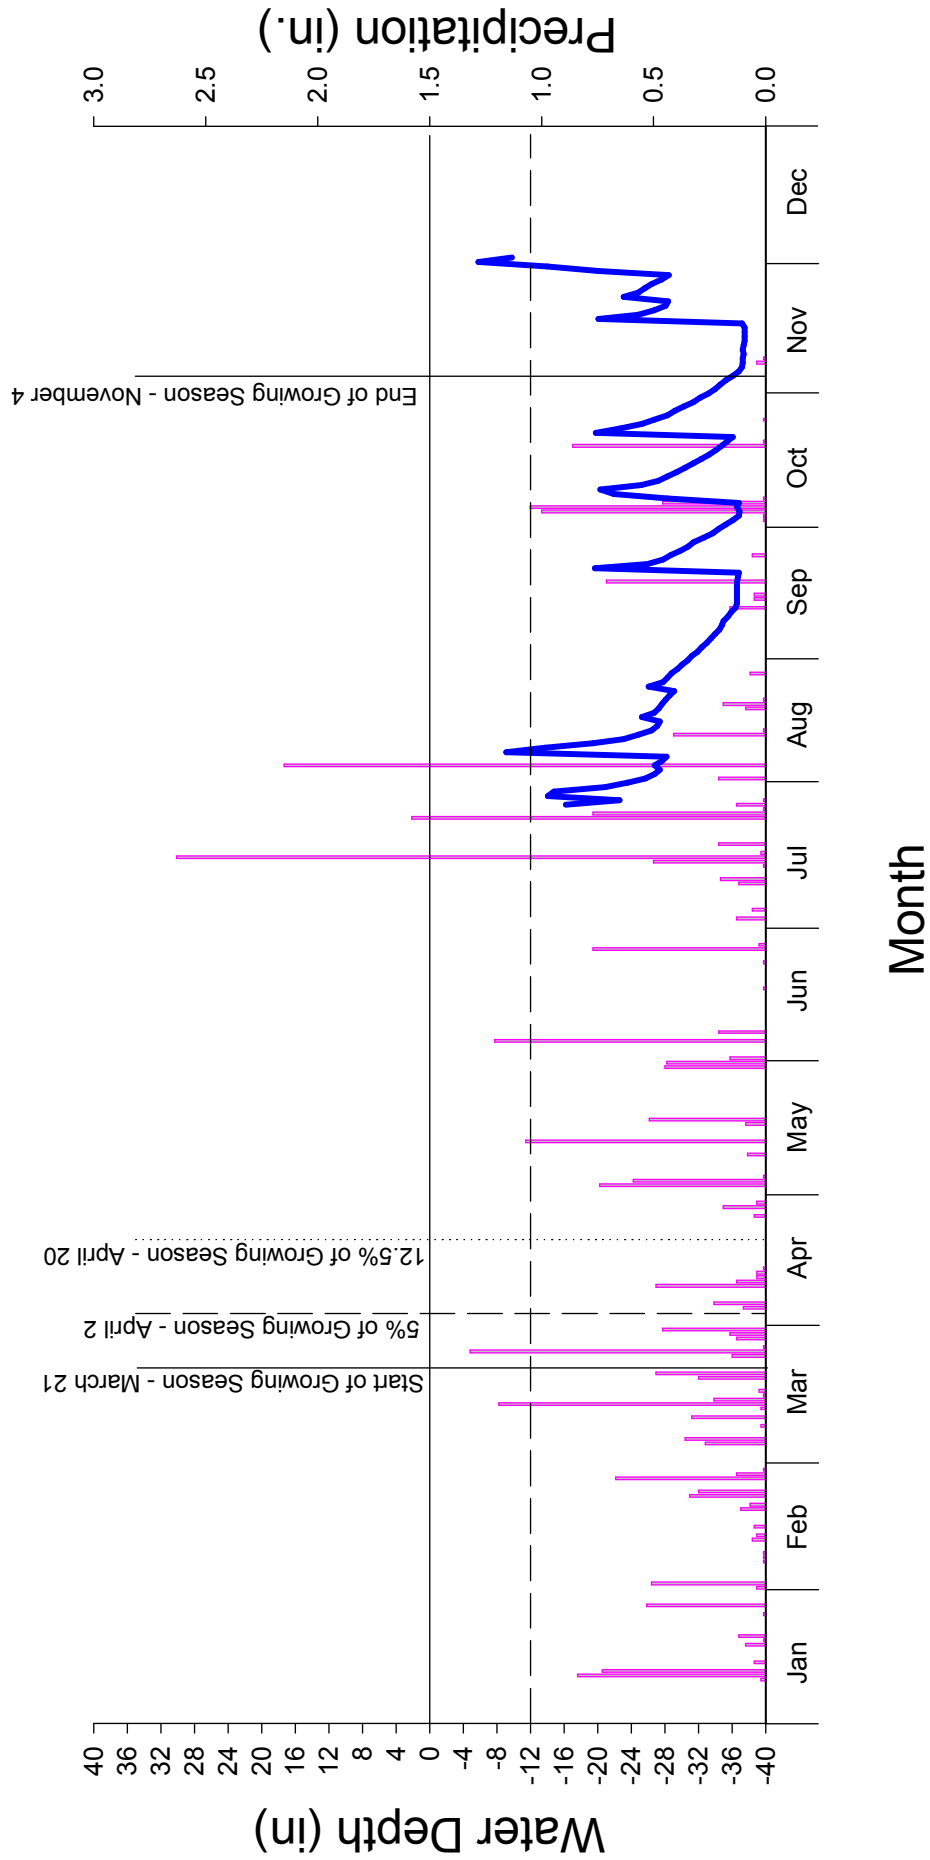
White Oak Creek 2005 Monitoring Gauge 20 - 9DE4B47

*Prior to July 2005 gauge was not functioning due to low battery charge. Batteries were replaced during first site visit in late July.

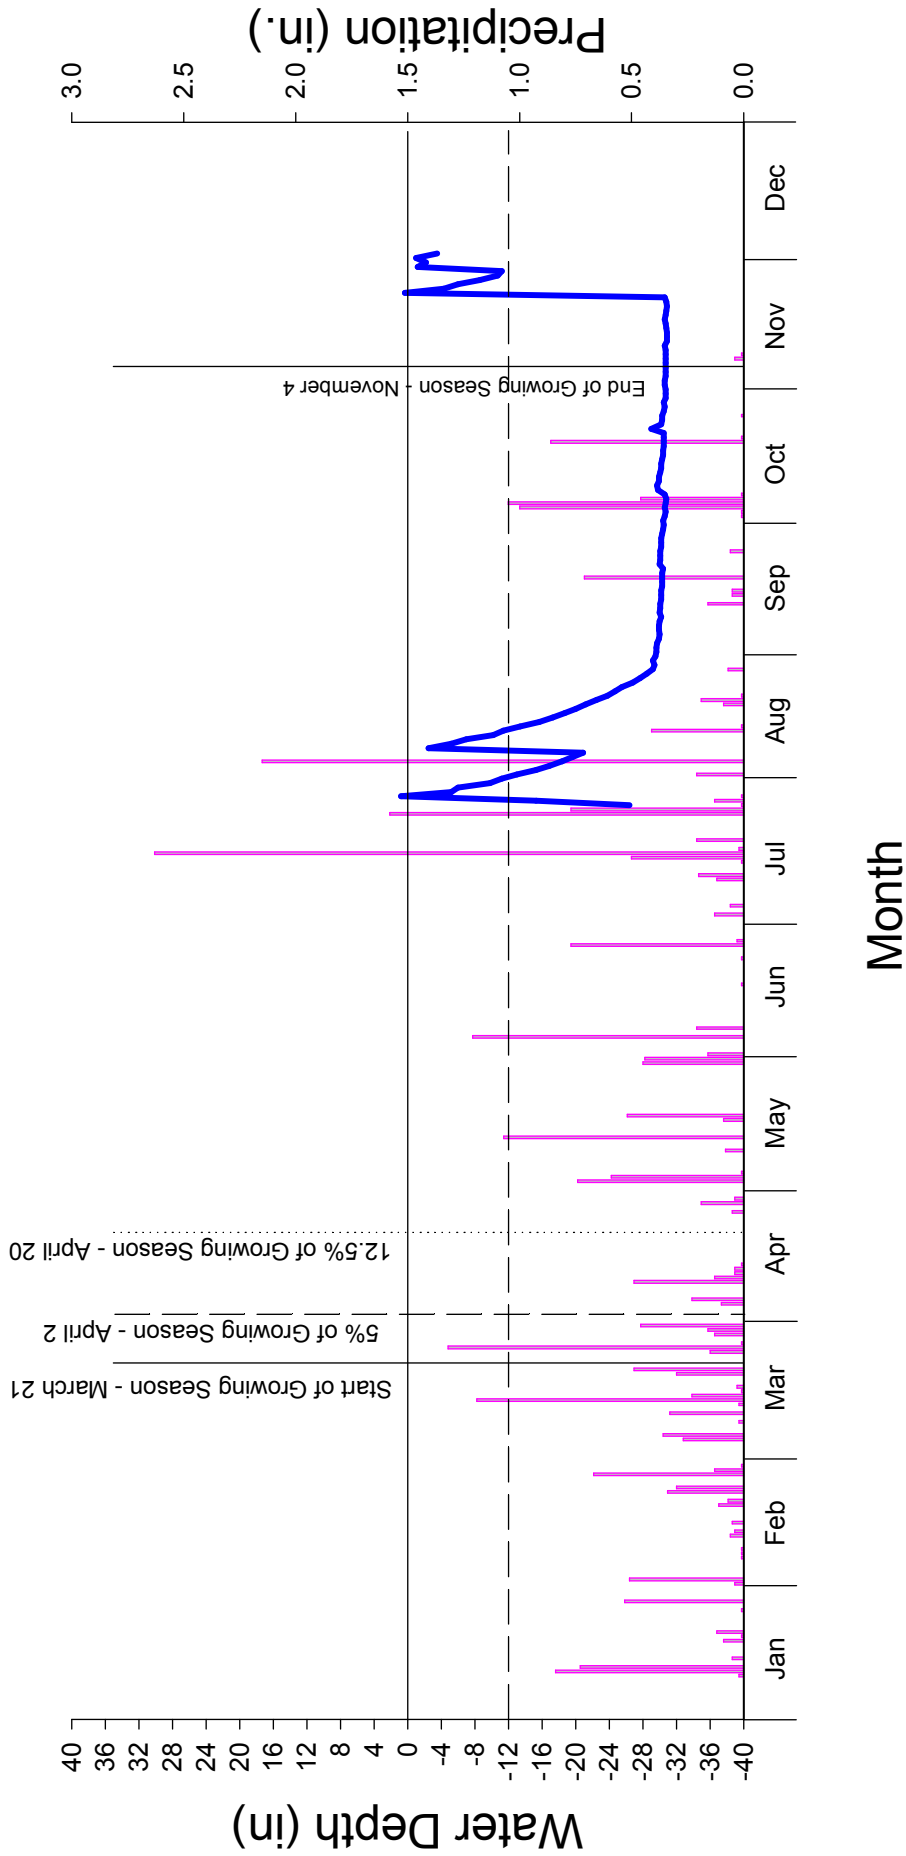
White Oak Creek 2005 Monitoring Gauge 23 - 8E546A7

*Prior to July 2005 gauge was not functioning due to low battery charge. Batteries were replaced during first site visit in late July.

⁶ Gauge 23 was non-functional for much of the growing season due to low battery charge. Batteries were replaced on July 29th, 2005 during the initial site visit.

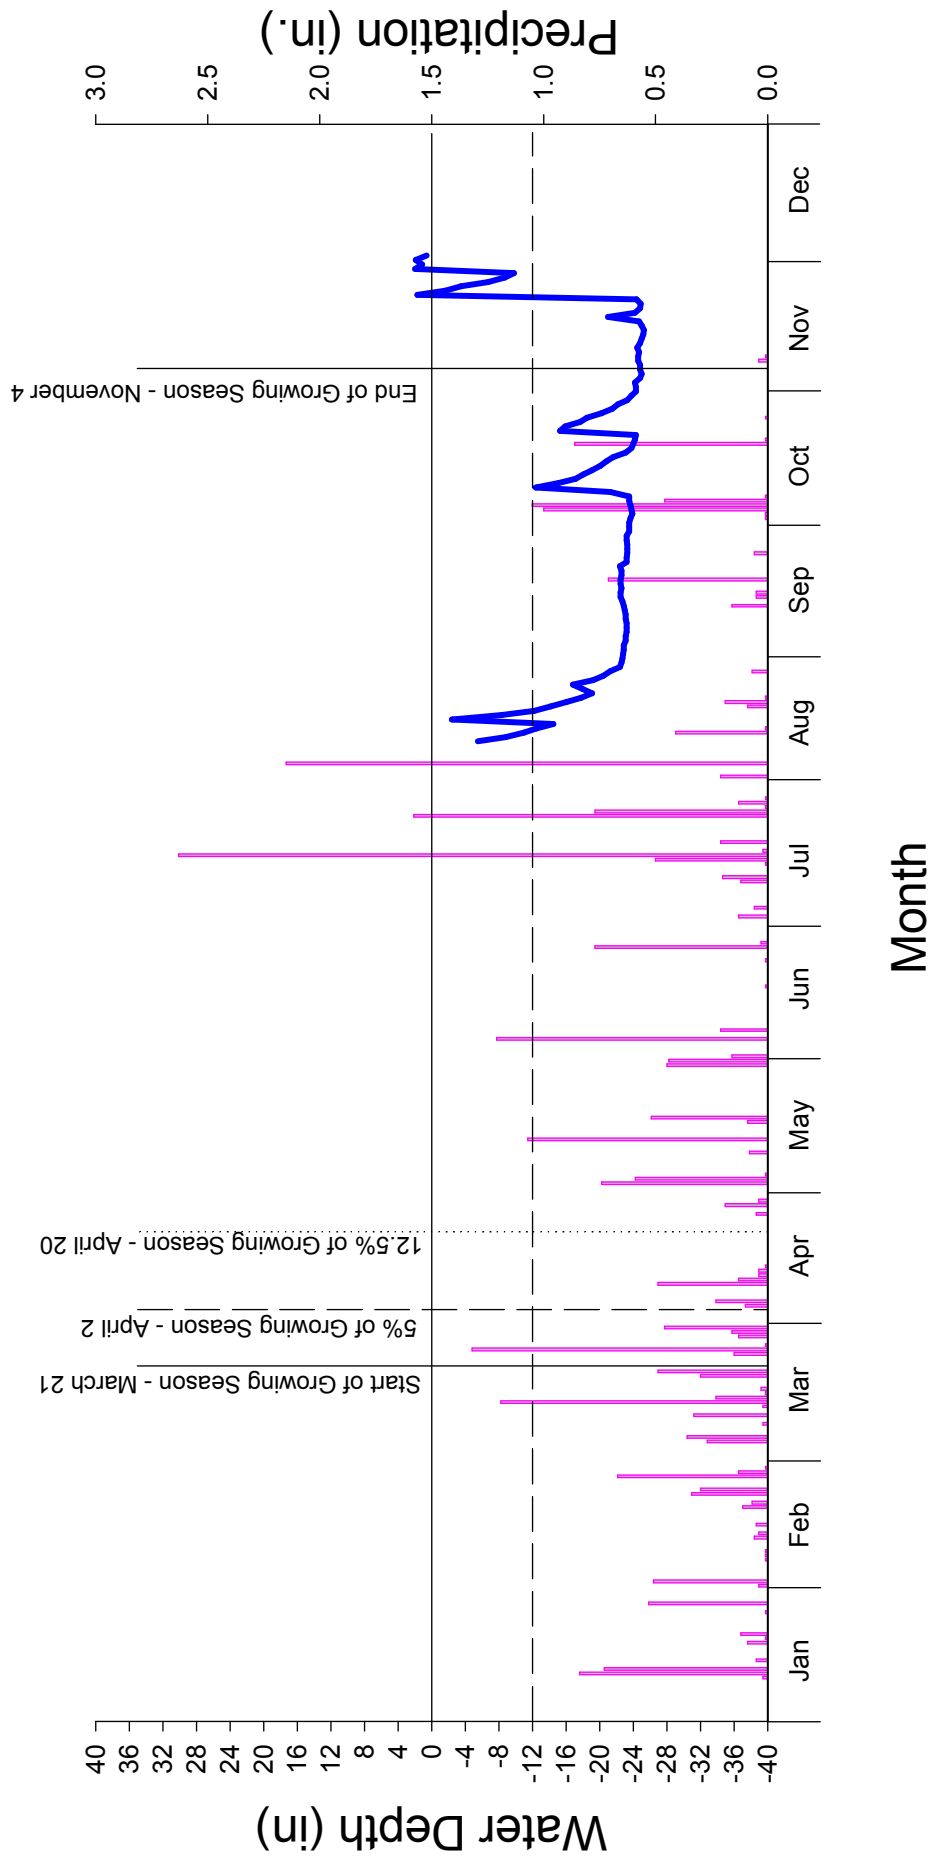
White Oak Creek 2005 Monitoring Gauge 25 - B652202

*Gauge was found to be non-functioning during first site visit in July 2005. Gauge was replaced in August 2005.

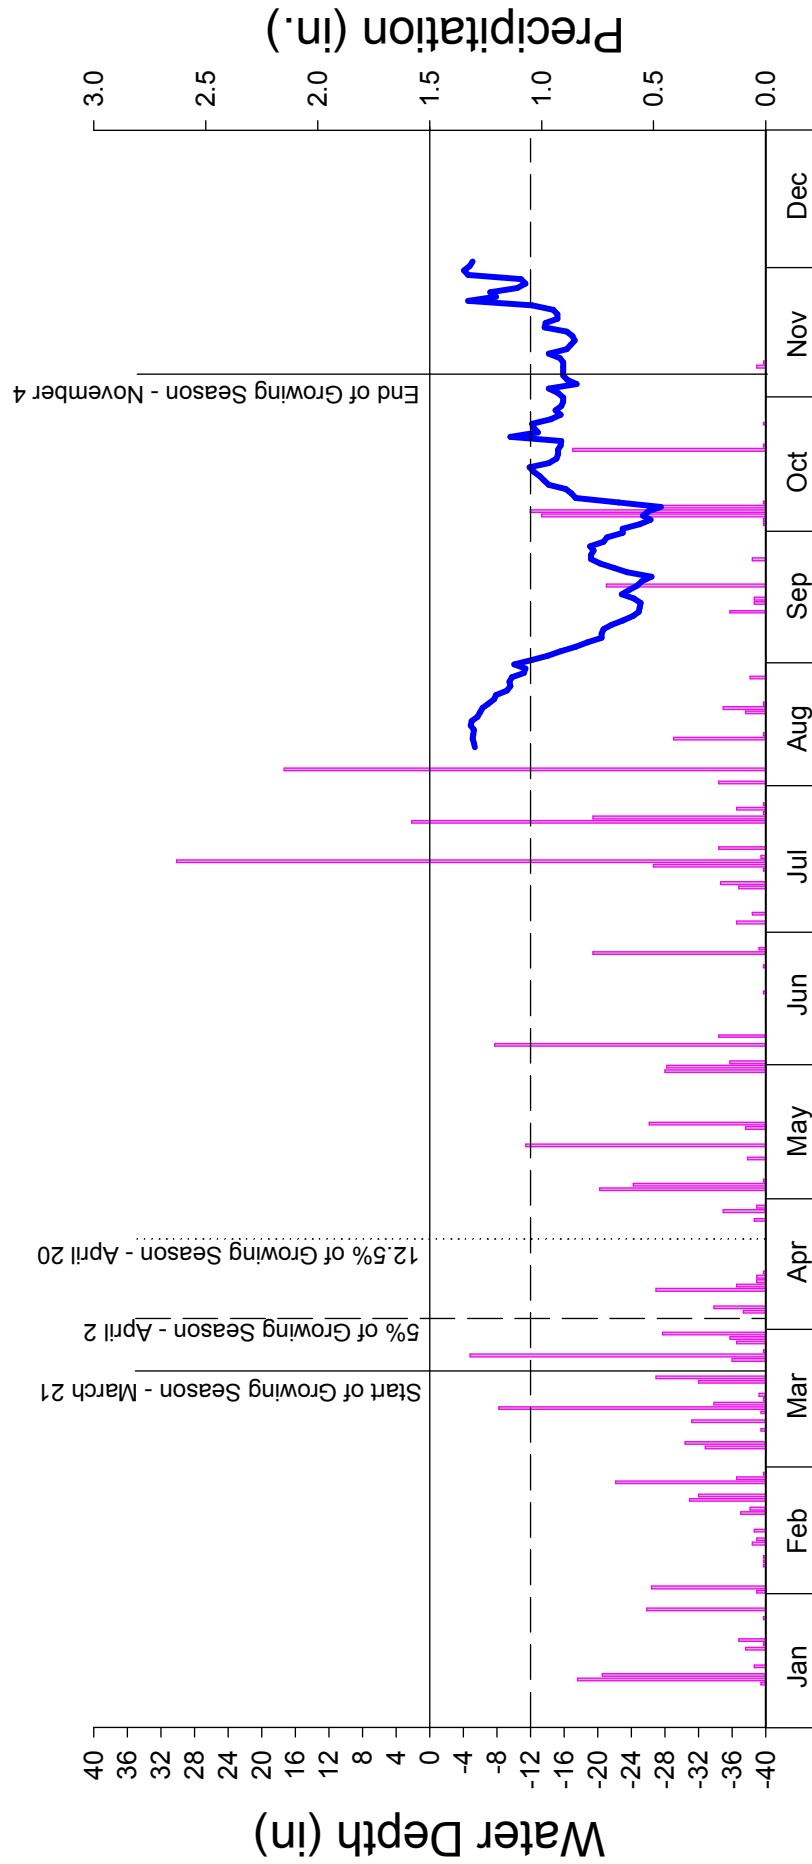
Monitoring Gauge 26 - B651934

*Gauge was found to be non-functioning during first site visit in July 2005. Gauge was replaced in August 2005.

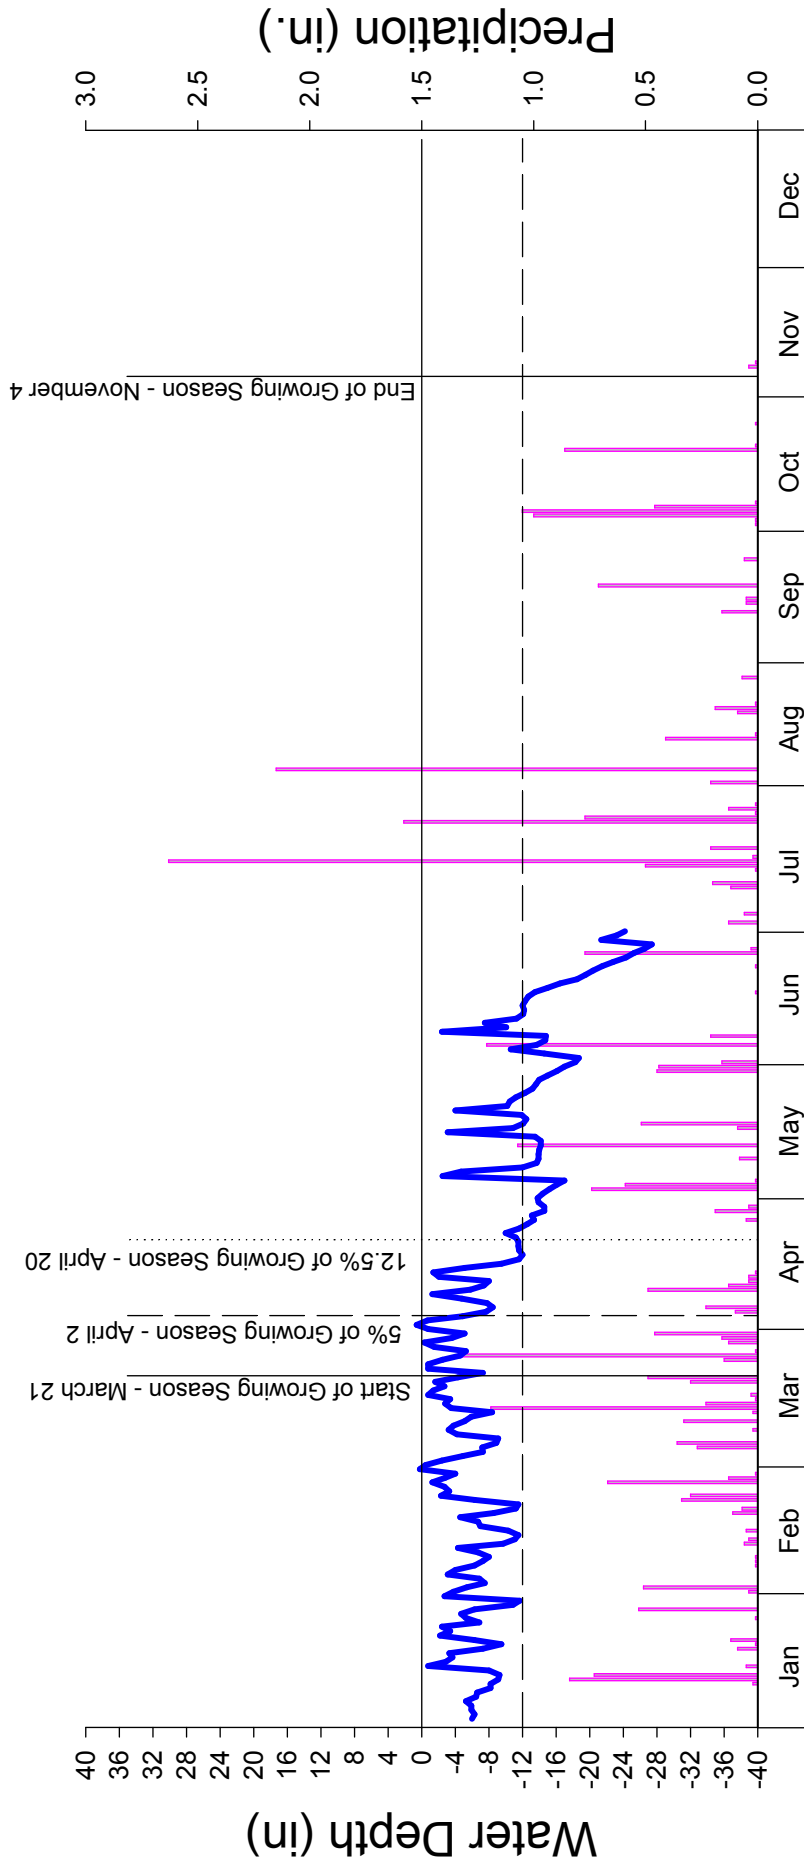
White Oak Creek 2005 Monitoring Gauge 28 - 8E52E9F

*Gauge was found to be non-functioning during first site visit in July 2005. Prior attained data was retrievable, although attempts to repair the gauge failed. Gauge will be replaced prior to 2006 growing season.

³ Gauge 28 ceased to function properly on July 1st and will be replaced prior to the 2006 growing season.

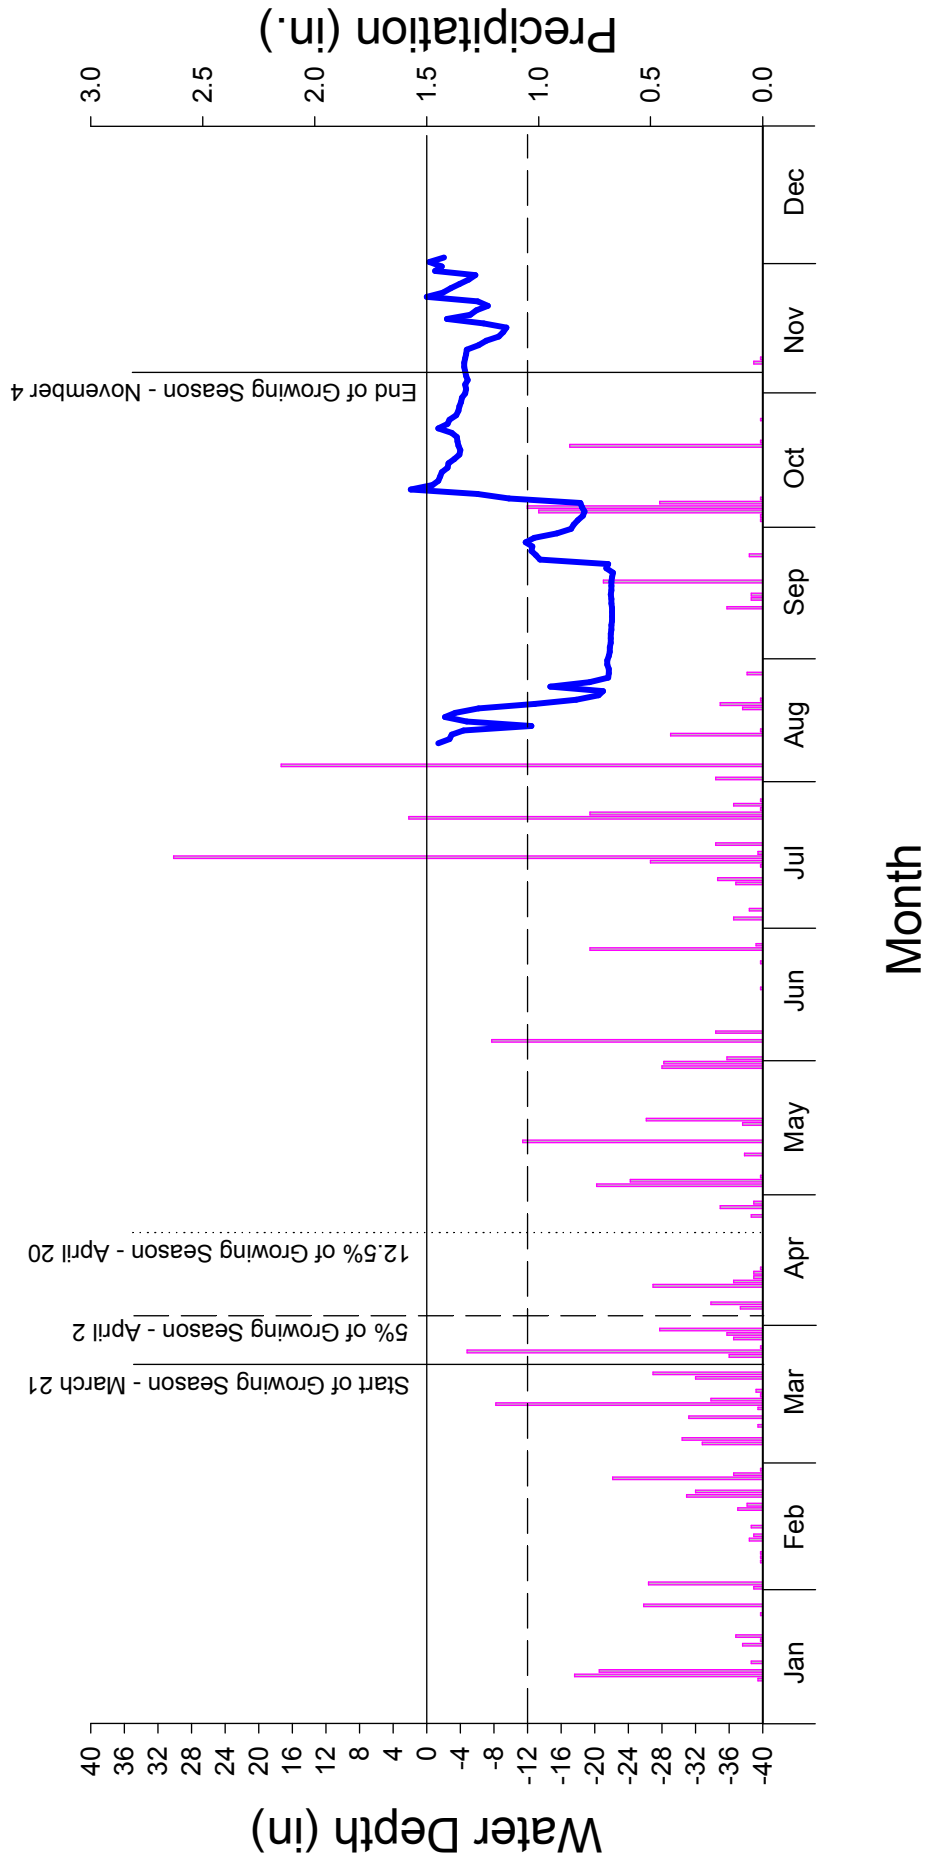
White Oak Creek 2005 Monitoring Gauge 29 - B65238F

*Gauge was found to be non-functioning during first site visit in July 2005. Gauge was replaced in August 2005.
