WHITE OAK CREEK MITIGATION SITE

2005 Annual Monitoring Report (Year 4)

Johnson County
EEP Project No. 417
Design Firm: Rummel, Klepper & Kahl, LLP

February 2006

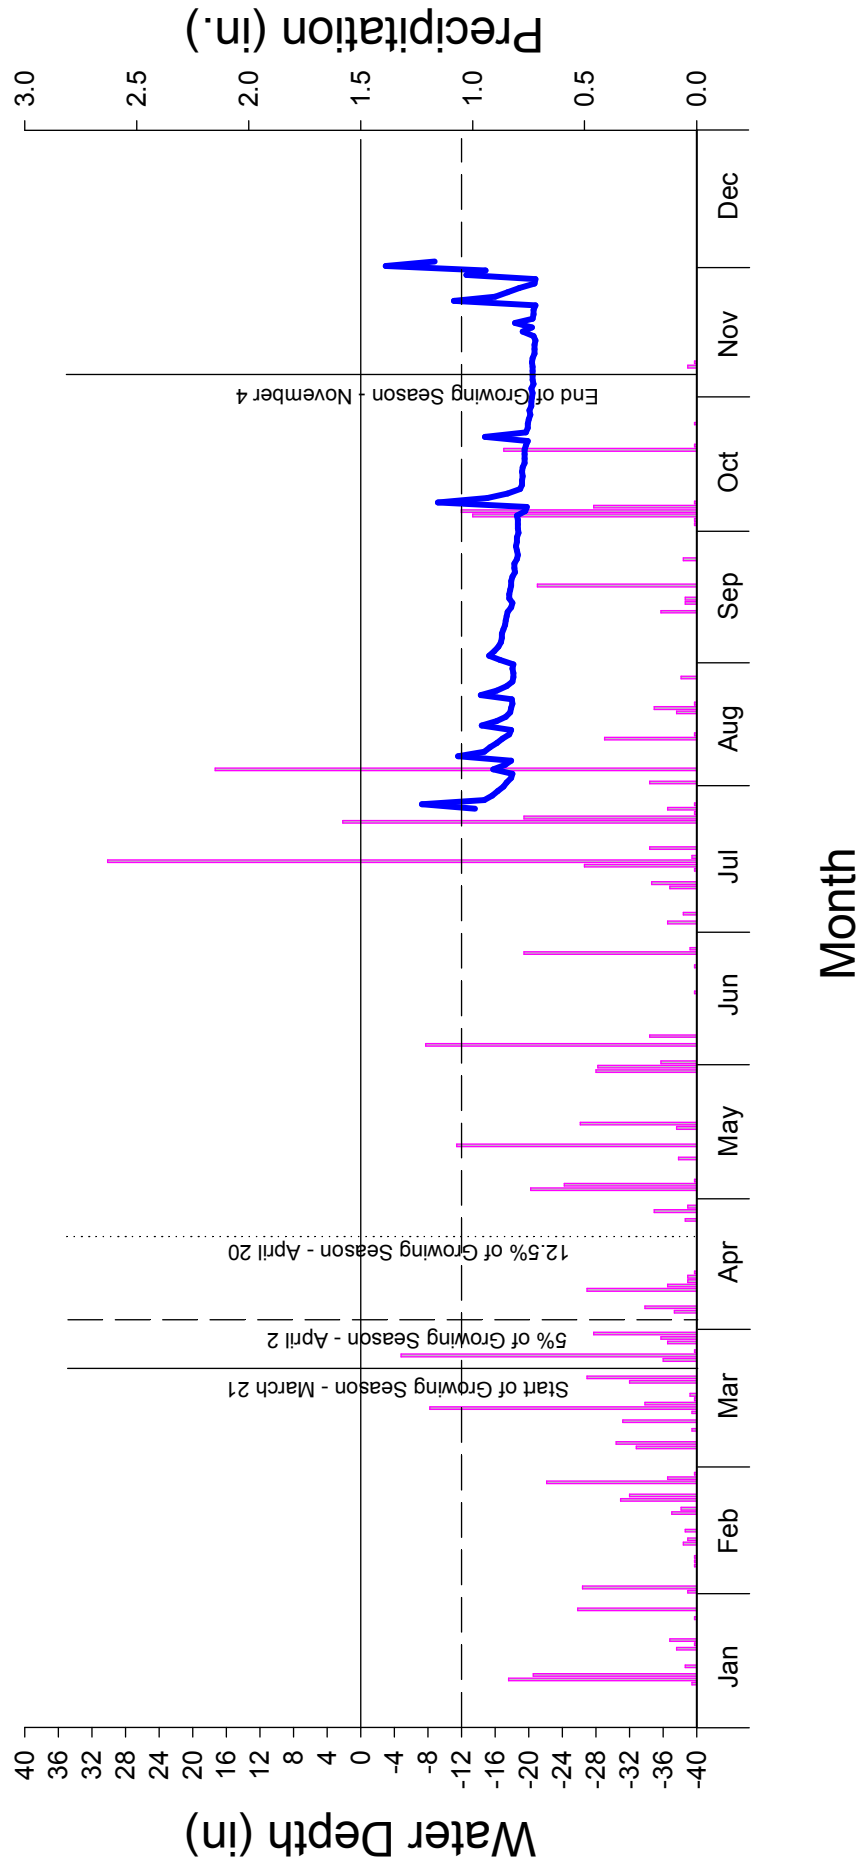
White Oak Creek 2005 Monitoring Gauge 30 - 8E556CA

*Prior to July 2005 gauge was not functioning due to low battery charge. Batteries were replaced during first site visit in late July.

¹ Gauges 3, 20, and 30 were non-functional for much of the growing season due to low battery charge. Batteries were replaced on July 29th, 2005 during the initial site visit.

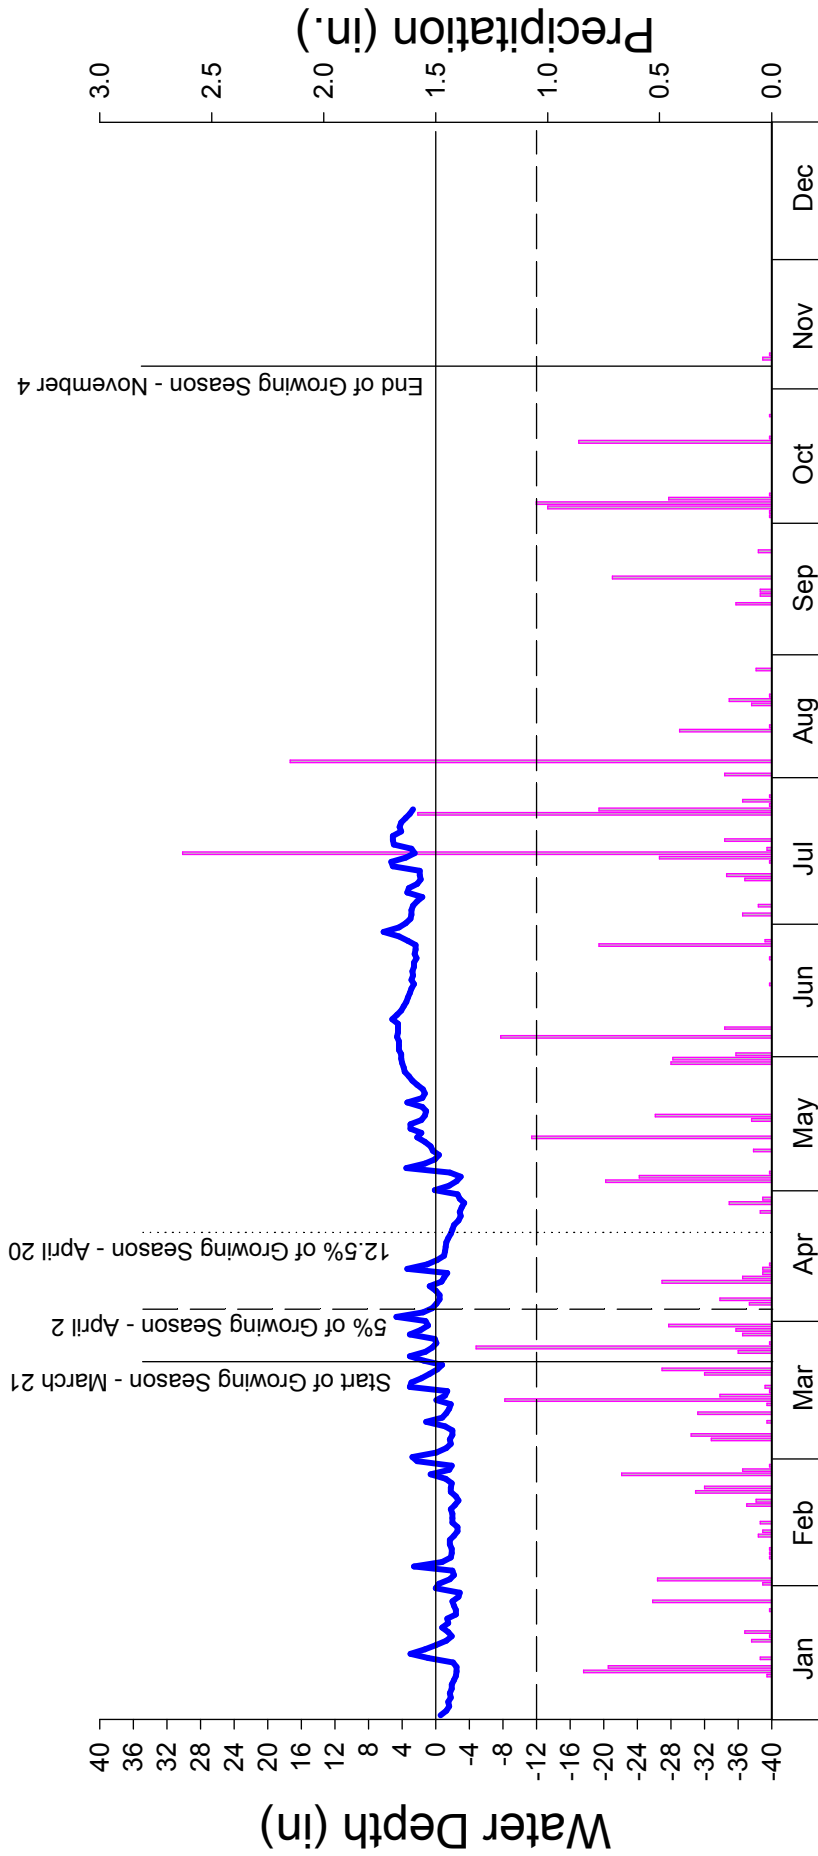
White Oak Creek 2005 Monitoring Gauge 31 - 8E576F0

*Gauge was found to be non-functioning during first site visit in July 2005. Prior attained data was retrievable, although attempts to repair the gauge failed. Gauge will be replaced prior to 2006 growing season.

⁴ Gauge 31 ceased to function properly on July 27th, 2005 and will be replaced prior to the 2006 growing season.
