WHITE OAK CREEK MITIGATION SITE

2006 Annual Monitoring Report (Year 5)

Johnson County
EEP Project No. 417
Design Firm: Rummel, Klepper & Kahl, LLP

January 2007

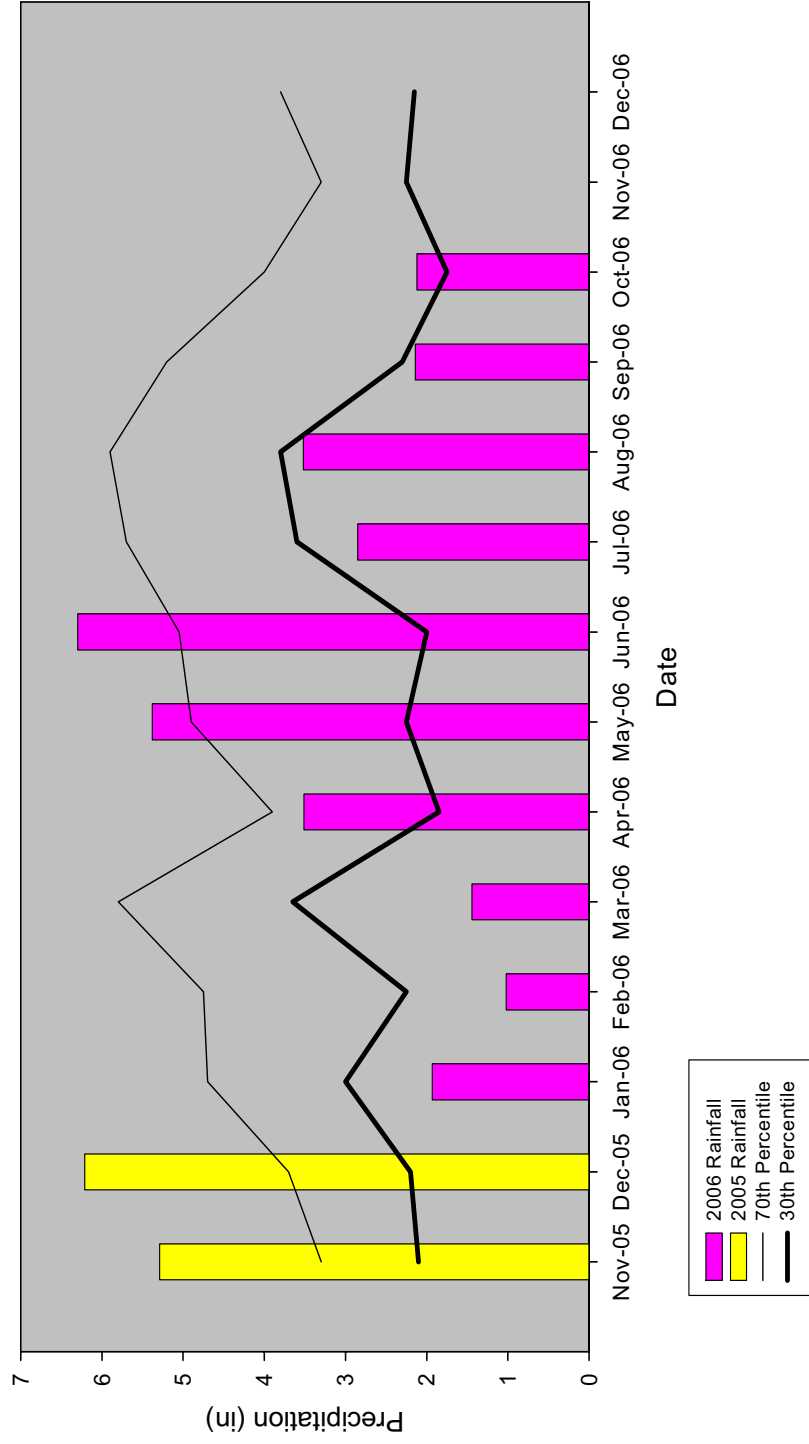
**Fig 3. White Oak Creek 30-70 Percentile Graph 2006
Clayton, NC**

Figure 3 (Appendix A) provides an evaluation of the local climate in comparison with historical data in order to determine whether 2006 was a year with “average” rainfall. The bars are the monthly rainfall totals for the 2006 hydrologic year collected from the on-site rain gauge. Also represented on the figure are the 30th and 70th percentiles of monthly precipitation for the Clayton weather station. The historical data and monthly data were collected by the Southeast Regional Climate Data.

Months with below average rainfall include: January, February, March, July, August, and September. The months of April and October experienced average rainfall. May and June

received above average rainfall. A normal yearly rainfall in the area is approximately 45.7 inches.

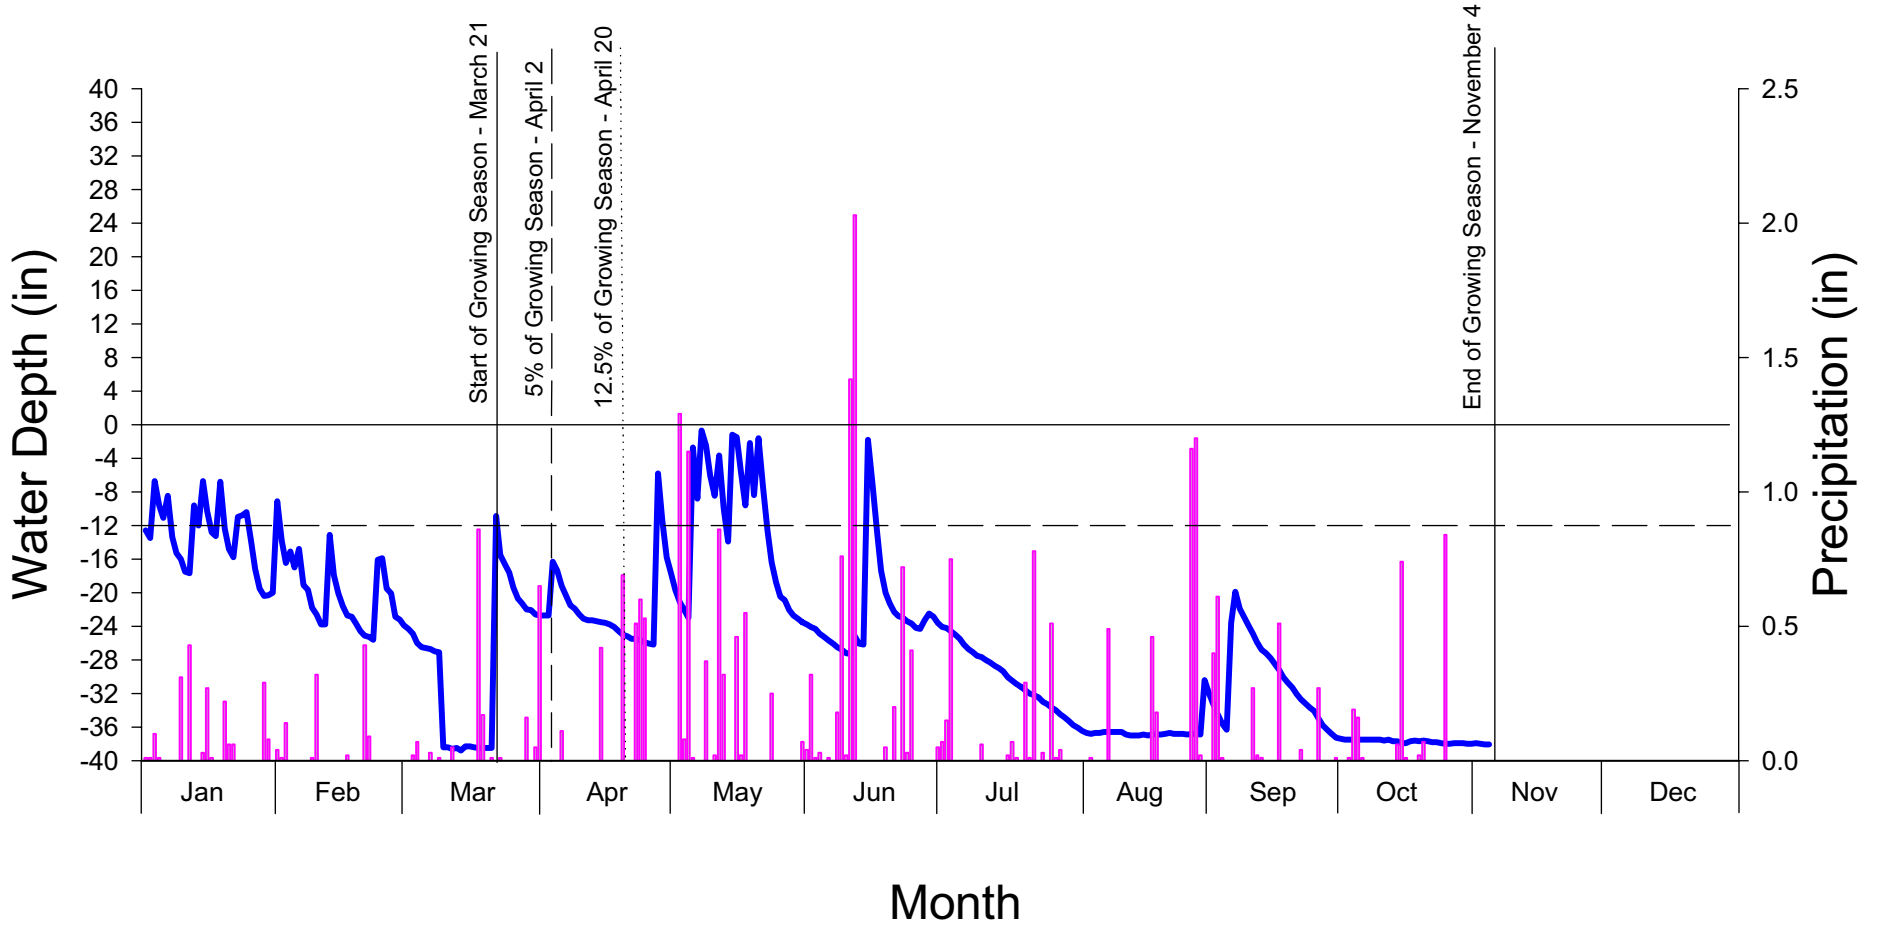
White Oak Creek 2006 Monitoring Gauge 1 - 9DE4246

| Monitoring Gauge* | <5% | 5-12.5% | >12.5% | Actual % | Success Date |
|---|---|---|---|---|---|
| GW-1 | ✓ | | | 4 | |

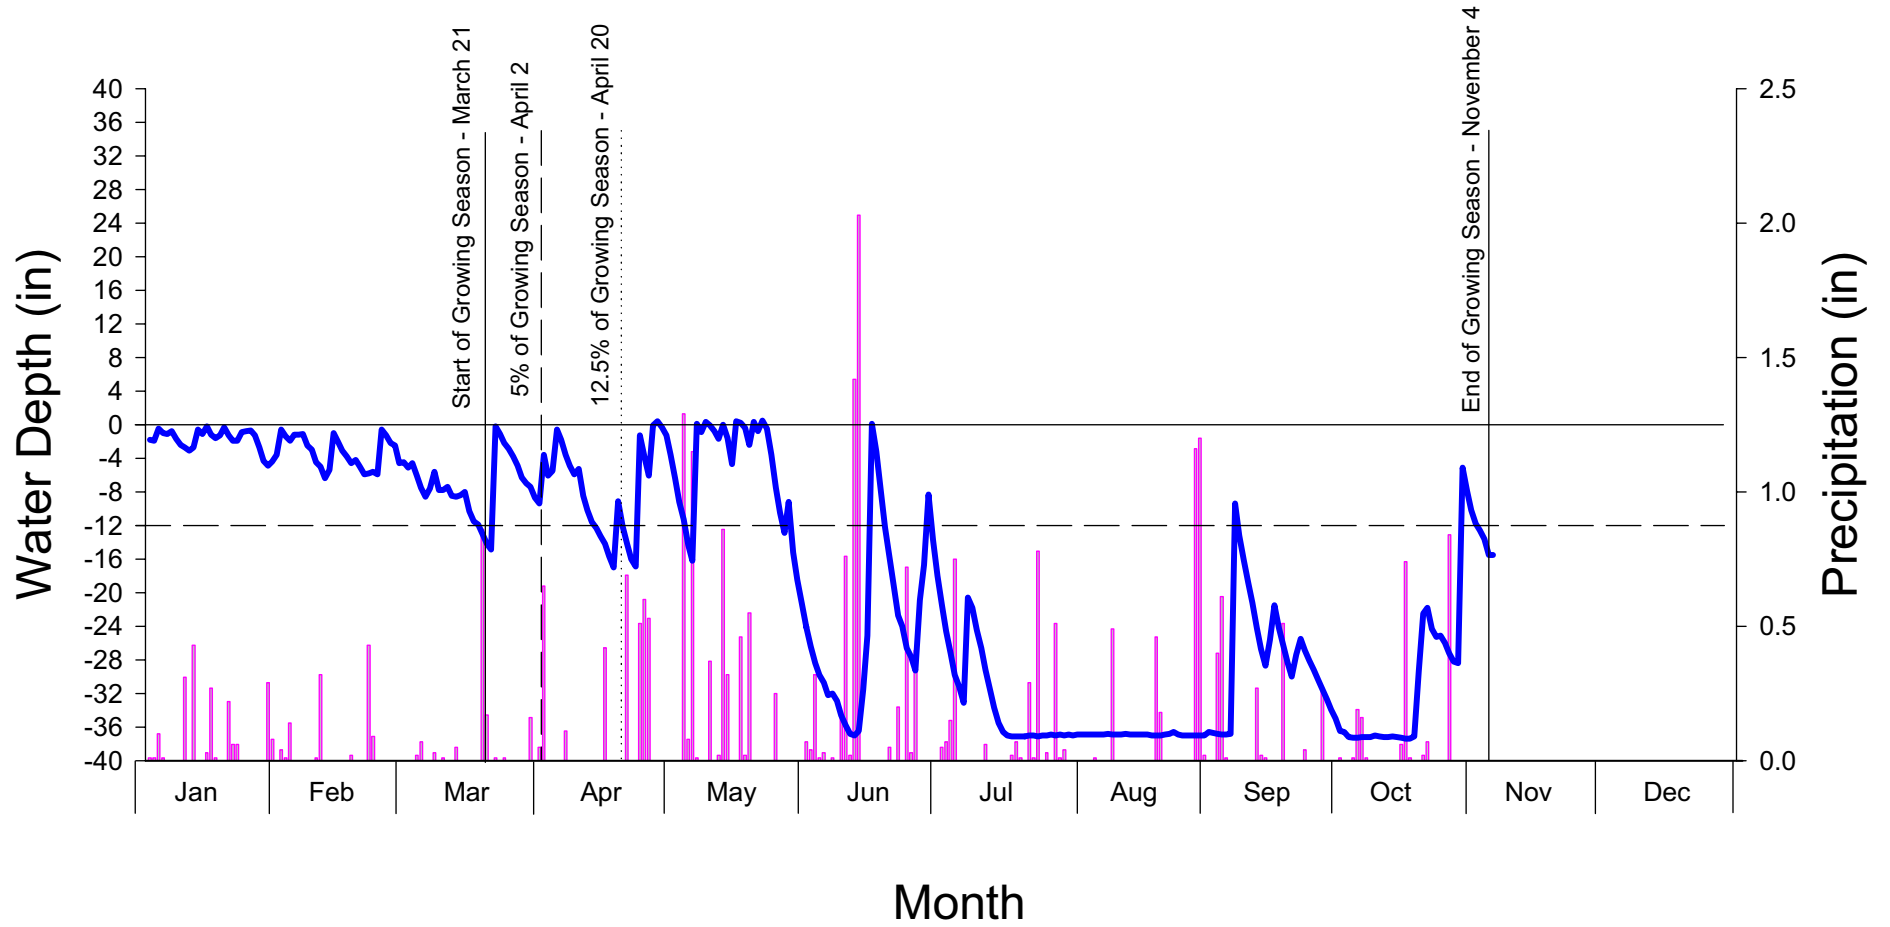
White Oak Creek 2006 Monitoring Gauge 2 - 9BEB CFA

| Monitoring Gauge* | <5% | 5-12.5% | >12.5% | Actual % | Success Date |
|---|---|---|---|---|---|
| GW-2 | | ✓ | | 9 | |

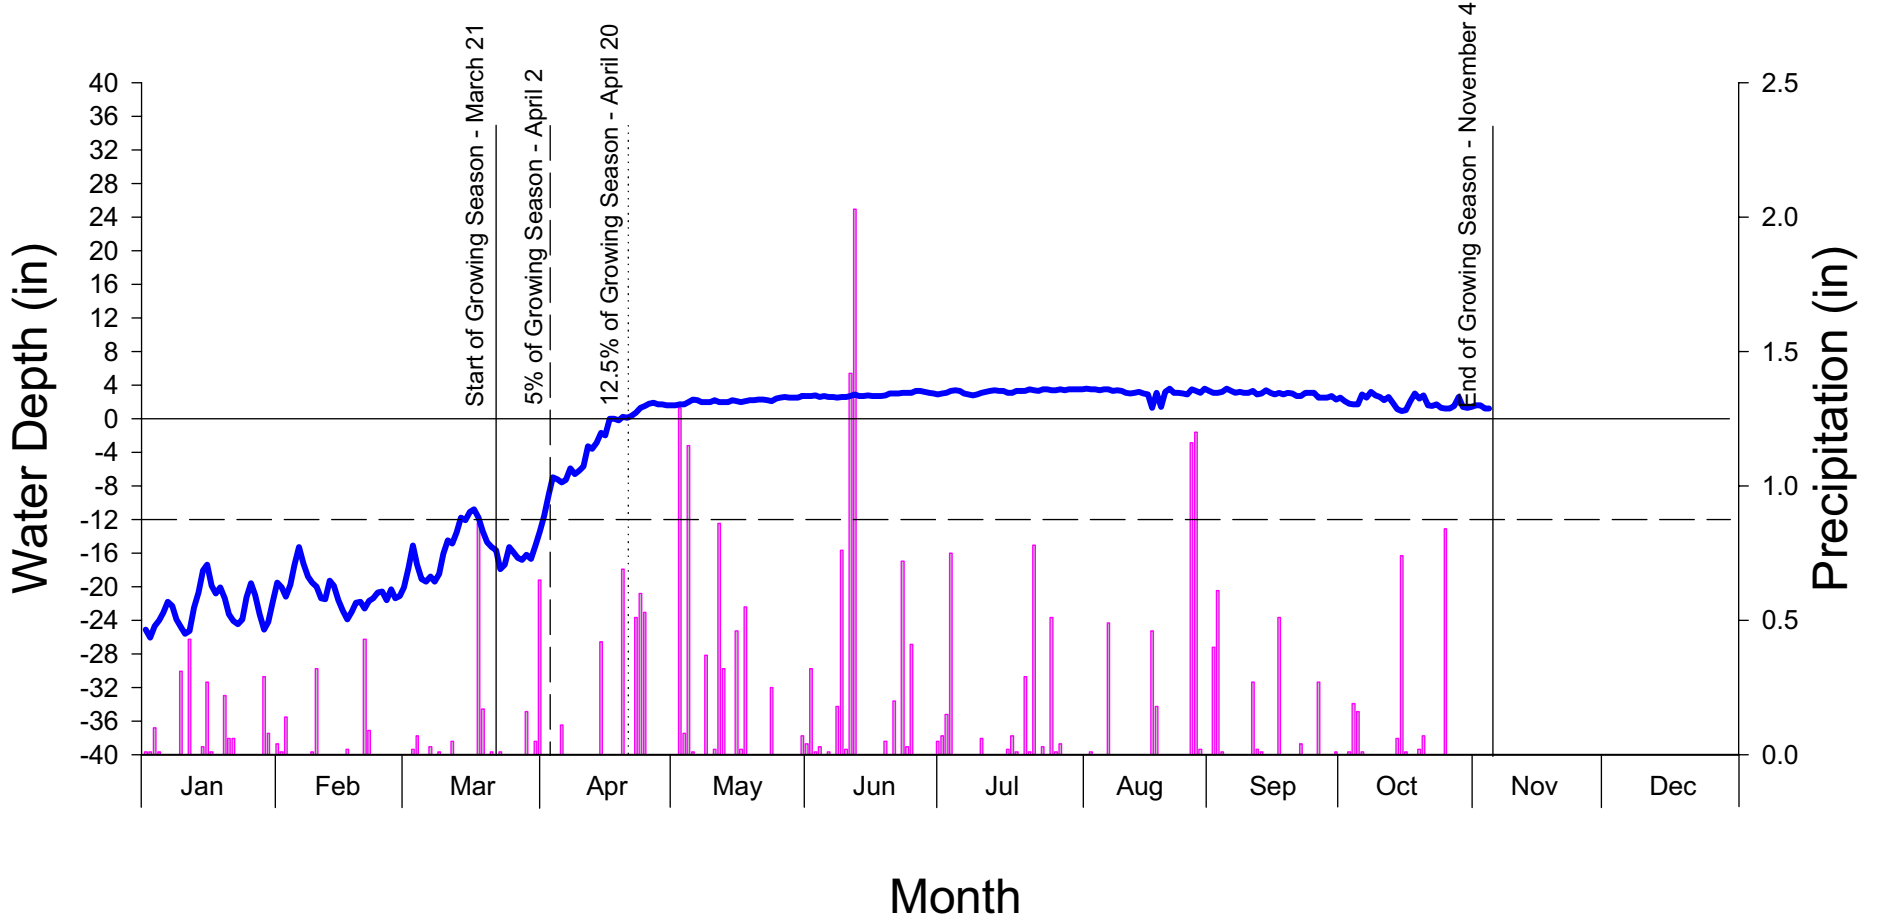
White Oak Creek 2006 Monitoring Gauge 3 - 8E529FC

| Monitoring Gauge* | <5% | 5-12.5% | >12.5% | Actual % | Success Date |
|---|---|---|---|---|---|
| GW-3 | | | ✓ | 94 | April 3 – November 4 |

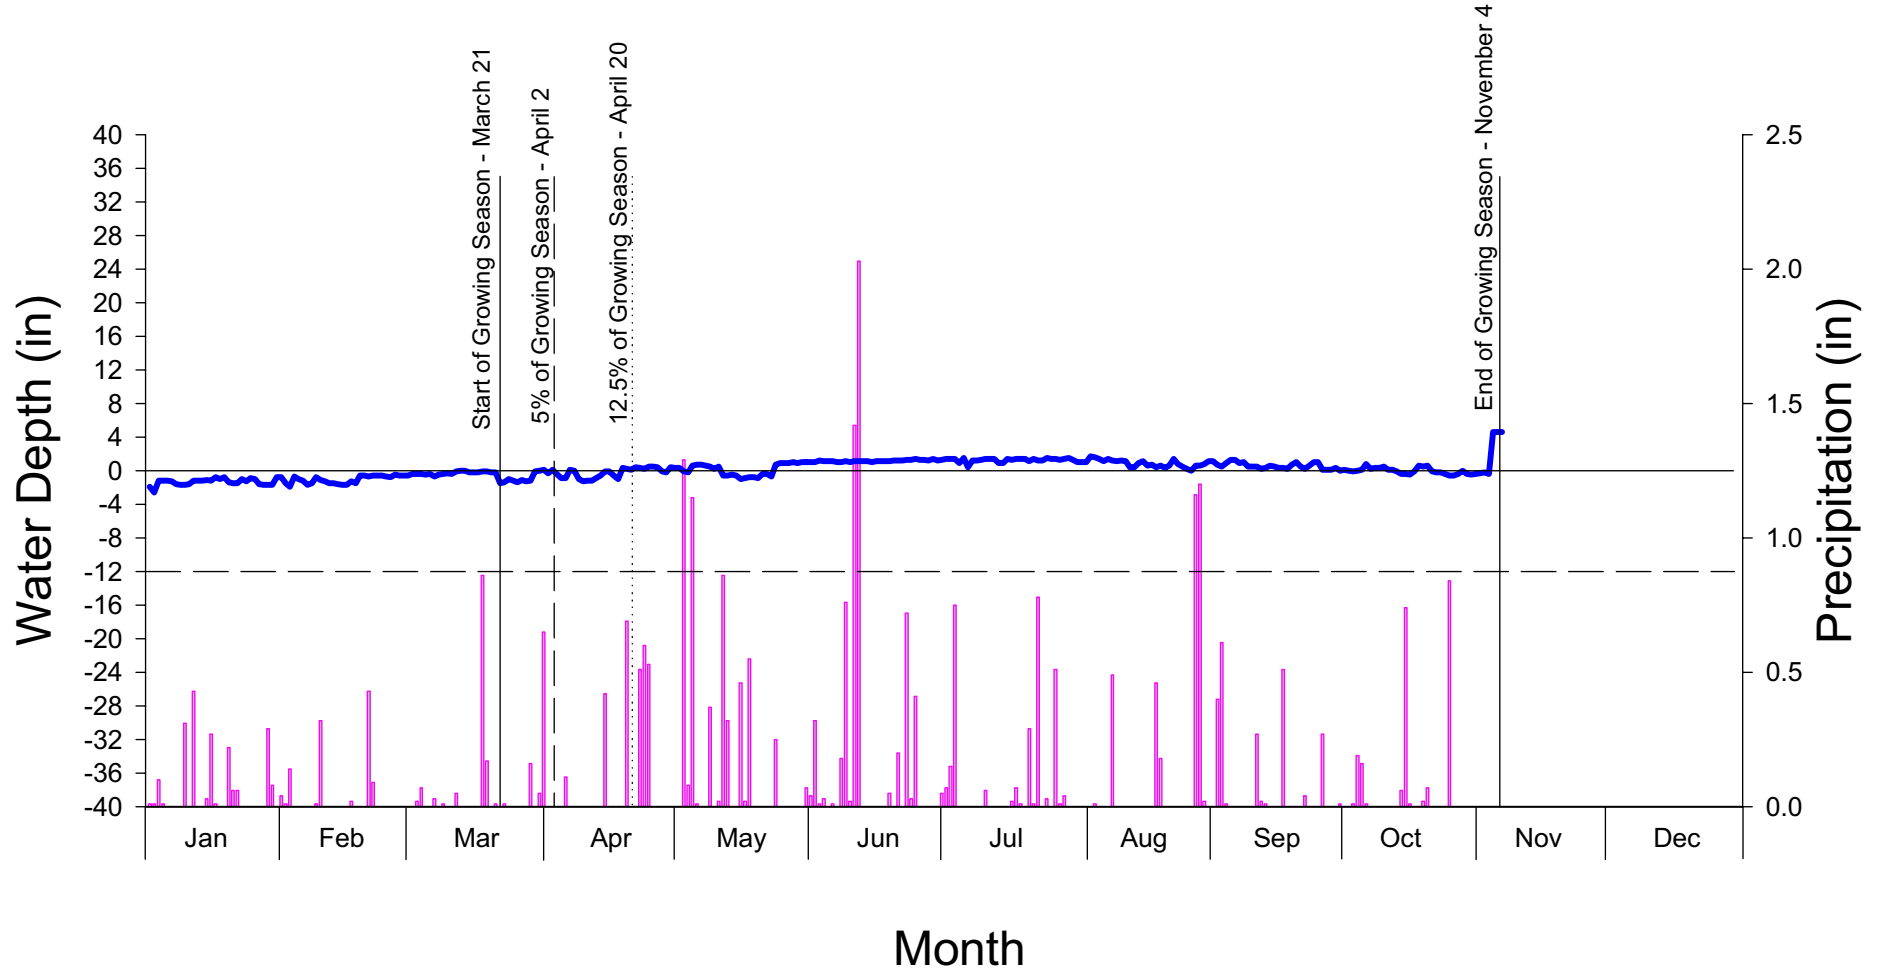
White Oak Creek 2006 Monitoring Gauge 4 - B651405

| Monitoring Gauge* | <5% | 5-12.5% | >12.5% | Actual % | Success Date |
|---|---|---|---|---|---|
| GW-4 | | | ✓ | 100 | March 21 – November 4 |

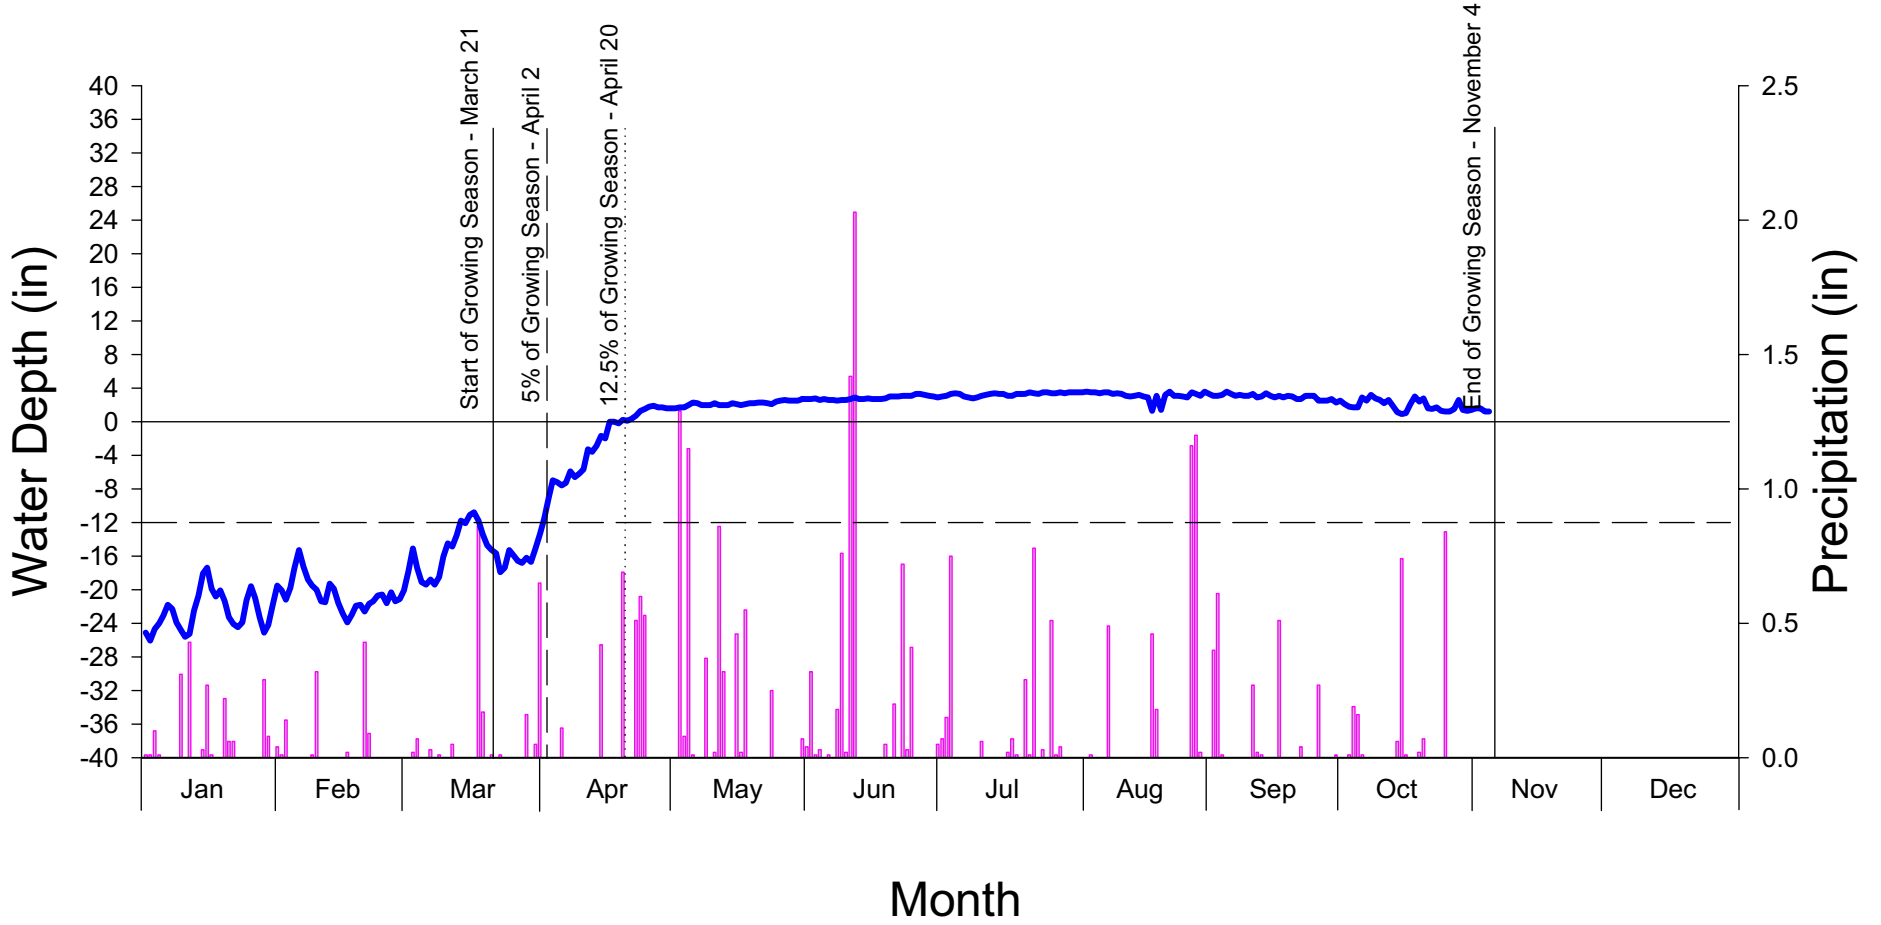
White Oak Creek 2006 Monitoring Gauge 5 - B65131A

| Monitoring Gauge* | <5% | 5-12.5% | >12.5% | Actual % | Success Date |
|---|---|---|---|---|---|
| GW-5 | | | ✓ | 94 | April 3 – November 4 |

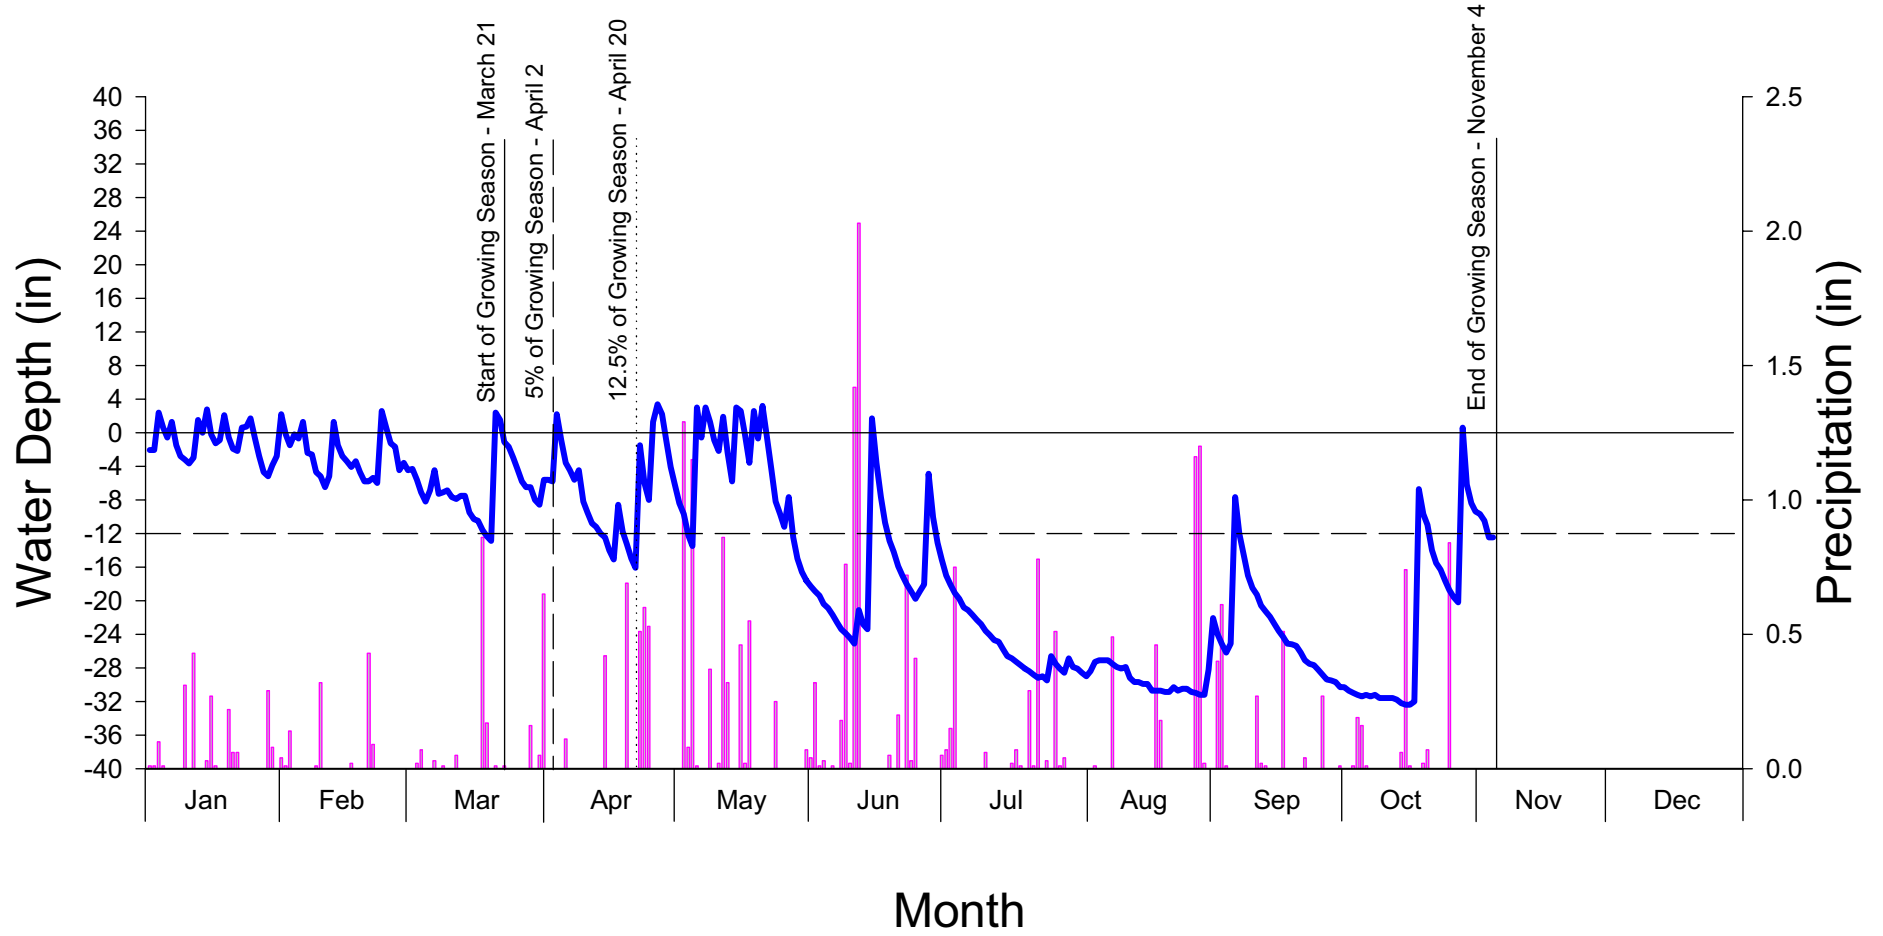
White Oak Creek 2006 Monitoring Gauge 6 - 04487EB

| Monitoring Gauge* | <5% | 5-12.5% | >12.5% | Actual % | Success Date |
|---|---|---|---|---|---|
| GW-6 | | ✓ | | 11 | |

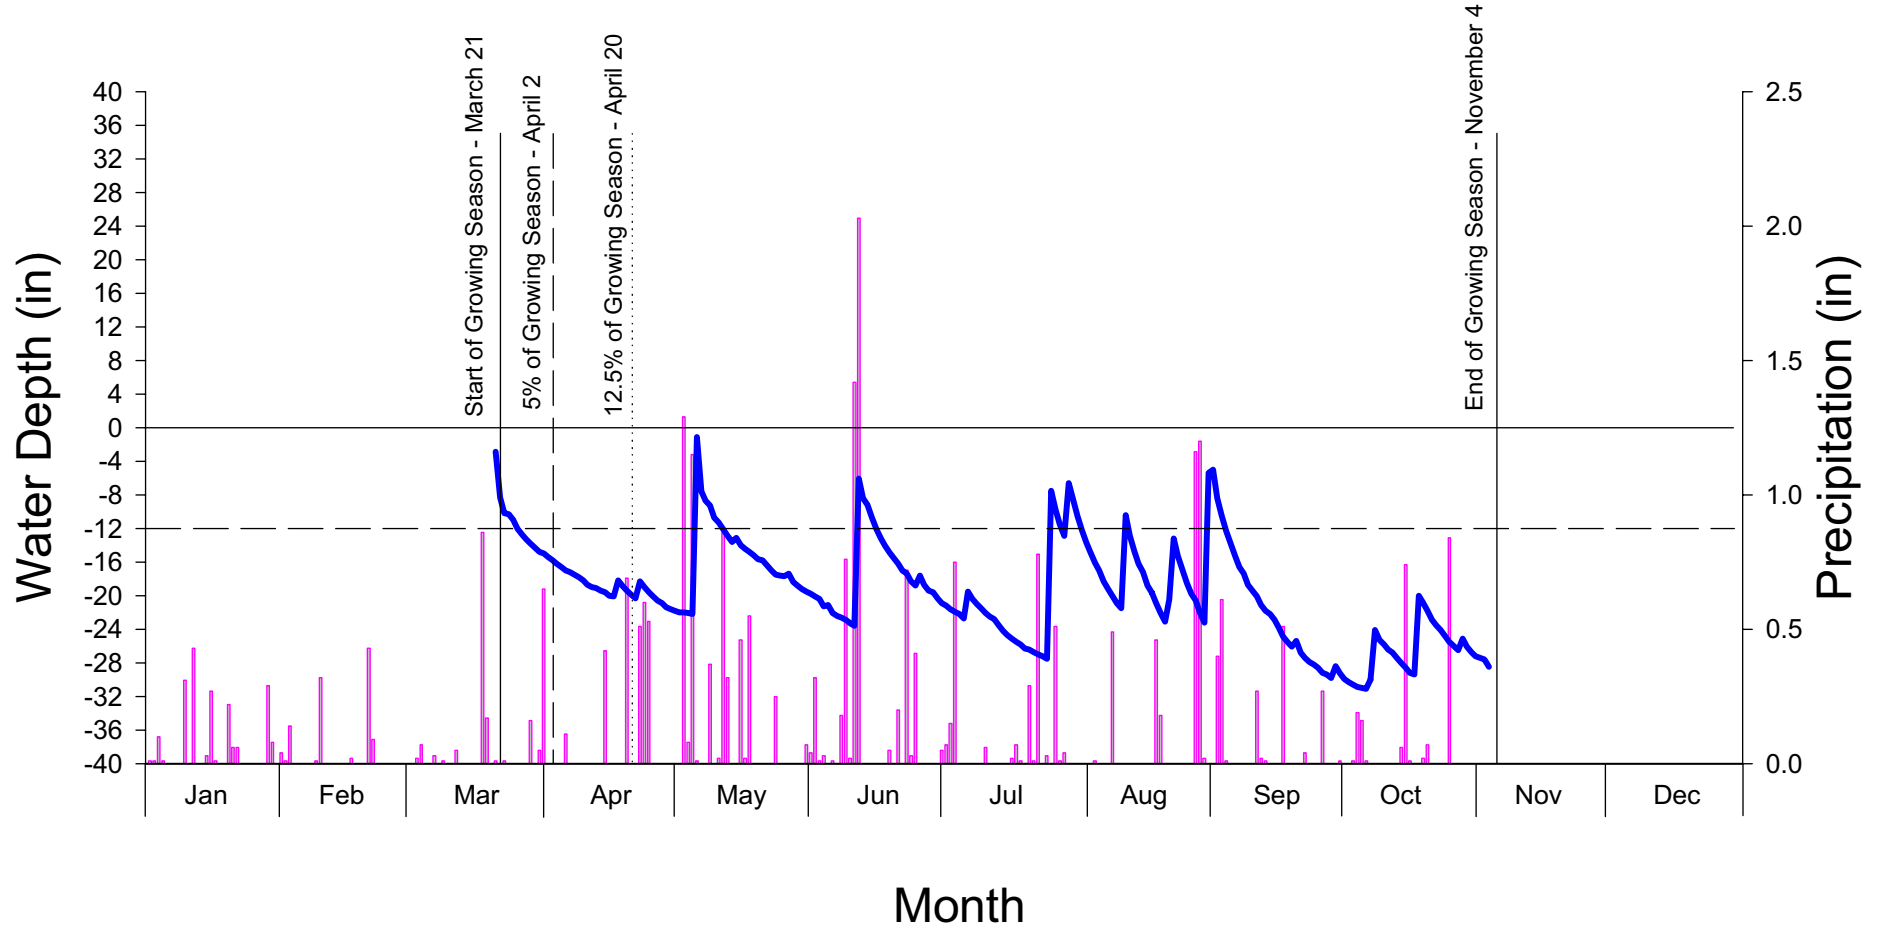
White Oak Creek 2006 Monitoring Gauge 7 - 0214102

| Monitoring Gauge* | <5% | 5-12.5% | >12.5% | Actual % | Success Date |
|---|---|---|---|---|---|
| GW-7 | ✓ | | | 3 | |

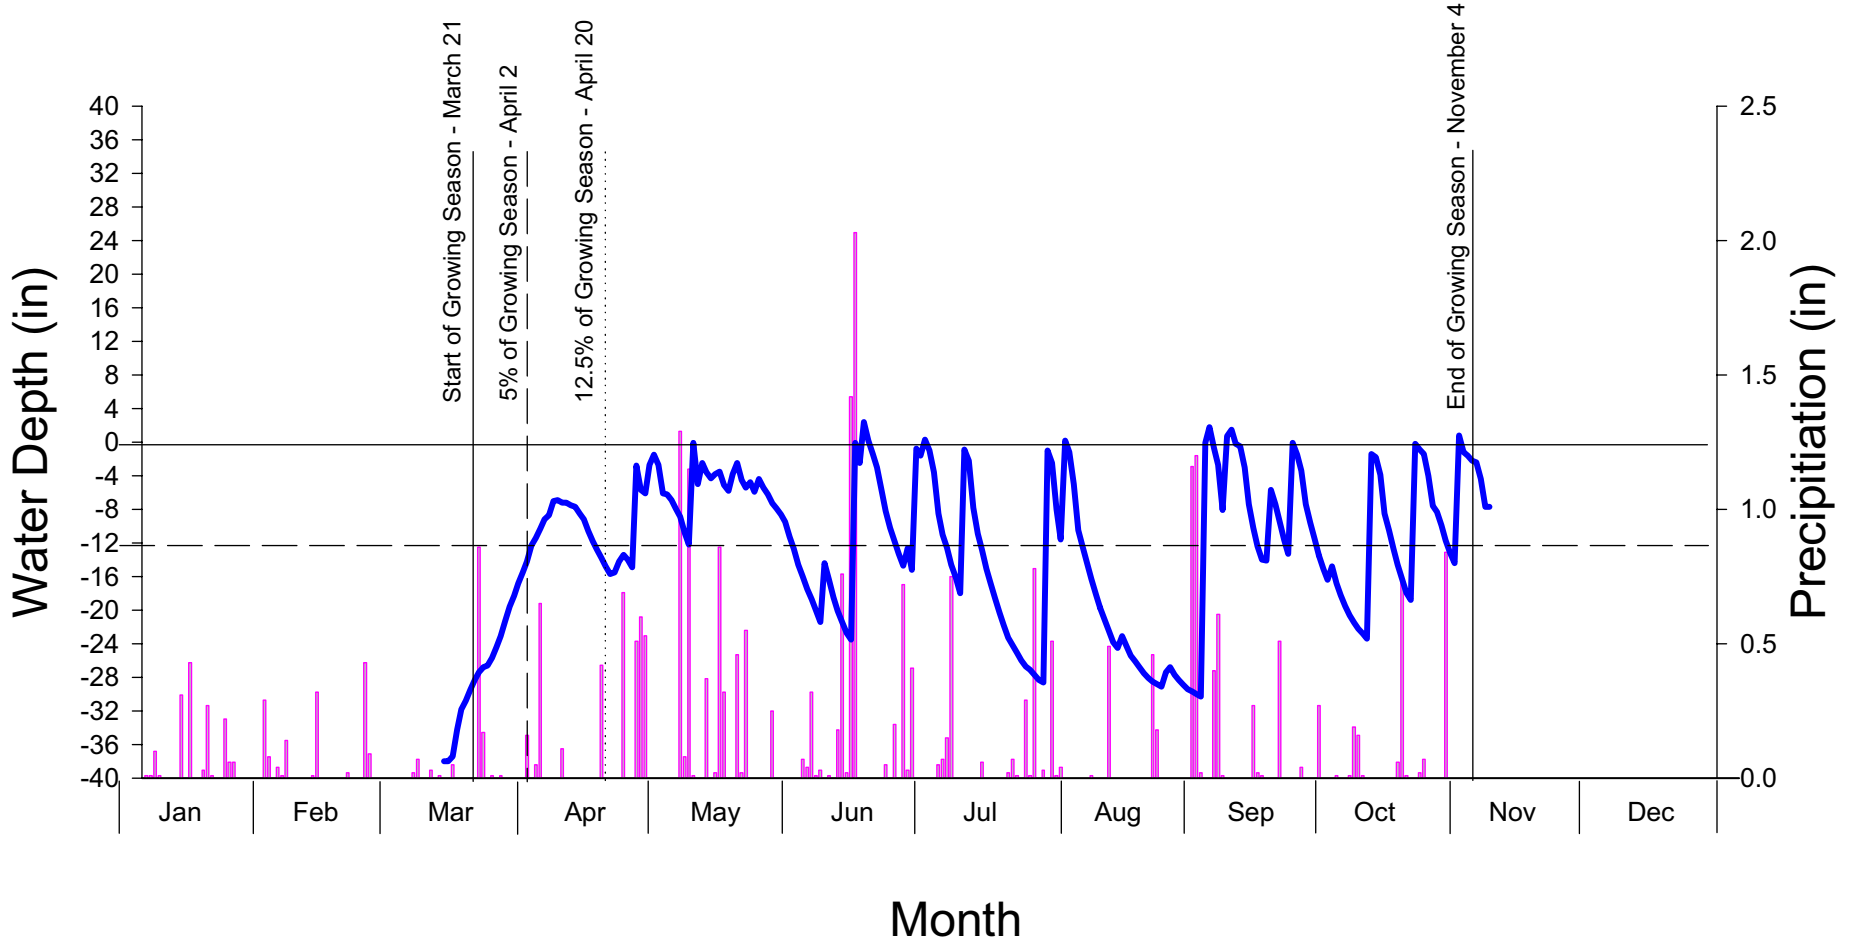
White Oak Creek 2006 Monitoring Gauge 8 - AB37304

| Monitoring Gauge* | <5% | 5-12.5% | >12.5% | Actual % | Success Date |
|---|---|---|---|---|---|
| GW-8 | | | ✓ | 15 | April 23 – May 28 |

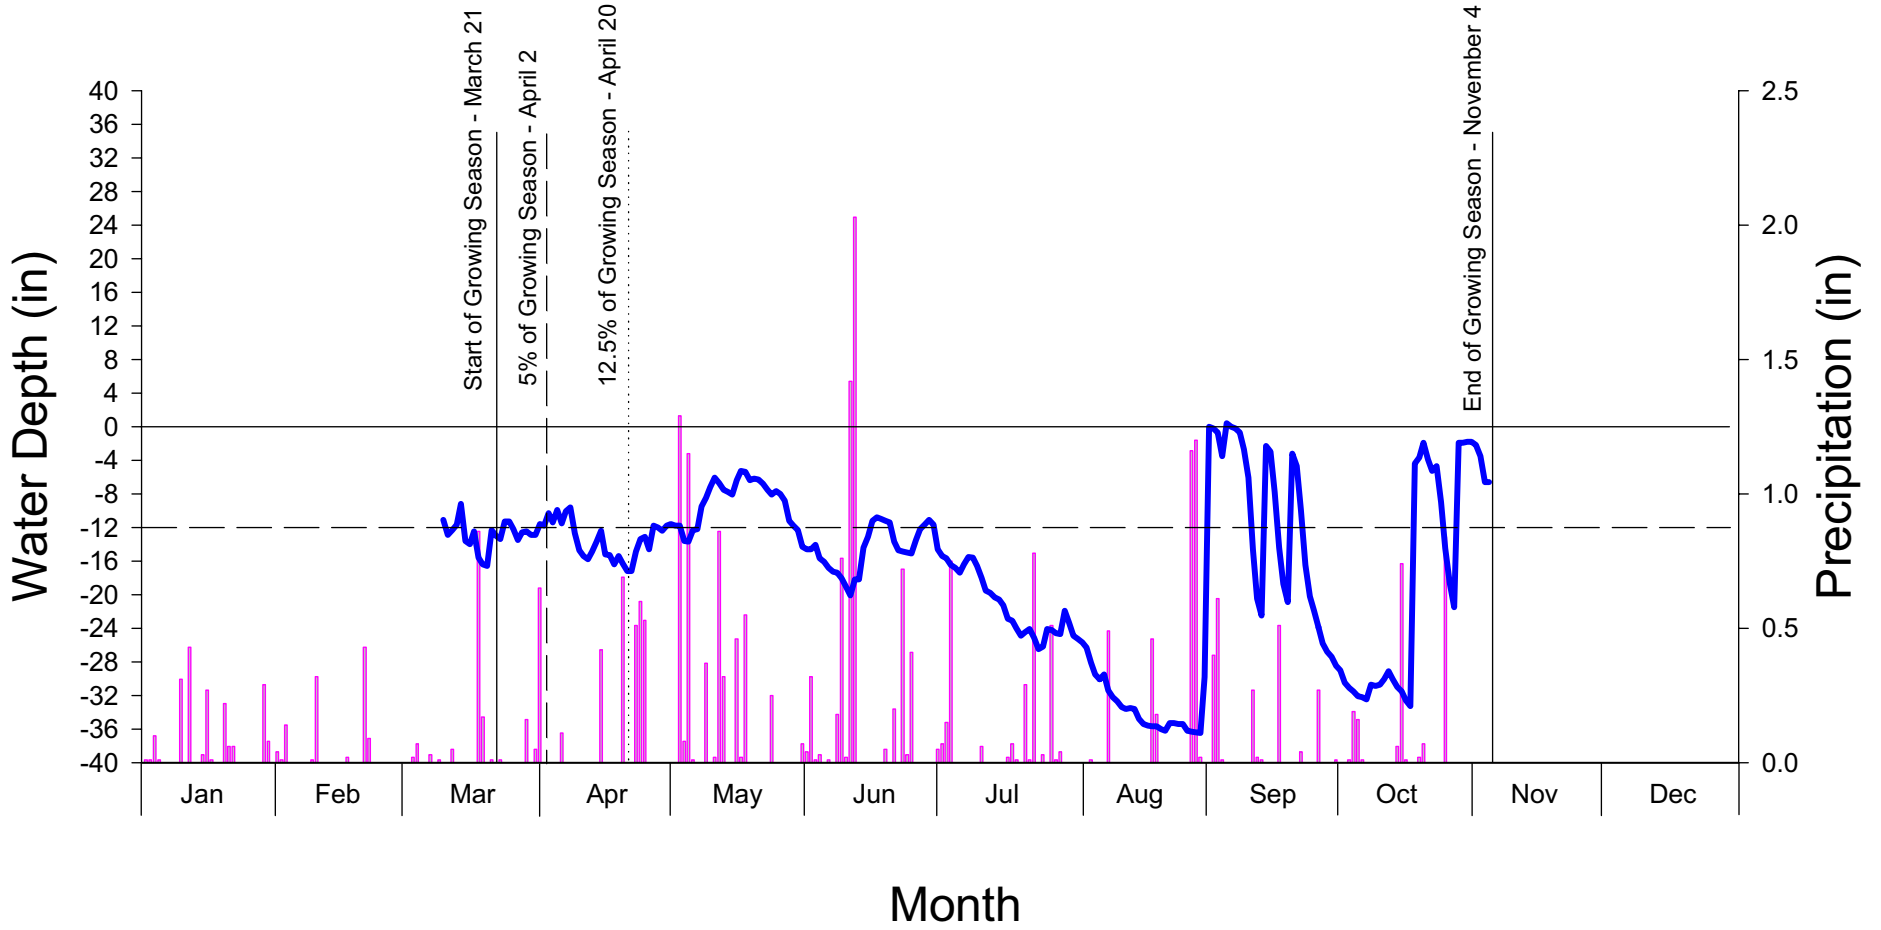
White Oak Creek 2006 Monitoring Gauge 10 - 9DE5CAE

| Monitoring Gauge* | <5% | 5-12.5% | >12.5% | Actual % | Success Date |
|---|---|---|---|---|---|
| GW-10 | | ✓ | | 9 | |

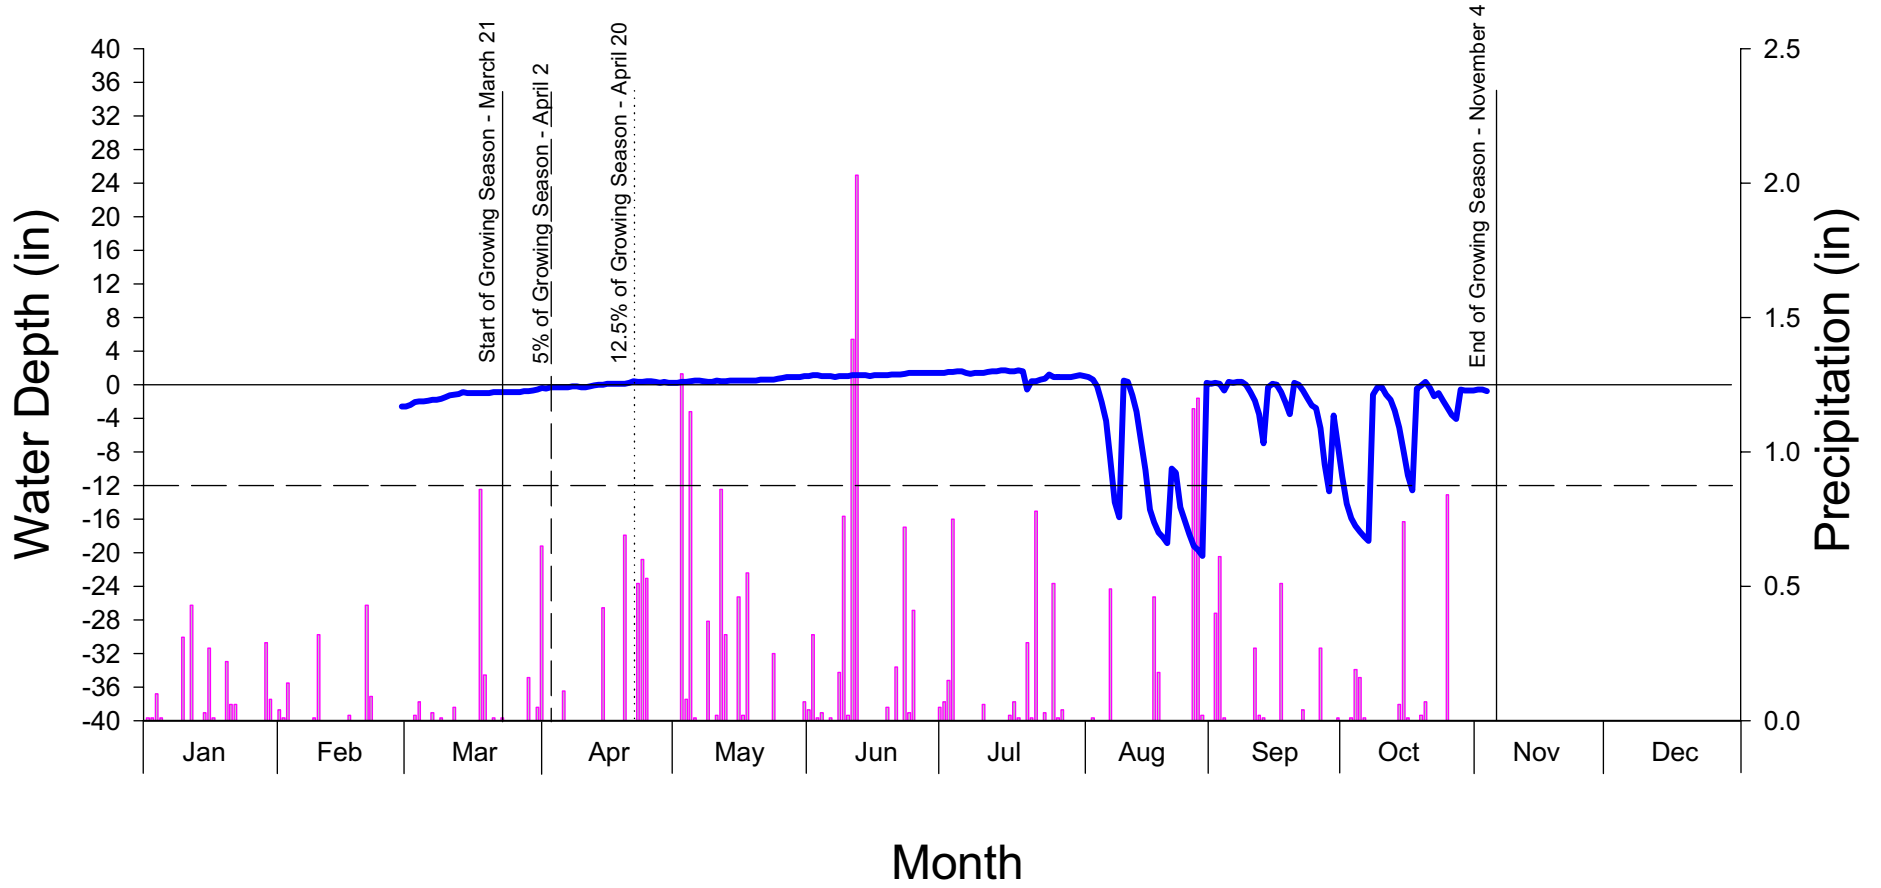
White Oak Creek 2006 Monitoring Gauge 11 - A3C2C3E

| Monitoring Gauge* | <5% | 5-12.5% | >12.5% | Actual % | Success Date |
|---|---|---|---|---|---|
| GW-11 | | | ✓ | 62 | March 21 – August 11 |

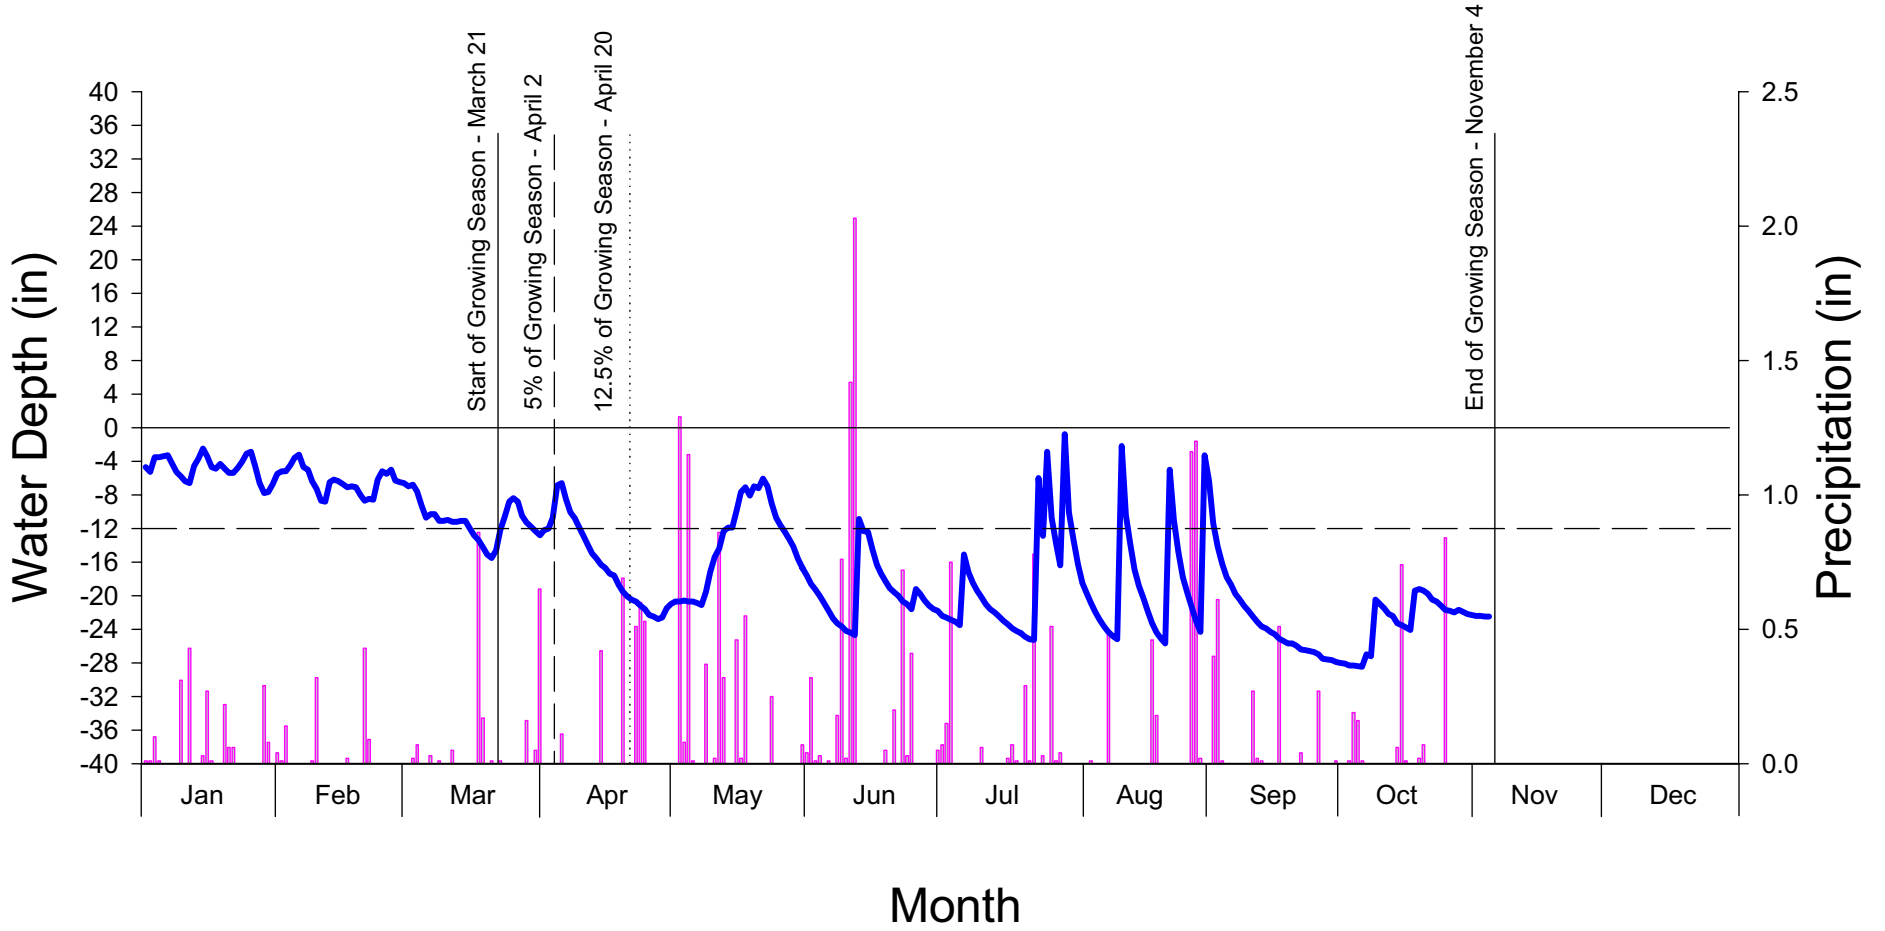
White Oak Creek 2006 Monitoring Gauge 12 - B65222F

| Monitoring Gauge* | <5% | 5-12.5% | >12.5% | Actual % | Success Date |
|---|---|---|---|---|---|
| GW-12 | | ✓ | | 6 | |

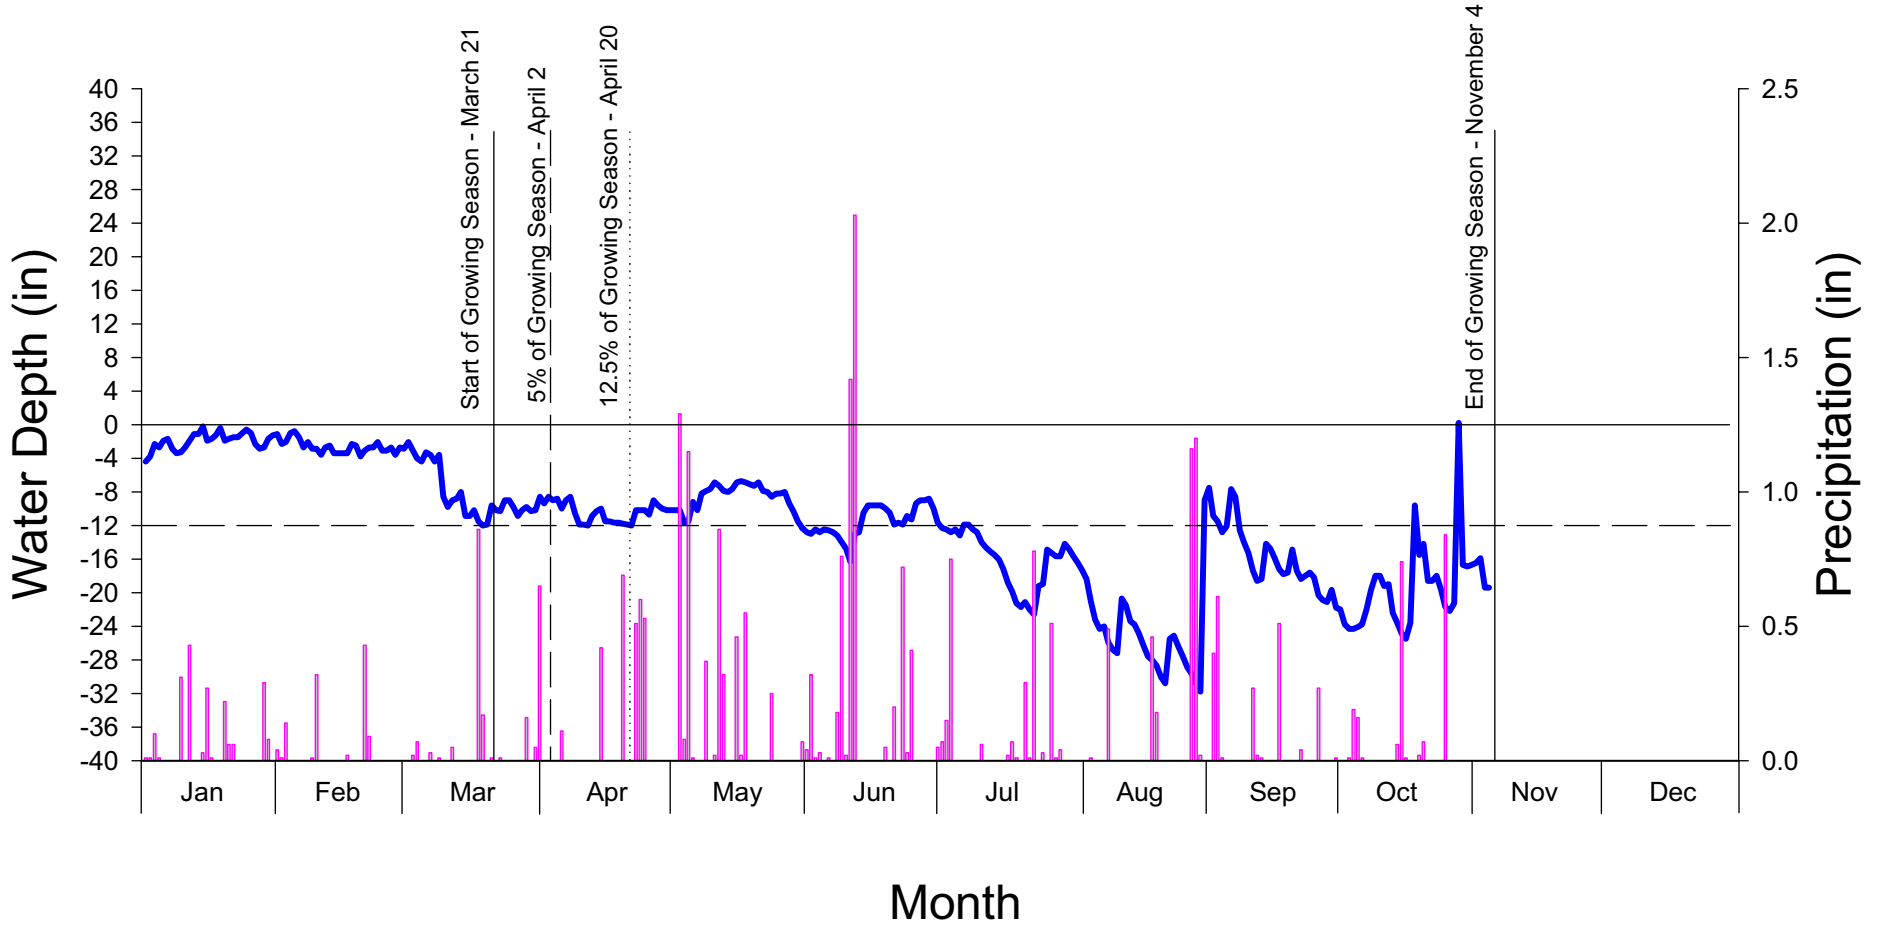
White Oak Creek 2006 Monitoring Gauge 13 - 04941F4

| Monitoring Gauge* | <5% | 5-12.5% | >12.5% | Actual % | Success Date |
|---|---|---|---|---|---|
| GW-13 | | | ✓ | 31 | March 21 – May 31 |
