WHITE OAK CREEK MITIGATION SITE

2006 Annual Monitoring Report (Year 5)

Johnson County
EEP Project No. 417
Design Firm: Rummel, Klepper & Kahl, LLP

January 2007

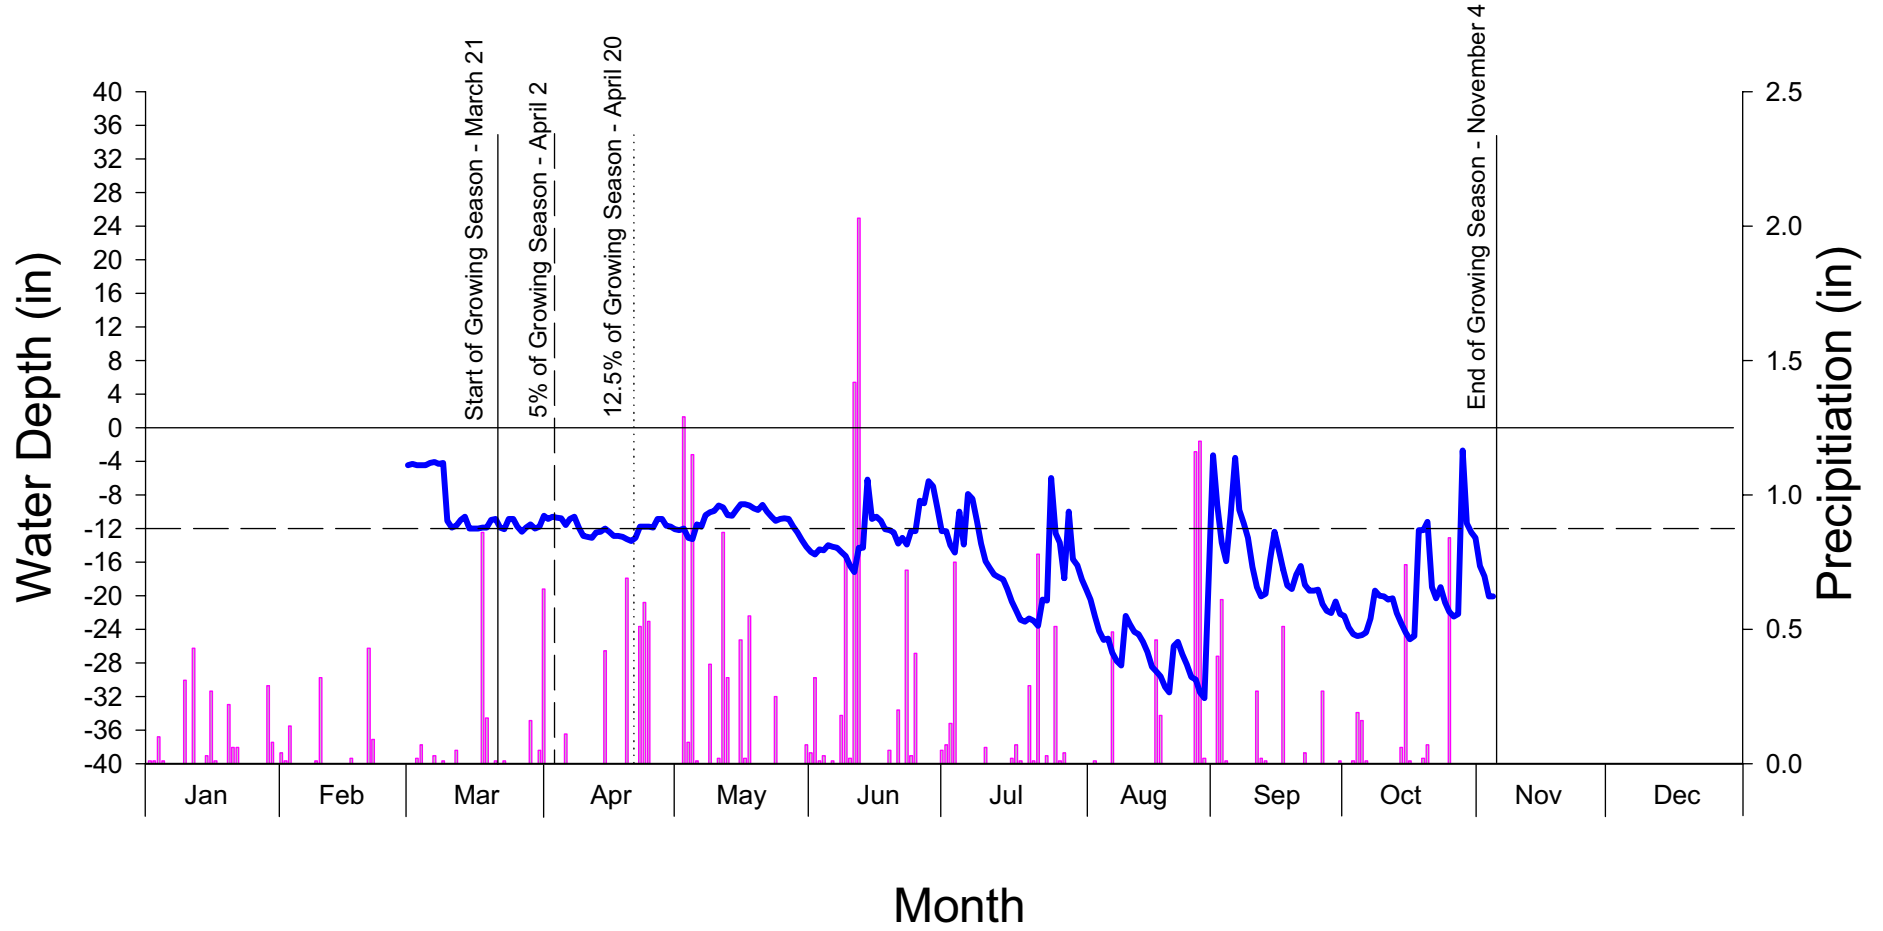
White Oak Creek 2006 Monitoring Gauge 14 - 9D7ECE7

| Monitoring Gauge* | <5% | 5-12.5% | >12.5% | Actual % | Success Date |
|---|---|---|---|---|---|
| GW-14 | | ✓ | | 10 | |

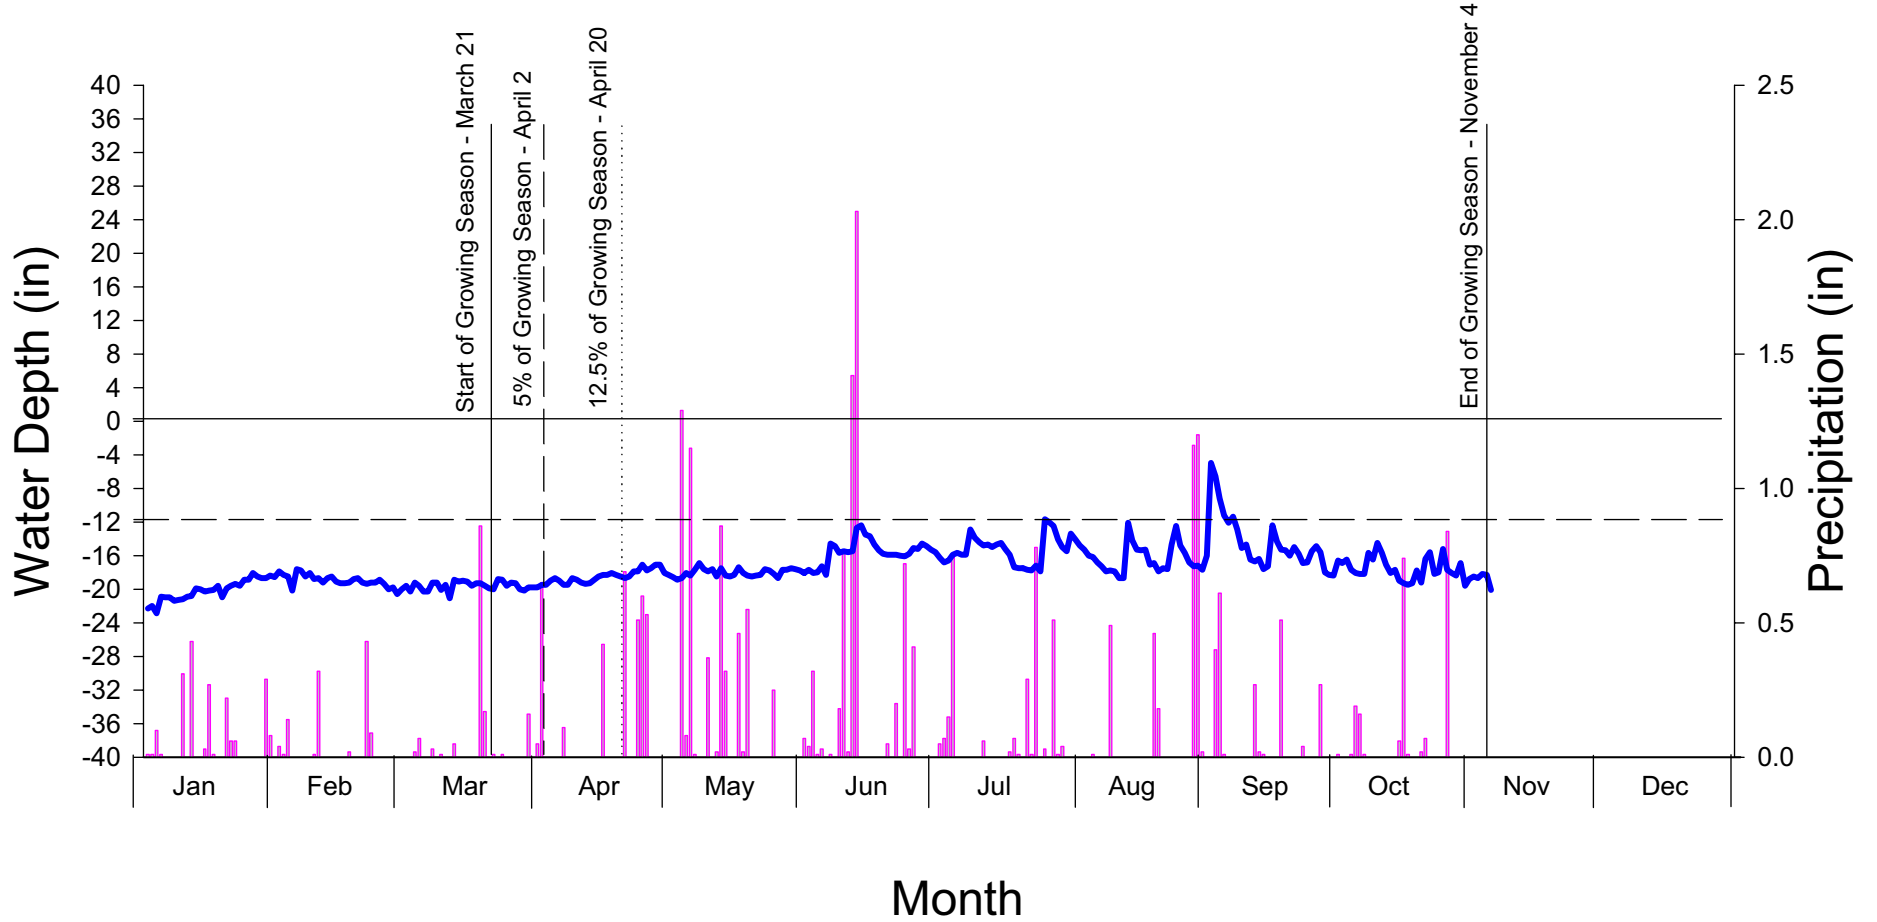
White Oak Creek 2006 Monitoring Gauge 15 - 9DE497E

| Monitoring Gauge* | <5% | 5-12.5% | >12.5% | Actual % | Success Date |
|---|---|---|---|---|---|
| GW-15 | ✓ | | | 1 | |

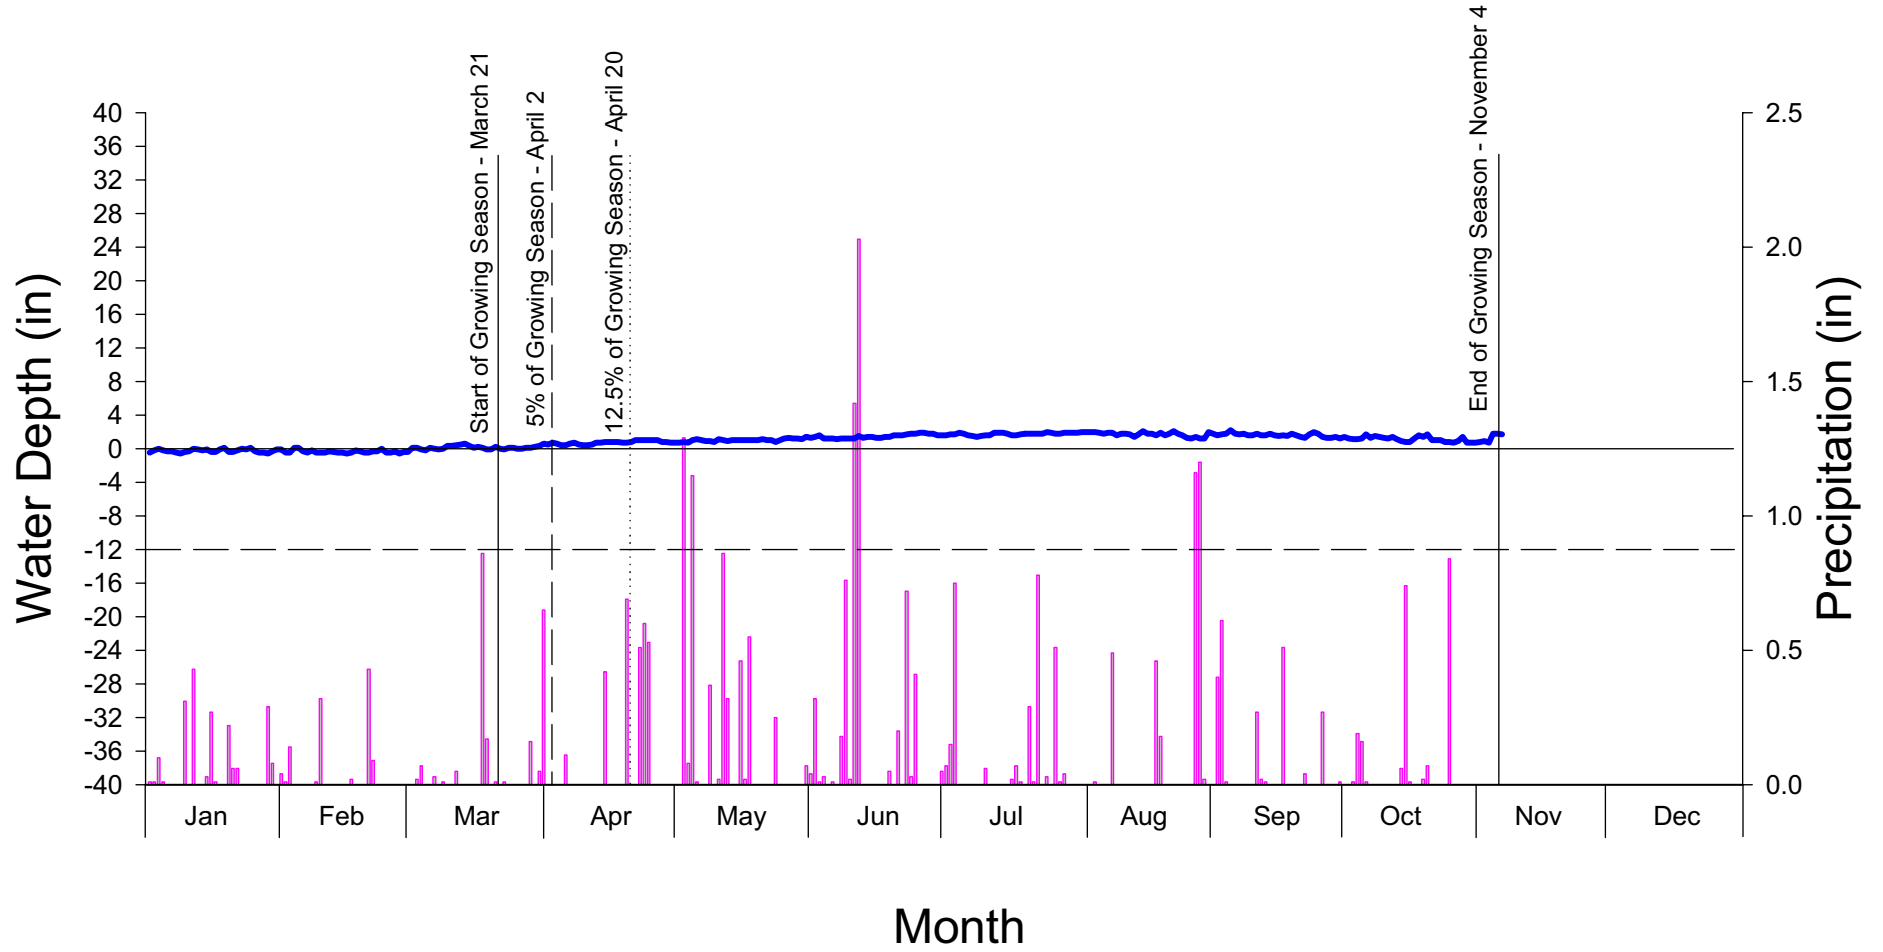
White Oak Creek 2006 Monitoring Gauge 16 - B6513D9

| Monitoring Gauge* | <5% | 5-12.5% | >12.5% | Actual % | Success Date |
|---|---|---|---|---|---|
| GW-16 | | | ✓ | 100 | March 21 – November 4 |

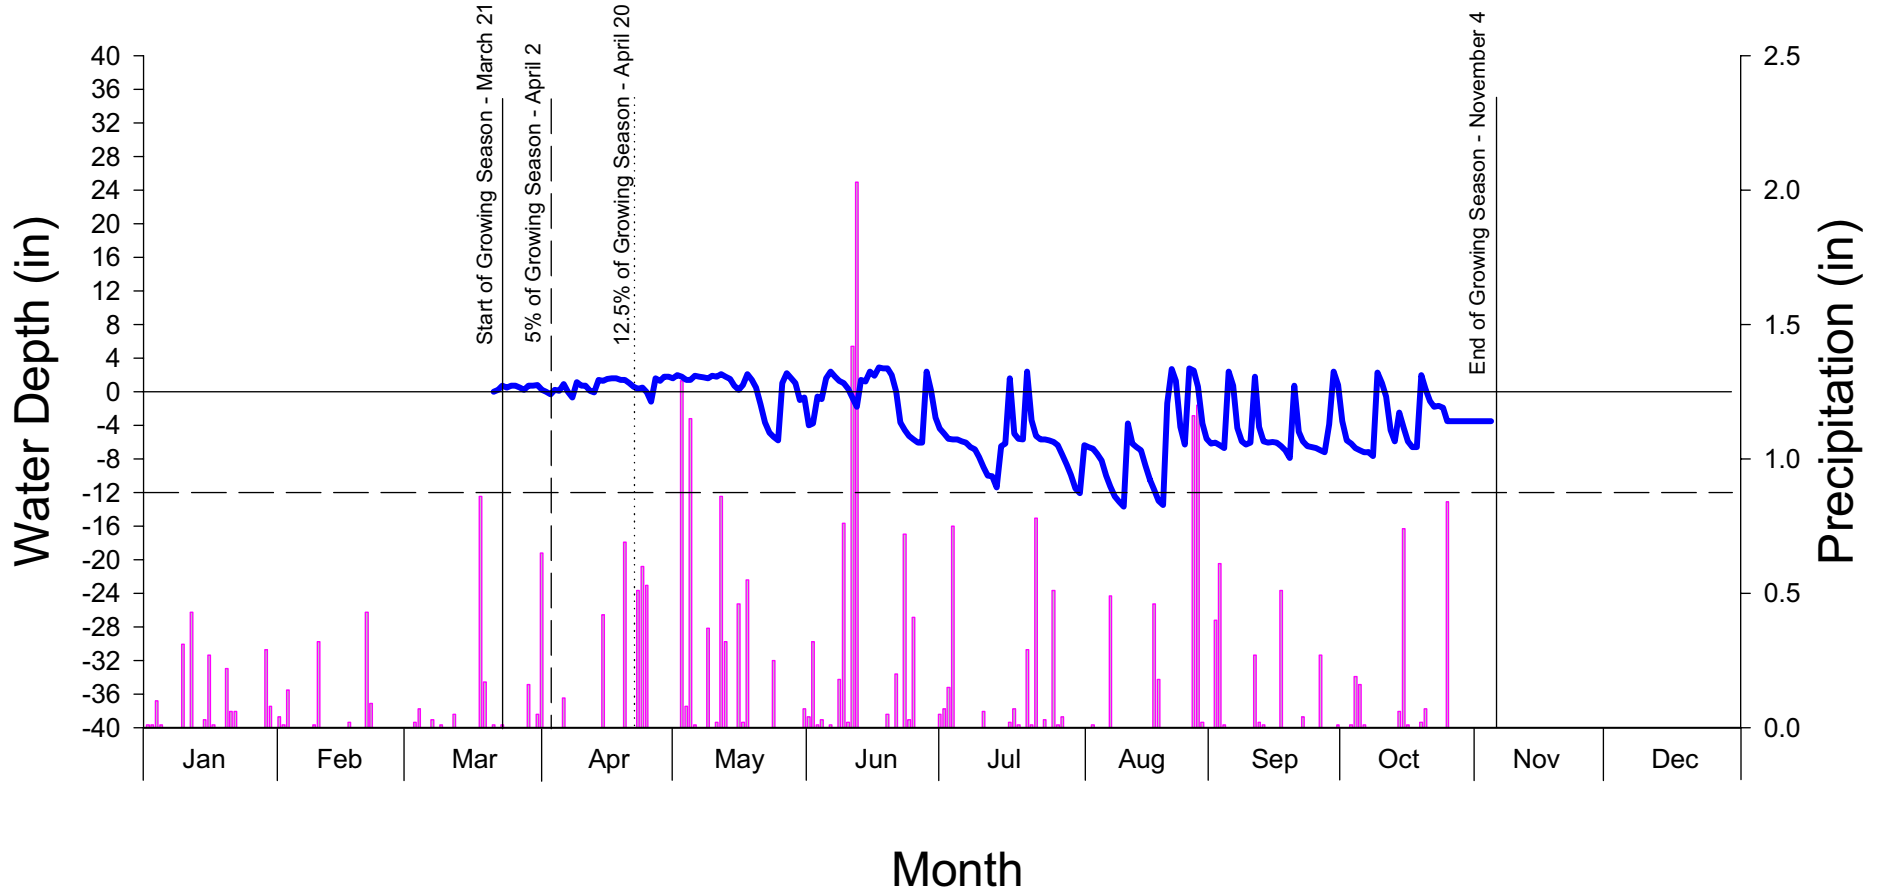
White Oak Creek 2006 Monitoring Gauge 17 - A28765B

| Monitoring Gauge* | <5% | 5-12.5% | >12.5% | Actual % | Success Date |
|---|---|---|---|---|---|
| GW-17 | | | ✓ | 62 | March 21 – August 10 |

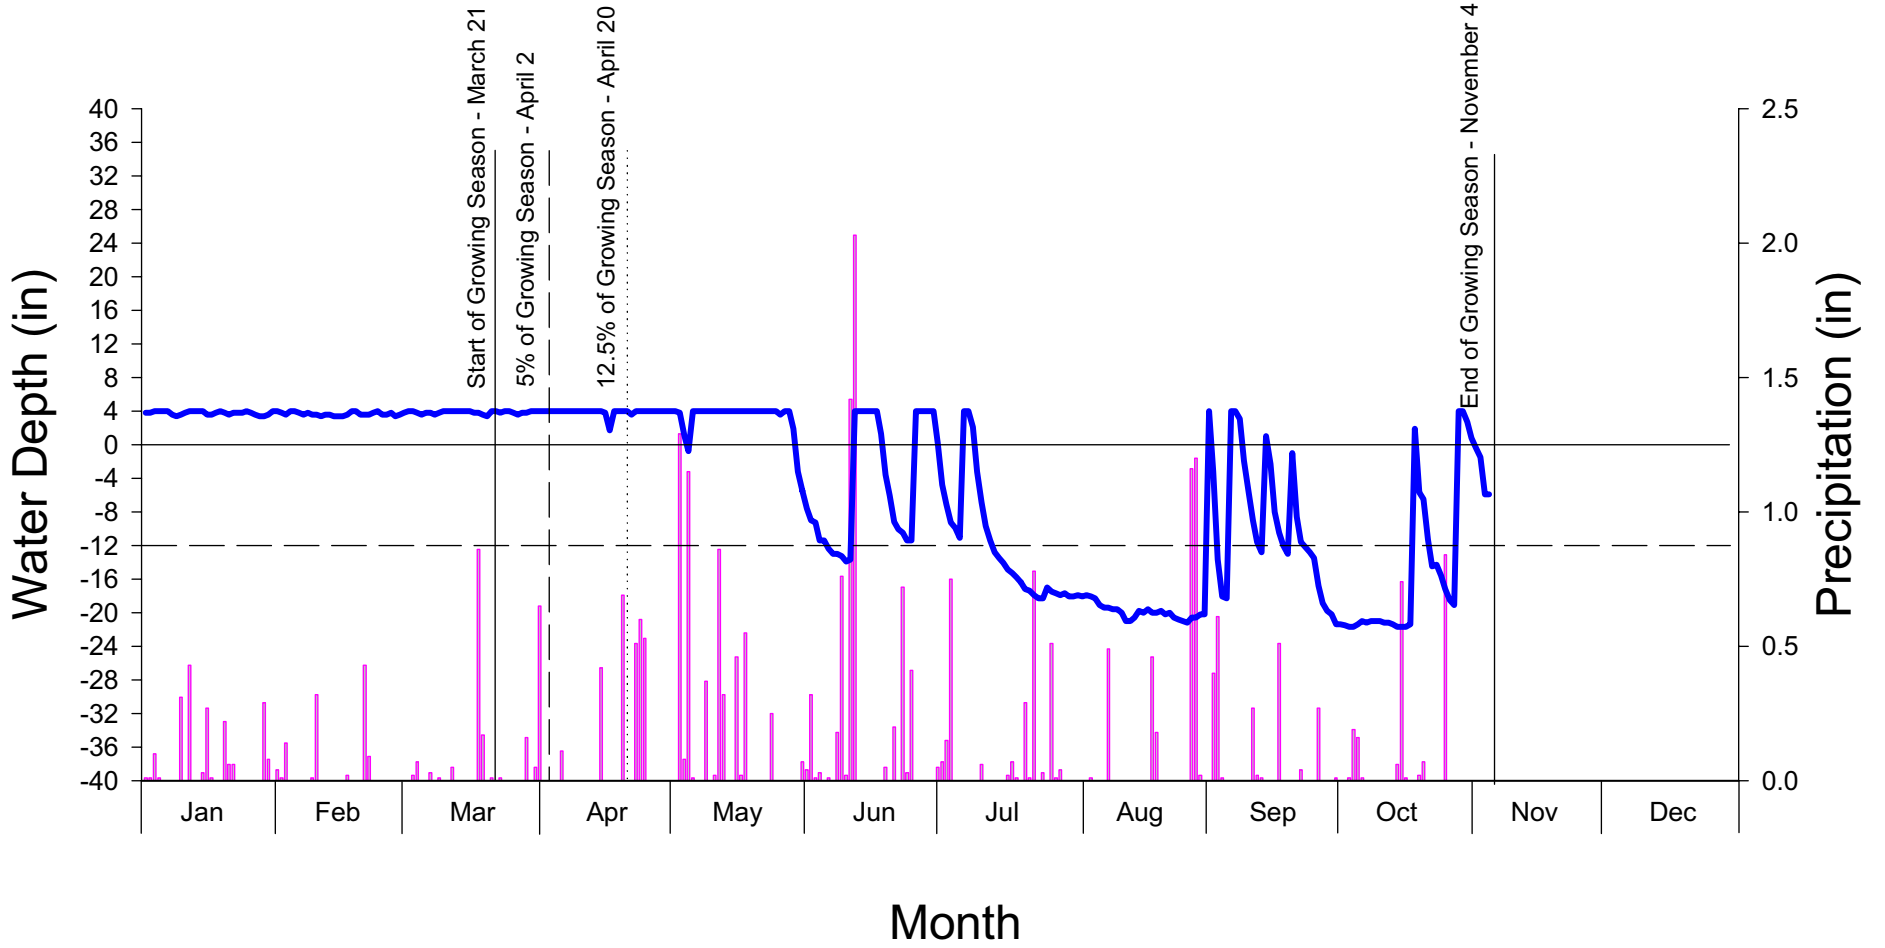
White Oak Creek 2006 Monitoring Gauge 18 - 04489A2

| Monitoring Gauge* | <5% | 5-12.5% | >12.5% | Actual % | Success Date |
|---|---|---|---|---|---|
| GW-18 | | | ✓ | 33 | March 21 – June 6 |

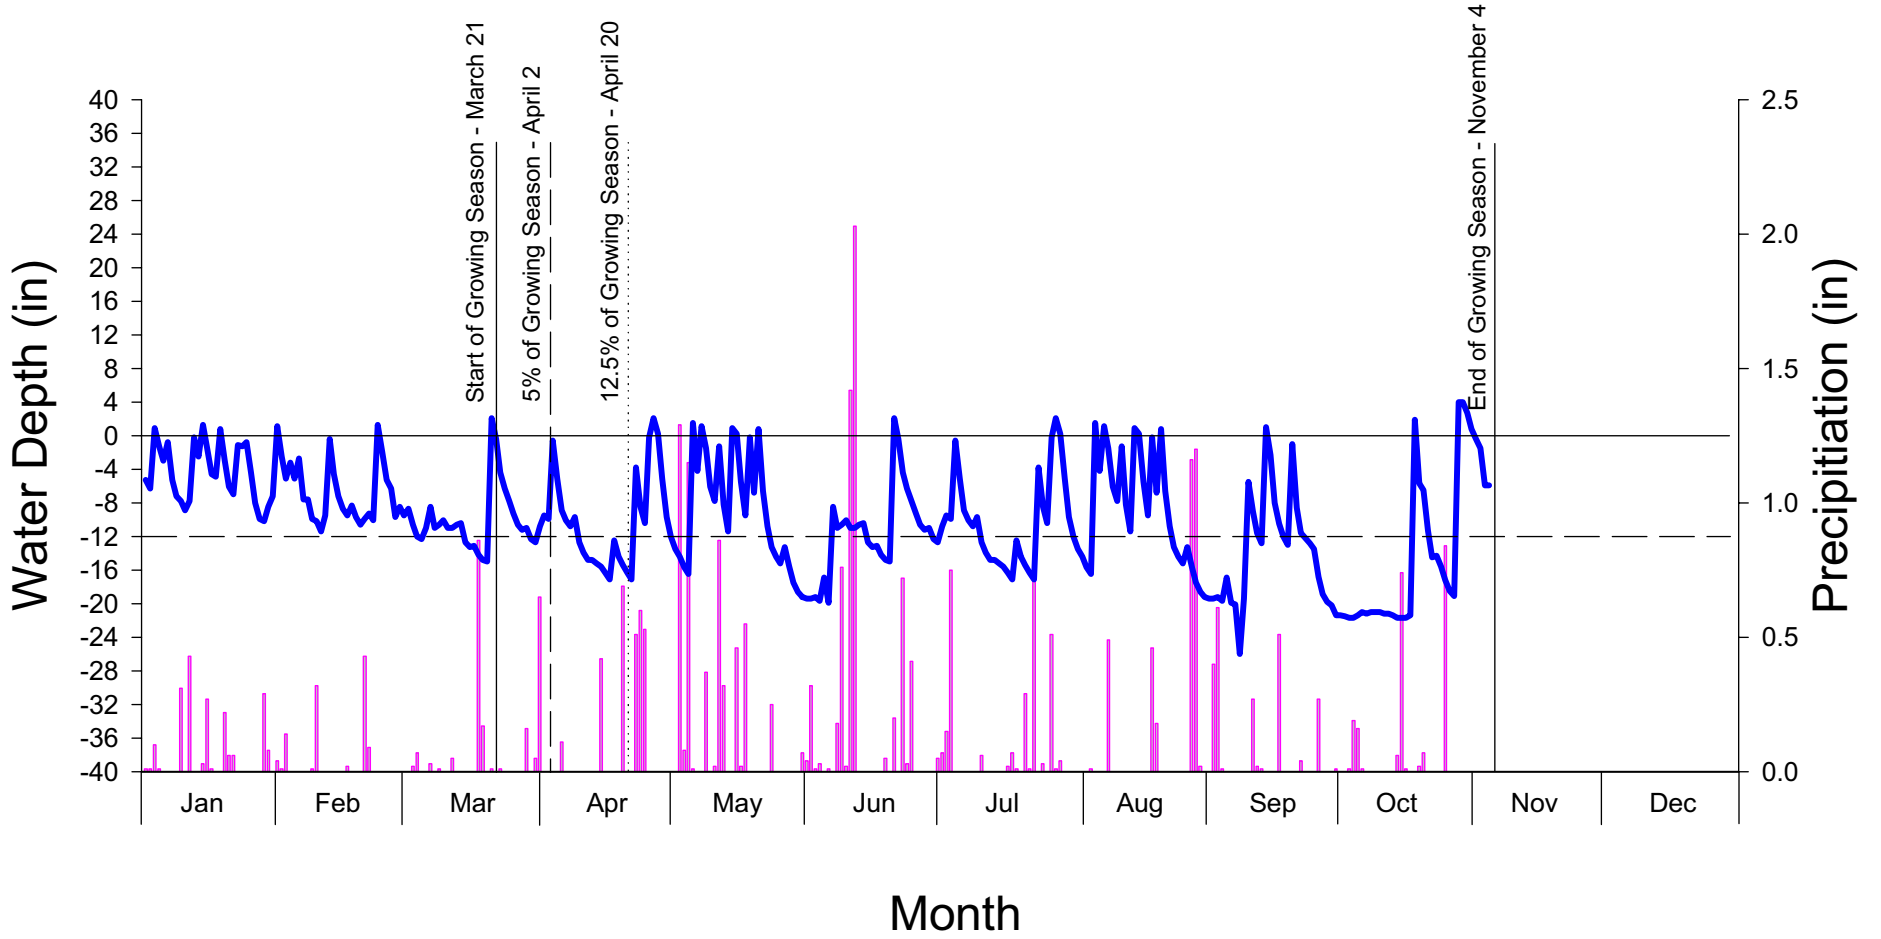
White Oak Creek 2006 Monitoring Gauge 19 - 04CFF90

| Monitoring Gauge* | <5% | 5-12.5% | >12.5% | Actual % | Success Date |
|---|---|---|---|---|---|
| GW-19 | | ✓ | | 8 | |

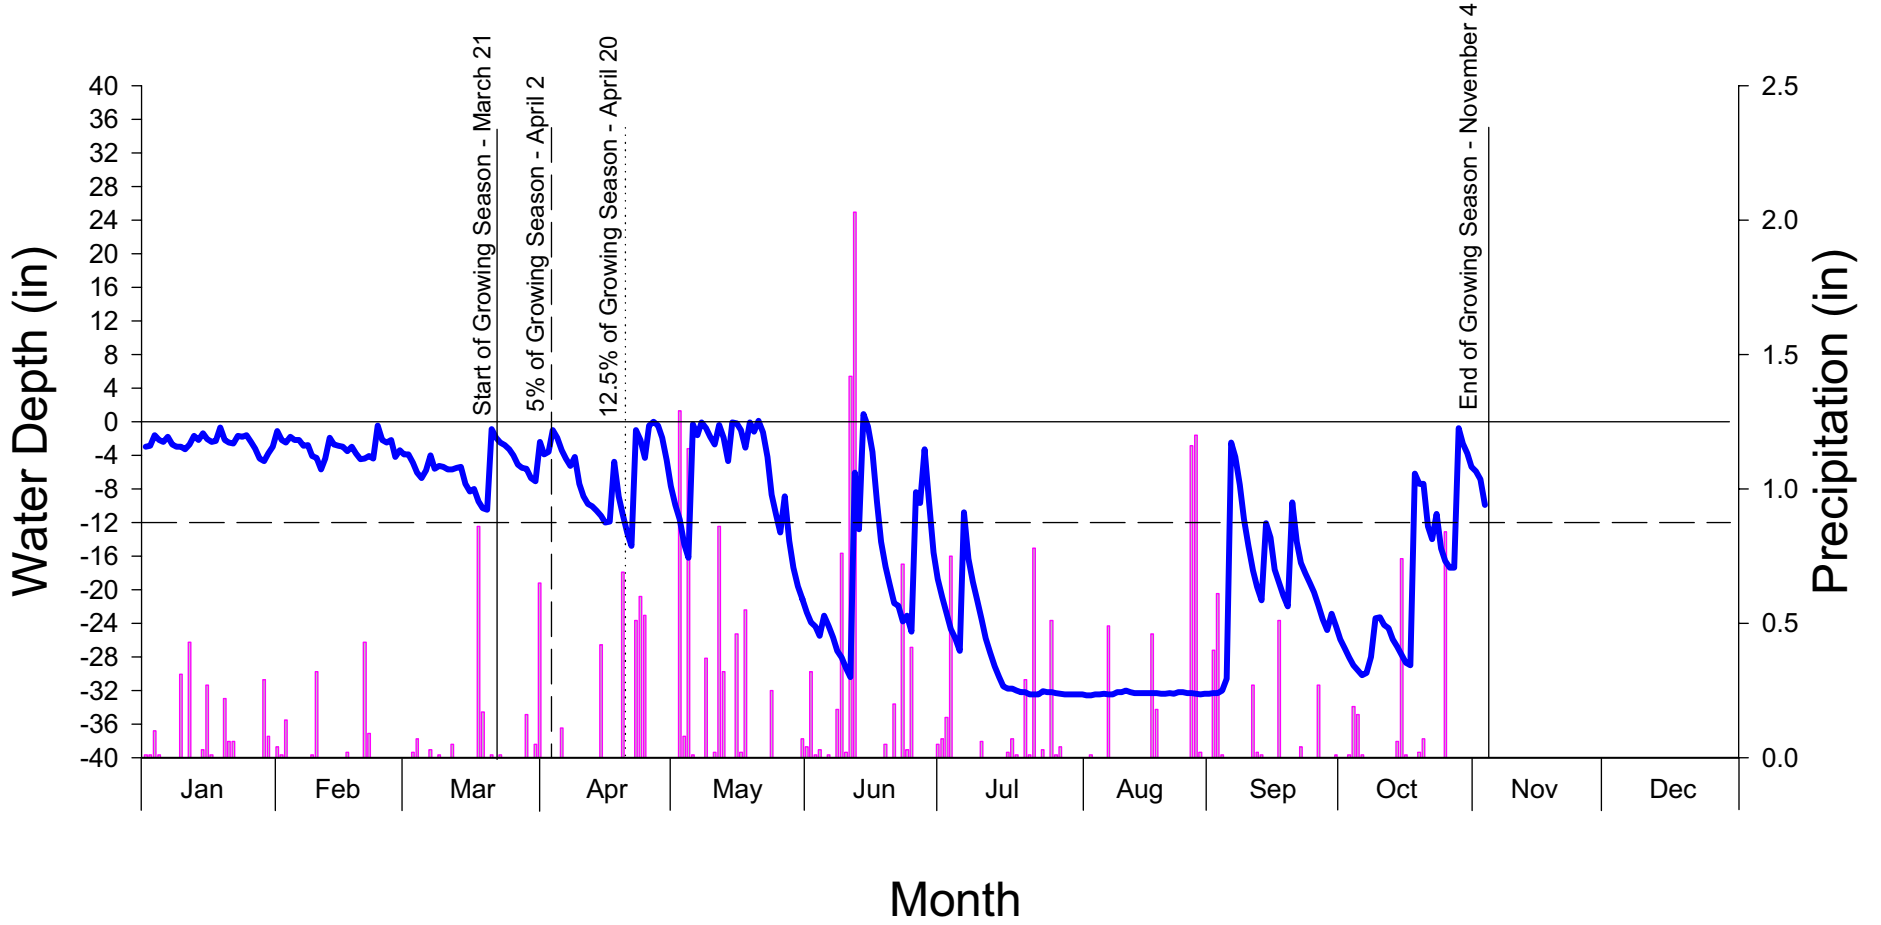
Monitoring Gauge 20 - 9DE4B47

| Monitoring Gauge* | <5% | 5-12.5% | >12.5% | Actual % | Success Date |
|---|---|---|---|---|---|
| GW-20 | | | ✓ | 13 | March 21 – April 20 |

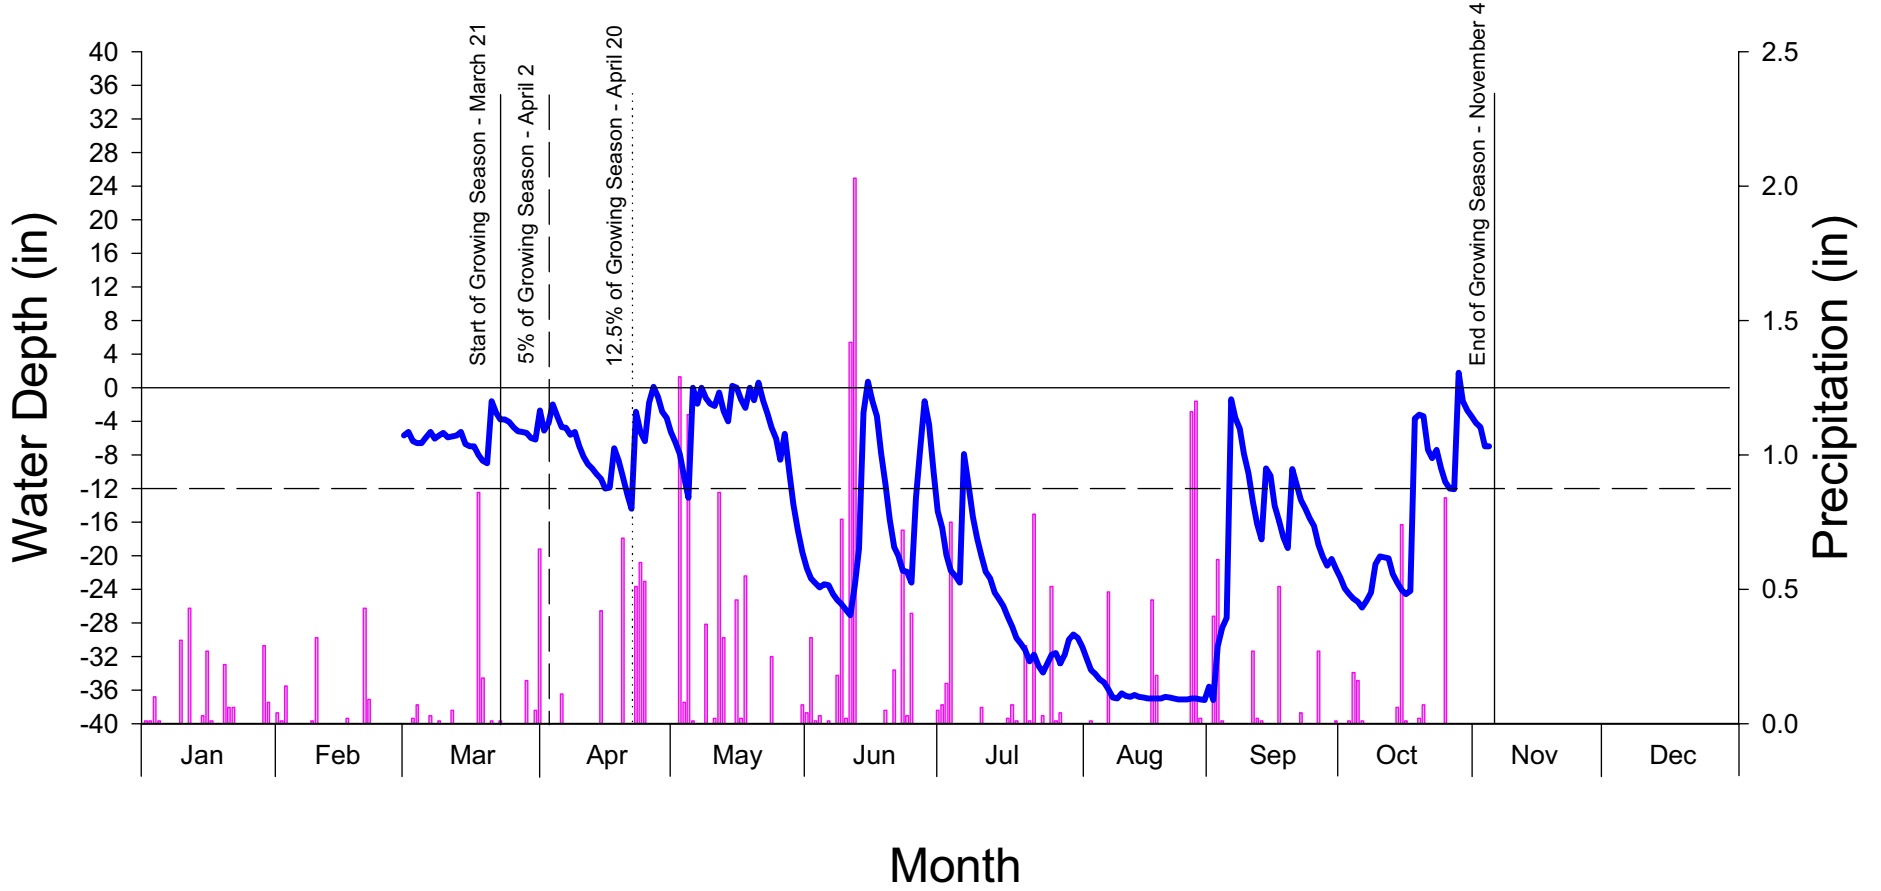
White Oak Creek 2006 Monitoring Gauge 21 - A28A703

| Monitoring Gauge* | <5% | 5-12.5% | >12.5% | Actual % | Success Date |
|---|---|---|---|---|---|
| GW-21 | | | ✓ | 13 | March 21 – April 19 |

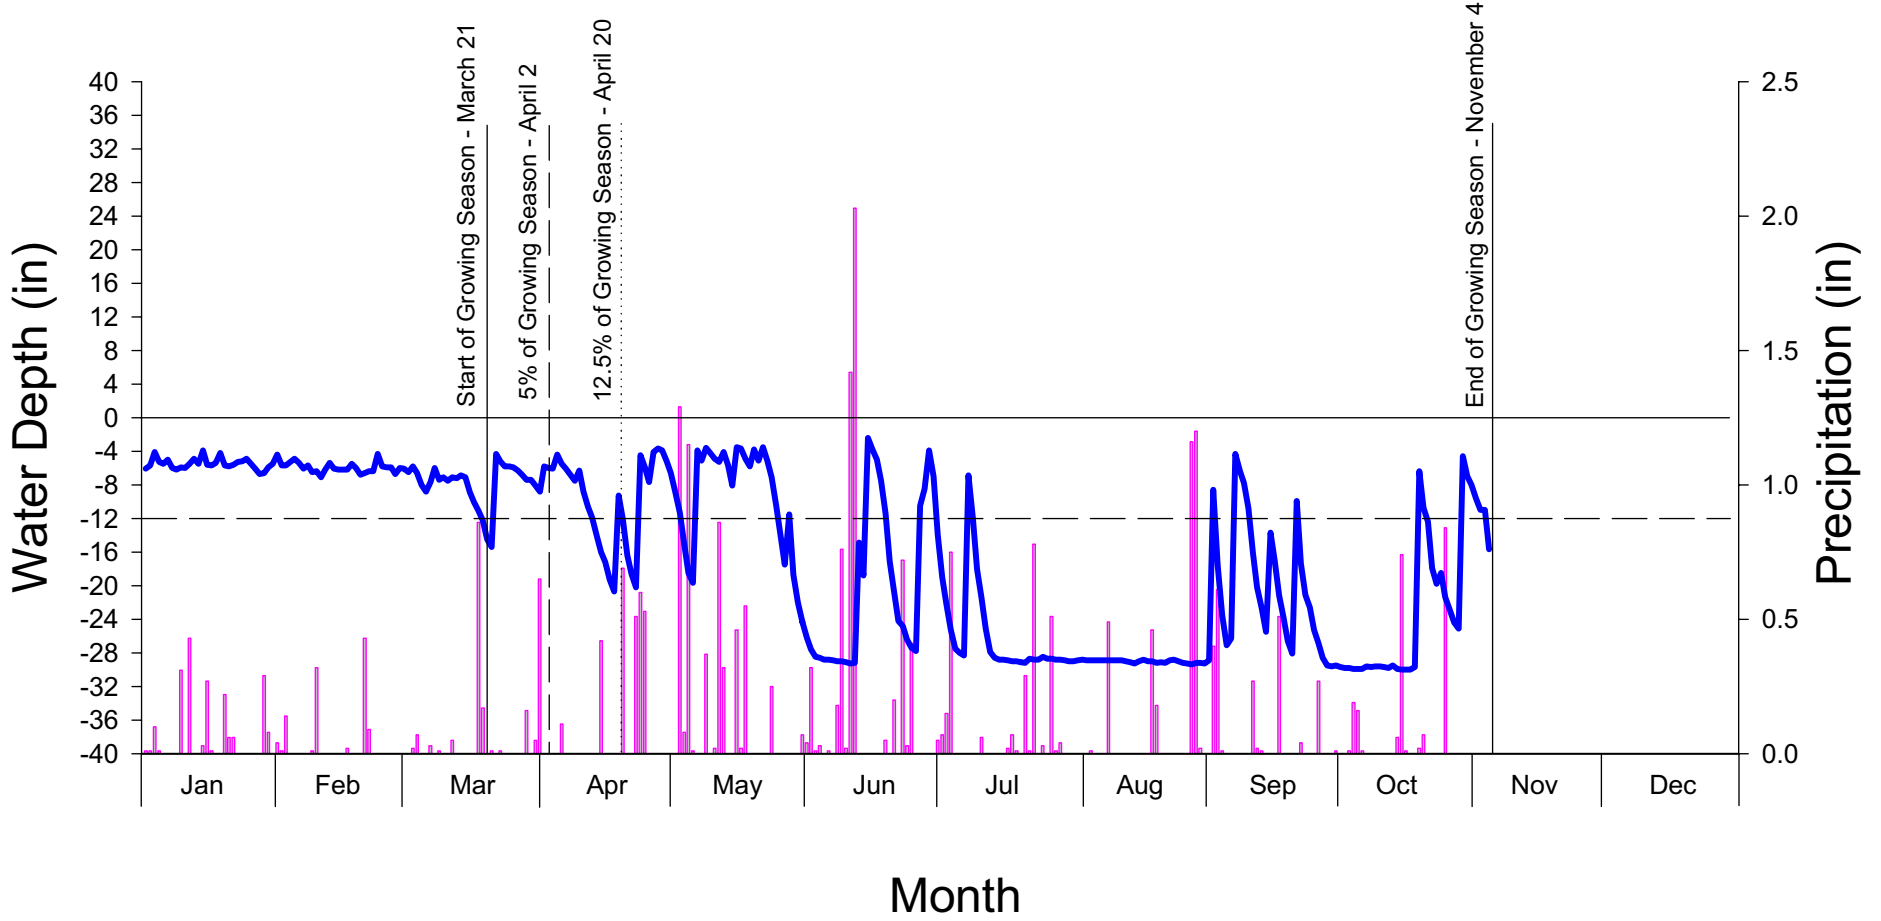
White Oak Creek 2006 Monitoring Gauge 22 - 9DE4889

| GW-22 | | ✓ | | 10 | |

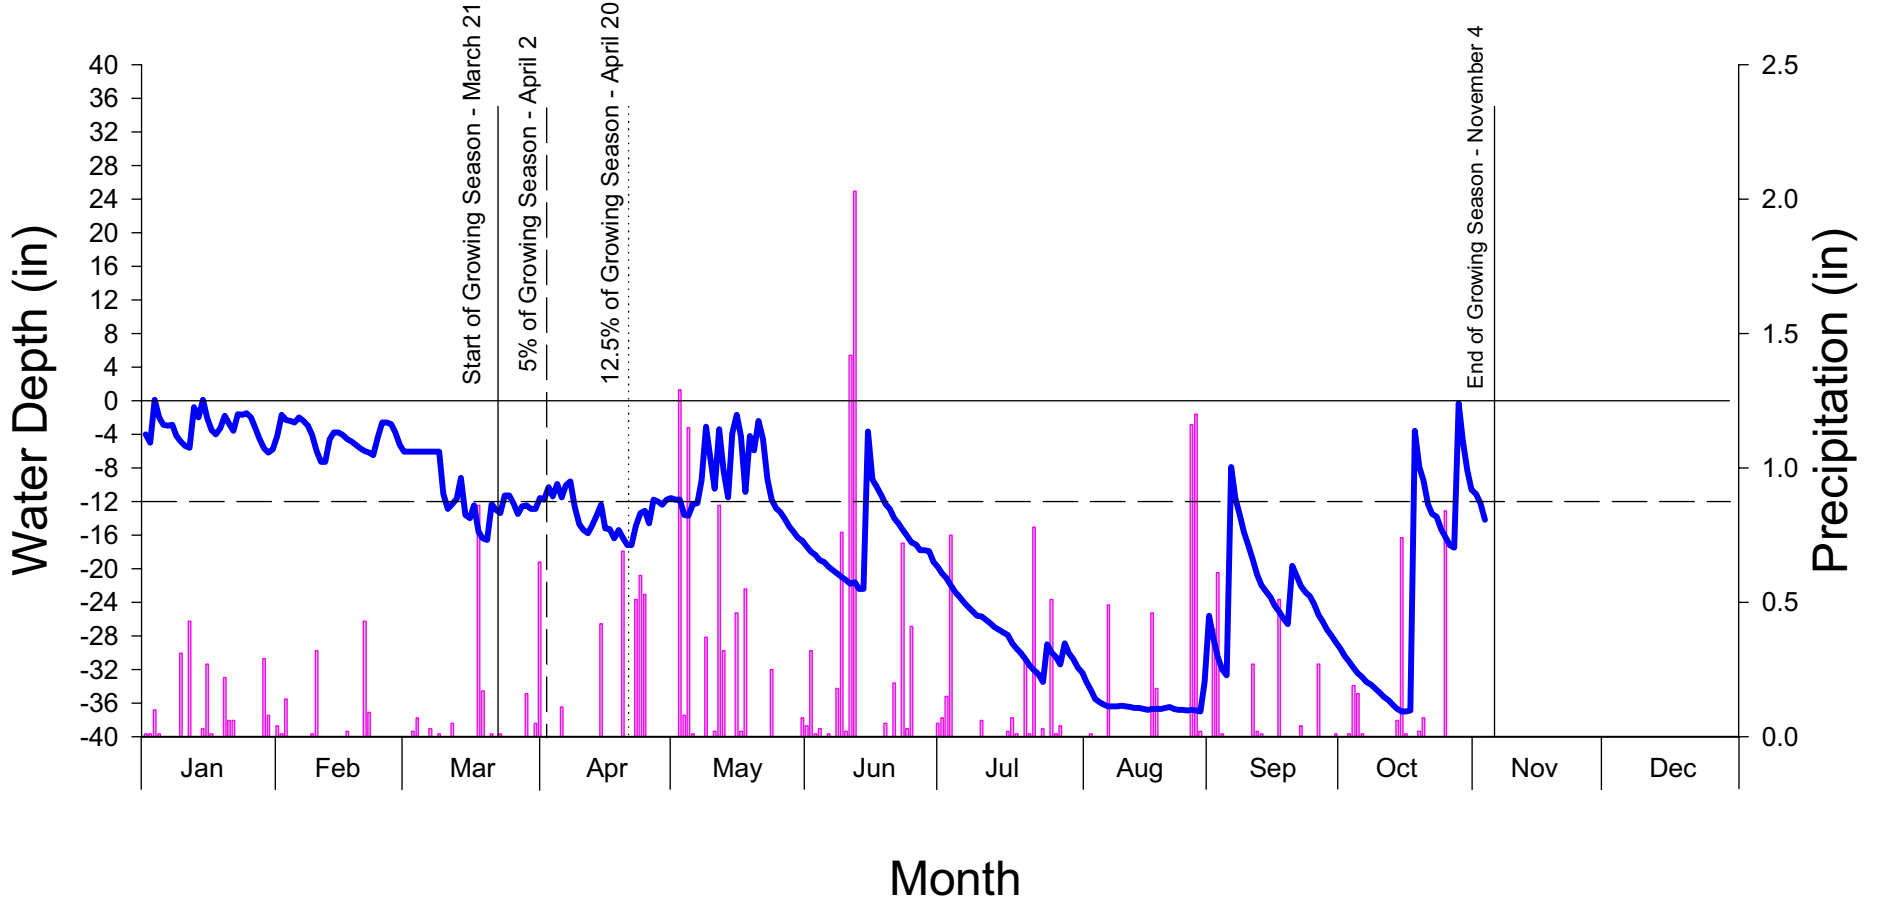
White Oak Creek 2006 Monitoring Gauge 23 - 8E546A7

| GW-23 | | ✓ | | 11 | |

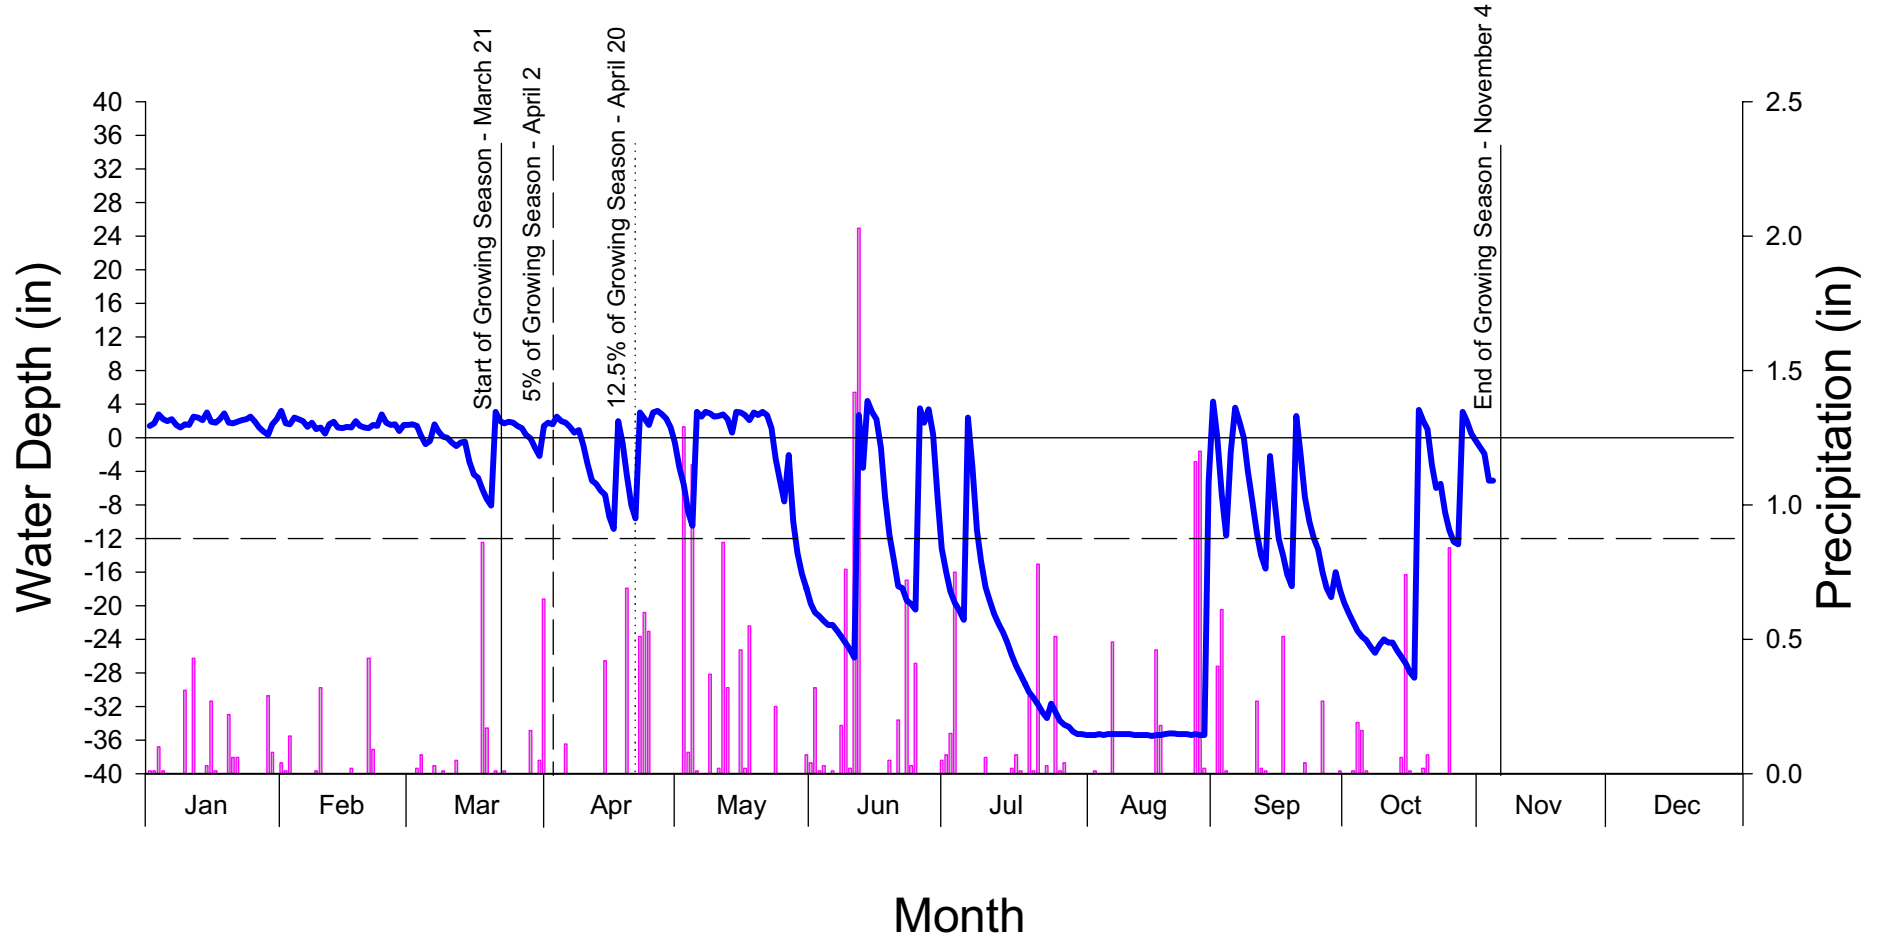
Monitoring Gauge 24 - 9DE55A7

| GW-24 | | | ✓ | 30 | March 21 – May 28 |

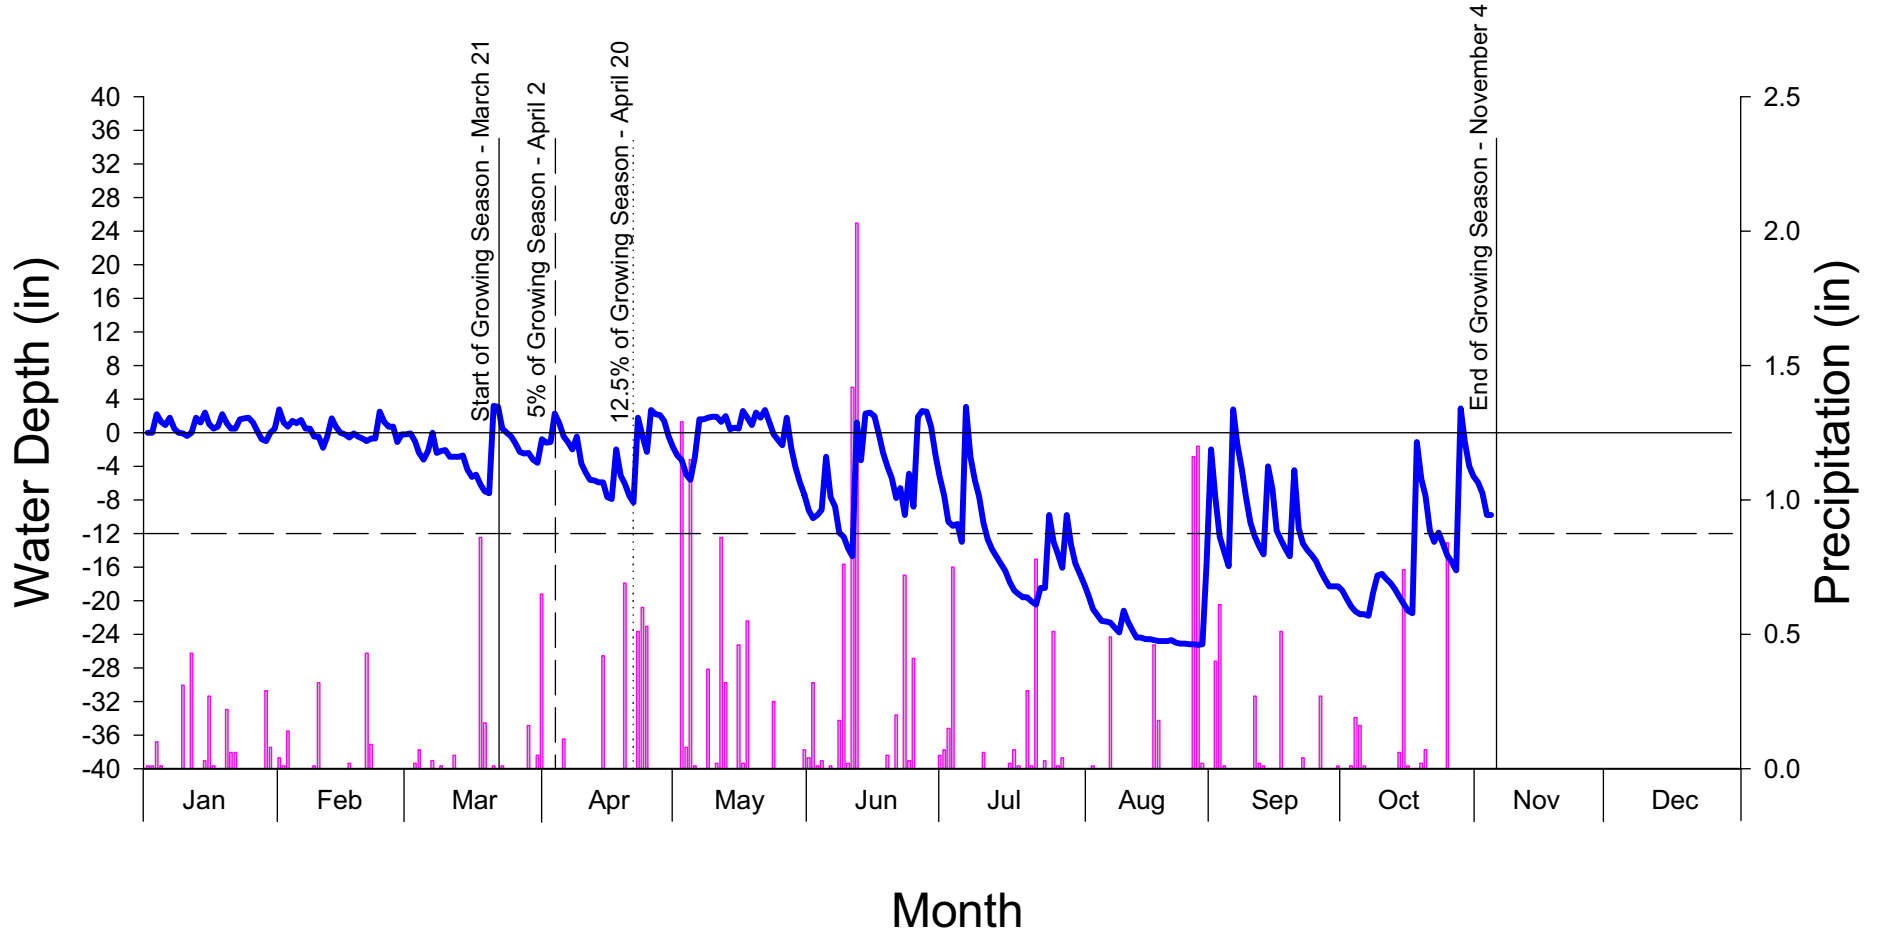
White Oak Creek 2006 Monitoring Gauge 25 - B652202

| GW-25 | | | ✓ | 35 | March 21 – June 8 |

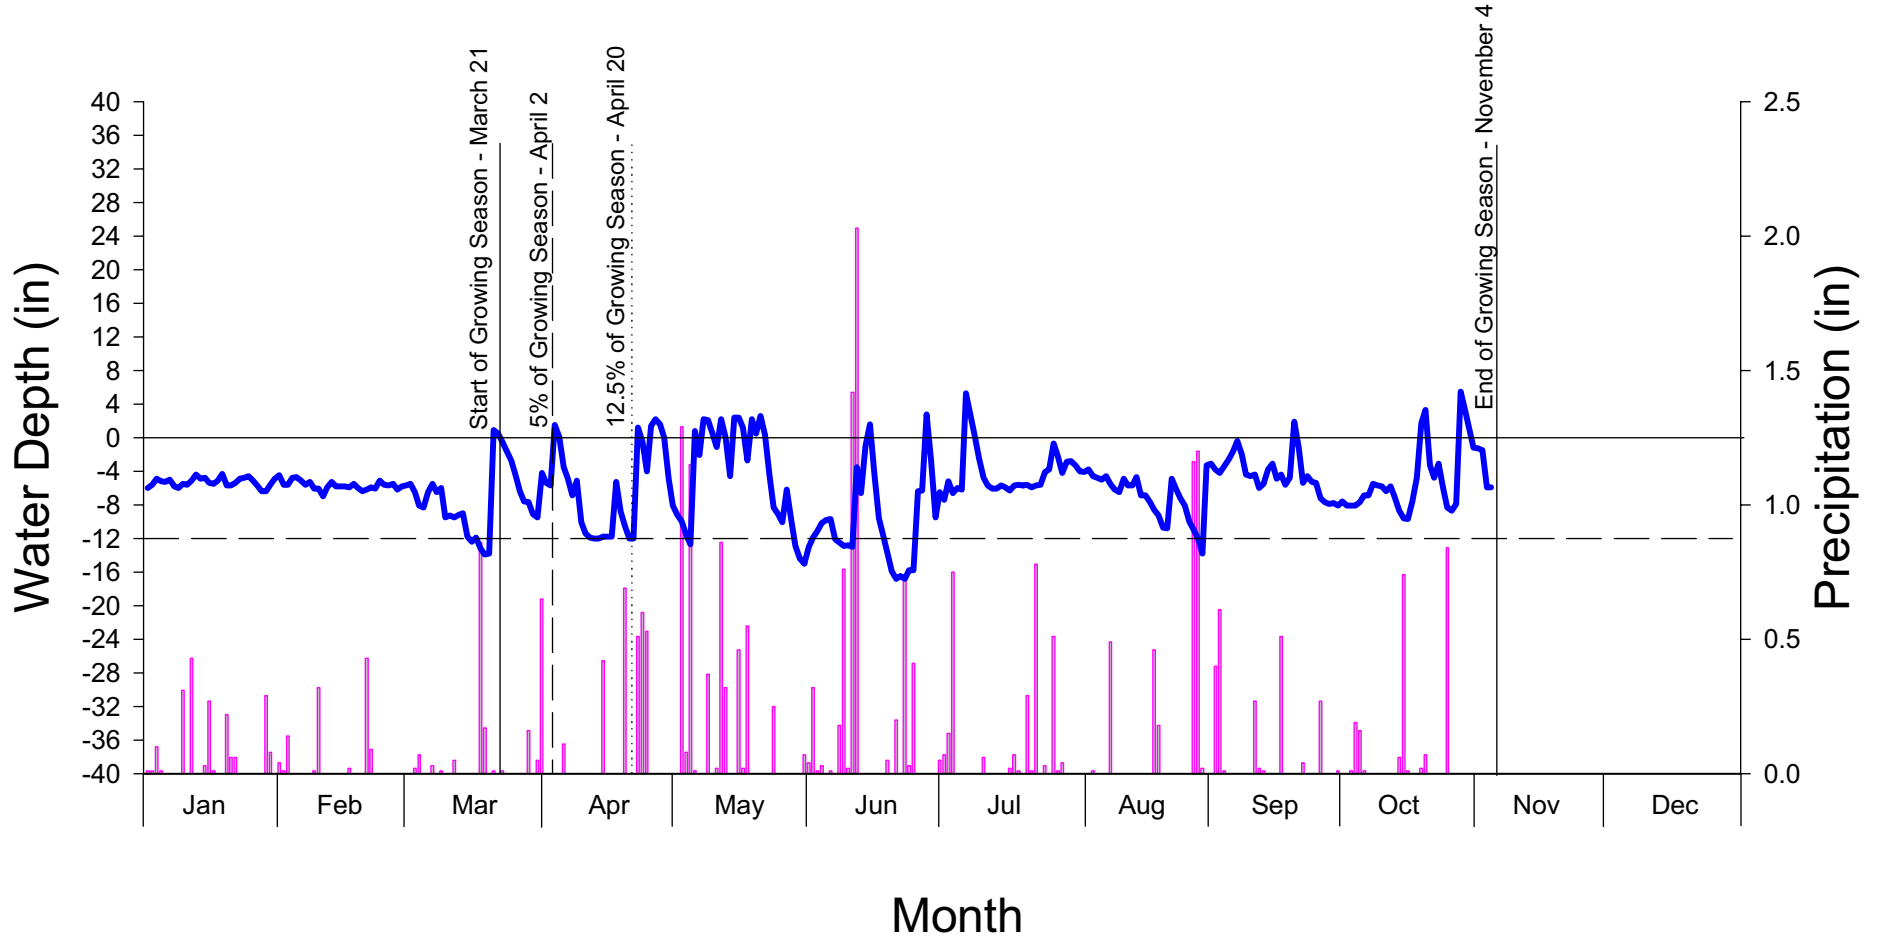
White Oak Creek 2006 Monitoring Gauge 26 - B651934

| GW-26 | | | ✓ | 19 | March 21 – May 4 |
