WHITE OAK CREEK MITIGATION SITE

2006 Annual Monitoring Report (Year 5)

Johnson County
EEP Project No. 417
Design Firm: Rummel, Klepper & Kahl, LLP

January 2007

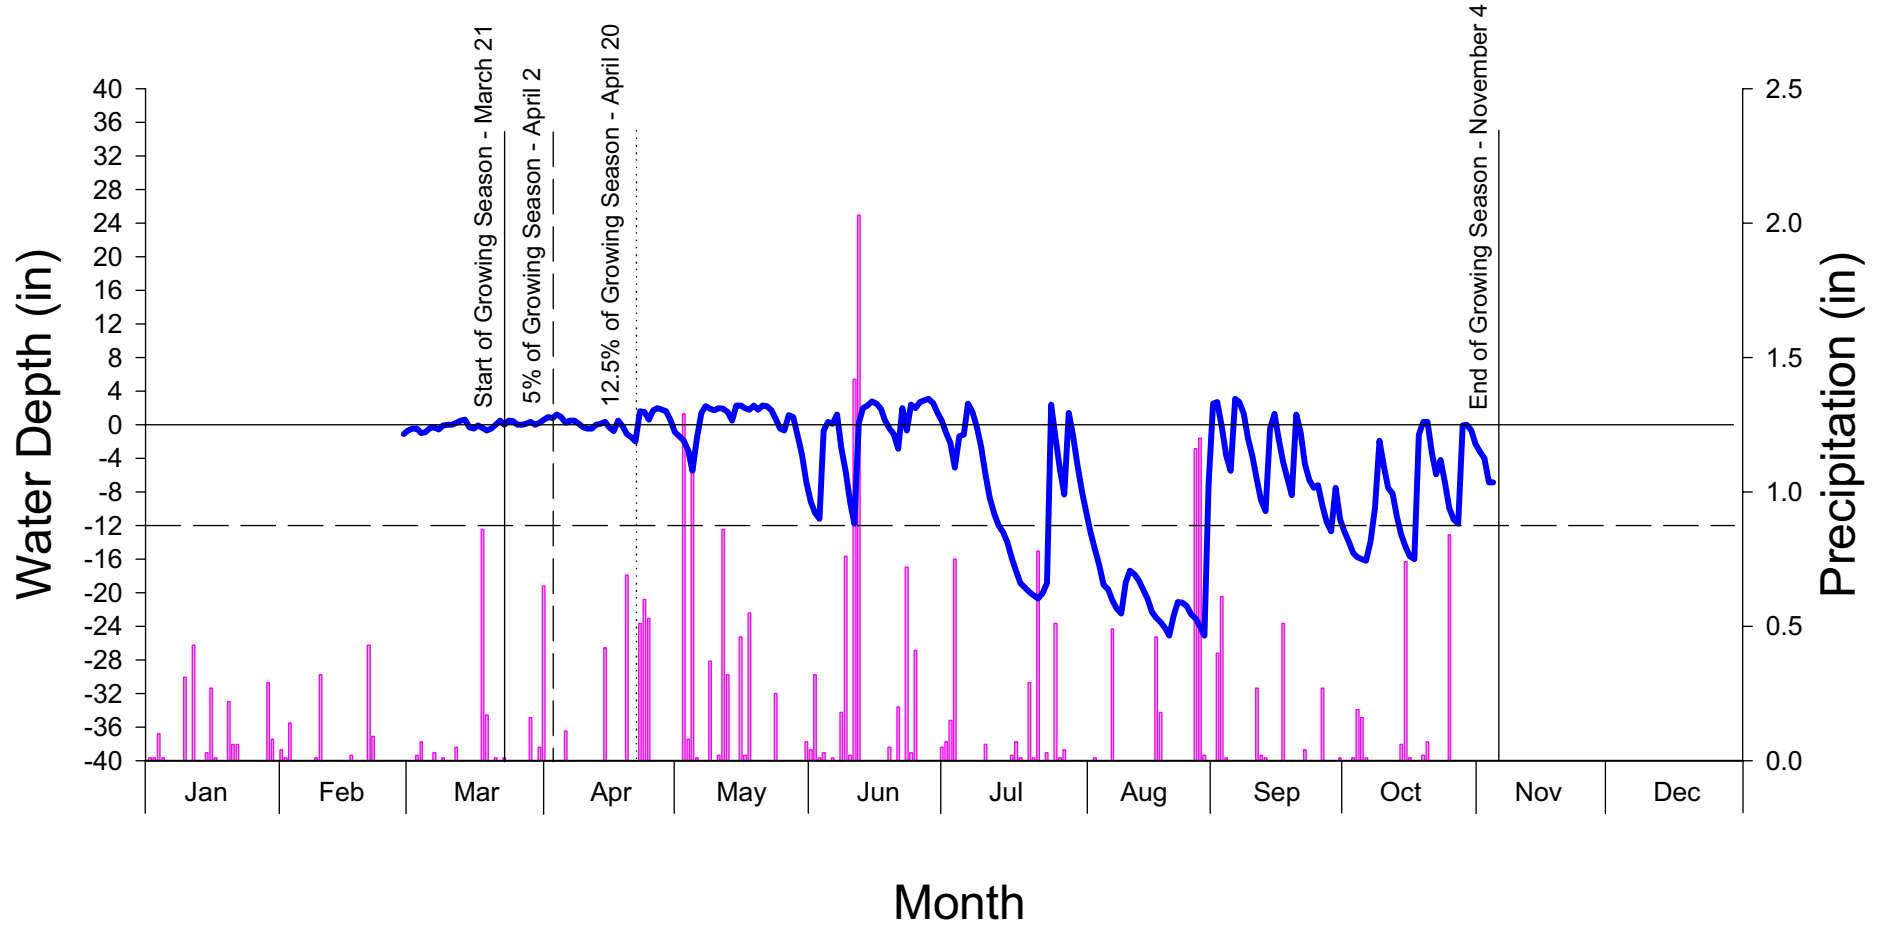
White Oak Creek 2006 Monitoring Gauge 27 - AB3548B

| GW-27 | | | ✓ | 50 | March 21 – July 14 |

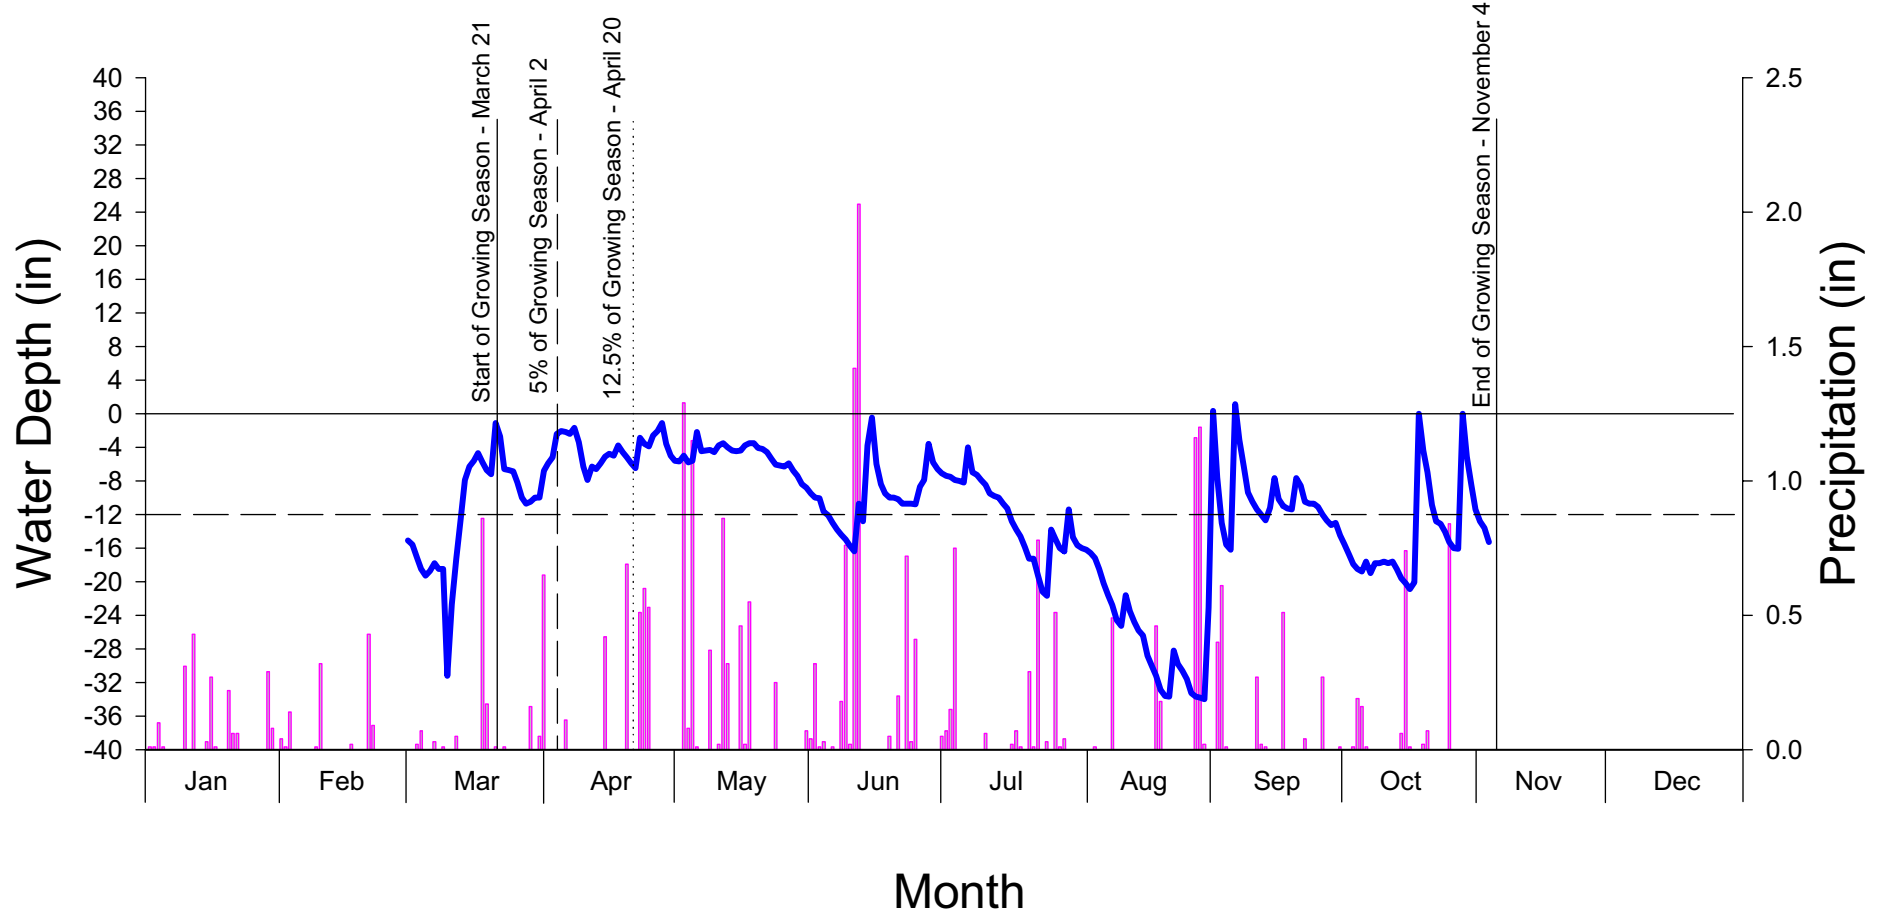
Monitoring Gauge 28 - 8E52E9F

| GW-28 | | | ✓ | 33 | March 21 – June 6 |

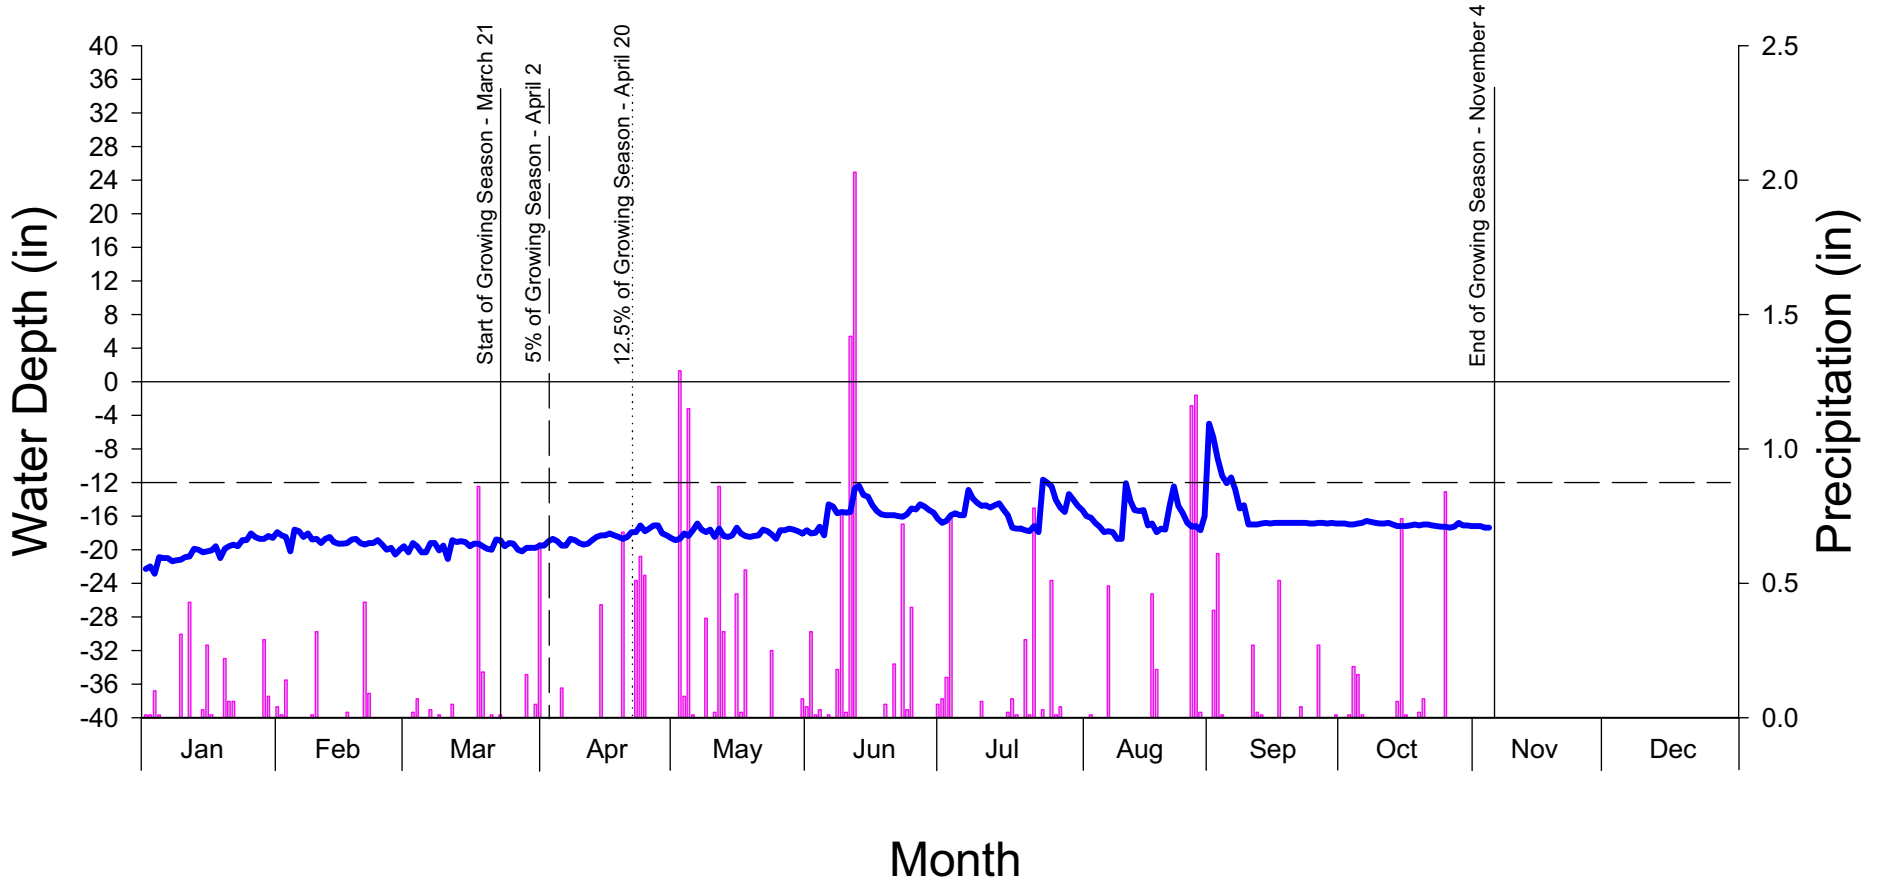
White Oak Creek 2006 Monitoring Gauge 30 - 8E556CA

| GW-30 | ✓ | | | 1 | |

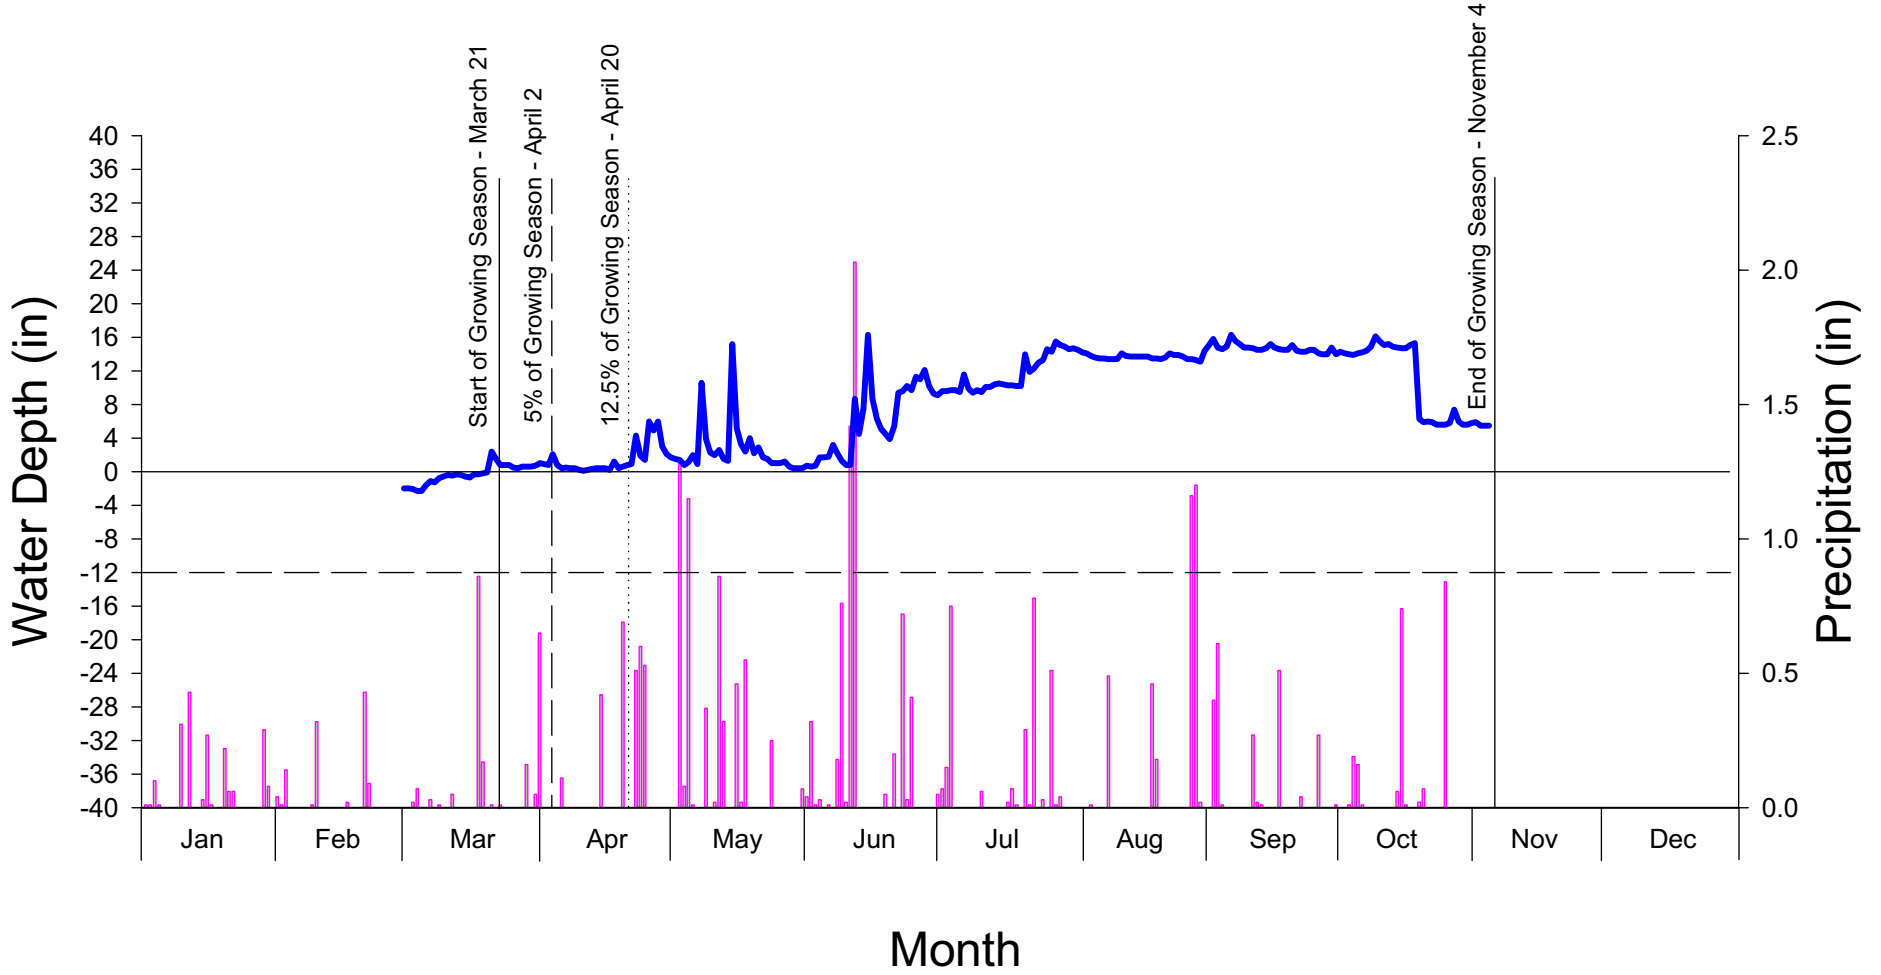
White Oak Creek 2006 Monitoring Gauge 31- 8E576F0

| GW-31 | | | ✓ | 100 | March 21 – November 4 |

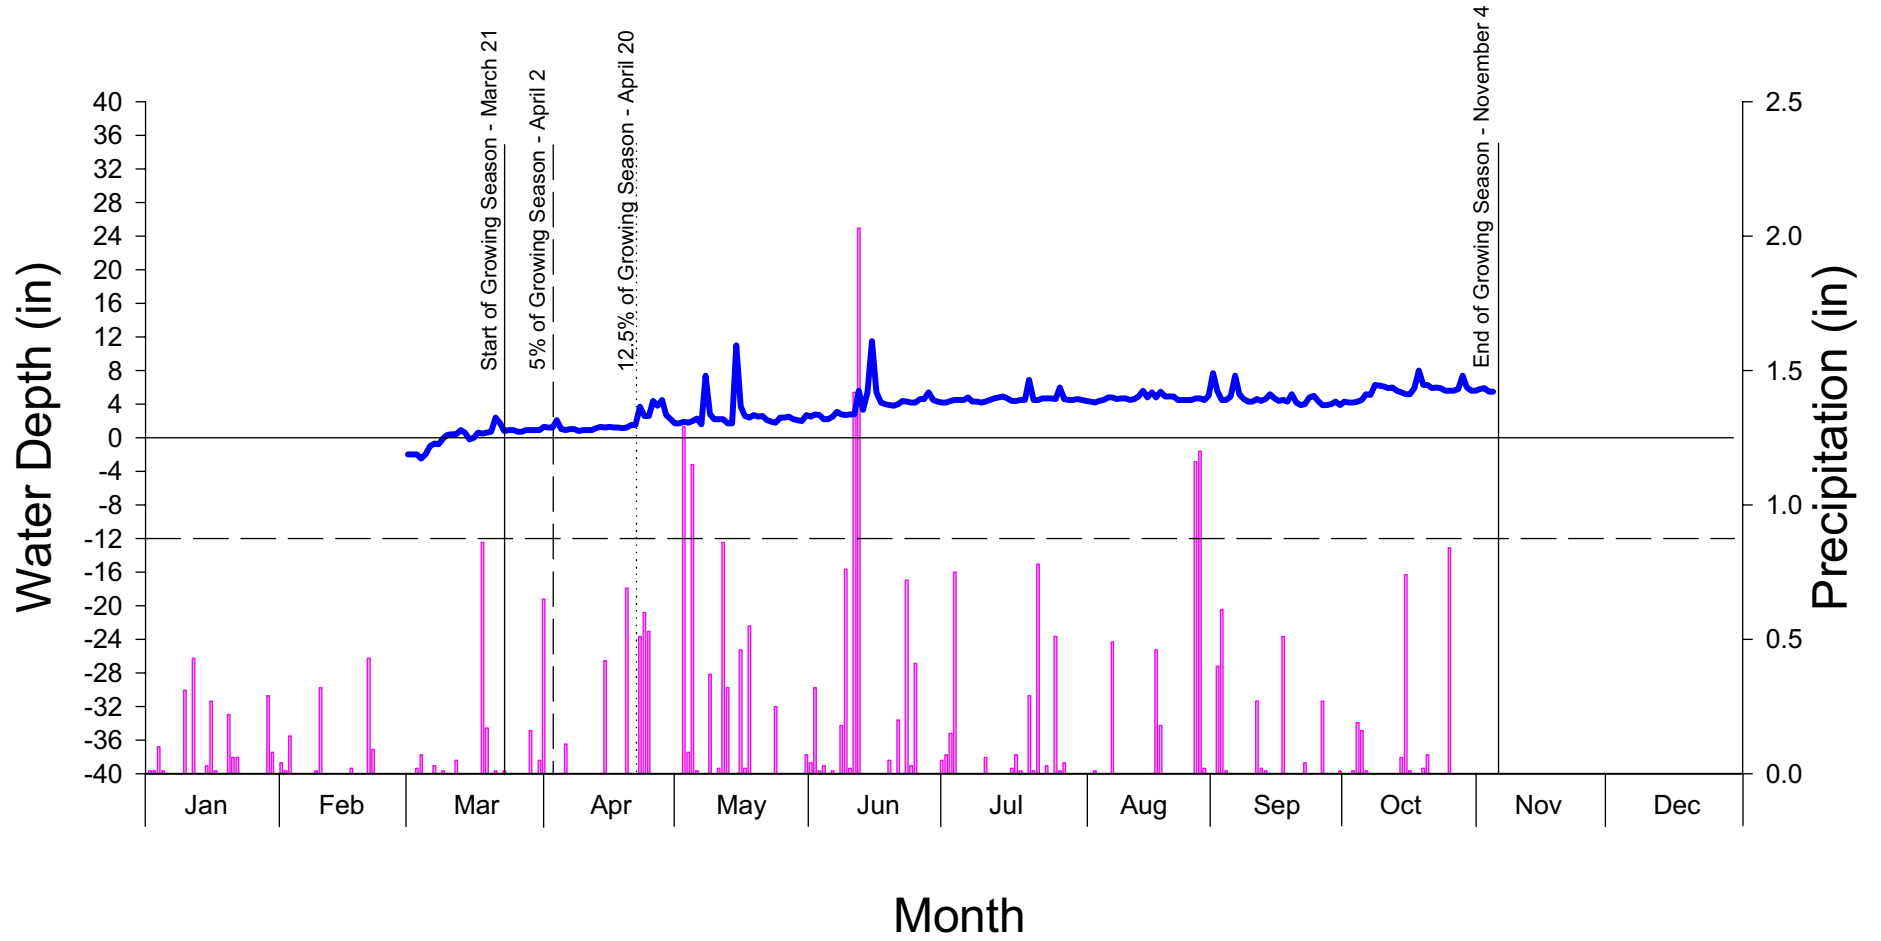
White Oak Creek 2006 Monitoring Gauge 32 - AB36B47

| GW-32 | | | ✓ | 100 | March 21 – November 4 |

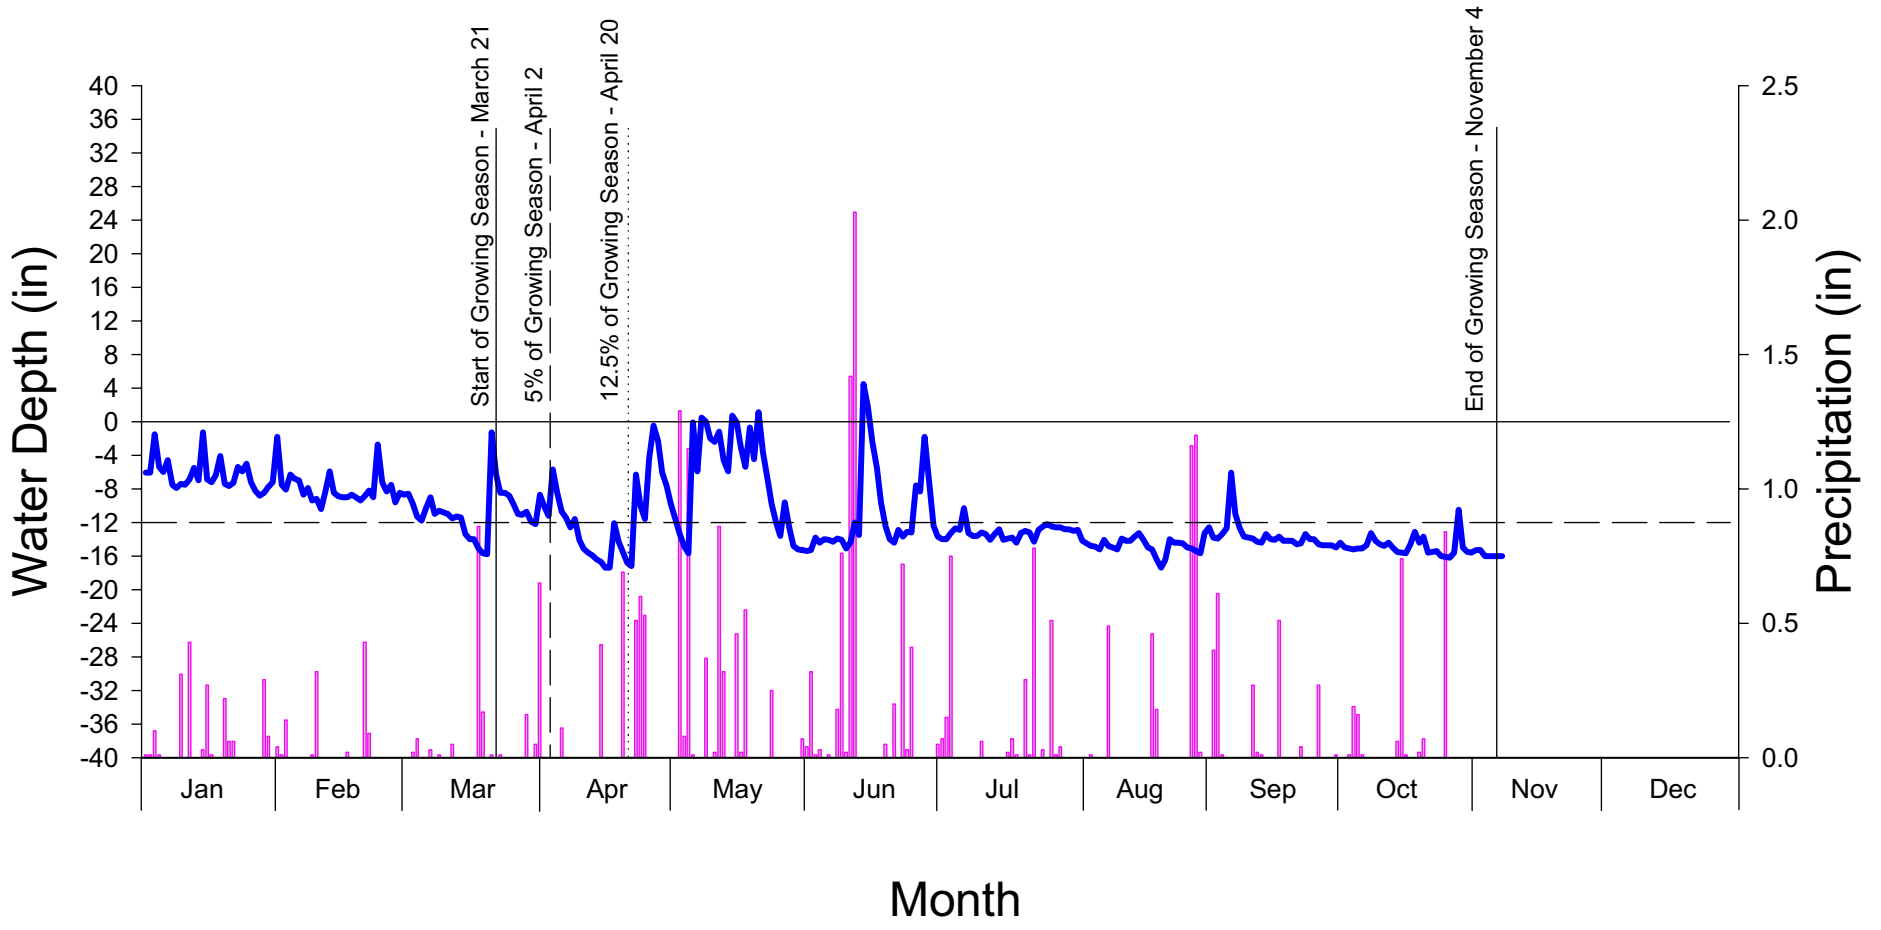
White Oak Creek 2006 Monitoring Gauge 33 - 9BEBE36

| GW-33 | | ✓ | | 9 | |

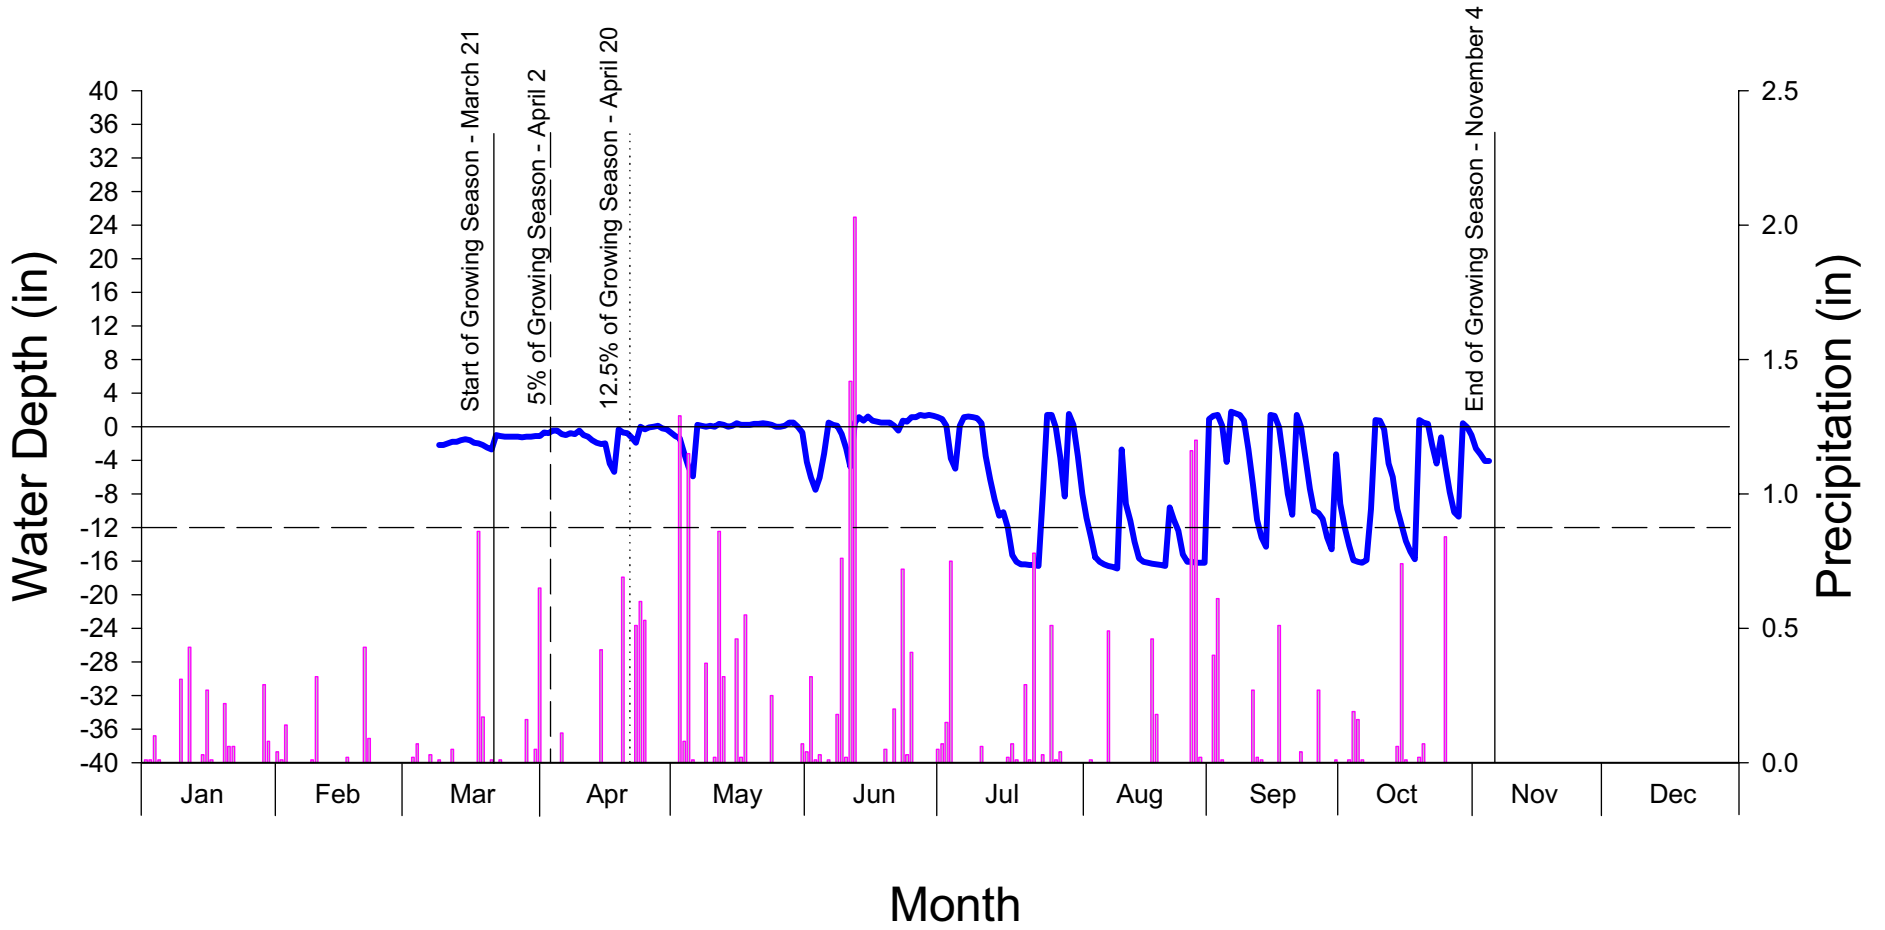
White Oak Creek 2006 Monitoring Gauge 34 - A285DB5

| GW-34 | | | ✓ | 52 | March 21 – July 16 |

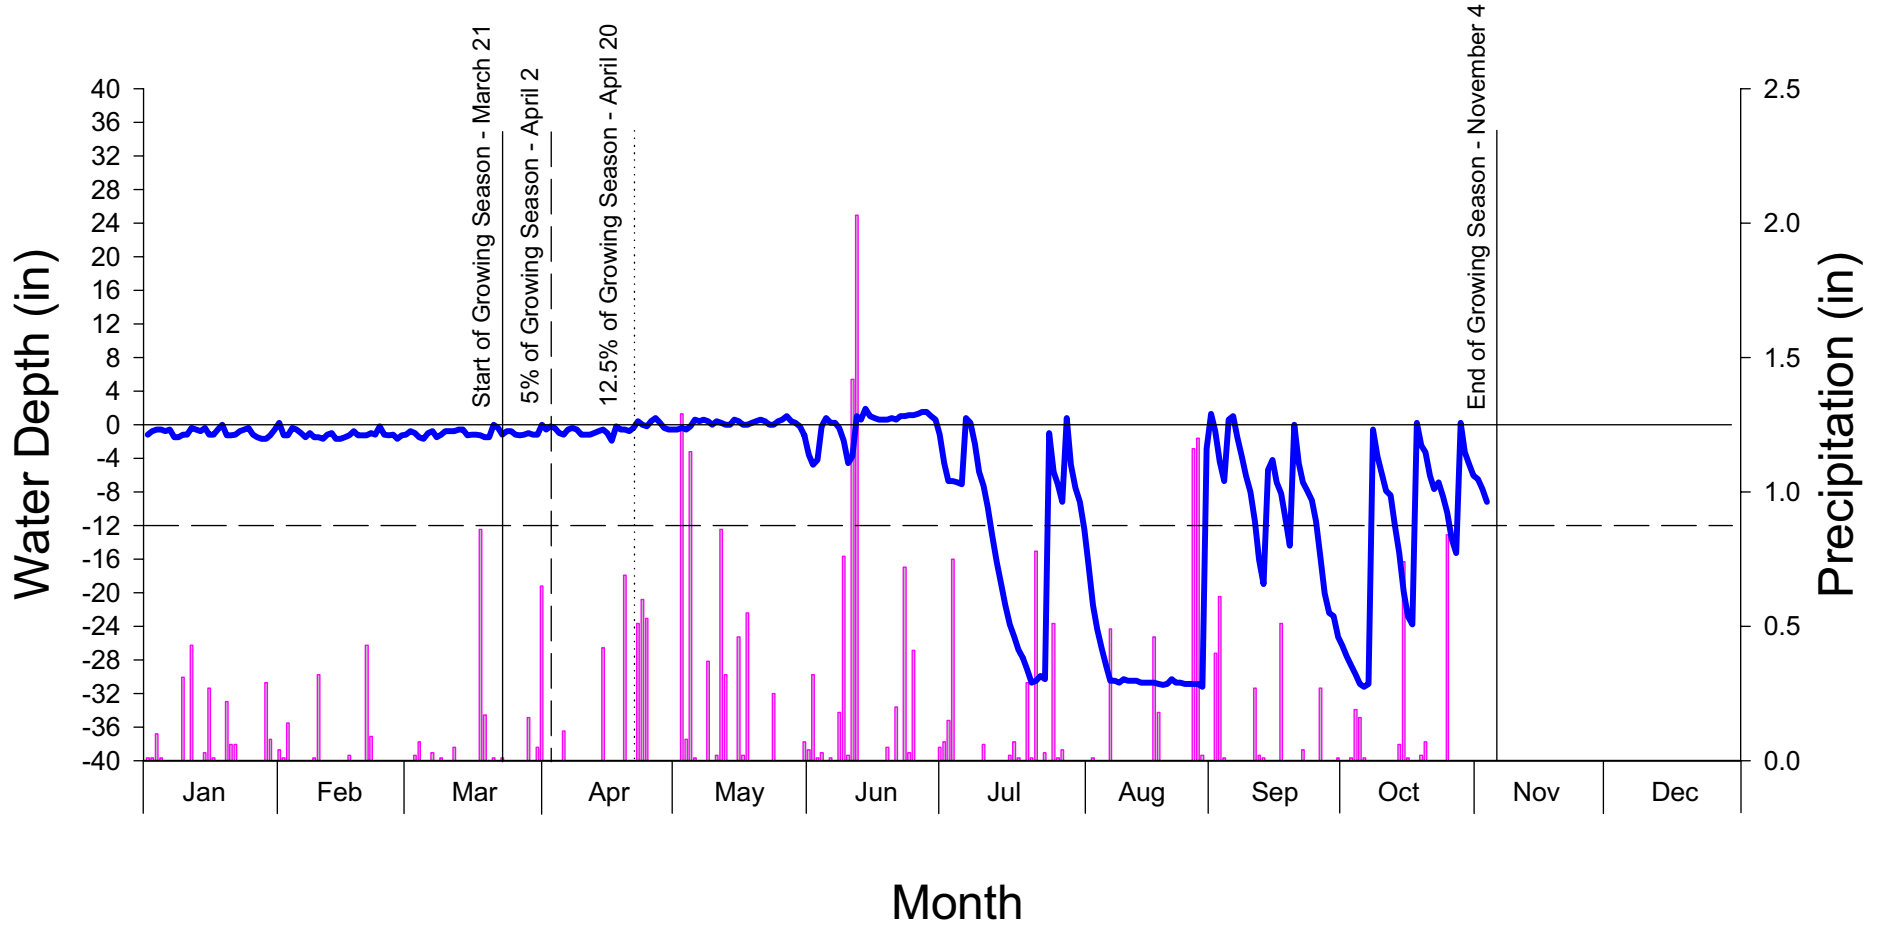
Monitoring Gauge 35 - 04CFEA0

| GW-35 | | | ✓ | 50 | March 21 – July 12 |

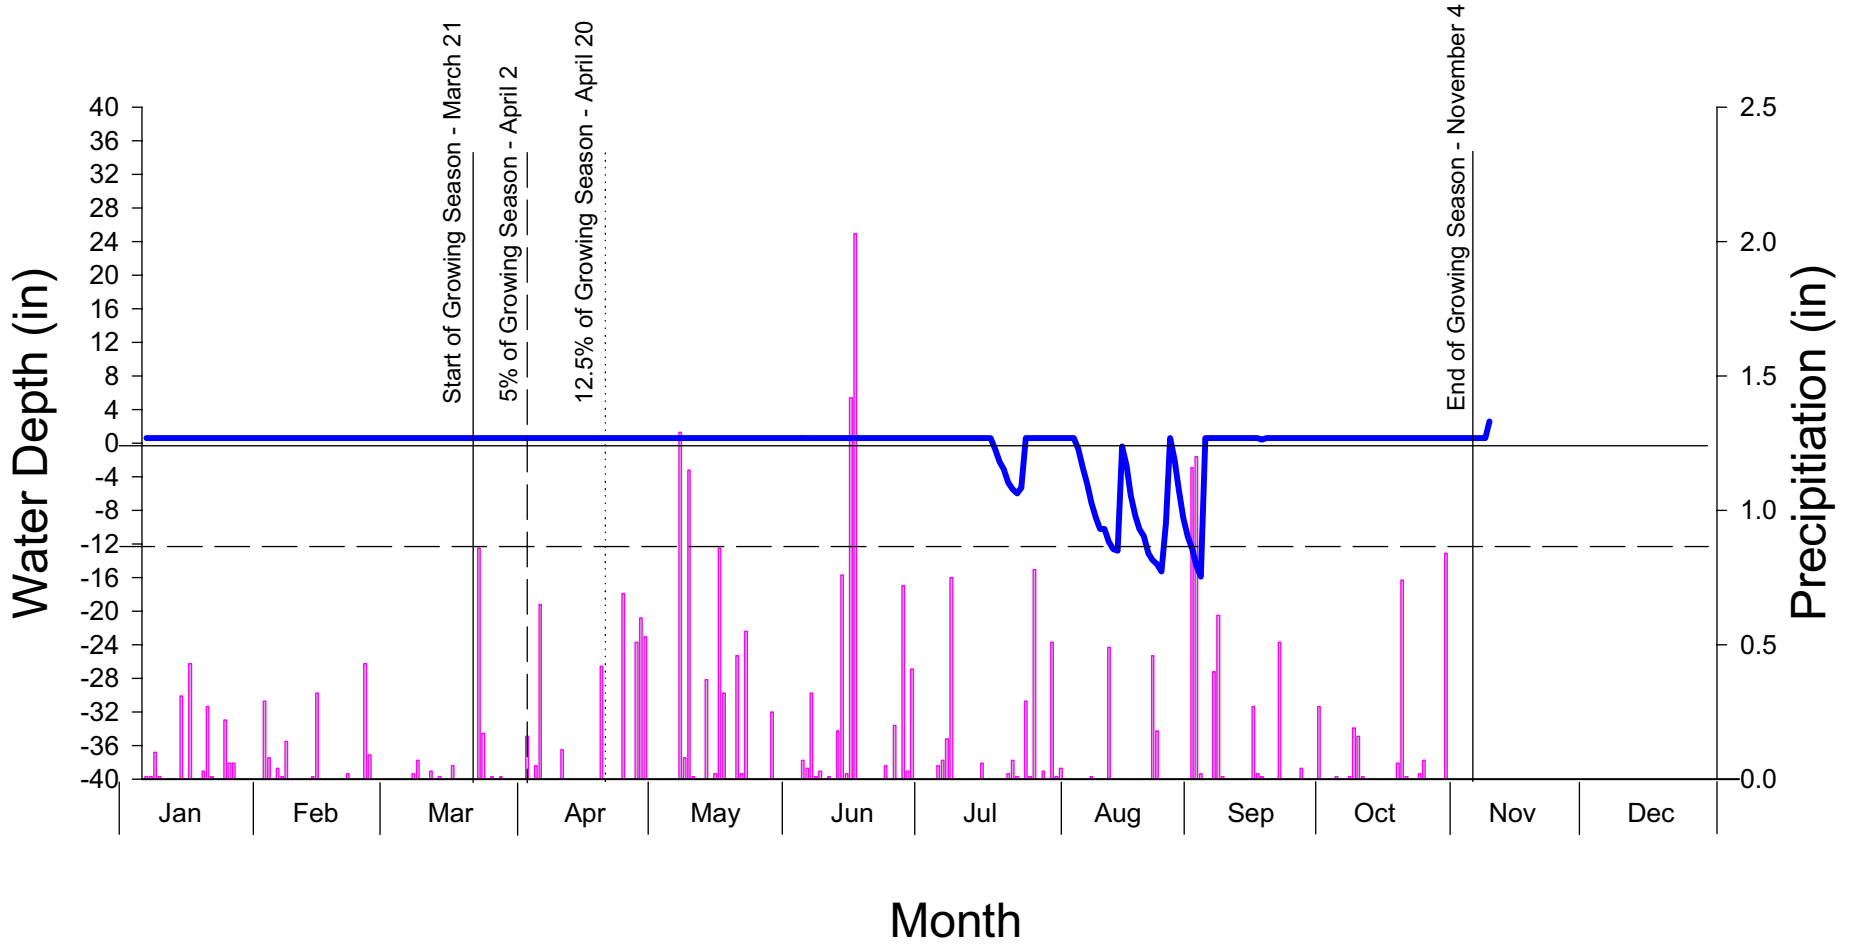
White Oak Creek 2006 Monitoring Gauge 36 - 031FA53

| GW-36 | | | ✓ | 62 | March 21 – August 19 |

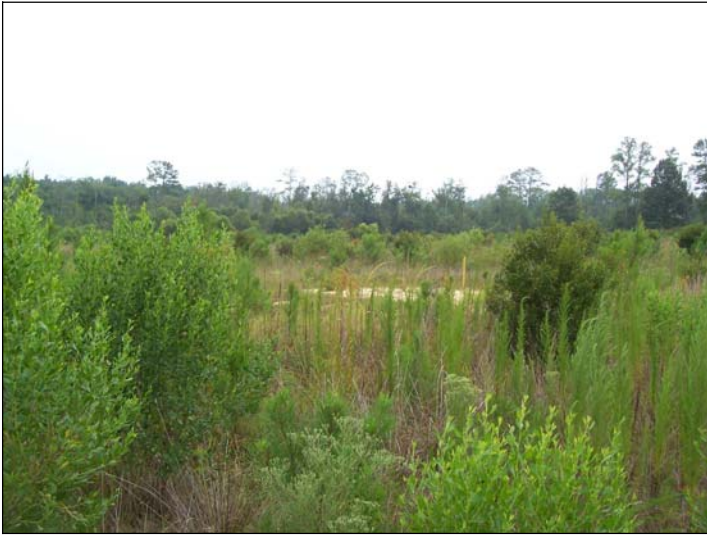
Vegetation Plot 1 looking southeast

Nuisance trees such as red maple and loblolly pine occur in significant amounts in some areas of the Site, as seen in Plots 1, 3, and 7. The increase in stem counts of these species over 2005, for example in Plot 1, is likely due to site characteristics and proximity to seed sources. These occurrences do not appear to have a direct effect on the survivability of planted species on the plots. However, several areas on the site are nearly devoid of vegetation with Plots 5 and 6 below minimum planted tree density.

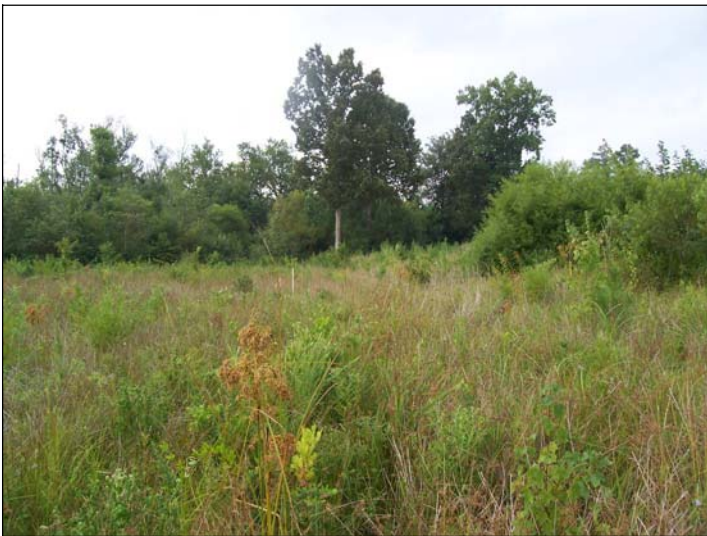
Vegetation Plot 3 looking south

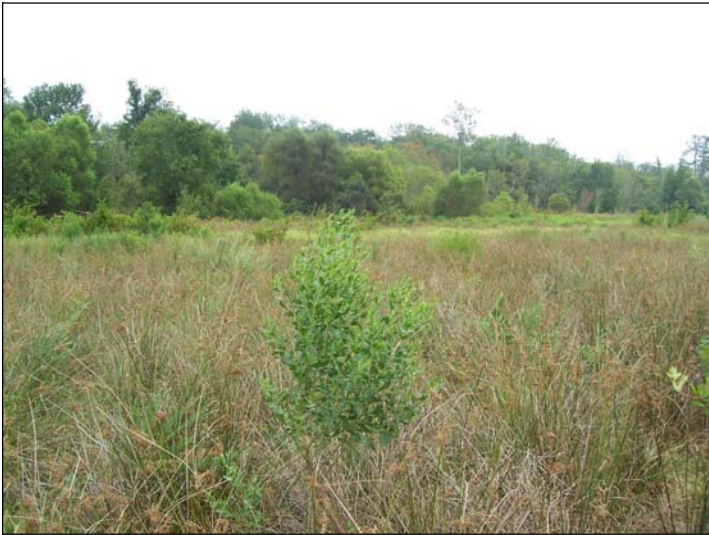
Vegetation Plot 5 looking southeast

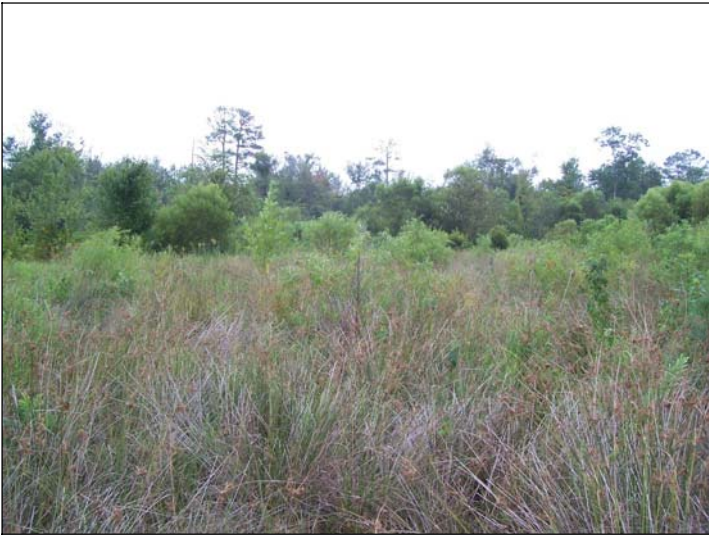
Vegetation Plot 6 looking southeast

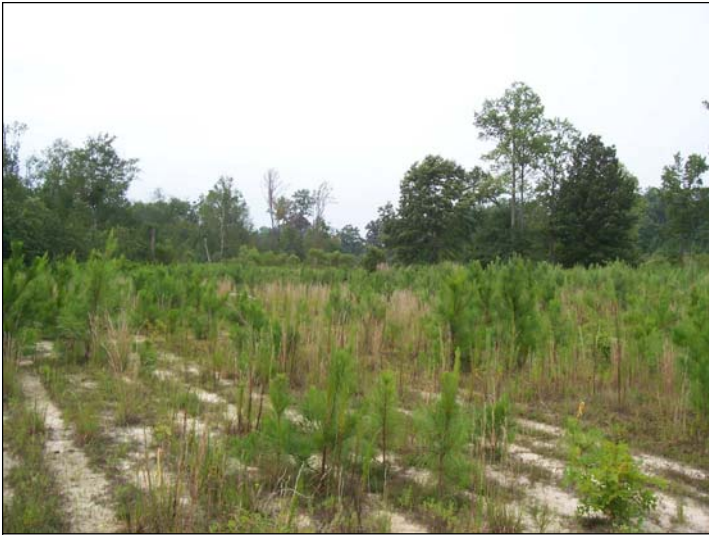
Vegetation Plot 7 looking south
