**Whitley Buffer Mitigation Site
Annual Vegetation Monitoring Report
2010 Growing Season
Year 5 Monitoring Report**

September 2010
NCEEP Contract # D05015-4

Appendix A. 2010 Site Photos

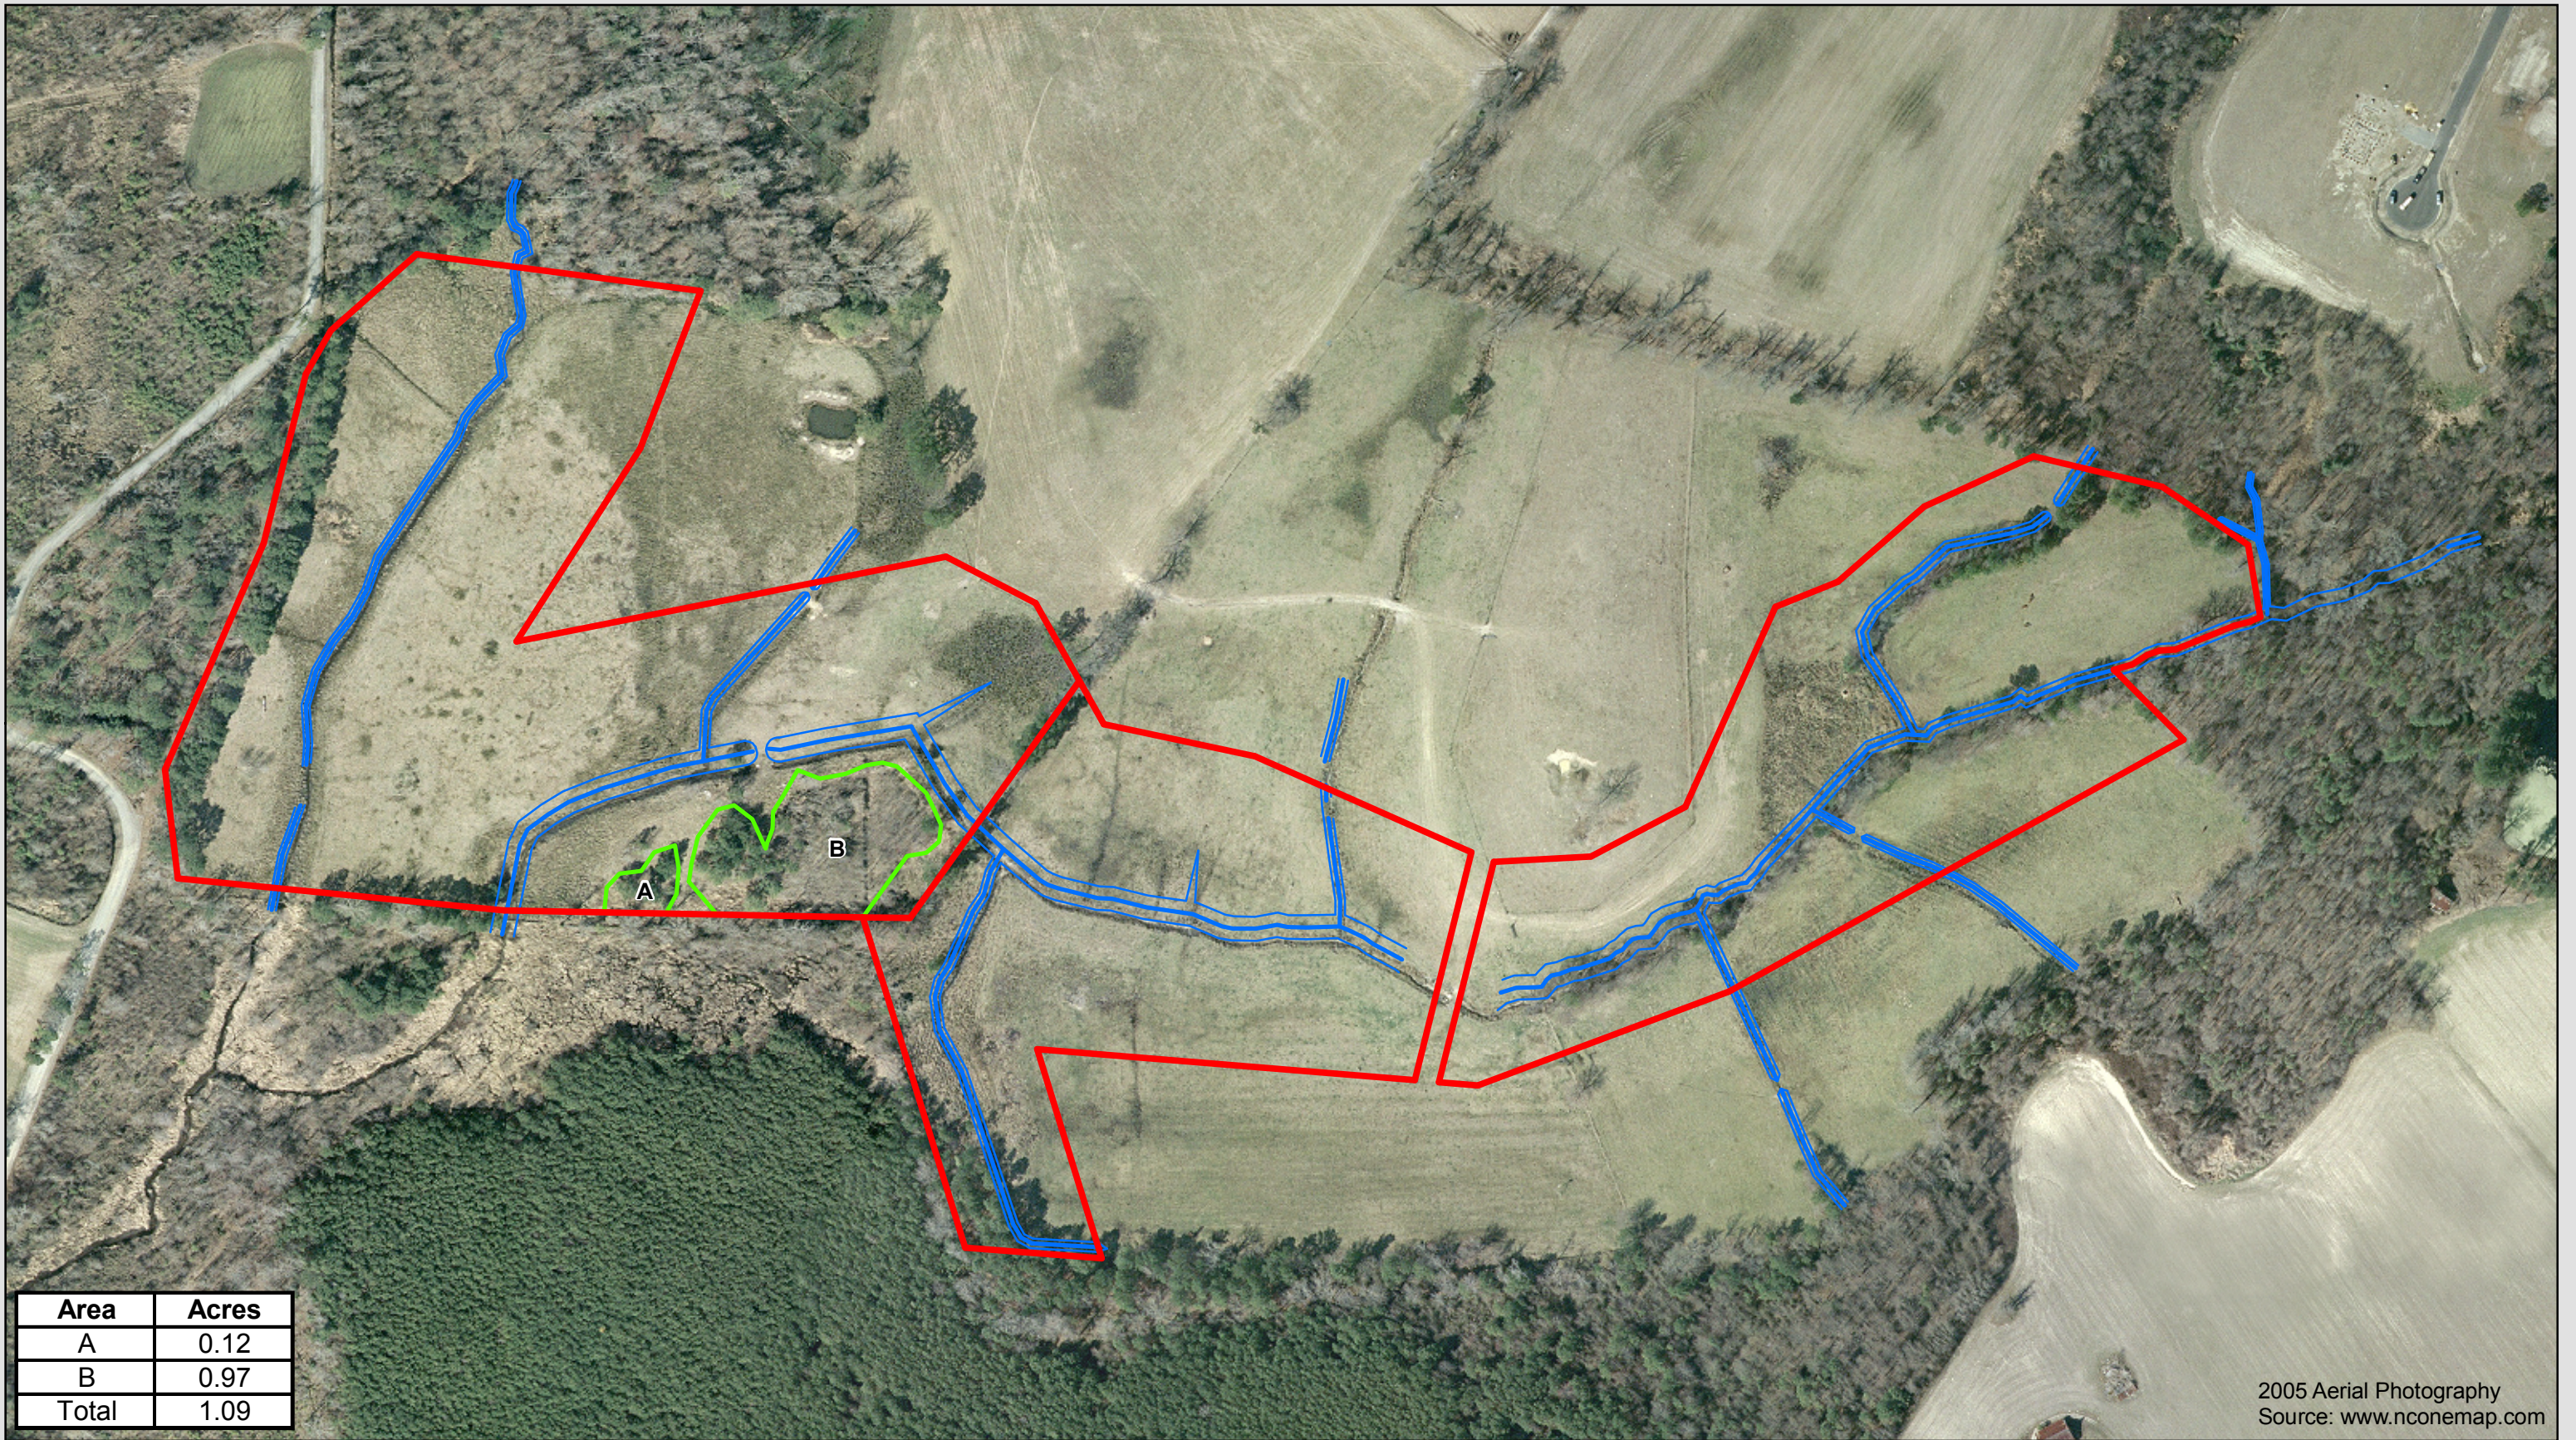
Appendix C: Buffer Mitigation Unit Reduction of Credit Map

The conservation easement is comprised of 27.5 acres. On February 9, 2010 during a DWQ site visit attended by Eric Kulz and Lia Gilleski two areas were delineated to be removed from the buffer credit calculation. These two areas A and B are shown as Appendix C. The sum of Area A 0.12 acres and Area B 0.97 acres resulted in a reduction of 1.09 credits lowering the BMU's onsite to 26.41. Appendix C has been provided to the NCDWQ.

Area	Acres
A	0.12
B	0.97
Total	1.09
