Mitigation Plan – FINAL

Whittier Creek Site – Option D Mitigation Project

Surry County, North Carolina

DMS Project ID No. 100020, DEQ Contract No. 7182, DEQ RFP #16-006993

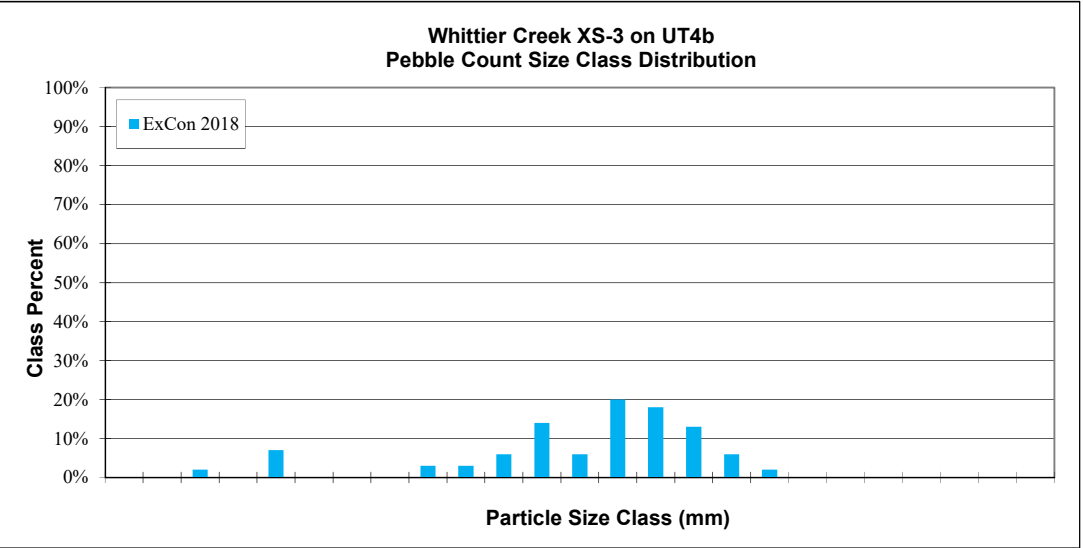
Pebble Count: Existing Conditions
Whittier Creek Mitigation Project, DMS# 100020

SITE OR PROJECT:	Whittier Creek
REACH/LOCATION:	XS-3 on UT4b
FEATURE:	Riffle
DATE:	04/09/2018

Summary Data			
Channel materials			
D16 =	8.4	D84 =	51.5
D35 =	16.0	D95 =	75.9
D50 =	26.4	D100 =	90 - 128

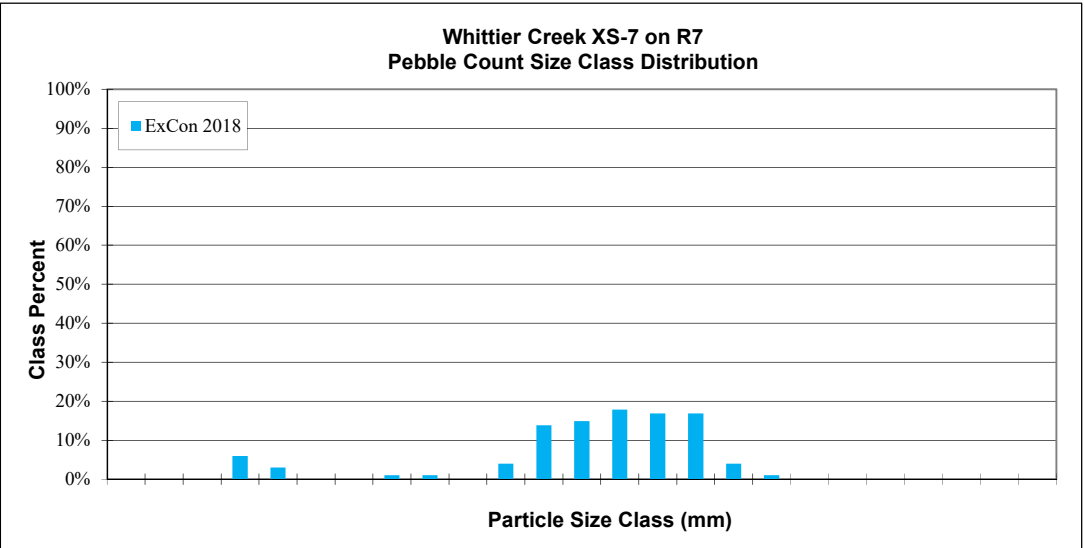
Pebble Count: Existing Conditions
Whittier Creek Mitigation Project, DMS# 100020

SITE OR PROJECT:	Whittier Creek
REACH/LOCATION:	XS-7 on R7
FEATURE:	Riffle
DATE:	04/09/2018

Summary Data			
Channel materials			
D16 =	11.3	D84 =	50.8
D35 =	18.5	D95 =	63.9
D50 =	25.6	D100 =	90 - 128
