ANNUAL MONITORING REPORT (MY1)

WICOMICO BUFFER MITIGATION SITE EDGECOMBE COUNTY, NORTH CAROLINA

DMS PROJECT NO.100188
NCDEQ CONTRACT NO. 200209-01
DWR PROJECT NO. 2021-0750 VERSION 2

Data Collection: September 2023
Submission: January 2024

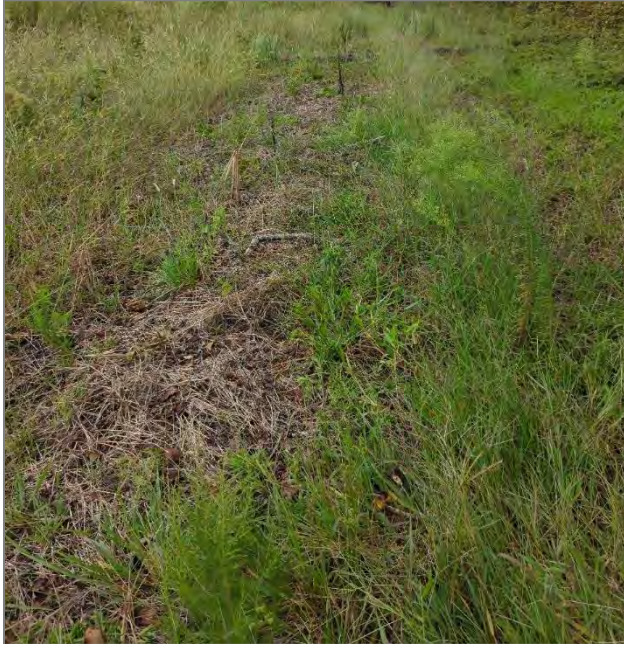
Photo 1. Sparsely vegetated area near the southern boundary of easement.

Area has been noted and will be monitored during MY2.

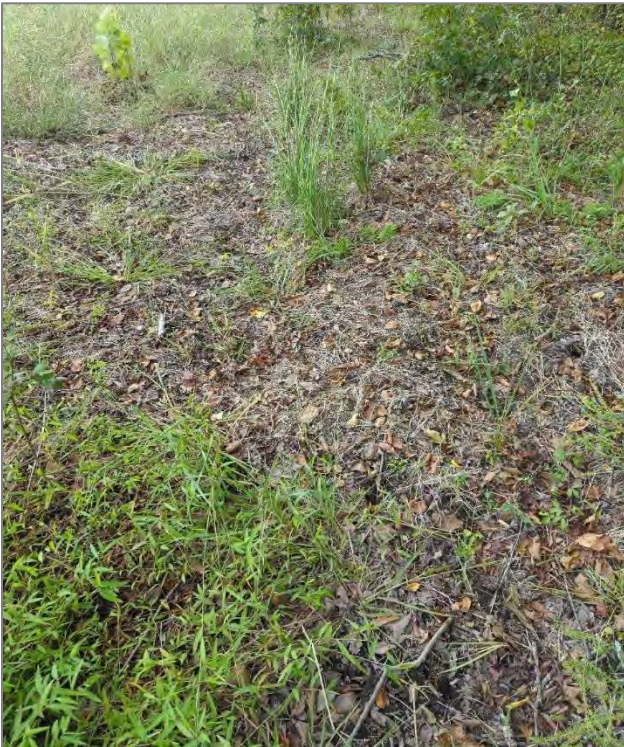
Photo 2. Sparsely vegetated area near middle of easement.

Area has been noted and will be monitored during MY2.

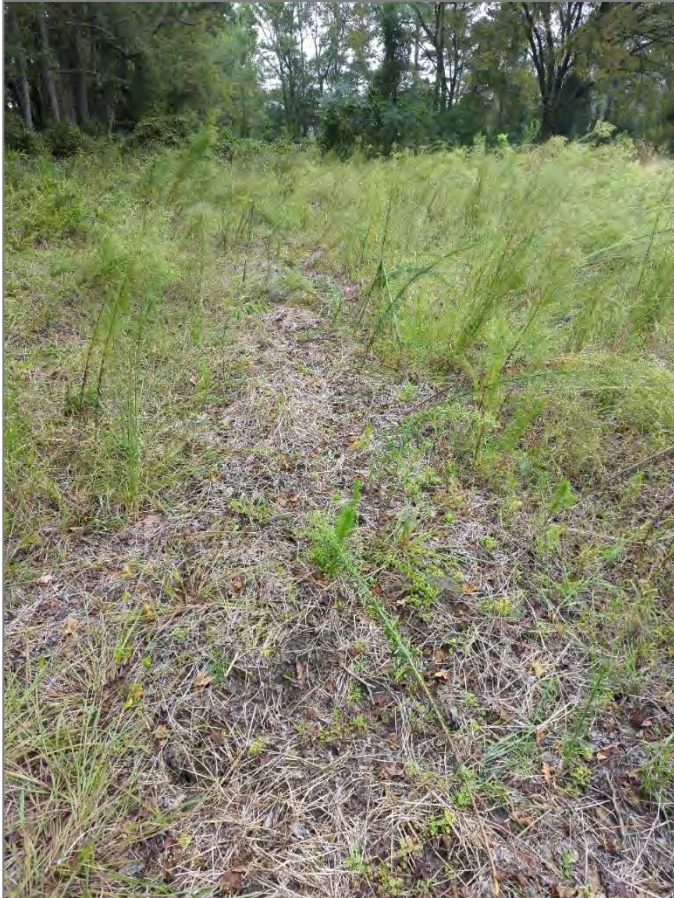
Photo 3. Sparsely vegetated area near the northern boundary of the easement.

Area has been noted and will be monitored during MY2.

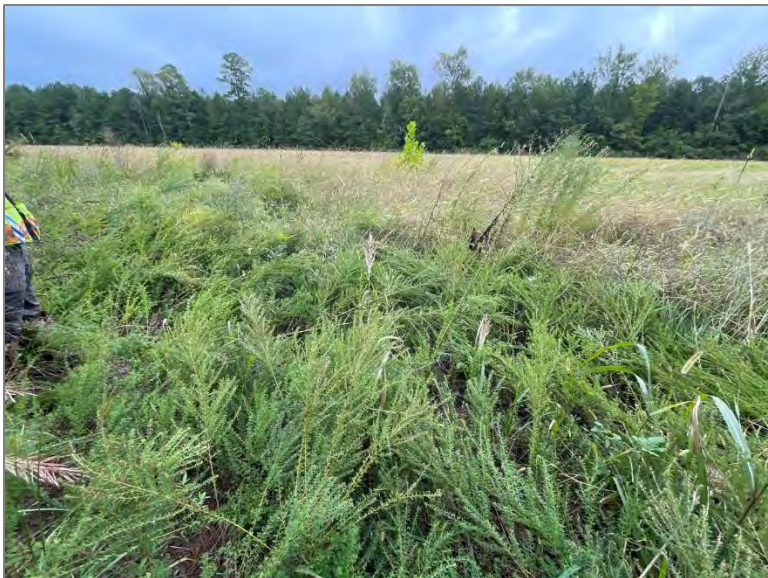
Photo 4. Patch of Invasive *Sericea lespedeza* (*Lespedeza cuneata*) adjacent to VP-04. Approximately 14,000 square feet.

Sericea lespedeza is a perennial legume native to Asia and was introduced in the United States in the 1890s for soil conservation and wildlife forage. While originally introduced as wildlife forage, the high tannin content of the woody stems makes it unpalatable for most wildlife and livestock. It has been a primary constituent of highway soil stabilization seed mixes, which has resulted in a geographically extensive seed bank that will remain viable for decades. The complete elimination of the species from natural areas is extremely difficult due to the large numbers of viable seeds in the surrounding landscape. The species can tolerate shade; however, vigor is greatly reduced as the tree canopy becomes denser (Cummings, et al., 2007). Chemical control of the species, particularly with triclopyr for post-emergence application, has been shown to be an effective method of reducing spread of the species (Farris and Murray, 2009), however post-emergence herbicide application does not provide a long-term solution to species management (Sherrill, et al., 2022). Given the concentrated population of the *lespedeza* observed at the Site, a mechanical and chemical control approach will be applied. The existing area of *lespedeza* will be mowed in the late fall/early winter after seed drop to reduce biomass within the Site, and a pre-emergence herbicide containing aminocyclopyrachlor (e.g., Streamline) will be applied to the mowed area in early March. Aminocyclopyrachlor is a selective herbicide that has minimal negative effects on cool and warm season grasses (Turner, et al., 2023). A triclopyr herbicide (e.g., Crossbow, Garlon 3A) in a 2% solution will be applied during June to mid-July when *lespedeza* plants are still vegetative and during early flowering. All herbicides will be applied by licensed applicators and will adhere to product label specifications. Areas of *sericea lespedeza* infestation will be monitored during MY2. Areas of mechanical and chemical treatment will be replanted with native species seed mix and if woody stem supplementation is needed, planting will be conducted with approved species from the mitigation plan.

Management tasks have been detailed in the MY1 report.

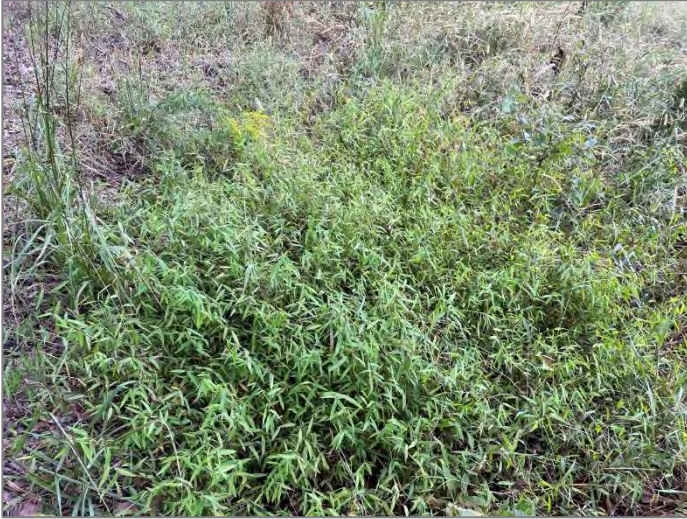
Photo 5. Patch of Invasive Japanese stiltgrass (*Microstegium vimineum*) near the middle of the easement. Approximately 80 square feet.

Japanese stiltgrass is an annual grass that was first documented around 1919 in Tennessee and has since spread to 25 states. Individual plants produce between 100 and 1,000 seeds annually, with seed viability extending beyond five years (Plant Conservation Alliance, 2007). Chemical control through use of systemic herbicides is the recommended chemical control for stiltgrass. Treatment in riparian areas should use glyphosate specifically formulated for aquatic sites to reduce potential stream impacts. A 2% solution of glyphosate (Rodeo or other formulations for aquatic sites) and a surfactant will be applied in late summer to identified areas of stiltgrass infestation. Herbicides will be applied by licensed applicators and will adhere to product label specifications. Areas of Japanese stiltgrass infestation will be monitored during MY2.

Management tasks have been detailed in the MY1 report.

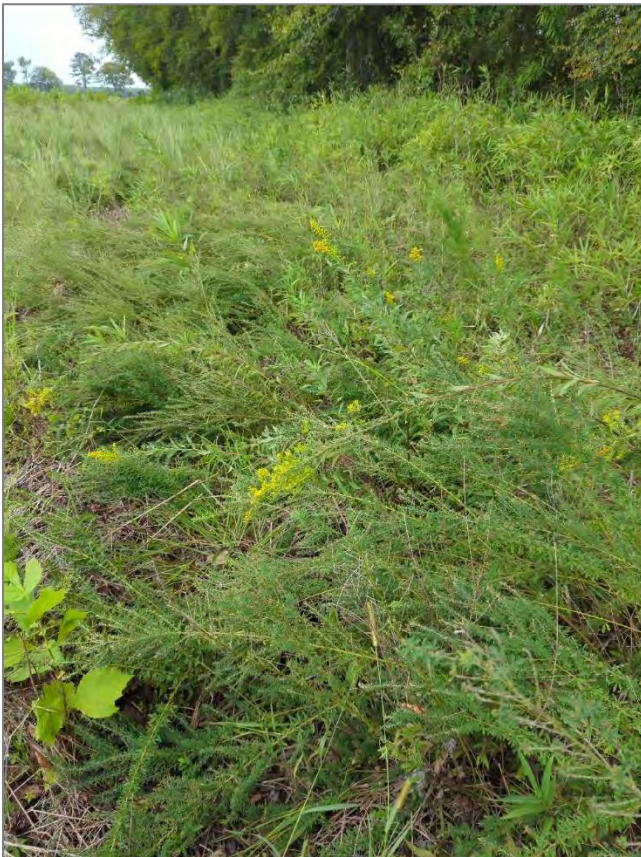
Photo 6. Patch of Invasive Sericea lespedeza (*Lespedeza cuneata*) near the northern boundary of the easement. Approximately 900 square feet.

Management tasks have been detailed in the MY1 report.

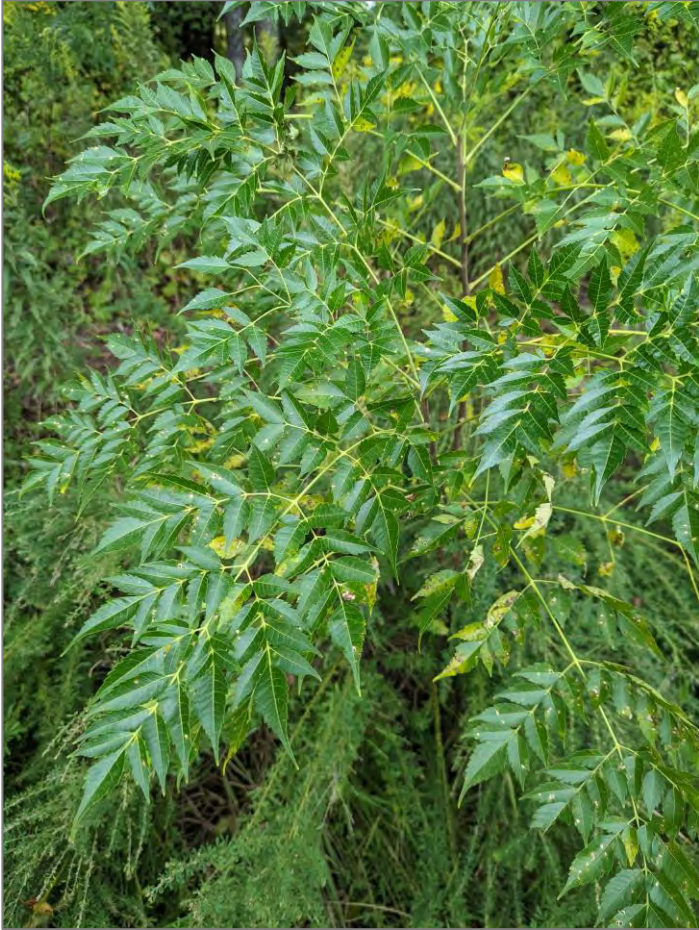
Photo 7. Chinaberry (*Melia azedarach*) scattered throughout the western tree line in the northern terminus of the easement. Approximately 3,500 square feet.

Chinaberry is a fast-growing tree with allelopathic roots and leaves that can form dense thickets that crowd out native vegetation. The tree was introduced as a medicinal plant in the late 18th century but has since spread prolifically throughout riparian areas of southeastern states, spreading primarily from root sprouts and bird-dispersed seeds (Miller, 2003; Plant Conservation Alliance, 2008). Given the propensity of the plant to colonize sites quickly, chemical controls will be applied in conjunction with the foliar treatment of lespedeza at the site. Chinaberry trees will be cut, and a cut-stump application of triclopyr herbicide (Garlon 3A or Garlon 4) in a 2% solution will be applied during June to mid-July when the trees are vegetative but before fruiting. Herbicides will be applied by licensed applicators and will adhere to product label specifications. Areas of chinaberry infestation will be monitored during MY2.

Management tasks have been detailed in the MY1 report.

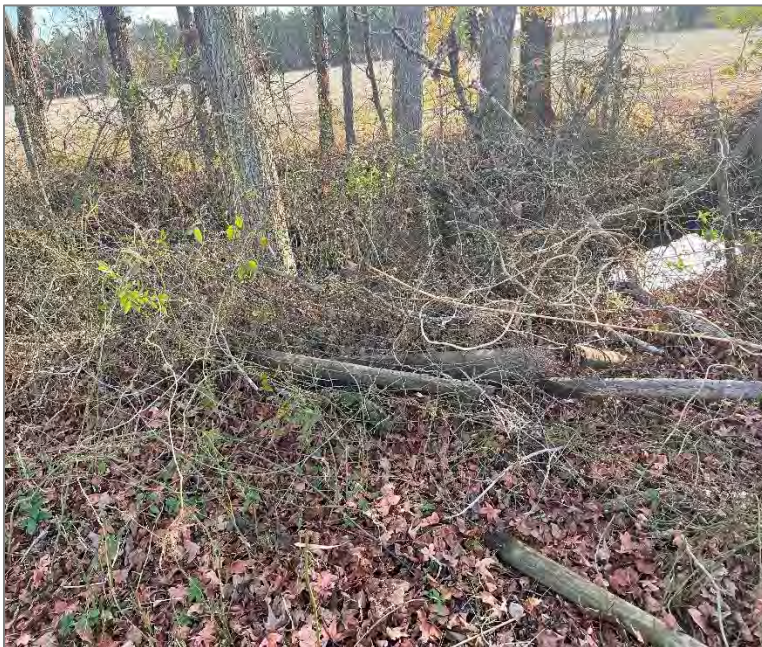
Photo 8. Pile of barbed wire during active fence removal on December 13, 2023.

❖ The fence was removed on December 13, 2023. Photographs of the fenceless area are attached.

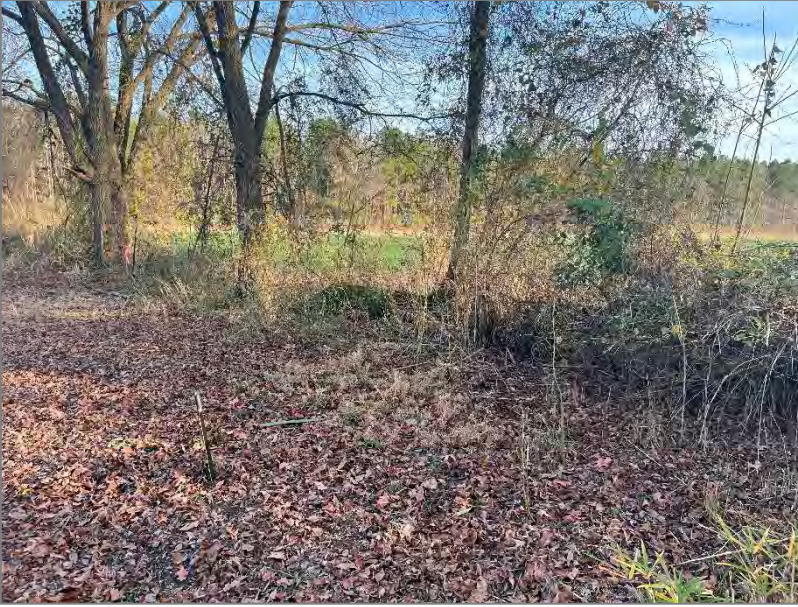
Photo 9. Previous location of the barbed wire fence.
