MY03 Monitoring Report

Wingfoot Riparian Buffer Mitigation Site

Pitt County, NC

DMS Project No. 100078

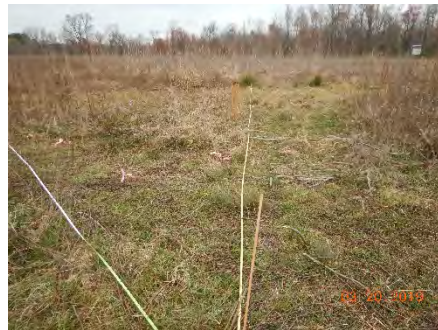
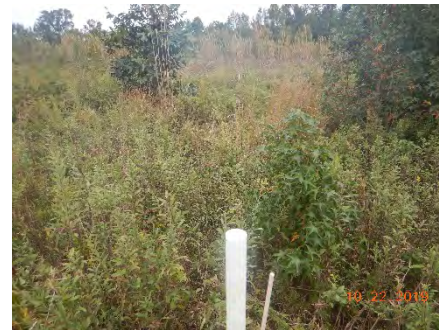
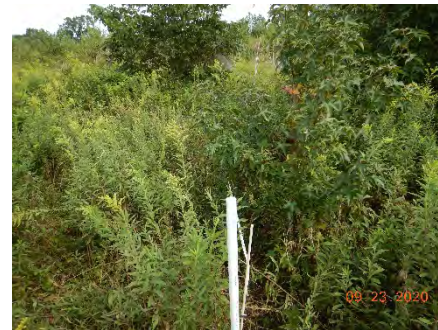
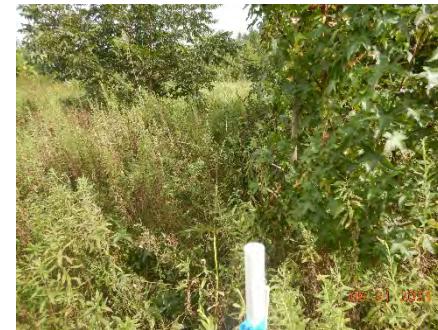
Plot 8:

As documented in previous years, invasive species were observed and limited to the vicinity of Plot 8 and consisted of Japanese honeysuckle (*Lonicera japonica*) and a few sporadic stems of Chinese privet (*Ligustrum sinense*). The project team treated these areas in the Spring of 2021 and will coordinate this effort with DMS. The continued presence of Japanese honeysuckle at this location appears to be affecting stem growth and survivorship. In addition, high density of blackberry was observed in this area and may also be contributing to planted tree mortality. Higher mortality and low vigor of planted stems were observed within Plot 8 during MY03, and the Plot has exhibited a decline in the number of stems documented each year since MY0. However, it should be noted that Plot 8 does meet the minimum stem count requirement for MY03 and is also likely to meet this requirement by MY05 with the inclusion of volunteer species recorded in subsequent monitoring years. Since this area is likely to populate with volunteers throughout the monitoring period, no additional planting is recommended at this time. Refer to Appendix B for monitoring year two (MY03) vegetation plot photographs and the planted and total stem counts.

Overall, the Site appears to be progressing well towards the target success criteria. Small populations of invasive species were noted in the vicinity of Plot 8. The project team plans to treat this area in the Spring of 2022 and will coordinate this effort with DMS. The site will continue to be monitored for problem areas. In addition, invasive treatment areas will continue to be monitored, and invasive vegetation management will continue to be implemented if additional exotic species volunteer into the site. If it is determined that the Site's ability to achieve the performance standards are jeopardized, staff members of NCDMS/NCDWR will be notified, and an adaptive management plan will be developed to address these issues.
