**MITIGATION PLAN
WITS END STREAM & WETLAND MITIGATION SITE
UNION COUNTY, NORTH CAROLINA**

**RFQ#: 16-032819-YD05 (Issued: 5/9/2019)
DMS PROJECT ID NO. 100164
DMS CONTRACT NO. 7968
USACE ACTION ID NO. SAW-2020-00455
NCDWR NO. 20200369**

**YADKIN RIVER BASIN
CATALOGING UNIT 03040105**

Prepared for:
NORTH CAROLINA DIVISION OF MITIGATION SERVICES
RALEIGH, NORTH CAROLINA

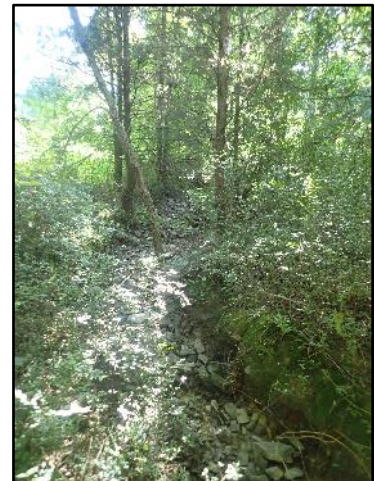
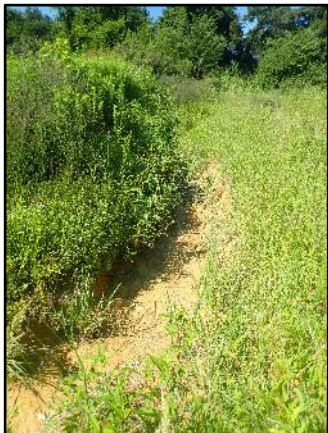
UT 1 drains 32 acres of agriculture fields and originates onsite on a forested edge abutting the fields. The reach is wooded but the uppermost section has significant exposed bare ground and minimal herbaceous vegetation due to heavy overland flow from the fields above. The underlying soils are part of the Cid Series which are typical of upland flats. The canopy is composed of Eastern red cedar (*Juniperus virginiana*), pignut hickory (*Carya glabra*), winged elm (*Ulmus alata*), sweet gum (*Liquidambar styraciflua*), and willow oak (*Quercus phellos*). Herbaceous species include Japanese silt grass (*Microstegium vimineum*), blackberry (*Rubus sp.*), and greenbrier (*Smilax rotundifolia*). Invasive Chinese privet (*Ligustrum sinense*) is also present. Substrate composition is primarily gravel and cobble with clay banks. The bottom of the channel is 2-3' wide and the top of bank is 2-5' wide and 0.5-2' deep. Approximately 60% of the banks are actively eroding, most likely from high flow events and agriculture drainage.

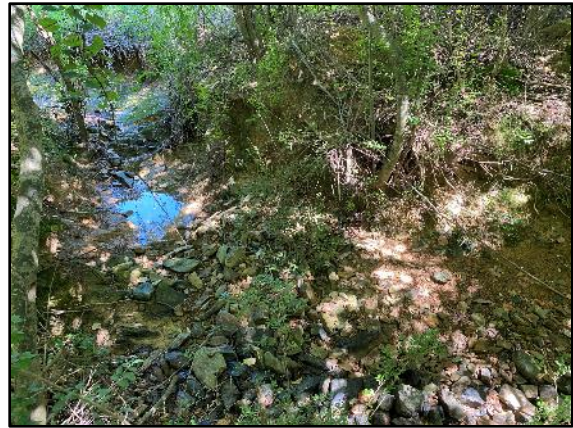
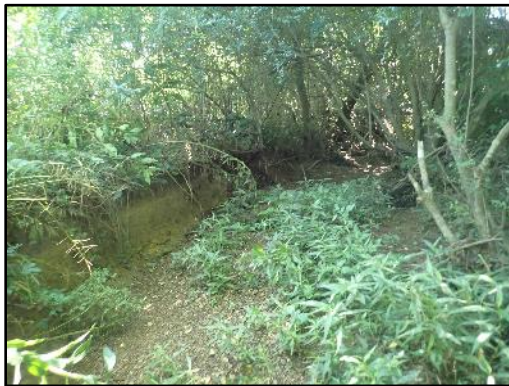
(*Celtis laevigata*), cottonwood (*Populus deltoides*), sweet gum (*Liquidambar styraciflua*), and Eastern red cedar (*Juniperus virginiana*). Understory species include groundseltree (*Baccharis halimifolia*) and green ash (*Fraxinus pennsylvanica*) and vines including Japanese honeysuckle (*Lonicera japonica*), poison ivy (*Toxicodendron radicans*), and greenbrier (*Smilax rotundifolia*). Herb species include elderberry (*Sambucus canadensis*), blackberry (*Rubus spp.*), pokeweed (*Phytolacca americana*), silverweed (*Cinquefoil sp.*), and spleenwort (*Asplenium platyneuron*). Invasive species present are Chinese privet (*Ligustrum sinense*), multiflora rose (*Rosa multiflora*), Chinaberry (*Melia azedarach*), and a small patch of bamboo (*Bambusoideae sp.*). The upper portion has a nearby adjacent ditch running along the edge of the agriculture field and experiences less erosion and incision than the reach below the upper pond. The bottom of the channel is approximately 3-5' wide and the top of bank is 3-8' wide. The uppermost reach is 2-4' deep and the section above the confluence with UT 3A is 3-6' deep with more heavily incised banks. Substrate composition is silt/clay, gravel, cobble, boulder, bedrock, and saprolite with the average size of substrate increasing as you travel downstream. Underlying soils are part of the Cid Series.

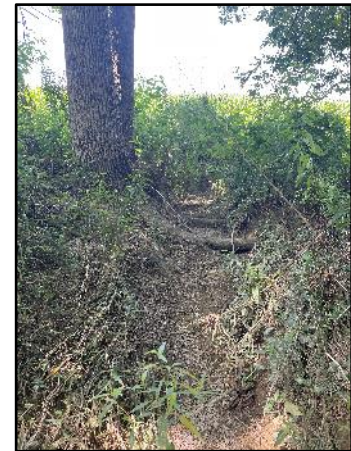
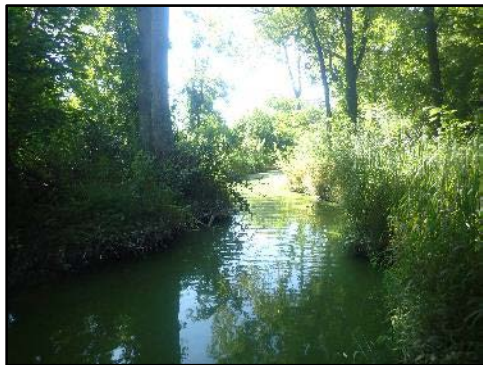
Woody canopy species include green ash (*Fraxinus pennsylvanica*), winged elm (*Ulmus alata*), and sweet gum (*Liquidambar styraciflua*). Herbaceous species and vines present are soft rush (*Juncus effuses*), pokeweed (*Phytolacca americana*), blackberry (*Rubus sp.*), greenbrier (*Smilax rotundifolia*), and Japanese silt grass (*Microstegium vimineum*). The dense understory is dominated by thick herbaceous species. The channel receives significant runoff from the upstream agriculture fields exposing some large root bases in-stream. The bottom of the channel is 1-1.5' wide and the top of the bank if 3-4' wide and 1-3' deep. Approximately 30% of the banks are actively eroding. Dominant substrate types are silt/clay and gravel. The underlying soils are from the Cid Series and the Goldston-Badin complex.

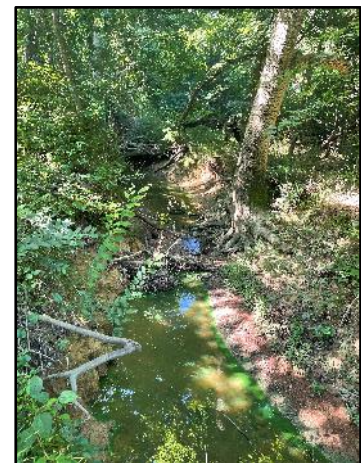
Below its confluence with UT 3, Waxhaw Branch enters a predominantly forested area with more mature (>15 years old) tree species before flowing offsite. Woody species include winged elm (*Ulmus alata*), sweet gum (*Liquidambar styraciflua*),

red maple (*Acer rubrum*), and green ash (*Fraxinus pennsylvanica*). Herbaceous species present are pokeweed (*Phytolacca americana*), goldenrod (*Solidago sp.*), and Japanese silt grass (*Microstegium vimineum*). Underlying soils continue as part of the Cid Series and the in-channel substrate is predominantly silt/clay, sand, and gravel. The bottom of the channel is 4-6' wide and the top of bank is 8-10' wide and 2-5' deep. Approximately 70% of the banks are eroding.
