# **MONITORING YEAR 0 ANNUAL REPORT FINAL**

September 2022

## **WYANT LANDS MITIGATION SITE PHASE II – PROJECT EXPANSION**

Lincoln County, NC  
Catawba River Basin  
HUC 03050102  
(03050103 Expanded Service Area)

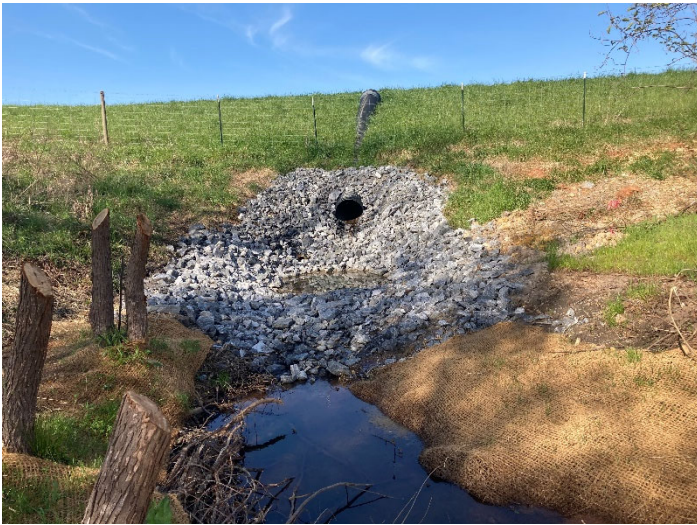
**UT2 R1** – Photo Point 21 looking upstream (4/12/2022)

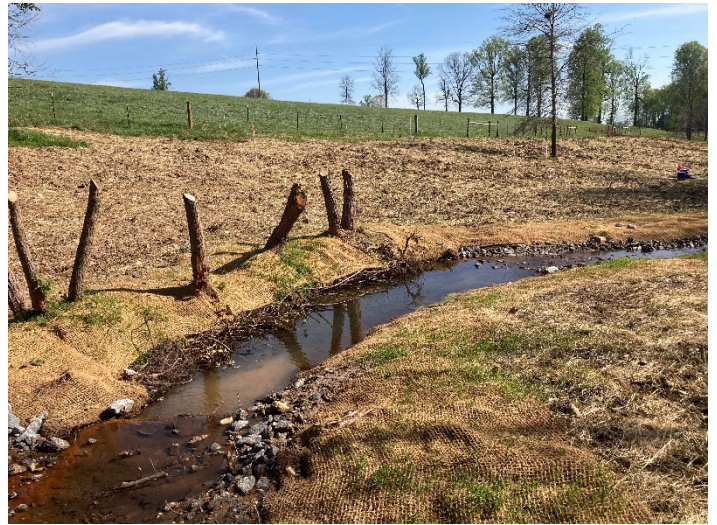
**UT2 R1** – Photo Point 21 looking downstream (4/12/2022)

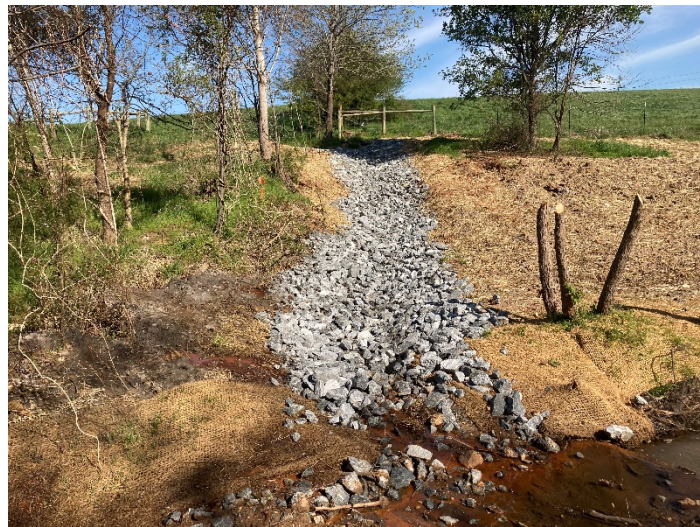
**UT2 R1** – Photo Point 21 looking northwest (4/12/2022)

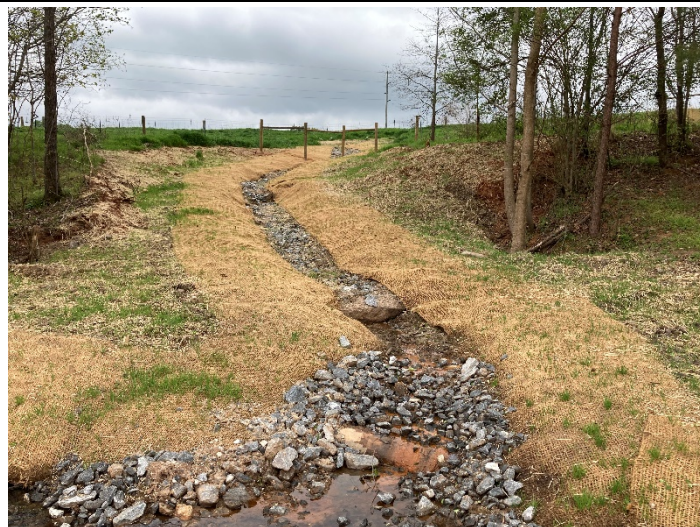
**UT2 R1** – Step-Pool Stormwater Conveyance looking southeast (4/12/2022)

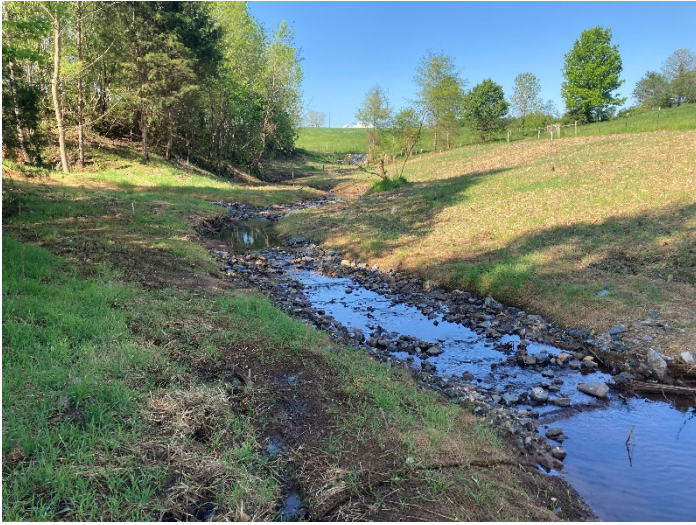
**UT2 R1** – Photo Point 15 looking upstream (4/25/2022)

- Photo Point 15 (PP15) was shifted slightly from its original location that was established in Phase I of the Wyant Mitigation Plan to capture as-built conditions of UT2 R1 after restoration slightly adjusted the stream channel location. Photo Point 15 is included in the Phase II MY0 report.

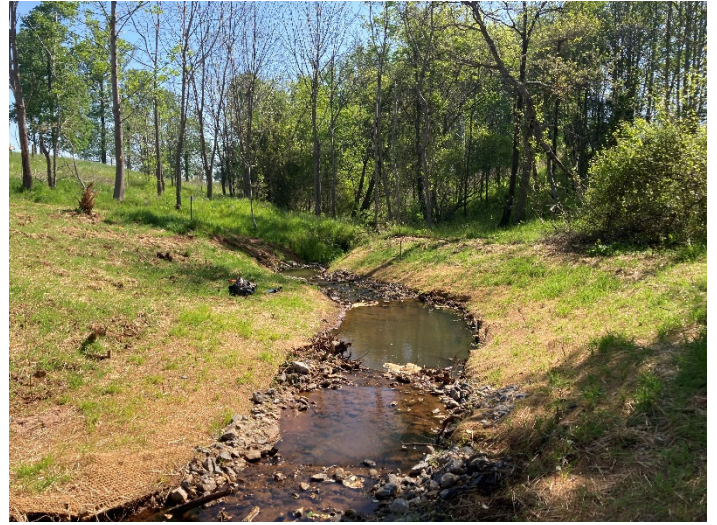
**UT2 R1** – Photo Point 15 looking downstream (4/25/2022)

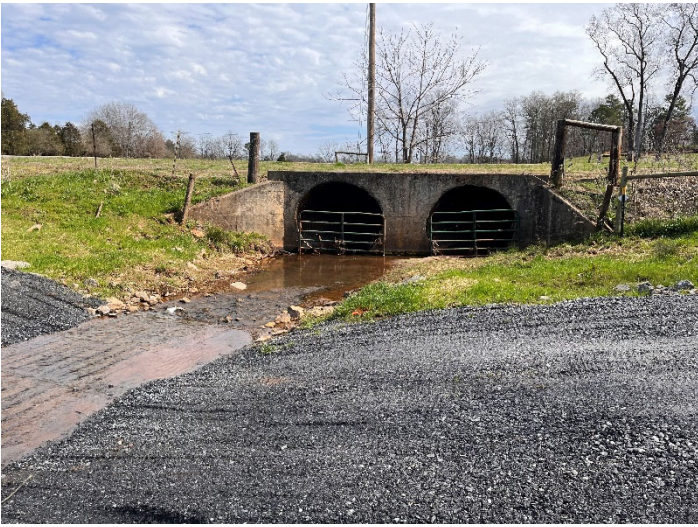
**Wyant R2 Crossing – Looking downstream inlet (3/8/2022)**

- **General:** As previously discussed with the IRT, please continue to provide photos of the upstream and downstream project crossing areas to confirm crossing stability and aquatic organism passage in the 2022 monitoring report and future monitoring reports.

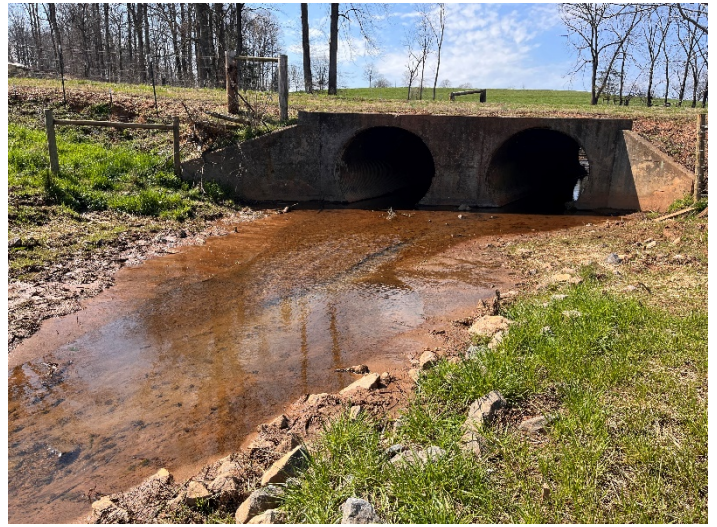
**Wyant R2 Crossing – Looking upstream outlet (3/8/2022)**

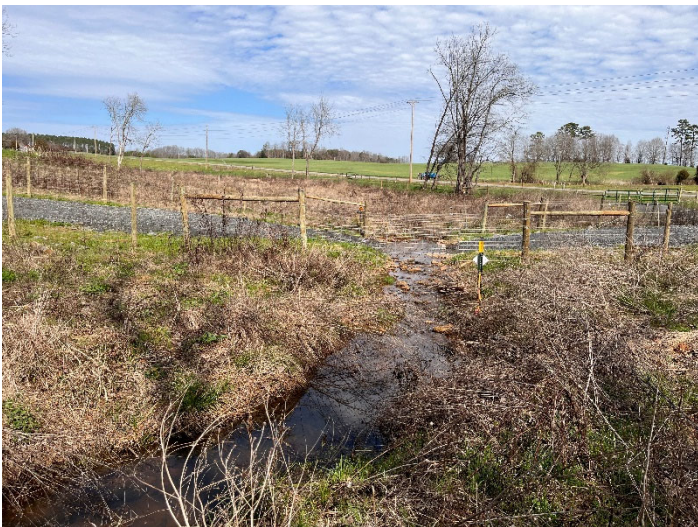
**UT2 R3 – Looking downstream (3/8/2022)**

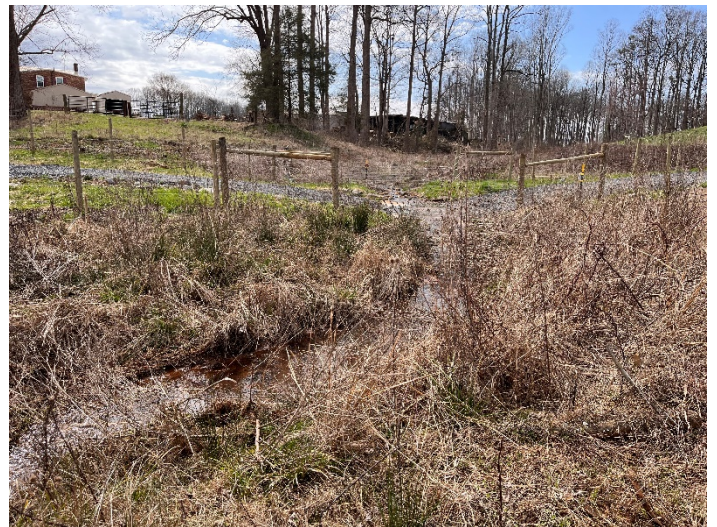
**UT2 R3 – Looking upstream (3/8/2022)**

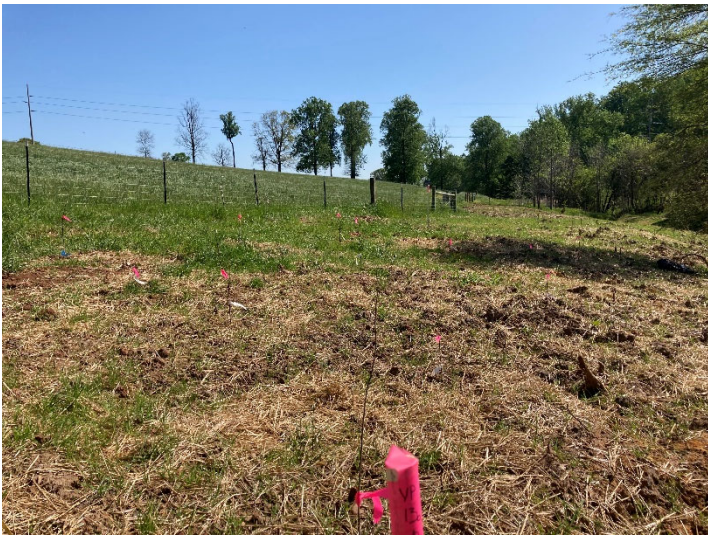
**PERMANENT VEGETATION PLOT 13 (04/25/2022)**

- Permanent vegetation plot 13 (VP13) was shifted slightly from its original location that was established in Phase I of the Wyant Mitigation Plan due to construction disturbance during the construction of Phase II. Vegetation plot 13 is included in the Phase II MY0 report in order to accurately represent as-built conditions.

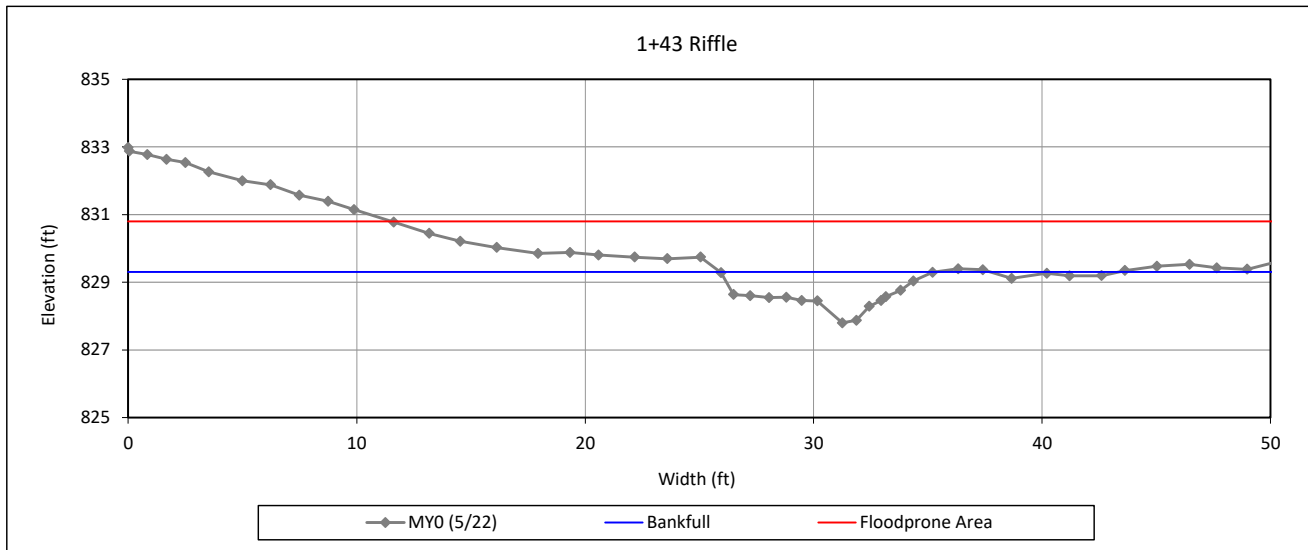
#### Cross-Section 19 - UT2 R1

- 7.2 x-section area (ft.sq.)
- 9.3 width (ft)
- 0.8 mean depth (ft)
- 1.5 max depth (ft)
- 10.1 wetted perimeter (ft)
- 0.7 hydraulic radius (ft)
- 12.0 width-depth ratio
- 43.9 W flood prone area (ft)
- 4.7 entrenchment ratio
- 1.0 low bank height ratio

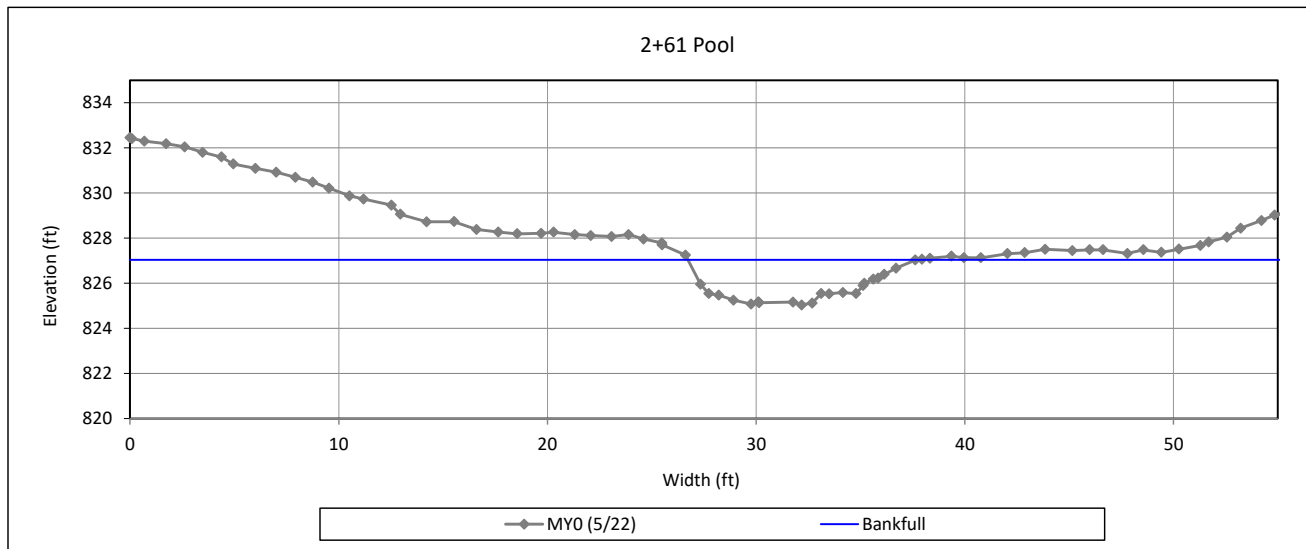
#### Cross-Section 20-UT2 R1

14.8	x-section area (ft.sq.)
10.9	width (ft)
1.4	mean depth (ft)
2.0	max depth (ft)
12.4	wetted perimeter (ft)
1.2	hydraulic radius (ft)
8.0	width-depth ratio

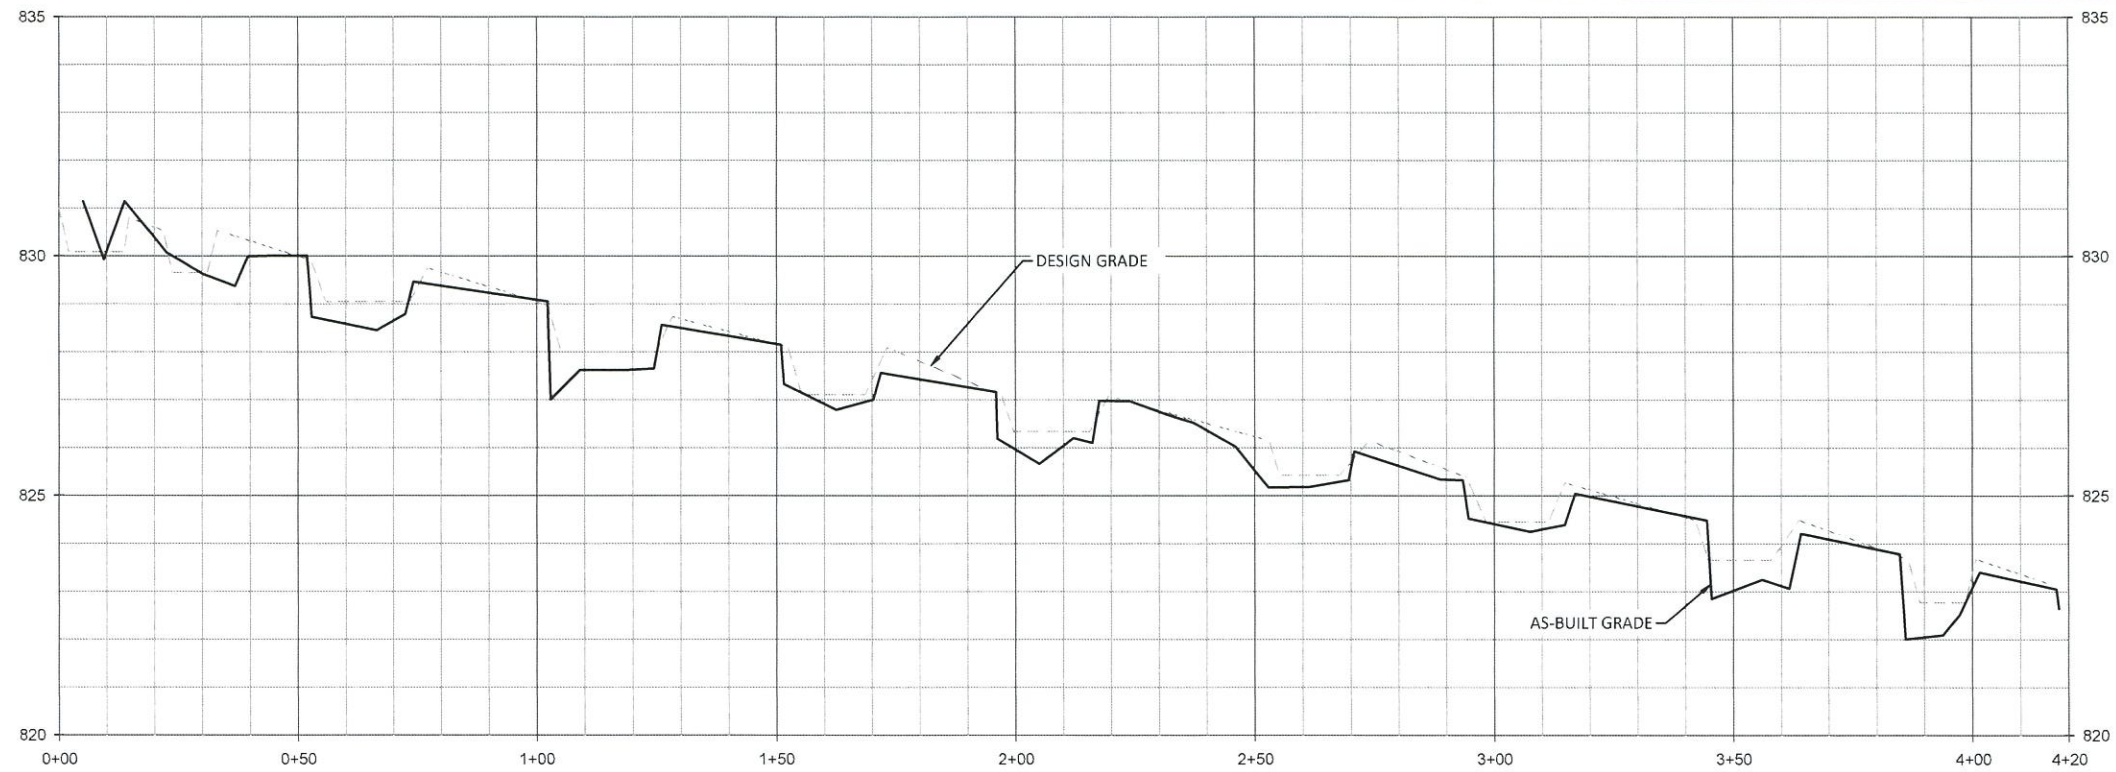
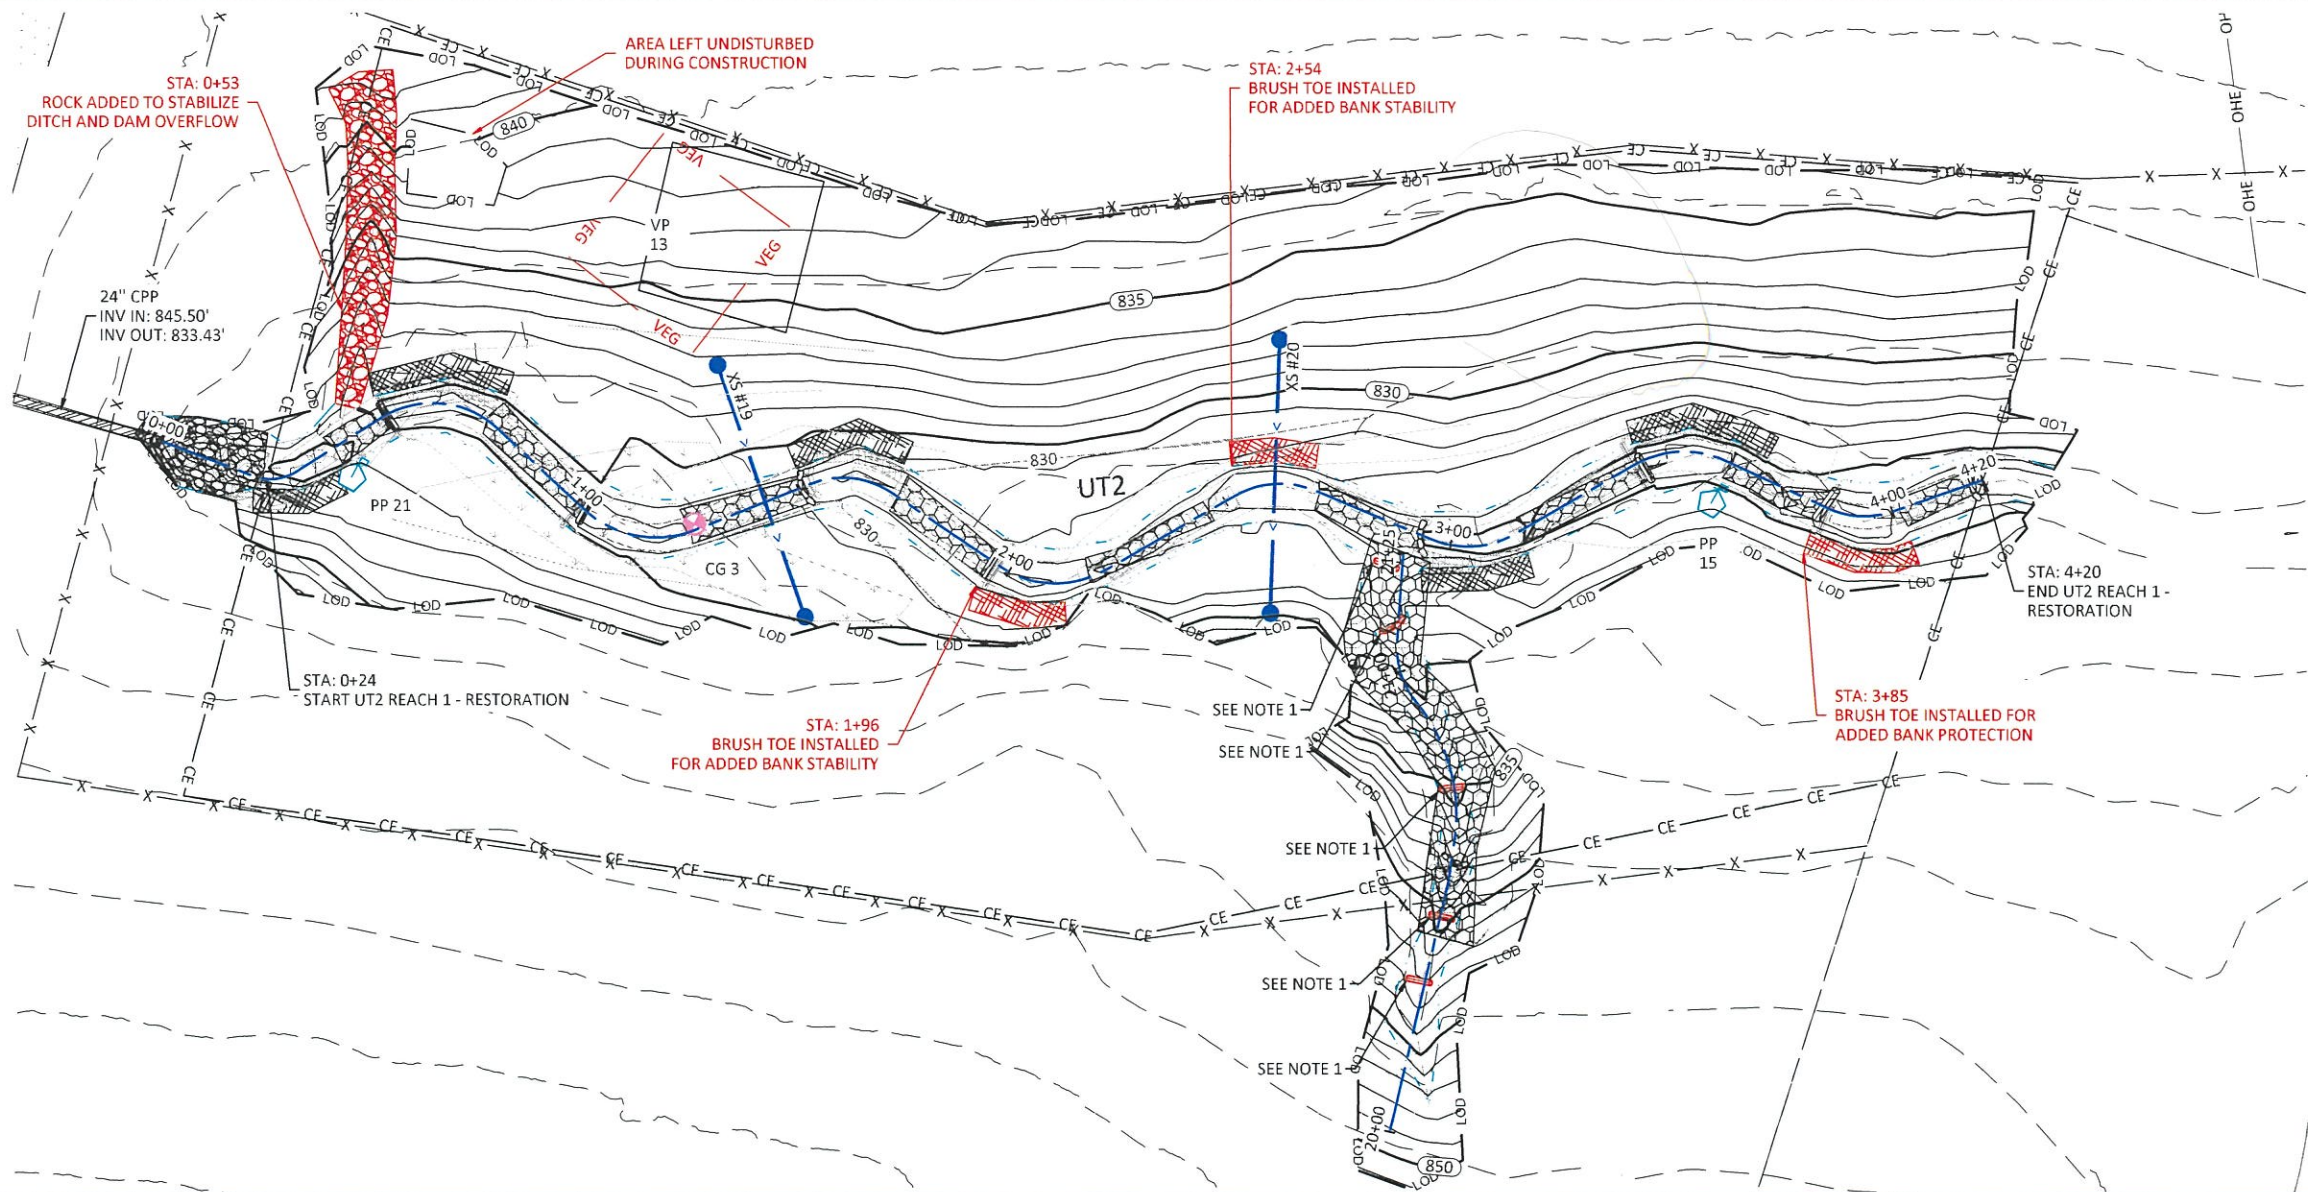
Wyant Lands Mitigation Site Phase II - Project Expansion Record Drawing  
 Lincoln County, North Carolina  
 UT2 Reach 1  
 Stream Plan and Profile

- NOTES:
1. SURVEYED SILLS ARE PART OF THE STEP-POOL STORMWATER CONVEYANCE DESIGNED PRIOR TO CONSTRUCTION AT STA: 20+31, STA: 20+46, STA: 20+73, STA: 21+10, AND STA: 21+22

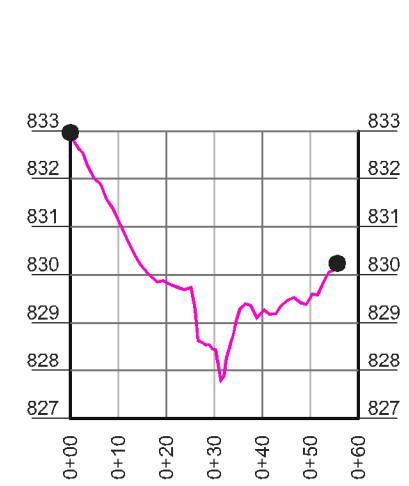
**CROSS-SECTION #19-UT2**  
HORIZONTAL SCALE: 1" = 20' FULL SIZE, 1" = 40' HALF SIZE  
VERTICAL SCALE: 1" = 2' FULL SIZE, 1" = 4' HALF SIZE

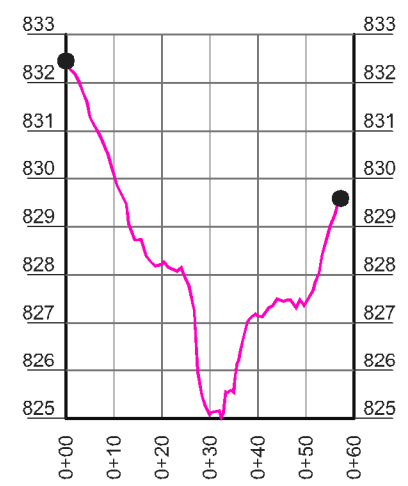
**CROSS-SECTION #20-UT2**  
HORIZONTAL SCALE: 1" = 20' FULL SIZE, 1" = 40' HALF SIZE  
VERTICAL SCALE: 1" = 2' FULL SIZE, 1" = 4' HALF SIZE

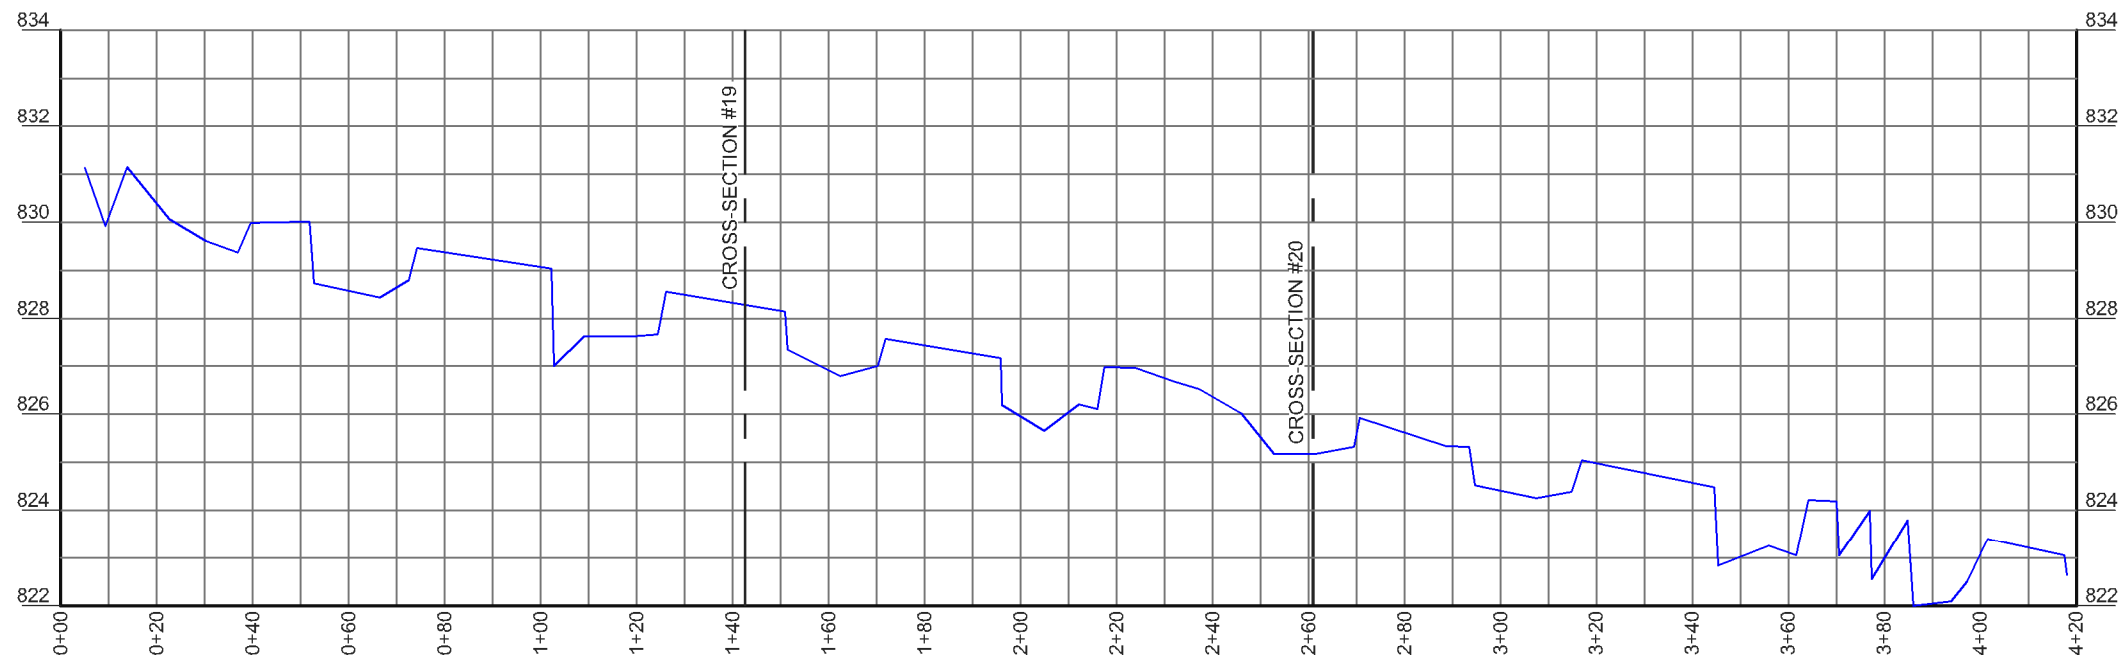
**LONGITUDINAL PROFILE- UT2**  
HORIZONTAL SCALE: 1" = 20' FULL SIZE, 1" = 40' HALF SIZE  
VERTICAL SCALE: 1" = 2' FULL SIZE, 1" = 4' HALF SIZE
