# MONITORING YEAR 2 ANNUAL REPORT FINAL

## WYANT LANDS MITIGATION SITE

Lincoln County, NC  
Catawba River Basin  
HUC 03050102  
(03050103 Expanded Service Area)

DMS Project No. 100067  
DMS Contract No. 7244  
DMS RFQ No. 16-007133-CT03 (*Issued: April 24, 2017*)  
USACE Action ID No. SAW-2017-02609 (Wyant Lands)  
USACE Action ID No. SAW-2021-02449 (Wyant Lands:  
Phase II)  
DWR Project No. 2018-0177 (Wyant Lands)  
DWR Project No. 2018-0177v.2 (Wyant Lands: Phase II)  
Data Collection Dates: March 2022 - November 2022

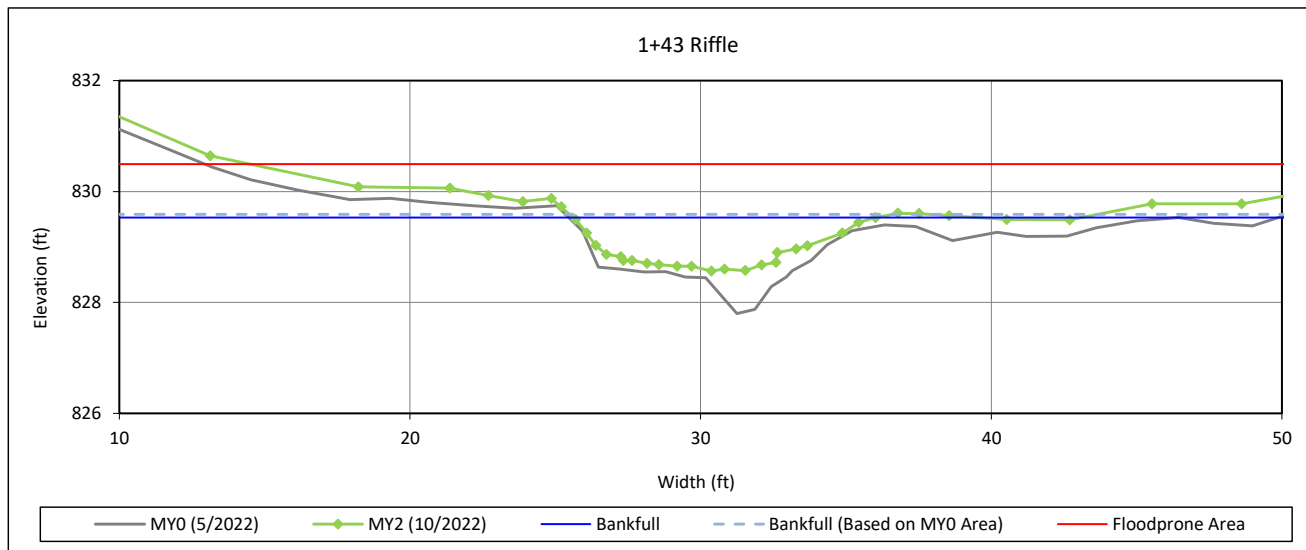
**Cross-Section 19 - UT2 R1**

6.6	x-section area (ft.sq.)
10.4	width (ft)
0.6	mean depth (ft)
1.0	max depth (ft)
10.8	wetted perimeter (ft)
0.6	hydraulic radius (ft)
16.3	width-depth ratio
40.9	W flood prone area (ft)
3.9	entrenchment ratio
< 1.0	low bank height ratio
