Common Pitfalls in Site/Property Management and Vapor Mitigation

*Department of Environmental Quality
Brownfields Redevelopment Section*

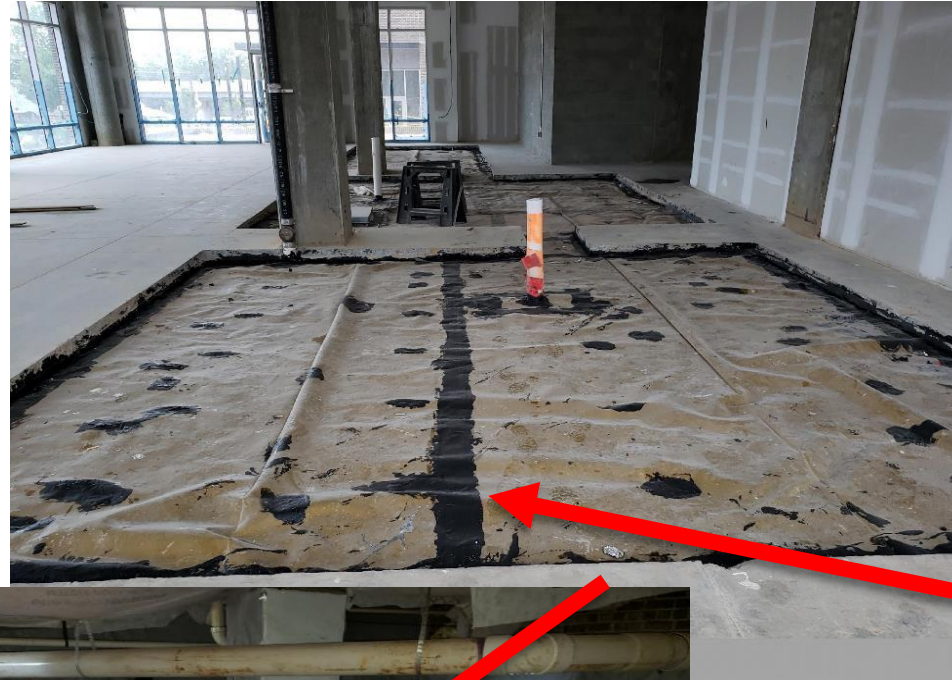
- Incomplete vapor collection systems
- Improper building materials in VIMS
 - Roofing tar for seal sealant
 - Stego barrier/tape
- Install variances not reported, found during review or inspections

✘ Roofing Mastic
