# BADIN BUSINESS PARK

# Solid Waste Management Units

# Interim Measures

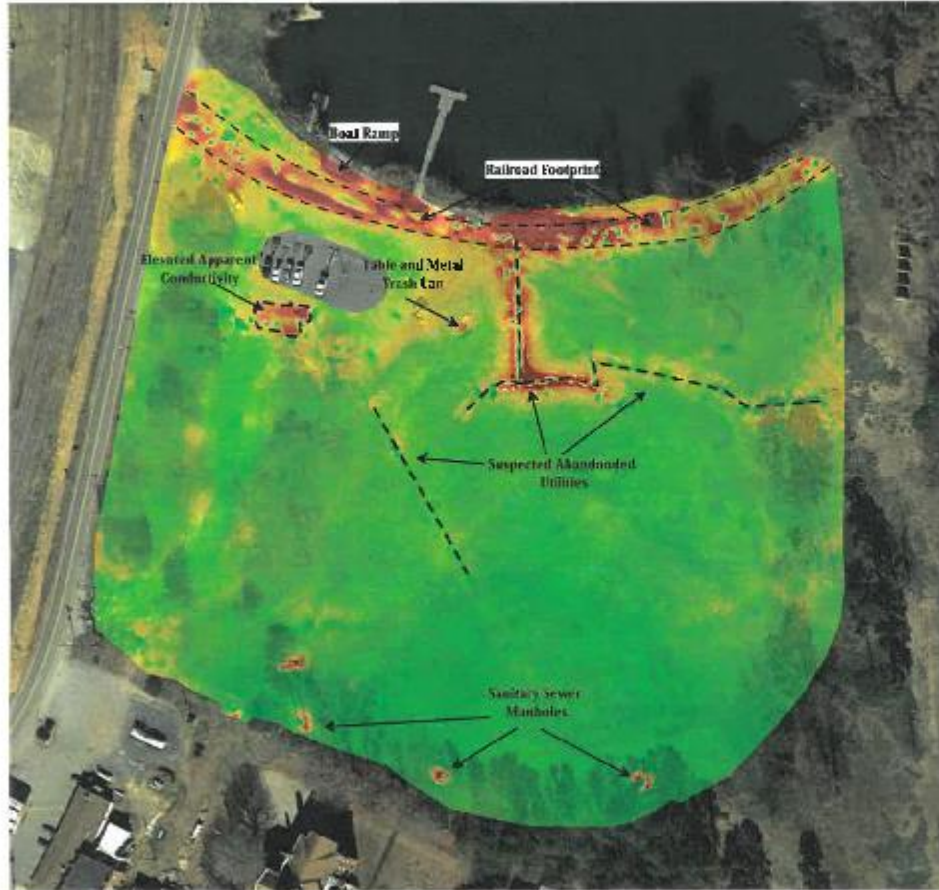
**Figure 5.**

Geophysical investigation included electromagnetic and ground penetrating radar surveys of the Former Ball Field and boat launch gravel parking lot. Neither survey indicted the presence of a disposal trench.

Apparent Conductivity  
Data  
32180 Hz

**MULTIFREQUENCY EM  
GEOPHYSICAL SURVEY  
Alcoa Ball Field, Badin NC**

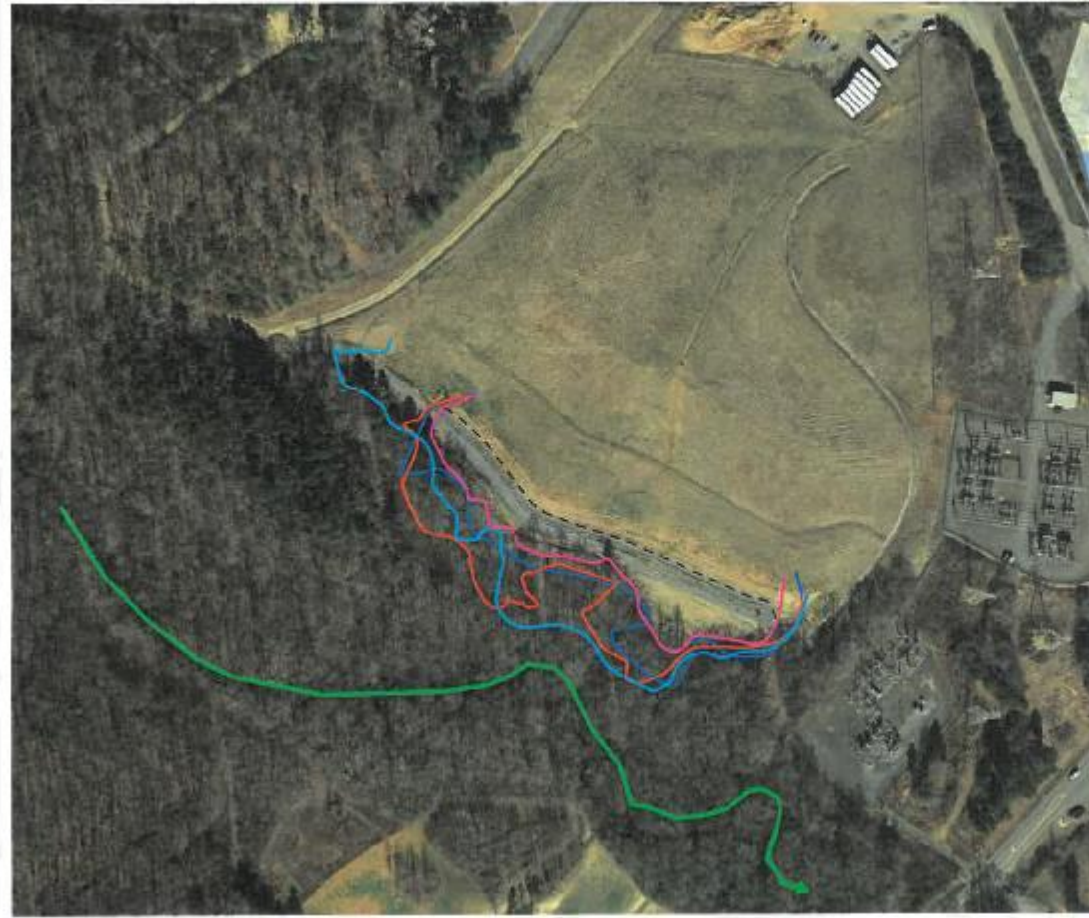
**FIGURE 8**

Delimitation of the  
50 mS/m Contour

- Quarter 1, April
- Quarter 2, July
- Quarter 3, October
- Quarter 4, January
- - - - - Collection Trench
- Approximate location  
of Little Mountain Creek

**MULTIFREQUENCY EM  
GEOPHYSICAL SURVEY  
Comparison of the Four Quarters  
Alcoa Badin Landfill, Badin NC**
