SITE SUMMARY REPORT
Southside Park Landfill
NONCD 0000807
Mecklenburg County

Senate Bill 1492
State of North Carolina
State Contract N06009S
Schnabel Project No. 06210002.30

July 21, 2010

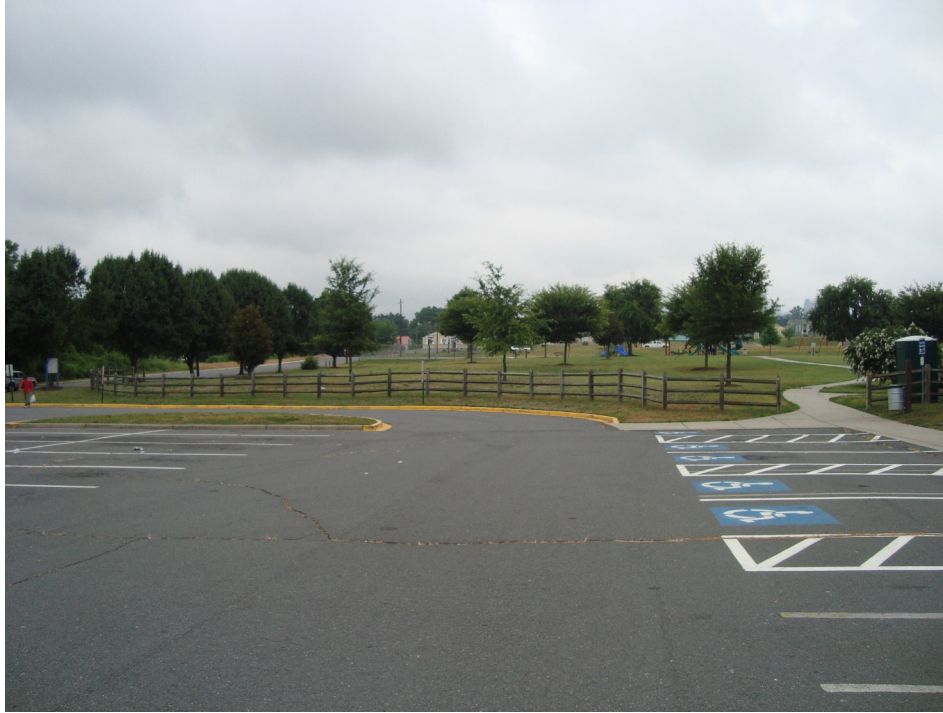
<p>PHOTOGRAPH No.: 1</p> <p>Photo Taken: 06-30-10</p>
<p>LOCATION:</p> <p>Site and Disposal Area entrance off of Toomey Road.</p>
<p>COMMENTS:</p> <p>Photo taken facing toward the north. Parking lot located on the northwestern portion of the Disposal Area.</p>

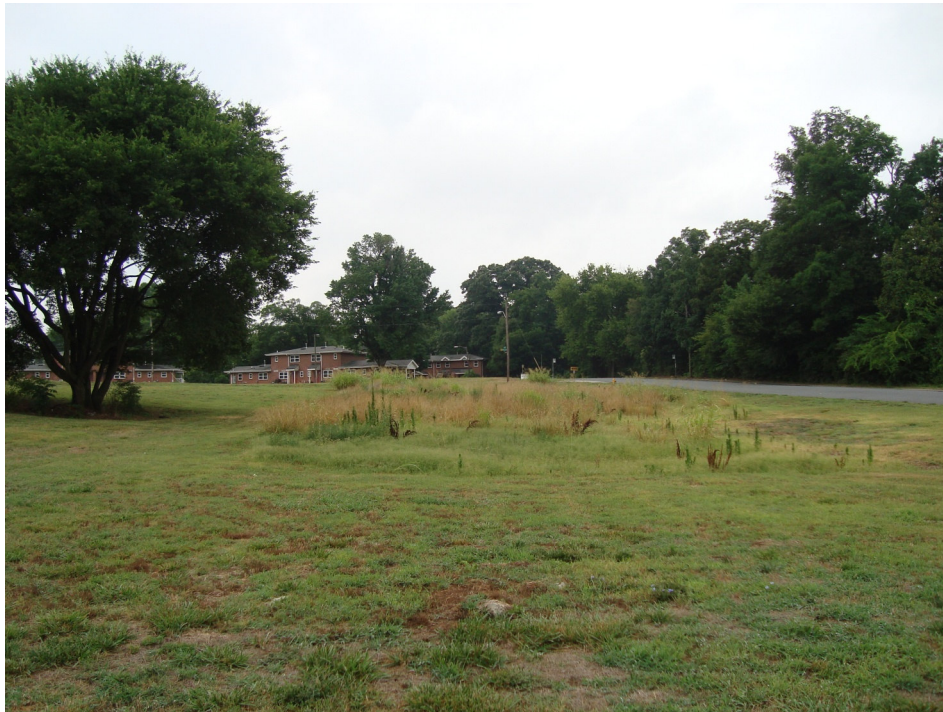
<p>PHOTOGRAPH No.: 2</p> <p>Photo Taken: 06-30-10</p>
<p>LOCATION:</p> <p>Western part of Disposal Area.</p>
<p>COMMENTS:</p> <p>Photo taken facing toward the west. Drainage and tall grasses.</p>

Two drainages were observed on the Disposal Area. The western drainage was surrounded by tall grasses and recent dumping was observed near and within the tall grass at the time of the site visit. The eastern drainage is located along a walking path to the north of the soccer fields. Recent dumping was not observed within this drainage at the time of the site visit. Both drainages were dry at the time of the site visit.

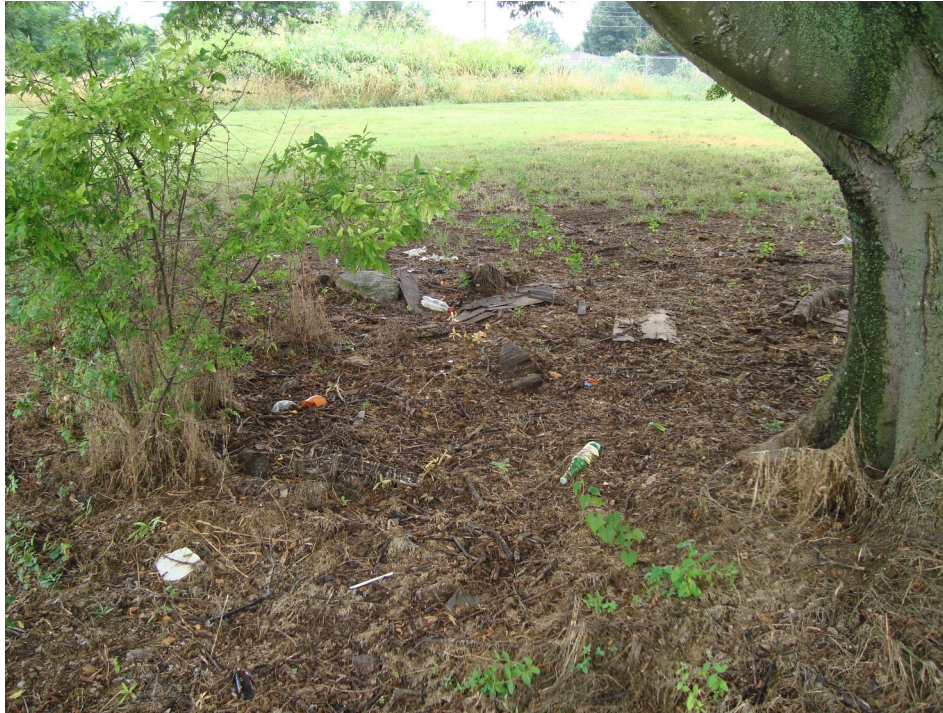
PHOTOGRAPH No.: 3
Photo Taken: 06-30-10
LOCATION:
Western portion of Disposal Area.
COMMENTS:
Recent disposal of trash.

During the site visit evidence of recent dumping of miscellaneous trash (cans, plastic and glass bottles, and clothing) was observed near the unnamed perennial stream at the time of the site visit (Photos 3 and 16).

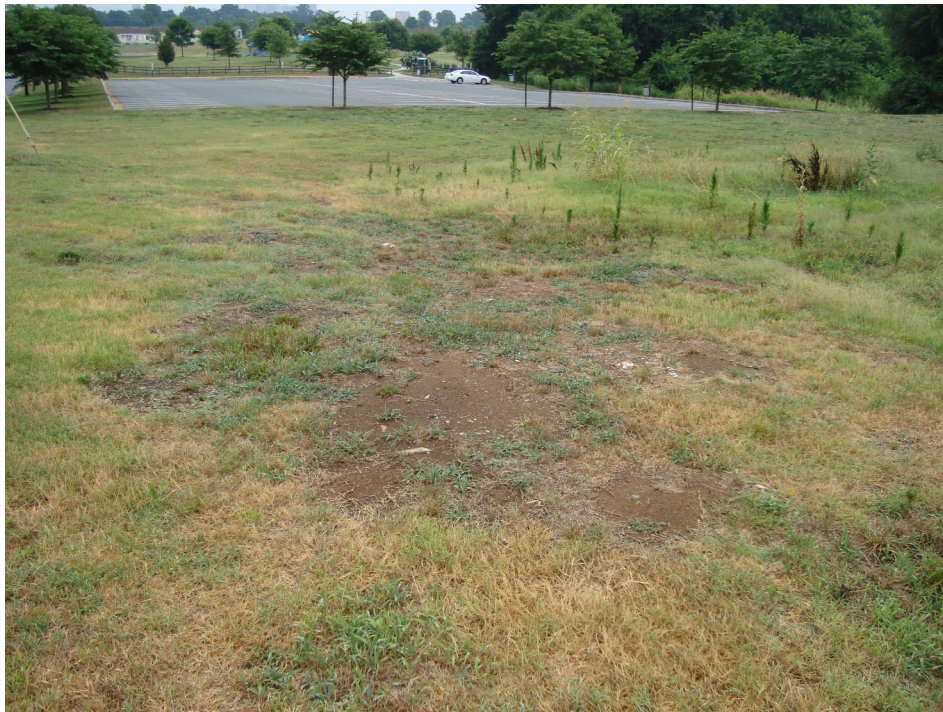
PHOTOGRAPH No.: 4
Photo Taken: 06-30-10
LOCATION:
Western portion of Disposal Area.
COMMENTS:
Bare ground along the northwestern perimeter of the Disposal Area.

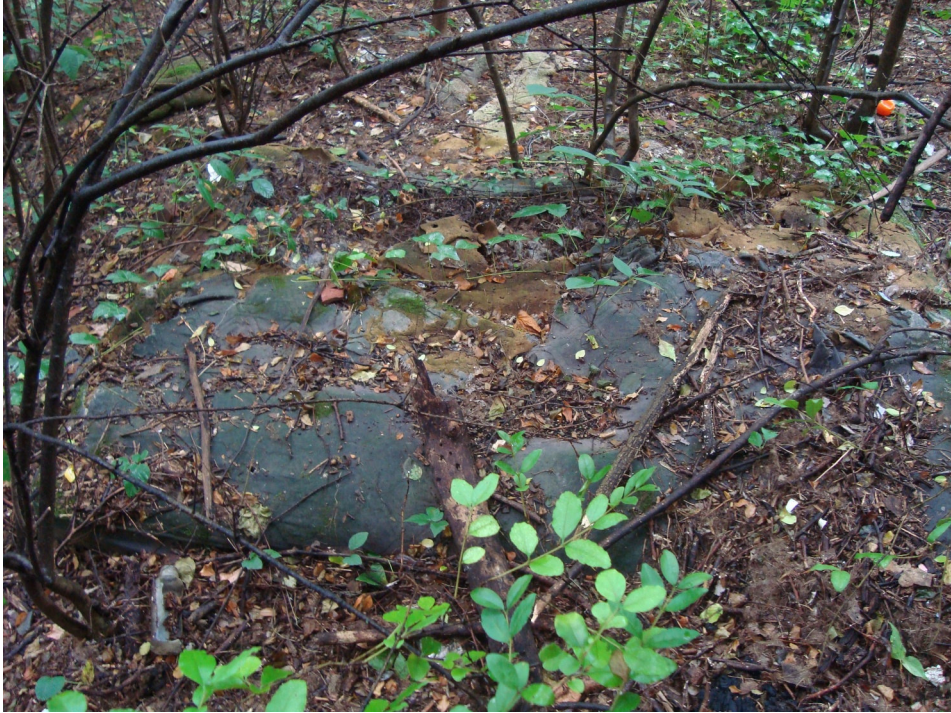
PHOTOGRAPH No.: 5 Photo Taken: 06-30-10
LOCATION: Southern part of Disposal Area.
COMMENTS: Mattress

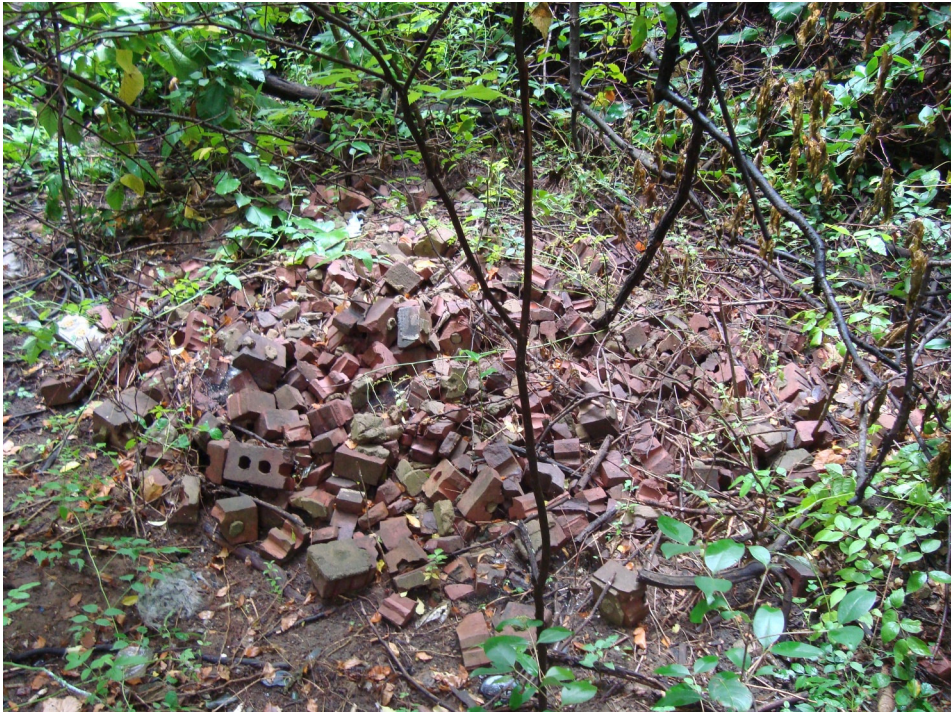
PHOTOGRAPH No.: 6 Photo Taken: 06-30-10
LOCATION: Southern part of Disposal Area.
COMMENTS: Pile of bricks.

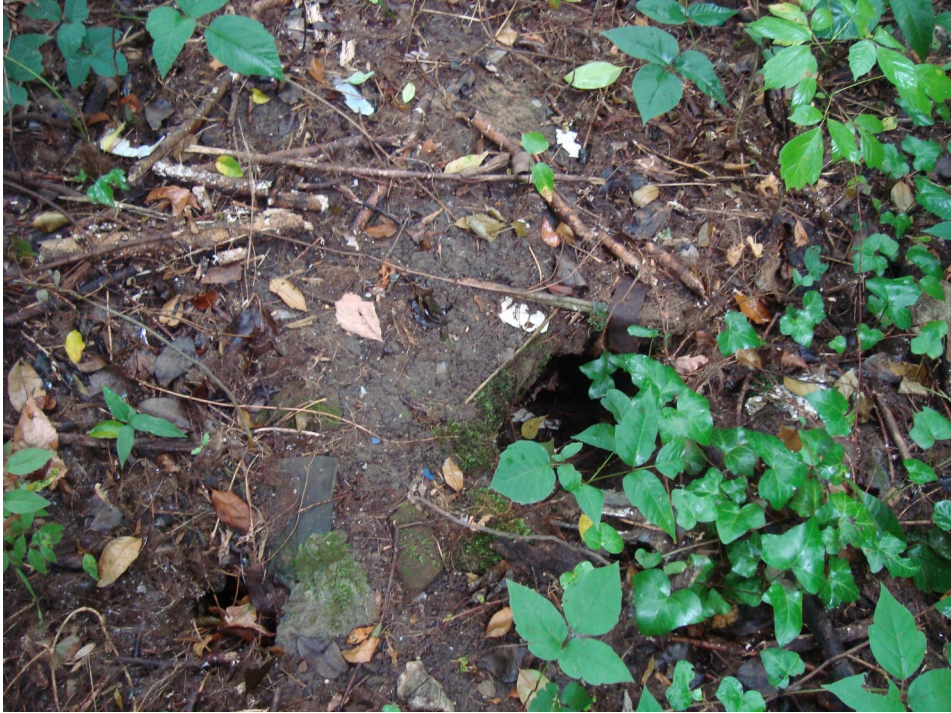
7. An undulation in the topography was observed on the concrete pathway in the eastern portion of the Disposal Area north of the soccer fields.
8. Holes were observed along the steep slope near the unnamed perennial stream on the southern part of the Disposal Area.

PHOTOGRAPH No.: 7 Photo Taken: 06-30-10
LOCATION: Southern part of Disposal Area.
COMMENTS: Hole approximately 1 foot wide on hill slope to the southwest of the unnamed perennial stream.

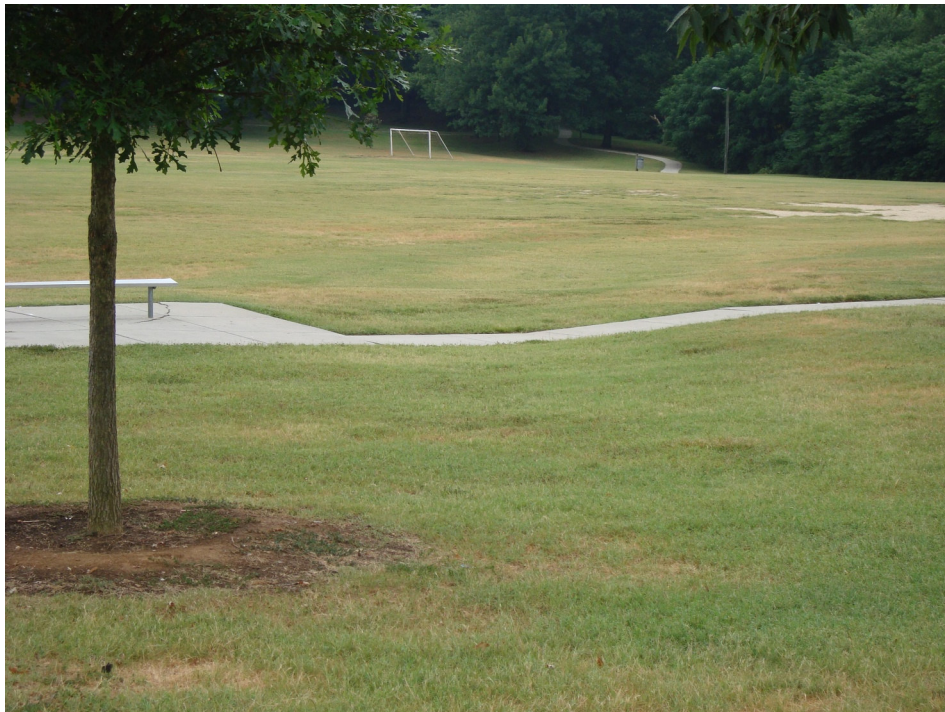
An undulation in the topography was observed on the concrete pathway in the eastern portion of the Disposal Area north of the soccer fields at the time of the site visit (Photo 10). Holes were observed along the steep slope near the unnamed perennial stream on the southern part of the Disposal Area (Photo 7). A slope failure was observed on the northwestern part of the Disposal Area above the culvert (Photo 17). No notable erosion, depressions, hummocky topography, offensive odors, or stained or discolored soils were observed during the site visit.

PHOTOGRAPH No.: 10
Photo Taken: 06-30-10
LOCATION:
Eastern portion of Disposal Area.
COMMENTS:
Photo taken facing toward the south. Undulation in topography visible in the soccer field and along concrete walkway.

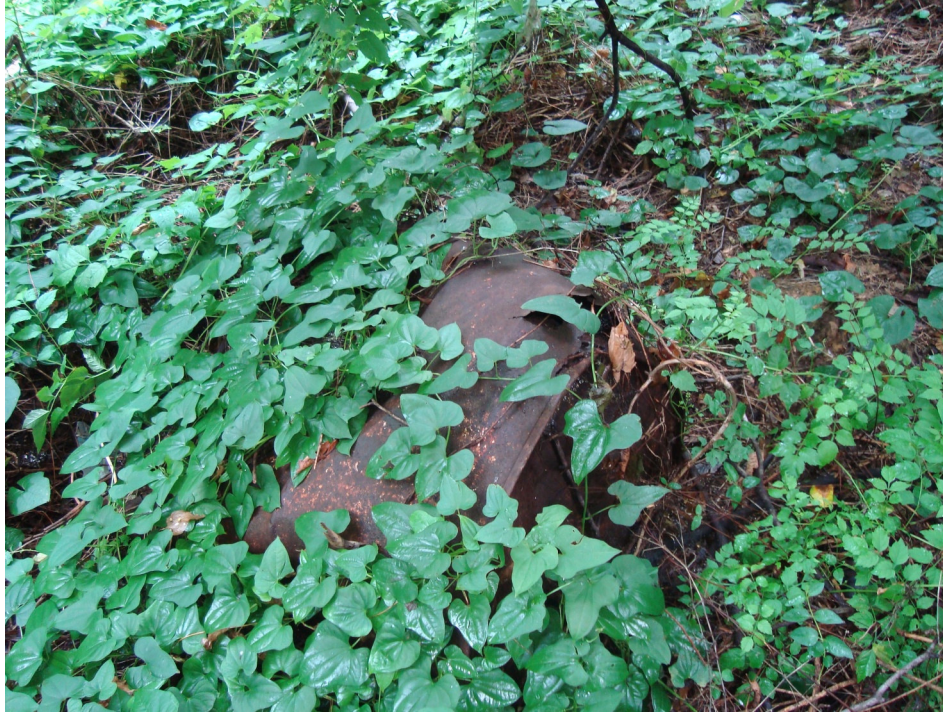
PHOTOGRAPH No.: 11 Photo Taken: 06-30-10
LOCATION: Southern part of Disposal Area.
COMMENTS: Rusted container.

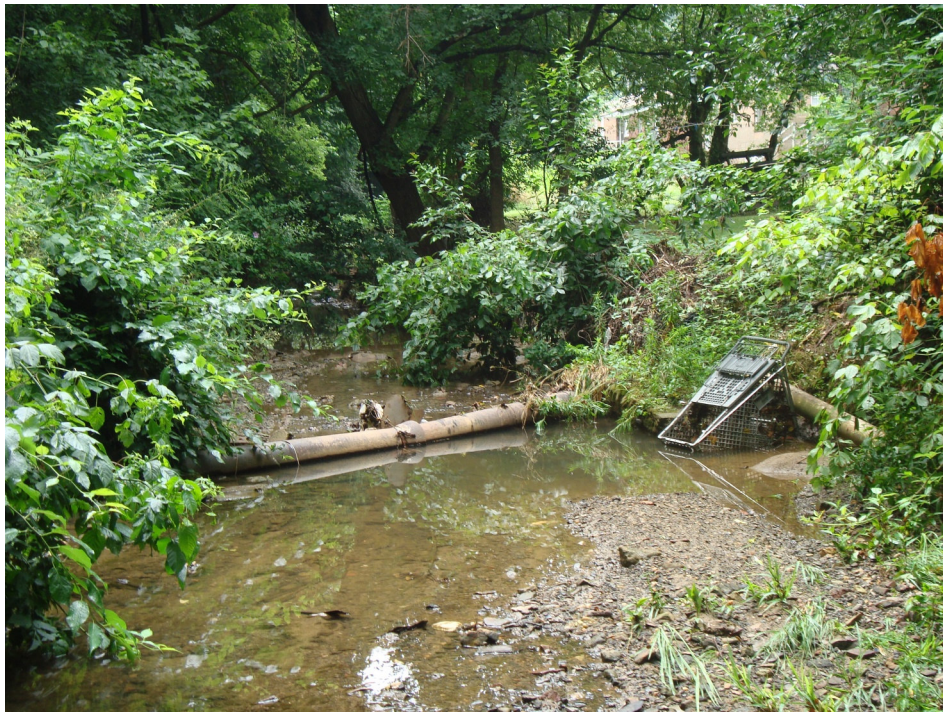
PHOTOGRAPH No.: 12 Photo Taken: 06-30-10
LOCATION: Southern part of Disposal Area.
COMMENTS: Bed of unnamed perennial stream approximately 10 feet wide, sandy with gravel and exposed disposal material consisting of bricks and plastic materials. Sewer pipe crossing unnamed perennial stream.

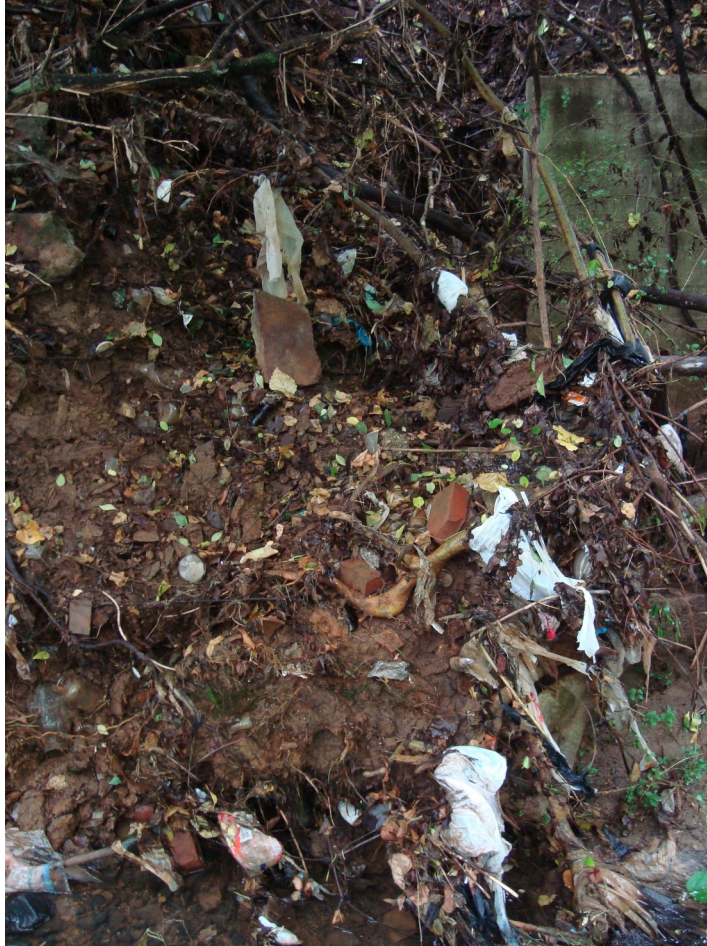
PHOTOGRAPH No.: 13
Photo Taken: 06-30-10

The Disposal Area was covered with grass, a parking lot, patches of bare ground, tall grasses, deciduous trees approximately three to ten inches in diameter, and vines. The majority of the Disposal Area is covered by the Southside Park, which consists of a playground, soccer fields, and parking lot. Exposed debris was observed in and around the unnamed perennial stream near the southwestern and northwestern perimeters of the Disposal Area above the culvert and in small areas along the perennial stream. The disposal material consisted of tires, scrap metal, glass and plastic bottles, clothing, rusted container, mattress, bricks and broken concrete. A steep 5 to 10 foot high slope was observed near the unnamed perennial stream above the culvert. Disposal material was observed protruding out of this slope at the time of the site visit (Photos 13 and 14).

LOCATION:
Southern part of Disposal Area near unnamed perennial stream.

COMMENTS:
Hill slope next to culvert by the unnamed perennial stream. Vertical image of disposal material and soil. Disposal material consists of brick, plastics, and glass bottles.

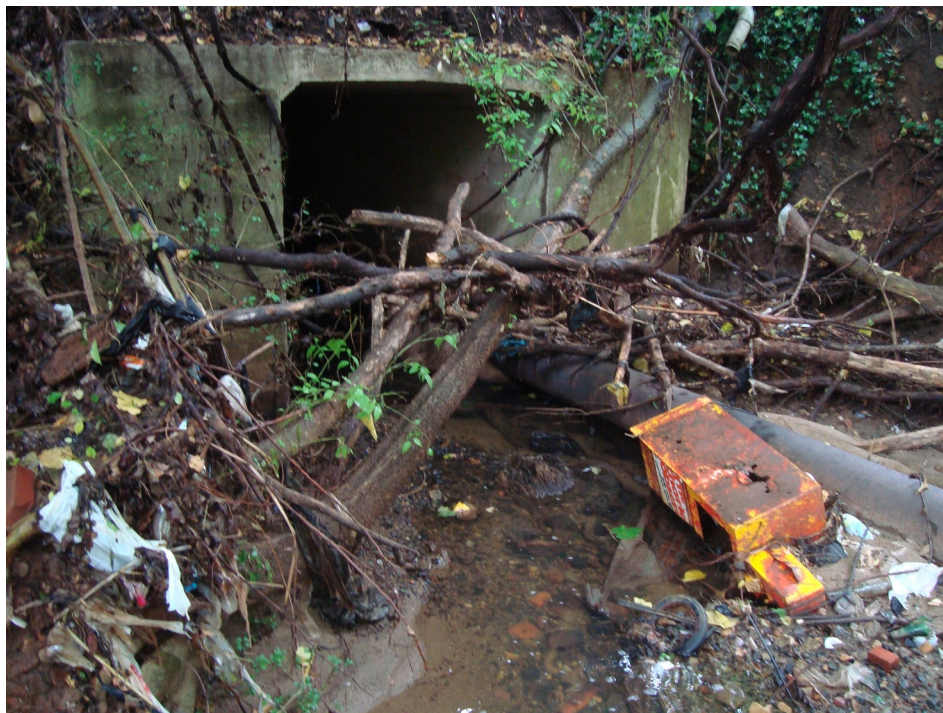
PHOTOGRAPH No.: 14
Photo Taken: 06-30-10

LOCATION:
Southern part of Disposal Area.

COMMENTS:
Culvert and unnamed perennial stream bed with disposal material and tree trunks.

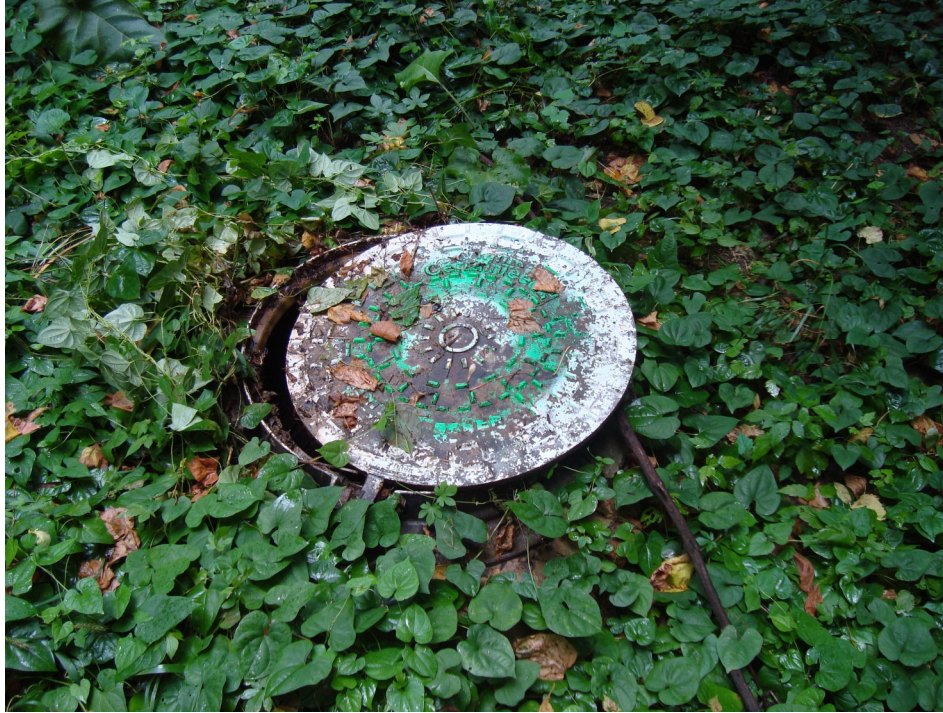
PHOTOGRAPH No.: 15
Photo Taken: 06-30-10
LOCATION:
Southern part of Disposal Area.
COMMENTS:
Sewer line manhole cover.

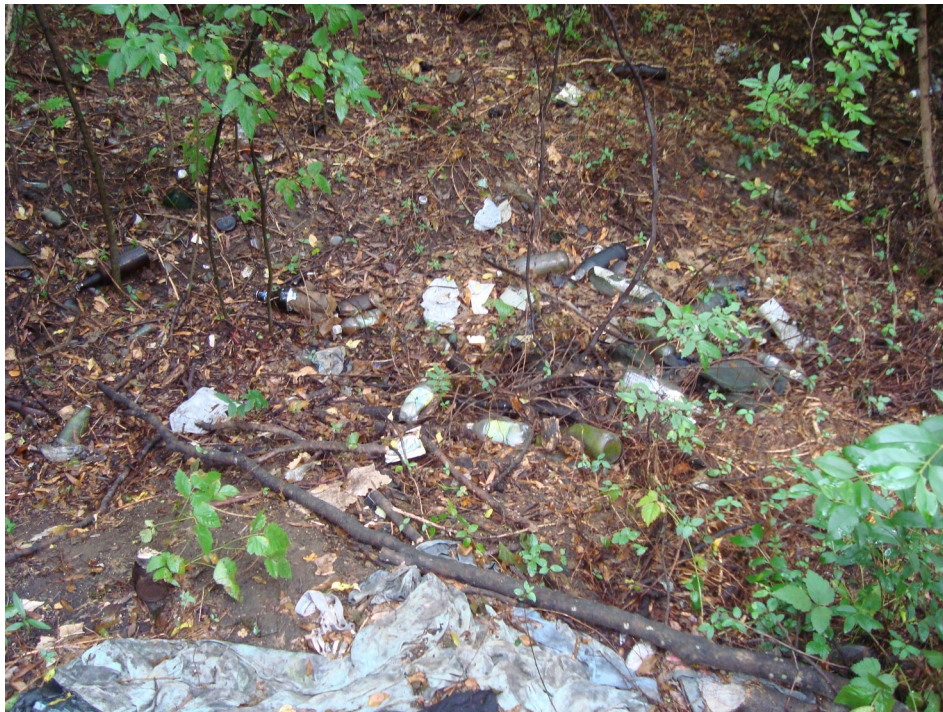
PHOTOGRAPH No.: 16
Photo Taken: 06-30-10
LOCATION:
Southern part of Disposal Area.
COMMENTS:
Recent trash disposal consisting of clothing and plastic and glass bottles.

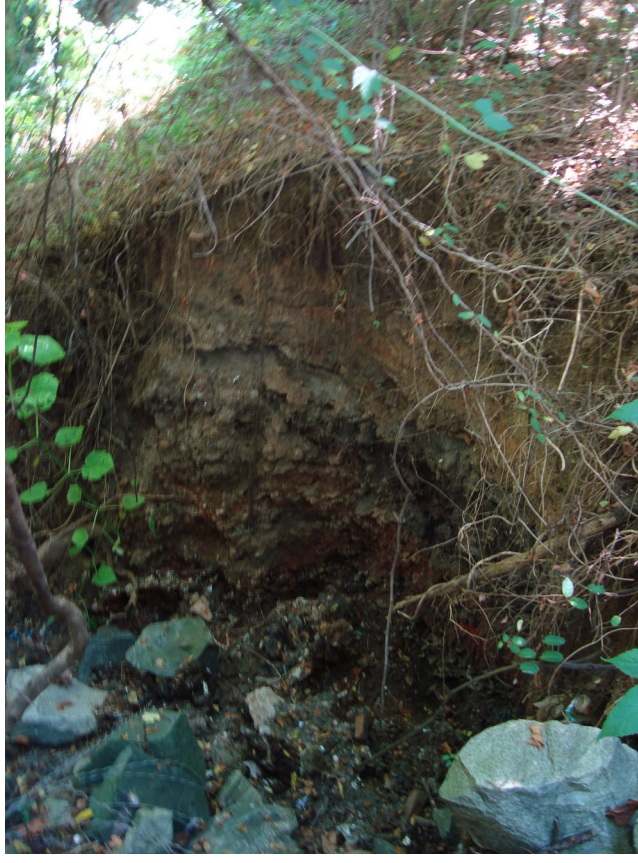
9. A slope failure was observed on the northwestern part of the Disposal Area above the culvert for the unnamed perennial stream.
10. Exposed debris observed on the Disposal Area consisted of tires, scrap metal, glass and plastic bottles, clothing, rusted container, mattress, bricks, and broken concrete. According to interviews and a Phase I Environmental Site Assessment performed by the City of Charlotte, ash from the incinerator located on Site was buried on the Disposal Area. Ash debris was not observed during the site visit.

-> Slope failure observed above culvert.

PHOTOGRAPH No.: 17
Photo Taken: 06-30-10
LOCATION:
Northwestern part of Disposal Area.
COMMENTS:
Slope failure observed above culvert.

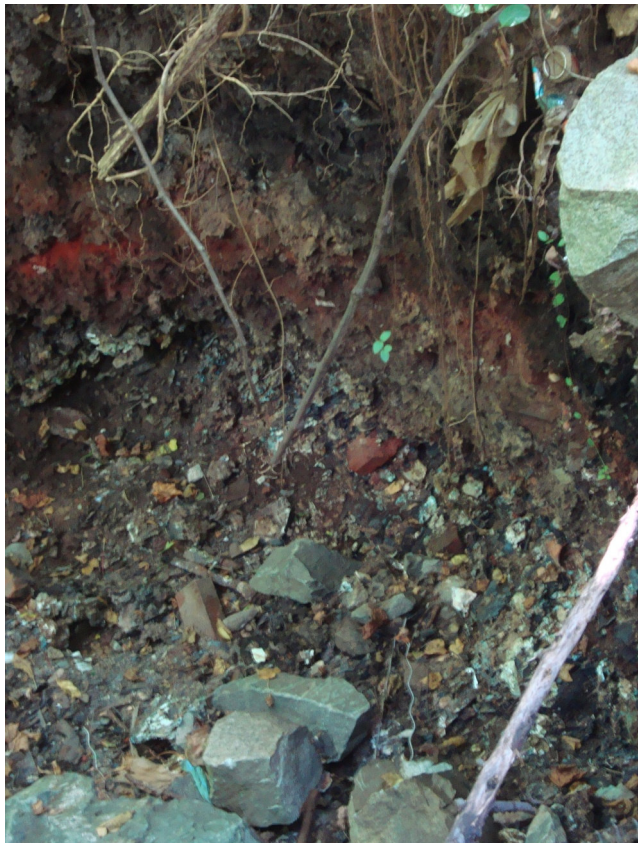
-> Culvert was filled with trash, trash observed under fill above the culvert

PHOTOGRAPH No.: 18
Photo Taken: 06-30-10
LOCATION:
Northwestern part of Disposal Area.
COMMENTS:
Disposal material observed below fill material above the culvert. Disposal material consists of brick, glass and metal fragments.
