BIOLOGICAL ASSESSMENT UNIT BASINWIDE ASSESSMENT REPORT

LUMBER RIVER BASIN

NORTH CAROLINA
DEPARTMENT OF ENVIRONMENT
AND NATURAL RESOURCES
Division of Water Quality
Environmental Sciences Section

April 2013

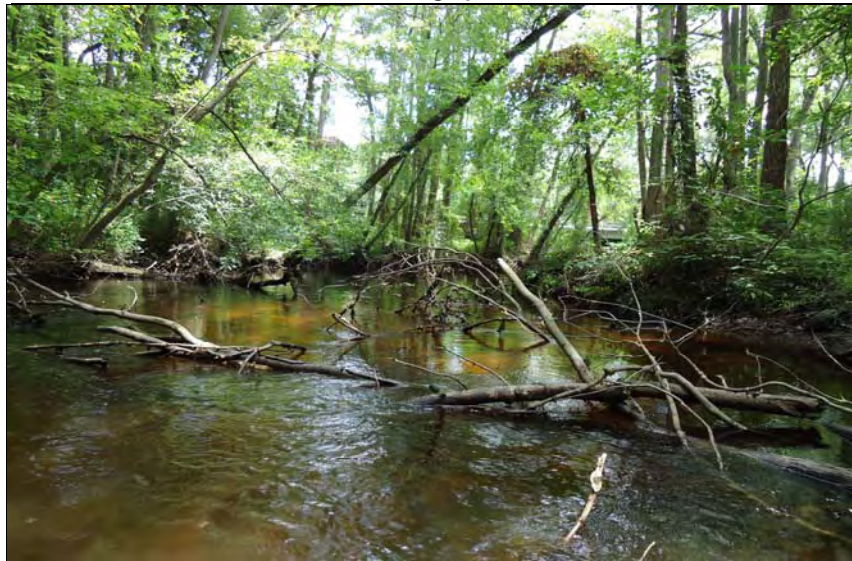
Site Photograph

Substrate mostly sand with some silt

The Gum Swamp Creek catchment drains a portion of east Scotland County and southeastern Richmond County. Land use in this watershed is primarily agriculture and forest (Sandhills State Game Lands). The basinwide sampling location for this stream was temporarily moved for the 2011 cycle upstream from SR 1323 to SR 1001 due to DOT bridge construction at SR 1323. This moved decreased the drainage area by about 5.5 square miles. In summary, water quality has remained relatively stable at Good-Fair since sampling began in 1991.

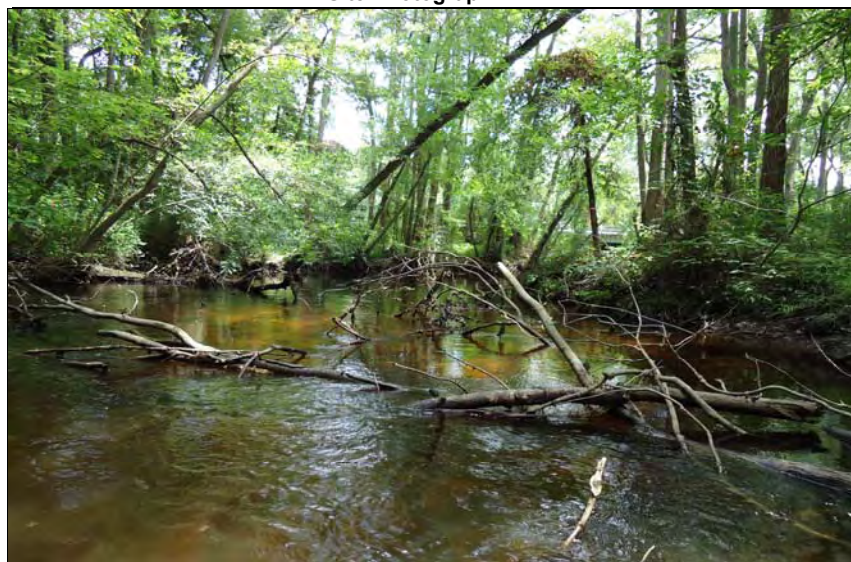
Site Photograph

Substrate sand on top of detritus with small amounts of silt

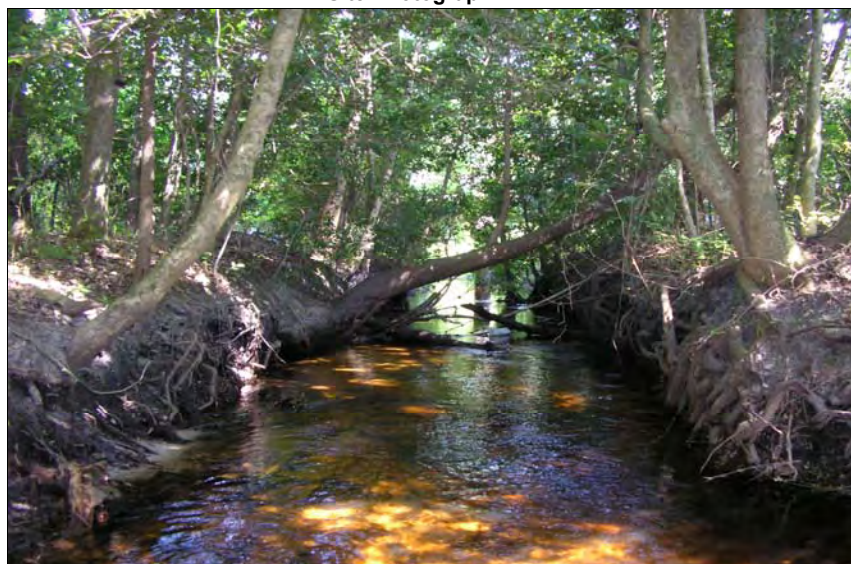
Site Photograph

Substrate mostly sand with some detritus and silt

A tributary of Shoe Heel Creek, Jordan Creek drains a portion of the Sandhills in north central Scotland County. Water quality condition and macroinvertebrate habitat have been relatively stable since sampling started in 1996 although the highest EPT richness to date was attained in 2011. This fifth consecutive Good-Fair bioclassification suggests stable conditions in this watershed.

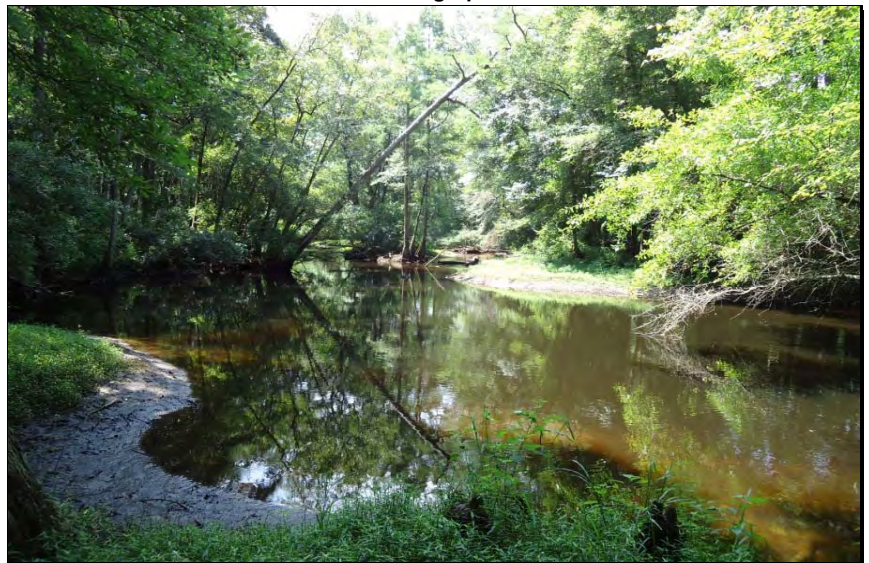
Site Photograph

Substrate sand and gravel, some silt

This is the furthest most upstream macroinvertebrate sampling site on the Lumber River. The river at this point is designated Wild and Scenic by the National Park Service and has little development in its riparian areas. While water levels were low at the time of sampling, habitat and water quality at this site is highly favorable and sustained a rich and healthy macroinvertebrate community which included the rarely collected and pollution intolerant stonefly *Perlinella*. The Lumber River at SR 1404 rates Excellent for the sixth consecutive time indicating stable conditions in this catchment.

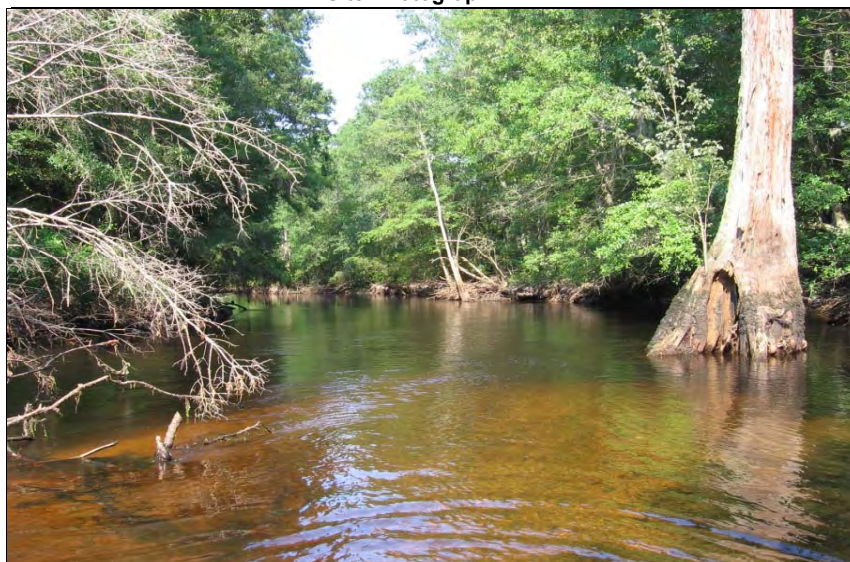
Site Photograph

Substrate	sand with detritus and silt
-----------	-----------------------------

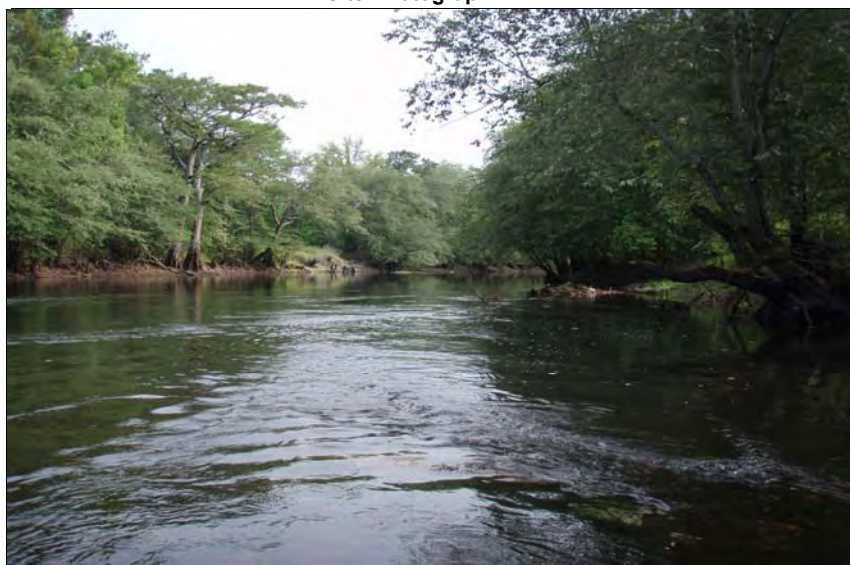
Site Photograph

Substrate: mostly sand with some cobble, gravel, and silt

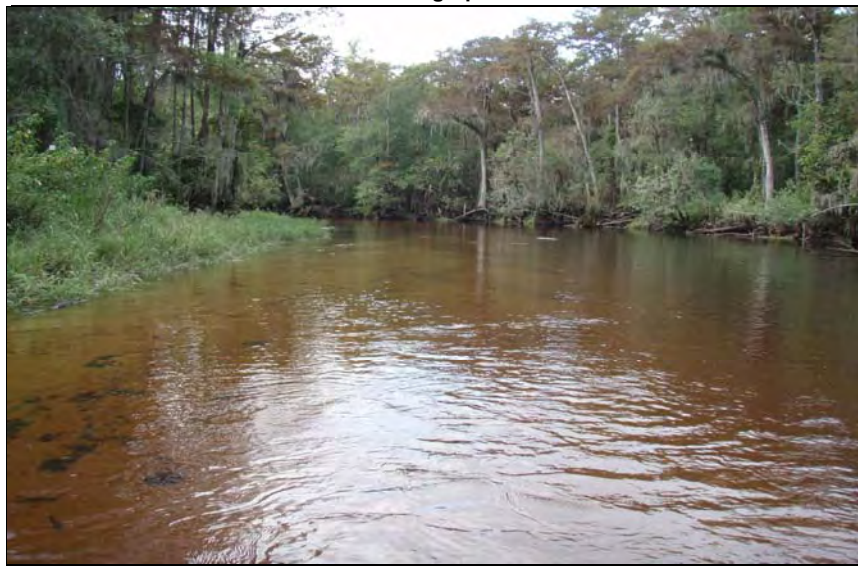
Site Photograph

Substrate sand with some detritus

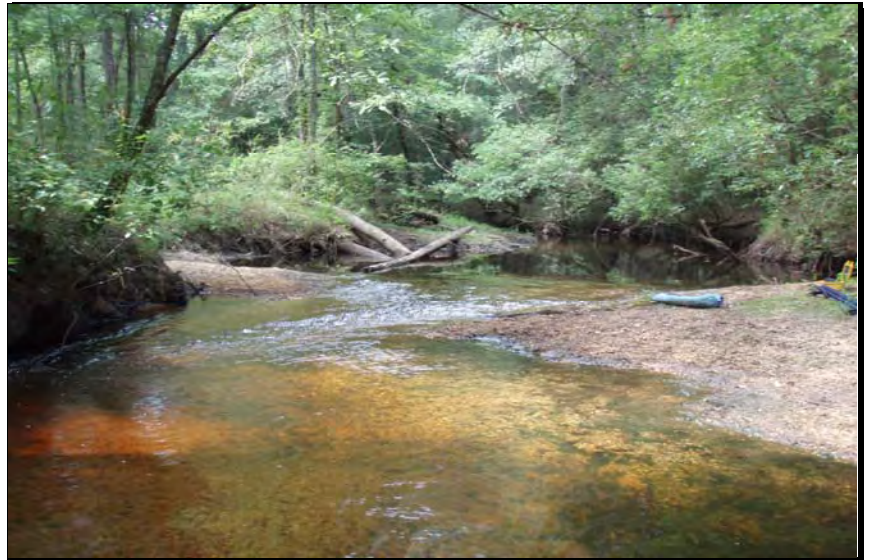
Site Photograph

Substrate mostly gravel with some sand and silt

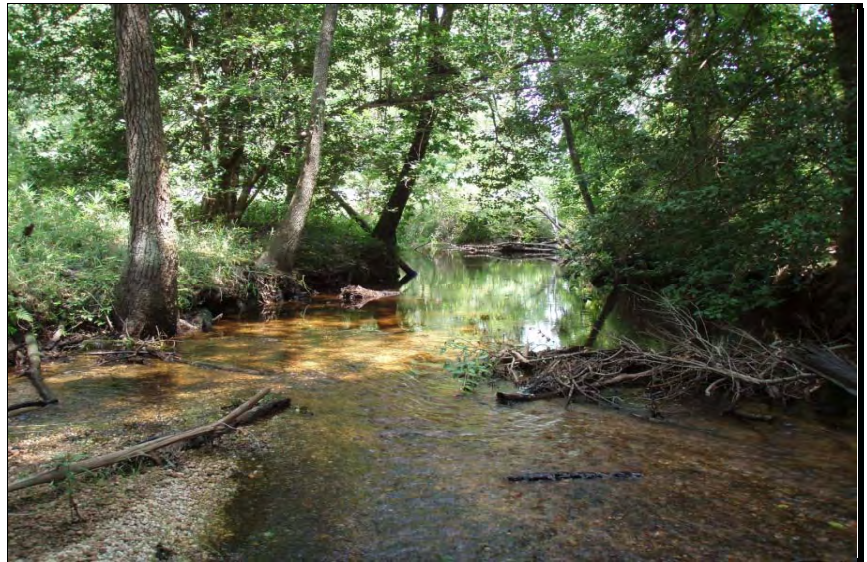
Site Photograph

Water Clarity clear/tannic

Channel Modification (15)	15
Instream Habitat (20)	15
Bottom Substrate (15)	12
Pool Variety (10)	6
Left Bank Stability (10)	6
Right Bank Stability (10)	8
Light Penetration (10)	10
Left Riparian Score (5)	5
Right Riparian Score (5)	5
Total Habitat Score (100)	82

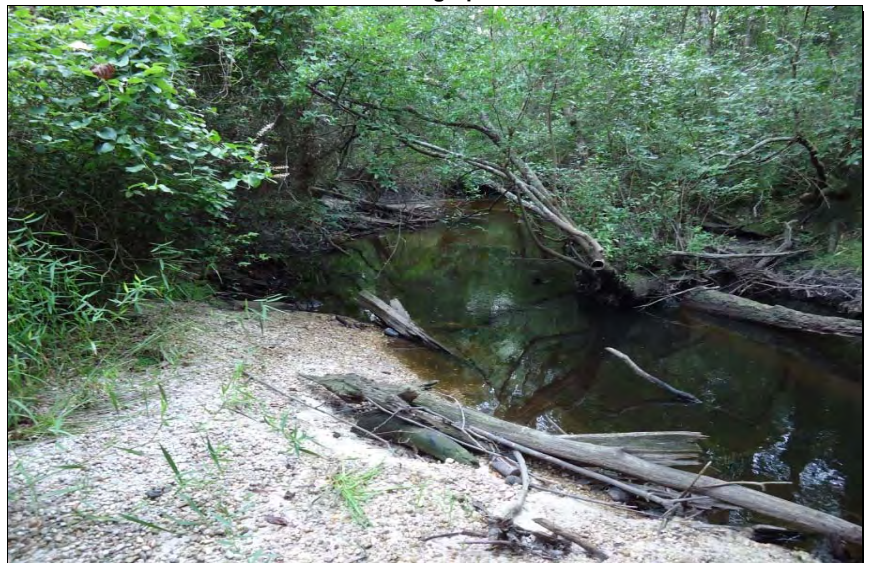
Site Photograph

Substrate sand with significant gravel, some silt

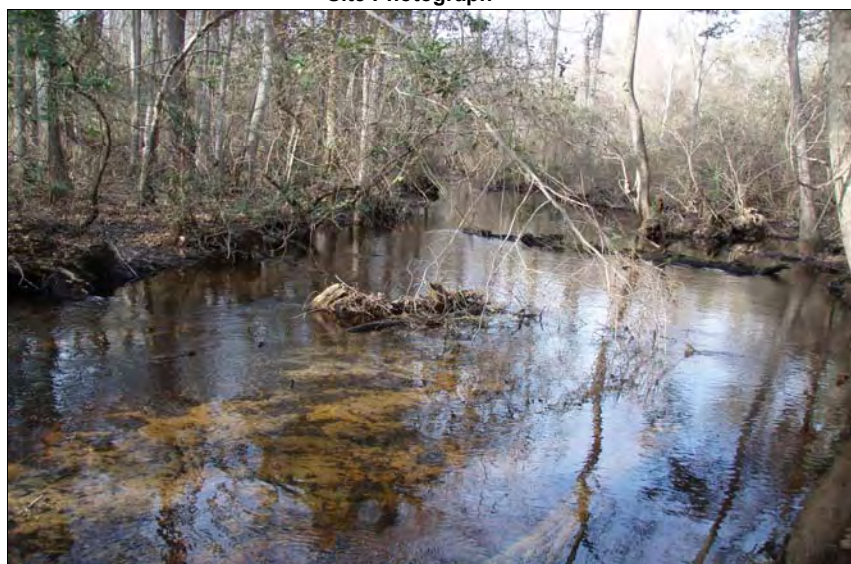
Site Photograph

Substrate sand and silt, detritus

The site is approximately 5 miles east of the town of Maxton. Land use is mostly forest although some previous logging activities have been noted. Gum Swamp is a well braided and sandy-bottomed swamp with many good flow areas. The high quality habitat is reflected in the high number of EPT taxa consistently collected for a swamp system. One endemic mayfly not previously recorded at this site, but present in 2011, was *Eurylophella oviruptis* which was described in the taxonomic literature since the last basinwide sample. The substantially lower biotic index is due primarily to the high number of Plecoptera (6) and fewer midge taxa (16) collected in 2011 compared to previous years. The fourth consecutive Natural rating indicates the benthic community is intolerant and that water quality is favorable with essentially no change since 2001.

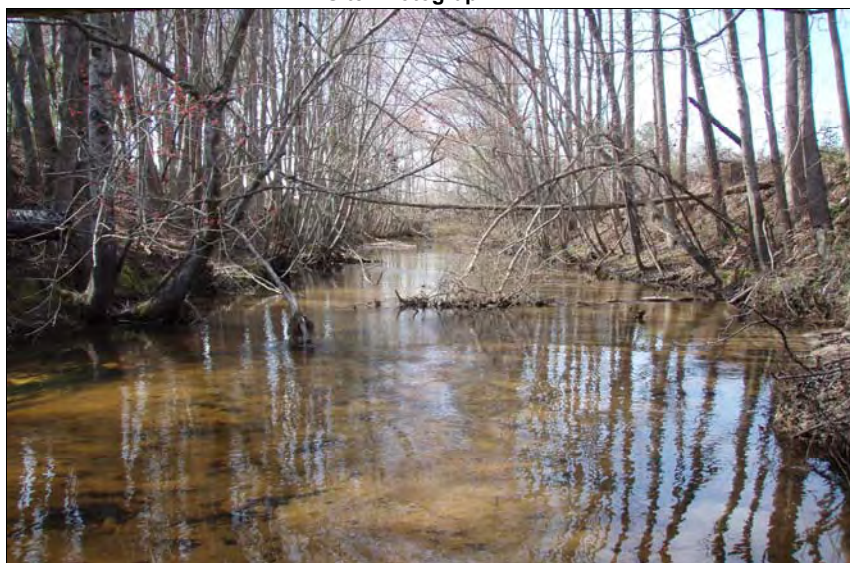
Site Photograph

Substrate	sand and silt
------------------	---------------

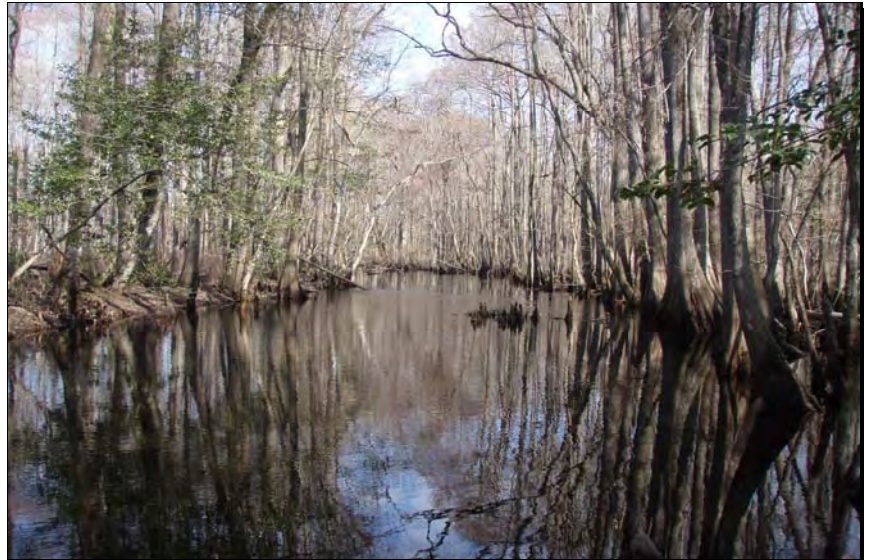
Site Photograph

Water Clarity: clear/tannic

Channel Modification (15)	15
Instream Habitat (20)	15
Bottom Substrate (15)	12
Pool Variety (10)	4
Left Bank Stability (10)	10
Right Bank Stability (10)	10
Light Penetration (10)	9
Left Riparian Score (5)	3
Right Riparian Score (5)	5
Total Habitat Score (100)	83

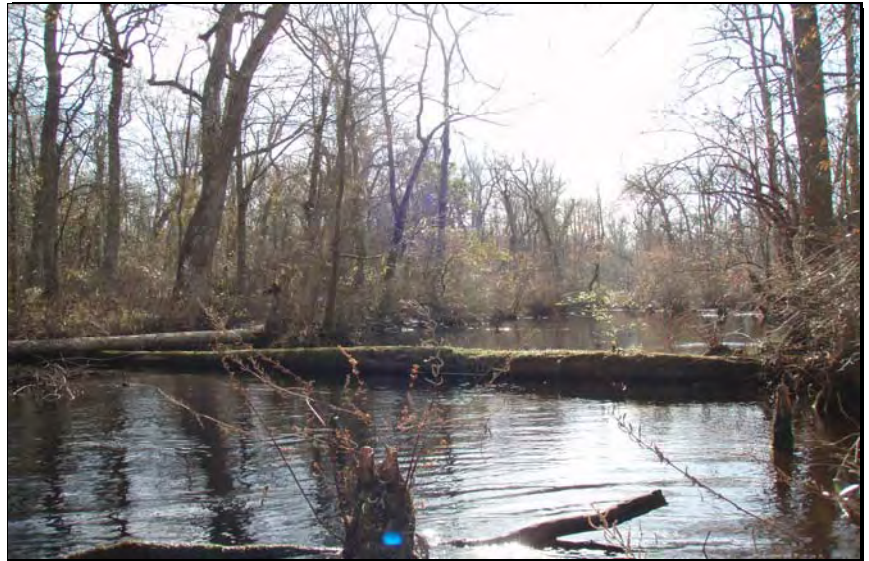
Site Photograph

Substrate detritus and silt

Big Marsh Swamp drains the area to the west and northwest of Robeson County. There are some minor dischargers into the stream but they are distant enough to have little impact on the water quality at the site. The macroinvertebrate community collected in 2011 closely resembles that collected during the 2006 basinwide cycle, particularly in EPT taxa. Overall, Big Marsh Swamp supports a healthy and stable benthic community. However, the steadily increasing BI and EPTBI (since 2001) suggests slowly worsening physico-chemical conditions at this location.

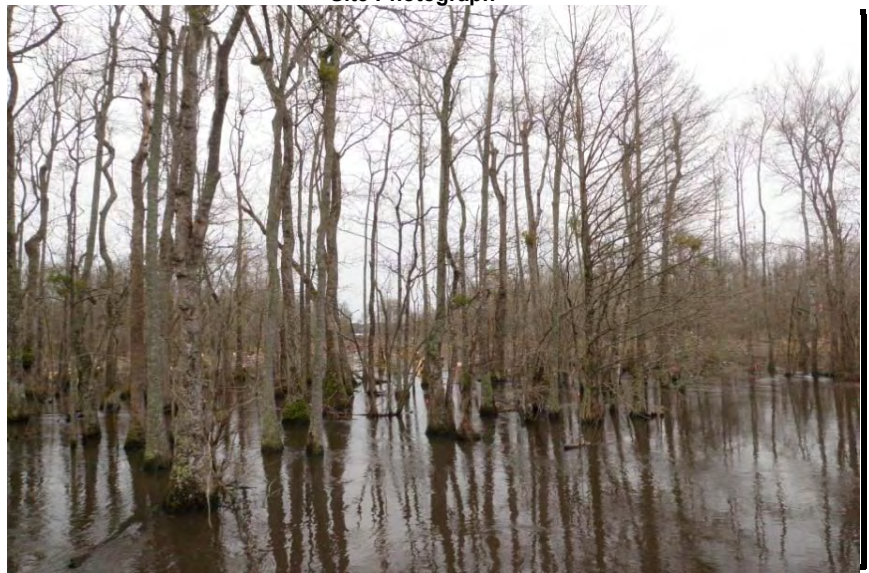
Site Photograph

Water Clarity clear/tannic

Channel Modification (5)	15
Instream Habitat (20)	16
Bottom Substrate (15)	4
Pool Variety (10)	8
Riffle Habitat (16)	0
Bank Erosion (7)	10
Bank Vegetation (7)	6
Light Penetration (10)	7
Left Riparian Score (5)	5
Right Riparian Score (5)	3
Total Habitat Score (100)	74

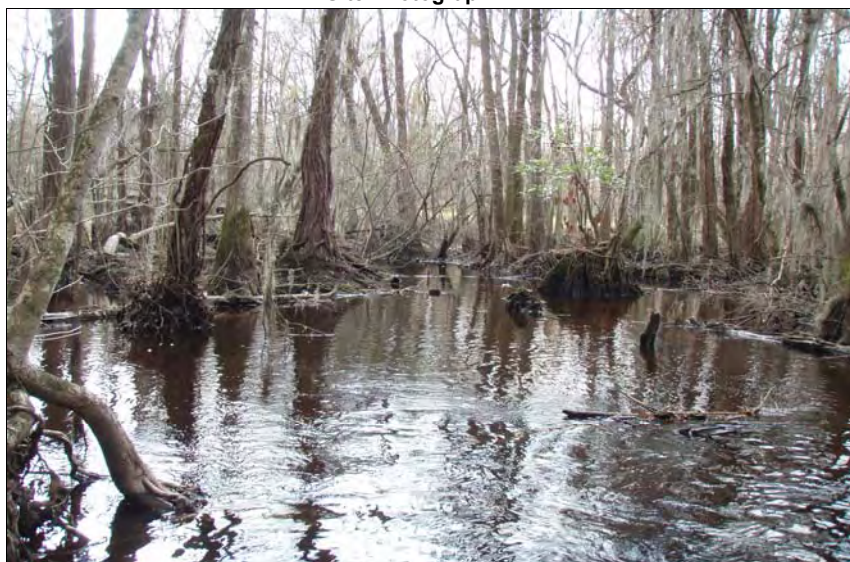
Site Photograph

Substrate sand, silt and detritus

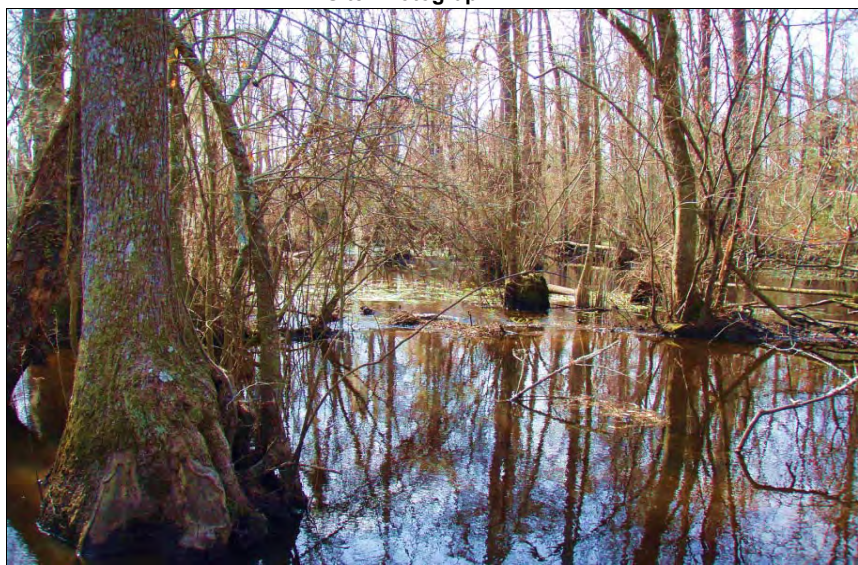
Site Photograph

Substrate	detritus and silt, some areas of sand
------------------	---------------------------------------

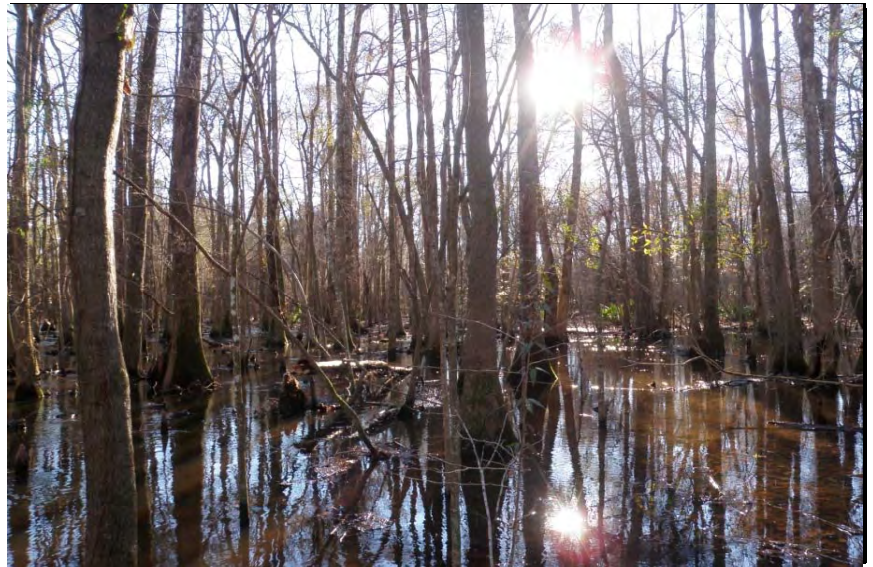
Site Photograph

Water Clarity **clear/tannic**

Channel Modification (5)	15
Instream Habitat (20)	16
Bottom Substrate (15)	7
Pool Variety (10)	5
Riffle Habitat (16)	0
Bank Erosion (7)	10
Bank Vegetation (7)	10
Light Penetration (10)	10
Left Riparian Score (5)	5
Right Riparian Score (5)	5
Total Habitat Score (100)	83

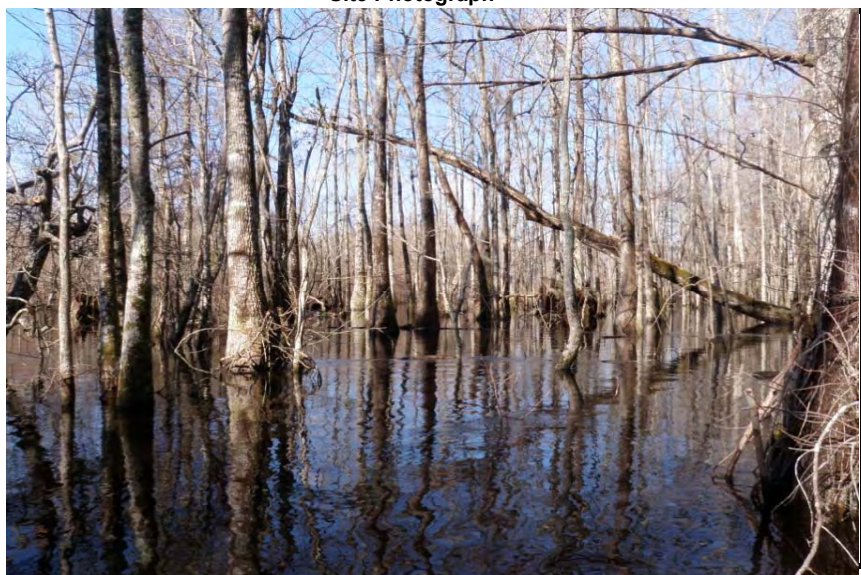
Site Photograph

Substrate Detritus and sand.

At this location, approximately 12 miles downstream of the Tabor City WWTP, Grissett Swamp is highly braided with four closely-spaced bridges of SR 1141 spanning the site. Compared to earlier collections, the 2011 benthic community had the lowest ST, EPT and highest BI since monitoring began here in 2001. Although flows appeared higher than normal during the sample, all available habitats were successfully sampled during the collection. Despite this, no representative species from the orders Ephemeroptera, Plecoptera, Odonata and Coleoptera were obtained in 2011. The absence of mayfly (Ephemeroptera) and stonefly (Plecoptera) taxa may indicate lower than average flows, and therefore increased physico-chemical in the months preceding the sample. In addition the absence of Odonata and Coleoptera taxa, which are typical of snag and root mat habitat, suggest flows may have been reduced enough that these habitats were not submerged for sometime prior to sampling. Follow up sampling in 2013 should be conducted to confirm the substantial drop in the 2011 bioclassification.

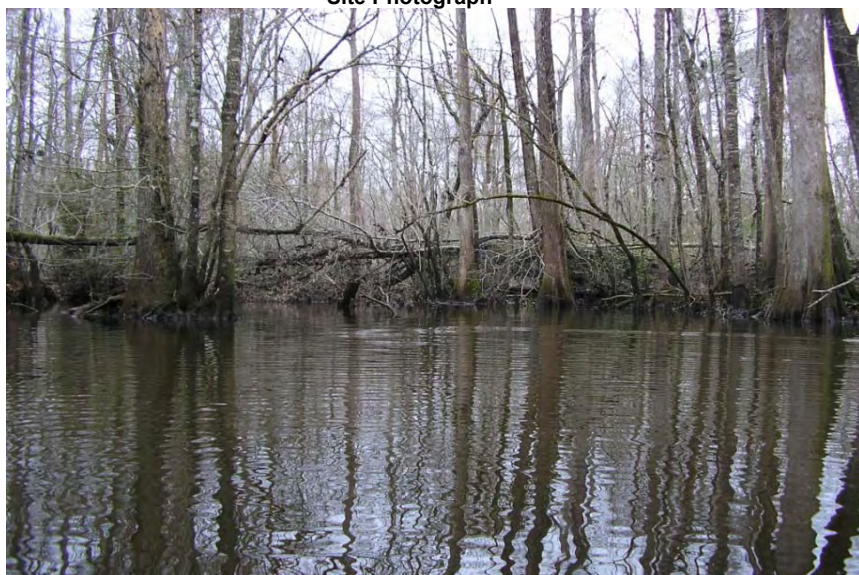
Site Photograph

Substrate: Sand and silt.
