BROAD RIVER

BASINWIDE WATER QUALITY PLAN

December 2008

Broad River Basin Plan 2008

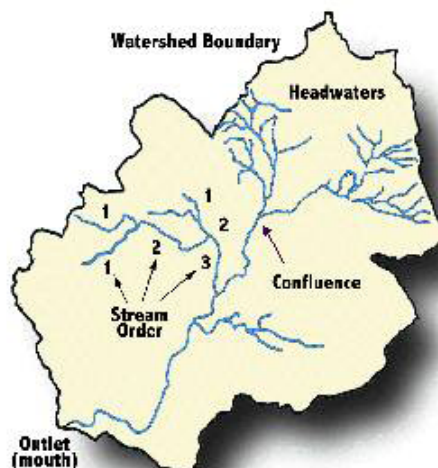
FIGURE 10-6 DIAGRAM OF HEADWATER STREAMS WITHIN A WATERSHED BOUNDARY
