# CATAWBA RIVER CHAIN OF LAKES

*Includes: Lake James, Lake Rhodhiss, Lake Hickory, Lookout Shoals Lake, Lake Norman, Mountain Island Lake & Lake Wylie*

## THE CATAWBA CHAIN OF LAKES

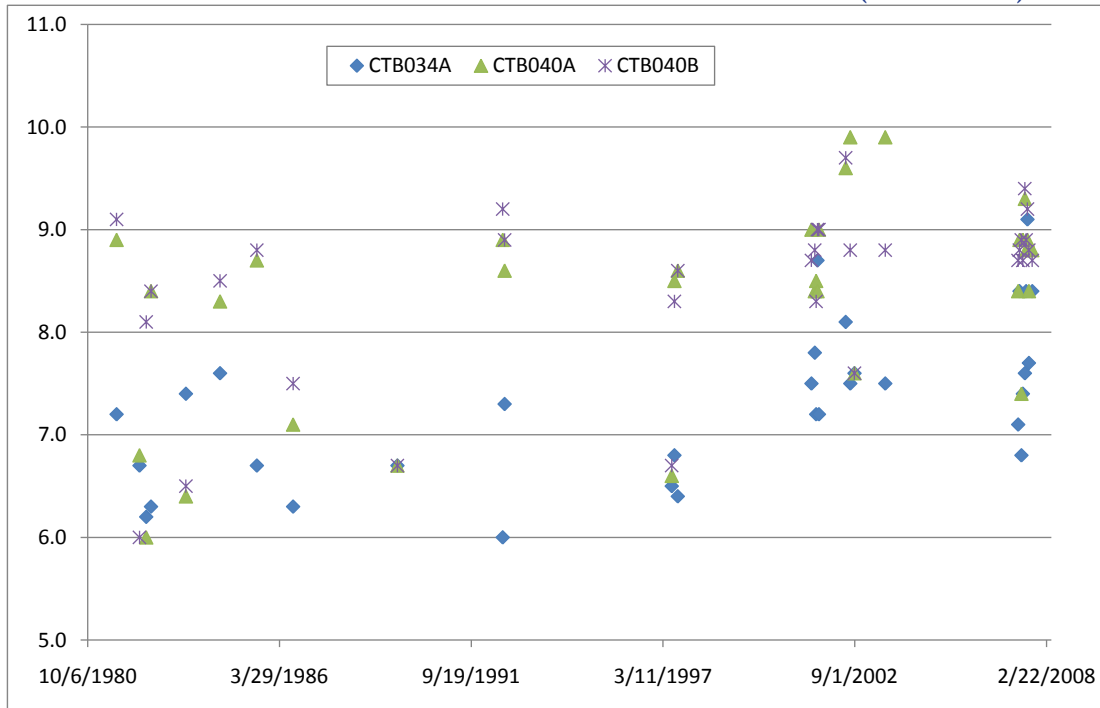
FIGURE 4-7: pH HISTORY OF THE THREE LAKE STATIONS IN LAKE RHODHISS (1982-2007)

In 2007, four out of the 27 total surface samples had pH values greater than the state standard of 9.0 su. Another ten surface samples were elevated above 8.7 su but did not exceed the state standard. This is not unlike what was observed during the 2002 sampling. Ambient stations located within the Lake Rhodhiss watershed and upstream of the lake stations, measured pH levels around 6.7 to 6.9 su; however, conditions in streams are not the same as those found in a lake due to water flow rates, water temperature, algal activity and loading rates. Figure 4-7 displays all pH samples for each of the three lake stations between 1981 and 2007. In the early 1980's, Lake Rhodhiss had a median pH of 7.0 su, which has increased over time. The median pH of samples taken in 2007 was 8.7 su.

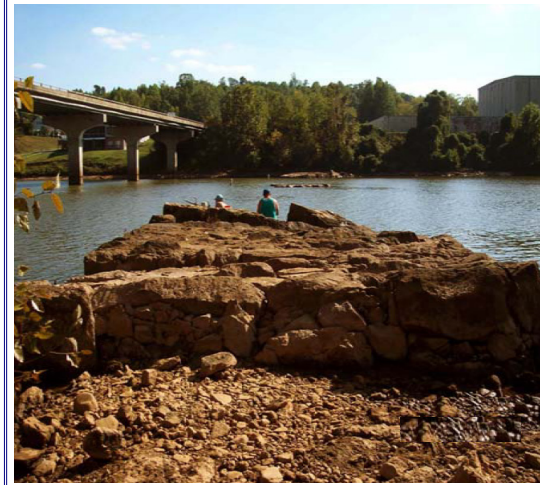
FIGURE 4-12: EXPOSED BRIDGE PILINGS

Lake Hickory was greatly impacted by the 2007 drought that caused water levels to drop to extreme lows. Figure 4-12 shows exposed structures normally several feet under water. These types of drought conditions can significantly reduce the amount and impacts of agricultural and urban nonpoint source runoff received by the lake; however, drought also increases the impacts of point sources. When there is less stream/lake volume, the percent of effluent within the receiving stream/lake is increased. Therefore, the normal effluent flow during an extended drought can have a greater impact on water quality than during normal rainfall.

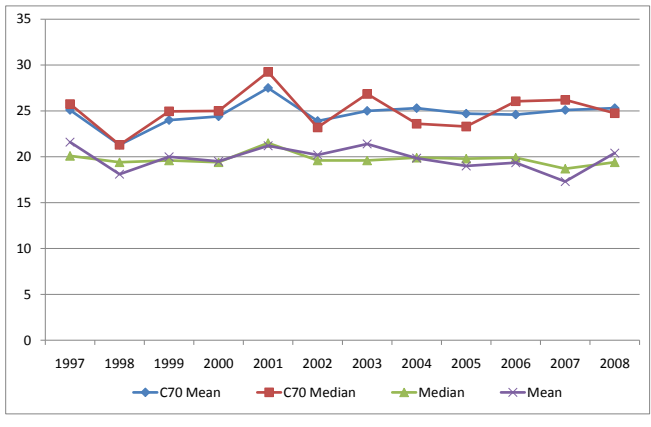
**FIGURE 4-16: SUMMARIZED TEMPERATURE (CFS) VALUES FOR AMS C7000000 AS COMPARED TO THE AVERAGE OF THE OTHER AMS SITES IN THIS HUC**

Out of the nine surface temperature samples taken at the lake station during 2007, six exceeded the state temperature standard. The high temperatures were also recorded at the AMS station C7000000 in 27% of samples. These co-located monitoring sites are about two and a half miles downstream of the Duke Energy’s Allen Steam Station discharge channel. Figure 4-16 shows the temperature mean and median of the AMS station C7000000 (blue and red lines, respectively) and the mean and median of five other AMS sites that are located on Lake Wylie (purple and green lines, respectively). As seen on the graph, the AMS stations average water temperature is roughly 5 °C higher than the other Wylie AMS station averages. Duke Energy conducted a water quality assessment study to evaluate whether the discharge is having a negative effect on aquatic life, which is required by the state every five years. DWQ reviewed the results of the study and confirmed that the facilities thermal discharge, even though periodically

above the state standard, is not negatively impacting aquatic life. Therefore, this segment will not be Impaired for high temperature.

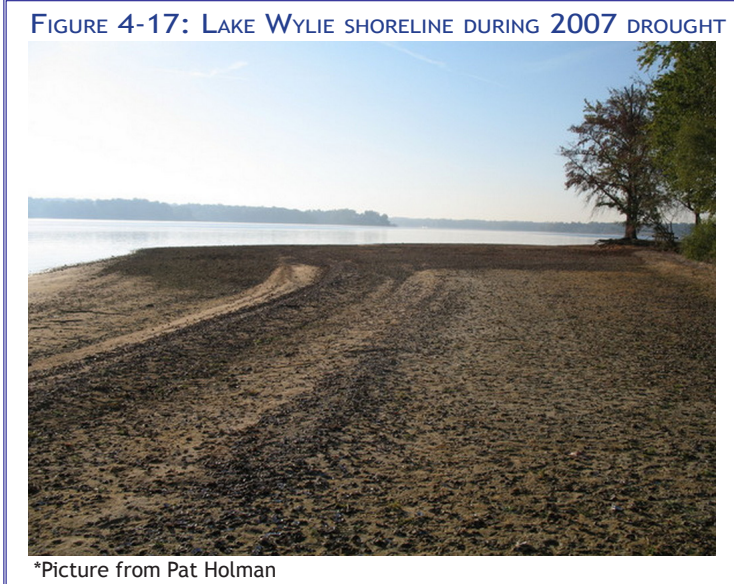
Lake Wylie was effected by the 2007 drought as were all of the lakes in the Catawba chain. The lake hit a record low level of 92.9 feet in October, which beat the 2002 record of 93.8 feet (Figure 4-17). Prolonged drought conditions can significantly reduce impacts of agricultural and urban nonpoint source runoff received by the lakes; however, drought increases the impacts of point sources. When there is less stream/lake volume, the concentration of effluent within the receiving waterbody is increased. Therefore, the normal effluent flow during an extended drought can have a greater impact on water quality than during normal rainfall.
