NORTH FORK NEW RIVER WATERSHED

HUC 0505000101

Includes: Three Top Creek, Big Laurel Creek, Buffalo & Little Buffalo Creeks, Little & Big Horse Creeks & Helton Creek

GENERAL WATERSHED DESCRIPTION

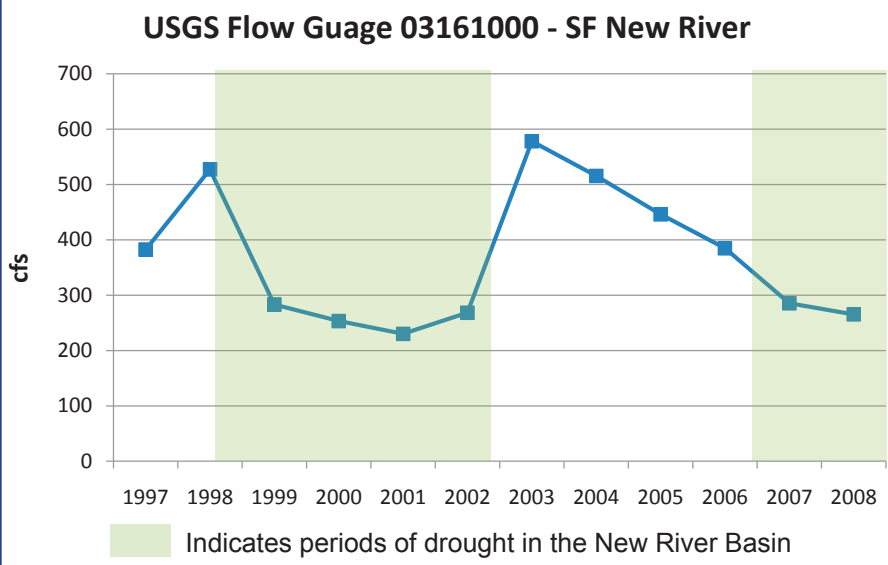
FIGURE 1-4: YEARLY AVERAGE FLOW RATES (CFS) OF THE USGS GAGE STATION IN THE NEW RIVER BASIN BETWEEN 1997 & 2008

The basin experienced prolonged droughts in 1998-2002 and 2007-2008 and exceptionally high flows resulting from the remnants of several hurricanes (Figure 1-4). During a three-week period in September 2004, the tropical storm remnants of Hurricanes Frances, Ivan, and Jeanne lead to wide-spread flooding throughout the central and northern mountains in the Catawba, French Broad, New, and Watauga River basins. Rainfall estimates for the combined three storms totaled more than 20-30 inches in certain watersheds. Runoff from the storms produced flash floods throughout the region, with peak flows in excess of 10,000 cfs (approximately 500 times median flows) in upper tributary streams; peaks flows in some tributary rivers exceeded 50,000 cfs. In the New River basin, the peak flow during Hurricane Frances (September 7th - 9th) was 14,700 cfs, which has an approximate recurrence interval of 10 to 25 years. During Hurricane Ivan (September 17th - 18th) the peak flow was 7,550 cfs, which has an approximate recurrence interval of 2 to 5 years. More detail about flows in the New River Basin can be found in the [2009 Basinwide Assessment Report: New River Basin](#) produced by DWQ-Environmental Science Section.

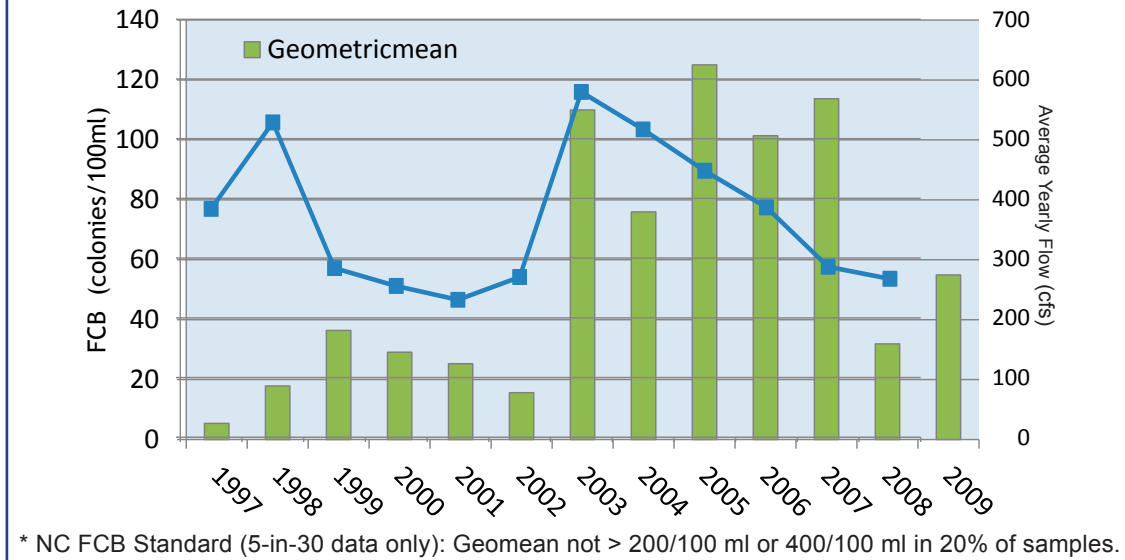
FIGURE 1-20: SUMMARIZED FECAL COLIFORM BACTERIA VALUES FOR ALL DATA COLLECTED AT AMBIENT SAMPLING STATIONS IN HUC 0505000101 WITH OVERLAYING FLOW

Figure 1-20 shows the geometric mean of FCB levels for all samples taken over the course of 13 years in the North Fork New River watershed. The geometric mean is a type of mean or average that indicates the central tendency or typical value of a data set. The highest yearly geometric mean for FCB was recorded in 2005 (125 colonies/100 ml). The figure also includes the yearly average stream flow, as seen in Figure 1-4, to show how flow can be closely linked to FCB levels. These slightly elevated FCB levels might have been caused by livestock with access to streams, failing septic systems or leaking municipal collection systems. For more specific information about AMS station K7500000 and its subwatershed see the subwatershed discussion below.

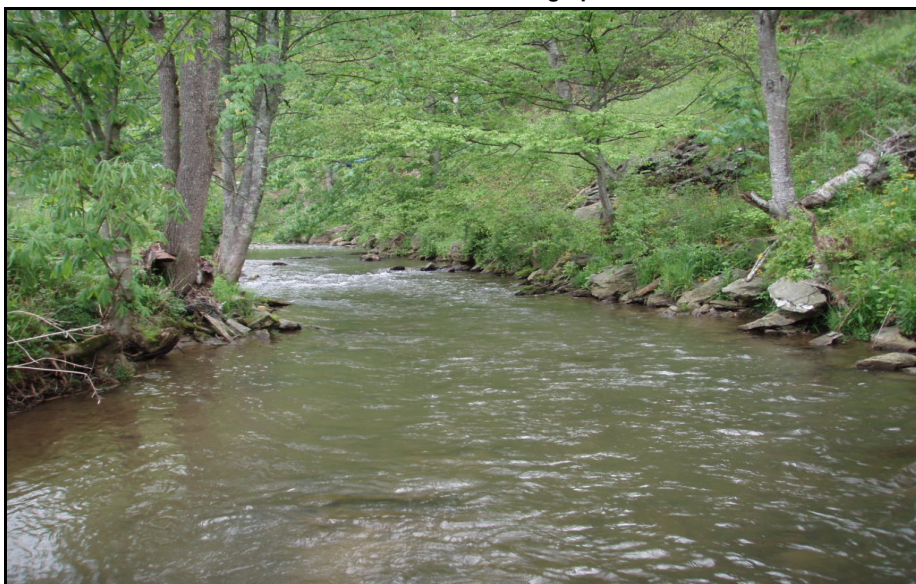
Site Photograph

Channel Modification (5)	5
Instream Habitat (20)	18
Bottom Substrate (15)	8
Pool Variety (10)	4
Riffle Habitat (16)	16
Left Bank Stability (7)	4
Right Bank Stability (7)	4
Light Penetration (10)	4
Left Riparian Score (5)	5
Right Riparian Score (5)	3
Total Habitat Score (100)	71

Substrate	cobble, gravel, sand, boulder.
-----------	--------------------------------

Sample Date	Sample ID	Species Total	NCIBI	Bioclassification
05/21/08	2008-46	15	48	Good
06/29/98	98-56	14	50	Good

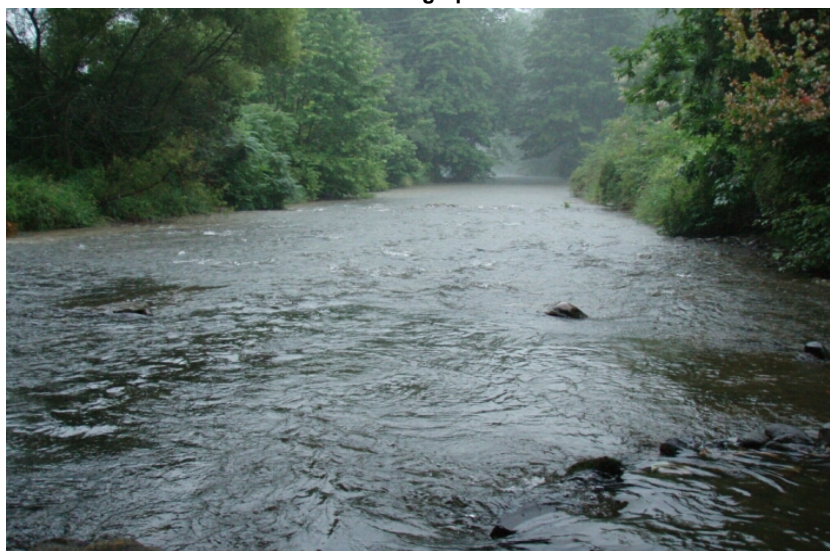
Site Photograph

Channel Modification (5)	5
Instream Habitat (20)	18
Bottom Substrate (15)	12
Pool Variety (10)	5
Riffle Habitat (16)	15
Left Bank Stability (7)	7
Right Bank Stability (7)	7
Light Penetration (10)	7
Left Riparian Score (5)	3
Right Riparian Score (5)	2
Total Habitat Score (100)	81

Substrate	mix of boulder, cobble, gravel
-----------	--------------------------------

Sample Date	Sample ID	ST	EPT	BI	EPT BI	Bioclassification
07/31/08	10517	119	57	3.67	2.73	Excellent
08/19/03	9222	81	44	3.96	3.51	Excellent
08/17/98	7710	96	52	4.05	3.23	Excellent
07/29/93	6296	102	50	3.95	3.01	Excellent

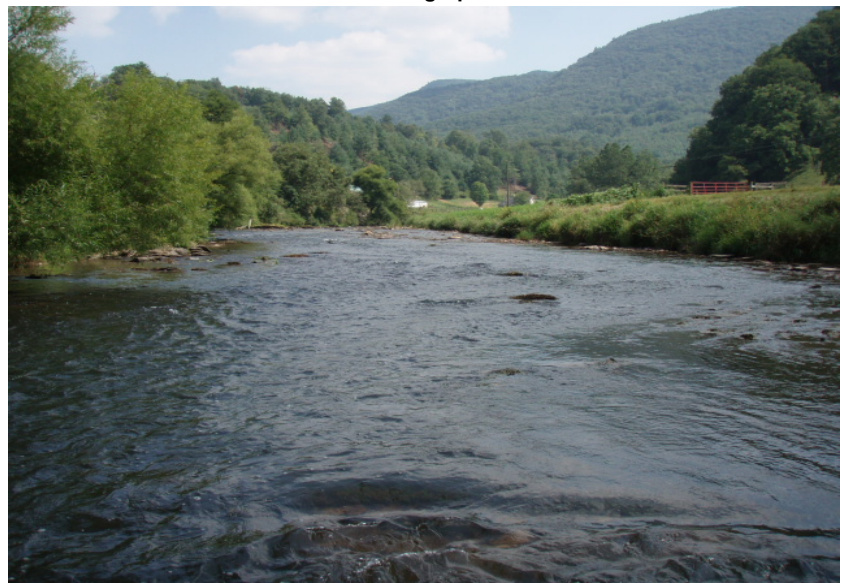
Site Photograph

Channel Modification (5)	4
Instream Habitat (20)	12
Bottom Substrate (15)	12
Pool Variety (10)	4
Riffle Habitat (16)	15
Left Bank Stability (7)	7
Right Bank Stability (7)	7
Light Penetration (10)	2
Left Riparian Score (5)	2
Right Riparian Score (5)	0
Total Habitat Score (100)	65

Substrate	mix of cobble, gravel, sand; some boulder, silt
-----------	---

Sample Date	Sample ID	ST	EPT	BI	EPT BI	Bioclassification
08/20/08	10541	99	49	3.93	3.31	Excellent
08/21/03	9234	72	45	3.66	3.31	Excellent
08/19/98	7719	87	50	3.77	2.91	Excellent
07/28/93	6294	93	46	4.00	2.94	Excellent

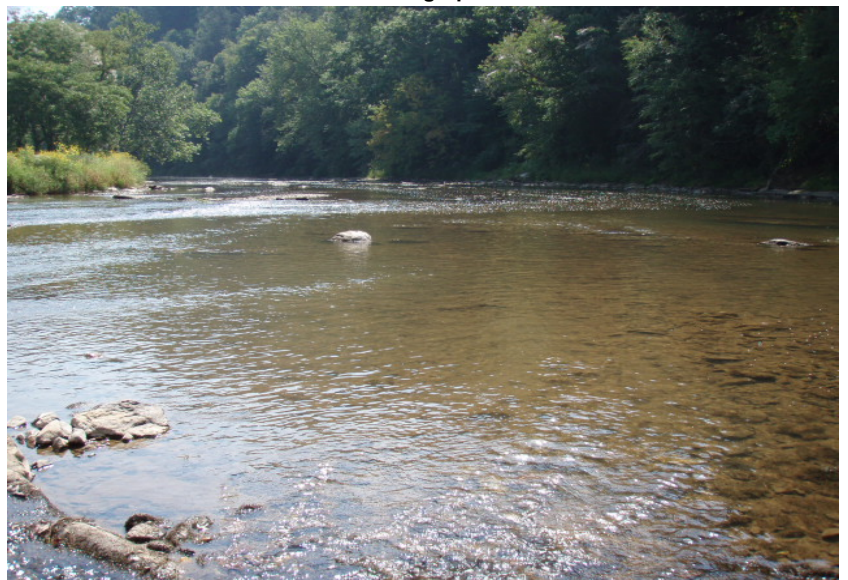
Site Photograph

Channel Modification (5)	5
Instream Habitat (20)	18
Bottom Substrate (15)	10
Pool Variety (10)	5
Riffle Habitat (16)	5
Left Bank Stability (7)	7
Right Bank Stability (7)	7
Light Penetration (10)	1
Left Riparian Score (5)	5
Right Riparian Score (5)	2
Total Habitat Score (100)	65

Substrate	primarily cobble and gravel; some sand, silt, boulder
------------------	---

Sample Date	Sample ID	ST	EPT	BI	EPT BI	Bioclassification
08/20/08	10539	108	55	4.08	3.07	Excellent

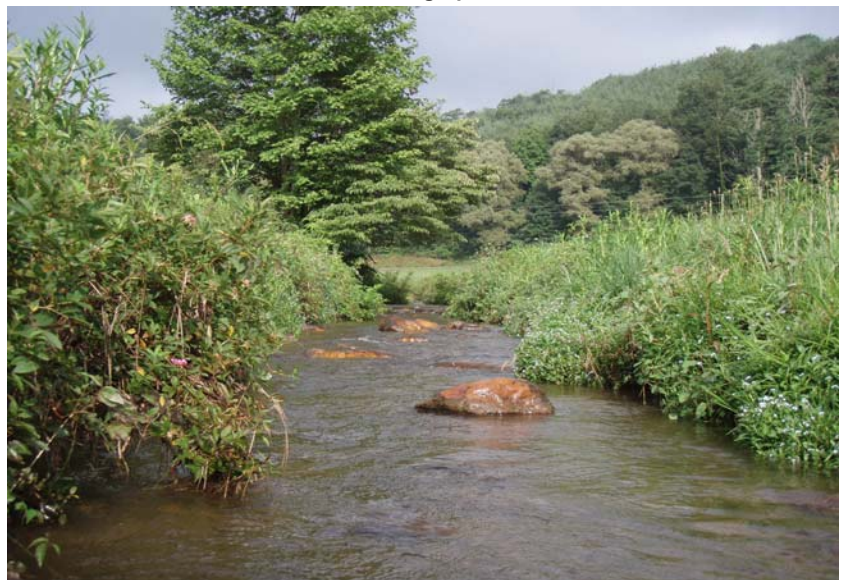
Site Photograph

Channel Modification (5)	4
Instream Habitat (20)	19
Bottom Substrate (15)	12
Pool Variety (10)	4
Riffle Habitat (16)	16
Left Bank Stability (7)	7
Right Bank Stability (7)	7
Light Penetration (10)	2
Left Riparian Score (5)	2
Right Riparian Score (5)	2
Total Habitat Score (100)	75

Substrate	mix of cobbole, gravel, boulder; some sand
-----------	--

Sample Date	Sample ID	ST	EPT	BI	EPT BI	Bioclassification
07/31/08	10514	---	38	---	3.18	Excellent
08/19/03	9221	---	37	---	2.92	Excellent
08/17/98	7709	---	35	---	3.59	Good
07/23/93	6299	---	30	---	3.56	Good

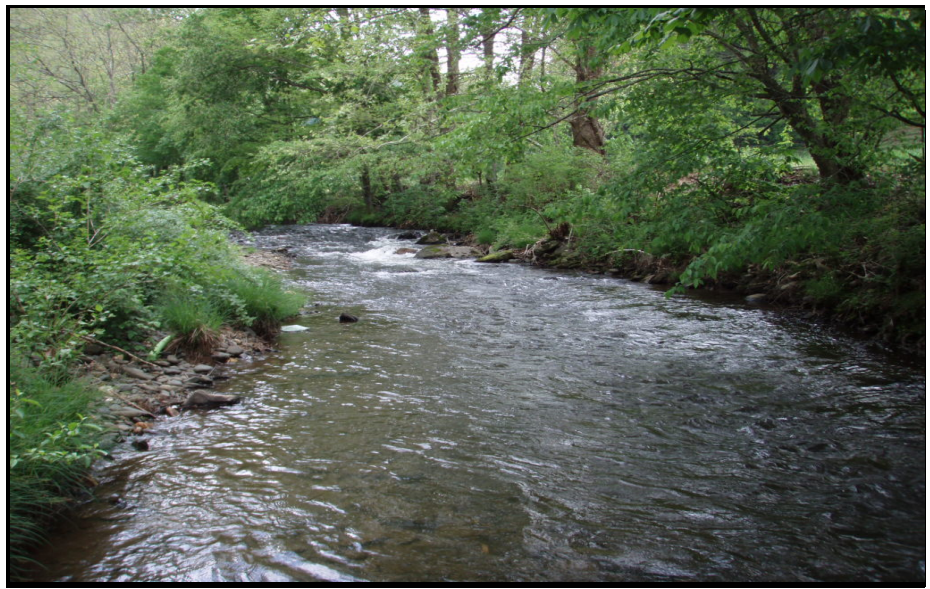
Site Photograph

Channel Modification (5)	5
Instream Habitat (20)	20
Bottom Substrate (15)	12
Pool Variety (10)	6
Riffle Habitat (16)	16
Left Bank Stability (7)	7
Right Bank Stability (7)	7
Light Penetration (10)	7
Left Riparian Score (5)	3
Right Riparian Score (5)	2
Total Habitat Score (100)	85

Substrate	flat cobble, boulder, bedrock, gravel, sand.
-----------	--

Sample Date	Sample ID	Species Total	NCIBI	Bioclassification
05/20/08	2008-45	15	--	Not Rated

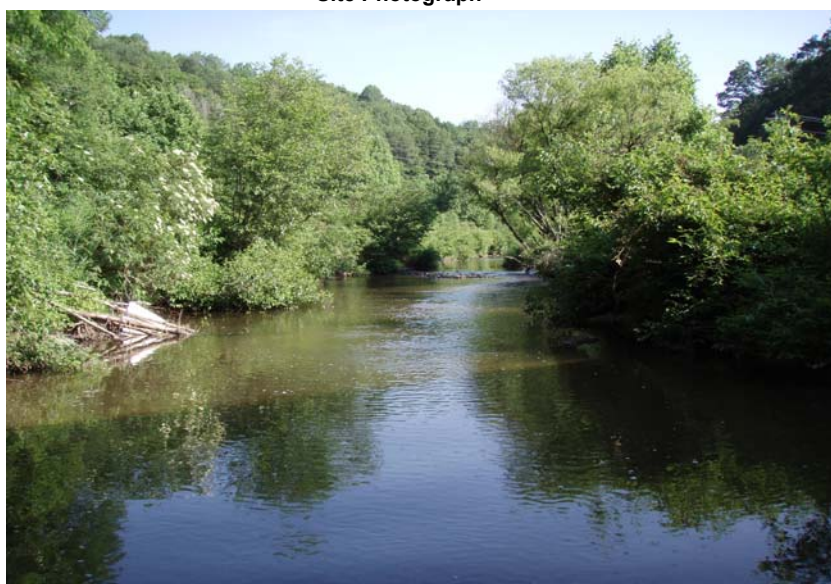
Site Photograph

Channel Modification (5)	4
Instream Habitat (20)	15
Bottom Substrate (15)	13
Pool Variety (10)	4
Riffle Habitat (16)	14
Left Bank Stability (7)	6
Right Bank Stability (7)	6
Light Penetration (10)	7
Left Riparian Score (5)	5
Right Riparian Score (5)	2
Total Habitat Score (100)	76

Substrate mix of cobble, gravel, sand; some boulder, silt

Sample Date	Sample ID	ST	EPT	BI	EPT BI	Bioclassification
06/19/08	10468	---	53	---	2.62	Excellent
08/19/03	9225	---	38	---	2.92	Excellent
07/17/98	7712	---	40	---	3.49	Excellent
07/29/93	6298	---	48	---	3.29	Excellent

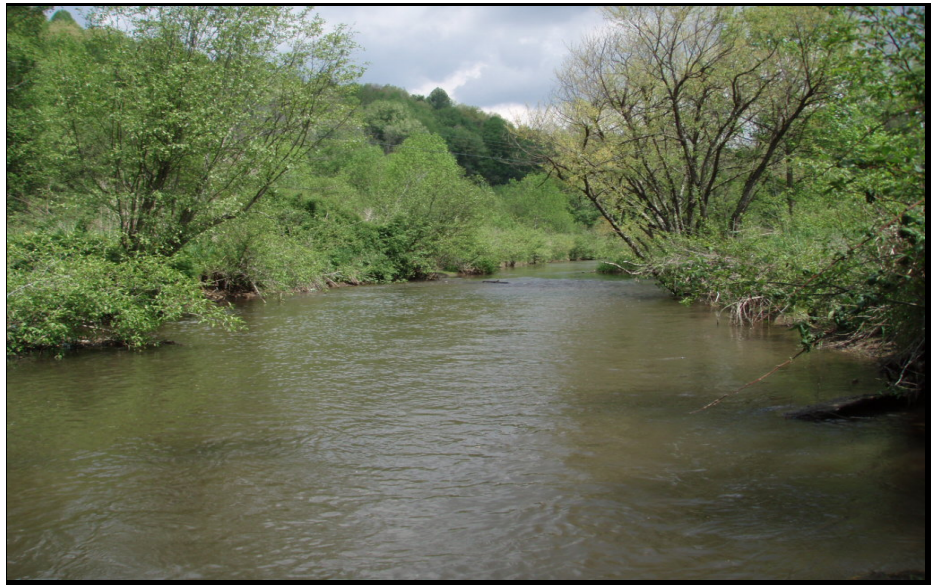
Site Photograph

Channel Modification (5)	5
Instream Habitat (20)	16
Bottom Substrate (15)	8
Pool Variety (10)	8
Riffle Habitat (16)	10
Left Bank Stability (7)	5
Right Bank Stability (7)	5
Light Penetration (10)	5
Left Riparian Score (5)	5
Right Riparian Score (5)	4
Total Habitat Score (100)	71

Substrate	sand, gravel, cobble, boulder.
-----------	--------------------------------

Sample Date	Sample ID	Species Total	NCIBI	Bioclassification
05/20/08	2008-44	19	52	Good

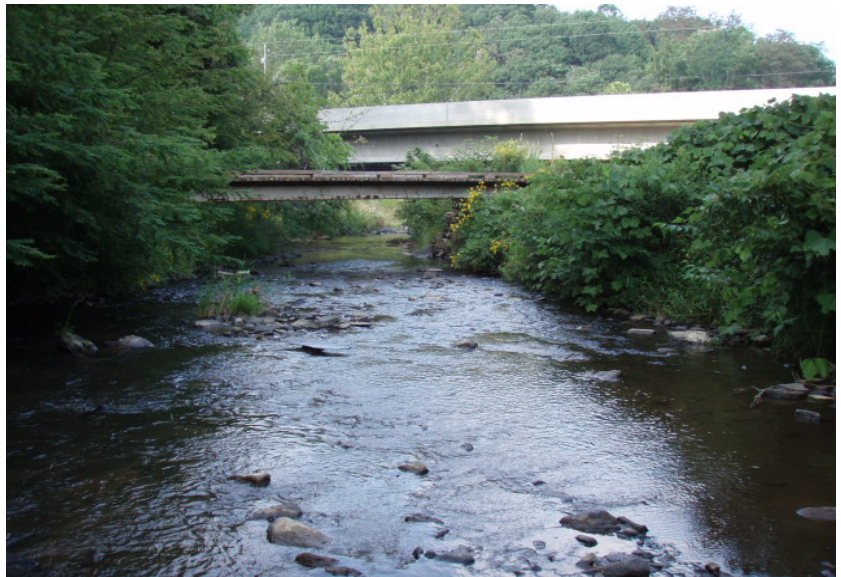
Site Photograph

Channel Modification (5)	4
Instream Habitat (20)	18
Bottom Substrate (15)	14
Pool Variety (10)	5
Riffle Habitat (16)	14
Left Bank Stability (7)	7
Right Bank Stability (7)	7
Light Penetration (10)	6
Left Riparian Score (5)	3
Right Riparian Score (5)	4
Total Habitat Score (100)	82

Substrate	mix of cobble, gravel, boulder; some sand
------------------	---

Sample Date	Sample ID	ST	EPT	BI	EPT BI	Bioclassification
08/20/08	10542	---	39	---	2.51	Excellent

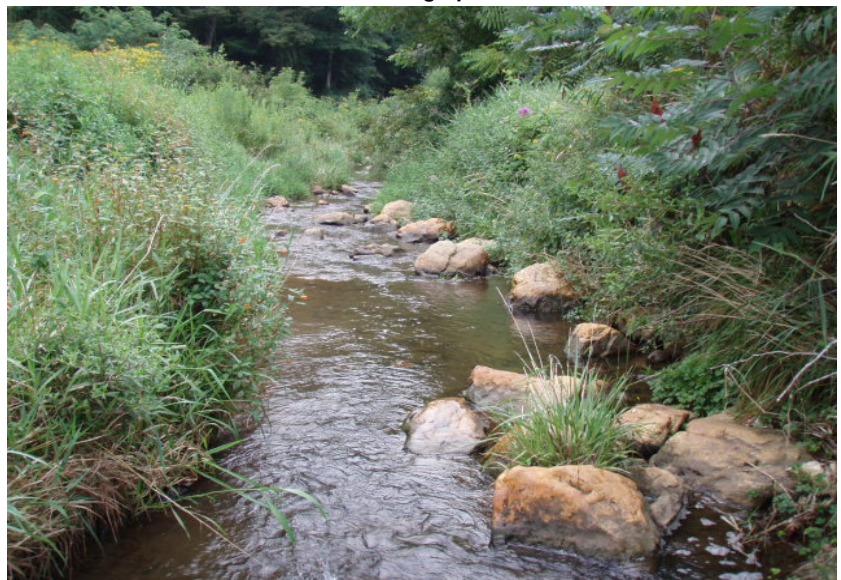
Site Photograph

Temperature (°C)	18.1
Dissolved Oxygen (mg/L)	8.7
Specific Conductance (µS/cm)	276
pH (s.u.)	---
Water Clarity	clear

Channel Modification (5)	3
Instream Habitat (20)	18
Bottom Substrate (15)	9
Pool Variety (10)	4
Riffle Habitat (16)	15
Left Bank Stability (7)	5
Right Bank Stability (7)	7
Light Penetration (10)	2
Left Riparian Score (5)	2
Right Riparian Score (5)	1
Total Habitat Score (100)	66

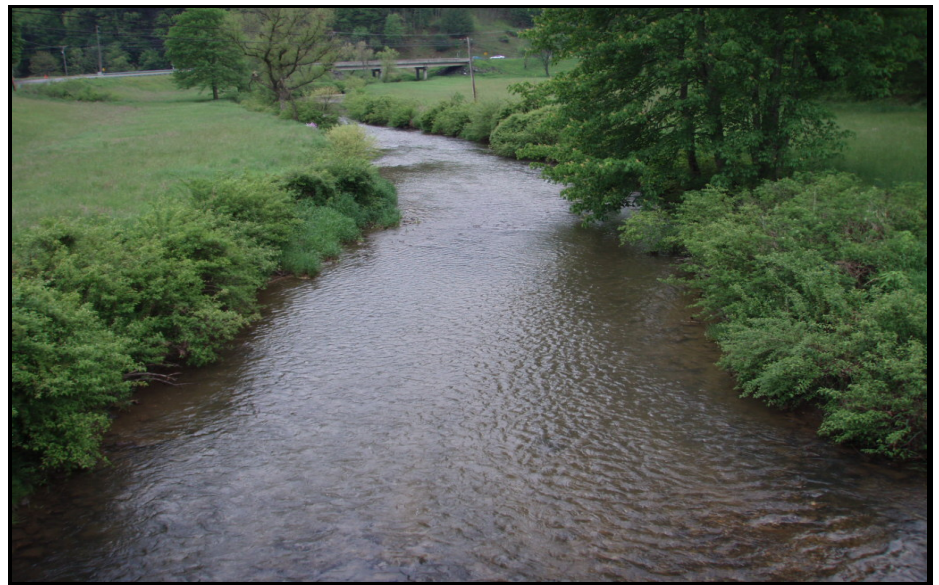
Site Photograph

Water Clarity	Slightly turbid
---------------	-----------------

Channel Modification (5)	5
Instream Habitat (20)	16
Bottom Substrate (15)	8
Pool Variety (10)	4
Riffle Habitat (16)	5
Left Bank Stability (7)	5
Right Bank Stability (7)	4
Light Penetration (10)	2
Left Riparian Score (5)	5
Right Riparian Score (5)	5
Total Habitat Score (100)	59

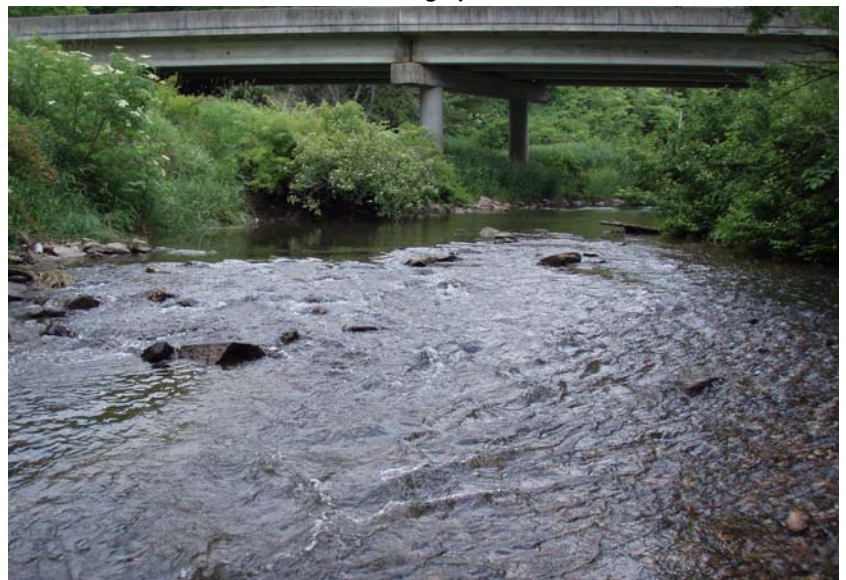
Site Photograph

Channel Modification (5)	4
Instream Habitat (20)	15
Bottom Substrate (15)	13
Pool Variety (10)	4
Riffle Habitat (16)	14
Left Bank Stability (7)	6
Right Bank Stability (7)	6
Light Penetration (10)	7
Left Riparian Score (5)	2
Right Riparian Score (5)	4
Total Habitat Score (100)	75

Substrate	mix of cobble, gravel, boulder; some sand
------------------	---

Sample Date	Sample ID	ST	EPT	BI	EPT BI	Bioclassification
06/10/08	10470	123	60	4.33	2.84	Excellent
08/19/03	9226	89	50	3.95	3.42	Excellent
08/18/98	7715	103	56	4.18	3.14	Excellent
07/28/93	6293	129	56	4.10	2.78	Excellent

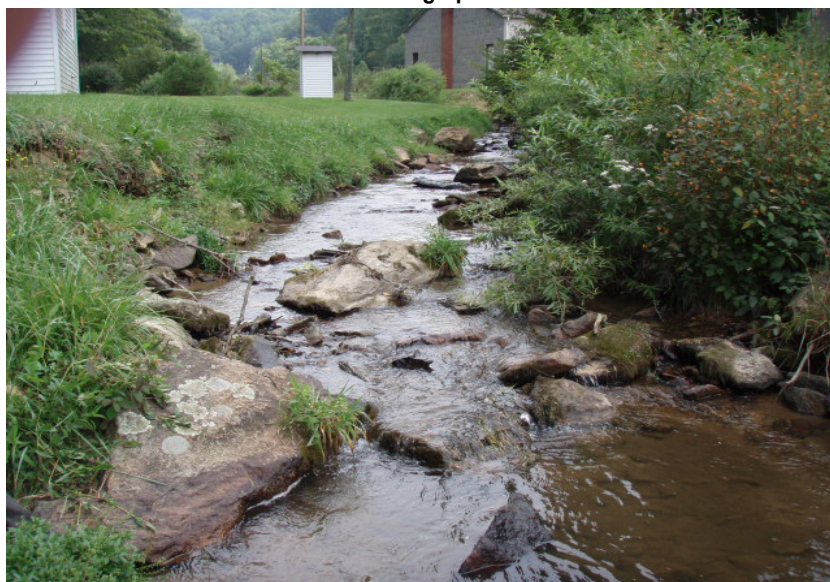
Site Photograph

Channel Modification (5)	4
Instream Habitat (20)	18
Bottom Substrate (15)	12
Pool Variety (10)	4
Riffle Habitat (16)	15
Left Bank Stability (7)	2
Right Bank Stability (7)	4
Light Penetration (10)	2
Left Riparian Score (5)	0
Right Riparian Score (5)	0
Total Habitat Score (100)	61

Substrate	mix of cobble, boulder, gravel, sand; some silt
-----------	---

Sample Date	Sample ID	ST	EPT	BI	EPT BI	Bioclassification
08/21/08	10544	---	38	---	2.92	Excellent
08/19/03	9227	---	33	---	3.03	Good
08/18/98	7716	---	35	---	3.62	Good

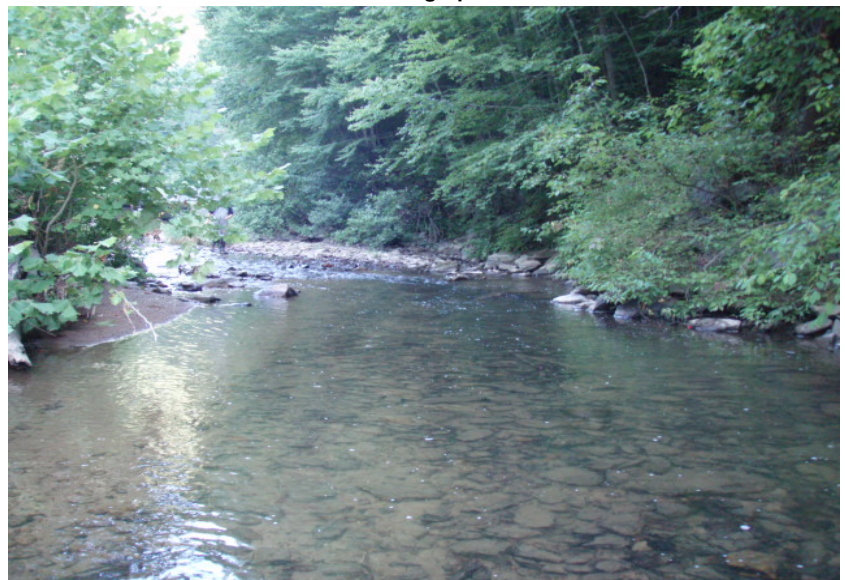
Site Photograph

Channel Modification (5)	5
Instream Habitat (20)	19
Bottom Substrate (15)	14
Pool Variety (10)	6
Riffle Habitat (16)	14
Left Bank Stability (7)	7
Right Bank Stability (7)	7
Light Penetration (10)	5
Left Riparian Score (5)	0
Right Riparian Score (5)	5
Total Habitat Score (100)	82

Substrate	mostly boulder, cobble; some gravel, sand
-----------	---

Sample Date	Sample ID	ST	EPT	BI	EPT BI	Bioclassification
08/20/08	10538	---	37	---	2.93	Excellent
08/18/03	9220	---	40	---	3.12	Excellent
08/18/98	7718	---	37	---	3.14	Excellent

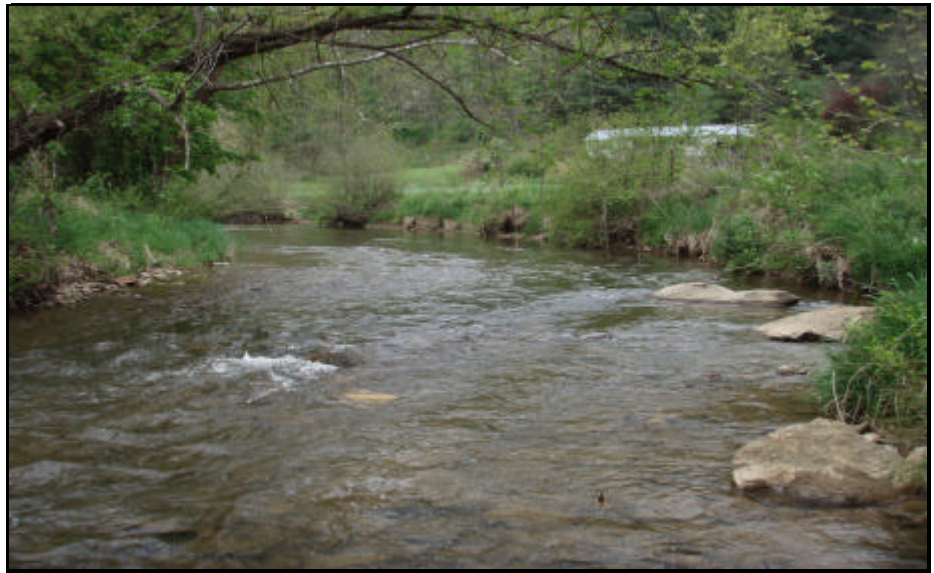
Site Photograph

Temperature (°C)	14.9
Dissolved Oxygen (mg/L)	9.7
Specific Conductance (µS/cm)	57
pH (s.u.)	7.4
Water Clarity	Clear

Channel Modification (5)	5
Instream Habitat (20)	18
Bottom Substrate (15)	13
Pool Variety (10)	4
Riffle Habitat (16)	15
Left Bank Stability (7)	6
Right Bank Stability (7)	4
Light Penetration (10)	7
Left Riparian Score (5)	5
Right Riparian Score (5)	3
Total Habitat Score (100)	80
