SOUTH FORK NEW RIVER & FOX CREEK WATERSHEDS

HUCs 0505000102 & 0505000103

GENERAL WATERSHED DESCRIPTION

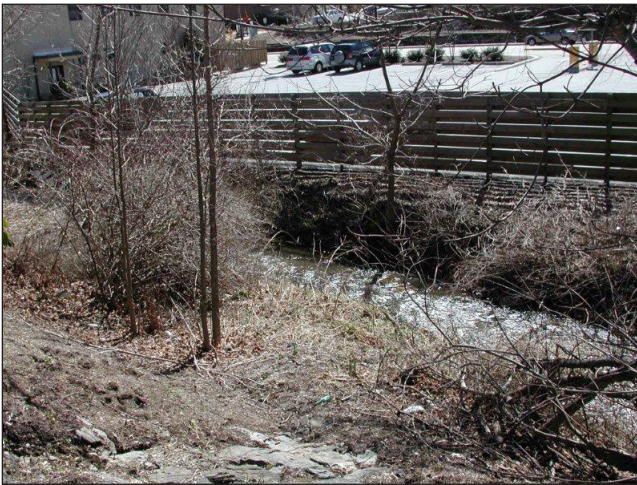
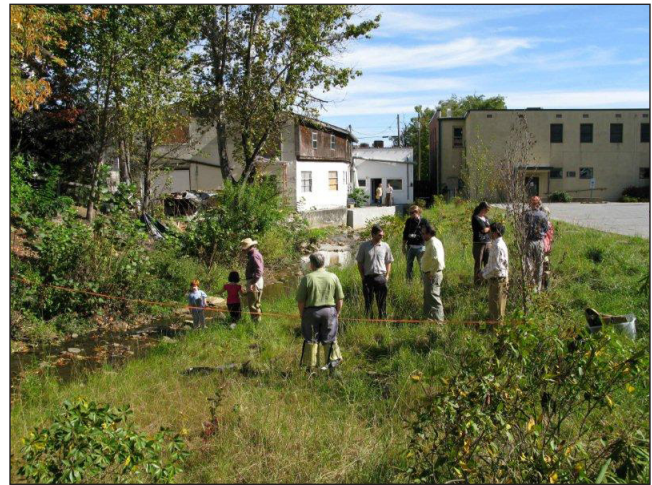
FIGURE 2-24: RIPARIAN BUFFER RESTORATION EFFORTS ALONG BOONE CREEK (LEFT: MARCH 2007; RIGHT: OCTOBER 2008)

This project was initiated by the Kraut Creek Committee of Boone and NCNR. Clean Water Management Trust Fund (CWMTF) provided most of the funding for the project. The Boone Chamber of Commerce provided a cash match, and Appalachian State University provided both cash and in-kind donations.

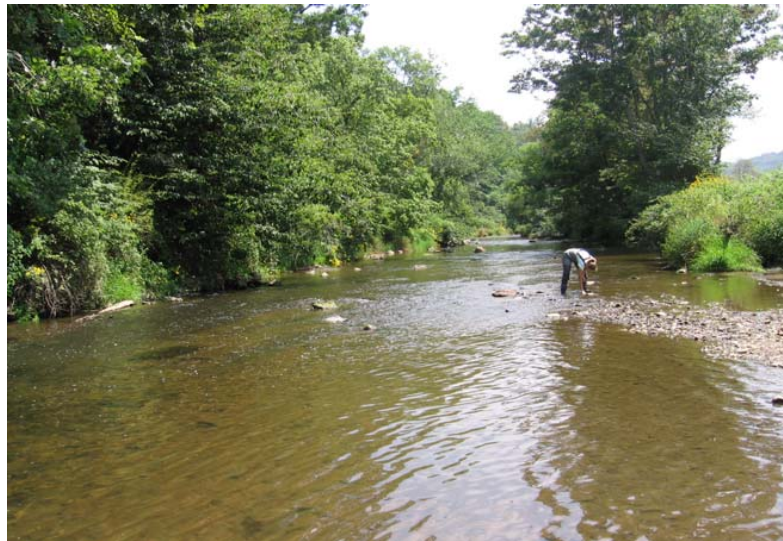
Site Photograph

Substrate	mix of cobble, gravel, sand and silt
------------------	--------------------------------------

The 2008 sample is dominated by taxa that are pollution-tolerant. Abundant mayflies found here in 2008 included: *Pseudocloeon propinquum*, *Plauditus dubius* group, *Heterocloeon anoka*, *Isonychia*, and *Baetis flavistriga*. Other abundant taxa here that are considered generalists and are tolerant were the caddisfly *Cheumatopsyche* and the dragonfly *Calopteryx*.

The South Fork New River at US 421/221 rated Fair in 2008, the same rating as in 2003. There have been eight samples collected here from 1984 through 2008. Of the seven summer samples (all Full Scale samples) this site rated Fair four times and Good-Fair thrice. This site is just downstream of the Boone WWTP. The 2004 Basinwide Assessment Report noted a gradual decrease in the Biotic Index here (indicating a slightly more pollution-sensitive benthic community) in relation to reductions in NH3 and TKN from effluent from the Boone WWTP beginning in 1998. Unfortunately this trend did not continue in 2008 and the Biotic Index is now back to the level it was in the mid 1990's which indicates a more pollution-tolerant benthic community. This watershed is also heavily agricultural. A large silt load covers 40% of the benthos of this reach limiting habitat for aquatic macroinvertebrates. There is very little substrate over 10 inches in length in this reach. Overall habitat quality here is low and has been since at least 2003 (scores of 58, 59 and 60).

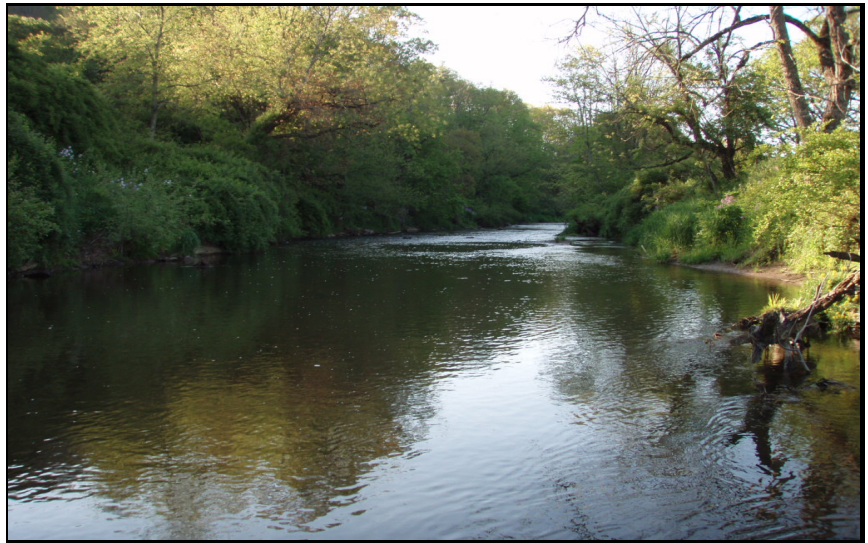
Site Photograph

Substrate	gravel, sand, boulder, silt.
-----------	------------------------------

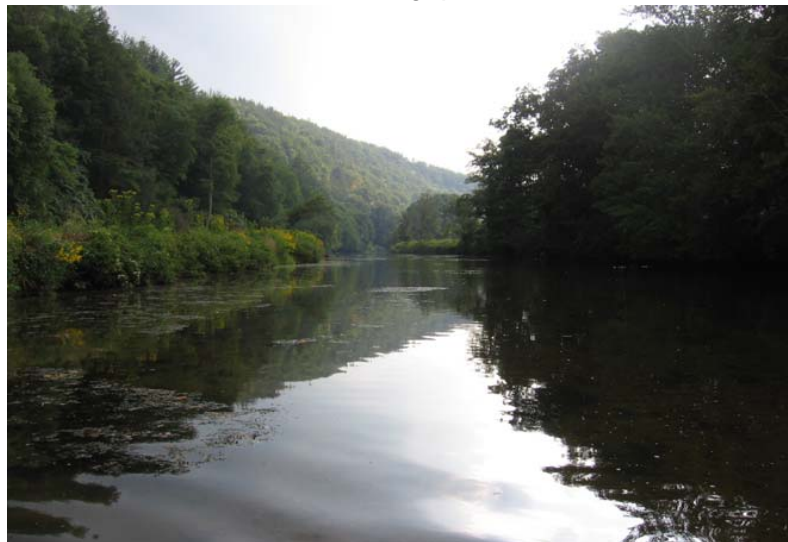
Site Photograph

Substrate	mix of cobble, gravel, sand and silt
-----------	--------------------------------------

Small changes in rare and in some cases common taxa were the main differences between the 2008 collection and past collections. Only one taxonomic group showed any drastic changes: the dragonfly family Gomphidae. In both 1998 and 2003 four taxa were found in the samples but in 2008, this group was absent. One unusual chironomid taxa was found in 2008: *Polypedium* sp. P. The infrequently collected caddisfly *Oecetis avara* was first collected here in 2008. There are only 37 BAU records of this species. Overall EPT and total diversity remains high here.

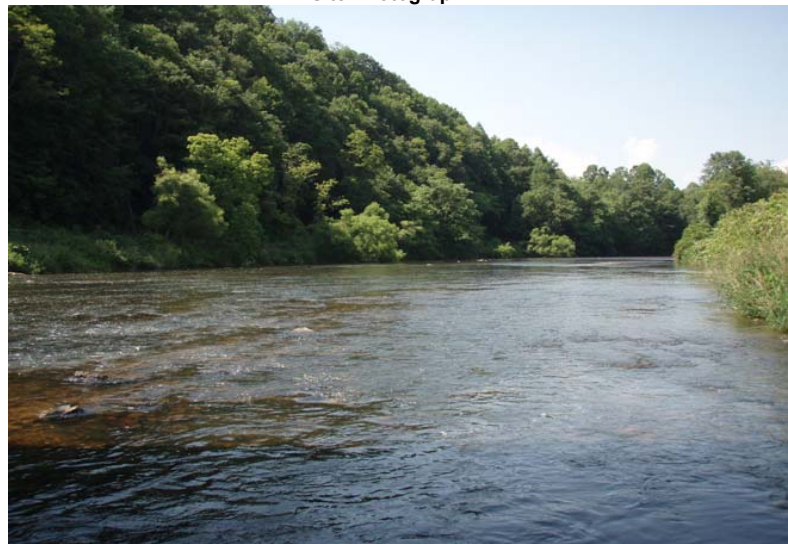
Site Photograph

Substrate	mix of bedrock, boulder, cobble, gravel, sand and silt
------------------	--

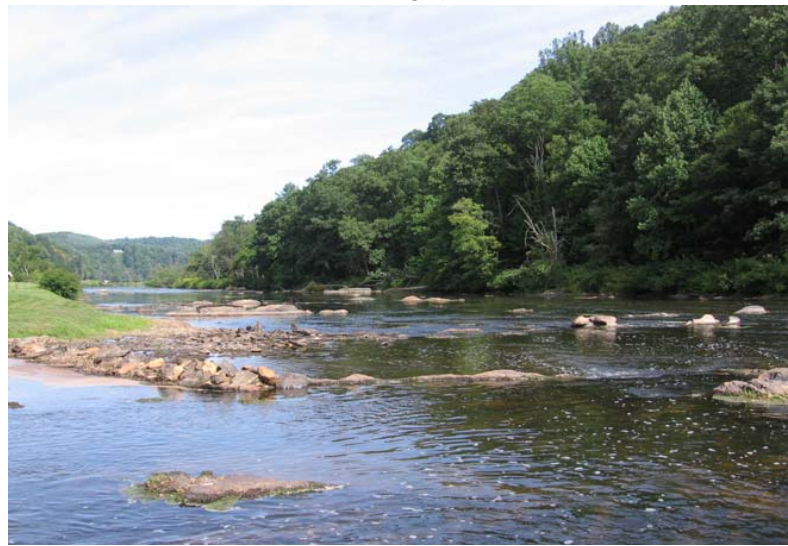
Site Photograph

Water Clarity	clear
---------------	-------

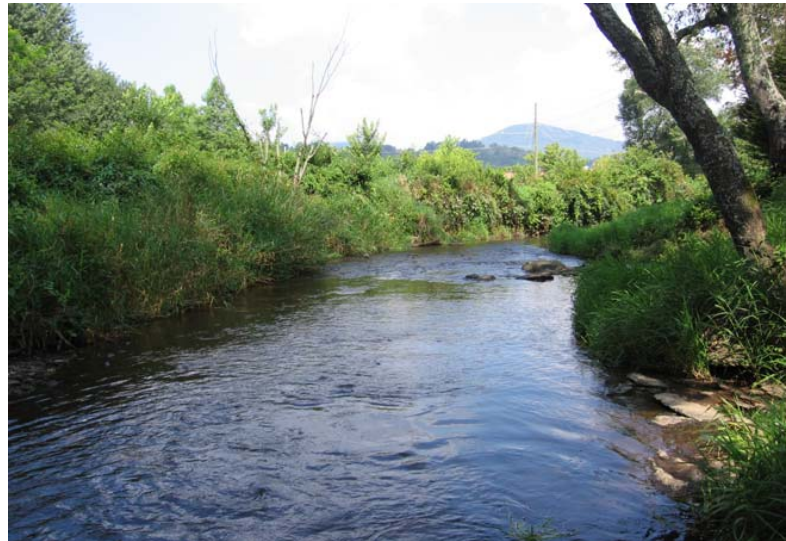
Site Photograph

Substrate	mix of cobble, gravel, sand and silt
-----------	--------------------------------------

In general, the EPT taxa found in the Middle Fork of the South Fork New River in 2008 were typical of previous collections. However, the most recent collection contained fewer EPT taxa than most of the past sampling efforts. This site supports an increasingly pollution-tolerant benthic community. Abundant taxa found in 2008 were cosmopolitan species (e.g. *Isonychia*, *Cheumatopsyche*, *Plauditus dubius* group) with few pollution-sensitive species.

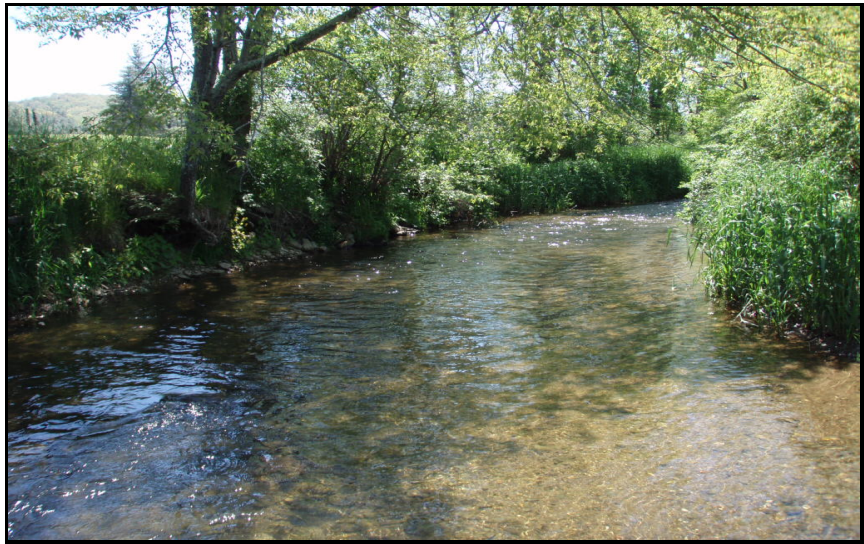
Site Photograph

Temperature (°C)	12.3
Dissolved Oxygen (mg/L)	9.3
Specific Conductance (µS/cm)	92
pH (s.u.)	6.4
Water Clarity	Clear

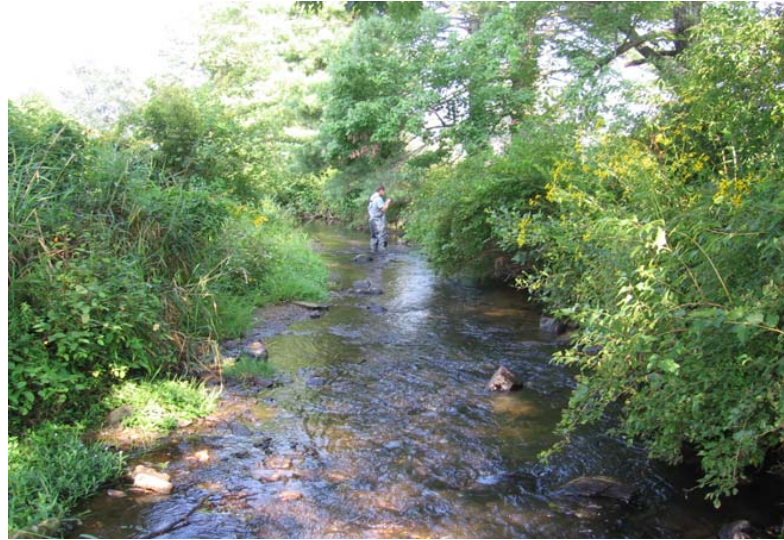
Site Photograph

Substrate	mix of boulder, cobble, gravel, sand and silt
------------------	---

The EPT taxa found in the East Fork of the South Fork New River in 2008 were similar to past basinwide collections. Some taxa were collected in lower abundances (e.g. *Isonychia*) and some have yet to reestablish (e.g. *Maccaffertium pudicum* and *Ceratopsyche sparna*) following an acute, unknown event that occurred in 2003 after the basinwide sampling event for that year. In terms of EPT richness the benthic community has recovered to summer 2003 levels. This site still supports a pollution-intolerant benthic community.

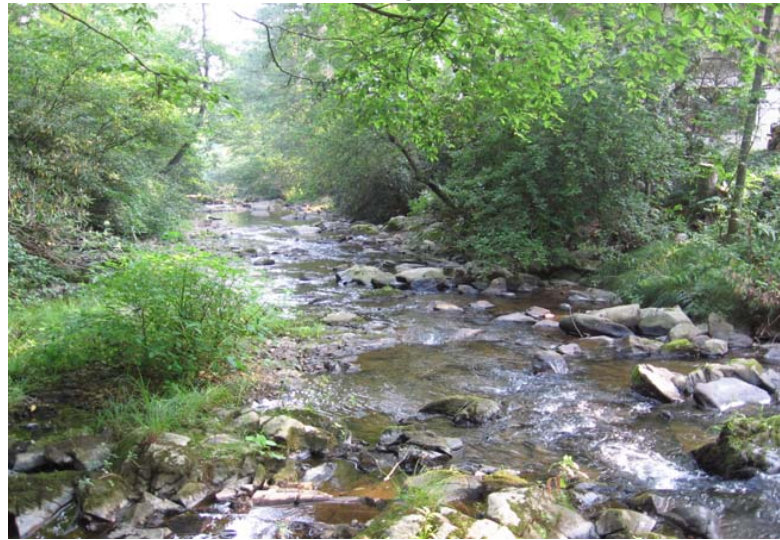
Site Photograph

Substrate	mix of mostly bedrock and boulder with some cobble and gravel
------------------	---

EPT taxa collected in 2008 were very similar to past samples here. Abundant taxa included the mayflies *Baetis pluto*, *Epeorus vitreus*, *Maccaffertium modestum*, *M. pudicum* and *Paraleptophlebia*. Six stonefly taxa were found at Winkler Creek with *Leuctra* and *Tallaperla* being dominant. Caddisflies were well represented with 12 taxa present, but only *Ceratopsyche sparna*, *Cheumatopsyche* and *Dolophilodes* were abundant. The less commonly collected caddisfly, *Mystacides* nr. *alafimbriata*, was found to be common here in 2008.

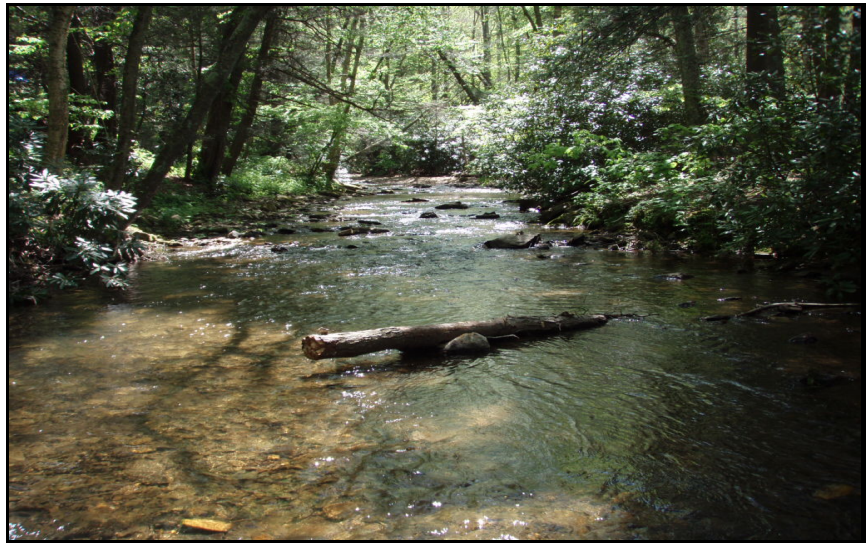
Site Photograph

Substrate	abundant flat rocks, cobble, gravel, boulder.
-----------	---

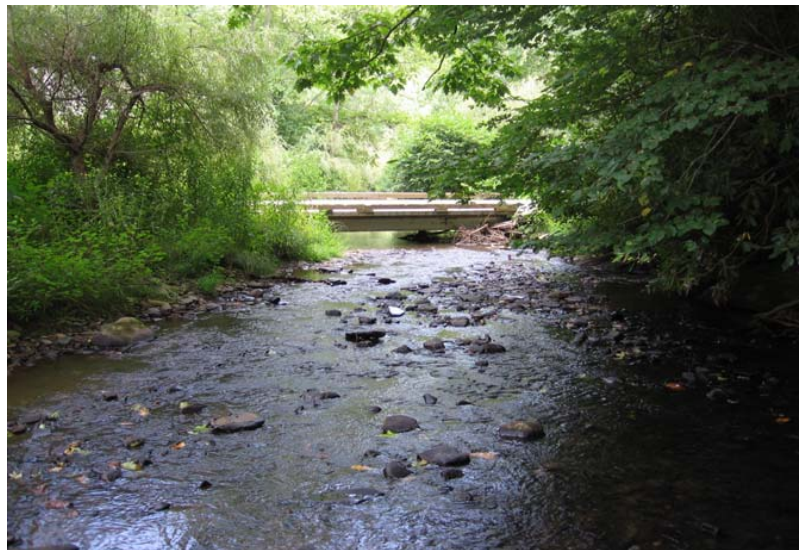
Site Photograph

Substrate	mix of boulder, cobble, gravel, sand and silt
------------------	---

Howard Creek rated Excellent in 2008, an increase from Good in 2003. As noted in the 2003 report, the Good rating was one EPT taxon away from an Excellent rating. Data from 1988 to 2008 show consistently high water quality with a diverse and pollution intolerant macroinvertebrate community. Residential and commercial development appears to be increasing in this watershed but the sampled reach did not appear to be affected by this as of August 2008.

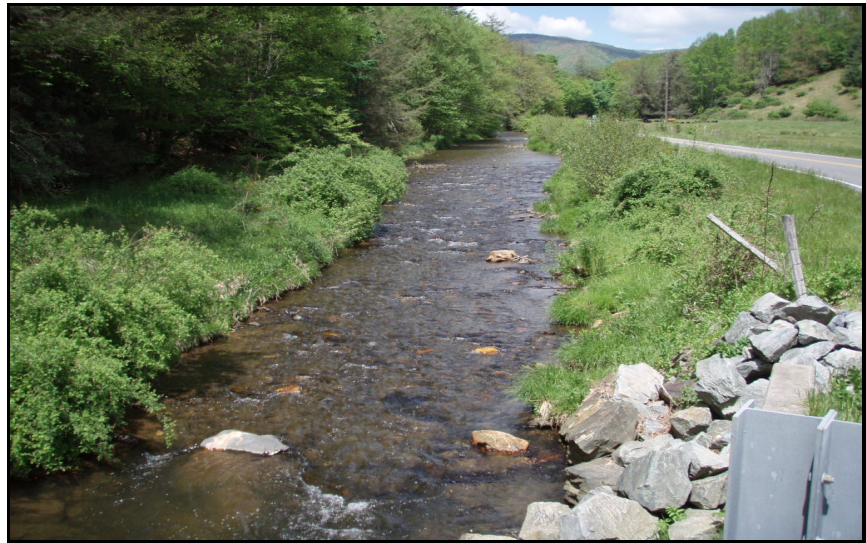
Site Photograph

Substrate	cobble, gravel, boulder.
-----------	--------------------------

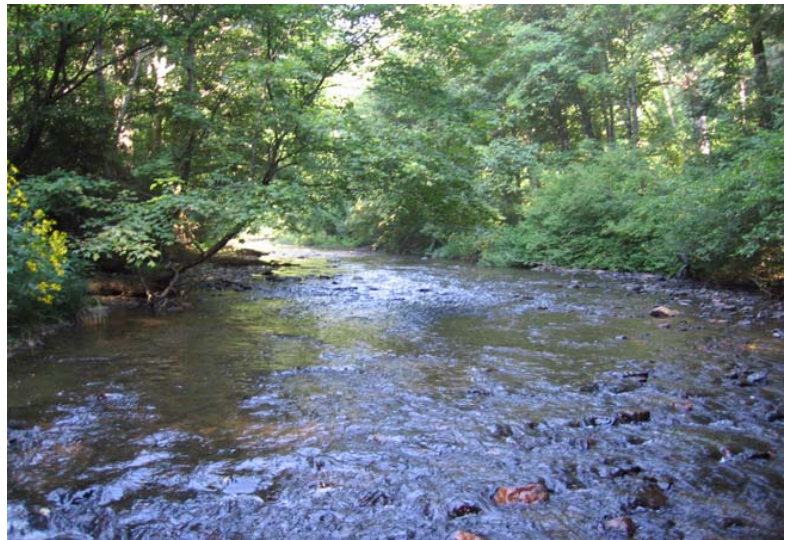
Site Photograph

Water Clarity slightly turbid

In 2008 Meat Camp Creek contained 39 EPT taxa, equaling the largest number of taxa collected from this stream. Many of the species collected in 2003 and previous samples were found in 2008. Most of these taxa are sensitive to aquatic pollution. Several taxa appeared for the first time here in 2008. These included the caddisflies *Neophylax consimilis* (abundant in the sample), *Goera fuscula* (common), *Ceratopsyche morosa*, and *Neureclipsis* (both rare in the sample). The pollution-sensitive mayfly *Stenacron pallidum* (common) and *Tricorythodes* (rare) also appeared at this site for the first time in 2008.

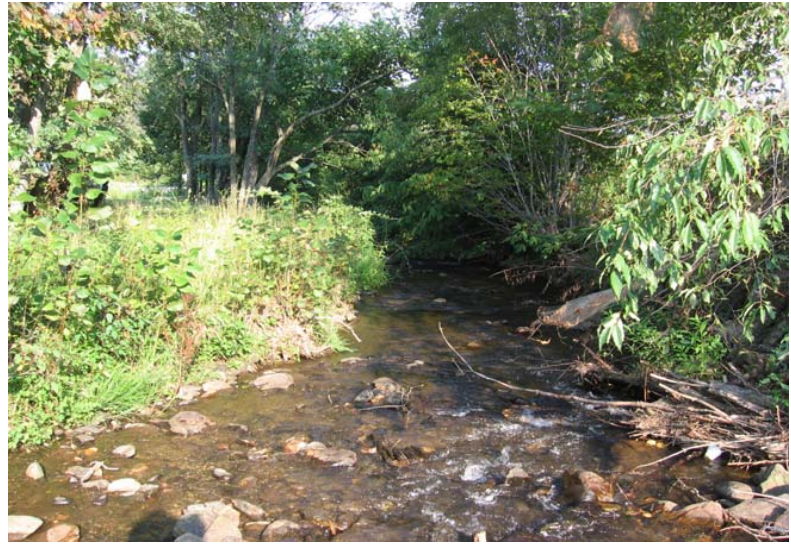
Site Photograph

Substrate	mix of boulder, cobble, gravel, sand and silt
-----------	---

Taxa collected in 2003 that were not found in 2008 included the caddisflies *Fattigia pele*, *Parapsyche cardis*, *Brachycentrus spinae* and *Apatania*. New caddisflies for this site in 2008 included *Ceratopsyche bronta*, *Pycnopysche gentilis* and a second (unidentified) species of *Pycnopysche*, *Polycentropus* and *Lype diversa*. The stoneflies *Suwallia* and *Isoperla* nr *holochlora* were present in 2003 though absent in 2008, while *Paragnetina immarginata* was absent in 2003 and present in 2008. These taxa differences resulted in a slightly higher EPT Biotic Index in 2008 compared with 2003. However, overall this site contains a pollution-intolerant macroinvertebrate community.

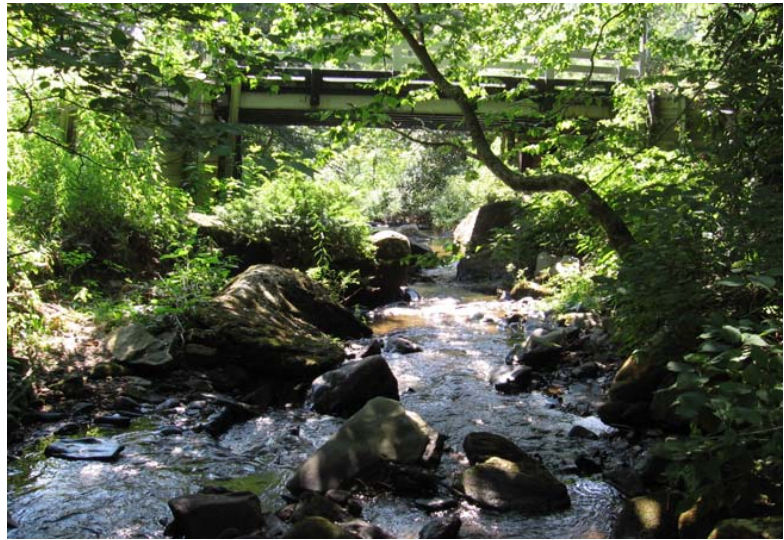
Site Photograph

Substrate	mix of boulder, cobble, and gravel with a large amount of silt
------------------	--

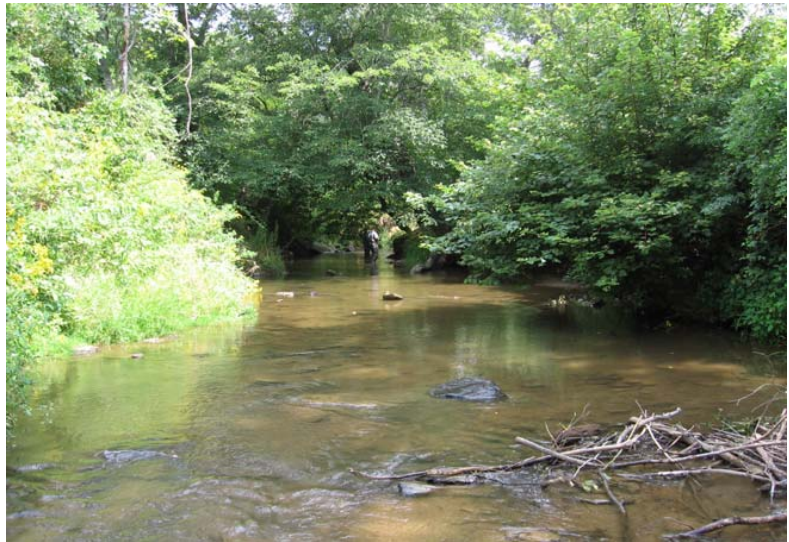
Site Photograph

Substrate	mix of bedrock, boulder, cobble, gravel, sand and silt
------------------	--

Pine Swamp Creek at SR 1179 rated Good in 2008 despite the lack of a healthy riparian zone upstream. Active cow pastures and tree farms constitute a sizeable portion of the visible watershed upstream of the sampling reach. A large amount of silt was visible in this stream (30% of the substrate by visual estimation). Though more EPT taxa were found in 2008 than 2003, the Biotic Index for these macroinvertebrates was higher, suggesting a response to either chemical or physical stressors at the site.

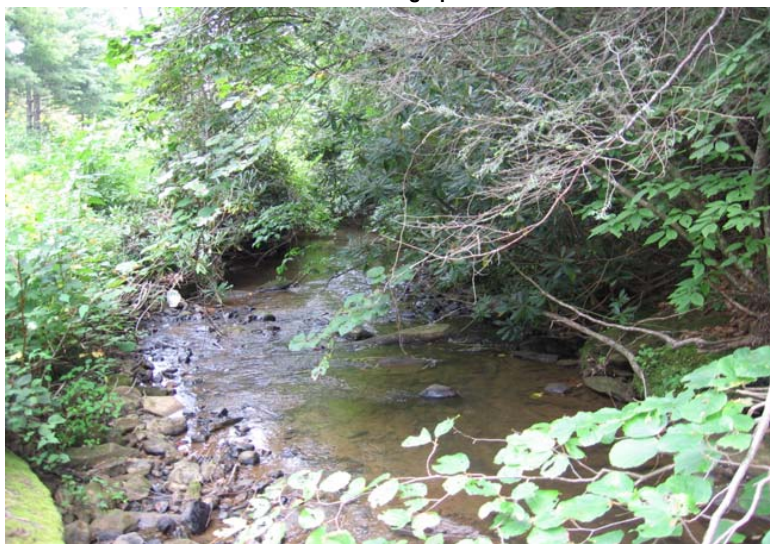
Site Photograph

Water Clarity	clear
---------------	-------

South Beaver Creek rated Good in 2008, the same rating as in 2003. One additional EPT taxon would have resulted in an Excellent bioclassification. Based on only two samples, the macroinvertebrate community at this site appears stable, diverse and pollution-sensitive. Drought conditions in 2008 resulted in most of the root mats being exposed. Typically, this type of habitat is heavily colonized by aquatic macroinvertebrates.

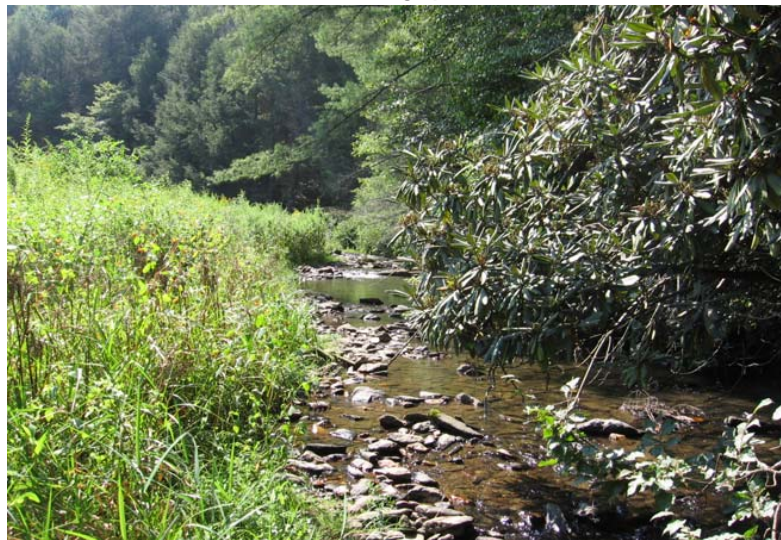
Site Photograph

Substrate	mostly cobble with some boulder and gravel
-----------	--

The EPT taxa collected from Obids Creek in 2008 are very similar to those from the 2003 collection. An exception to this was the baetid mayfly *Baetis tricaudatus*, which was abundant in 2003 and absent in 2008. Despite this, all six other taxa from the mayfly family Baetidae were found here in 2008. Other "missing" taxa in 2008 were the heptageniid mayflies *Maccaffertium pudicum* and *M. ithaca*, which were common and abundant respectively. One rare taxon, *Mystacides nr alafimbriata*, was found in 2008. Only 17 records of this species exist in the BAU database going back to 1985. Four of these records, however, are in the New River drainage. Overall, 31 EPT taxa were found in 2008, one fewer than the number in the 2003 collection.

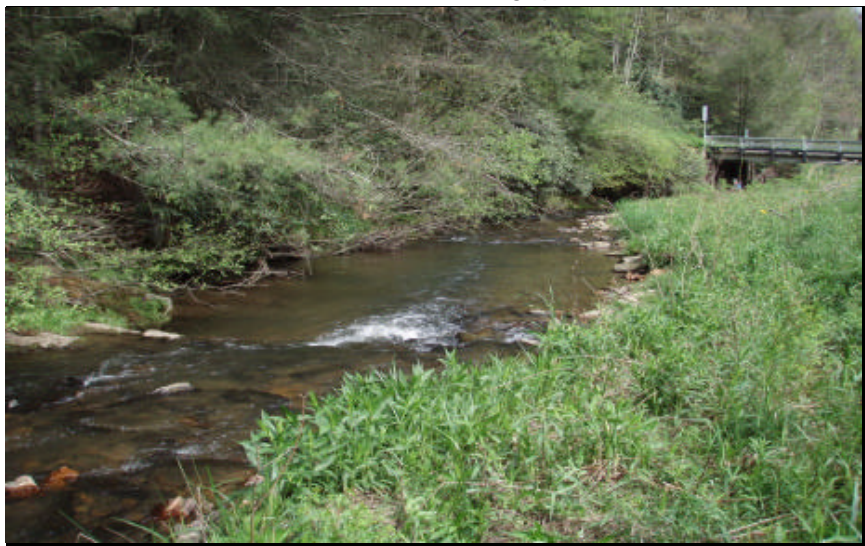
Site Photograph

Substrate	Cobble, boulder, gravel, and silt
-----------	-----------------------------------

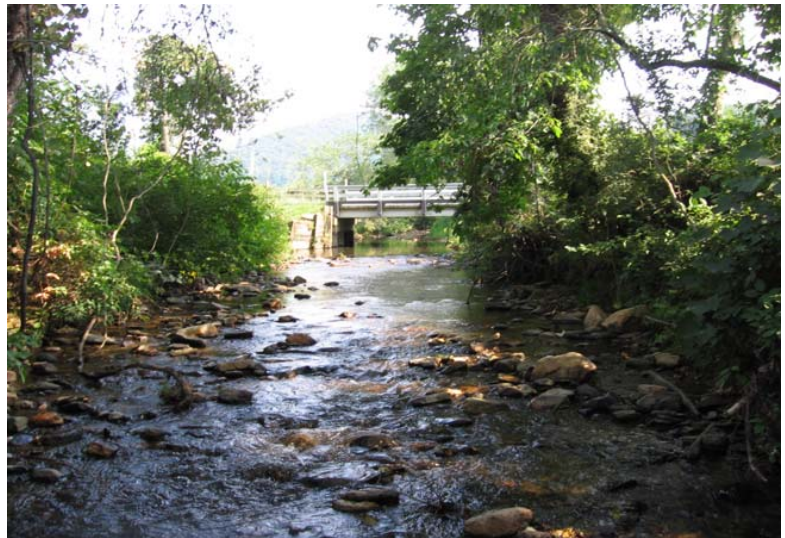
Site Photograph

Substrate	mix of boulder, cobble, gravel and silt
-----------	---

Most taxonomic differences between 2003 and 2008 pertained to rare taxa. Exceptions to this were: the stone-cased caddisfly *Glossosoma*, which was abundant in 2003 but absent in 2008; the stoneflies *Isoperla* and *Malirekus hastatus* and the caddisfly *Rhyacophila fuscula*, which were all common in 2003 though absent in 2008. The caddisfly *Triaenodes ignitus* appeared here in 2008 (and was common in the sample) but had not been found in previous collections.

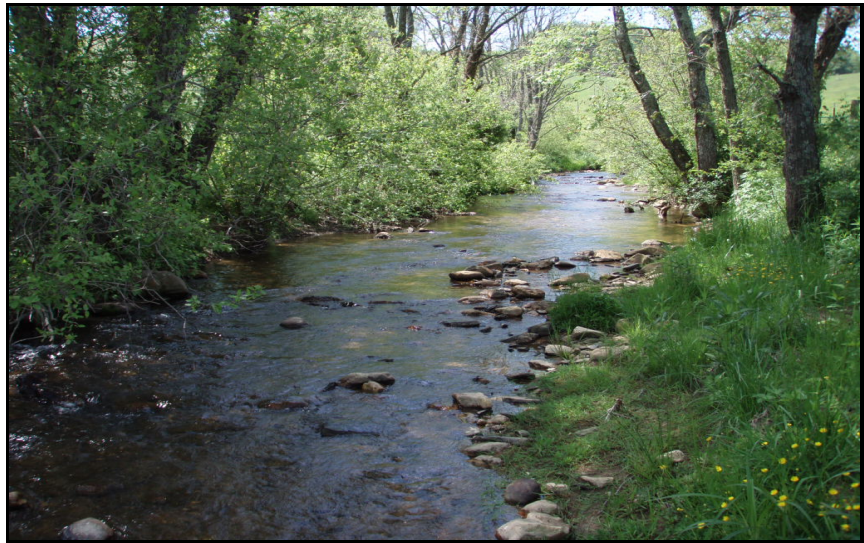
Site Photograph

Substrate	gravel, cobble, sand, boulder.
-----------	--------------------------------

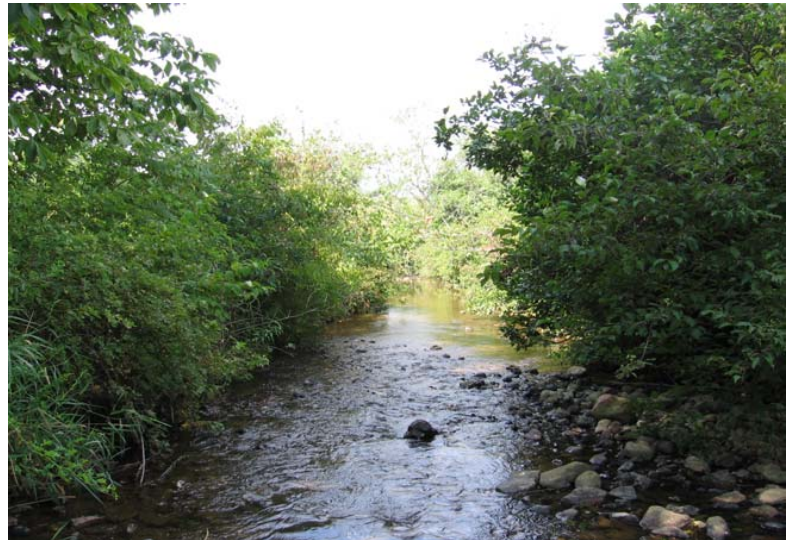
Site Photograph

Substrate	a mix of boulder, cobble, gravel sand and silt
------------------	--

The few additional EPT taxa found in 2008 elevated this sample from Good-Fair to Good. Though this stream reach is entirely within an agricultural area (corn production), the headwaters of some small tributaries to this stream originate in Mount Jefferson State Park. A forested riparian buffer along this section of stream could aid in maintaining the Good bioclassification or possibly improving it.

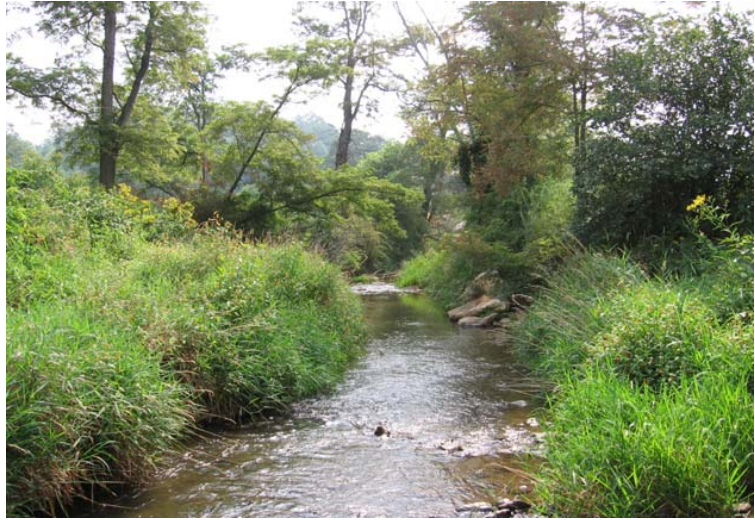
Site Photograph

Temperature (°C)	20.8
Dissolved Oxygen (mg/L)	8.6
Specific Conductance (µS/cm)	140
pH (s.u.)	6.9
Water Clarity	slightly turbid

A greater number of taxa were collected here in 2008 compared with the former basinwide site in 2003. Coleoptera (beetles) and Gastropoda (snails) were the most notable groups that reflected greater diversity in 2008, with increases of five and four taxa respectively. Overall, most taxa collected in 2003 at the former basinwide site were also found in 2008 at the new site.

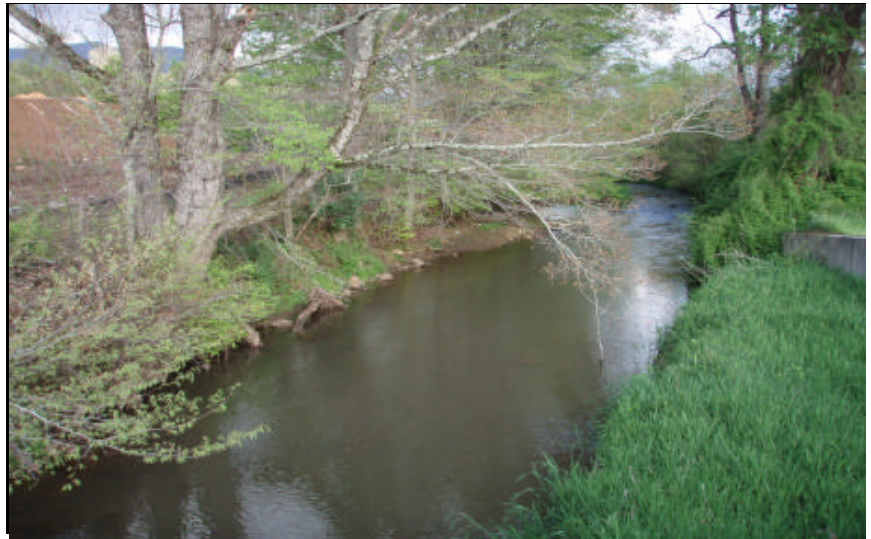
Site Photograph

Temperature (°C)	15.6
Dissolved Oxygen (mg/L)	8.1
Specific Conductance (µS/cm)	104
pH (s.u.)	6.2
Water Clarity	Turbid

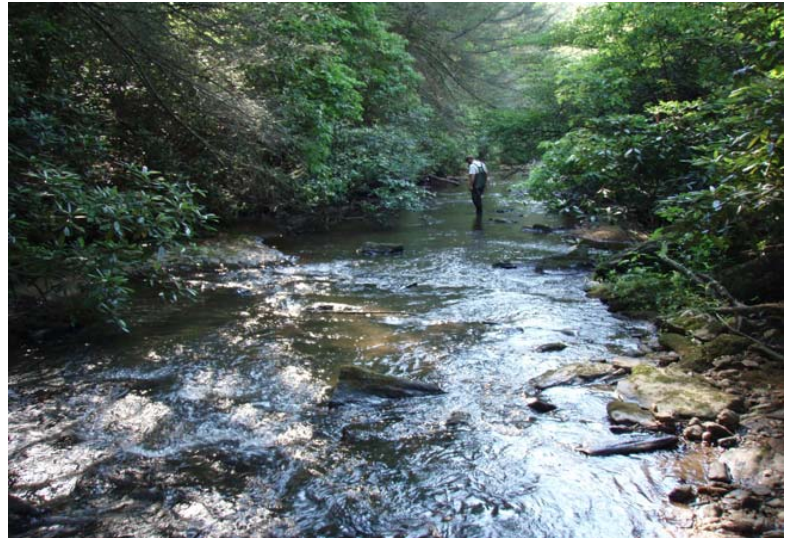
Site Photograph

Substrate	mix of bedrock, boulder, cobble, gravel and sand
-----------	--

This section of Peak Creek rated Excellent in 2008. The second highest EPT totals and the lowest EPT Biotic Index summarize the 2008 sample here and highlight the high water quality conditions in this stream. An undisturbed riparian zone, diverse in-stream benthic surfaces and a mostly forested watershed have resulted in favorable conditions for macroinvertebrate colonization in this stream (as indicated by the high habitat score received).

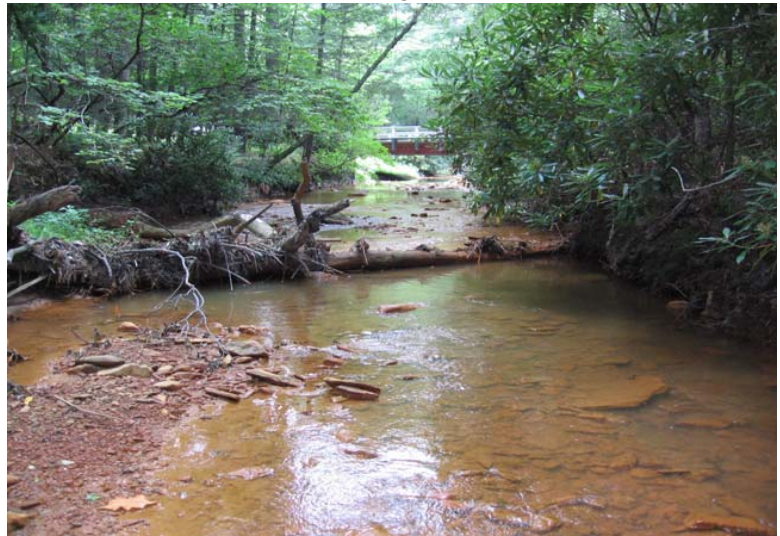
Site Photograph

Channel Modification (5)	5
Instream Habitat (20)	16
Bottom Substrate (15)	3
Pool Variety (10)	10
Riffle Habitat (16)	16
Left Bank Stability (7)	6
Right Bank Stability (7)	6
Light Penetration (10)	10
Left Riparian Score (5)	5
Right Riparian Score (5)	5
Total Habitat Score (100)	82

Substrate mix of bedrock, boulder, cobble, gravel, sand and silt

Sample Date	Sample ID	ST	EPT	BI	EPT BI	Bioclassification
08/21/08	10561	---	3	---	2.62	Poor
08/18/03	9247	---	6	---	1.91	Poor
01/13/99	7798	---	5*	---	1.60	Poor
08/19/98	7747	---	23	---	3.10	Good-Fair
04/08/96	7026	30	14*	4.18*	2.10	Fair

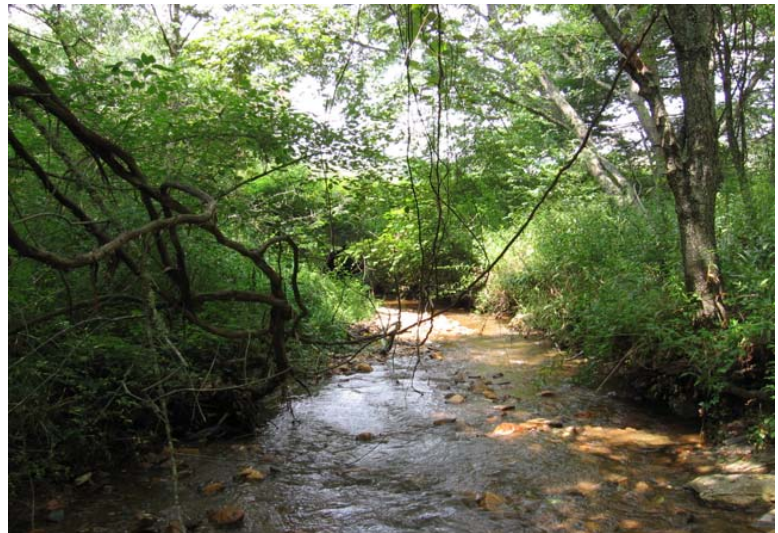
Site Photograph

Channel Modification (5)	3
Instream Habitat (20)	18
Bottom Substrate (15)	12
Pool Variety (10)	5
Riffle Habitat (16)	16
Left Bank Stability (7)	6
Right Bank Stability (7)	6
Light Penetration (10)	10
Left Riparian Score (5)	5
Right Riparian Score (5)	5
Total Habitat Score (100)	86

Substrate	mix of boulder, cobble, gravel, sand and silt
-----------	---

Sample Date	Sample ID	ST	EPT	BI	EPT BI	Bioclassification
08/21/08	10560	---	7	---	2.12	Poor
08/19/03	9249	---	6	---	1.95	Poor
08/19/98	7744	---	7	---	2.02	Poor
04/08/96	7030	16	6*	3.58*	1.77	Poor
04/16/91	5551	---	5	---	2.01	Poor

Only seven EPT taxa were found in Little Peak Creek in 2008. Abundant taxa collected here were similar to previous samples (*Leuctra*, *Tallaperla*, and *Diplectrona modesta*). Three larger-bodied case caddisflies were present (all common in the sample): *Hydatophylax*, *Pycnopsyche gentilis*, and a second unidentified species of *Pycnopsyche*. Acid mine drainage from Ore Knob continues to suppress macroinvertebrate diversity and densities here.

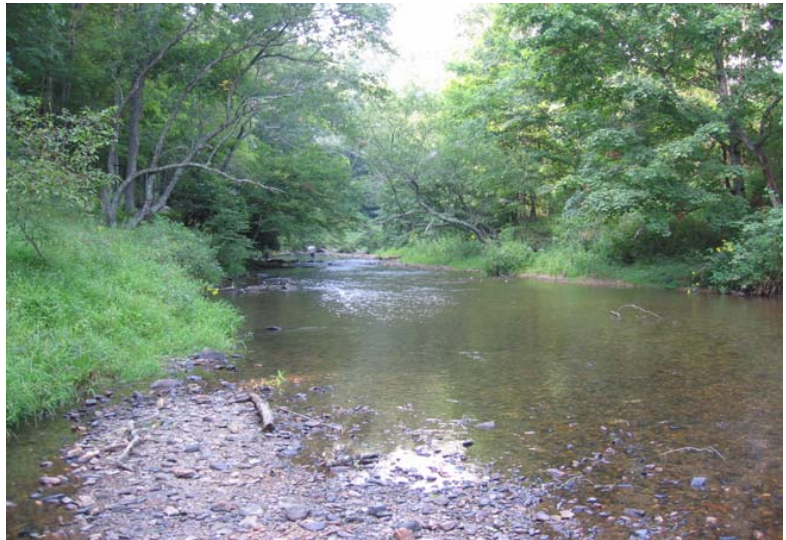
Site Photograph

Water Clarity	clear
---------------	-------

Channel Modification (5)	5
Instream Habitat (20)	13
Bottom Substrate (15)	11
Pool Variety (10)	6
Riffle Habitat (16)	15
Left Bank Stability (7)	6
Right Bank Stability (7)	6
Light Penetration (10)	7
Left Riparian Score (5)	3
Right Riparian Score (5)	3
Total Habitat Score (100)	75

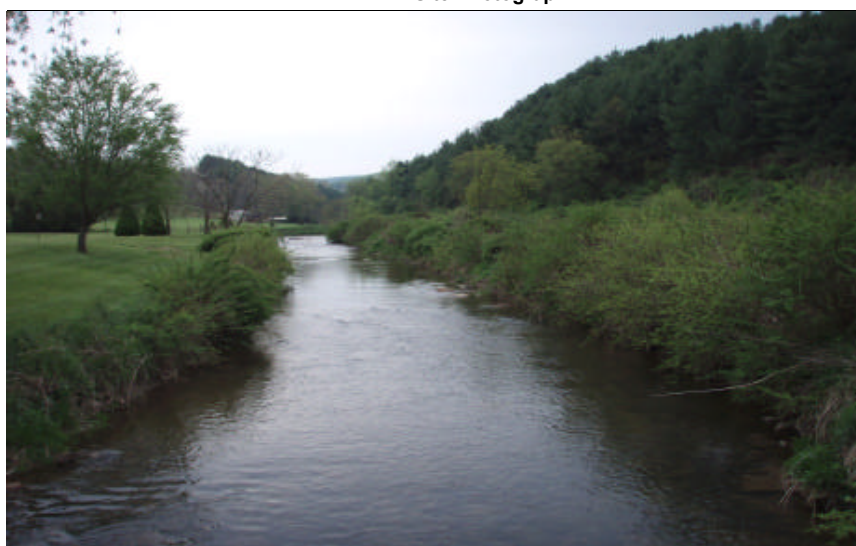
Site Photograph

Channel Modification (5)	4
Instream Habitat (20)	16
Bottom Substrate (15)	8
Pool Variety (10)	4
Riffle Habitat (16)	14
Left Bank Stability (7)	2
Right Bank Stability (7)	3
Light Penetration (10)	0
Left Riparian Score (5)	1
Right Riparian Score (5)	1
Total Habitat Score (100)	53

Substrate	Cobble, gravel, sand, and boulders
-----------	------------------------------------

Sample Date	Sample ID	Species Total	NCIBI	Bioclassification
05/08/08	2008-33	22	56	Good
06/30/98	98-59	20	60	Excellent

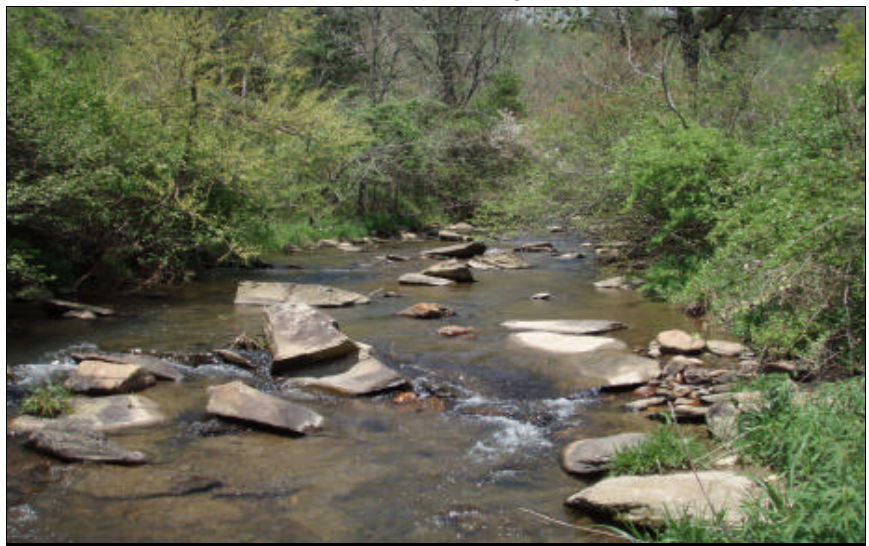
Site Photograph

Channel Modification (5)	5
Instream Habitat (20)	18
Bottom Substrate (15)	14
Pool Variety (10)	6
Riffle Habitat (16)	16
Left Bank Stability (7)	4
Right Bank Stability (7)	4
Light Penetration (10)	4
Left Riparian Score (5)	2
Right Riparian Score (5)	2
Total Habitat Score (100)	75

Substrate	Cobble and boulder
-----------	--------------------

Sample Date	Sample ID	Species Total	NCIBI	Bioclassification
05/07/08	2008-32	19	46	Good-Fair

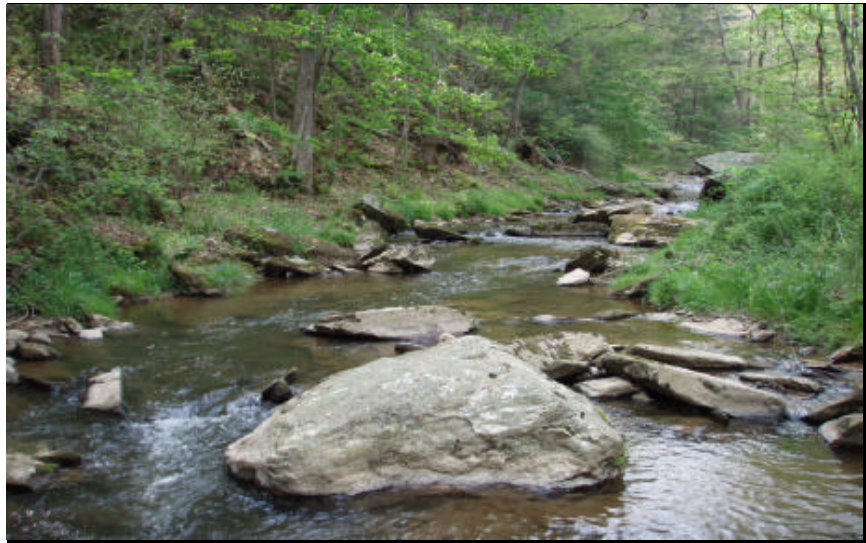
Site Photograph

Channel Modification (5)	5
Instream Habitat (20)	19
Bottom Substrate (15)	14
Pool Variety (10)	8
Riffle Habitat (16)	16
Left Bank Stability (7)	7
Right Bank Stability (7)	7
Light Penetration (10)	9
Left Riparian Score (5)	5
Right Riparian Score (5)	5
Total Habitat Score (100)	95

Substrate	Cobble, boulder, and silts on the rocks
-----------	---

Sample Date	Sample ID	Species Total	NCIBI	Bioclassification
05/08/08	2008-35	18	40	Good-Fair
