# LITTLE RIVER & CHESTNUT CREEK WATERSHEDS

HUC 0505000104 & 0505000106

*Includes: Elk Creek, Bledsoe Creek, Pine Swamp Creek, Glade Creek, Brush Creek & Crab Creek*

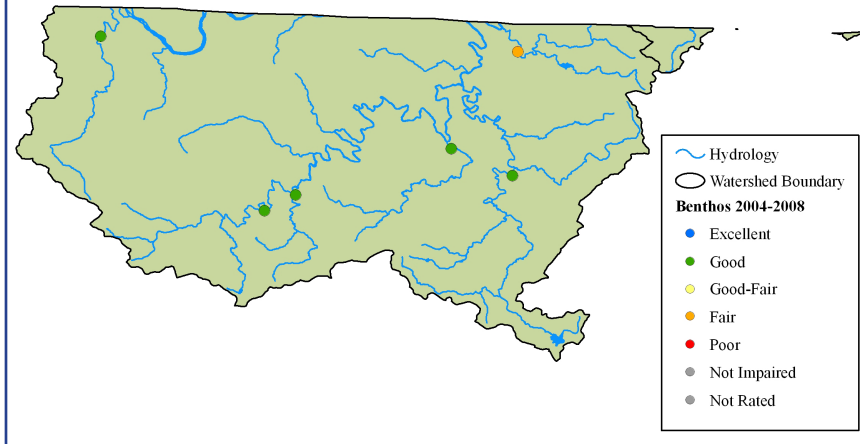
FIGURE 3-8: FISH COMMUNITY STATIONS COLOR CODED BY CURRENT RATING IN THE LITTLE RIVER WATERSHED

Each fish community station monitored during the current cycle is shown in Figure 3-8 and color coded based on the current rating. Three of the sites were new monitoring sites located in rural watersheds with no NPDES dischargers. These sites were selected to determine their potential for becoming fish community regional reference sites.

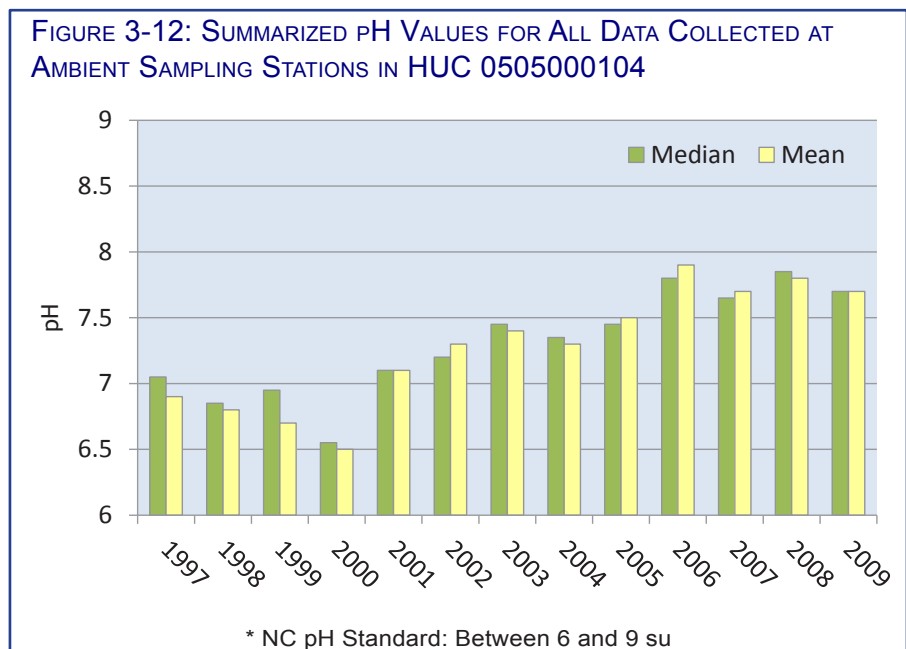
The water quality standard for pH in surface freshwater is 6.0 to 9.0 su. Both AMS stations in these watersheds were each monitored 58 times and each exceeded the high pH standard of 9 once. As seen in Figure 3-11, this is less than 10% of samples taken and neither stream will be listed as Impaired for pH. Figure 3-12 shows the mean and median pH levels for all samples taken over the course of 13 years in the Little River watershed. The pH pattern seen during this 13 year period is a steady increase towards the upper 7 range. This trend is seen in all three 10-digit watersheds in the New River Basin and is discussed further in the [Executive Summary](#).

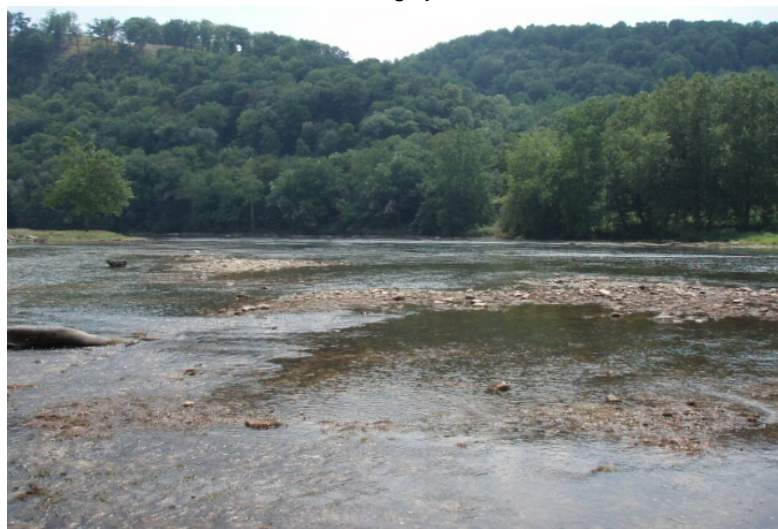
**Site Photograph**

Channel Modification (5)	4
Instream Habitat (20)	18
Bottom Substrate (15)	13
Pool Variety (10)	6
Riffle Habitat (16)	3
Left Bank Stability (7)	7
Right Bank Stability (7)	7
Light Penetration (10)	0
Left Riparian Score (5)	3
Right Riparian Score (5)	0
<b>Total Habitat Score (100)</b>	<b>61</b>

**Substrate** mix of gravel, sand; some boulder, cobble, bedrock

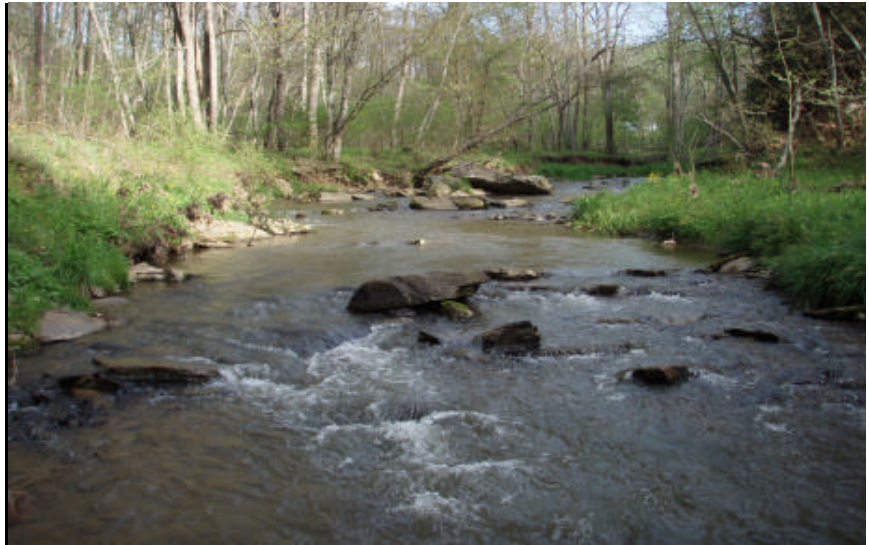
**Site Photograph**

Channel Modification (5)	5
Instream Habitat (20)	20
Bottom Substrate (15)	12
Pool Variety (10)	10
Riffle Habitat (16)	16
Left Bank Stability (7)	3
Right Bank Stability (7)	3
Light Penetration (10)	5
Left Riparian Score (5)	5
Right Riparian Score (5)	5
<b>Total Habitat Score (100)</b>	<b>84</b>

Substrate	Cobble, boulder, bedrock, and silts and sands in the pools
-----------	--

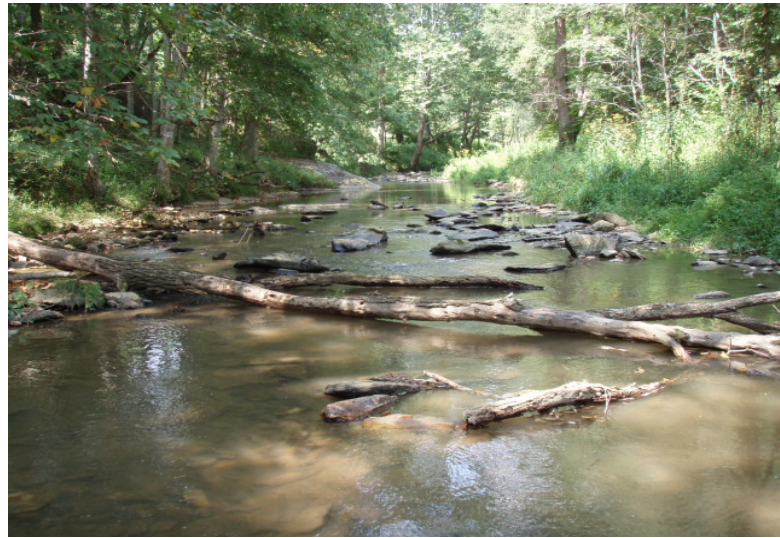
**Site Photograph**

Channel Modification (5)	4
Instream Habitat (20)	19
Bottom Substrate (15)	11
Pool Variety (10)	6
Riffle Habitat (16)	14
Left Bank Stability (7)	7
Right Bank Stability (7)	7
Light Penetration (10)	10
Left Riparian Score (5)	1
Right Riparian Score (5)	5
<b>Total Habitat Score (100)</b>	<b>84</b>

<b>Substrate</b>	mix of boulder, cobble; some gravel, sand, silt
------------------	---

The site is 0.4 stream-miles above the confluence with New River and within 0.2 miles of the Virginia border. The drop in the number of EPT taxa collected between 2003 and 2008 may be indicative of impacts to the benthic community, though that is offset by the decrease in the EPT BI value. As in 2003, periphyton was noted on the boulders and cobbles, which indicates some nutrient enrichment at the site.

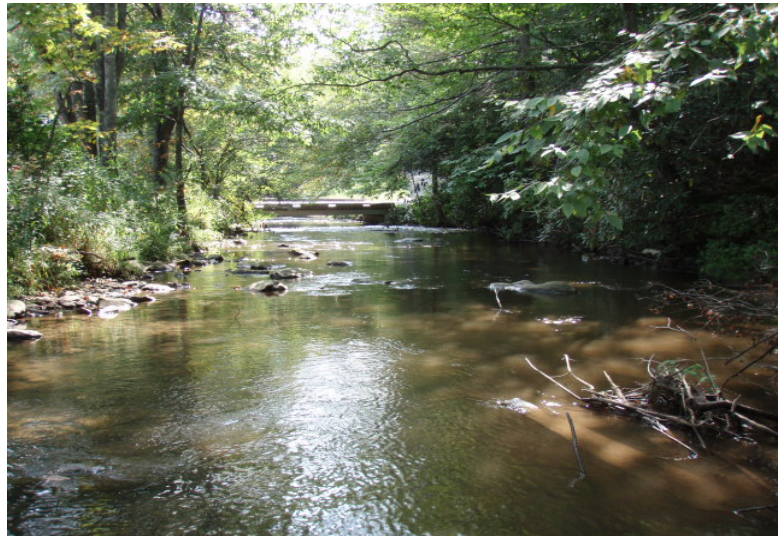
**Site Photograph**

Channel Modification (5)	4
Instream Habitat (20)	14
Bottom Substrate (15)	12
Pool Variety (10)	5
Riffle Habitat (16)	7
Left Bank Stability (7)	6
Right Bank Stability (7)	6
Light Penetration (10)	9
Left Riparian Score (5)	5
Right Riparian Score (5)	2
<b>Total Habitat Score (100)</b>	<b>70</b>

<b>Substrate</b>	mostly sand, gravel, silt; some bedrock, boulder, cobble
------------------	--

The number of EPT taxa collected in 2008 is significantly higher than in 1998 and 2003, though still lower than in 1993. There are a few notable differences in the EPT taxa present between 1993 and the following years. Two ephemerelellids, *Drunella conestee* and *Serratella serratoidea*, were both abundant in the 1993 sample but have not been recorded from any sampling event since. Also, *Drunella cornutella* was abundant in 1993, rare in 1998, and absent in each following sampling event. *Serratella deficiens* was also abundant in 1993 and absent from each summer sampling event since, though it was common in the spring sample collected in 2006.

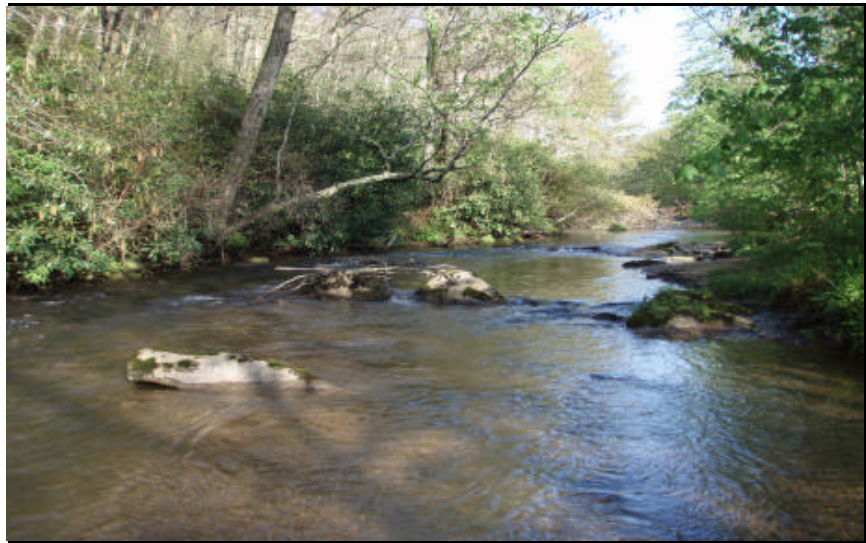
**Site Photograph**

Channel Modification (5)	5
Instream Habitat (20)	19
Bottom Substrate (15)	10
Pool Variety (10)	6
Riffle Habitat (16)	16
Left Bank Stability (7)	7
Right Bank Stability (7)	6
Light Penetration (10)	8
Left Riparian Score (5)	5
Right Riparian Score (5)	3
<b>Total Habitat Score (100)</b>	<b>85</b>

Substrate	Cobble and silt
-----------	-----------------

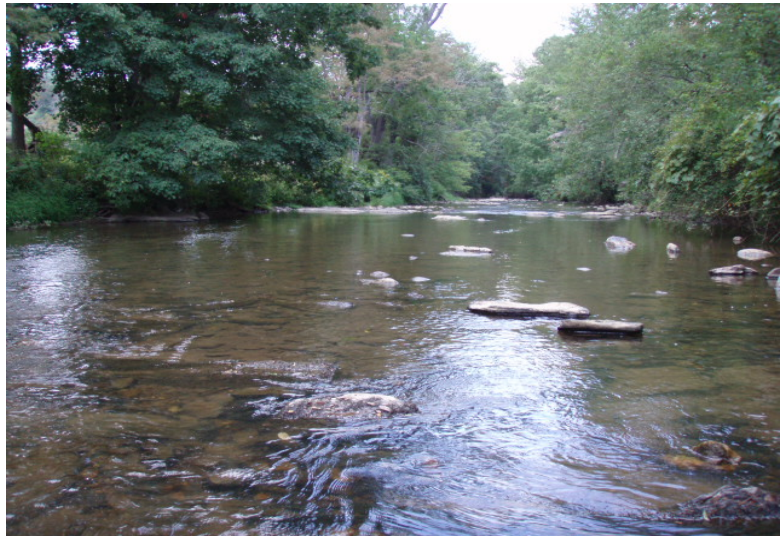
**Site Photograph**

Channel Modification (5)	4
Instream Habitat (20)	18
Bottom Substrate (15)	13
Pool Variety (10)	6
Riffle Habitat (16)	14
Left Bank Stability (7)	7
Right Bank Stability (7)	7
Light Penetration (10)	4
Left Riparian Score (5)	2
Right Riparian Score (5)	1
<b>Total Habitat Score (100)</b>	<b>76</b>

Substrate	mix of cobble, boulder, gravel, sand; some silt
-----------	---

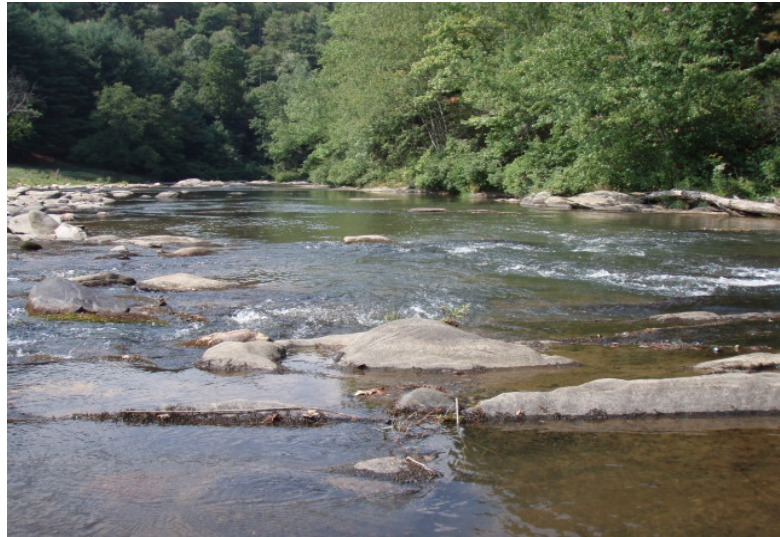
**Site Photograph**

Channel Modification (5)	5
Instream Habitat (20)	12
Bottom Substrate (15)	13
Pool Variety (10)	6
Riffle Habitat (16)	12
Left Bank Stability (7)	7
Right Bank Stability (7)	7
Light Penetration (10)	0
Left Riparian Score (5)	5
Right Riparian Score (5)	0
<b>Total Habitat Score (100)</b>	<b>67</b>

**Substrate** mostly bedrock and boulder; some sand, cobble, gravel, silt

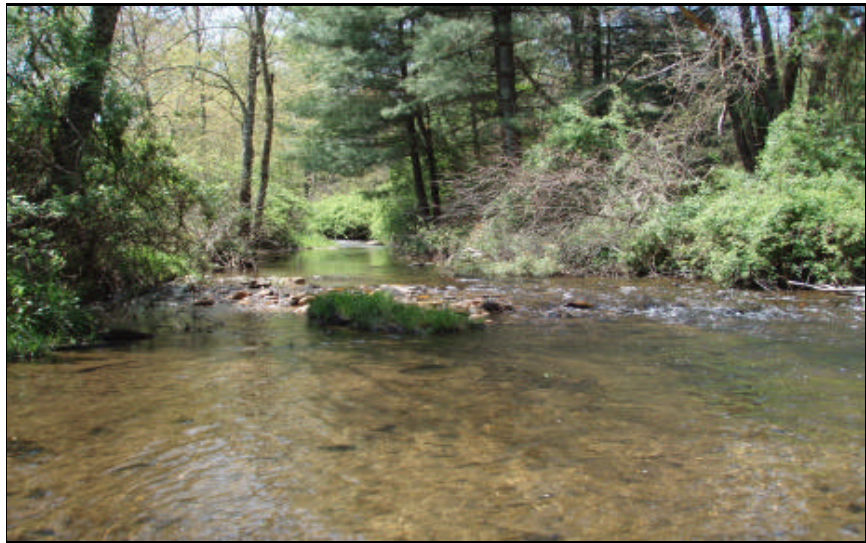
**Site Photograph**

Channel Modification (5)	5
Instream Habitat (20)	20
Bottom Substrate (15)	13
Pool Variety (10)	8
Riffle Habitat (16)	16
Left Bank Stability (7)	6
Right Bank Stability (7)	6
Light Penetration (10)	8
Left Riparian Score (5)	4
Right Riparian Score (5)	5
<b>Total Habitat Score (100)</b>	<b>91</b>

Substrate	Cobble, boulder, and angular bedrock
-----------	--------------------------------------

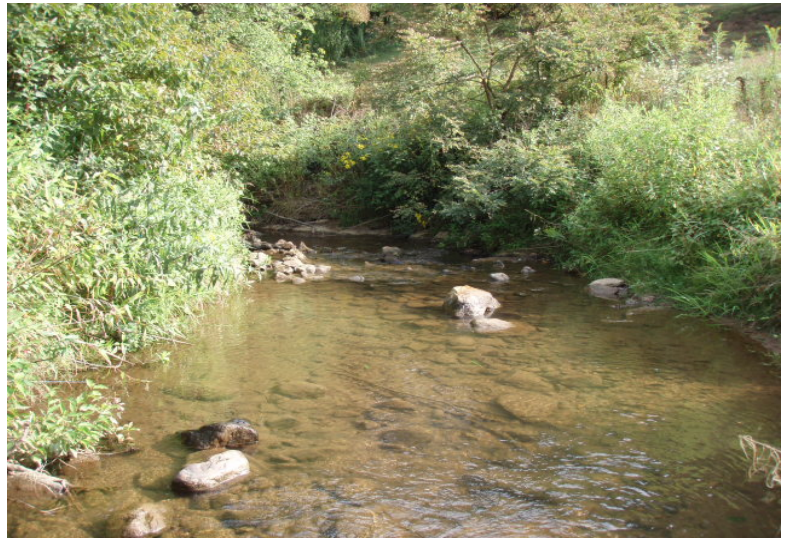
**Site Photograph**

Channel Modification (5)	5
Instream Habitat (20)	17
Bottom Substrate (15)	13
Pool Variety (10)	6
Riffle Habitat (16)	7
Left Bank Stability (7)	7
Right Bank Stability (7)	7
Light Penetration (10)	2
Left Riparian Score (5)	0
Right Riparian Score (5)	4
<b>Total Habitat Score (100)</b>	<b>68</b>

Substrate	mix of gravel, cobble, sand; some boulder, silt
-----------	---

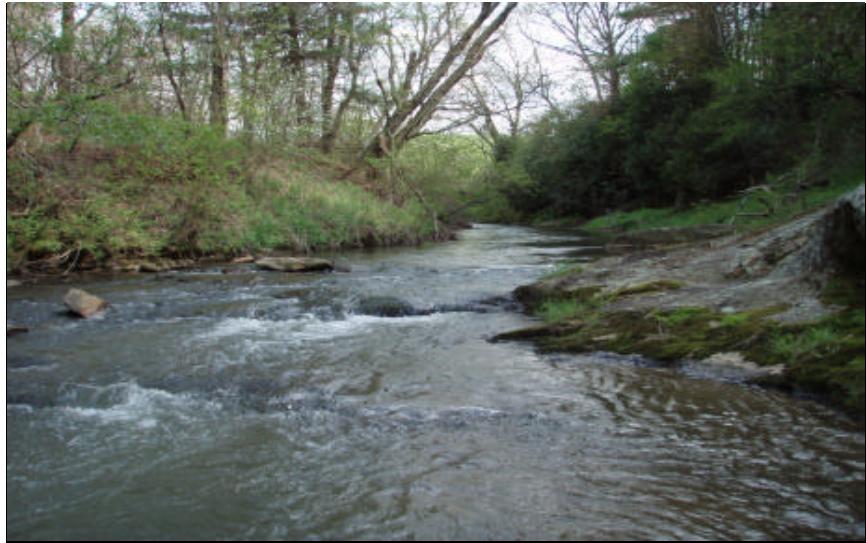
**Site Photograph**

Channel Modification (5)	5
Instream Habitat (20)	15
Bottom Substrate (15)	5
Pool Variety (10)	6
Riffle Habitat (16)	15
Left Bank Stability (7)	4
Right Bank Stability (7)	4
Light Penetration (10)	5
Left Riparian Score (5)	5
Right Riparian Score (5)	4
<b>Total Habitat Score (100)</b>	<b>68</b>

Substrate	Sand, silt, and bedrock
-----------	-------------------------

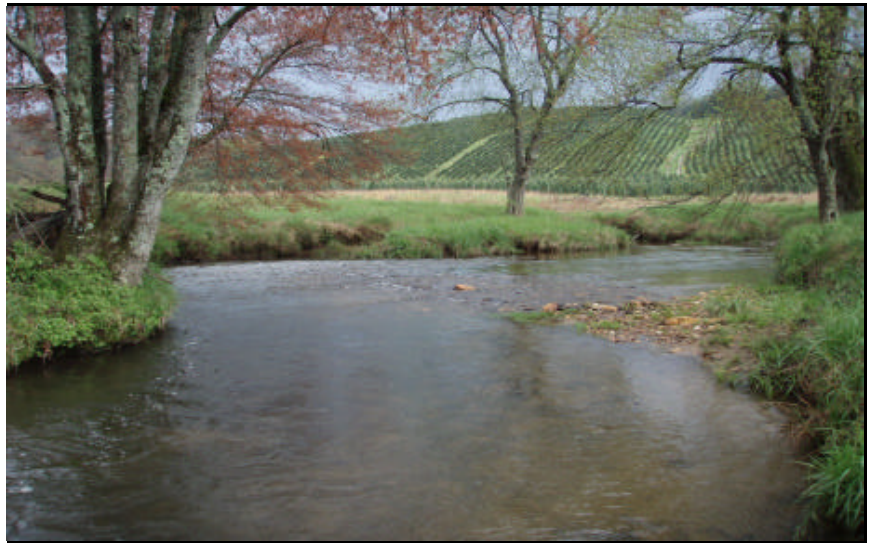
**Site Photograph**

Channel Modification (5)	5
Instream Habitat (20)	19
Bottom Substrate (15)	13
Pool Variety (10)	6
Riffle Habitat (16)	16
Left Bank Stability (7)	5
Right Bank Stability (7)	5
Light Penetration (10)	2
Left Riparian Score (5)	2
Right Riparian Score (5)	2
<b>Total Habitat Score (100)</b>	<b>75</b>

Substrate	Cobble, gravel, and soft silts along the banks
-----------	--

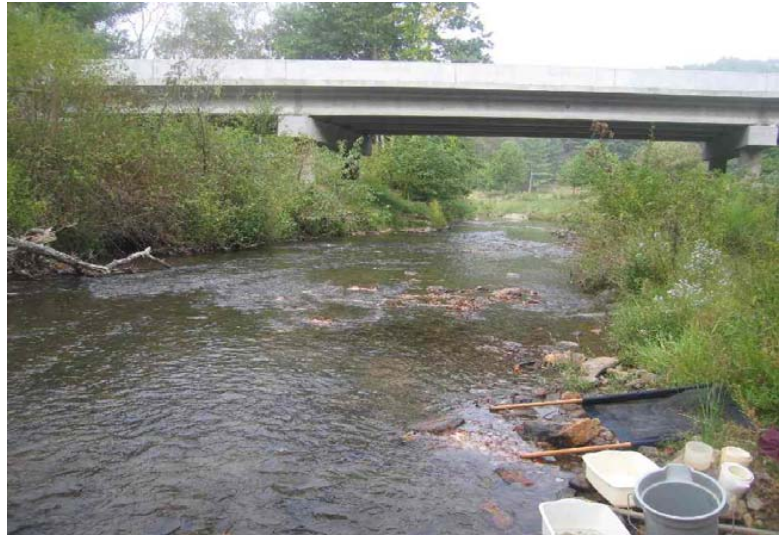
**Site Photograph**

Channel Modification (5)	5
Instream Habitat (20)	20
Bottom Substrate (15)	8
Pool Variety (10)	6
Riffle Habitat (16)	14
Left Bank Stability (7)	3
Right Bank Stability (7)	3
Light Penetration (10)	7
Left Riparian Score (5)	1
Right Riparian Score (5)	2
<b>Total Habitat Score (100)</b>	<b>69</b>

<b>Substrate</b>	mix of cobble, sand; some boulder, gravel, silt, bedrock
------------------	--

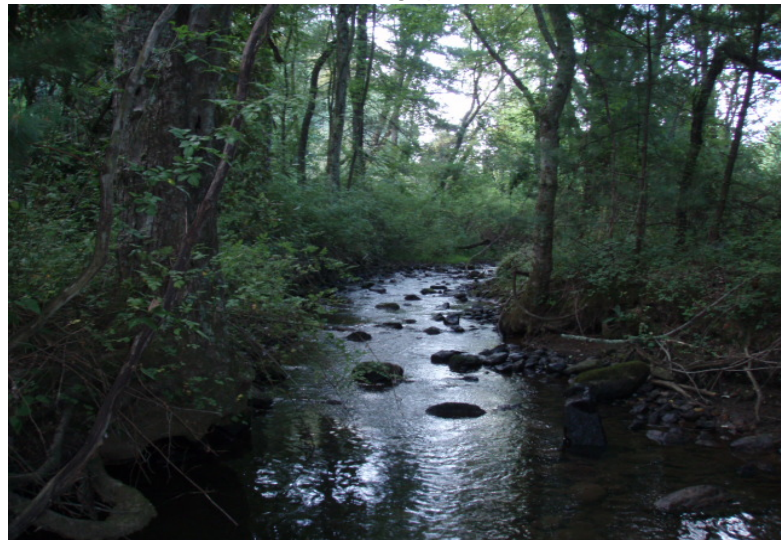
**Site Photograph**

Channel Modification (5)	4
Instream Habitat (20)	19
Bottom Substrate (15)	12
Pool Variety (10)	8
Riffle Habitat (16)	16
Left Bank Stability (7)	6
Right Bank Stability (7)	6
Light Penetration (10)	9
Left Riparian Score (5)	3
Right Riparian Score (5)	4
<b>Total Habitat Score (100)</b>	<b>87</b>

<b>Substrate</b>	mix of cobble, boulder, gravel, sand; some silt
------------------	---

Due to the small size of the stream it was decided for the latest sampling effort to use EPT rather than Full-Scale collection methods (as was used for the prior three sampling events at the site); part of the reason for the decrease in EPT Richness between 2008 and the prior summer sampling event in 2003 is certainly due to the different collection methods used. The EPT BI is better for comparison of conditions when those two sampling methods are used; there is no evidence of change in water quality between 2003 and 2008 using that metric.

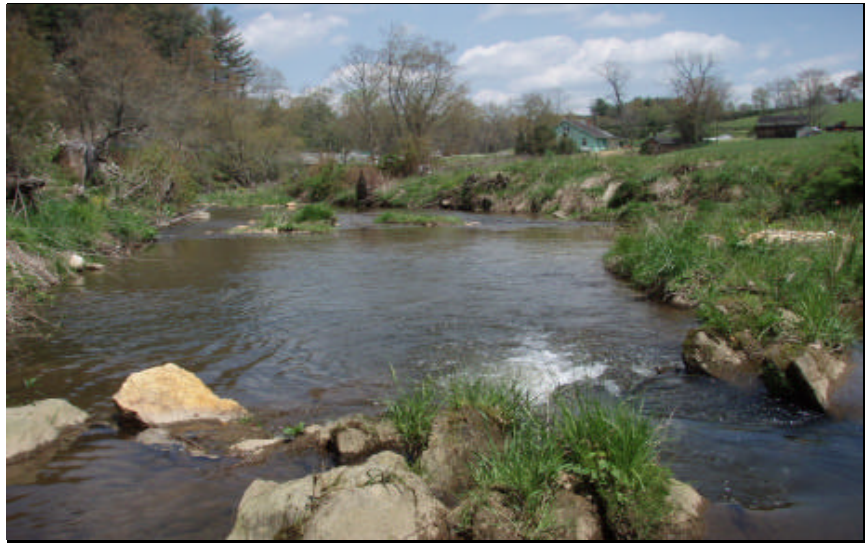
**Site Photograph**

Channel Modification (5)	5
Instream Habitat (20)	19
Bottom Substrate (15)	12
Pool Variety (10)	10
Riffle Habitat (16)	16
Left Bank Stability (7)	4
Right Bank Stability (7)	4
Light Penetration (10)	2
Left Riparian Score (5)	1
Right Riparian Score (5)	4
<b>Total Habitat Score (100)</b>	<b>77</b>

<b>Substrate</b>	Slick bedrock, boulders, silts on the substrate
------------------	---
