# Appendix 1B

## Biological Assessment

### Macroinvertebrate and Fish Site Sample Results

Site Summaries for the Hiwassee Basin

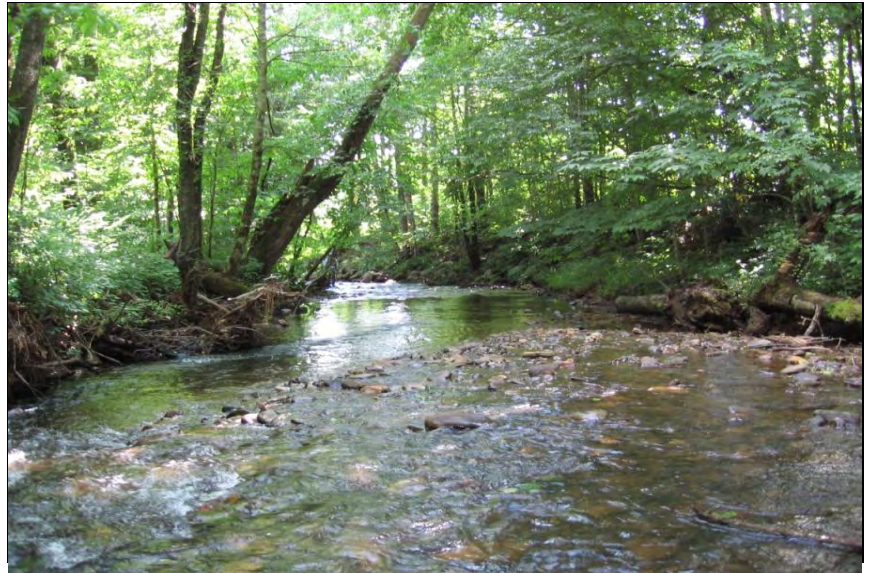
**Site Photograph**

Channel Modification (5)	5
Instream Habitat (20)	16
Bottom Substrate (15)	15
Pool Variety (10)	6
Riffle Habitat (16)	14
Bank Erosion (7)	6
Bank Vegetation (7)	6
Light Penetration (10)	10
Left Riparian Score (5)	5
Right Riparian Score (5)	5
<b>Total Habitat Score (100)</b>	<b>88</b>

**Substrate** Mostly cobble and gravel with small amounts of boulder and sand

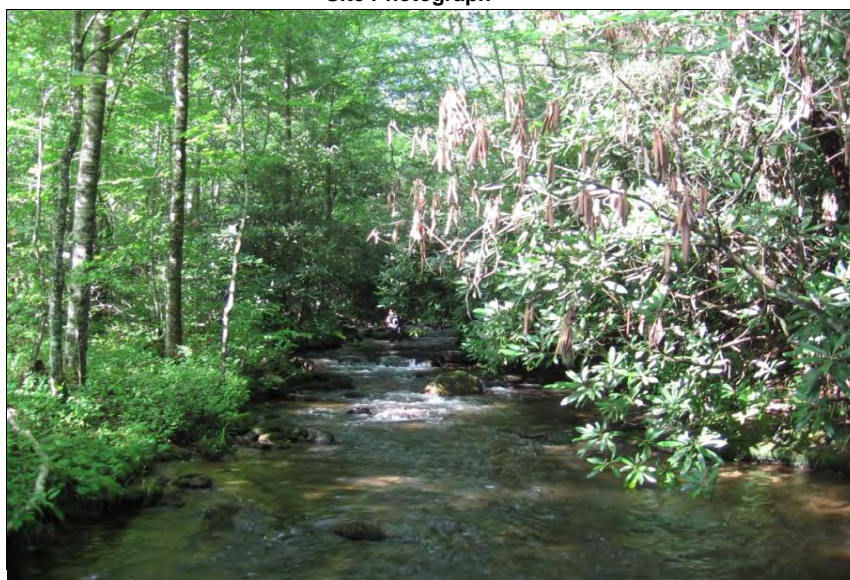
**Site Photograph**

Channel Modification (5)	5
Instream Habitat (20)	19
Bottom Substrate (15)	8
Pool Variety (10)	6
Riffle Habitat (16)	15
Bank Erosion (7)	7
Bank Vegetation (7)	6
Light Penetration (10)	10
Left Riparian Score (5)	5
Right Riparian Score (5)	5
<b>Total Habitat Score (100)</b>	<b>86</b>

**Substrate** Good mix of boulder, cobble, gravel with small amounts of sand

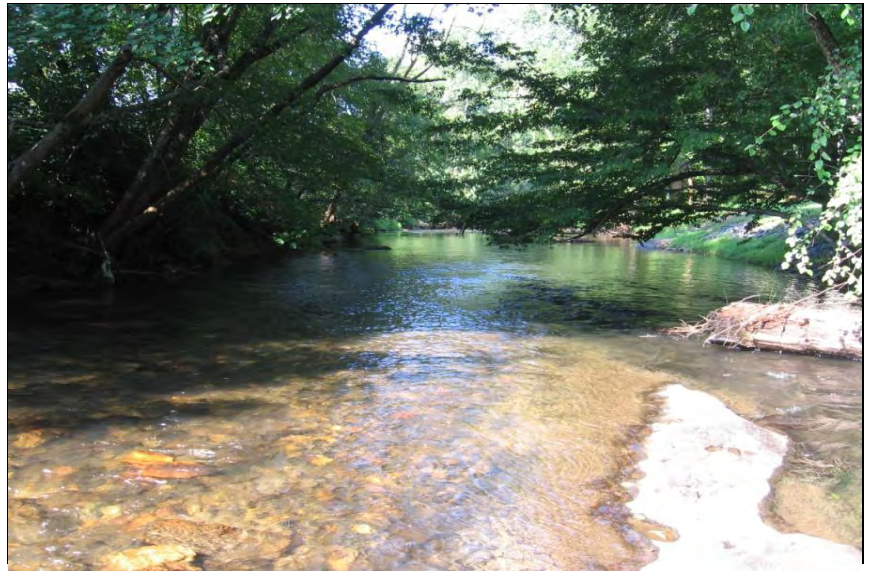
**Site Photograph**

Channel Modification (5)	5
Instream Habitat (20)	20
Bottom Substrate (15)	12
Pool Variety (10)	6
Riffle Habitat (16)	12
Bank Erosion (7)	6
Bank Vegetation (7)	9
Light Penetration (10)	7
Left Riparian Score (5)	1
Right Riparian Score (5)	3
<b>Total Habitat Score (100)</b>	<b>75</b>

**Substrate** A mix of bedrock, boulder, cobble, gravel and sand

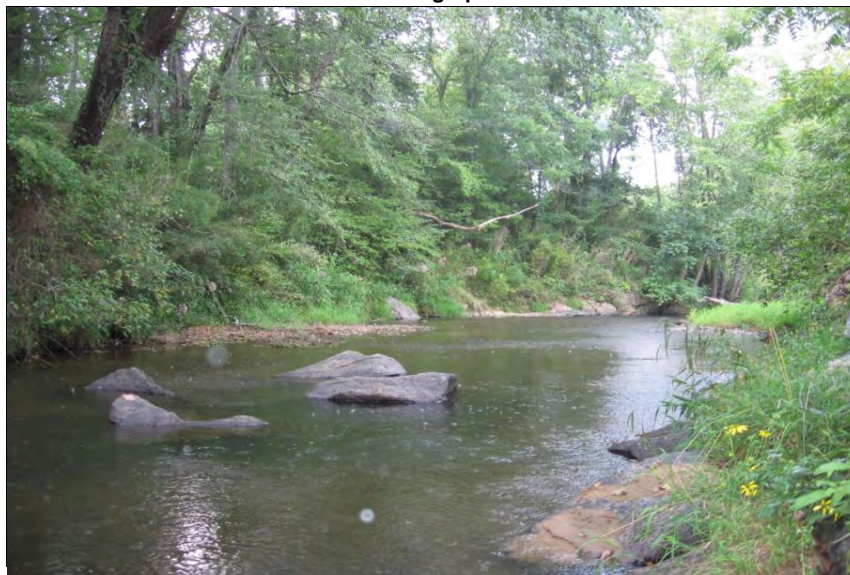
**Site Photograph**

Channel Modification (5)	5
Instream Habitat (20)	16
Bottom Substrate (15)	7
Pool Variety (10)	10
Riffle Habitat (16)	7
Bank Erosion (7)	6
Bank Vegetation (7)	4
Light Penetration (10)	7
Left Riparian Score (5)	4
Right Riparian Score (5)	4
<b>Total Habitat Score (100)</b>	<b>70</b>

**Substrate** A mix of bedrock, boulder, cobble, gravel and sand

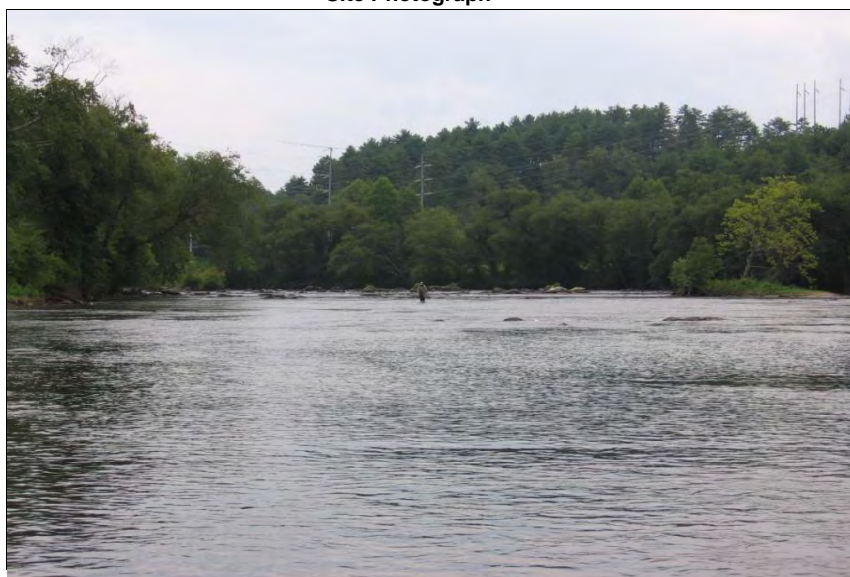
### Site Photograph

Channel Modification (5)	4
Instream Habitat (20)	20
Bottom Substrate (15)	10
Pool Variety (10)	8
Riffle Habitat (16)	12
Bank Erosion (7)	5
Bank Vegetation (7)	6
Light Penetration (10)	3
Left Riparian Score (5)	3
Right Riparian Score (5)	4
<b>Total Habitat Score (100)</b>	<b>75</b>

Substrate: Mostly boulder and cobble with small amounts of gravel and sand

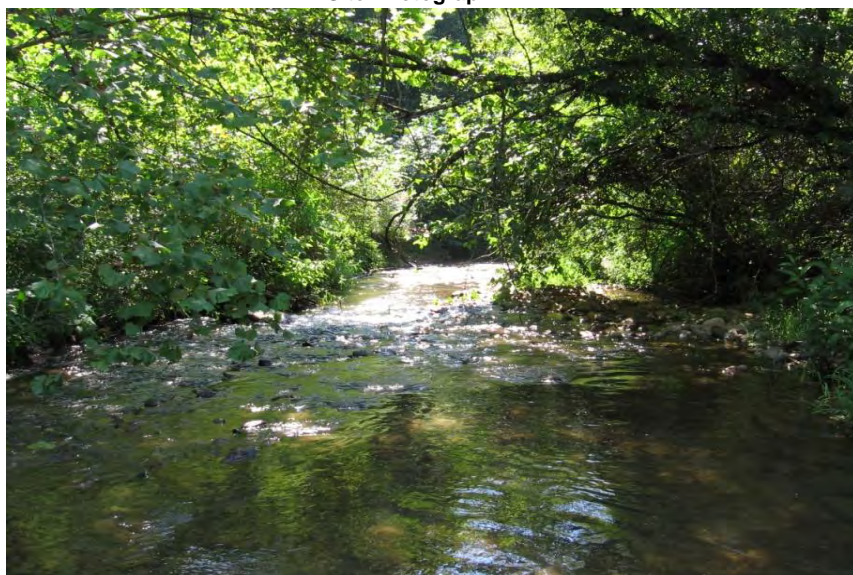
### Site Photograph

Channel Modification (5)	5
Instream Habitat (20)	20
Bottom Substrate (15)	12
Pool Variety (10)	6
Riffle Habitat (16)	16
Bank Erosion (7)	7
Bank Vegetation (7)	4
Light Penetration (10)	7
Left Riparian Score (5)	5
Right Riparian Score (5)	5
<b>Total Habitat Score (100)</b>	<b>87</b>

Substrate	Mostly cobble with small amounts of boulder and gravel
-----------	--

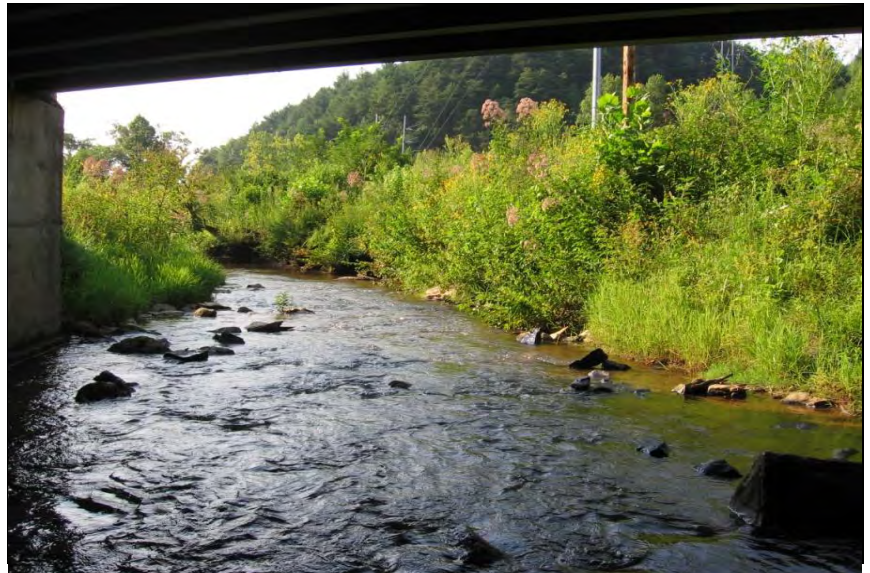
**Site Photograph**

Channel Modification (5)	5
Instream Habitat (20)	16
Bottom Substrate (15)	11
Pool Variety (10)	8
Riffle Habitat (16)	7
Bank Erosion (7)	6
Bank Vegetation (7)	5
Light Penetration (10)	5
Left Riparian Score (5)	4
Right Riparian Score (5)	4
<b>Total Habitat Score (100)</b>	<b>71</b>

Substrate	Some boulder, cobble and sand that is heavily coated iwith silt
-----------	---

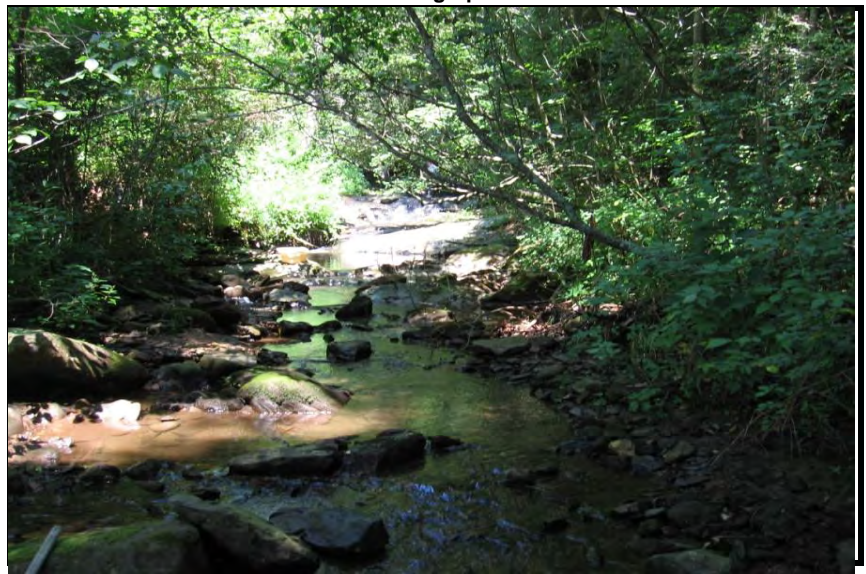
**Site Photograph**

Channel Modification (5)	5
Instream Habitat (20)	20
Bottom Substrate (15)	12
Pool Variety (10)	10
Riffle Habitat (16)	16
Bank Erosion (7)	7
Bank Vegetation (7)	7
Light Penetration (10)	10
Left Riparian Score (5)	3
Right Riparian Score (5)	5
<b>Total Habitat Score (100)</b>	<b>95</b>

**Substrate** Mostly bedrock with some boulder, cobble, gravel and sand.

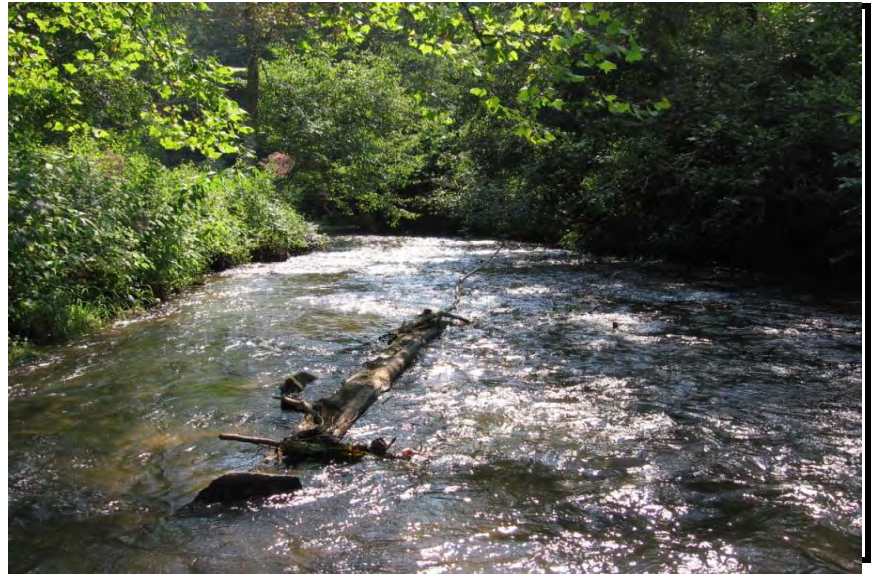
**Site Photograph**

Channel Modification (5)	4
Instream Habitat (20)	18
Bottom Substrate (15)	8
Pool Variety (10)	4
Riffle Habitat (16)	16
Bank Erosion (7)	6
Bank Vegetation (7)	4
Light Penetration (10)	4
Left Riparian Score (5)	3
Right Riparian Score (5)	3
<b>Total Habitat Score (100)</b>	<b>70</b>

Substrate Mix of boulder, cobble, gravel and sand

Hanging Dog Creek is a tributary to Hiwassee Lake and drains a portion of the Nantahala National Forest north of Murphy, NC. Although much of the watershed is forested, a road follows almost the entire main stem of this water body and has resulted in residential development along much of the stream channel. This along with a few erosional areas and narrow riparian vegetation along both banks resulted in a moderate habitat score. Bottom substrate was diverse but it appears the amount of sand has increased from that noted in previous habitat assessments.

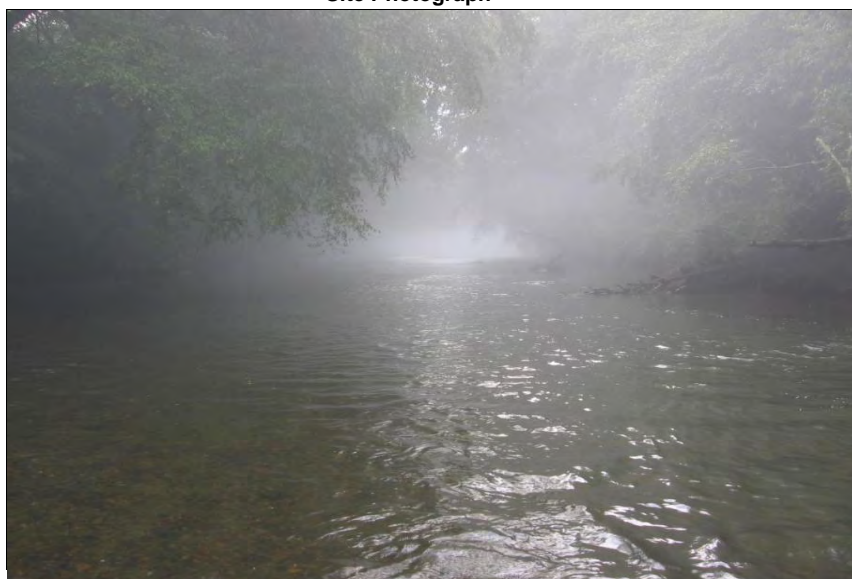
### Site Photograph

Channel Modification (5)	5
Instream Habitat (20)	20
Bottom Substrate (15)	8
Pool Variety (10)	4
Riffle Habitat (16)	7
Bank Erosion (7)	5
Bank Vegetation (7)	7
Light Penetration (10)	7
Left Riparian Score (5)	5
Right Riparian Score (5)	5
<b>Total Habitat Score (100)</b>	<b>73</b>

Substrate	Mostly gravel and cobble with small amounts of boulder and sand
-----------	---

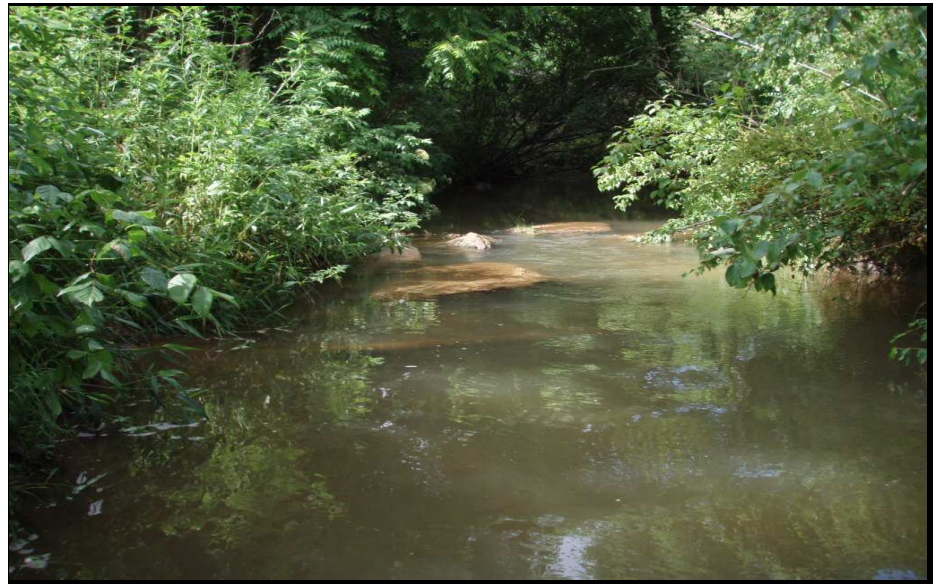
**Site Photograph**

Channel Modification (5)	4
Instream Habitat (20)	14
Bottom Substrate (15)	5
Pool Variety (10)	6
Riffle Habitat (16)	3
Bank Erosion (7)	4
Bank Vegetation (7)	4
Light Penetration (10)	8
Left Riparian Score (5)	3
Right Riparian Score (5)	4
<b>Total Habitat Score (100)</b>	<b>55</b>

Substrate	sand, silt, boulder
-----------	---------------------

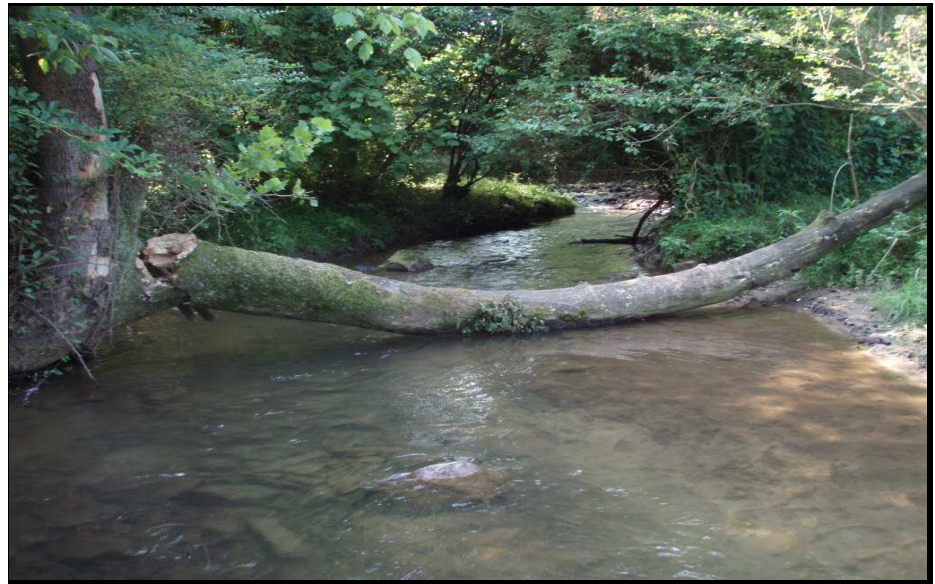
**Site Photograph**

Channel Modification (5)	5
Instream Habitat (20)	16
Bottom Substrate (15)	10
Pool Variety (10)	6
Riffle Habitat (16)	12
Bank Erosion (7)	3
Bank Vegetation (7)	6
Light Penetration (10)	7
Left Riparian Score (5)	1
Right Riparian Score (5)	1
<b>Total Habitat Score (100)</b>	<b>67</b>

Substrate	cobble, bedrock, gravel, silt
-----------	-------------------------------

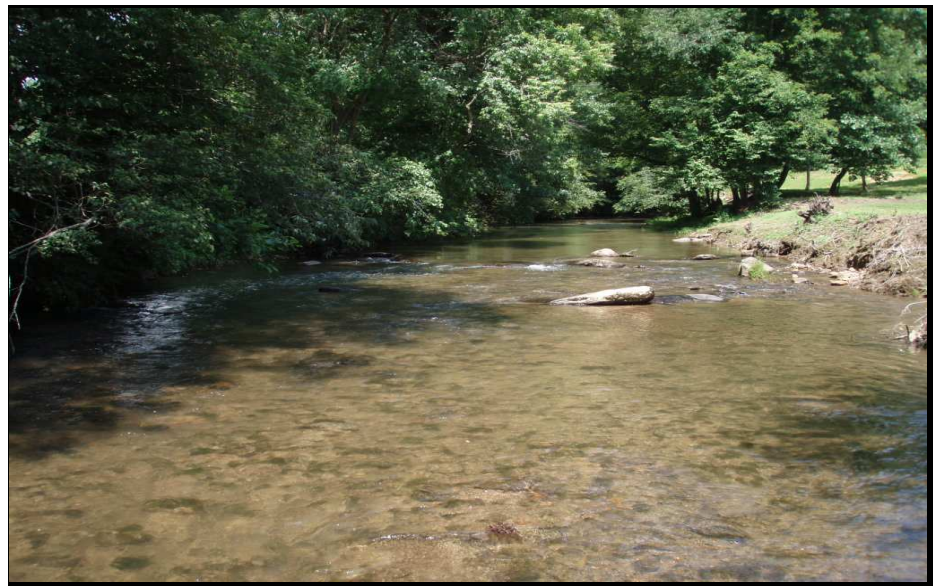
**Site Photograph**

Channel Modification (5)	5
Instream Habitat (20)	18
Bottom Substrate (15)	12
Pool Variety (10)	6
Riffle Habitat (16)	16
Bank Erosion (7)	5
Bank Vegetation (7)	5
Light Penetration (10)	7
Left Riparian Score (5)	3
Right Riparian Score (5)	2
<b>Total Habitat Score (100)</b>	<b>79</b>

Substrate	cobble, bedrock, gravel, sand
-----------	-------------------------------

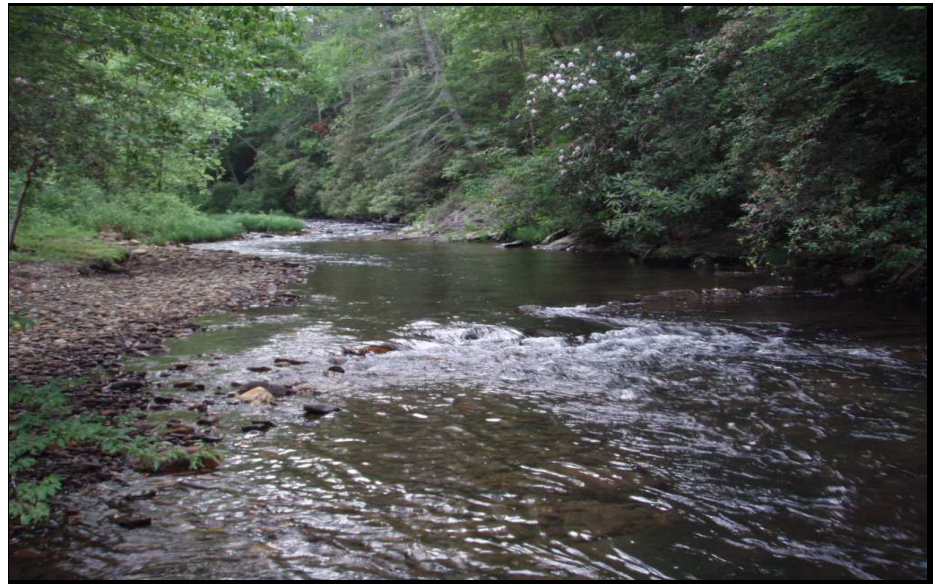
**Site Photograph**

Channel Modification (5)	5
Instream Habitat (20)	20
Bottom Substrate (15)	15
Pool Variety (10)	8
Riffle Habitat (16)	16
Bank Erosion (7)	7
Bank Vegetation (7)	7
Light Penetration (10)	10
Left Riparian Score (5)	4
Right Riparian Score (5)	5
<b>Total Habitat Score (100)</b>	<b>97</b>

Substrate	cobble, boulder, bedrock, gravel
-----------	----------------------------------

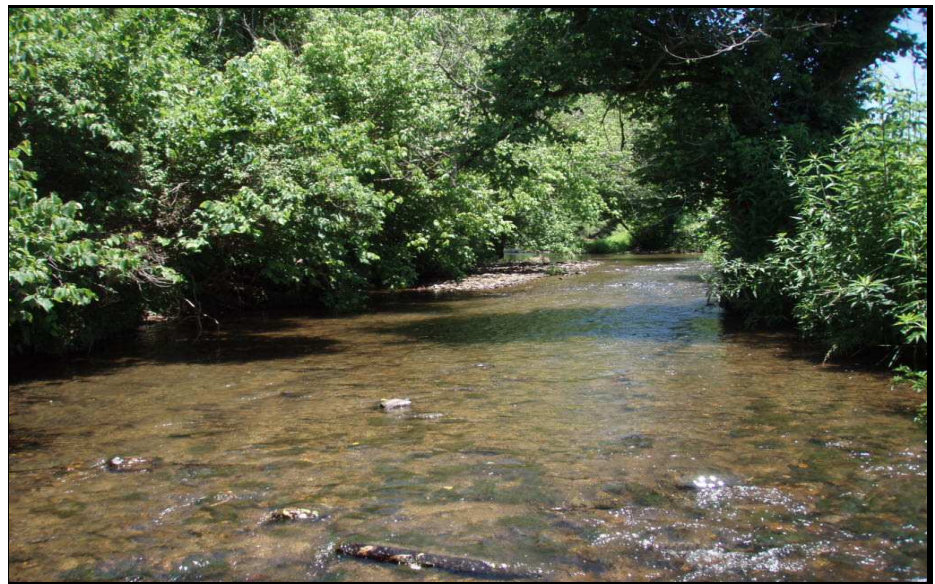
**Site Photograph**

Channel Modification (5)	5
Instream Habitat (20)	16
Bottom Substrate (15)	10
Pool Variety (10)	10
Riffle Habitat (16)	10
Bank Erosion (7)	6
Bank Vegetation (7)	5
Light Penetration (10)	7
Left Riparian Score (5)	3
Right Riparian Score (5)	2
<b>Total Habitat Score (100)</b>	<b>74</b>

Substrate	cobble, gravel, boulder, silt
-----------	-------------------------------

**Watershed** - located east of Murphy about 1/2 mile above the Hiwassee River confluence; drains the mid-eastern edge of Cherokee County. **Habitats** - Instream habitats include runs, riffles, and side snag pools. The riparian widths remain thin but intact, except where soil was being pushed over the right bank from the adjacent field. The total habitat score has improved by 16 points since 2004, mostly due to higher bank stability and vegetation scores; scoured banks from high flows just prior to the 2004 sample have since healed. **2009** - an extremely rich and trophically balanced assemblage of cold, cool, and warm water species was collected, including three intolerants (Rock Bass, Silver Shiner, Gilt Darter). Almost twice the total abundance as collected in 2004 (n= 982 vs 535), mostly due to increases in Tennessee Shiner (n=284 vs 77) and Mottled Sculpin (n=327 vs 197). Two hellbenders (pollution intolerant) were also collected in 2009. **2004 - 2009** - the NCIBI metrics have remained stable; despite the elevated specific conductance, the fish community here continues to suggest excellent water quality.

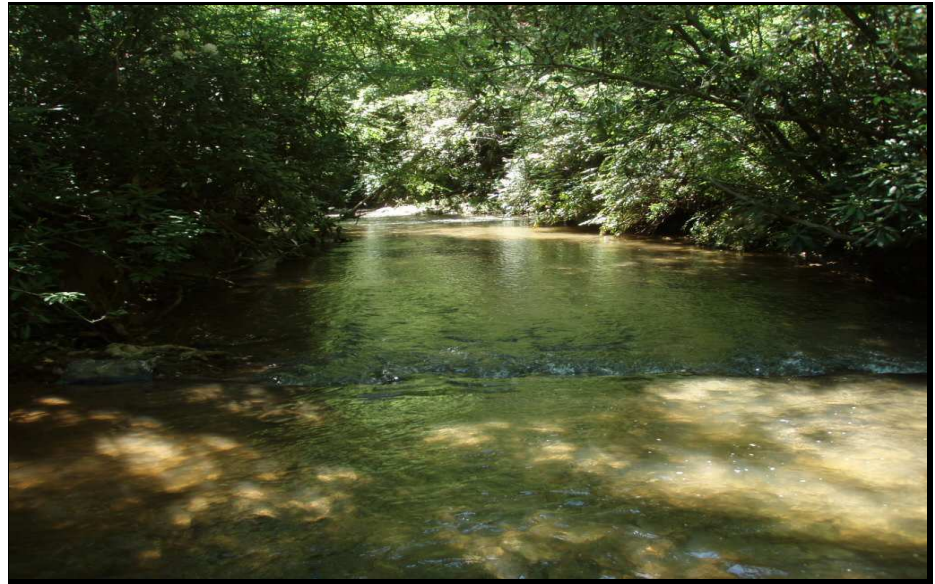
**Site Photograph**

Channel Modification (5)	5
Instream Habitat (20)	18
Bottom Substrate (15)	8
Pool Variety (10)	4
Riffle Habitat (16)	5
Bank Erosion (7)	5
Bank Vegetation (7)	7
Light Penetration (10)	10
Left Riparian Score (5)	5
Right Riparian Score (5)	5
<b>Total Habitat Score (100)</b>	<b>72</b>

Substrate	flat cobble, sand, boulder, bedrock
-----------	-------------------------------------

**Watershed** - drains part of the southeast corner of Cherokee County; the site is located just below Murphy, about 400 meters above the Hiwassee River confluence. The urban and agricultural land uses of this catchment is reflected in the relatively high conductivity at this site. **Habitat** - instream habitats consist of moderately embedded shallow runs, bedrock shelves, and some side root snags and short riffles. A slight increase in fine silts upon substrates was observed in 2009. Although crossed by the newly constructed US 64 just upstream, the riparian corridor is densely vegetated here, primarily with Rhododendron. **2009** - a moderately abundant (n = 449) and rich assemblage of cool and warm water fish was collected at this regional reference site, including three top predator species (Largemouth Bass, Spotted Bass and young of year Walleye). However, no Rock Bass, Smallmouth Bass or trout were collected. These additions, and the 10 fold increase in the intolerant Highland Shiner in 2009 (n=233 vs 22 in 2006, and 26 in 2004) are likely due to the recruitment opportunities provided by the nearby river. 2004 - 2009 - The fluctuations in ratings here seem to be the result of trophic shifts within the fish community between insectivores and omnivores + herbivores, which may be due to the forementioned recruitment potential. Overall, the cause of impairment is unclear.

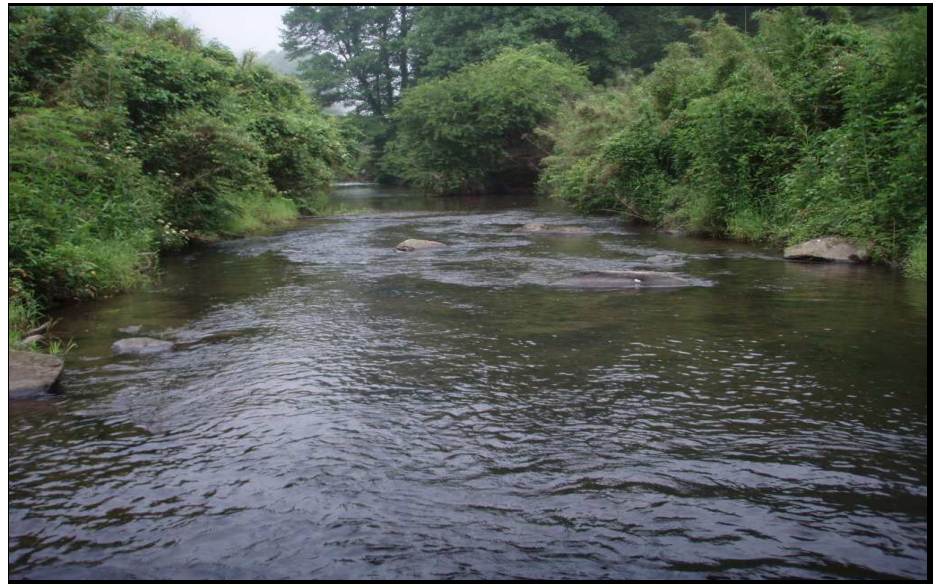
**Site Photograph**

Substrate	cobble, bedrock, gravel, sand, silt
-----------	-------------------------------------

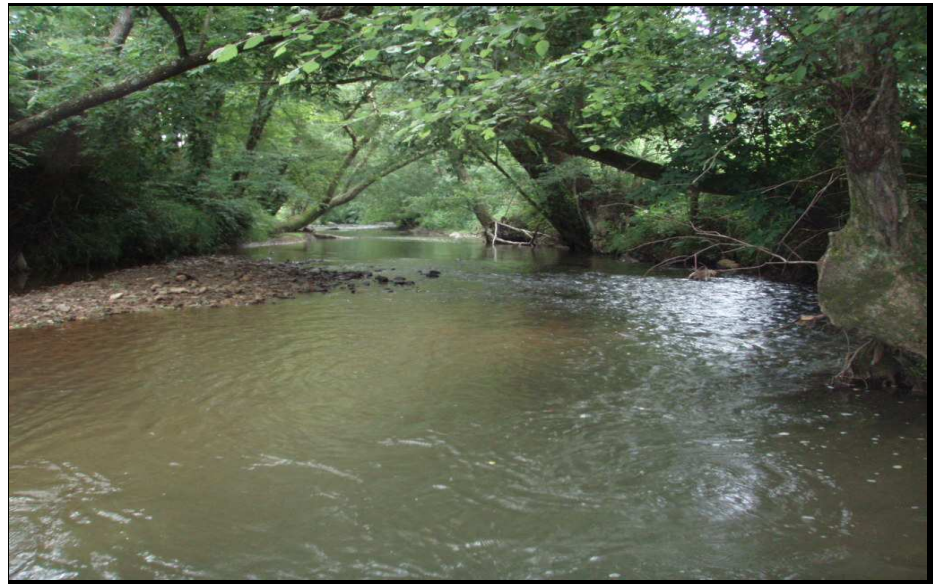
**Site Photograph**

Substrate	cobble, gravel, boulder, sand
-----------	-------------------------------

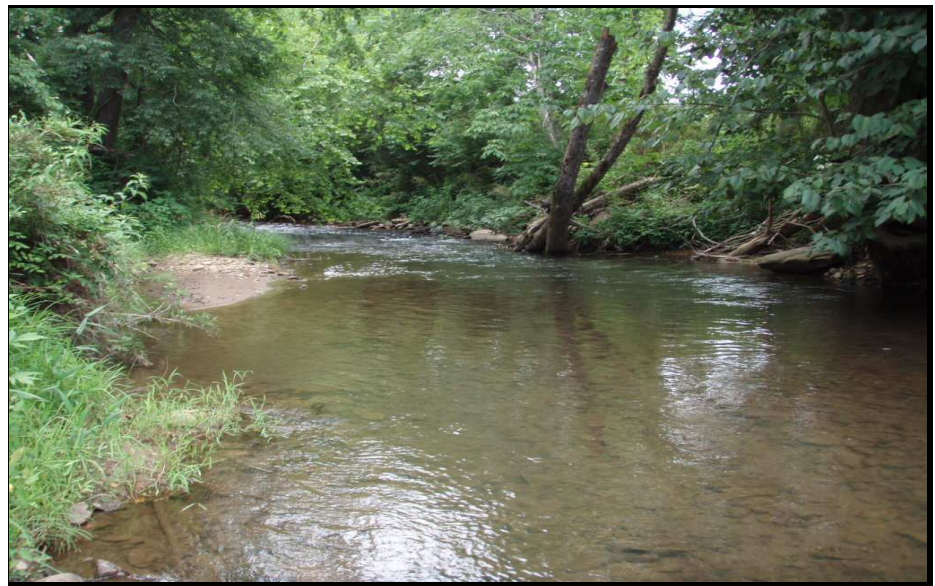
**Site Photograph**

Substrate	cobble, boulder, sand, bedrock
-----------	--------------------------------

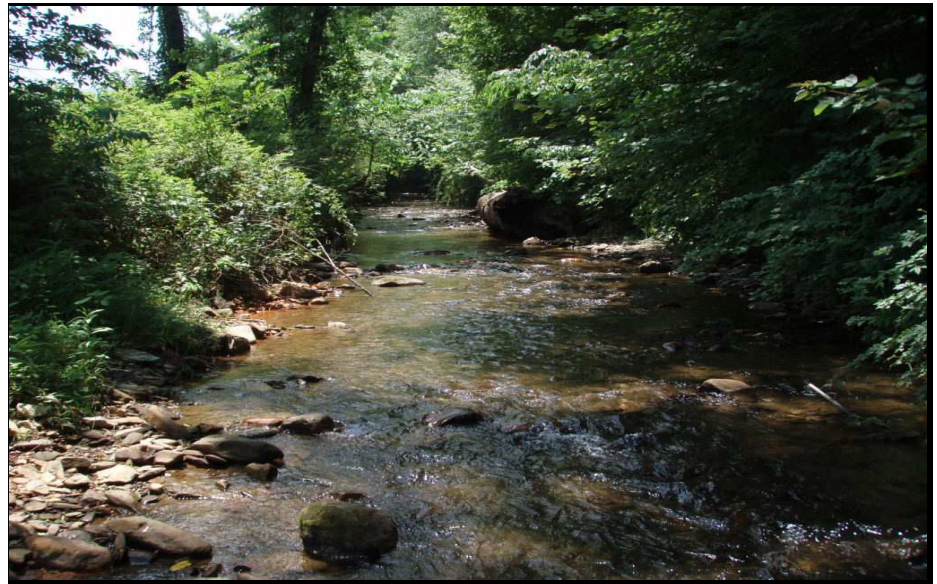
**Site Photograph**

Channel Modification (5)	5
Instream Habitat (20)	20
Bottom Substrate (15)	14
Pool Variety (10)	4
Riffle Habitat (16)	16
Bank Erosion (7)	7
Bank Vegetation (7)	6
Light Penetration (10)	7
Left Riparian Score (5)	2
Right Riparian Score (5)	5
<b>Total Habitat Score (100)</b>	<b>86</b>

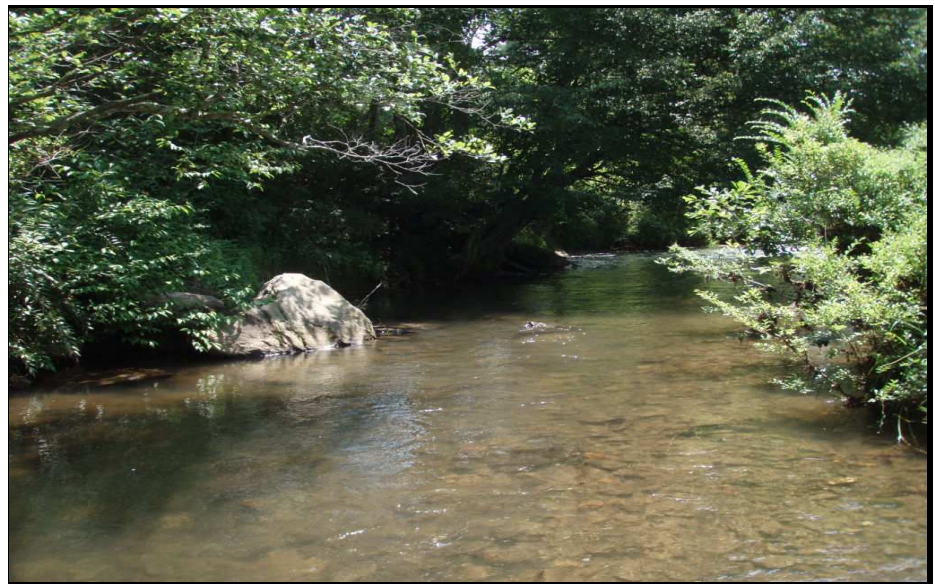
**Site Photograph**

Channel Modification (5)	5
Instream Habitat (20)	18
Bottom Substrate (15)	10
Pool Variety (10)	10
Riffle Habitat (16)	14
Bank Erosion (7)	6
Bank Vegetation (7)	5
Light Penetration (10)	5
Left Riparian Score (5)	2
Right Riparian Score (5)	1
<b>Total Habitat Score (100)</b>	<b>76</b>
