UPPER LITTLE TENNESSEE RIVER SUBBASIN

HUC 06010202

2012 DWQ LITTLE TENNESSEE RIVER BASIN PLAN: UPPER LITTLE TENNESSEE SUBBASIN (HUC 06010202)

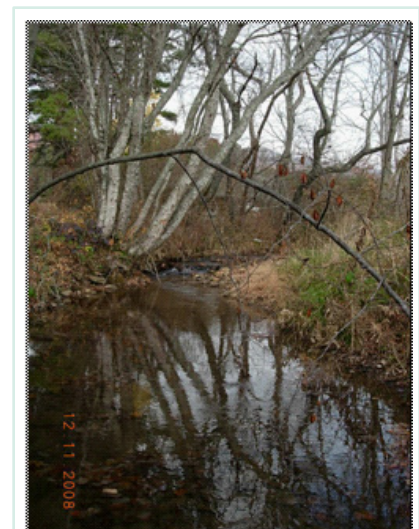
Good fish habitat in Matlock Creek

LTWA collected fish samples on Cowee Creek and three of its larger tributaries: Caler Fork, Matlock Creek, and Beasley Creek. Their results compare well with the DWQ samples and indicate the fish community in the downstream reach is in good health, but also note an increase in stream temperature and disappearance of trout. Significant sedimentation impacts are noted in and above Caler Fork from failing roads in the Wildflower development. LTWA measured the single largest drop in stream health at their site on Caler Fork. They report turbidity problems on this stream even during dry spells. Caler Fork received a Fair IBI fish rating; details of their monitoring results are described on their [Health Report Card](#). LTWA noted Matlock Creek is also deteriorating, perhaps due to an increase in organic loading from development. Beasley is in good condition and supports a healthy population of rainbow trout.
