HIWASSEE LAKE WATERSHED

HUC 0602000207

NC Division of Water Quality
 Basinwide Planning Unit
 March 2012

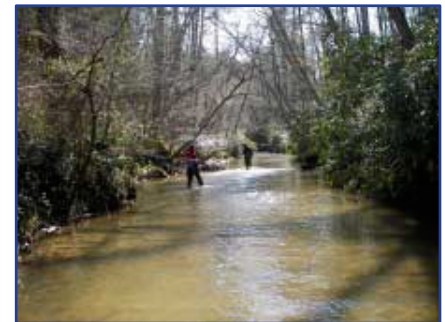
Martin Creek at SR 1558, Sites FF7 & FB14

In 2004, Martin Creek at SR 1558 (sites FF7 & FB14) was considered a regional reference site because of its instream, riparian, and watershed characteristics. At that time, based upon an examination of topographic maps, it was estimated that approximately 60 percent of the watershed upstream from the site was forested. GIS analyses, based upon 1993-1995 landuse coverage, showed that approximately 75 percent of the watershed was forested and approximately 20 percent in pasture. Thus, despite the prevalence of pasture alongside the creek throughout the middle of the watershed and that which was observed in 2006 at sites FB51 and FB14 technically continued to qualify as a regional reference site. However, the fish community has not been rated Good or Excellent even though this site has moderately high quality instream and riparian habitats. There are no known upstream dischargers and nonpoint source runoff should not be affecting this moderate gradient stream. But clearly, some factor(s) is impacting the fish community. Effects from historical land use practices within the watershed and illegal discharges (e.g., "straight pipes") may be impacting the stream. The uniform depth, the relatively homogenous flat cobble substrate covered with fine silts, the lack of productive riffles, and the lack of deep pools with submerged structures undoubtedly all contribute to the low total abundance of fish, the low diversities and abundance of cyprinids, darters, and Rock Bass, Smallmouth Bass, and Trout, and ultimately the continued lower than expected NCIBI ratings. Although the watershed is predominantly forested, land use practices closest to the stream throughout the watershed and upstream from the SR 1558 monitoring site may be having a negative impact on the downstream fish community that far exceeds the moderately high quality habitat benefits at the monitoring site. (BAU Memorandum B-20060731).

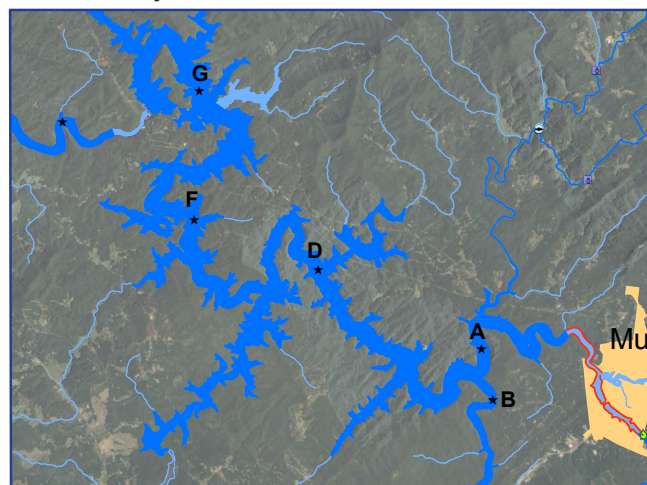
Hiwassee Lake Station Locations

Hiwassee Lake [AU# 1-(53)] was built by the Tennessee Valley Authority (TVA) between 1936 and 1940 to provide hydroelectric power and is the second largest TVA-owned lake in North Carolina. Hiwassee Reservoir's classifications include C and B, for the protection of primary recreation and aquatic life. DWQ took water quality samples in the lake from May through September 2009 and did not detect any water quality parameters of concern. The locations of samples sites are located on the figure to the right. For more details regarding the data collected see the [ESS Lake & Reservoir Assessment report](#).

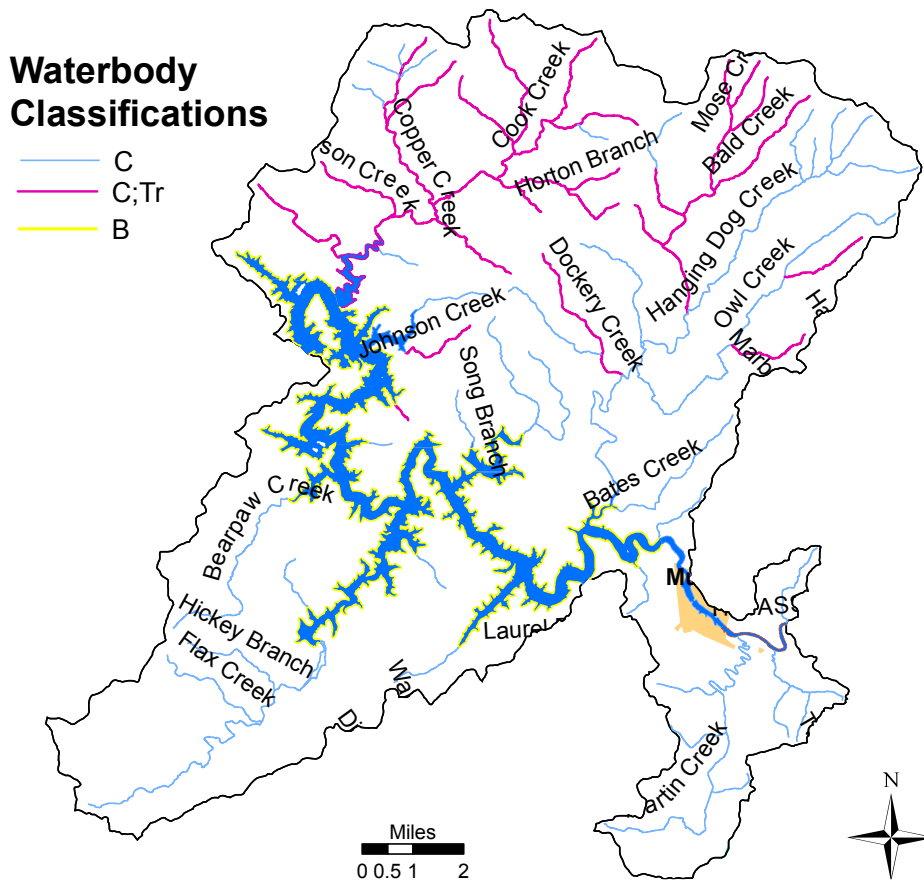
FIGURE 1-3: WATERBODY CLASSIFICATIONS

All surface waters in the state are assigned at least one primary classification and they may also be assigned one or more supplemental classifications, Figure 1-3 . A list of classifications with a description of their requirements can be found in Chapter 2 of the [Supplemental Guide to Basinwide Planning](#).
