# UPPER DAN RIVER SUBBASIN

HUC 03010103

## SUBBASIN WATER QUALITY OVERVIEW

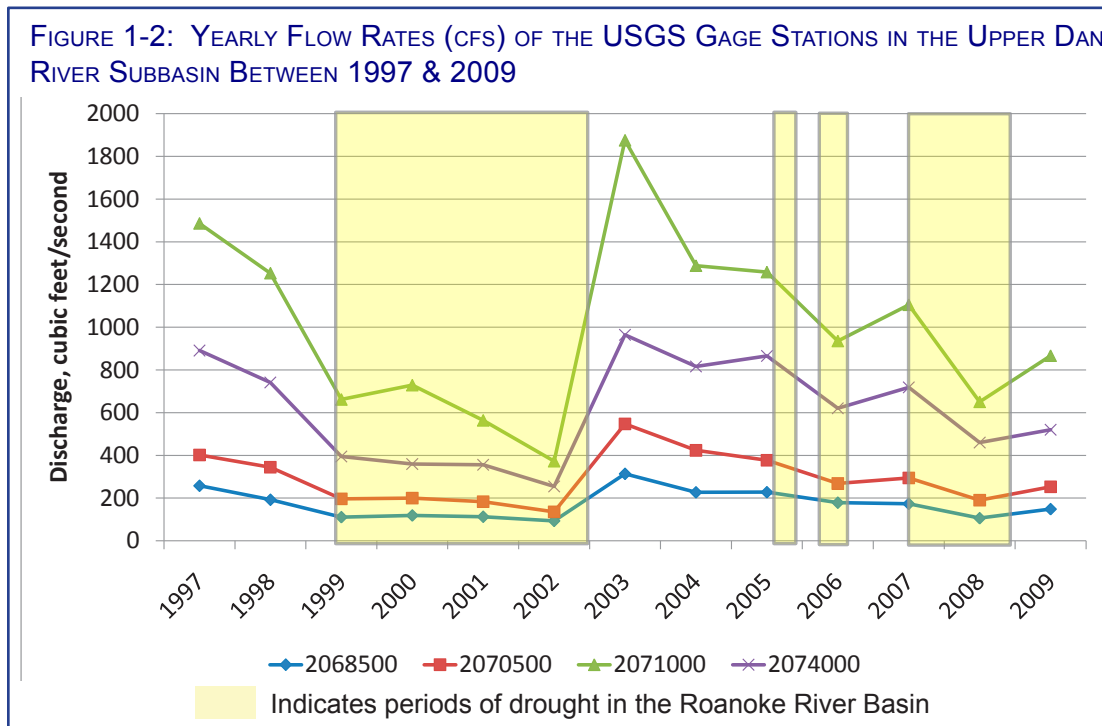
The basin experienced prolonged droughts from 1998-2002 and again from 2007-2008, with moderate droughts in 2005 and 2006 (Figure 1-2). More detail about flows in the Roanoke River Basin can be found in the [2010 Roanoke River Basinwide Assessment Report](#) produced by DWQ-Environmental Science Section.

From Left to Right:

- 2068500: Dan River (Francisco)
- 2070500: Mayo River
- 2071000: Dan River (Wentworth)
- 2074000: Smith River

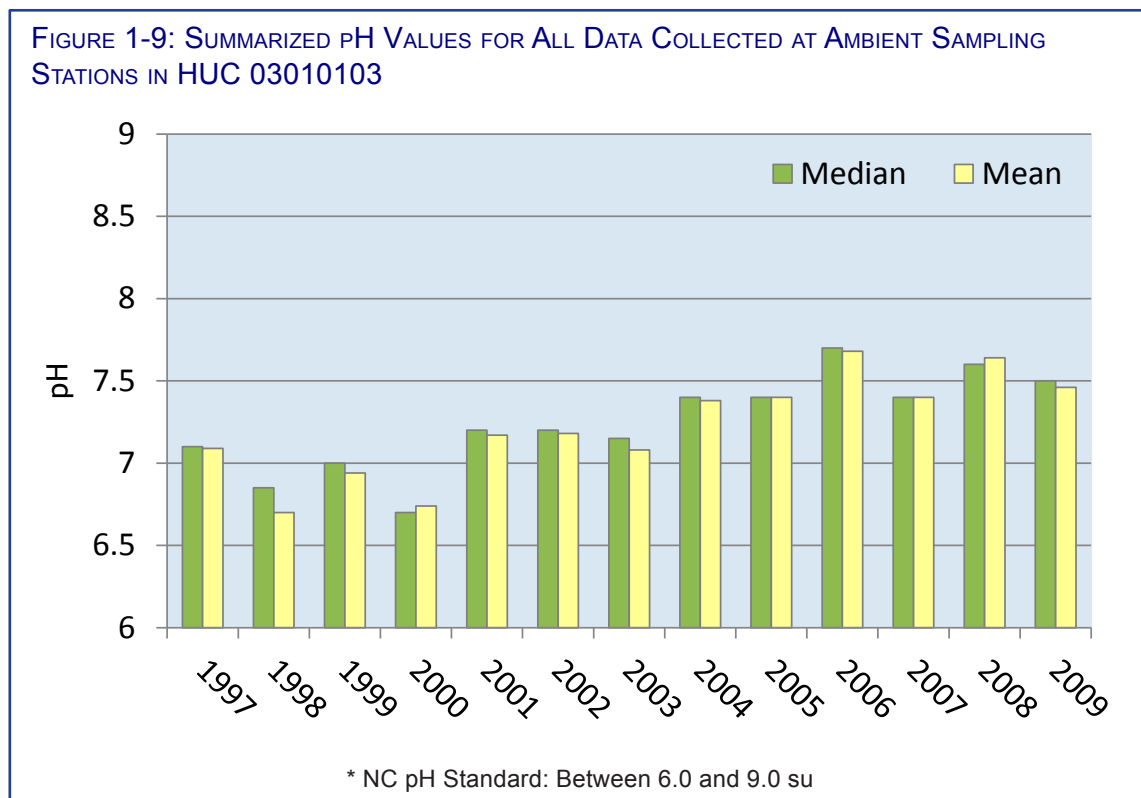
Figure 1-9 shows the mean and median pH levels for all samples taken over the course of 13 years in the Upper Dan River Subbasin. The pH pattern seen during this time period is a steady increase until 2006 when it dips back down. This pattern is seen in other parts of the northwestern corner of the state. Possible causes of the increasing levels in this subbasin could be atmospheric deposition, groundwater influences or precipitation influences. However, the exact reason is unknown at this time.

Proper riparian buffers throughout the subbasin could reduce the impact of stormwater runoff, which can include nutrients from farm or lawn fertilizers, as well as impacts from acid rain. Trees within riparian buffers are also beneficial for shading streams and reducing water temperatures. It is recommended to continue monitoring pH levels within the subbasin and investigate possible causes.

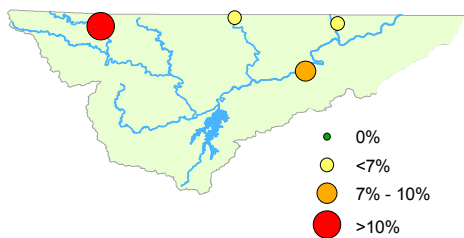
**FIGURE 1-10: PERCENTAGE OF SAMPLES EXCEEDING THE TURBIDITY STANDARD (2005-2009)**

All four AMS stations within the Upper Dan River subbasin exceeded the state's turbidity standard in 6 to 23 percent of samples, as seen in Figure 1-10 indicated by yellow and red dots. Possible sources of the elevated turbidity levels are discussed in the 10-digit watershed section. Figure 1-11 shows the mean and median turbidity levels for all samples taken over the course of 13 years in the Upper Dan River subbasin. The yearly averages are well below the state standard of 50 NTUs with the exception of the 2009 mean. The western most station is located in a designated Trout Water which has a standard of 10 NTU.

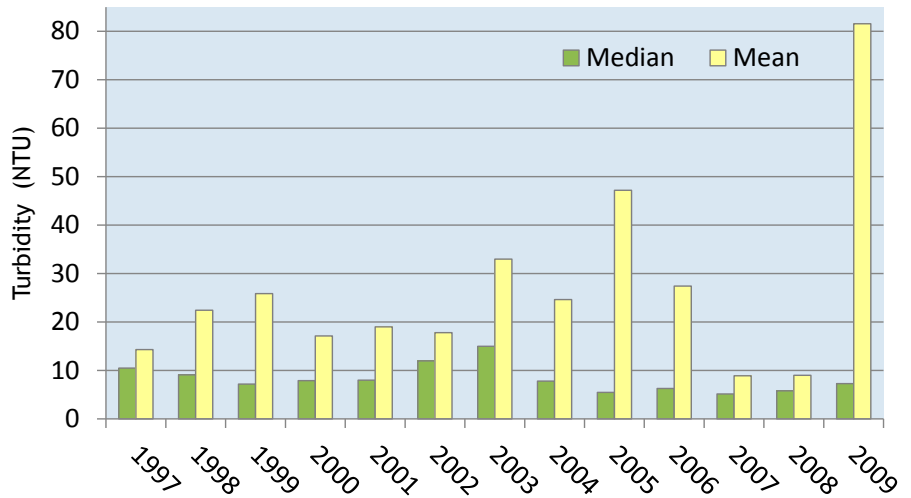
**FIGURE 1-11: SUMMARIZED TURBIDITY VALUES FOR ALL DATA COLLECTED AT AMBIENT SAMPLING STATIONS IN HUC 03010103**

\* NC Turbidity Standard: Class C Waters = 50 NUT; Class Tr Waters = 10 NTU

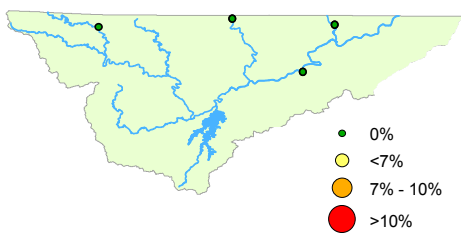
**FIGURE 1-12: PERCENTAGE OF SAMPLES EXCEEDING THE DO STANDARD (2005-2009)**

As seen in Figure 1-12, none of the four sites recorded DO standard exceedance during this monitoring cycle. Figure 1-13 shows the mean and median of DO levels for all samples taken over the course of 13 years in the Upper Dan River subbasin. These averages are well within the normal DO range.

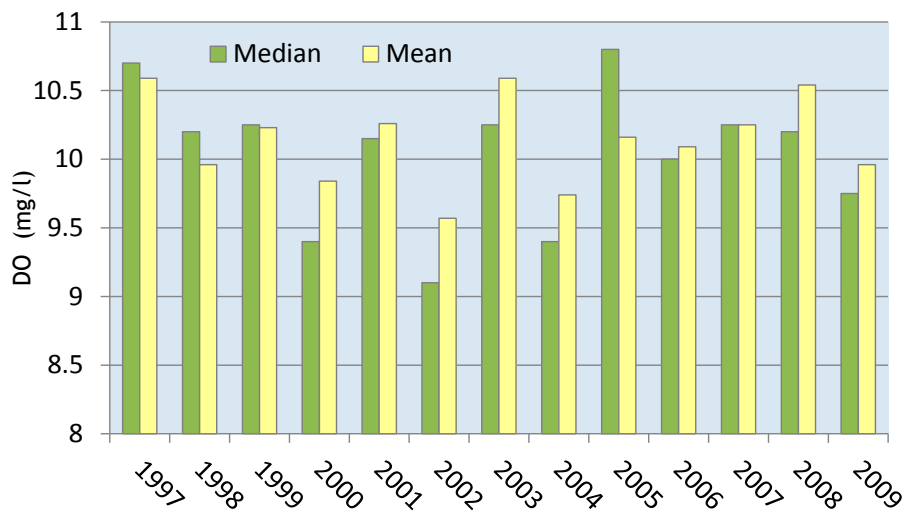
**FIGURE 1-13: SUMMARIZED DO VALUES FOR ALL DATA COLLECTED AT AMBIENT SAMPLING STATIONS IN HUC 0301010**

\* NC DO Standard: Not < 5 mg/l daily avg. or not < 4 mg/l instantaneous

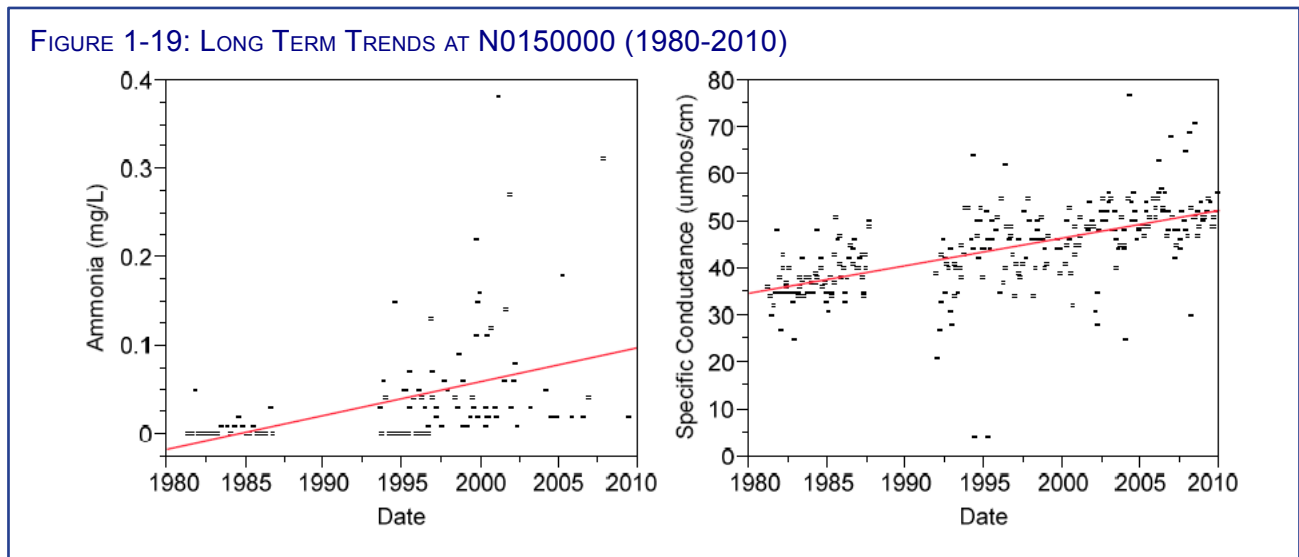
A nutrient and sediment trend analysis was completed during this cycle. The analysis showed nutrients peaking in February and August and decreasing to a minimum in October. Turbidity and total suspended solid levels peaked in late spring and early summer months. Long term trends were evaluated during this cycle for data collected between 1980 and 2009. Ammonia and specific conductance increased +0.004 mg/l per year and +0.60 umhos/cm per year, respectively (Figure 1-19). See the [Roanoke River Ambient Monitoring Report](#) for more details.

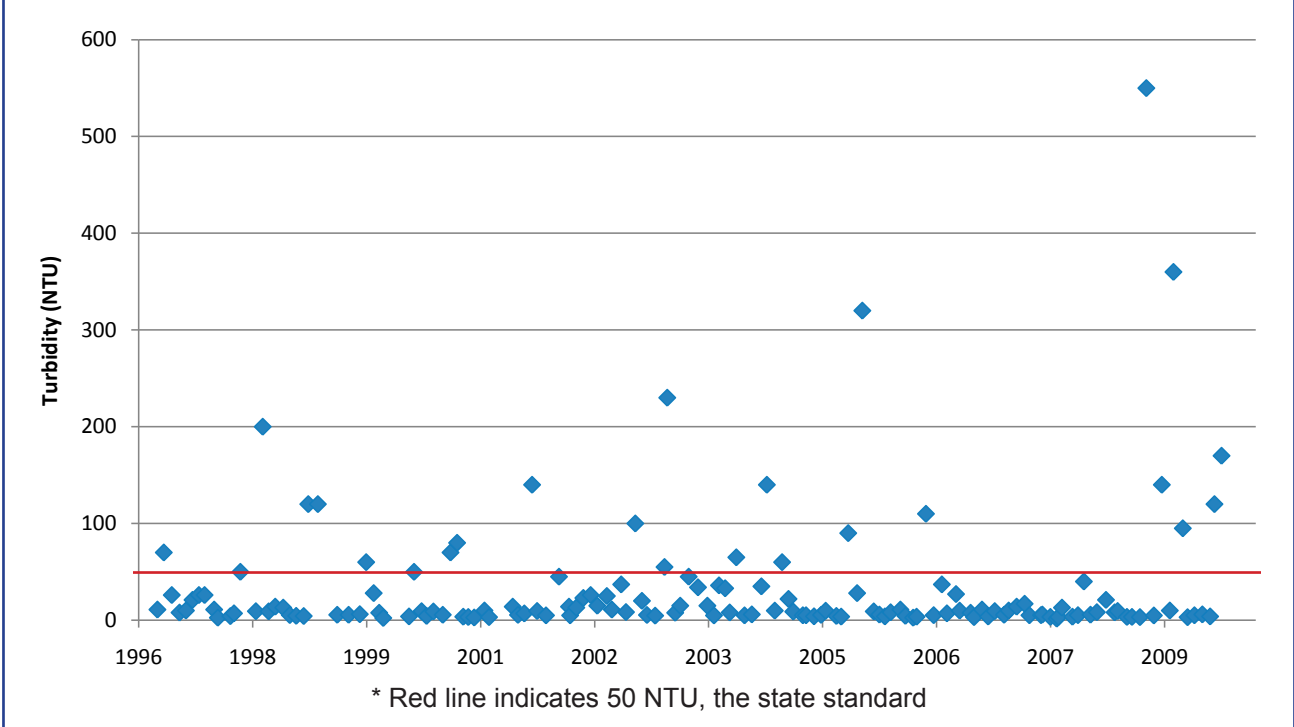
FIGURE 1-20: LONG TERM TURBIDITY SAMPLING AT N2300000 (1997-2009)

There is one monitoring (AMS) station between these two segments. Almost 15% of turbidity samples exceeded the state standard at this station. Instream mining operations have been noted as a source in past plans. DWQ developed a [TMDL for turbidity](#) for this section of the Dan River in 2005. The TMDL recommended a 59% reduction in total suspended solids between both point and nonpoint sources. As seen in Figure 1-20, majority of sampling results have been reduced to below 35 NTUs since the TMDL was released in 2005 indicating progress.

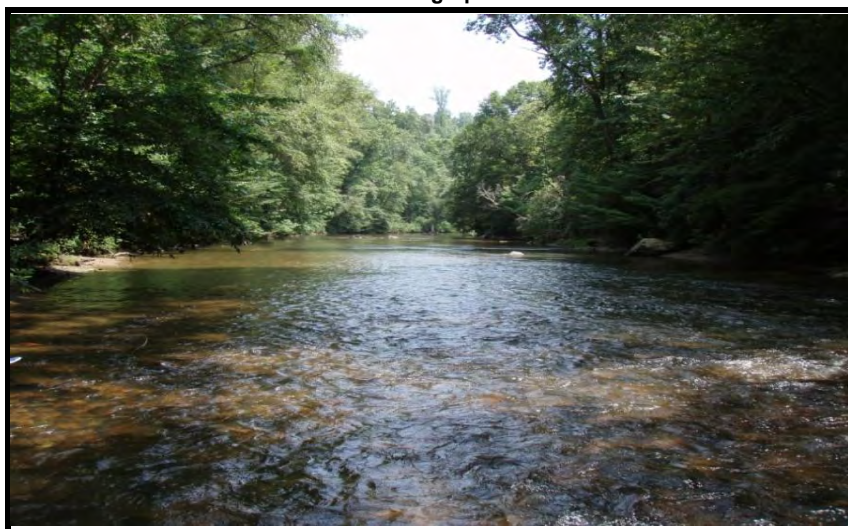
**Site Photograph**

Temperature (°C)	26.0
Dissolved Oxygen (mg/L)	10.8
Specific Conductance (µS/cm)	49
pH (s.u.)	8.2
Water Clarity	clear

Channel Modification (5)	5
Instream Habitat (20)	19
Bottom Substrate (15)	8
Pool Variety (10)	10
Riffle Habitat (16)	16
Bank Erosion (7)	7
Bank Vegetation (7)	7
Light Penetration (10)	10
Left Riparian Score (5)	5
Right Riparian Score (5)	5
<b>Total Habitat Score (100)</b>	<b>92</b>

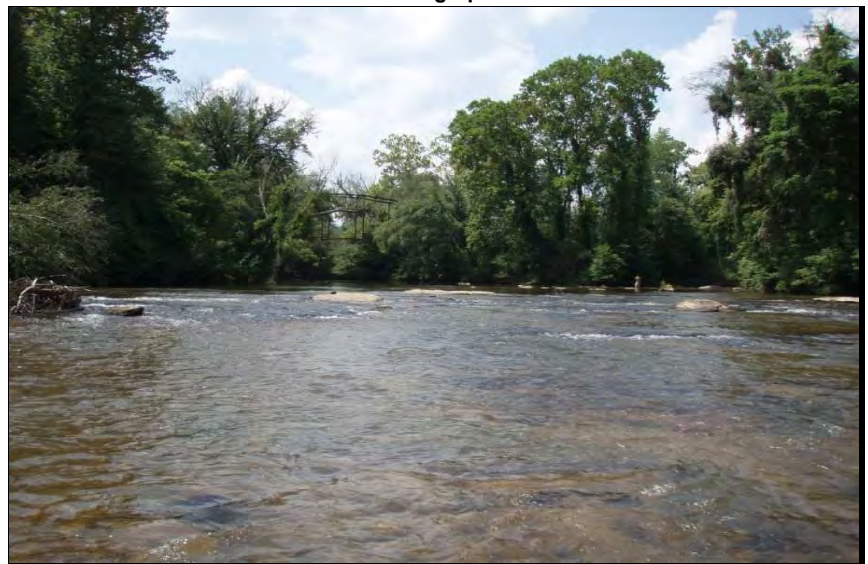
**Site Photograph**

Water Clarity slightly turbid

Channel Modification (5)	5
Instream Habitat (20)	20
Bottom Substrate (15)	13
Pool Variety (10)	9
Riffle Habitat (16)	7
Bank Erosion (7)	6
Bank Vegetation (7)	6
Light Penetration (10)	2
Left Riparian Score (5)	5
Right Riparian Score (5)	5
<b>Total Habitat Score (100)</b>	<b>78</b>

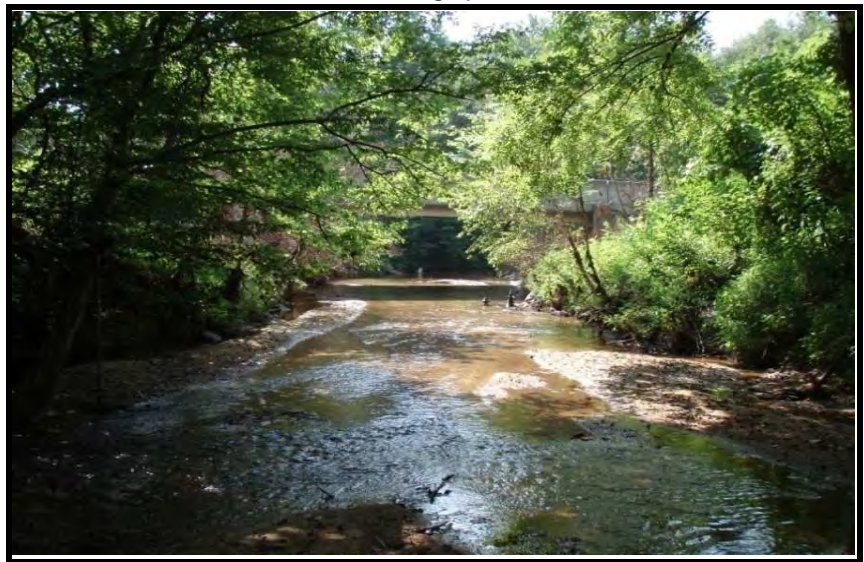
**Site Photograph**

Channel Modification (5)	5
Instream Habitat (20)	18
Bottom Substrate (15)	14
Pool Variety (10)	10
Riffle Habitat (16)	7
Bank Erosion (7)	5
Bank Vegetation (7)	5
Light Penetration (10)	10
Left Riparian Score (5)	4
Right Riparian Score (5)	5
<b>Total Habitat Score (100)</b>	<b>83</b>

<b>Substrate</b>	Mostly gravel and sand with some cobble substrate.
------------------	--

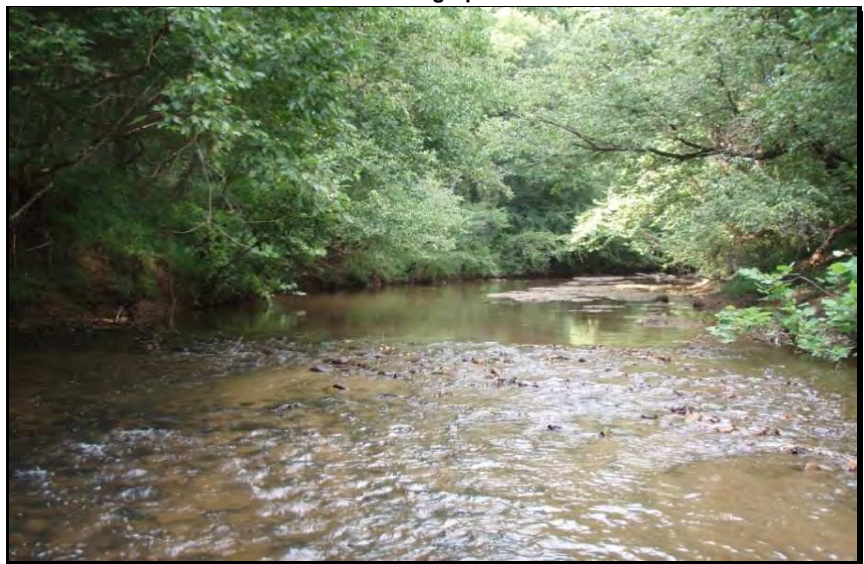
**Site Photograph**

Channel Modification (5)	5
Instream Habitat (20)	18
Bottom Substrate (15)	8
Pool Variety (10)	8
Riffle Habitat (16)	5
Bank Erosion (7)	3
Bank Vegetation (7)	5
Light Penetration (10)	7
Left Riparian Score (5)	5
Right Riparian Score (5)	4
<b>Total Habitat Score (100)</b>	<b>68</b>

<b>Substrate</b>	Mostly sand with minimal cobble and gravel.
------------------	---

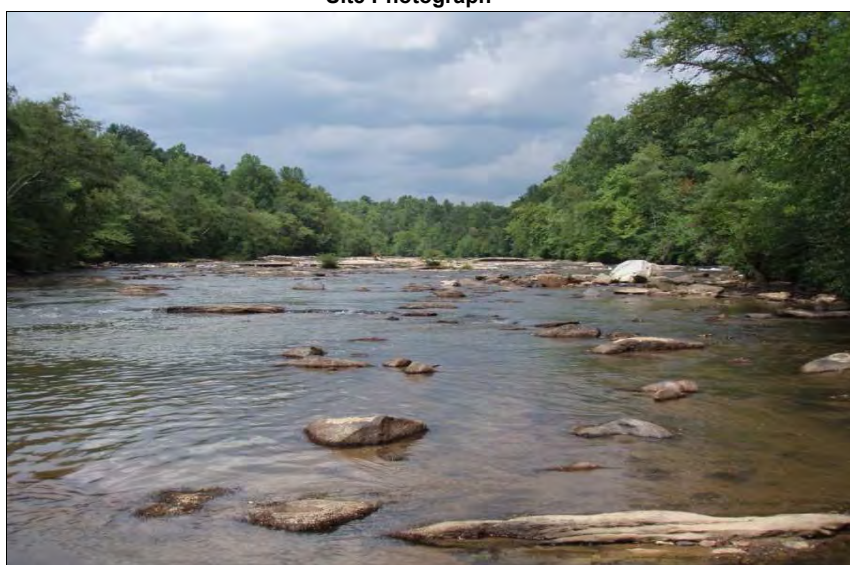
**Site Photograph**

Temperature (°C)	26.6
Dissolved Oxygen (mg/L)	10.2
Specific Conductance (µS/cm)	53
pH (s.u.)	7.3
Water Clarity	clear

Channel Modification (5)	5
Instream Habitat (20)	18
Bottom Substrate (15)	12
Pool Variety (10)	10
Riffle Habitat (16)	16
Bank Erosion (7)	7
Bank Vegetation (7)	6
Light Penetration (10)	5
Left Riparian Score (5)	5
Right Riparian Score (5)	5
<b>Total Habitat Score (100)</b>	<b>89</b>

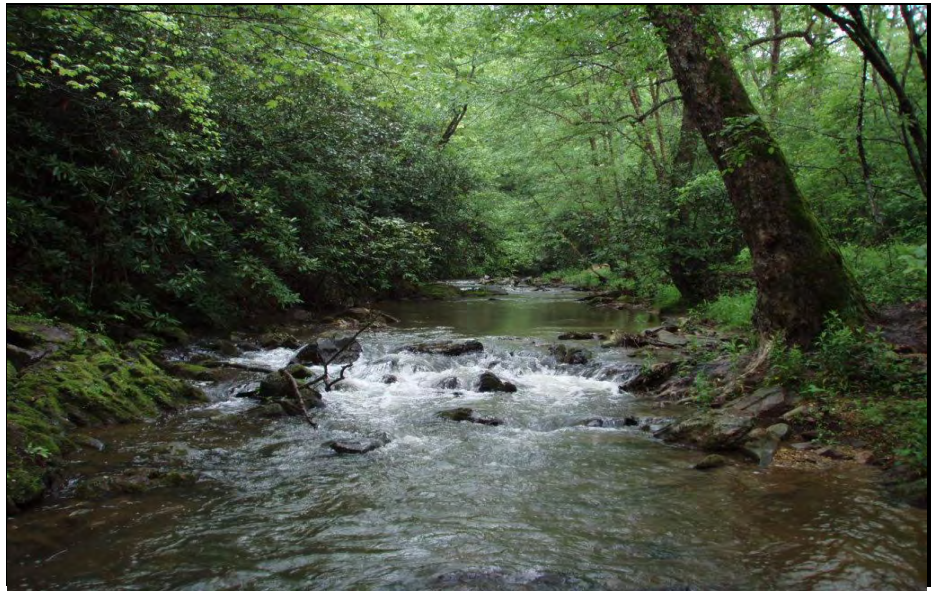
**Site Photograph**

Water Clarity	Slightly turbid
---------------	-----------------

Channel Modification (5)	5
Instream Habitat (20)	19
Bottom Substrate (15)	12
Pool Variety (10)	10
Riffle Habitat (16)	16
Erosion (7)	7
Bank Vegetation (7)	7
Light Penetration (10)	9
Left Riparian Score (5)	5
Right Riparian Score (5)	3
<b>Total Habitat Score (100)</b>	<b>93</b>

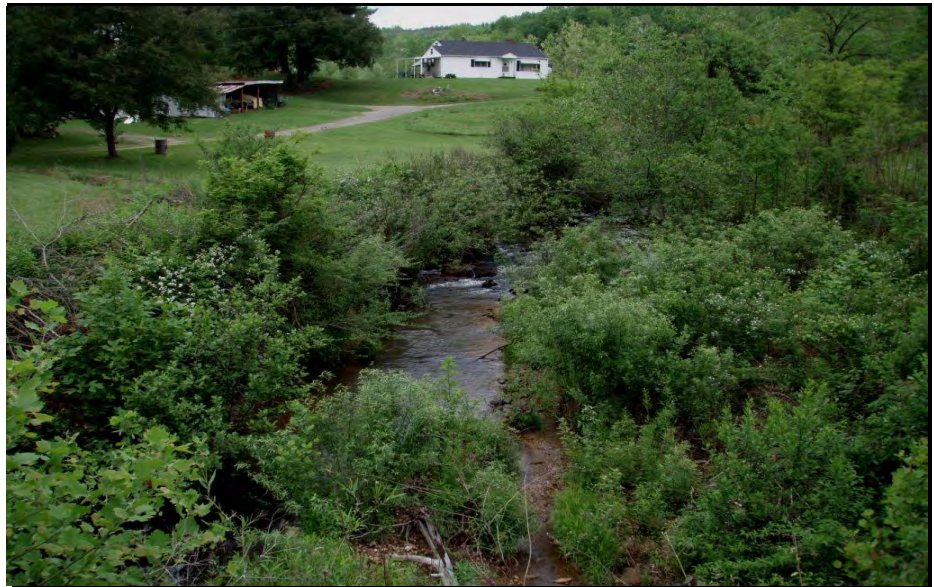
**Site Photograph**

Channel Modification (5)	5
Instream Habitat (20)	17
Bottom Substrate (15)	12
Pool Variety (10)	9
Riffle Habitat (16)	16
Erosion (7)	6
Bank Vegetation (7)	3
Light Penetration (10)	4
Left Riparian Score (5)	1
Right Riparian Score (5)	2
<b>Total Habitat Score (100)</b>	<b>75</b>

Substrate	Bedrock, boulder, cobble, gravel, silt, sand
-----------	--

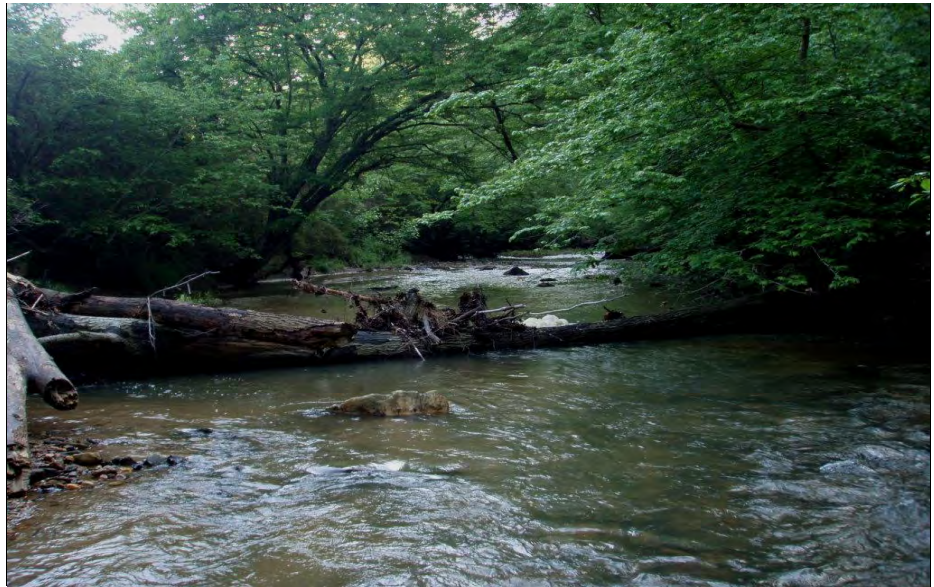
**Site Photograph**

Water Clarity	Slightly turbid
---------------	-----------------

Channel Modification (5)	5
Instream Habitat (20)	16
Bottom Substrate (15)	12
Pool Variety (10)	10
Riffle Habitat (16)	11
Erosion (7)	4
Bank Vegetation (7)	7
Light Penetration (10)	10
Left Riparian Score (5)	3
Right Riparian Score (5)	5
<b>Total Habitat Score (100)</b>	<b>83</b>

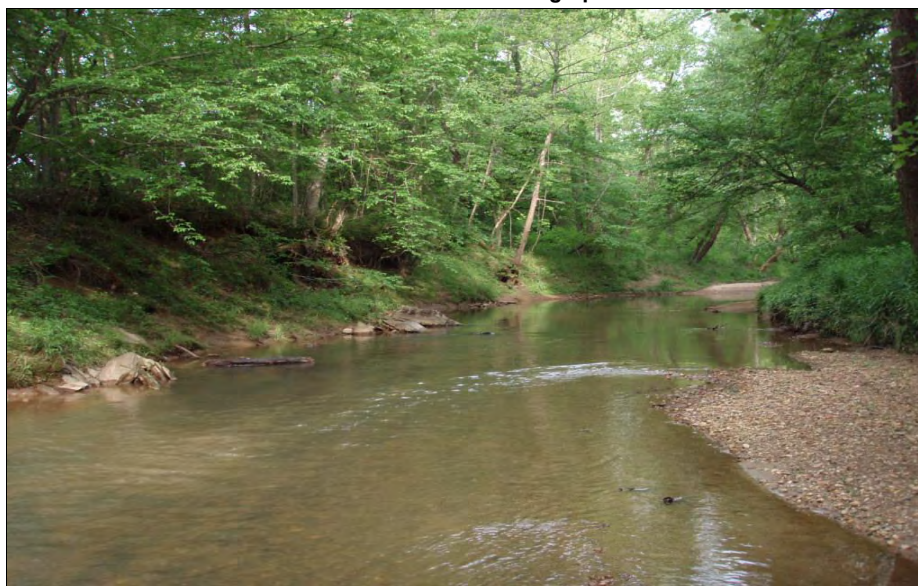
**Site Photograph**

Channel Modification (5)	5
Instream Habitat (20)	16
Bottom Substrate (15)	5
Pool Variety (10)	10
Riffle Habitat (16)	7
Erosion (7)	4
Bank Vegetation (7)	7
Light Penetration (10)	9
Left Riparian Score (5)	5
Right Riparian Score (5)	5
<b>Total Habitat Score (100)</b>	<b>73</b>

Substrate	Sand, gravel, boulder, bedrock
-----------	--------------------------------

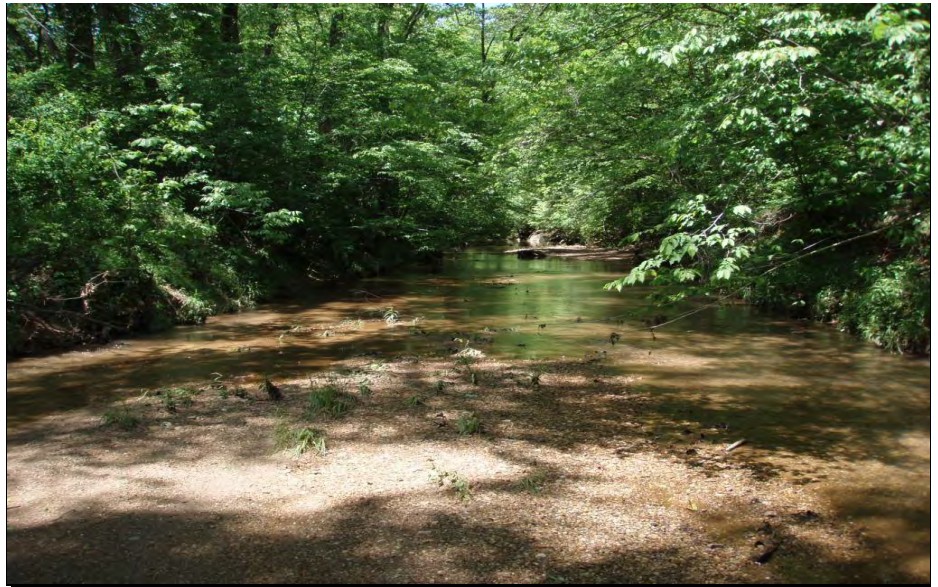
**Site Photograph**

Channel Modification (5)	5
Instream Habitat (20)	14
Bottom Substrate (15)	4
Pool Variety (10)	8
Riffle Habitat (16)	12
Erosion (7)	6
Bank Vegetation (7)	7
Light Penetration (10)	9
Left Riparian Score (5)	3
Right Riparian Score (5)	5
<b>Total Habitat Score (100)</b>	<b>73</b>

Substrate	Sand, gravel, some cobble
-----------	---------------------------

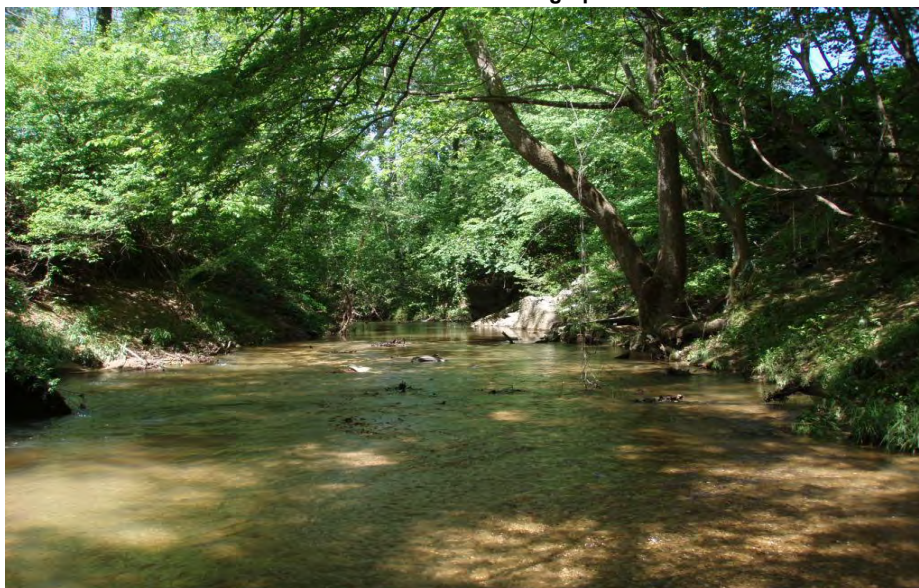
**Site Photograph**

Water Clarity	Slightly turbid
---------------	-----------------

Channel Modification (5)	5
Instream Habitat (20)	14
Bottom Substrate (15)	3
Pool Variety (10)	10
Riffle Habitat (16)	5
Erosion (7)	6
Bank Vegetation (7)	6
Light Penetration (10)	9
Left Riparian Score (5)	3
Right Riparian Score (5)	4
<b>Total Habitat Score (100)</b>	<b>65</b>

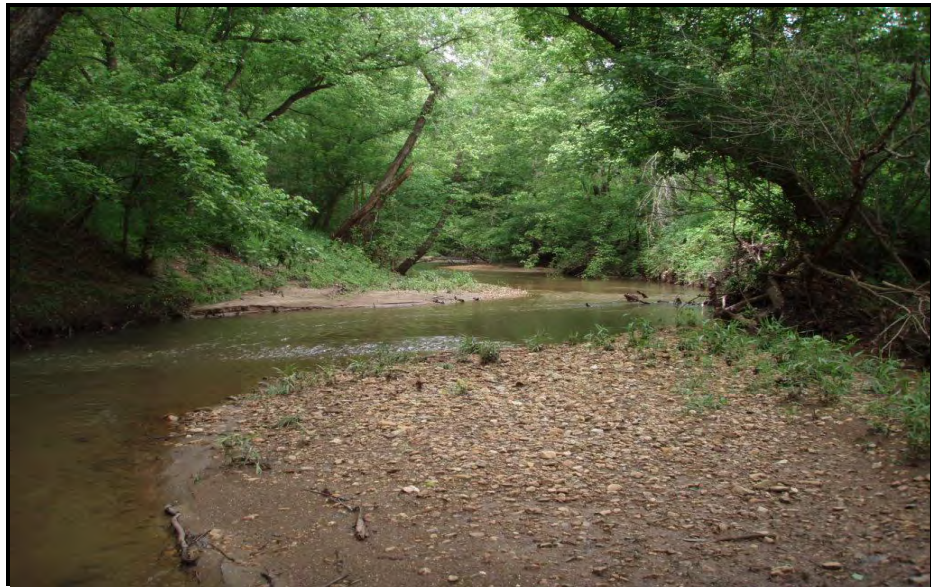
**Site Photograph**

Channel Modification (5)	5
Instream Habitat (20)	16
Bottom Substrate (15)	4
Pool Variety (10)	6
Riffle Habitat (16)	10
Erosion (7)	4
Bank Vegetation (7)	7
Light Penetration (10)	10
Left Riparian Score (5)	5
Right Riparian Score (5)	5
<b>Total Habitat Score (100)</b>	<b>72</b>

Substrate	Sand, gravel, cobble, silt
-----------	----------------------------

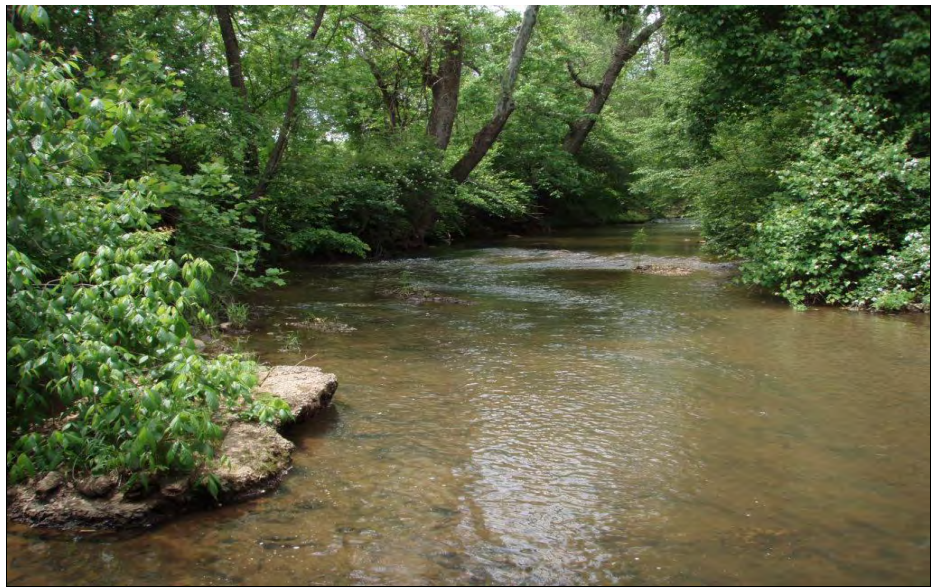
**Site Photograph**

Channel Modification (5)	5
Instream Habitat (20)	18
Bottom Substrate (15)	8
Pool Variety (10)	7
Riffle Habitat (16)	15
Erosion (7)	6
Bank Vegetation (7)	7
Light Penetration (10)	7
Left Riparian Score (5)	3
Right Riparian Score (5)	3
<b>Total Habitat Score (100)</b>	<b>79</b>

Substrate	Bedrock shelves, gravel, cobble
-----------	---------------------------------

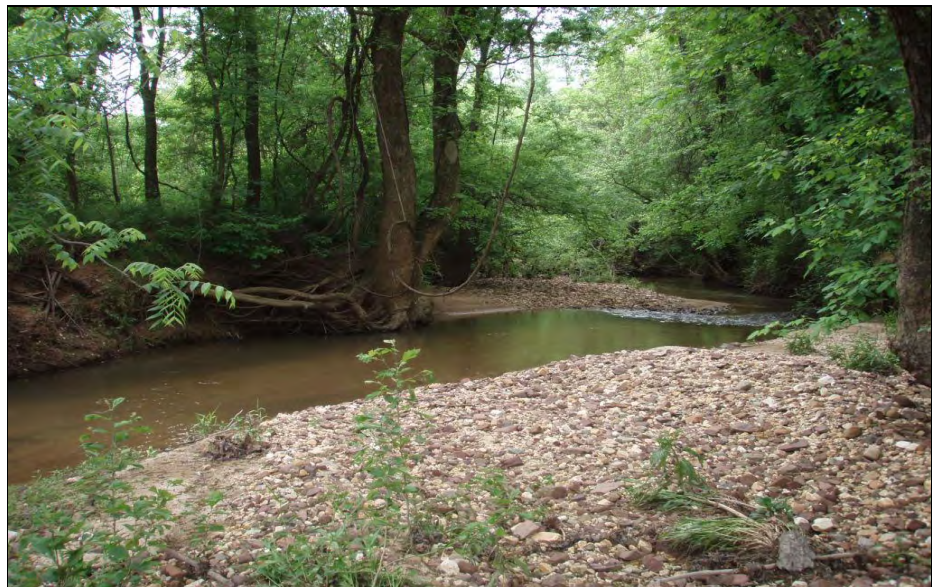
**Site Photograph**

Water Clarity	Clear, easily silted
---------------	----------------------

Channel Modification (5)	5
Instream Habitat (20)	14
Bottom Substrate (15)	6
Pool Variety (10)	8
Riffle Habitat (16)	10
Erosion (7)	1
Bank Vegetation (7)	7
Light Penetration (10)	9
Left Riparian Score (5)	3
Right Riparian Score (5)	4
<b>Total Habitat Score (100)</b>	<b>67</b>

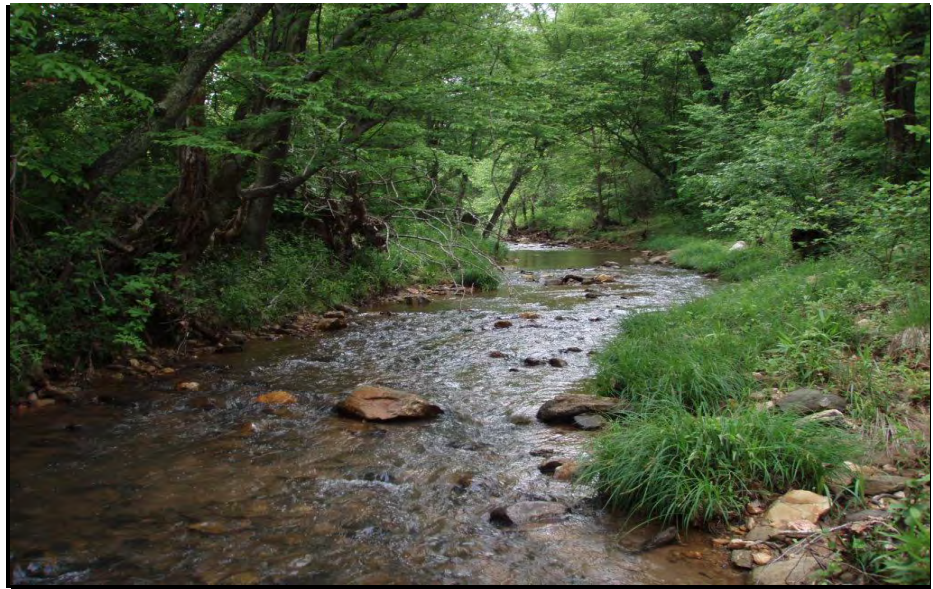
**Site Photograph**

Channel Modification (5)	5
Instream Habitat (20)	17
Bottom Substrate (15)	10
Pool Variety (10)	4
Riffle Habitat (16)	15
Erosion (7)	5
Bank Vegetation (7)	6
Light Penetration (10)	7
Left Riparian Score (5)	3
Right Riparian Score (5)	3
<b>Total Habitat Score (100)</b>	<b>75</b>

Substrate	Cobble, gravel
-----------	----------------

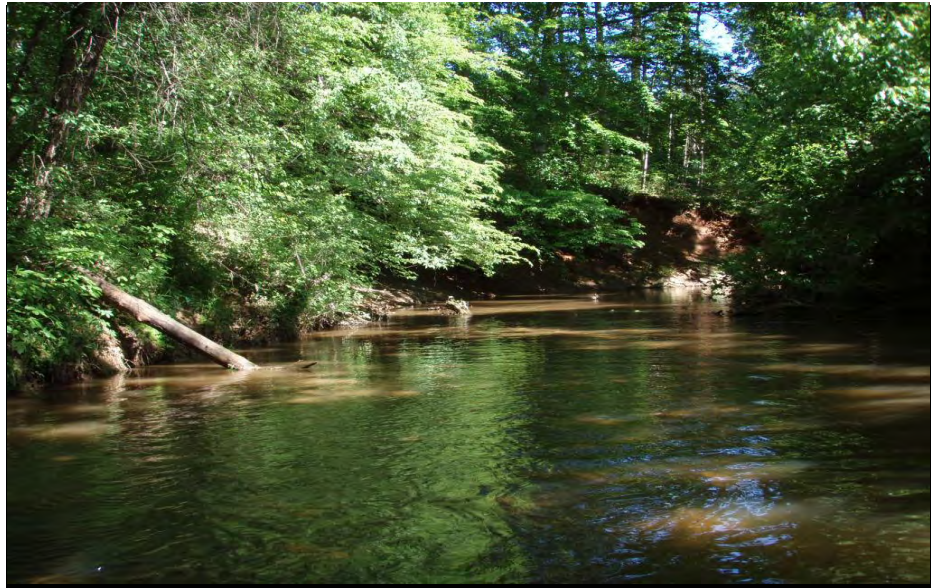
**Site Photograph**

Channel Modification (5)	5
Instream Habitat (20)	17
Bottom Substrate (15)	4
Pool Variety (10)	4
Riffle Habitat (16)	3
Erosion (7)	2
Bank Vegetation (7)	4
Light Penetration (10)	8
Left Riparian Score (5)	3
Right Riparian Score (5)	5
<b>Total Habitat Score (100)</b>	<b>55</b>

Substrate	Sand, gravel
-----------	--------------

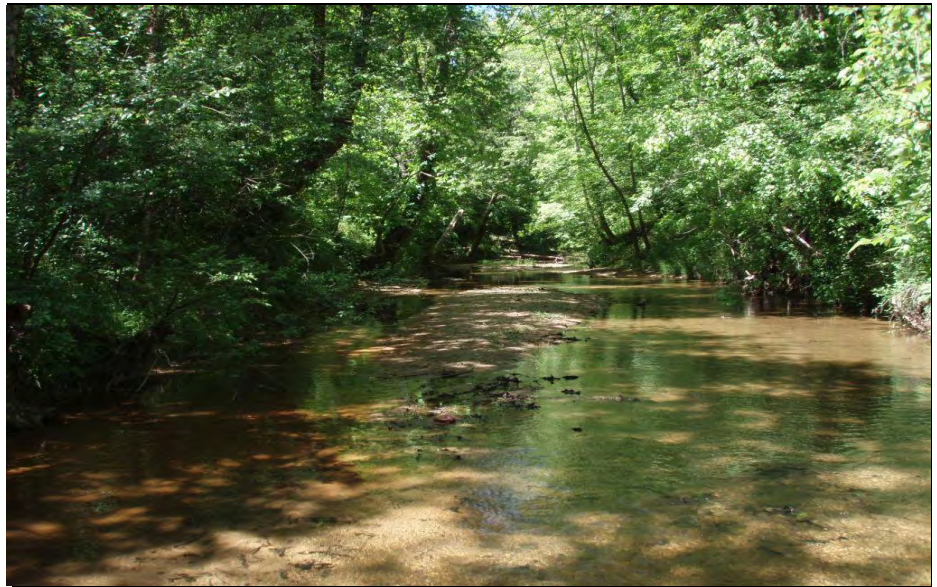
**Site Photograph**

Channel Modification (5)	5
Instream Habitat (20)	14
Bottom Substrate (15)	4
Pool Variety (10)	6
Riffle Habitat (16)	7
Erosion (7)	6
Bank Vegetation (7)	7
Light Penetration (10)	9
Left Riparian Score (5)	5
Right Riparian Score (5)	5
<b>Total Habitat Score (100)</b>	<b>68</b>

Substrate	Sand, gravel, some cobble
-----------	---------------------------

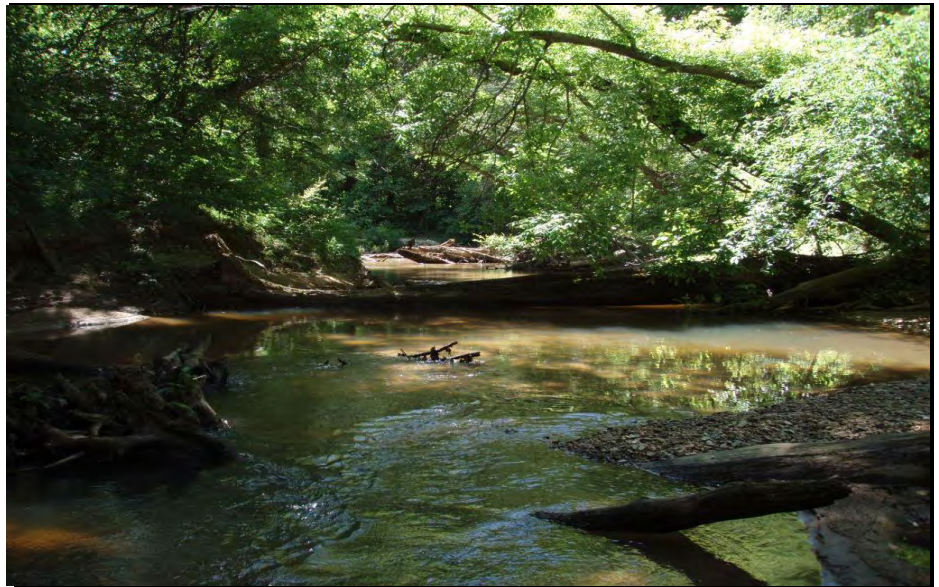
**Site Photograph**

Channel Modification (5)	5
Instream Habitat (20)	16
Bottom Substrate (15)	3
Pool Variety (10)	10
Riffle Habitat (16)	7
Erosion (7)	1
Bank Vegetation (7)	6
Light Penetration (10)	5
Left Riparian Score (5)	5
Right Riparian Score (5)	5
<b>Total Habitat Score (100)</b>	<b>63</b>

Substrate	Sand, gravel, silt
-----------	--------------------
