# ROANOKE RAPIDS SUBBASIN

*HUC 03010106*

## SUBBASIN WATER QUALITY OVERVIEW

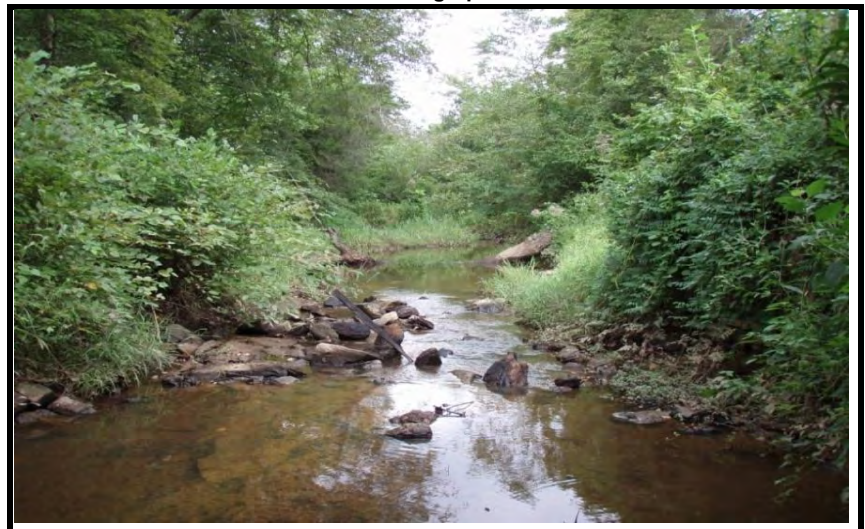
**Site Photograph**

Temperature (°C)	23.8
Dissolved Oxygen (mg/L)	8.5
Specific Conductance (µS/cm)	62
pH (s.u.)	6.6
Water Clarity	slightly turbid

Channel Modification (5)	5
Instream Habitat (20)	18
Bottom Substrate (15)	5
Pool Variety (10)	8
Riffle Habitat (16)	7
Bank Erosion (7)	5
Bank Vegetation (7)	5
Light Penetration (10)	10
Left Riparian Score (5)	5
Right Riparian Score (5)	5
<b>Total Habitat Score (100)</b>	<b>73</b>

No NPDES dischargers are located upstream from this location and land use is mostly rural with some agricultural portions. This site received a bioclassification of Good-Fair for the third year in a row. The NCBI and EPTBI dropped since 2004 potentially due to half as many chironomid taxa present in 2009. Also *Pycnopsyche spp.* were found rare at the site in 2004 and abundant in 2009. It was noted that water in the channel in certain sections did not reach the bottom of both banks, flows were low, and detritus was abundant similar to that found in swamp-like conditions. These observations and the presence of so many odonates suggests the site suffers from low flow conditions. Physical parameters such as infrequent embedded riffles and low flows may limit habitat necessary for colonization of some rheophilic macroinvertebrates such as long-lived stonefly taxa.

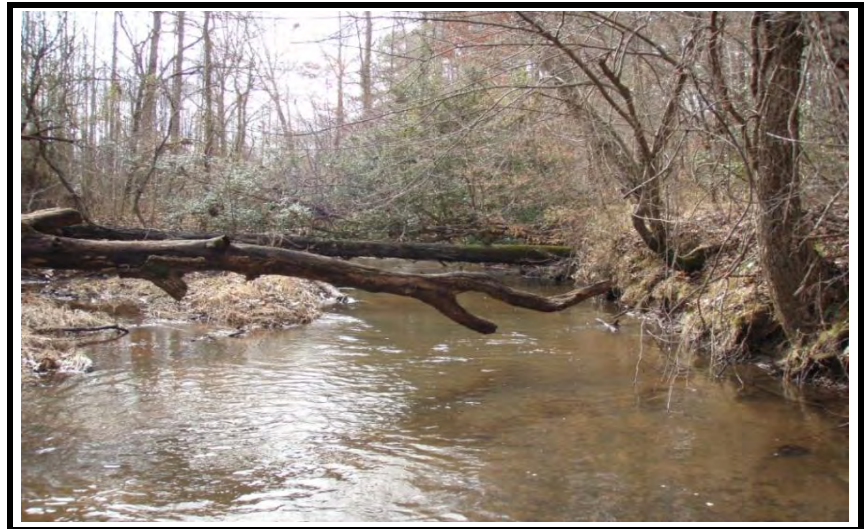
**Site Photograph**

Temperature (°C)	6.5
Dissolved Oxygen (mg/L)	11.4
Specific Conductance (µS/cm)	69
pH (s.u.)	5.9
Water Clarity	Clear

Channel Modification (5)	15
Instream Habitat (20)	18
Bottom Substrate (15)	15
Pool Variety (10)	9
Riffle Habitat (16)	0
Bank Erosion (7)	7
Bank Vegetation (7)	7
Light Penetration (10)	9
Left Riparian Score (5)	5
Right Riparian Score (5)	5
<b>Total Habitat Score (100)</b>	<b>90</b>

Bioclassification and macroinvertebrate metrics have generally been stable at this location since sampling commenced in 2004 with both winter samples producing Natural bioclassifications. However, the slight increase in both the BI and EPTBI in 2009 relative to the 2004 sample correlates to the increasing trend in conductivity observed at this site as previous measurements in 1999 (21 µS/cm) and 2004 (47 µS/cm) were much lower than the 2009 measurement (69 µS/cm). These data combined may suggest a slight decrease in overall physical conditions at this site.

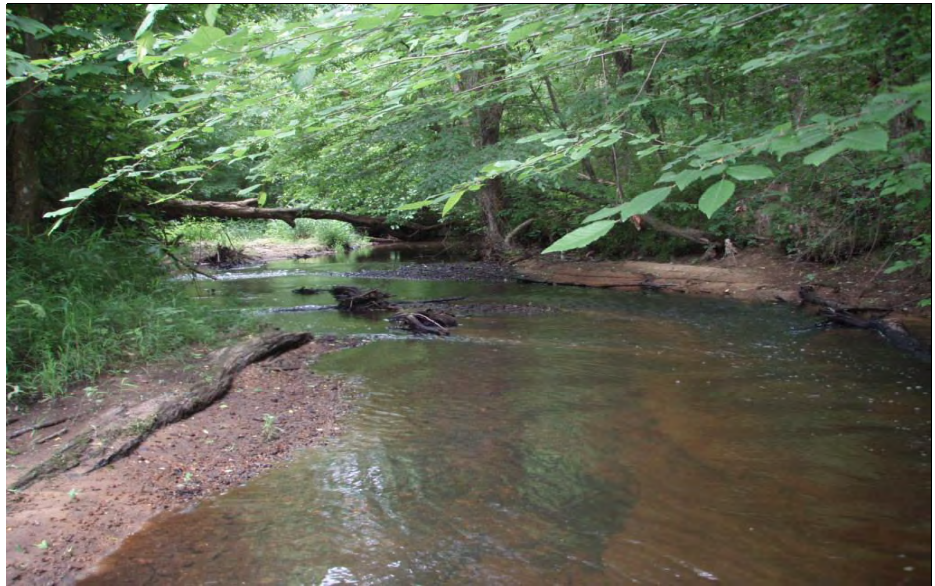
Site Photograph

Water Clarity	Clear, slightly tannin stained
---------------	--------------------------------

Channel Modification (5)	5
Instream Habitat (20)	16
Bottom Substrate (15)	4
Pool Variety (10)	10
Riffle Habitat (16)	5
Erosion (7)	6
Bank Vegetation (7)	7
Light Penetration (10)	10
Left Riparian Score (5)	5
Right Riparian Score (5)	5
<b>Total Habitat Score (100)</b>	<b>73</b>

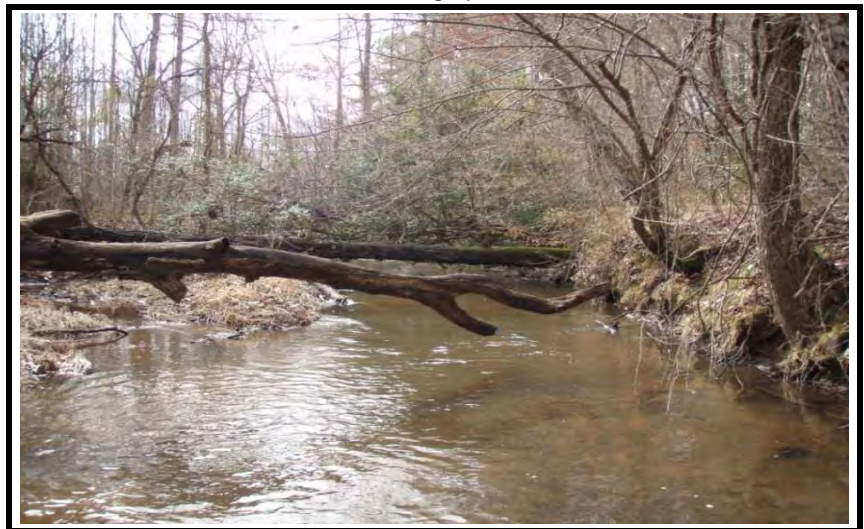
**Site Photograph**

Channel Modification (5)	15
Instream Habitat (20)	18
Bottom Substrate (15)	15
Pool Variety (10)	9
Riffle Habitat (16)	0
Bank Erosion (7)	7
Bank Vegetation (7)	7
Light Penetration (10)	9
Left Riparian Score (5)	5
Right Riparian Score (5)	5
<b>Total Habitat Score (100)</b>	<b>90</b>

<b>Substrate</b>	Rubble, gravel, sand, silt, and detritus.
------------------	---

Bioclassification and macroinvertebrate metrics have generally been stable at this location since sampling commenced in 2004 with both winter samples producing Natural bioclassifications. However, the slight increase in both the BI and EPTBI in 2009 relative to the 2004 sample correlates to the increasing trend in conductivity observed at this site as previous measurements in 1999 (21 µS/cm) and 2004 (47 µS/cm) were much lower than the 2009 measurement (69 µS/cm). These data combined may suggest a slight decrease in overall physical conditions at this site.

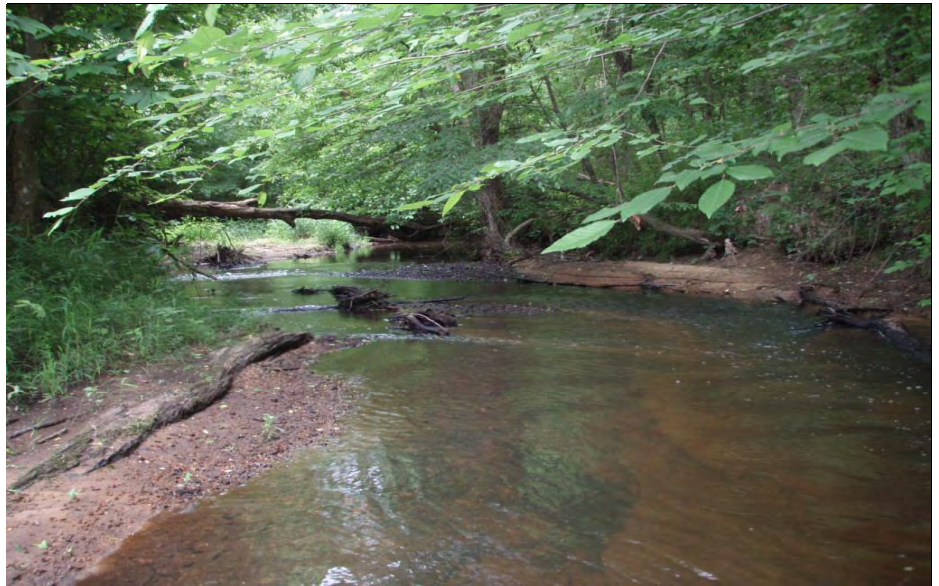
Site Photograph

Water Clarity	Clear, slightly tannin stained
---------------	--------------------------------

Channel Modification (5)	5
Instream Habitat (20)	16
Bottom Substrate (15)	4
Pool Variety (10)	10
Riffle Habitat (16)	5
Erosion (7)	6
Bank Vegetation (7)	7
Light Penetration (10)	10
Left Riparian Score (5)	5
Right Riparian Score (5)	5
<b>Total Habitat Score (100)</b>	<b>73</b>
