HIWASSEE RIVER BASINWIDE WATER QUALITY PLAN

Summary

This 2012 document is the fourth five-year update of the Hiwassee River Basinwide Water Quality Plan. Previous basinwide plans for the Hiwassee River Basin were completed in 1997, 2002, and 2007 and are available from the NC Division of Water Quality Basinwide Planning [website](#). This basin plan was written to provide guidance for watershed stakeholders, municipal planners, natural resource regulators, and other environmental professionals with identifying and addressing water quality stressors, sources, and emerging issues. This document can be used in conjunction with the [Supplemental Guide to Basinwide Planning](#) which provides general information about water quality issues and DWQ programs.

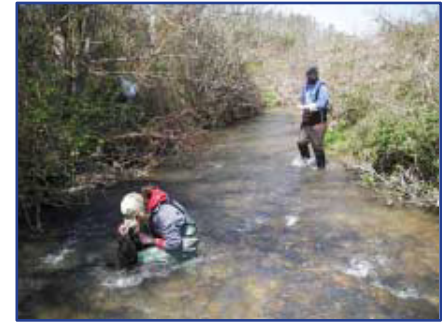
Martin Creek at SR 1576, Sites FB51 & FF14

The basinwide benthic sample in Martin Creek at SR 1558, (FB14) near the confluence with the Hiwassee River received a Good-Fair bioclassification in 2009, which is a decrease from the Good rating it received in 2004. The basinwide site FB14 was sampled in 2006 as part of the special study and resulted in a Good-Fair rating, with noted sedimentation as being an issue, but also noting a healthy and diverse riparian vegetation. The fish community sample (FF7) taken at the same location resulted in a Fair rating with a noted shift in trophic community, which is a decline from the special study sample taken in 2006, which received a Good-Fair rating. Benthic site FB51 at SR 1576 is about halfway upstream from the mouth resulted in a Good rating, while the fish sample (FF14) at the same location was Not Rated because of the stream is a low elevation trout-type stream and criteria have not been developed for those streams. Biologists noted areas of habitat degradation, sedimentation and abundant periphyton growth. Most of the stream reach has been channelized with limited riparian vegetation and evidence of cattle access. Two additional sites were sampled as part of the special study in the winter of 2006, one site is near the headwaters (FB52) and another (FB71) on a unnamed tributary to Martin Creek; both were Not Rated because of their small stream status. The unnamed tributary was noted as having nutrients and habitat degradation as stressors. The declining stream conditions are likely a result of steep slope and ridgetop residential development that occurred in this area between 2005-2008.

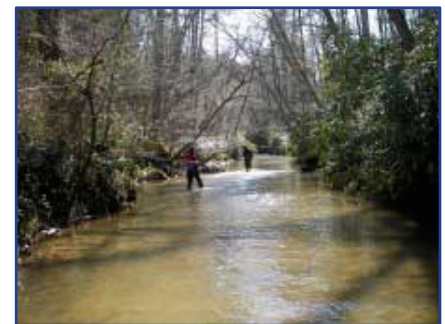
Martin Creek at SR 1558, Sites FF7 & FB14

In 2004, Martin Creek at SR 1558 (sites FF7 & FB14) was considered a regional reference site because of its instream, riparian, and watershed characteristics. At that time, based upon an examination of topographic maps, it was estimated that approximately 60 percent of the watershed upstream from the site was forested. GIS analyses, based upon 1993-1995 landuse coverage, showed that approximately 75 percent of the watershed was forested and approximately 20 percent in pasture. Thus, despite the prevalence of pasture alongside the creek throughout the middle of the watershed and that which was observed in 2006 at sites FB51 and FB14 technically continued to qualify as a regional reference site. However, the fish community has not been rated Good or Excellent even though this site has moderately high quality instream and riparian habitats. There are no known upstream dischargers and nonpoint source runoff should not be affecting this moderate gradient stream. But clearly, some factor(s) is impacting the fish community. Effects from historical land use practices within the watershed and illegal discharges (e.g., "straight pipes") may be impacting the stream. The uniform depth, the relatively homogenous flat cobble substrate covered with fine silts, the lack of productive riffles, and the lack of deep pools with submerged structures undoubtedly all contribute to the low total abundance of fish, the low diversities and abundance of cyprinids, darters, and Rock Bass, Smallmouth Bass, and Trout, and ultimately the continued lower than expected NCIBI ratings. Although the watershed is predominantly forested, land use practices closest to the stream throughout the watershed and upstream from the SR 1558 monitoring site may be having a negative impact on the downstream fish community that far exceeds the moderately high quality habitat benefits at the monitoring site. (BAU Memorandum B-20060731).

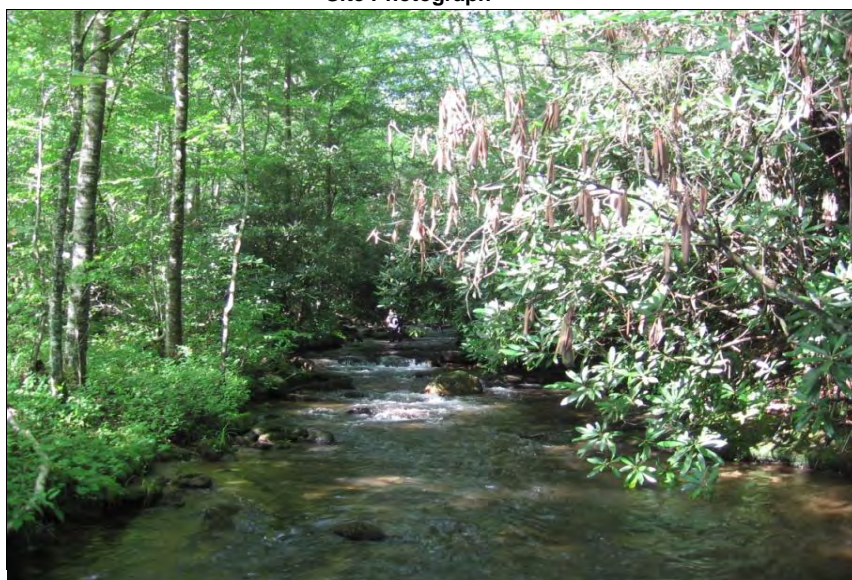
Site Photograph

Channel Modification (5)	5
Instream Habitat (20)	19
Bottom Substrate (15)	8
Pool Variety (10)	6
Riffle Habitat (16)	15
Bank Erosion (7)	7
Bank Vegetation (7)	6
Light Penetration (10)	10
Left Riparian Score (5)	5
Right Riparian Score (5)	5
Total Habitat Score (100)	86

Substrate	Good mix of boulder, cobble, gravel with small amounts of sand
------------------	--

Sample Date	Sample ID	ST	EPT	BI	EPT BI	Bioclassification
07/06/09	10692	---	35	---	1.83	Good
08/16/04	9488	---	48	---	1.59	Excellent
08/11/99	7941	---	45	---	1.61	Excellent
07/13/94	6574	62	37	2.09	1.55	Excellent
03/31/89	4895	83	45	2.89	2.11	Excellent

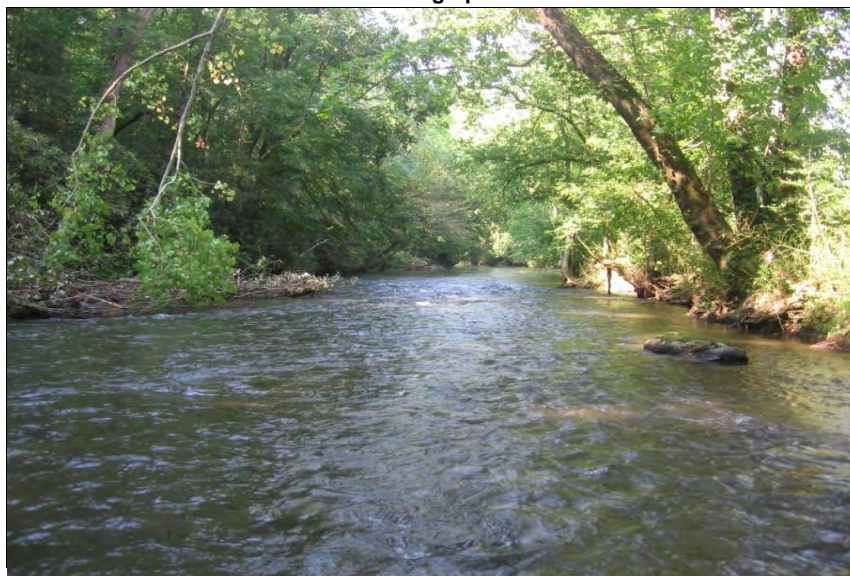
Site Photograph

Channel Modification (5)	4
Instream Habitat (20)	12
Bottom Substrate (15)	12
Pool Variety (10)	4
Riffle Habitat (16)	10
Bank Erosion (7)	6
Bank Vegetation (7)	5
Light Penetration (10)	6
Left Riparian Score (5)	4
Right Riparian Score (5)	1
Total Habitat Score (100)	64

Substrate	A mix of bedrock, boulder, cobble, gravel, sand and silt
-----------	--

Sample Date	Sample ID	ST	EPT	BI	EPT BI	Bioclassification
08/26/09	10718	78	38	4.50	3.91	Good
08/17/04	9492	100	36	5.03	3.97	Good
08/10/99	7928	80	33	5.08	4.12	Good-Fair
07/11/94	6588	77	29	5.02	4.31	Good-Fair

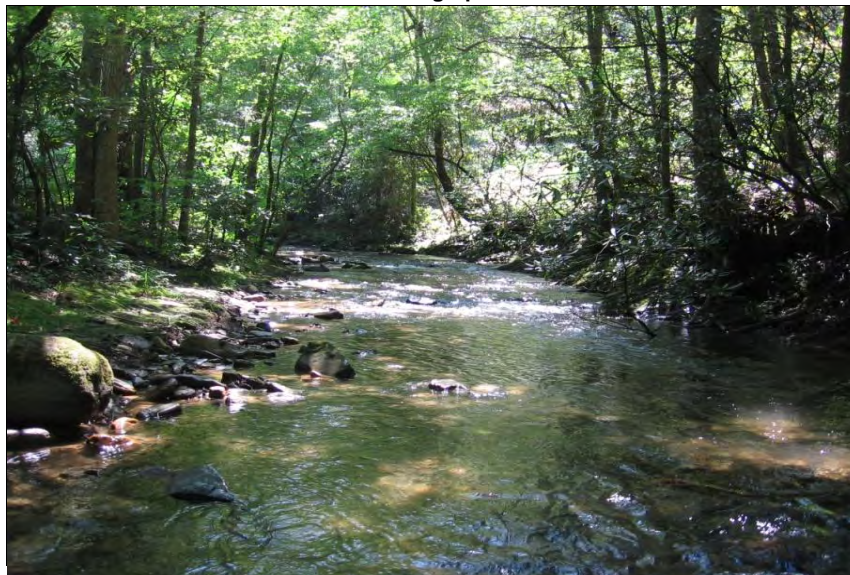
Site Photograph

Channel Modification (5)	5
Instream Habitat (20)	19
Bottom Substrate (15)	12
Pool Variety (10)	4
Riffle Habitat (16)	16
Bank Erosion (7)	7
Bank Vegetation (7)	6
Light Penetration (10)	10
Left Riparian Score (5)	2
Right Riparian Score (5)	5
Total Habitat Score (100)	86

Substrate	Good mix of boulder, cobble and gravel
-----------	--

Sample Date	Sample ID	ST	EPT	BI	EPT BI	Bioclassification
08/26/09	10719	---	37	---	2.87	Excellent
08/17/04	9490	---	40	---	2.26	Excellent
08/12/99	7946	---	31	---	3.09	Good
08/31/94	6678	---	22	---	2.51	Good-Fair

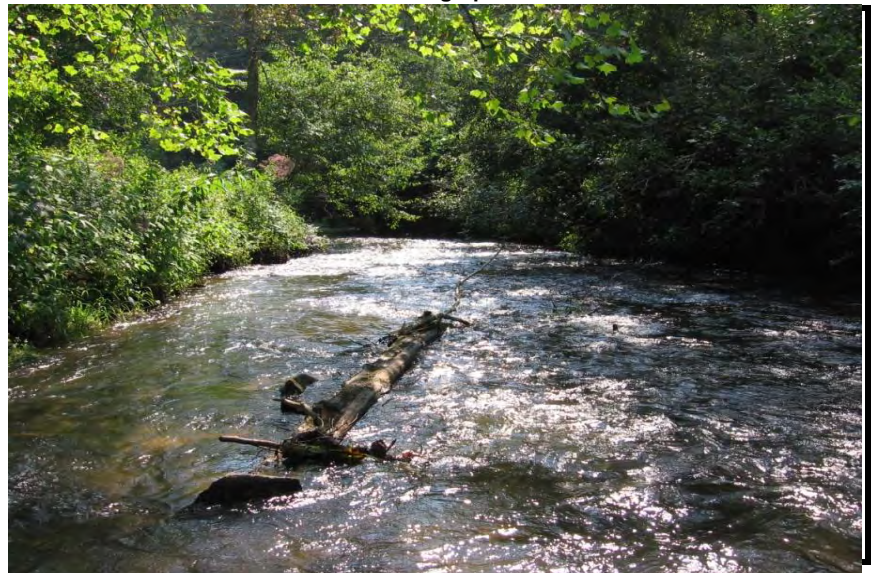
Site Photograph

Channel Modification (5)	4
Instream Habitat (20)	18
Bottom Substrate (15)	8
Pool Variety (10)	4
Riffle Habitat (16)	16
Bank Erosion (7)	6
Bank Vegetation (7)	4
Light Penetration (10)	4
Left Riparian Score (5)	3
Right Riparian Score (5)	3
Total Habitat Score (100)	70

Substrate	Mix of boulder, cobble, gravel and sand
-----------	---

Sample Date	Sample ID	ST	EPT	BI	EPT BI	Bioclassification
08/26/09	10722	---	40	---	3.05	Excellent
08/17/04	9495	---	41	---	2.47	Excellent
08/10/99	7937	---	40	---	2.50	Excellent
07/12/94	6570	---	46	---	2.70	Excellent

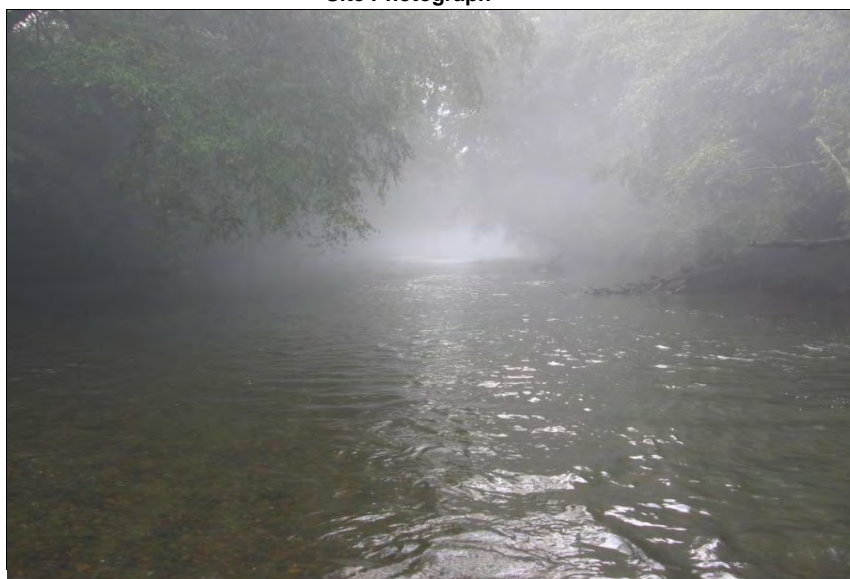
Site Photograph

Channel Modification (5)	5
Instream Habitat (20)	20
Bottom Substrate (15)	8
Pool Variety (10)	4
Riffle Habitat (16)	7
Bank Erosion (7)	5
Bank Vegetation (7)	7
Light Penetration (10)	7
Left Riparian Score (5)	5
Right Riparian Score (5)	5
Total Habitat Score (100)	73

Substrate	Mostly gravel and cobble with small amounts of boulder and sand
-----------	---

Sample Date	Sample ID	ST	EPT	BI	EPT BI	Bioclassification
08/27/09	10723	---	26	---	2.98	Good-Fair
08/19/04	9500	---	32	---	2.60	Good
08/12/99	7947	---	33	---	3.36	Good
07/12/94	6571	---	36	---	2.86	Excellent

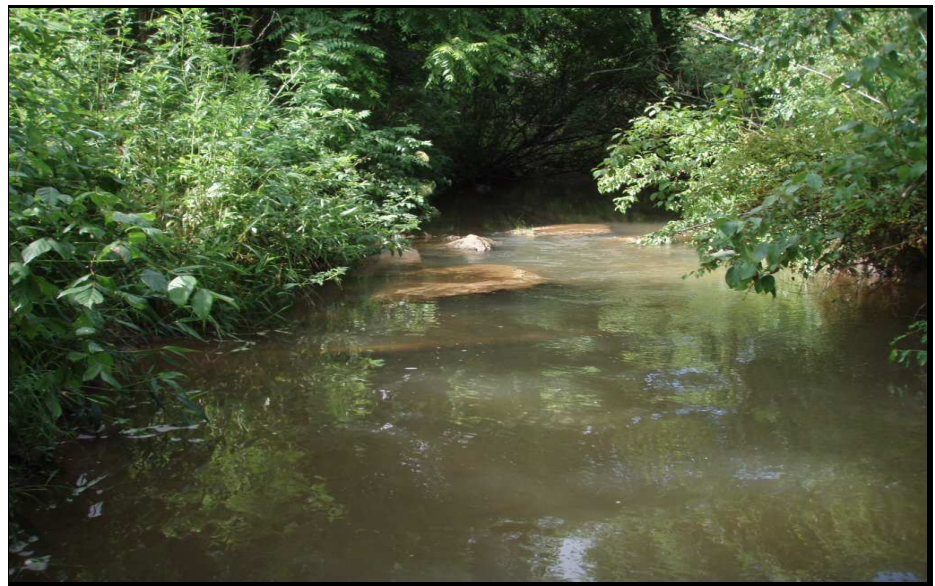
Site Photograph

Channel Modification (5)	4
Instream Habitat (20)	14
Bottom Substrate (15)	5
Pool Variety (10)	6
Riffle Habitat (16)	3
Bank Erosion (7)	4
Bank Vegetation (7)	4
Light Penetration (10)	8
Left Riparian Score (5)	3
Right Riparian Score (5)	4
Total Habitat Score (100)	55

Substrate	sand, silt, boulder
-----------	---------------------

Sample Date	Sample ID	Species Total	NCIBI	Bioclassification
06/23/09	2009-70	19	40	Good-Fair
06/17/04	2004-91	20	44	Good-Fair

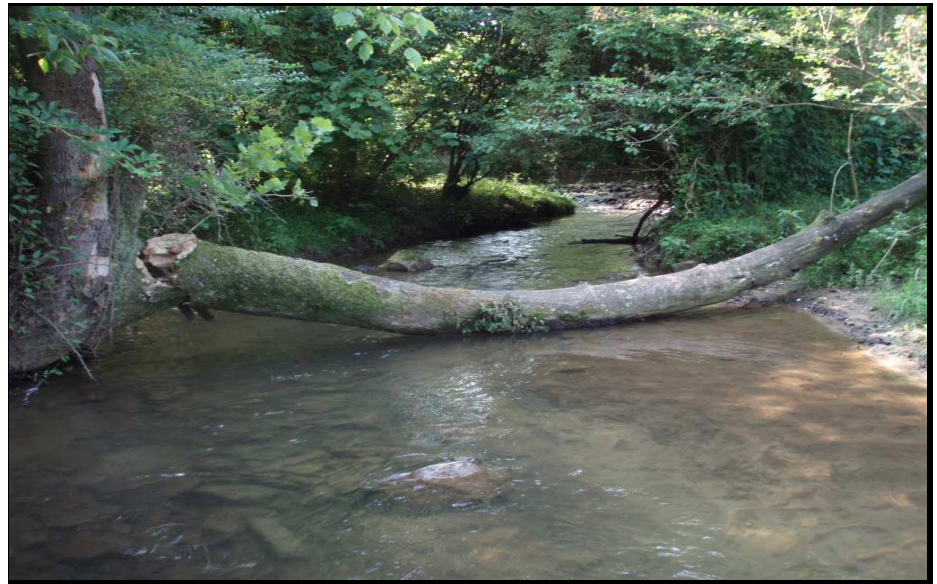
Site Photograph

Channel Modification (5)	5
Instream Habitat (20)	16
Bottom Substrate (15)	10
Pool Variety (10)	6
Riffle Habitat (16)	12
Bank Erosion (7)	3
Bank Vegetation (7)	6
Light Penetration (10)	7
Left Riparian Score (5)	1
Right Riparian Score (5)	1
Total Habitat Score (100)	67

Substrate	cobble, bedrock, gravel, silt
-----------	-------------------------------

Sample Date	Sample ID	Species Total	NCIBI	Bioclassification
06/25/09	2009-77	15	44	Good-Fair
06/18/04	2004-94	15	44	Good-Fair

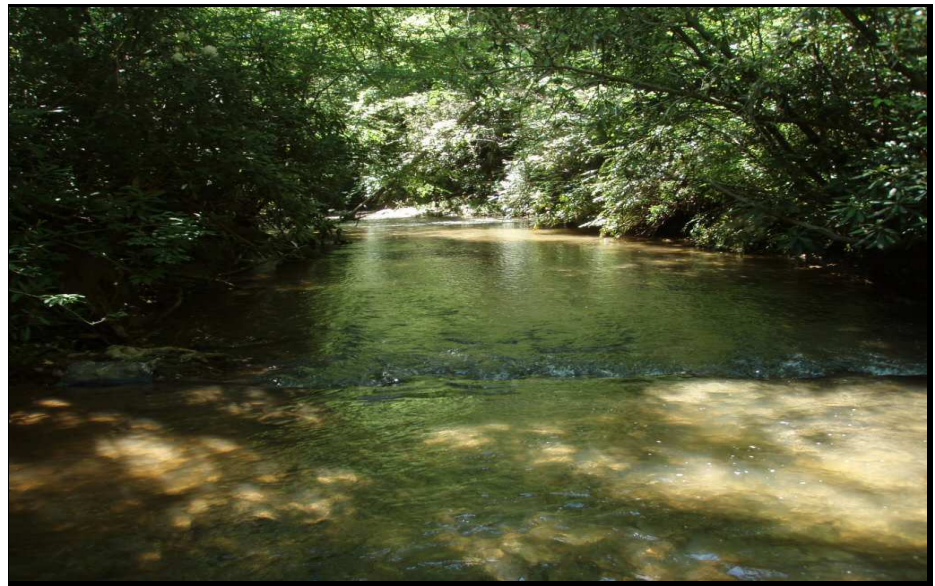
Site Photograph

Channel Modification (5)	5
Instream Habitat (20)	18
Bottom Substrate (15)	8
Pool Variety (10)	4
Riffle Habitat (16)	5
Bank Erosion (7)	5
Bank Vegetation (7)	7
Light Penetration (10)	10
Left Riparian Score (5)	5
Right Riparian Score (5)	5
Total Habitat Score (100)	72

Substrate	flat cobble, sand, boulder, bedrock
-----------	-------------------------------------

Sample Date	Sample ID	Species Total	NCIBI	Bioclassification
06/23/09	2009-72	22	38	Fair
03/23/06	2006-03	20	46	Good-Fair
06/17/04	2004-92	19	38	Fair

Watershed - drains part of the southeast corner of Cherokee County; the site is located just below Murphy, about 400 meters above the Hiwassee River confluence. The urban and agricultural land uses of this catchment is reflected in the relatively high conductivity at this site. **Habitat** - instream habitats consist of moderately embedded shallow runs, bedrock shelves, and some side root snags and short riffles. A slight increase in fine silts upon substrates was observed in 2009. Although crossed by the newly constructed US 64 just upstream, the riparian corridor is densely vegetated here, primarily with Rhododendron. **2009** - a moderately abundant (n = 449) and rich assemblage of cool and warm water fish was collected at this regional reference site, including three top predator species (Largemouth Bass, Spotted Bass and young of year Walleye). However, no Rock Bass, Smallmouth Bass or trout were collected. These additions, and the 10 fold increase in the intolerant Highland Shiner in 2009 (n=233 vs 22 in 2006, and 26 in 2004) are likely due to the recruitment opportunities provided by the nearby river. 2004 - 2009 - The fluctuations in ratings here seem to be the result of trophic shifts within the fish community between insectivores and omnivores + herbivores, which may be due to the forementioned recruitment potential. Overall, the cause of impairment is unclear.

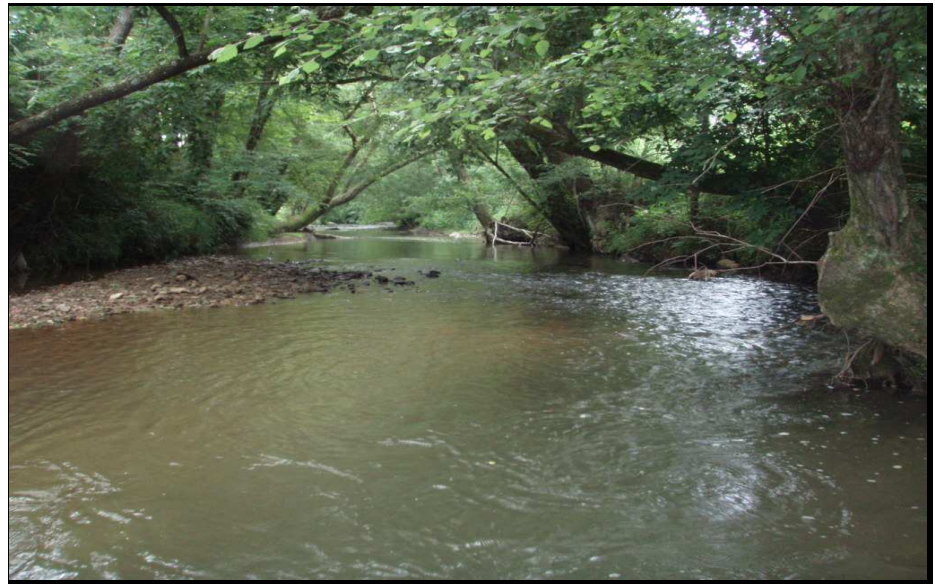
Site Photograph

Channel Modification (5)	5
Instream Habitat (20)	18
Bottom Substrate (15)	12
Pool Variety (10)	8
Riffle Habitat (16)	12
Bank Erosion (7)	6
Bank Vegetation (7)	7
Light Penetration (10)	10
Left Riparian Score (5)	3
Right Riparian Score (5)	3
Total Habitat Score (100)	84

Substrate	cobble, gravel, boulder, sand
-----------	-------------------------------

Sample Date	Sample ID	Species Total	NCIBI	Bioclassification
06/22/09	2009-68	17	50	Good
06/14/04	2004-84	18	46	Good-Fair
