LITTLE TENNESSEE RIVER BASINWIDE WATER QUALITY PLAN

Summary

This 2012 document is the fourth five-year update of the Little Tennessee River Basinwide Water Quality Plan. Previous basinwide plans for the Little Tennessee River Basin were completed in 1997, 2002, and 2007 and are available from the DWQ Basinwide Planning [website](#). This basin plan was written to provide guidance for watershed stakeholders, municipal planners, natural resource regulators, and other environmental professionals with identifying and addressing water quality stressors, sources, and emerging issues. This document can be used in conjunction with the [Supplemental Guide to Basinwide Planning](#) which provides general information about water quality issues and DWQ programs.

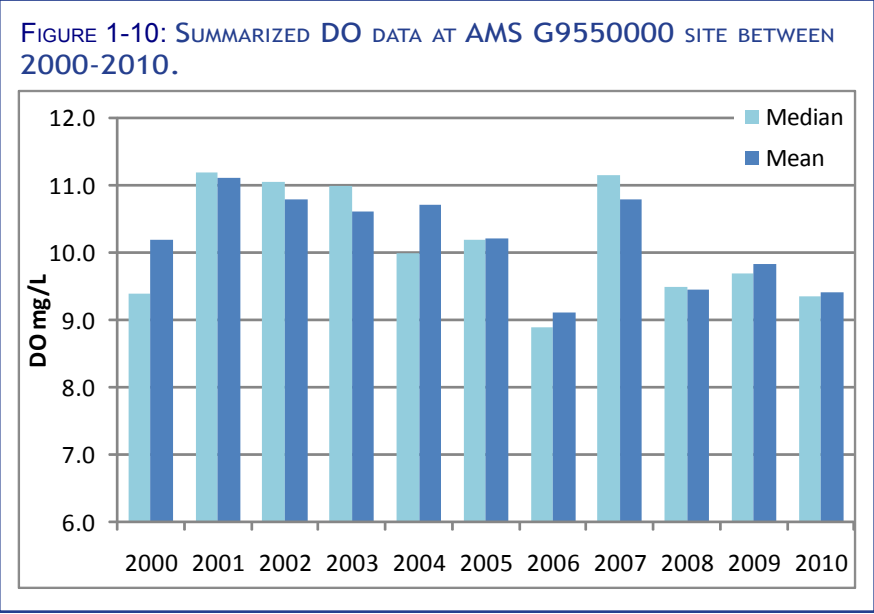
Over the past 11 years (Figure 1-10), no samples were collected with dissolved oxygen levels below 6mg/l standard for trout waters. As seen in Figure 1-11, which represents the data window for the 2010 [303\(d\)](#) list, AMS station G9550000 did not have any exceedances of its DO standards.

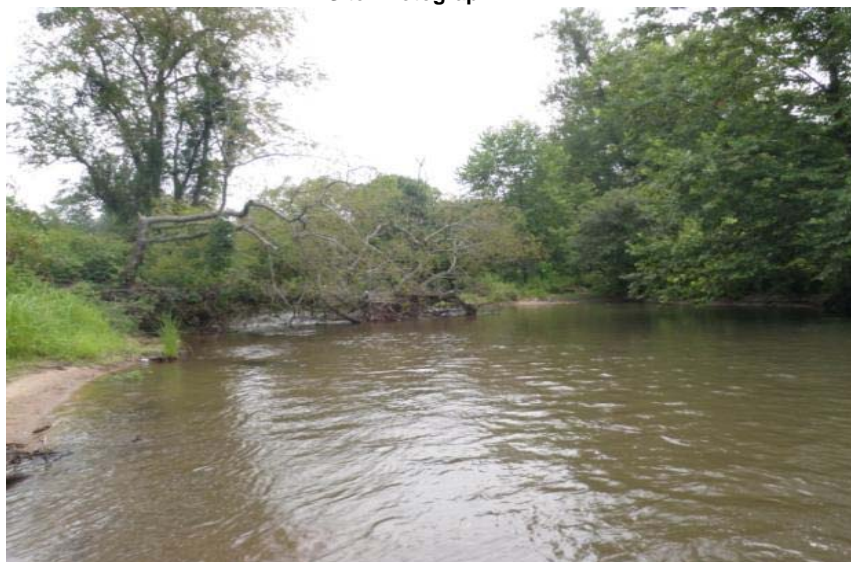
Site Photograph

Channel Modification (5)	4
Instream Habitat (20)	16
Bottom Substrate (15)	8
Pool Variety (10)	10
Riffle Habitat (16)	7
Bank Erosion (7)	3
Bank Vegetation (7)	3
Light Penetration (10)	2
Left Riparian Score (5)	1
Right Riparian Score (5)	2
Total Habitat Score (100)	58

Substrate	Sand, gravel, cobble, silt with a trace of boulder
------------------	--

Sample Date	Sample ID	ST	EPT	BI	EPT BI	Bioclassification
08/04/10	11014	72	24	5.72	4.61	Good-Fair
09/11/00	8303	67	15	6.35	4.08	Fair

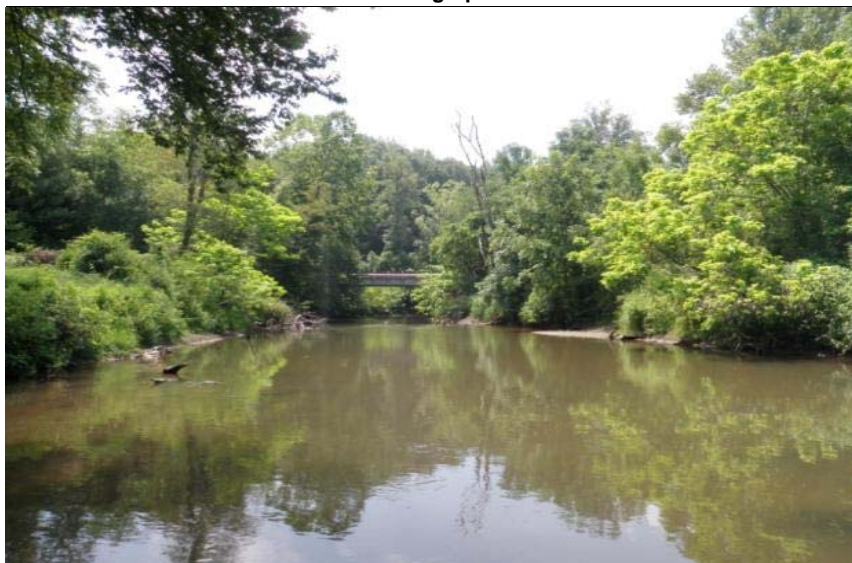
Site Photograph

Channel Modification (5)	5
Instream Habitat (20)	9
Bottom Substrate (15)	8
Pool Variety (10)	4
Riffle Habitat (16)	7
Bank Erosion (7)	3
Bank Vegetation (7)	3
Light Penetration (10)	2
Left Riparian Score (5)	3
Right Riparian Score (5)	1
Total Habitat Score (100)	45

Substrate	Sand, silt, gravel, cobble, trace of boulder
------------------	--

Sample Date	Sample ID	ST	EPT	BI	EPT BI	Bioclassification
08/04/10	11015	93	35	5.03	4.12	Good
07/22/04	9435	93	37	5.30	3.62	Good
10/20/99	7993	62	29	4.16	3.27	Good-Fair
08/05/87	4196	64	20	5.59	4.73	Good-Fair
08/06/85	3536	52	18	5.48	4.66	Fair

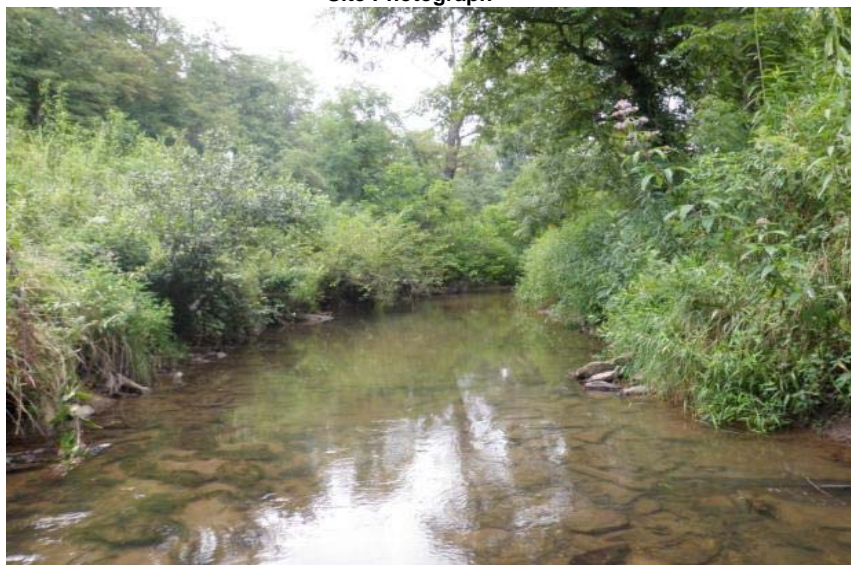
Site Photograph

Channel Modification (5)	4
Instream Habitat (20)	14
Bottom Substrate (15)	11
Pool Variety (10)	8
Riffle Habitat (16)	14
Bank Erosion (7)	5
Bank Vegetation (7)	3
Light Penetration (10)	7
Left Riparian Score (5)	1
Right Riparian Score (5)	1
Total Habitat Score (100)	68

Substrate	rubble, boulder, sand, silt and gravel
-----------	--

Sample Date	Sample ID	ST	EPT	BI	EPT BI	Bioclassification
08/03/10	11013		38		2.77	Excellent
07/22/04	9427		43		2.37	Excellent
08/24/99	7979		25		3.94	Good-Fair

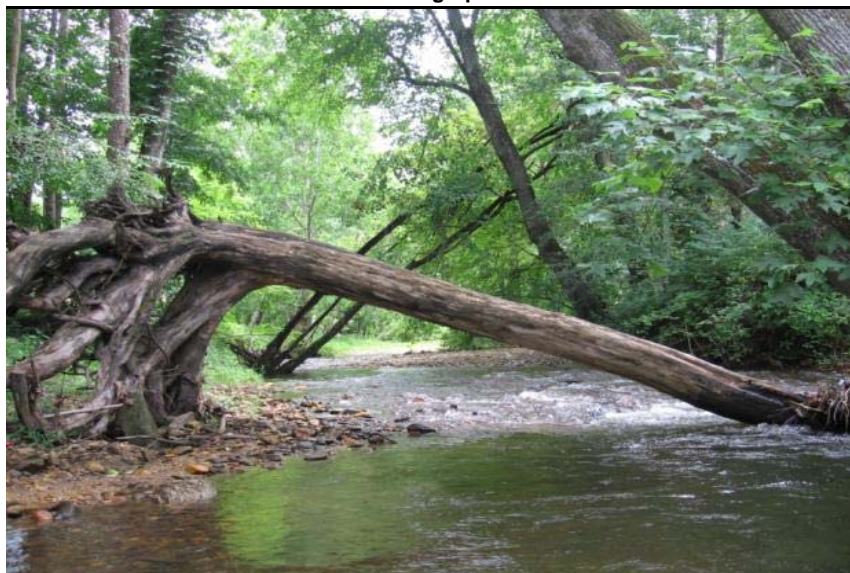
Site Photograph

Channel Modification (5)	5
Instream Habitat (20)	16
Bottom Substrate (15)	14
Pool Variety (10)	10
Riffle Habitat (16)	16
Bank Erosion (7)	6
Bank Vegetation (7)	7
Light Penetration (10)	10
Left Riparian Score (5)	3
Right Riparian Score (5)	5
Total Habitat Score (100)	92

Substrate	mostly cobble and gravel
-----------	--------------------------

Sample Date	Sample ID	ST	EPT	BI	EPT BI	Bioclassification
07/29/09	10787	---	41	---	2.73	Excellent
07/22/04	9429	---	45	---	2.62	Excellent
08/21/99	7948	---	39	---	2.88	Excellent
07/27/94	6622	---	39	---	2.75	Excellent

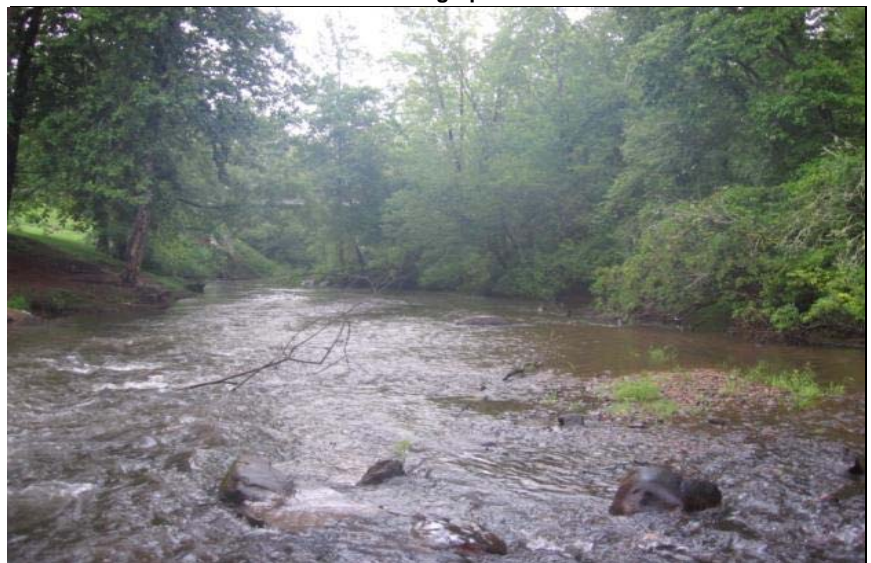
Site Photograph

Channel Modification (5)	5
Instream Habitat (20)	14
Bottom Substrate (15)	12
Pool Variety (10)	8
Riffle Habitat (16)	12
Bank Erosion (7)	6
Bank Vegetation (7)	2
Light Penetration (10)	5
Left Riparian Score (5)	4
Right Riparian Score (5)	0
Total Habitat Score (100)	68

Substrate	boulder, cobble, gravle, sand, and silt
-----------	---

Sample Date	Sample ID	ST	EPT	BI	EPT BI	Bioclassification
07/28/09	10784		30		3.24	Good
07/21/04	9446		31		3.03	Good
08/24/99	7977		41		2.81	Excellent
07/27/94	6623		30		2.91	Good

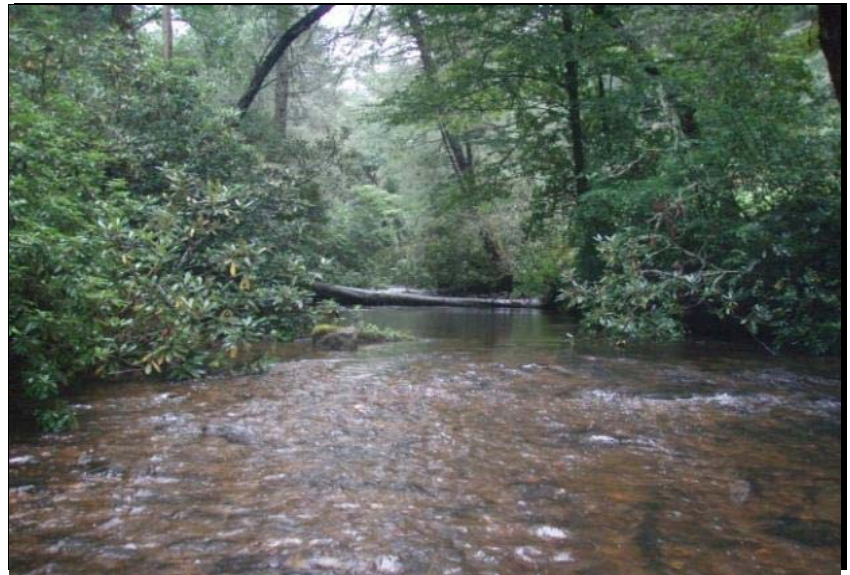
Site Photograph

Temperature (°C)	17.8
Dissolved Oxygen (mg/L)	7.9
Specific Conductance (µS/cm)	13
pH (s.u.)	5.7
Water Clarity	clear

Channel Modification (5)	4
Instream Habitat (20)	18
Bottom Substrate (15)	11
Pool Variety (10)	6
Riffle Habitat (16)	16
Bank Erosion (7)	5
Bank Vegetation (7)	7
Light Penetration (10)	10
Left Riparian Score (5)	5
Right Riparian Score (5)	2
Total Habitat Score (100)	84

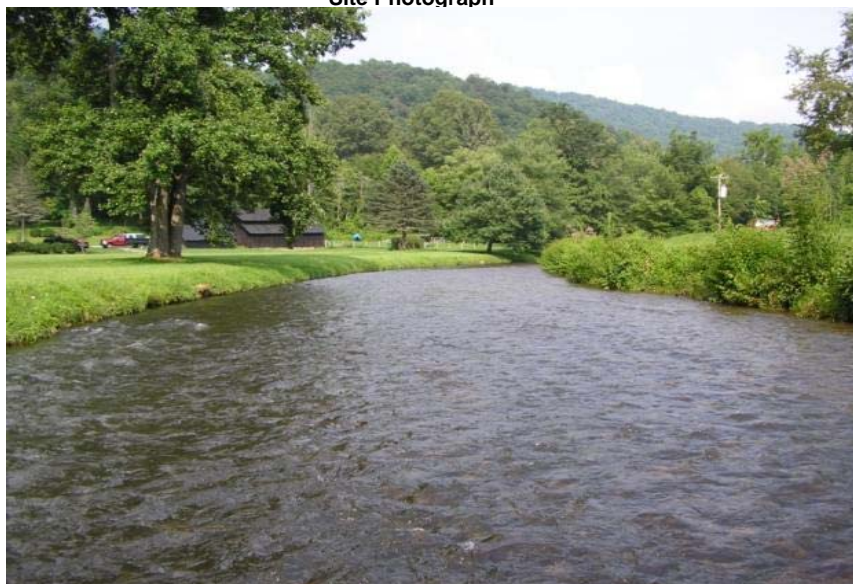
Site Photograph

Channel Modification (5)	3
Instream Habitat (20)	16
Bottom Substrate (15)	8
Pool Variety (10)	0
Riffle Habitat (16)	10
Bank Erosion (7)	5
Bank Vegetation (7)	5
Light Penetration (10)	7
Left Riparian Score (5)	4
Right Riparian Score (5)	0
Total Habitat Score (100)	58

Substrate	boulder, silt, sand, and cobble
-----------	---------------------------------

Sample Date	Sample ID	ST	EPT	BI	EPT BI	Bioclassification
08/04/09	10790	83	32	4.63	3.92	Good
05/24/07	10188		31		3.62	Good
07/22/04	9449	73	32	4.66	3.86	Good
08/10/99	7960		35		3.50	Good
07/27/94	6624		21		4.28	Good-Fair

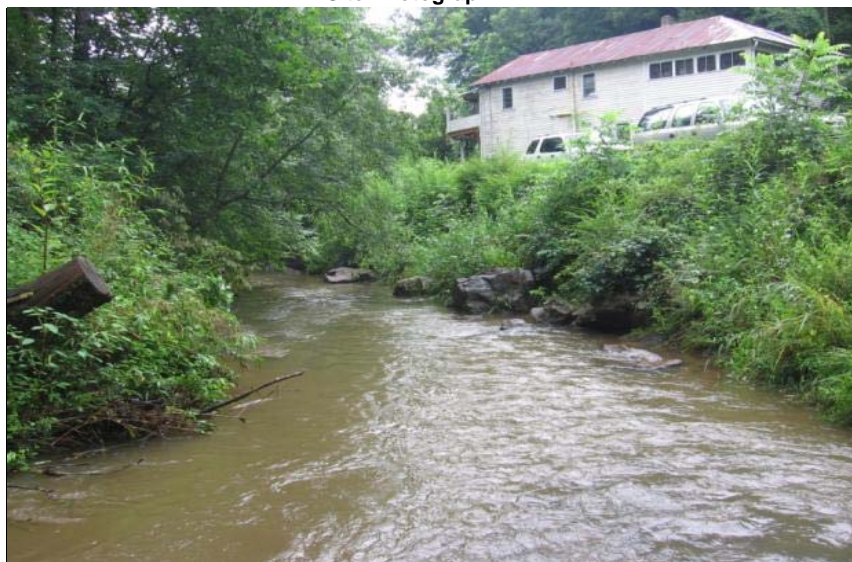
Site Photograph

Channel Modification (5)	4
Instream Habitat (20)	18
Bottom Substrate (15)	8
Pool Variety (10)	4
Riffle Habitat (16)	16
Bank Erosion (7)	5
Bank Vegetation (7)	5
Light Penetration (10)	6
Left Riparian Score (5)	0
Right Riparian Score (5)	4
Total Habitat Score (100)	70

Substrate	Boulder, cobble, gravel
-----------	-------------------------

Sample Date	Sample ID	ST	EPT	BI	EPT BI	Bioclassification
07/29/09	10786		40		2.94	Excellent
05/23/07	10187		43		2.81	Excellent
07/22/04	9451		38		2.82	Excellent
08/10/99	7962		35		2.37	Good
07/26/94	6620		24		3.31	Good-Fair

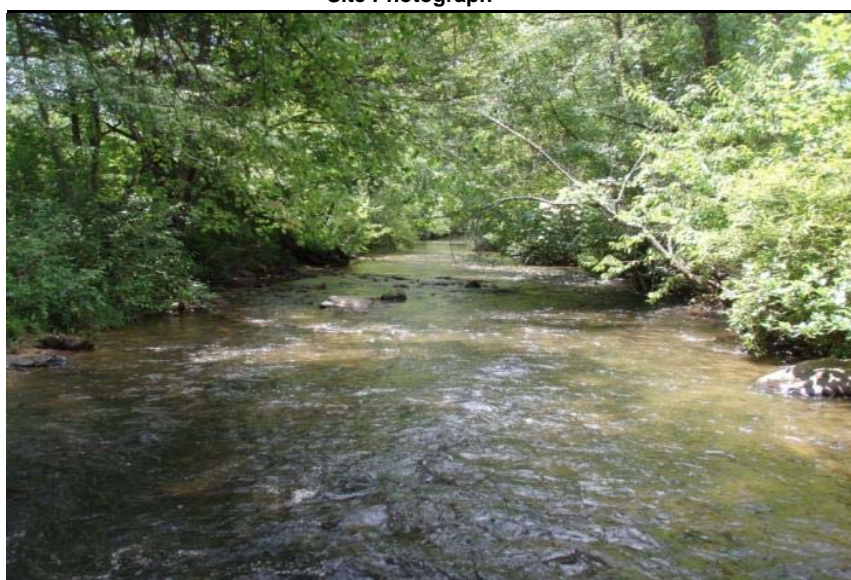
Site Photograph

Channel Modification (5)	4
Instream Habitat (20)	15
Bottom Substrate (15)	10
Pool Variety (10)	4
Riffle Habitat (16)	16
Bank Erosion (7)	6
Bank Vegetation (7)	6
Light Penetration (10)	10
Left Riparian Score (5)	5
Right Riparian Score (5)	1
Total Habitat Score (100)	77

Substrate	mix of bolder, rubble, gravel and sand
-----------	--

Sample Date	Sample ID	ST	EPT	BI	EPT BI	Bioclassification
08/04/09	10789	---	37	---	3.41	Excellent
08/03/04	9477	---	43	---	3.12	Excellent
08/10/99	7959	---	39	---	3.06	Excellent
07/26/94	6619	---	30	---	2.89	Good

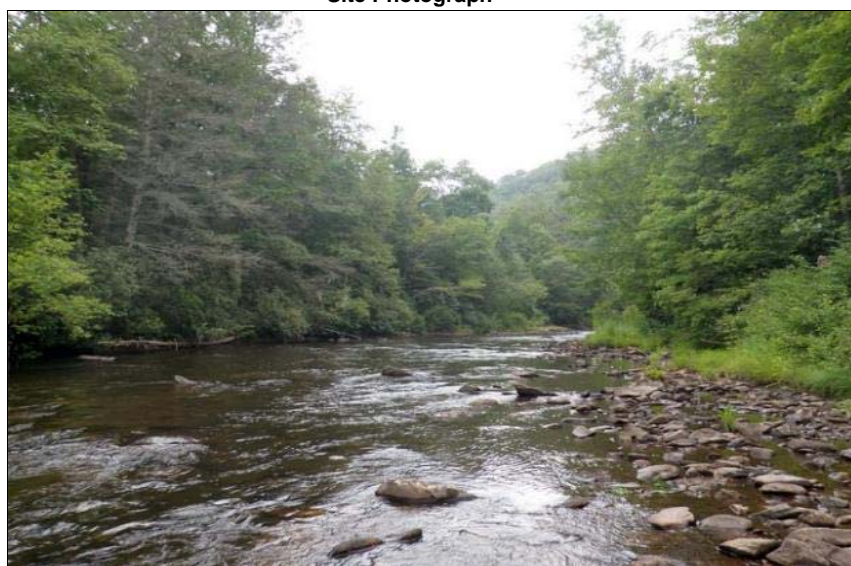
Site Photograph

Channel Modification (5)	5
Instream Habitat (20)	19
Bottom Substrate (15)	15
Pool Variety (10)	4
Riffle Habitat (16)	16
Bank Erosion (7)	7
Bank Vegetation (7)	7
Light Penetration (10)	5
Left Riparian Score (5)	5
Right Riparian Score (5)	5
Total Habitat Score (100)	88

Substrate	mostly boulder, cobble and gravel with some sand and silt
-----------	---

Sample Date	Sample ID	ST	EPT	BI	EPT BI	Bioclassification
08/04/10	11016	108	56	3.01	1.93	Excellent
07/21/04	9445	92	49	2.90	1.60	Excellent
08/24/99	7976	100	49	3.11	2.02	Excellent
07/26/94	6627	77	48	2.40	1.95	Excellent
07/10/91	5655	94	54	2.34	1.48	Excellent

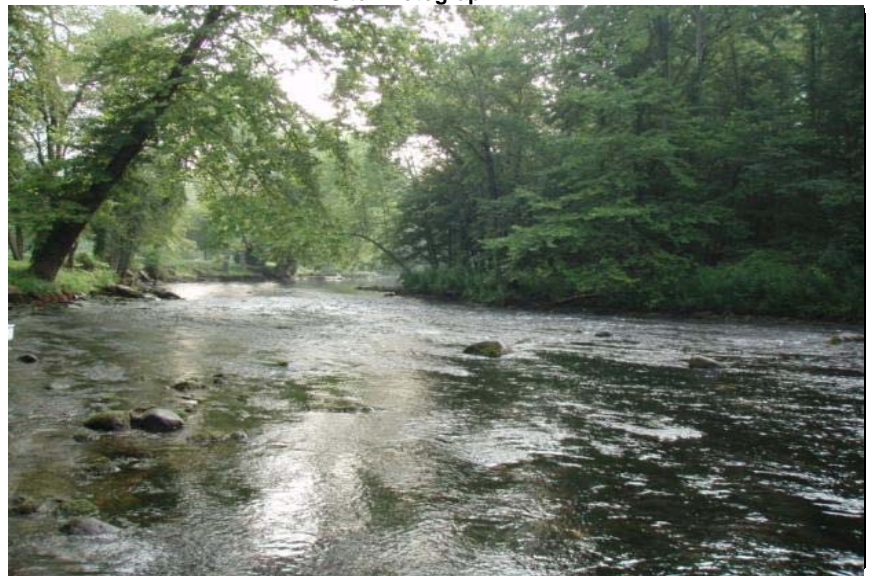
Site Photograph

Channel Modification (5)	5
Instream Habitat (20)	20
Bottom Substrate (15)	12
Pool Variety (10)	6
Riffle Habitat (16)	16
Bank Erosion (7)	7
Bank Vegetation (7)	7
Light Penetration (10)	5
Left Riparian Score (5)	5
Right Riparian Score (5)	2
Total Habitat Score (100)	85

Substrate	mostly rubble with some boulder and gravel
-----------	--

Sample Date	Sample ID	ST	EPT	BI	EPT BI	Bioclassification
08/04/09	10782	93	37	3.90	2.42	Good
07/20/04	9438	83	35	4.19	2.26	Good
08/23/99	7953	---	35	---	2.25	Good
07/26/94	6617	71	36	3.64	2.15	Good
11/15/93	6419	65	32	4.07	2.15	Good

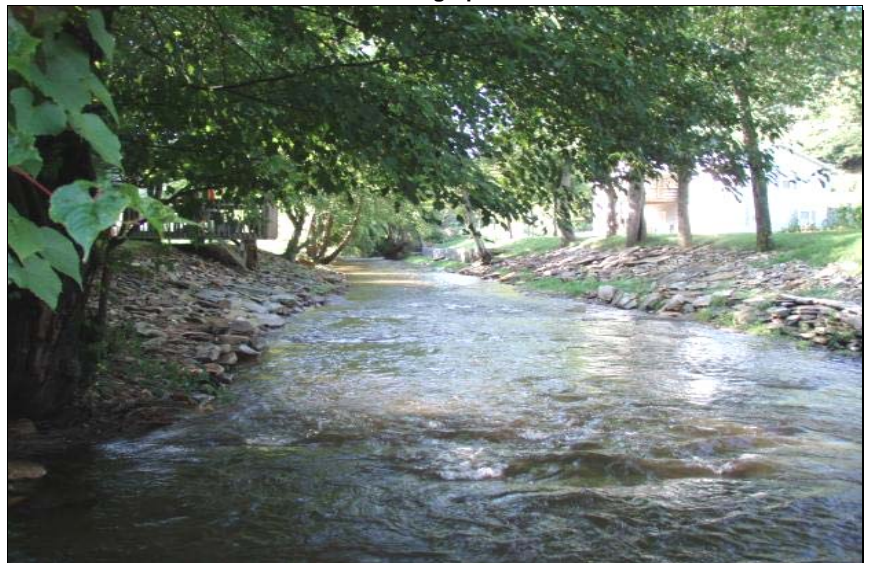
Site Photograph

Channel Modification (5)	3
Instream Habitat (20)	18
Bottom Substrate (15)	10
Pool Variety (10)	4
Riffle Habitat (16)	16
Bank Erosion (7)	7
Bank Vegetation (7)	5
Light Penetration (10)	10
Left Riparian Score (5)	1
Right Riparian Score (5)	4
Total Habitat Score (100)	78

Substrate	Cobble, boulder, and gravel with some bedrock, sand, and silt
------------------	---

Sample Date	Sample ID	ST	EPT	BI	EPT BI	Bioclassification
07/29/09	10769	110	53	3.59	2.66	Excellent
08/02/04	9453	101	46	3.88	2.67	Excellent
08/09/99	7956	86	51	3.62	3.03	Excellent
07/11/94	6580	91	48	3.70	2.99	Excellent

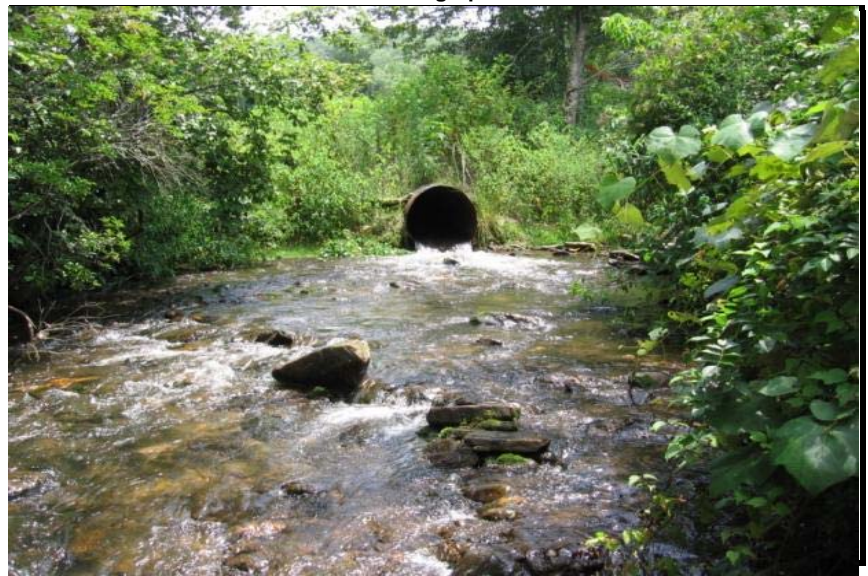
Site Photograph

Channel Modification (5)	3
Instream Habitat (20)	19
Bottom Substrate (15)	8
Pool Variety (10)	6
Riffle Habitat (16)	16
Bank Erosion (7)	5
Bank Vegetation (7)	3
Light Penetration (10)	7
Left Riparian Score (5)	1
Right Riparian Score (5)	3
Total Habitat Score (100)	71

Substrate	mix of boulders, rubble, gravel and silt
-----------	--

Sample Date	Sample ID	ST	EPT	BI	EPT BI	Bioclassification
07/28/09	10783	57	21	4.84	1.73	Good-Fair
07/21/04	9443	63	26	4.53	2.34	Good-Fair
08/09/90	5426	60	20	5.83	2.20	Fair
05/15/90	5278	79	35	4.06	1.96	Good-Fair
01/23/90	5159	83	39	3.91	2.26	Good-Fair

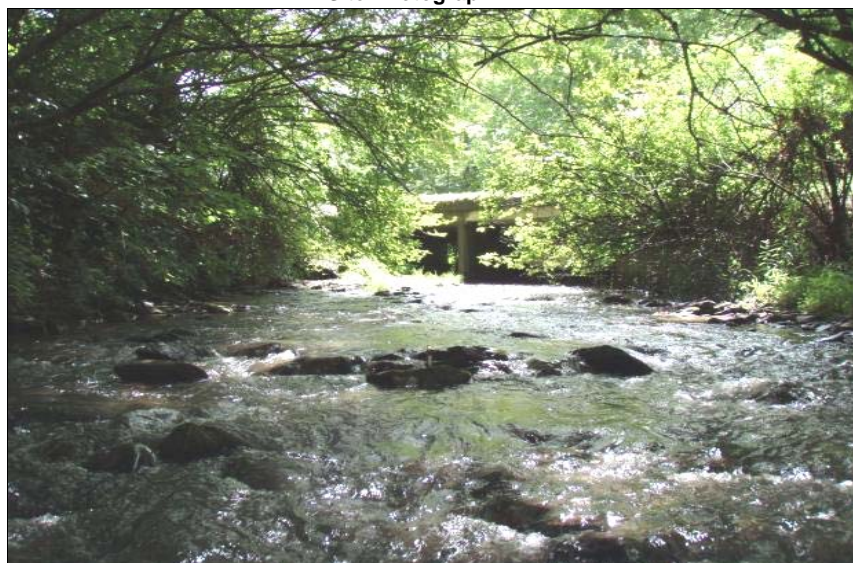
Site Photograph

Channel Modification (5)	4
Instream Habitat (20)	18
Bottom Substrate (15)	14
Pool Variety (10)	4
Riffle Habitat (16)	16
Bank Erosion (7)	6
Bank Vegetation (7)	6
Light Penetration (10)	10
Left Riparian Score (5)	5
Right Riparian Score (5)	3
Total Habitat Score (100)	86

Substrate	Cobble, gravel, and boulder with some bedrock
------------------	---

Sample Date	Sample ID	ST	EPT	BI	EPT BI	Bioclassification
07/29/09	10701	---	45	---	2.13	Excellent
08/04/04	9457	---	35	---	2.07	Good
08/10/99	7963	---	39	---	2.15	Excellent
07/13/94	6585	---	37	---	1.93	Excellent

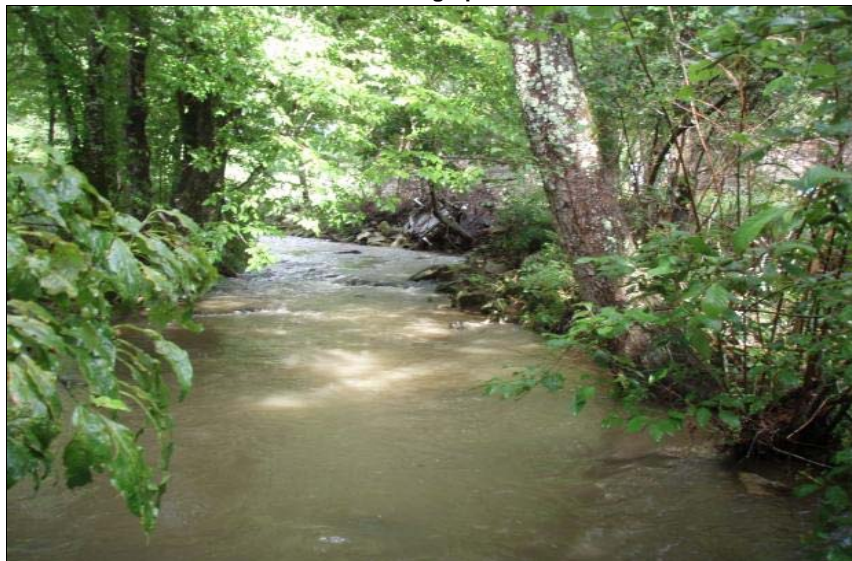
Site Photograph

Channel Modification (5)	4
Instream Habitat (20)	15
Bottom Substrate (15)	12
Pool Variety (10)	6
Riffle Habitat (16)	16
Bank Erosion (7)	6
Bank Vegetation (7)	5
Light Penetration (10)	10
Left Riparian Score (5)	3
Right Riparian Score (5)	2
Total Habitat Score (100)	79

Substrate	Cobble and gravel with some boulder and gravel
-----------	--

Sample Date	Sample ID	ST	EPT	BI	EPT BI	Bioclassification
07/29/09	10700	---	41	---	3.18	Excellent
08/04/04	9458	---	30	---	2.94	Good
08/11/99	7964	---	39	---	2.94	Excellent
07/13/94	6584	---	29	---	3.51	Good

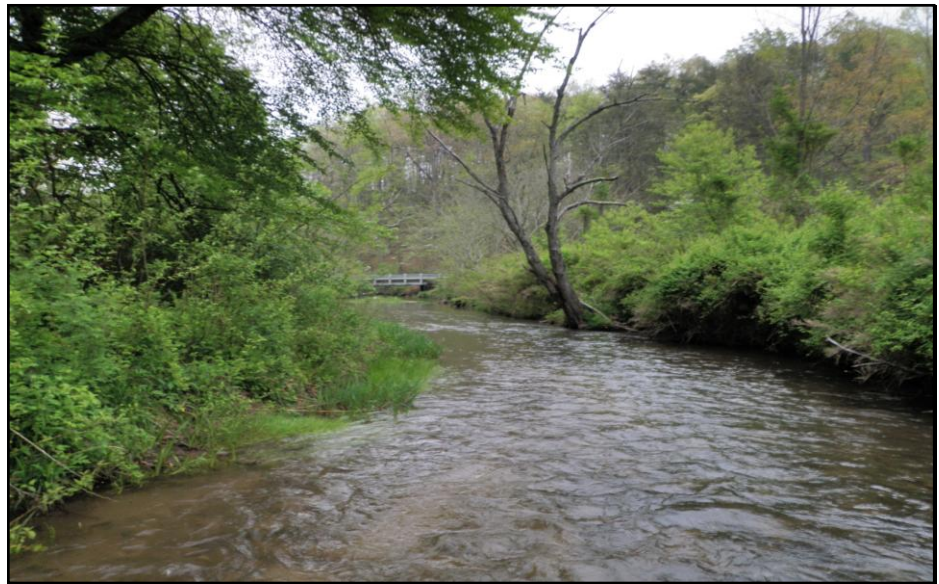
Site Photograph

Channel Modification (5)	5
Instream Habitat (20)	16
Bottom Substrate (15)	8
Pool Variety (10)	10
Riffle Habitat (16)	7
Erosion (7)	4
Bank Vegetation (7)	4
Light Penetration (10)	7
Left Riparian Score (5)	3
Right Riparian Score (5)	1
Total Habitat Score (100)	65

Substrate	Cobble, gravel, sand, silt
-----------	----------------------------

Sample Date	Sample ID	Species Total	NCIBI	Bioclassification
04/30/09	2009-24	19	58	Excellent
05/17/04	2004-44	16	56	Good

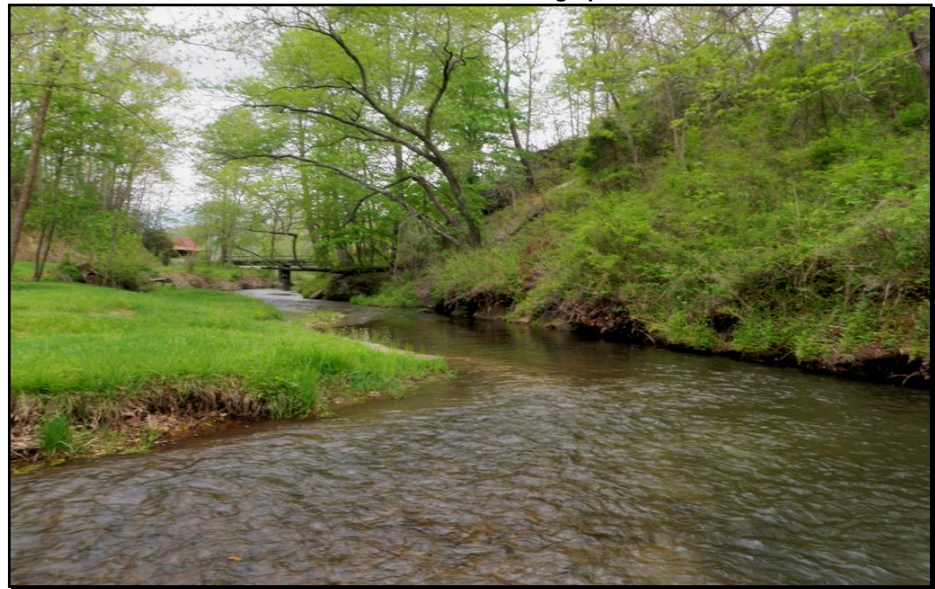
Site Photograph

Channel Modification (5)	5
Instream Habitat (20)	18
Bottom Substrate (15)	8
Pool Variety (10)	10
Riffle Habitat (16)	10
Left Bank Stability (7)	2
Erosion (7)	4
Bank Vegetation (7)	7
Left Riparian Score (5)	5
Right Riparian Score (5)	1
Total Habitat Score (100)	70

Substrate	Cobble, gravel, sand, silt
-----------	----------------------------

Sample Date	Sample ID	Species Total	NCIBI	Bioclassification
04/30/09	2009-25	19	52	Good
05/18/04	2004-46	16	52	Good
05/03/95	95-38	16	56	Good

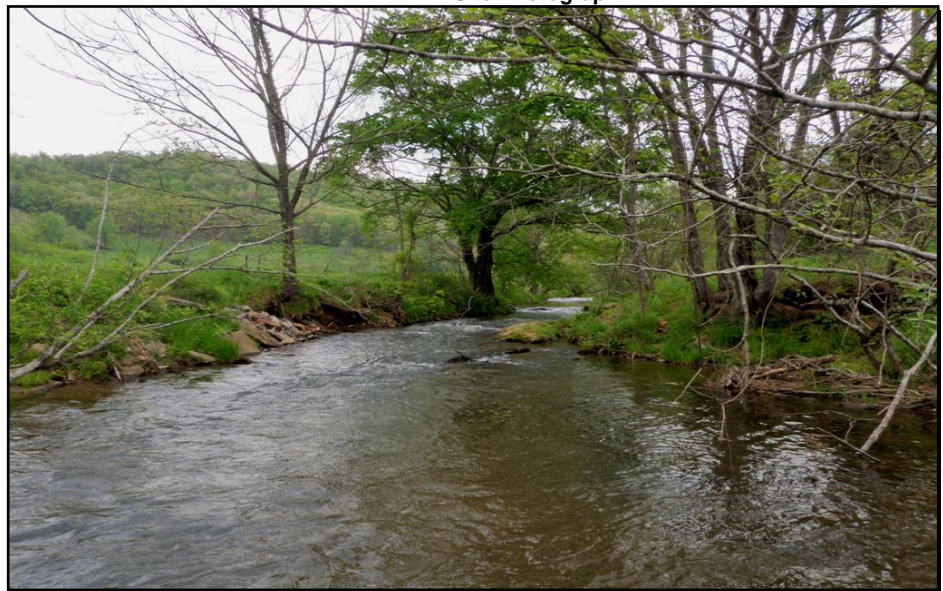
Site Photograph

Channel Modification (5)	4
Instream Habitat (20)	18
Bottom Substrate (15)	10
Pool Variety (10)	9
Riffle Habitat (16)	16
Erosion (7)	7
Bank Vegetation (7)	4
Light Penetration (10)	5
Left Riparian Score (5)	2
Right Riparian Score (5)	2
Total Habitat Score (100)	77

Substrate	Cobble, bedrock, boulder, gravel, silt, sand
-----------	--

Sample Date	Sample ID	Species Total	NCIBI	Bioclassification
04/30/09	2009-26	19	50	Good
05/20/04	2004-51	20	56	Good

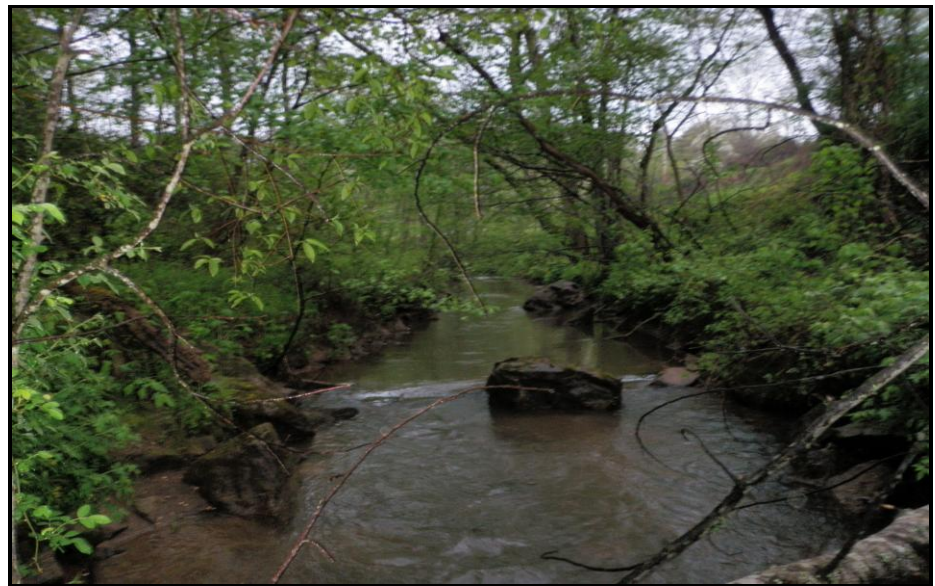
Site Photograph

Channel Modification (5)	5
Instream Habitat (20)	17
Bottom Substrate (15)	6
Pool Variety (10)	8
Riffle Habitat (16)	10
Erosion (7)	4
Bank Vegetation (7)	5
Light Penetration (10)	8
Left Riparian Score (5)	4
Right Riparian Score (5)	2
Total Habitat Score (100)	69

Substrate	Cobble, boulder, sand, silt
-----------	-----------------------------

Sample Date	Sample ID	Species Total	NCIBI	Bioclassification
05/01/09	2009-27	22	48	Good
05/19/04	2004-48	18	44	Good-Fair

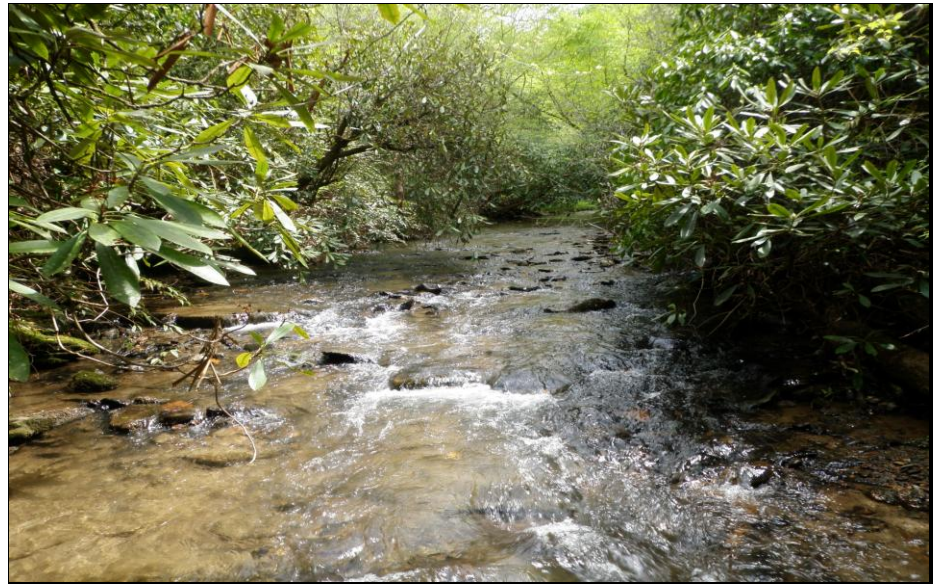
Site Photograph

Channel Modification (5)	5
Instream Habitat (20)	18
Bottom Substrate (15)	8
Pool Variety (10)	8
Riffle Habitat (16)	14
Erosion (7)	7
Bank Vegetation (7)	7
Light Penetration (10)	10
Left Riparian Score (5)	5
Right Riparian Score (5)	5
Total Habitat Score (100)	87

Substrate	Cobble, boulder, silt, gravel, sand
-----------	-------------------------------------

Sample Date	Sample ID	Species Total	NCIBI	Bioclassification
04/29/09	2009-23	15	52	Good
05/19/04	2004-50	16	50	Good

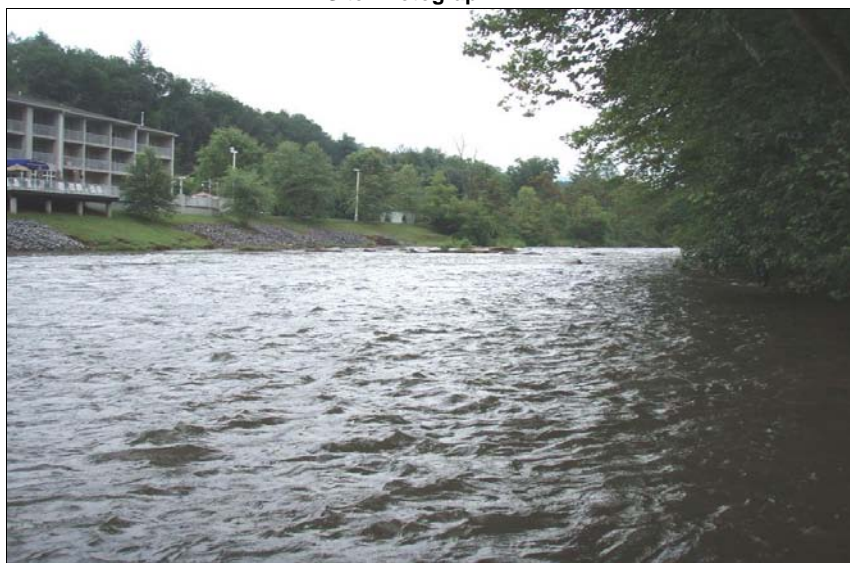
Site Photograph

Channel Modification (5)	5
Instream Habitat (20)	15
Bottom Substrate (15)	11
Pool Variety (10)	4
Riffle Habitat (16)	12
Bank Erosion (7)	6
Bank Vegetation (7)	3
Light Penetration (10)	2
Left Riparian Score (5)	1
Right Riparian Score (5)	4
Total Habitat Score (100)	63

Substrate	Cobble and boulder with some bedrock, gravel, sand, and silt
-----------	--

Sample Date	Sample ID	ST	EPT	BI	EPT BI	Bioclassification
07/30/09	10770	75	43	4.29	3.52	Good
08/04/04	9484	84	44	4.27	3.44	Excellent
07/21/99	7932	75	40	4.34	3.73	Good
07/14/94	6591	100	47	4.38	3.32	Excellent
08/10/90	5366	86	43	4.10	3.20	Good

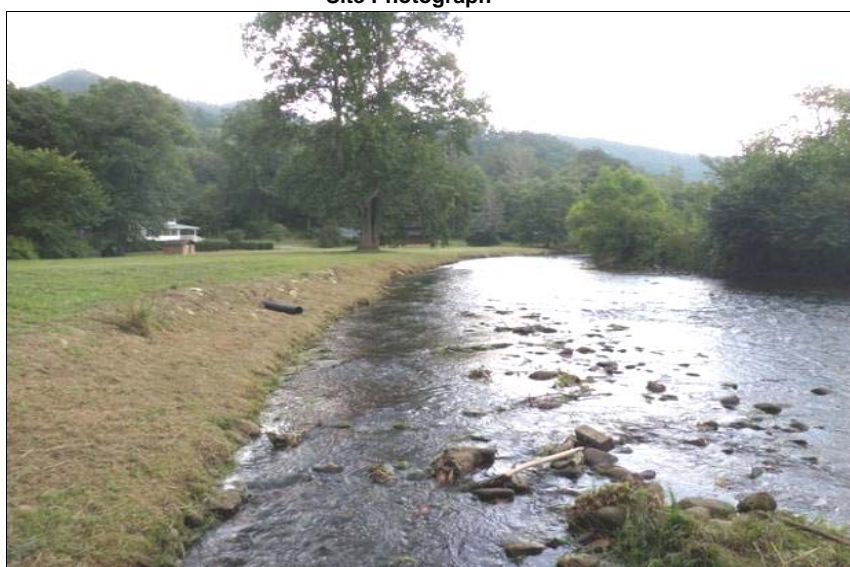
Site Photograph

Channel Modification (5)	5
Instream Habitat (20)	18
Bottom Substrate (15)	14
Pool Variety (10)	7
Riffle Habitat (16)	14
Bank Erosion (7)	6
Bank Vegetation (7)	6
Light Penetration (10)	7
Left Riparian Score (5)	3
Right Riparian Score (5)	2
Total Habitat Score (100)	82

Substrate	good mix of cobble (40), gravel (30), boulder (20), and sand (10)
-----------	---

Sample Date	Sample ID	ST	EPT	BI	EPT BI	Bioclassification
08/02/10	11088	107	52	3.13	2.20	Excellent
08/02/04	9474	107	54	3.39	2.33	Excellent
07/20/99	7912	97	53	3.26	2.50	Excellent
07/15/94	6593	93	56	3.01	2.38	Excellent

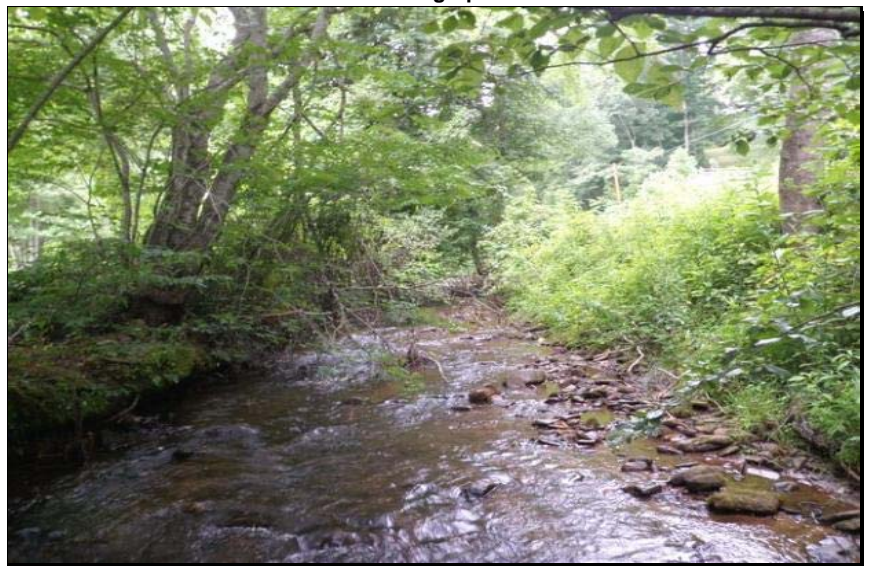
Site Photograph

Channel Modification (5)	5
Instream Habitat (20)	18
Bottom Substrate (15)	14
Pool Variety (10)	5
Riffle Habitat (16)	16
Bank Erosion (7)	6
Bank Vegetation (7)	5
Light Penetration (10)	7
Left Riparian Score (5)	2
Right Riparian Score (5)	3
Total Habitat Score (100)	81

Substrate	mostly cobble (50) and boulder (25), with some gravel (10)
------------------	--

Sample Date	Sample ID	ST	EPT	BI	EPT BI	Bioclassification
08/02/10	11089	---	42	---	1.64	Excellent
08/02/04	9475	---	46	---	1.38	Excellent
07/20/99	7913	---	37	---	1.57	Excellent

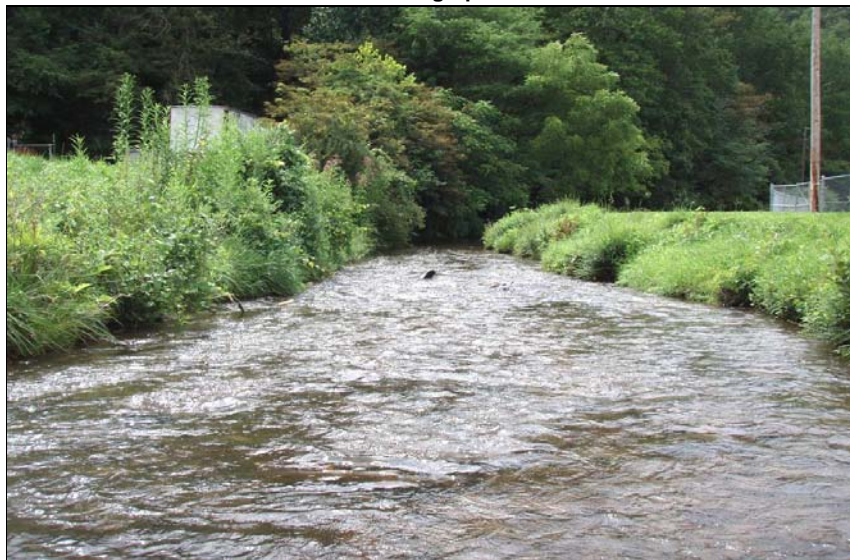
Site Photograph

Water Clarity slightly turbid

Channel Modification (5)	4
Instream Habitat (20)	14
Bottom Substrate (15)	8
Pool Variety (10)	4
Riffle Habitat (16)	9
Bank Erosion (7)	7
Bank Vegetation (7)	4
Light Penetration (10)	7
Left Riparian Score (5)	1
Right Riparian Score (5)	3
Total Habitat Score (100)	61

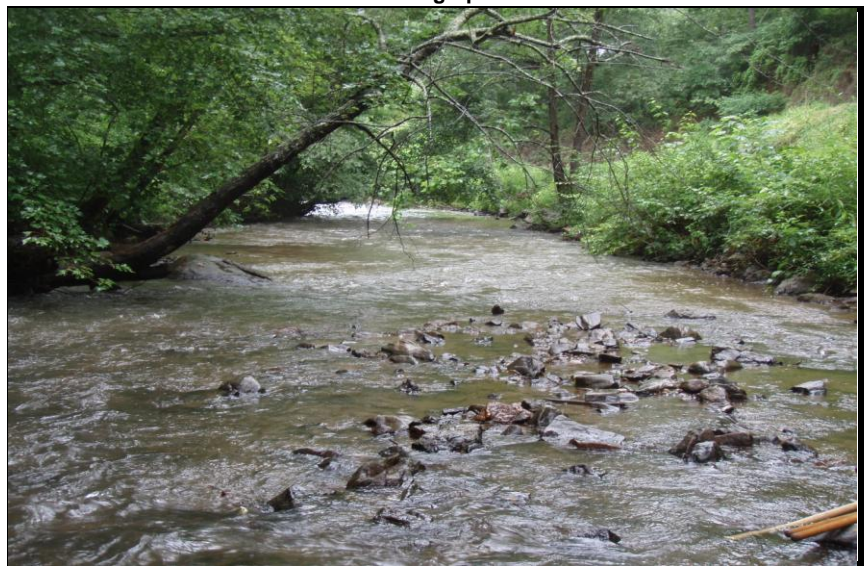
Site Photograph

Channel Modification (5)	4
Instream Habitat (20)	16
Bottom Substrate (15)	7
Pool Variety (10)	5
Riffle Habitat (16)	14
Bank Erosion (7)	5
Bank Vegetation (7)	4
Light Penetration (10)	10
Left Riparian Score (5)	1
Right Riparian Score (5)	4
Total Habitat Score (100)	70

Substrate Cobble and sand with some bedrock and gravel, extremely silty

Sample Date	Sample ID	ST	EPT	BI	EPT BI	Bioclassification
07/30/09	10772	83	45	3.59	3.06	Excellent
08/04/04	9482	91	40	4.15	3.11	Good
07/21/99	7930	53	32	3.72	3.36	Good
07/26/94	6603	77	40	3.78	3.06	Excellent

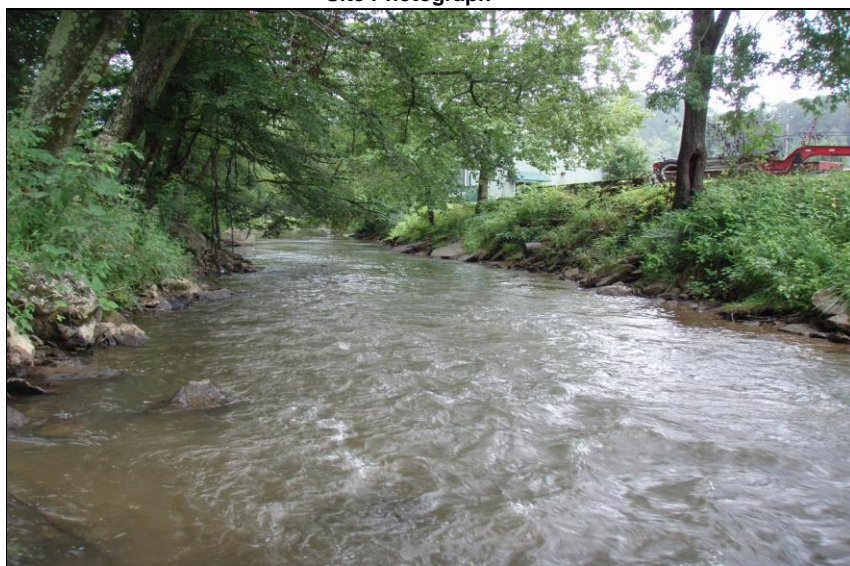
Site Photograph

Channel Modification (5)	3
Instream Habitat (20)	18
Bottom Substrate (15)	6
Pool Variety (10)	4
Riffle Habitat (16)	12
Bank Erosion (7)	6
Bank Vegetation (7)	4
Light Penetration (10)	9
Left Riparian Score (5)	1
Right Riparian Score (5)	1
Total Habitat Score (100)	64

Substrate	Gravel and cobble with some boulder and sand, silty
-----------	---

Sample Date	Sample ID	ST	EPT	BI	EPT BI	Bioclassification
07/30/09	10771	98	46	4.12	3.34	Excellent
08/09/07	10309	---	37	---	3.23	Excellent
08/04/04	9483	74	35	4.07	3.23	Good
07/21/99	7931	70	36	4.07	3.09	Good
07/14/94	6592	68	28	5.19	3.65	Good-Fair

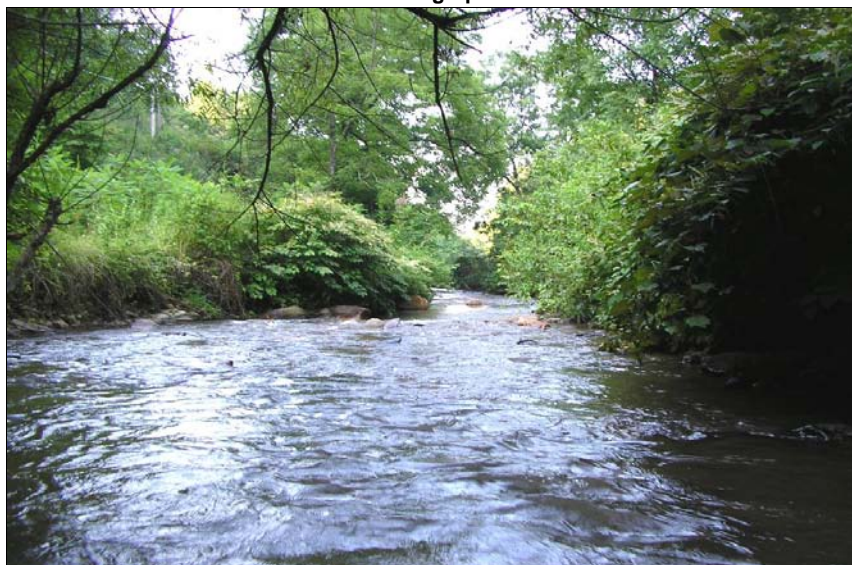
Site Photograph

Channel Modification (5)	4
Instream Habitat (20)	18
Bottom Substrate (15)	14
Pool Variety (10)	5
Riffle Habitat (16)	16
Bank Erosion (7)	6
Bank Vegetation (7)	5
Light Penetration (10)	10
Left Riparian Score (5)	5
Right Riparian Score (5)	1
Total Habitat Score (100)	84

Substrate	Mostly cobble mixed with gravel and boulder, some bedrock
-----------	---

Sample Date	Sample ID	ST	EPT	BI	EPT BI	Bioclassification
07/29/09	10713	---	44	---	2.46	Excellent
08/03/04	9480	---	34	---	2.82	Good
07/21/99	7933	---	44	---	3.06	Excellent
07/14/94	6589	94	42	3.57	3.00	Excellent

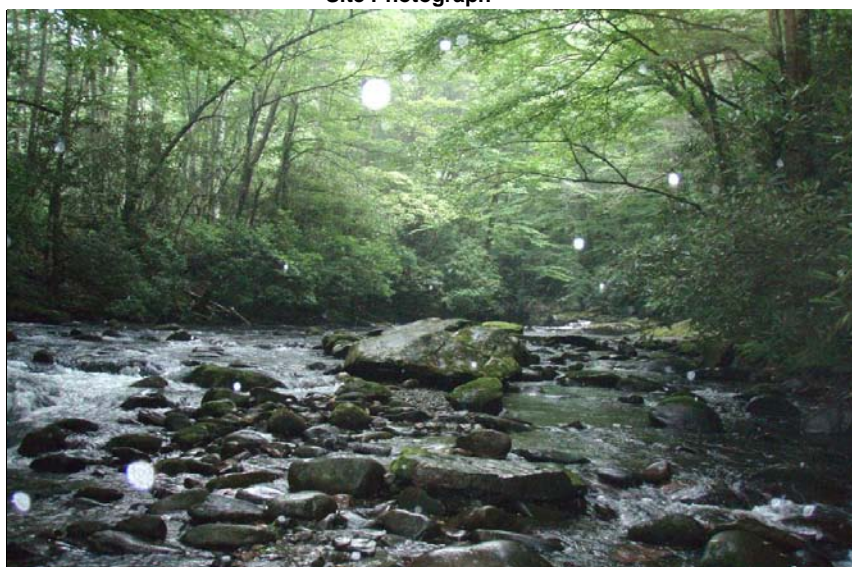
Site Photograph

Channel Modification (5)	5
Instream Habitat (20)	20
Bottom Substrate (15)	15
Pool Variety (10)	8
Riffle Habitat (16)	16
Bank Erosion (7)	7
Bank Vegetation (7)	6
Light Penetration (10)	10
Left Riparian Score (5)	4
Right Riparian Score (5)	4
Total Habitat Score (100)	95

Substrate a mix of boulder, cobble, and gravel with some bedrock and sand

Sample Date	Sample ID	ST	EPT	BI	EPT BI	Bioclassification
07/29/09	10694	86	48	2.50	1.70	Excellent
08/03/04	9479	79	47	2.61	2.02	Excellent
07/22/99	7935	67	39	2.58	1.75	Excellent
10/12/95	6981	69	42	1.95	1.40	Excellent
09/01/94	6682	---	31	---	1.27	Good

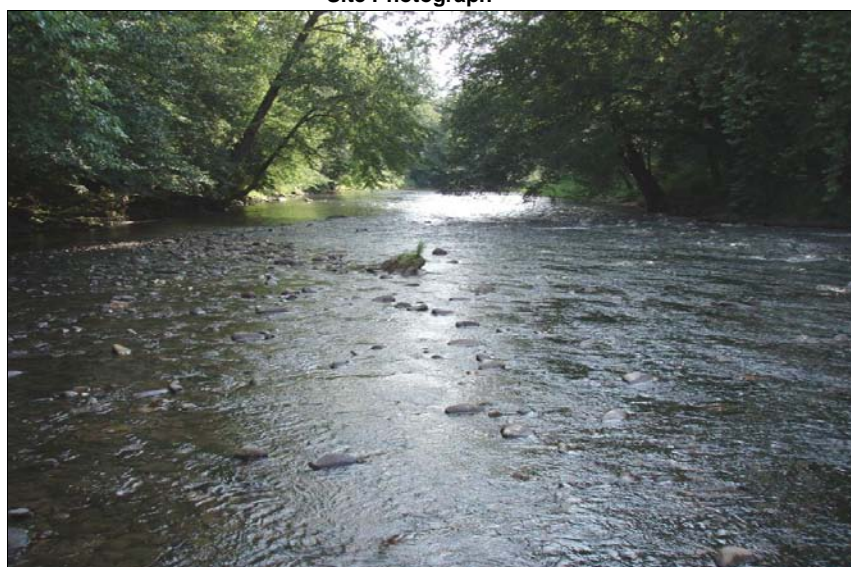
Site Photograph

Channel Modification (5)	5
Instream Habitat (20)	18
Bottom Substrate (15)	11
Pool Variety (10)	6
Riffle Habitat (16)	12
Bank Erosion (7)	7
Bank Vegetation (7)	6
Light Penetration (10)	4
Left Riparian Score (5)	2
Right Riparian Score (5)	2
Total Habitat Score (100)	73

Substrate	Cobble and gravel with some boulder and sand, silty at times
-----------	--

Sample Date	Sample ID	ST	EPT	BI	EPT BI	Bioclassification
07/27/09	10695	98	47	4.07	3.11	Excellent
08/05/04	9485	106	51	3.95	2.97	Excellent
07/22/99	7934	104	53	3.93	3.20	Excellent
07/14/94	6590	86	46	4.05	2.99	Excellent
07/26/89	5029	88	47	4.13	3.22	Excellent

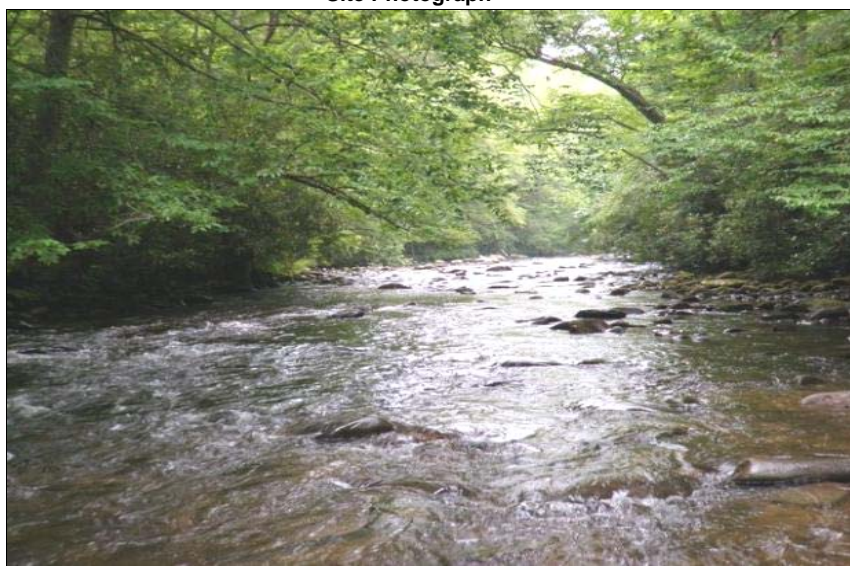
Site Photograph

Channel Modification (5)	5
Instream Habitat (20)	19
Bottom Substrate (15)	13
Pool Variety (10)	5
Riffle Habitat (16)	16
Bank Erosion (7)	7
Bank Vegetation (7)	7
Light Penetration (10)	10
Left Riparian Score (5)	4
Right Riparian Score (5)	5
Total Habitat Score (100)	91

Substrate mix of cobble (35), boulder (30), and gravel (25); some sand (10)

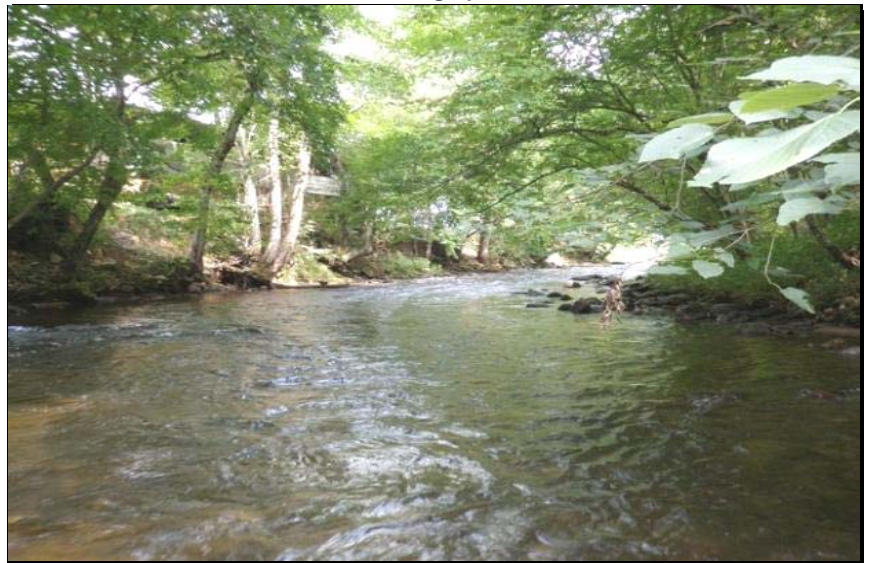
Site Photograph

Channel Modification (5)	5
Instream Habitat (20)	19
Bottom Substrate (15)	12
Pool Variety (10)	6
Riffle Habitat (16)	16
Bank Erosion (7)	6
Bank Vegetation (7)	6
Light Penetration (10)	10
Left Riparian Score (5)	1
Right Riparian Score (5)	2
Total Habitat Score (100)	83

Substrate	mix of cobble (30), boulder (20), gravel (20), sand (20); silty (10)
------------------	--

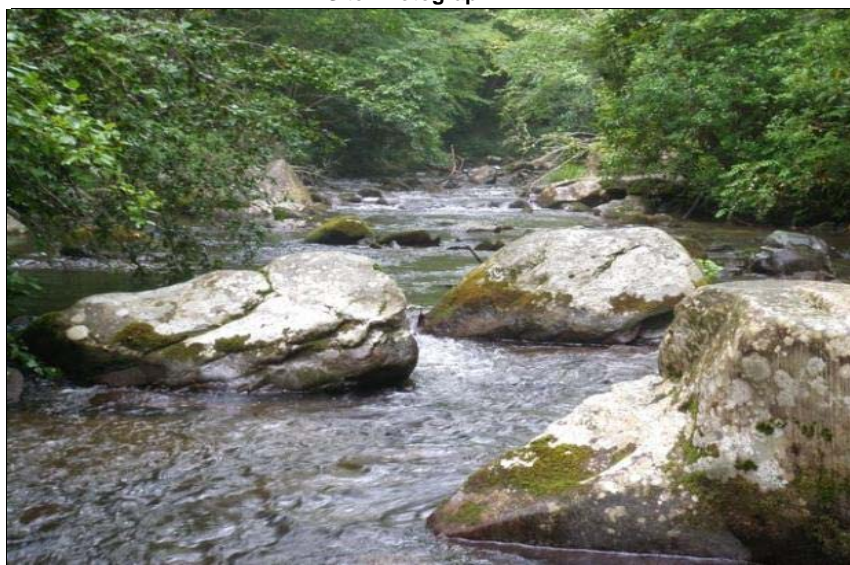
Site Photograph

Channel Modification (5)	5
Instream Habitat (20)	20
Bottom Substrate (15)	14
Pool Variety (10)	9
Riffle Habitat (16)	15
Bank Erosion (7)	7
Bank Vegetation (7)	7
Light Penetration (10)	10
Left Riparian Score (5)	5
Right Riparian Score (5)	4
Total Habitat Score (100)	96

Substrate	mix of cobble (35), boulder (30), and gravel (25), some sand (10)
------------------	---

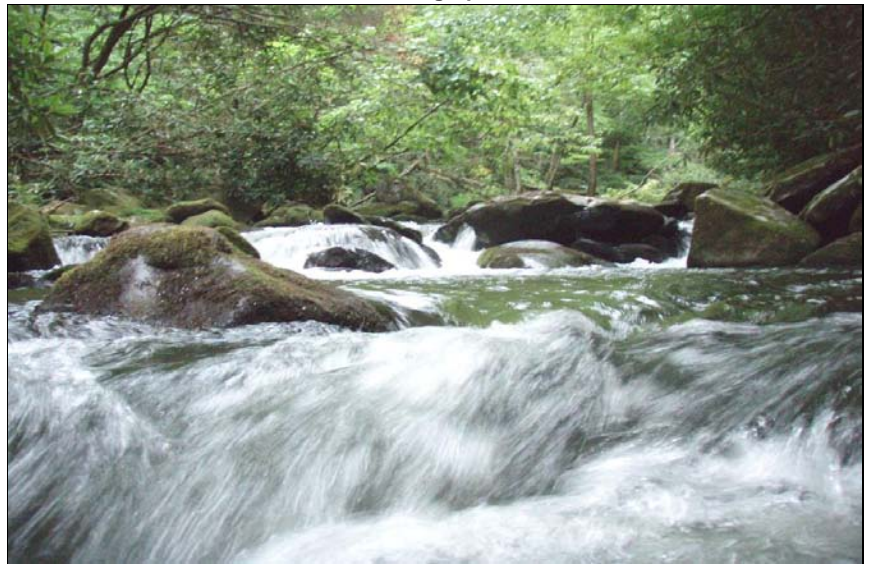
Site Photograph

Channel Modification (5)	5
Instream Habitat (20)	18
Bottom Substrate (15)	13
Pool Variety (10)	10
Riffle Habitat (16)	16
Bank Erosion (7)	7
Bank Vegetation (7)	7
Light Penetration (10)	10
Left Riparian Score (5)	5
Right Riparian Score (5)	4
Total Habitat Score (100)	95

Substrate	Boulder and cobble with some bedrock and gravel, very little silt
------------------	---

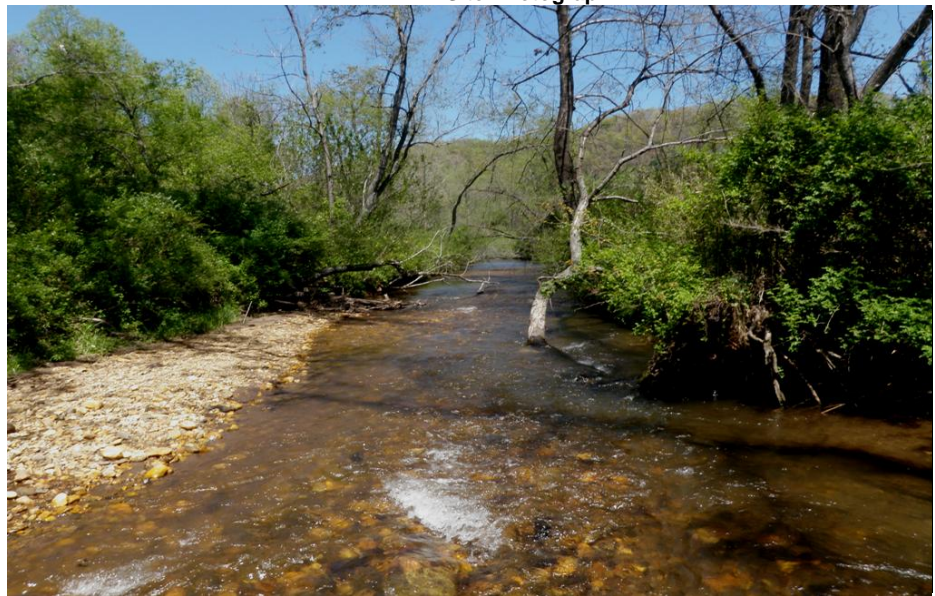
Site Photograph

Channel Modification (5)	5
Instream Habitat (20)	18
Bottom Substrate (15)	11
Pool Variety (10)	10
Riffle Habitat (16)	16
Erosion (7)	7
Bank Vegetation (7)	5
Light Penetration (10)	5
Left Riparian Score (5)	3
Right Riparian Score (5)	5
Total Habitat Score (100)	85

Substrate	Cobble, gravel, silt
-----------	----------------------
