LITTLE TENNESSEE RIVER BASINWIDE WATER QUALITY PLAN

Summary

This 2012 document is the fourth five-year update of the Little Tennessee River Basinwide Water Quality Plan. Previous basinwide plans for the Little Tennessee River Basin were completed in 1997, 2002, and 2007 and are available from the DWQ Basinwide Planning [website](#). This basin plan was written to provide guidance for watershed stakeholders, municipal planners, natural resource regulators, and other environmental professionals with identifying and addressing water quality stressors, sources, and emerging issues. This document can be used in conjunction with the [Supplemental Guide to Basinwide Planning](#) which provides general information about water quality issues and DWQ programs.

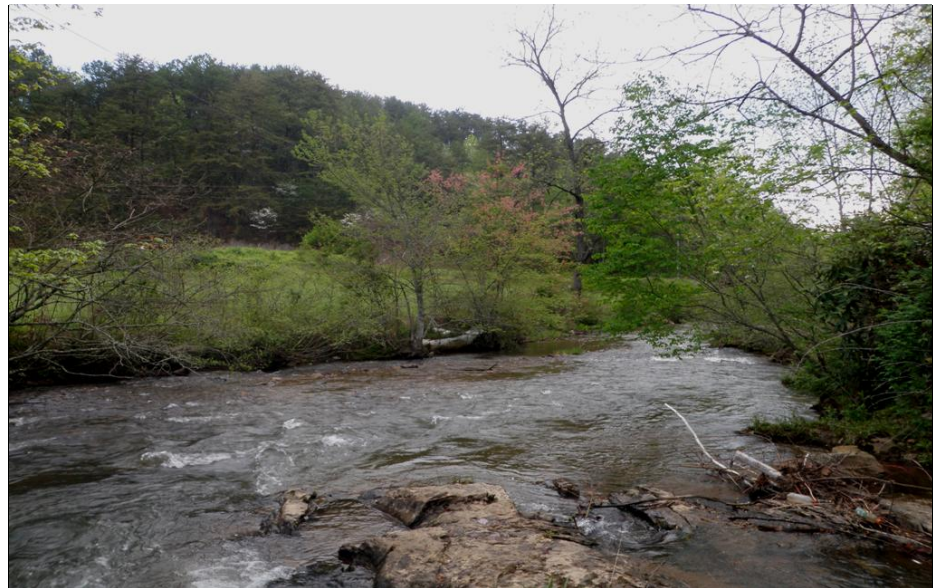
Site Photograph

Channel Modification (5)	3
Instream Habitat (20)	18
Bottom Substrate (15)	12
Pool Variety (10)	6
Riffle Habitat (16)	15
Erosion (7)	4
Bank Vegetation (7)	3
Light Penetration (10)	4
Left Riparian Score (5)	1
Right Riparian Score (5)	2
Total Habitat Score (100)	68

Substrate	Cobble, boulder, rip/rap
-----------	--------------------------

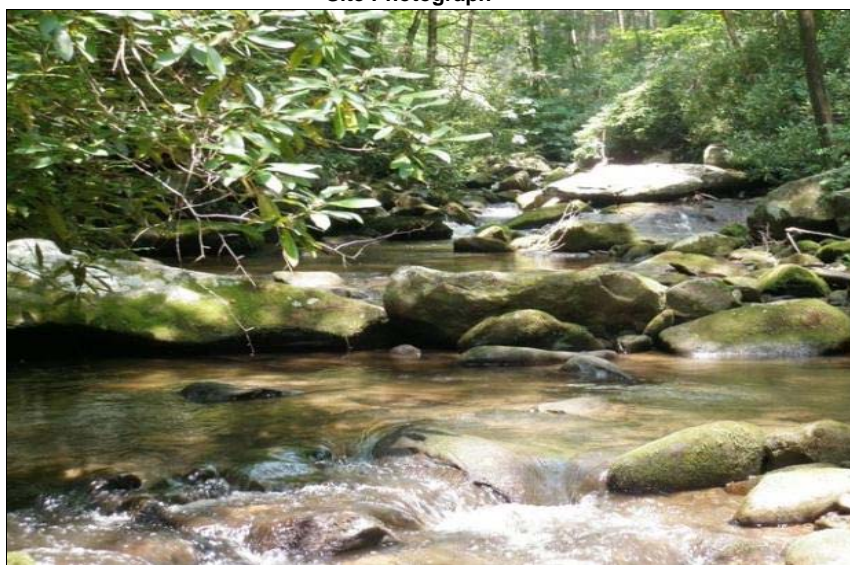
Site Photograph

Channel Modification (5)	5
Instream Habitat (20)	20
Bottom Substrate (15)	14
Pool Variety (10)	9
Riffle Habitat (16)	15
Bank Erosion (7)	7
Bank Vegetation (7)	7
Light Penetration (10)	10
Left Riparian Score (5)	4
Right Riparian Score (5)	5
Total Habitat Score (100)	96

Substrate	mostly cobble (35), boulder (25) and gravel (25)
------------------	--

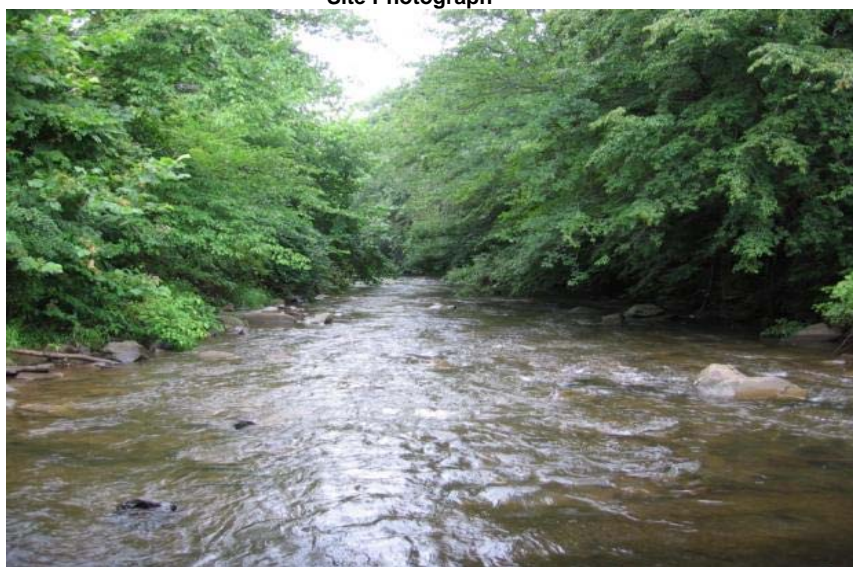
Site Photograph

Channel Modification (5)	4
Instream Habitat (20)	19
Bottom Substrate (15)	8
Pool Variety (10)	4
Riffle Habitat (16)	16
Bank Erosion (7)	5
Bank Vegetation (7)	6
Light Penetration (10)	7
Left Riparian Score (5)	2
Right Riparian Score (5)	2
Total Habitat Score (100)	73

Substrate	Boulder, cobble, gravel and sand
-----------	----------------------------------

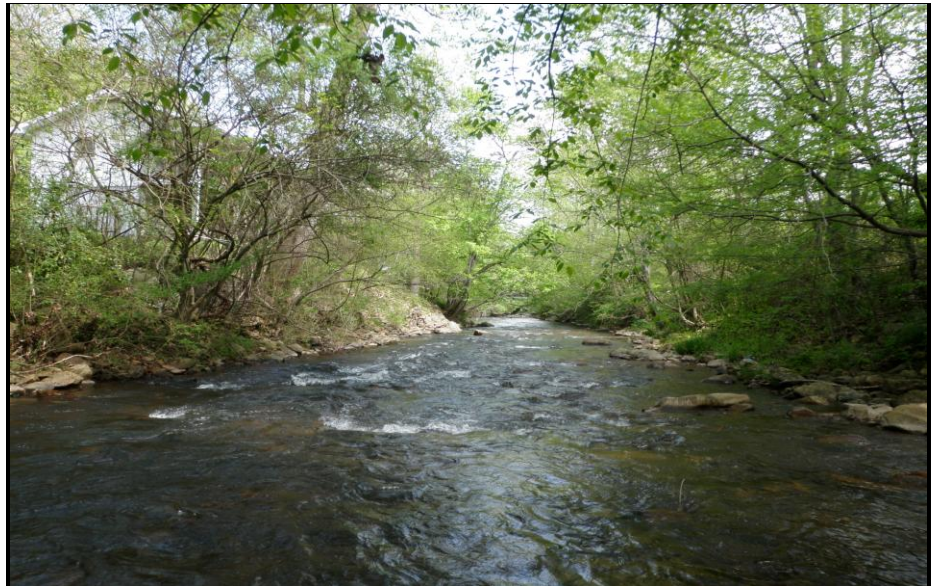
Site Photograph

Channel Modification (5)	5
Instream Habitat (20)	18
Bottom Substrate (15)	13
Pool Variety (10)	8
Riffle Habitat (16)	16
Erosion (7)	4
Bank Vegetation (7)	6
Light Penetration (10)	7
Left Riparian Score (5)	5
Right Riparian Score (5)	3
Total Habitat Score (100)	85

Substrate	Cobble, boulder, bedrock
-----------	--------------------------

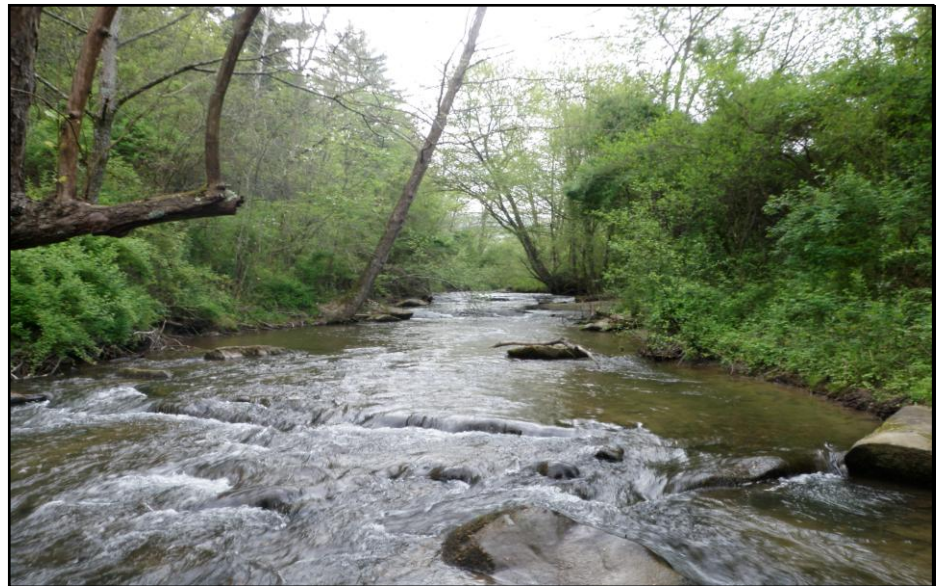
Site Photograph

Channel Modification (5)	5
Instream Habitat (20)	19
Bottom Substrate (15)	10
Pool Variety (10)	8
Riffle Habitat (16)	16
Erosion (7)	7
Bank Vegetation (7)	6
Light Penetration (10)	9
Left Riparian Score (5)	5
Right Riparian Score (5)	4
Total Habitat Score (100)	89

Substrate	Bedrock shelves, cobble, boulder
-----------	----------------------------------

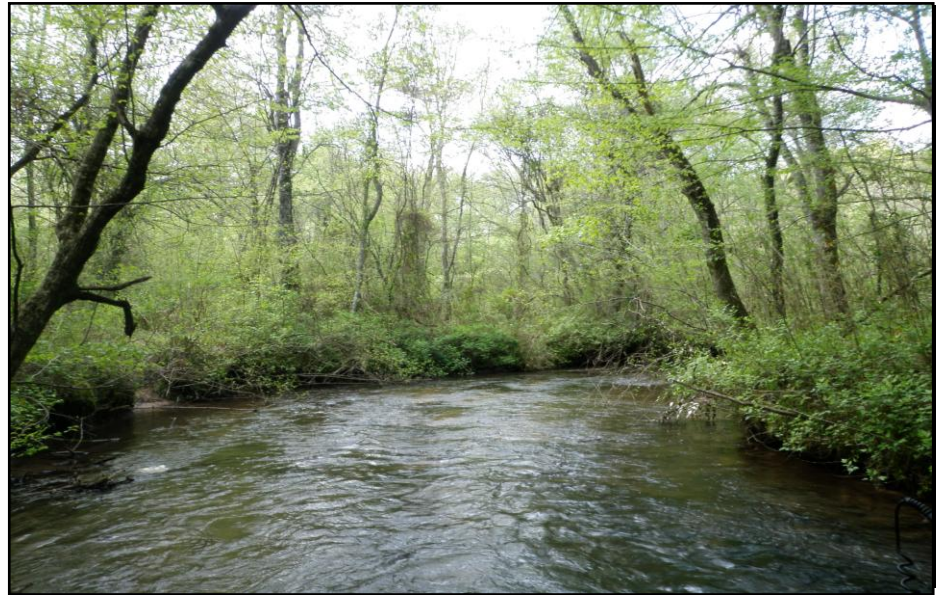
Site Photograph

Channel Modification (5)	5
Instream Habitat (20)	18
Bottom Substrate (15)	8
Pool Variety (10)	6
Riffle Habitat (16)	10
Erosion (7)	7
Bank Vegetation (7)	6
Light Penetration (10)	10
Left Riparian Score (5)	4
Right Riparian Score (5)	5
Total Habitat Score (100)	79

Substrate	Sand, cobble, gravel, bedrock, silt
-----------	-------------------------------------
