EXECUTIVE SUMMARY

ROANOKE RIVER BASIN

NC Division of Water Quality
 Basinwide Planning Unit
 September 2011

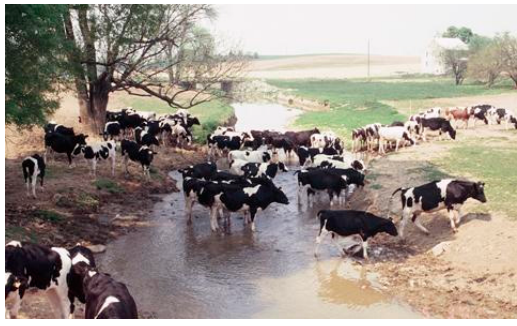
FIGURE ES-14: LIVESTOCK IN STREAM

The overall decrease in levels from 2003-2008 could be attributed to a number of reasons including reduced flow levels and watershed groups that have actively been fencing livestock out of streams, as in Figure ES-14. Recommendations to further reduce FCB levels can be found in the subbasin chapters.

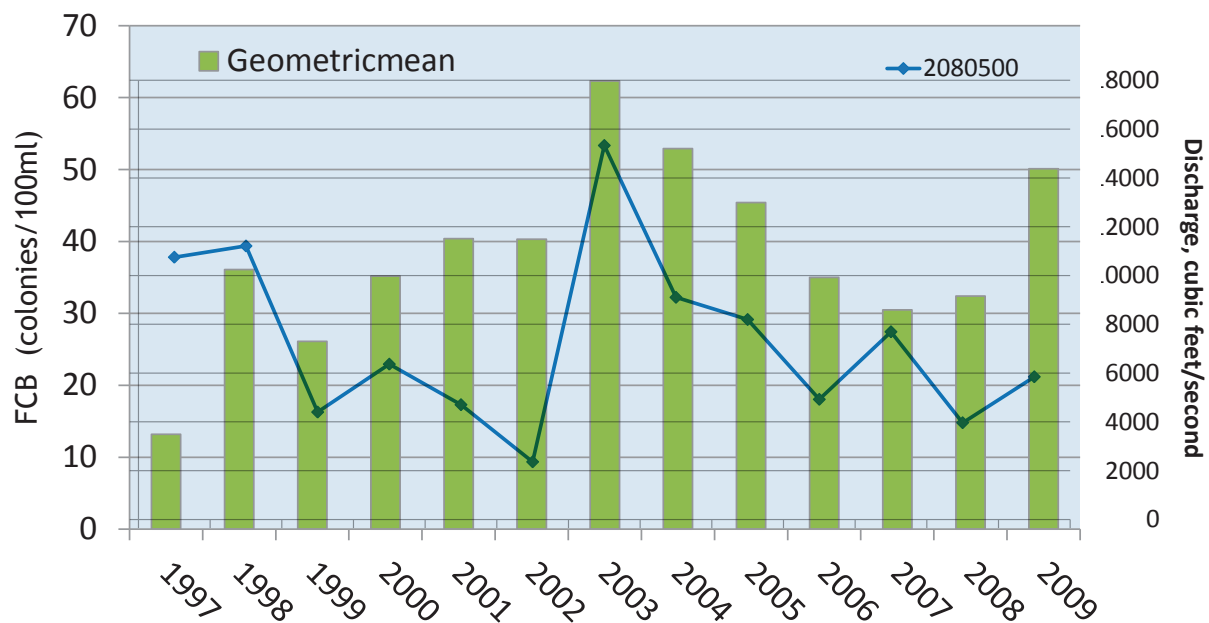
FIGURE ES-15: YEARLY GEOMETRIC MEAN FECAL COLIFORM BACTERIA DATA WITHIN THE ROANOKE RIVER BASIN WITH FLOW GAGE DATA FROM THE ROANOKE RIVER AT ROANOKE RAPIDS (BETWEEN 1997 & 2009)

The geometric mean of FCB per year for the basin between 1997 and 2009 is shown in Figure ES-15. Overlaying the yearly flow averages for the Roanoke River with the yearly geometric mean of FCB indicates an influence of flow on FCB levels.

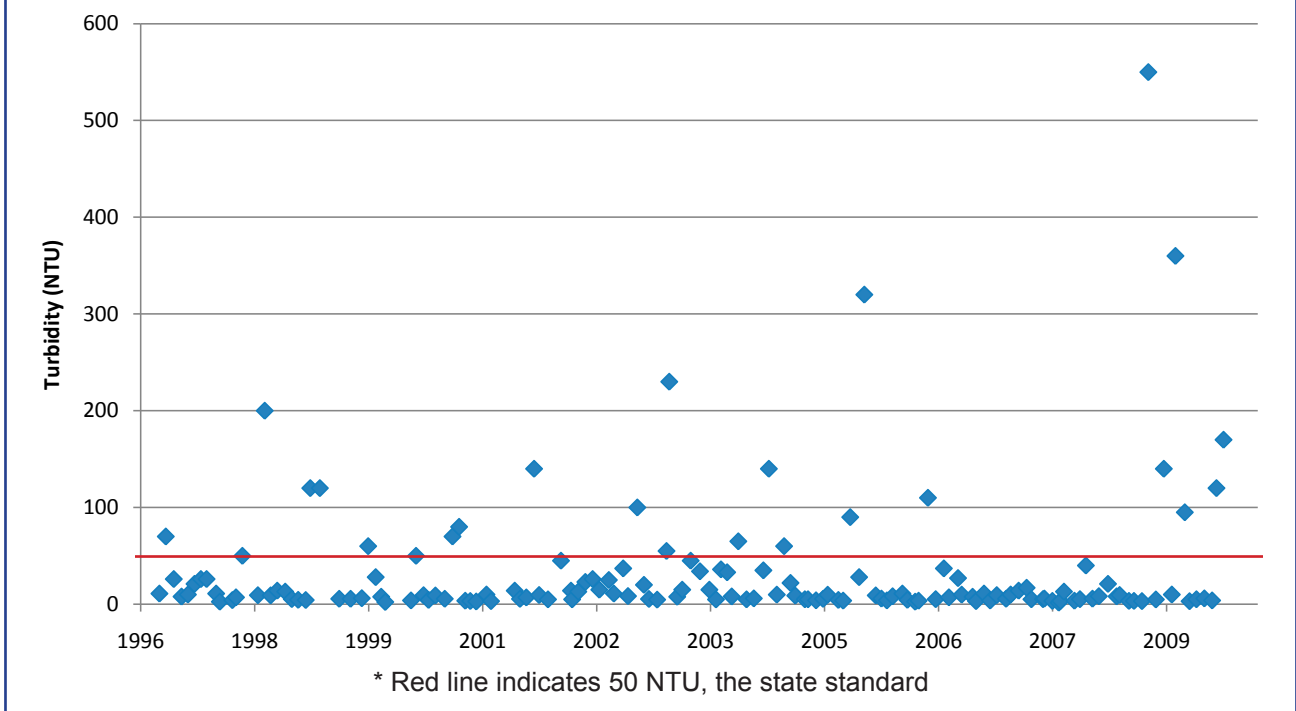
FIGURE 1-20: LONG TERM TURBIDITY SAMPLING AT N2300000 (1997-2009)

There is one monitoring (AMS) station between these two segments. Almost 15% of turbidity samples exceeded the state standard at this station. Instream mining operations have been noted as a source in past plans. DWQ developed a [TMDL for turbidity](#) for this section of the Dan River in 2005. The TMDL recommended a 59% reduction in total suspended solids between both point and nonpoint sources. As seen in Figure 1-20, majority of sampling results have been reduced to below 35 NTUs since the TMDL was released in 2005 indicating progress.

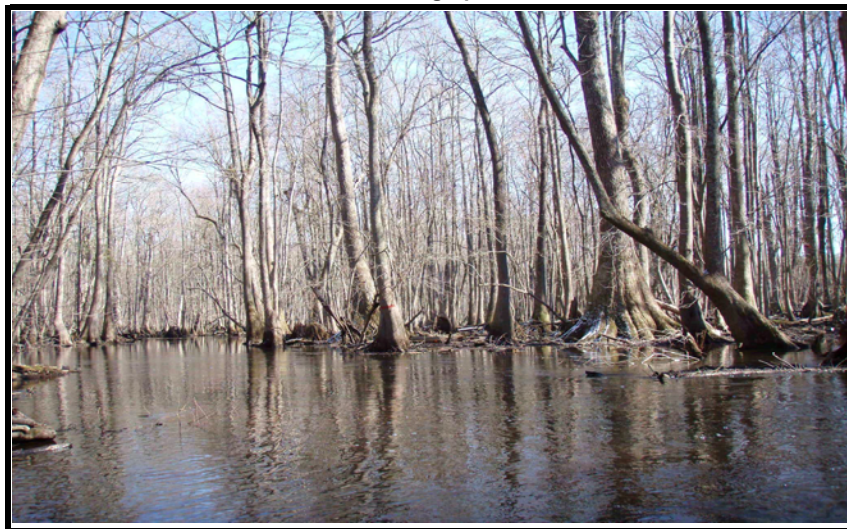
Site Photograph

This sampling site maintained its EPT richness of 6 taxa from the previous sampling event. Two species of mayflies collected in 2004, *Caenis* and *Eurylophella doris* were absent in 2009 as was the caddisfly *Platycentropus*. *Ironoquia punctatissima*, a caddisfly often found in swamp-like conditions, was collected for the first time in 10 years. Additionally, total taxa richness decreased from 2004 levels reflected in fewer tolerant midges, oligochaetes and crustacea collected. Although still higher than that measured in 1999, the biotic index was lower than in 2004 due in part to the more intolerant EPT community observed.

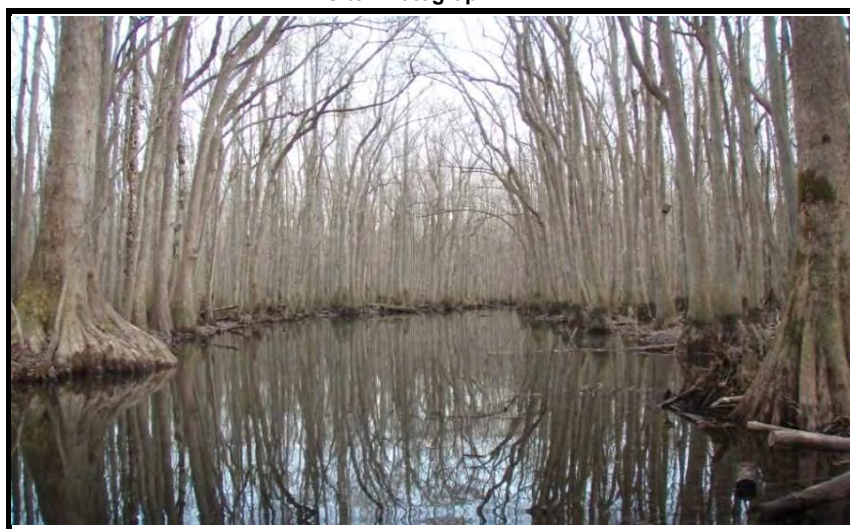
Site Photograph

The 2009 sample produced a drastic decline in chironomid taxa relative to previous collections. Given the increase in specific conductance, it would have been expected that the diversity of the generally pollution tolerant chironomids would have increased or at least maintained levels previously recorded from this station. It is unclear as to why this reduction was observed in 2009 but it might be related to the very low pH (4.3) which was lower than previous collections (4.6 in 2004, 5.5 in 1999). However, the most significant change in this community was the total absence of the flow-dependent blackflies *Simulium spp.* and *Stegopterna spp.* which were both abundant or common from all previous collections. Their absence in 2009 strongly suggests that poor flows have been persistent at this location and may have had a role in the lowered ST and higher BI although the extremely low pH likely exacerbated this condition.

Although the ST and EPT metrics reached all time lows for 2009, the BI, although higher, was generally comparable to previous collections. Moreover, the EPTBI in 2009 was intermediate between the two previous records. The primary difference in the benthic macroinvertebrate community observed at this location in 2009 relative to previous assessments was the drastic decrease in the diversity of chironomid larvae. Indeed, only two chironomid taxa were collected in 2009 versus 20 in 2004 and seven in 1999. The absence of the flow-dependent blackflies suggest that there have been persistent low flow conditions at this site. Indeed, flow conditions were marginal at the time of sampling. This likely explains, at least in part, the increased BI and lowered ST. However, specific conductance at this site was drastically higher in 2009 (179.1 µS/cm) versus levels measured in 2004 (58 µS/cm) and 1999 (65µS/cm). Consequently, deleterious anthropogenic influence at this station cannot be ruled out. In addition to the low flows and elevated conductivity, the very low pH likely played a role in the decline in the invertebrate community. Indeed, benthic macroinvertebrate communities are known to degrade with very low pH .

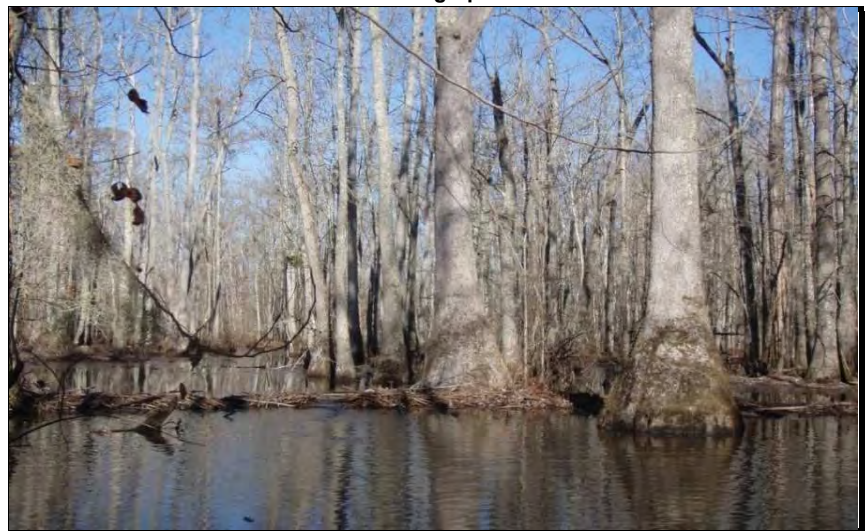
Site Photograph

Substrate Detritus and fine particulate organic matter was dominant.

A mostly tolerant benthic community was observed at this sampling location in 2009. No stoneflies or mayflies were collected at this monitoring station. Caddisflies present in the sample included *Isonychia punctatissima* and *Ptilostomis* spp. These are common somewhat tolerant caddisflies found in North Carolina swamp benthic communities. Chironomid taxa richness was also low (8) with only two taxa that were common and abundant including *Orthocladus obumbratus* and the recently described *Tvetenia* sp. NC (Epler 2001) respectively.

A Moderate bioclassification was retained at this site in 2009. Total taxa richness (26) and EPT taxa richness (2) dropped slightly compared to 2004. The NCBI was elevated from the 2004 sample. Despite the Moderate bioclassification, water quality parameters suggests some degradation. Conductivity was twice as high (190 µS/cm) and acidic conditions (pH=4.7) were observed in 2009 compared to 1999 (82 µS/cm, pH=6.2). Physico-chemical data was not collected at this site in 2004. The elevated conductivity suggest the possibility of upstream point source pollution inputs from the Lewiston-Woodeville WWTP. Additionally, naturally acidic waters occur in North Carolina swamp ecosystems and can lead to reductions in benthic taxa richness. A small beaverdam was observed within the sampling area in 2004 and 2009 and low flow conditions with nearly homogenous detrital substrate were noted in 2009 compared to other Roanoke Basinwide swamp sites. This lack of flow and lack of mixed substrate could lead to the absence of some mayflies and stoneflies adapted to those conditions.

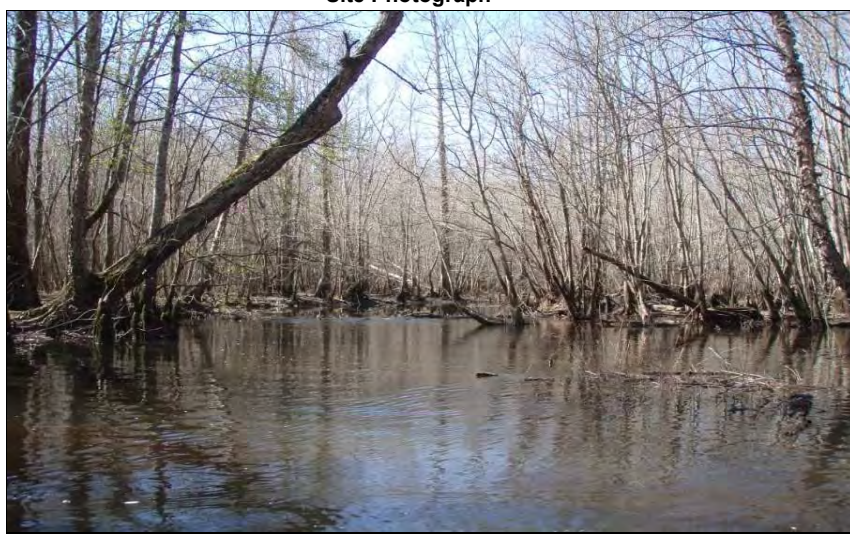
Site Photograph

Substrate Fine particulate organic matter and detritus was dominant.

Total taxa richness remained similar to samples in the past, however, EPT taxa richness dropped from seven taxa in 1999 and 2004 to only three in 2009. This drop in EPT richness in addition to the highest NCBI and EPTBI recorded from this site lowered the bioclassification from Natural in 2004 to Moderate in 2009. Habitat parameters in 2009 (86) were higher than that observed in 2004 (70), yet similar to that observed in 1999 (85) suggesting no reduction in the bioclassification due to physical parameters. More acidic conditions were found in 2009 (pH=5.1) compared to 2004 (pH=5.6) and 1999 (pH=6.4) which could lead to the recent depletion of EPT taxa. Additionally, conductivity was elevated in 2009 (133 µS/cm) compared to in 2004 (64 µS/cm) and 1999 (72 µS/cm) similar to the upstream site at SR 1219 suggesting inputs from an upstream discharger or another unknown source.

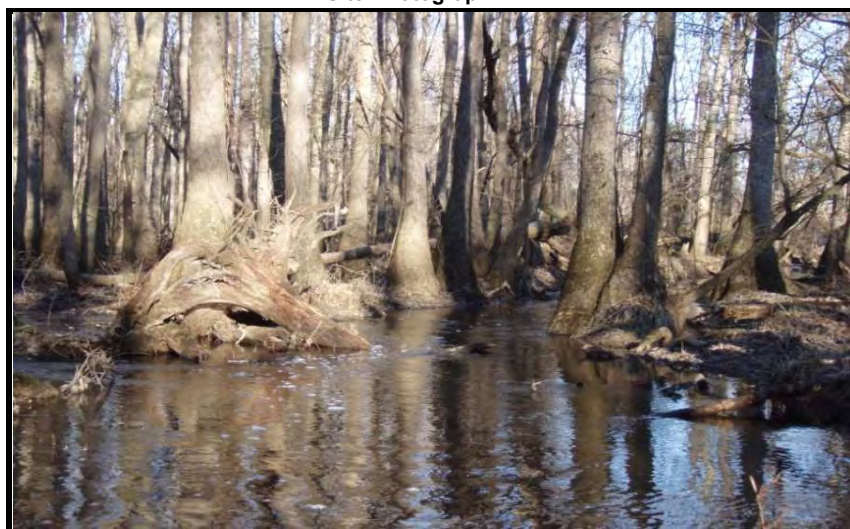
Site Photograph

The 2009 sample continues the trend observed here since the 1999 collection in that there has been a decline in intolerant taxa and an increase in tolerant taxa. For 2009, this trend in reduced presence (or total absence) of intolerant taxa is exemplified by the lack of the stonefly *Amphinemura spp.*, a substantial decrease in the abundance of the stonefly *Taeniopteryx spp.* (abundant in 1999 and 2004, rare in 2009), the absence of the caddisfly *Platycentropus spp.*, and the first time appearance of the tolerant beetle *Coptotomus spp.*, the hemipteran *Pelocoris spp.*, as well as the tolerant chironomids *Cricotopus annulator* and *Cricotopus bicinctus*.

As can be seen from the BI (and to a lesser extent the EPTBI data), as well as the ST and (to a lesser extent) the EPTS, the benthic macroinvertebrate community metrics continue to decline at this site since its first assessment in 1999. The data show a continuing shift from pollution intolerant taxa to more pollution tolerant taxa. It is possible that the prolonged drought may have resulted in very low flow conditions at this site for much of the year before the February sample and that may have caused natural stress due to lowered dissolved oxygen levels. Although dissolved oxygen data is extremely variable, it does not support this conclusion as the dissolved oxygen levels in 2009 (10.2 mg/l) was higher than in either 2004 (8.9 mg/l) or 1999 (8.6 mg/l). Conversely, the much higher specific conductance at this location (89.4 µS/cm) in 2009 relative to levels measured from previous observations in 2004 (60 µS/cm) and 1999 (70 µS/cm) may suggest a possible anthropogenic component to the increasing biotic indices observed at this location since 1999.

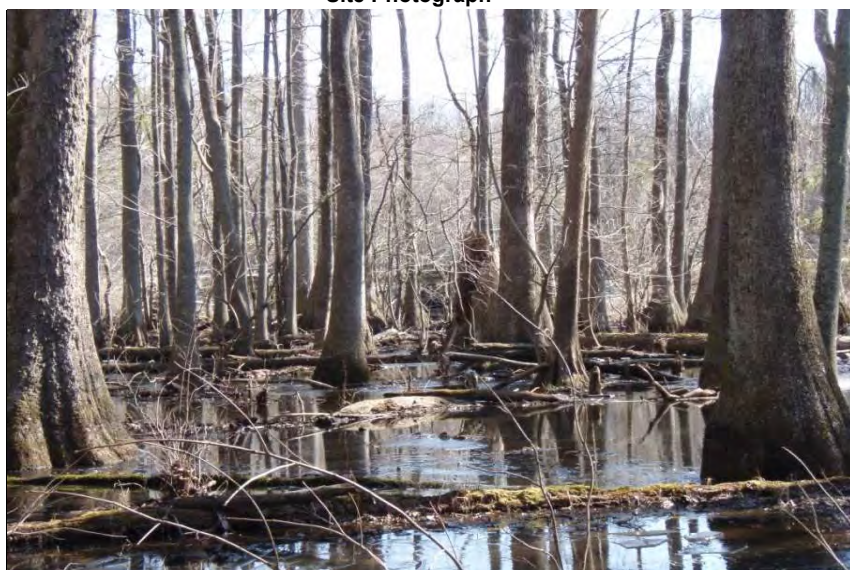
Site Photograph

| Substrate | Sand, silt, and detritus. |

The 2009 collection produced the first record at this location for the facultative caddisfly *Ptilostomis spp.* and the intolerant caddisfly *Lepidostoma spp.* In addition, the previous two collections included the collection of the pollution tolerant mayfly *Caenis spp.* but was absent in 2009. Other pollution tolerant taxa collected from 1999 and 2004 but absent from 2009 sample included the chironomids *Kiefferulus spp.*, *Procladius spp.*, as well as the gastropods *Micromenetus dilatatus* and *Ferrissia spp.*
