**North Carolina Division of Water Quality
Water Quality Section
Environmental Sciences Branch**

MEMORANDUM

Subject: 2004 Stressor Surveys – Neuse River Basin
Perry Creek – subbasin 030402
Core Creek – subbasin 030408
South Flat River – subbasin 030401
Knap of Reeds Creek – subbasin 030401

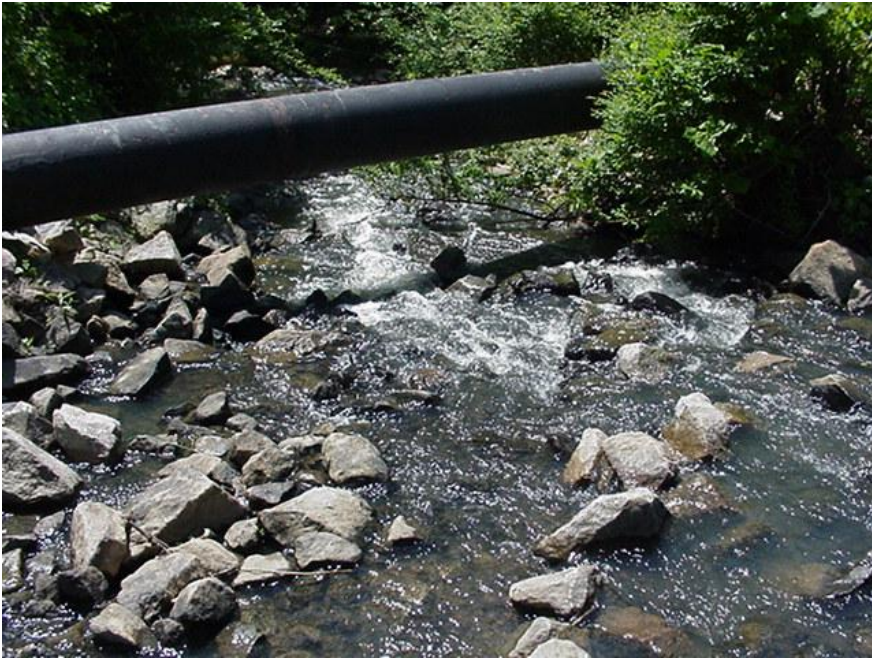
Station PC3: Perry Creek at Power Line off Jacqueline Lane (downstream view)

The Perry Creek watershed was surveyed on May 5, 2004. A map of the watershed is attached in Appendix 1 and photographs of each of the sampling stations are attached at the end of this report. Visual observations of the watershed revealed large suburban and urban areas associated with the City of Raleigh. A golf course and residential areas are present in the upstream portion of the watershed. The area surrounding Greshams Lake is surrounded by heavy commercial development including several businesses, a landfill, and a cement operation. Algae and greenish/turbid water, along with a small sheen of oil on the surface was observed at the drain from the lake. Evidence of sedimentation was seen at several stations with sandy creek bottoms, sandbars, and other indicators of sedimentation. This was especially prevalent at the most downstream stations including the historical biologically impaired station, Perry Creek at Perry Creek Road. Road construction with land clearing was in progress near this station with sedimentation fences in place. Stream bank erosion was also observed at several stations. At the two most upstream stations, Perry Creek at Rainwater Road (station PC1) and Perry Creek at Litchford Road (station PC2), the creek bottom was rocky in nature. Periphyton was observed on the rocks at these stations. Periphyton was also observed on the rocks at Perry Creek at the power line off Jacqueline Lane (PC3).

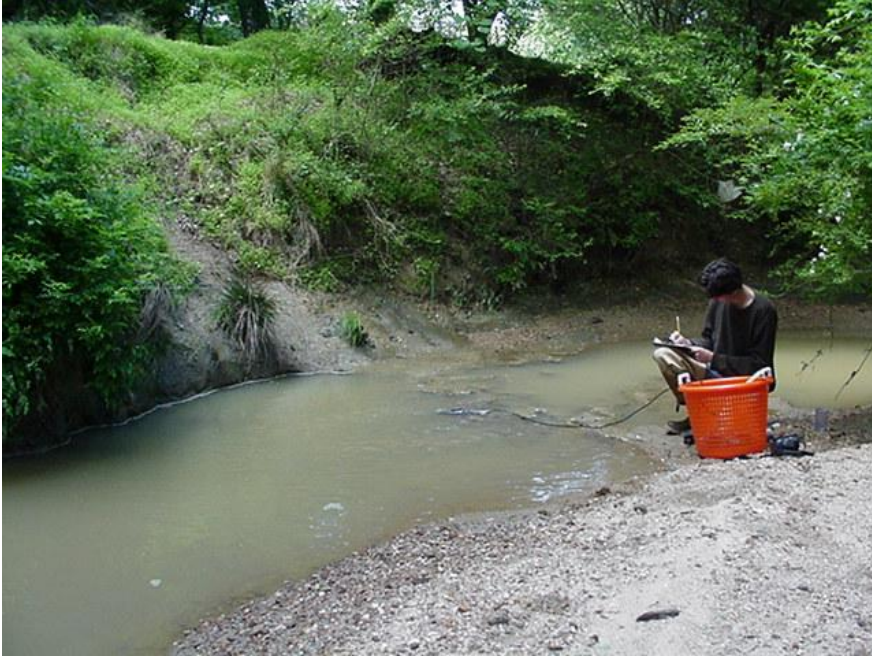
Station PC4: Unnamed Tributary to Perry Creek downstream of I-540 (upstream view)

Physical measurements were collected at each of the sampling stations and are included in Appendix 2. These measurements indicated violations of the Division of Water Quality standard for pH of a range between 6.0 and 9.0 s.u.. The violations were found at station PC4 (5.8 s.u.), station PC5 (5.7 s.u.), and station PC6 (5.7 s.u.). Conductivity values were highest at Perry Creek at the Power Line off Jacqueline Lane (station PC3). The high conductivity value found at this station (169 umhos/cm) was traced upstream to the drain from Greshams Lake where a conductivity value of 162 umhos/cm was found. At stations upstream of Greshams Lake, conductivity values were lower. As mentioned previously, the area surrounding Greshams Lake is heavily industrialized.

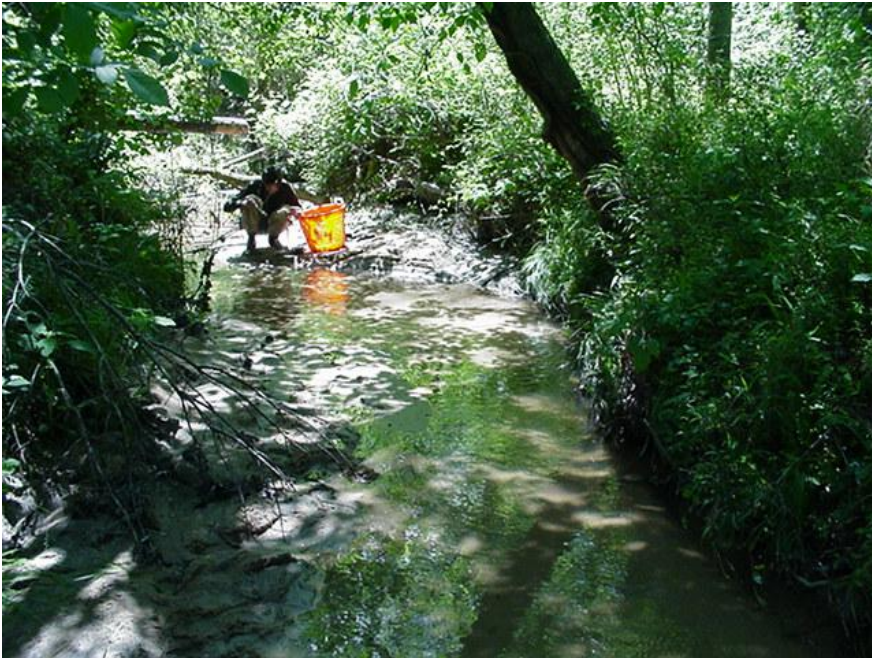
Station PC5: Unnamed Tributary to Perry Creek at Fox Road (upstream view)

At the unnamed tributary to Perry Creek at Fox Road, debris from previously higher flows was observed trapped at the bridge culvert, although this tributary is fairly small. At the unnamed tributary to Perry Creek at Berkshire Downs Drive, grassed yards were located right next to the creek with no riparian area. Stream bank erosion was noticed at this station. Turbid water was observed at the unnamed tributary to Perry Creek downstream of I-540. A shopping mall and storm water pond is located upstream of this tributary. Water clarity was fairly good at most other stations. Sewer lines, manholes, and storm water drains were observed near several stations although no indications of leaking sewer lines were found.

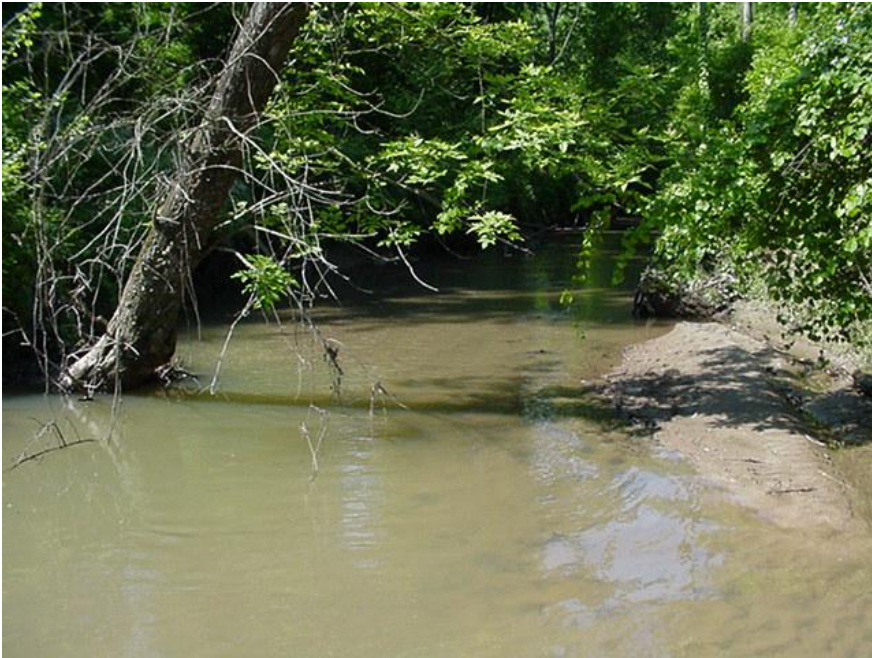
Station PC7: Perry Creek at Perry Creek Road (upstream view)

Water column metals samples taken at three stations (PC2, PC3, and PC7) indicated elevated values for aluminum, iron, and manganese but this is not unusual due to the presence of these metals in local soil types. Additionally, the iron levels at stations PC3 and PC7 were above the action level water quality standard but this standard is only applicable to dischargers and there are no dischargers present near these stations. A sediment metals sample taken at Perry Creek at Perry Creek Road (station PC7) indicated similar results with naturally high aluminum, iron,

and manganese values. The sediment metals values found at station PC7 were typical of those found in historical sediment metals samples collected throughout the state with analyses performed by the NC DWQ Chemistry Laboratory (Roy Byrd, NCDWQ Laboratory Section, personal communication). None of the sediment metals values found were above the hazardous waste site screening values used by the Environmental Protection Agency¹. These values are used to determine if there is a need to conduct further investigations at the sites. Sediment pesticides and organics results from the station PC7 indicated 2 unidentified chlorinated pesticides. Unidentified peaks are compounds that are detected in the pesticides and organics sample that are not present in the laboratory sample library of approximately 125 pesticides and organics. Microtoxicity sediment samples were collected at station PC7 and will be discussed in a later memorandum from Sandy Mort of the Aquatic Toxicology Unit. A five-day biochemical oxygen demand sample taken at Perry Creek at Perry Creek Road was low and below the laboratory reporting limit of 2.0 mg/L indicating no problems with oxygen demanding wastes.

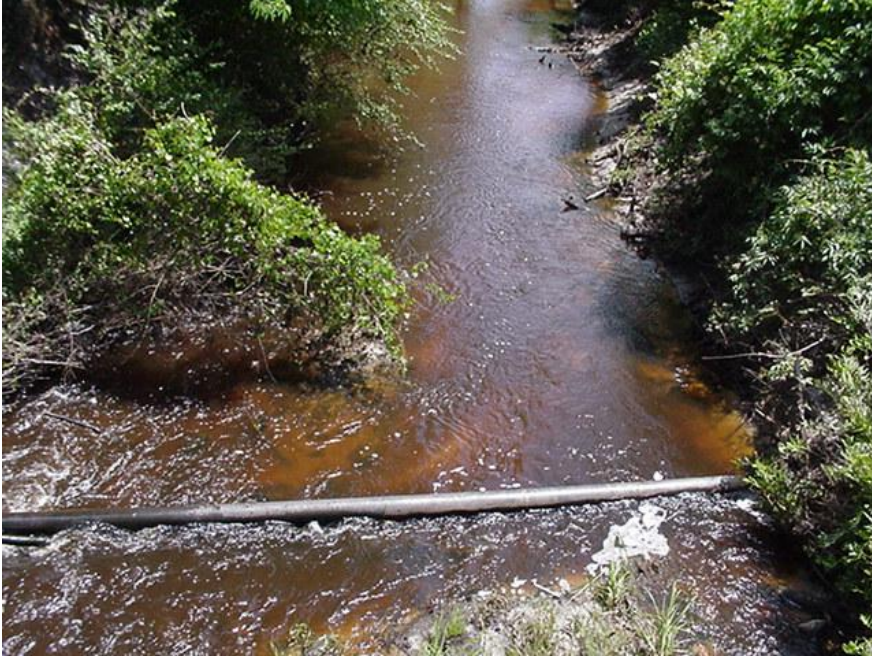
Station CC1: Core Creek at SR 1239 upstream (downstream view)

The Core Creek watershed was surveyed on May 11, 2004. A map of the watershed is attached in Appendix 1 and photographs of each of the sampling stations are attached at the end of this report. Numerous agricultural fields were observed throughout the watershed. Some of these fields appeared freshly planted. Some houses and farms were also observed throughout the watershed with the most residential development located in the Cove City area. Some horses in pastures were observed at a few areas in the watershed and a cattle animal operation was observed between stations CC1 and CC2 in the upstream portion of the watershed. The cattle operation itself was not visited to determine if cattle had direct access to the creek. Evidence of stream bank erosion and previous higher flows (disturbed vegetation on the stream banks) was observed at several stations. These stations included Core Creek at SR1239 upstream and downstream (stations CC1 and CC2) and Core Creek at SR 1001 (station CC3). The stream banks at these stations were a mixture of sand and vegetation. The water at all stations appeared to be murky and a tannic and reddish brown color. Good flow was present at all stations except the most downstream stations, Core Creek at SR1245 (station CC4) and Core Creek at NC55 (station CC5). The lowest visible flow conditions were noted at Core Creek at SR 1245 (station CC4). The creek at this location had the greatest width of all stations and some areas of aquatic weeds were noticed that also probably contributed to lower flow conditions. Periphyton on the rocks in the creek was observed at Core Creek at SR 1239 upstream (station CC1) while some algae was noticed on the sides of the creek at Core Creek at SR 1245 (station CC4).

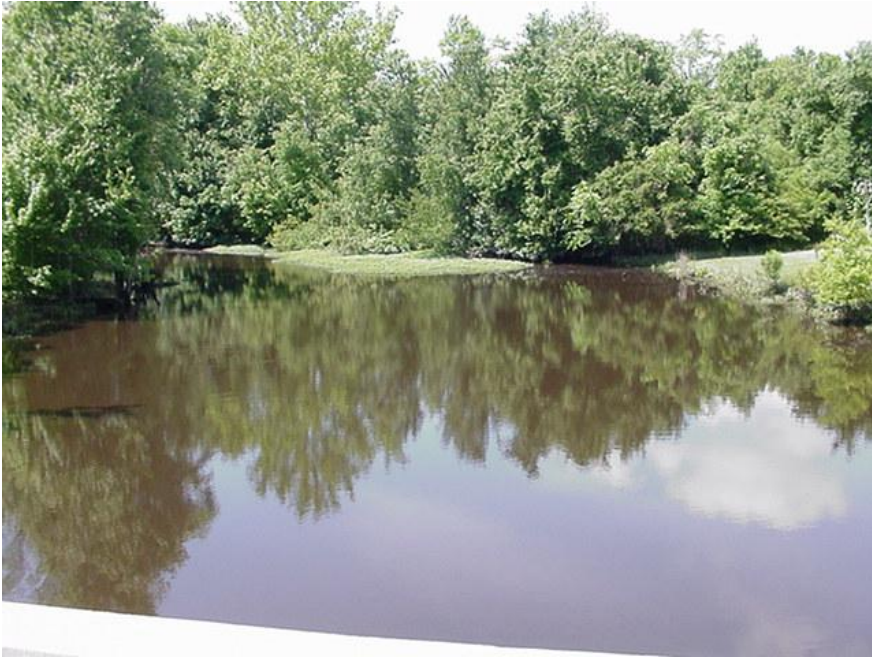
Station CC4: Core Creek at SR 1245 (upstream view)

Physical measurements were collected at each of the sampling stations and are included in Appendix 2. These measurements indicated a low dissolved oxygen value of 4.6 mg/L at Core Creek at SR 1245 (station CC4). This dissolved oxygen value was, however, above the North Carolina surface water quality standard of an instantaneous value of 4.0 mg/L. The low dissolved oxygen value may have been due to the lower stream flow velocity noted at this station. The creek was the widest here of any stations and areas of aquatic weeds were observed. These factors may have contributed to the lower velocity. An increase in conductivity was seen at Core Creek at SR 1239 downstream (station CC2) from the value found upstream at Core Creek at SR 1239 upstream (station CC1). A cattle farm with a lagoon was observed in the upstream area of the watershed downstream of Core Creek at SR 1239 upstream (station CC1). Animal waste originating from this farm may be the reason for the higher conductivity values found downstream although no direct observance of animal waste in the stream was noticed.

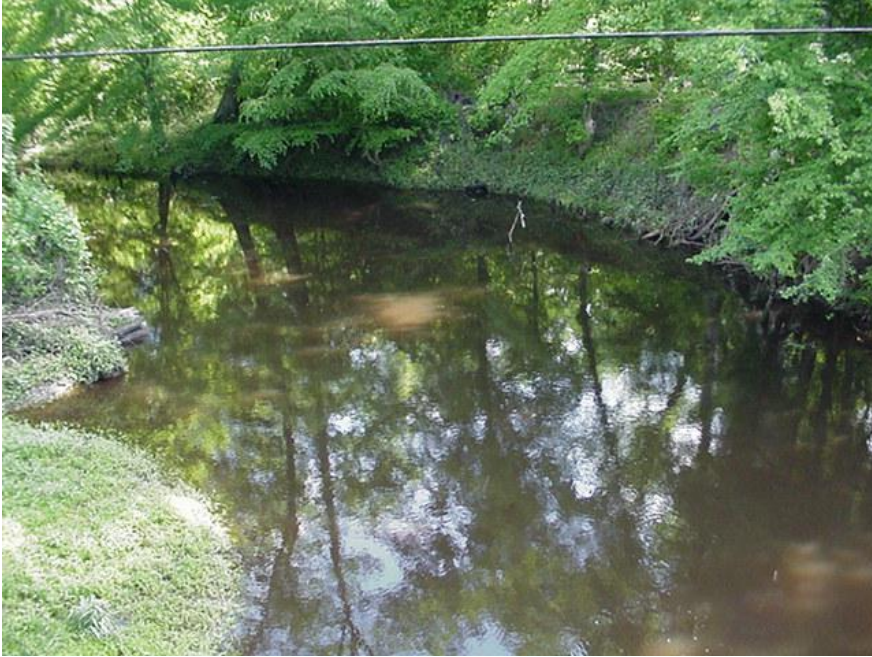
Station CC5: Core Creek at NC 55 (downstream view)

Chemical samples were collected at several stations in the watershed and results are included in Appendix 3. Nutrient samples were taken at the historical biologically impaired station, Core Creek at NC 55 (station CC5) and also at Core Creek at SR 1239 upstream (station CC1) and Core Creek at SR 1245 (station CC4). The nutrient samples were collected at stations CC1 and CC4 because of the presence of periphyton on the rocks. Nutrient values at every station were present in high amounts indicating enrichment possibly from fertilizers used on the agricultural fields in the area. A five-day biochemical oxygen demand sample was taken at the historical biologically impaired station (CC5) and the value found was low and below the reporting limit of 2.0 mg/L.

A water column metals sample taken at station CC5 indicated high values for aluminum and iron but this is expected due to high naturally occurring amounts of these metals in local soil types. The iron value of 1100 ug/L was above the state water quality standard but this standard is designed as an action level for dischargers and there are no dischargers in the immediate vicinity of this station. A sediment metals sample was also taken at station CC5 and the results indicated high amounts of aluminum, iron, and manganese also due to the presence of these metals in the local soils. The sediment metals values found at station CC5 were typical of those

found in historical sediment metals samples collected throughout the state with analyses performed by the NC DWQ Chemistry Laboratory (Roy Byrd, NCDWQ Laboratory Section, personal communication). There were no sediment metals values found above the hazardous waste site screening values used by the Environmental Protection Agency. The sediment pesticides and organics sample taken at station CC5 revealed some unidentified peaks for chlorinated pesticides, organophosphate pesticides, and semi-volatile organics. Unidentified peaks are compounds that are detected in the pesticides and organics sample that are not present in the laboratory sample library of approximately 125 pesticides and organics. Other semi-volatile organics found included benzene acetic acid, alkanes, and hexadecanoic acid. These pesticides and organics may have been related to fish kills in the Core Creek area on April 23, 2003 and May 3, 2003. A subsequent investigation of these fish kills conducted by the Neuse River Rapid Response Team found toxic pesticides in the creek. The Neuse River Rapid Response Team performed sampling for toxic compounds until August of 2003, when toxin levels had decreased and remained similar in subsequent sampling and fish were observed in the area again. No dead fish were observed during the 2004 Core Creek Stressor Study and small fish were observed swimming at several stations. None of the pesticides and organic values found at station CC5 on May 11, 2004 exceeded the EPA hazardous waste site screening values. Microtoxicity sediment samples were collected at station CC5 and will be discussed in a later memorandum from Sandy Mort of the Aquatic Toxicology Unit.

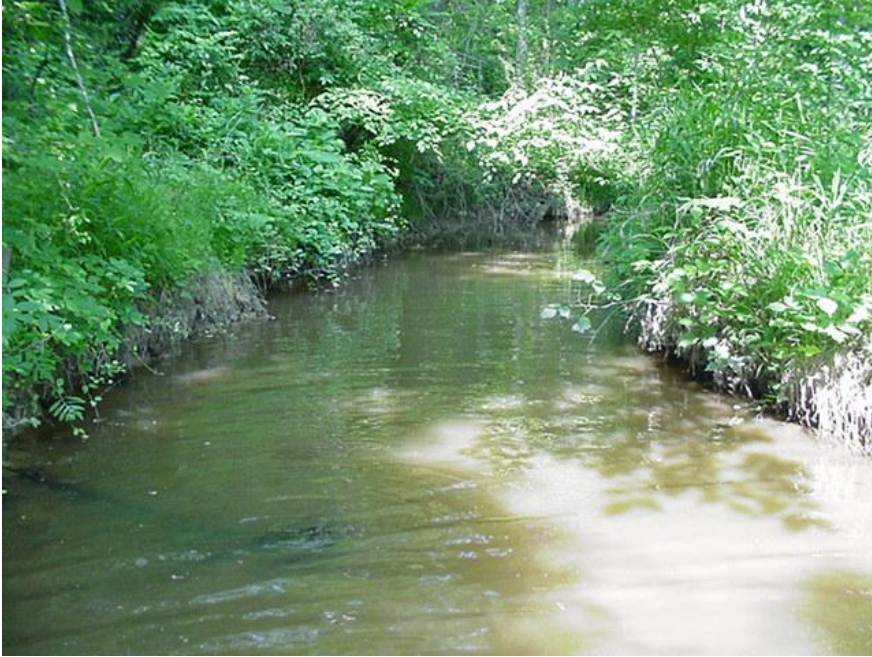
Station FR1: South Flat River at SR 1109 (upstream view)

Physical measurements were collected at each of the sampling stations and are included in Appendix 2. These measurements indicated low dissolved oxygen values at the historical biologically impaired station, South Flat River at SR 1109 (station FR1) and the South Flat River at SR1111 (station FR2). These dissolved oxygen values were 4.5 mg/L and 4.9 mg/L respectively. The dissolved oxygen values, however, were above the Division of Water Quality standard of an instantaneous value of 4.0 mg/L. The low dissolved oxygen values may have been due to stagnant water from the low stream flow velocities noted at these stations. Conductivity values were consistently higher at the upstream stations possibly also due to the stagnant conditions present.

A turbidity sample was collected at station FR1 due to the presence of muddy water. The turbidity value found of 20 NTU was within the state standard for turbidity. A water column metals sample was taken at the South Flat River at SR 1109 (station FR1). Metals analyses indicated elevated aluminum, iron, and manganese concentrations but this is due to naturally high amounts of these metals in local soil types. The iron value of 3300 ug/L found at this station was well above the state water quality standard but this standard is designed as an action level for dischargers and there are no dischargers in the vicinity of this station. A sediment metals sample taken at this station also showed elevated amounts of aluminum, iron, and manganese, also due to natural conditions. The sediment metals values found at station FR1 were typical of those found in historical sediment metals samples collected throughout the state with analyses performed by the NC DWQ Laboratory (Roy Byrd, NCDWQ Laboratory Section, personal communication). No sediment metals values were above the EPA hazardous waste site screening values. A sediment pesticides and organics sample was also taken at station FR1. The results indicated some unidentified peaks for chlorinated pesticides, organophosphate pesticides, and semi-volatile compounds. Unidentified peaks are compounds that are detected in

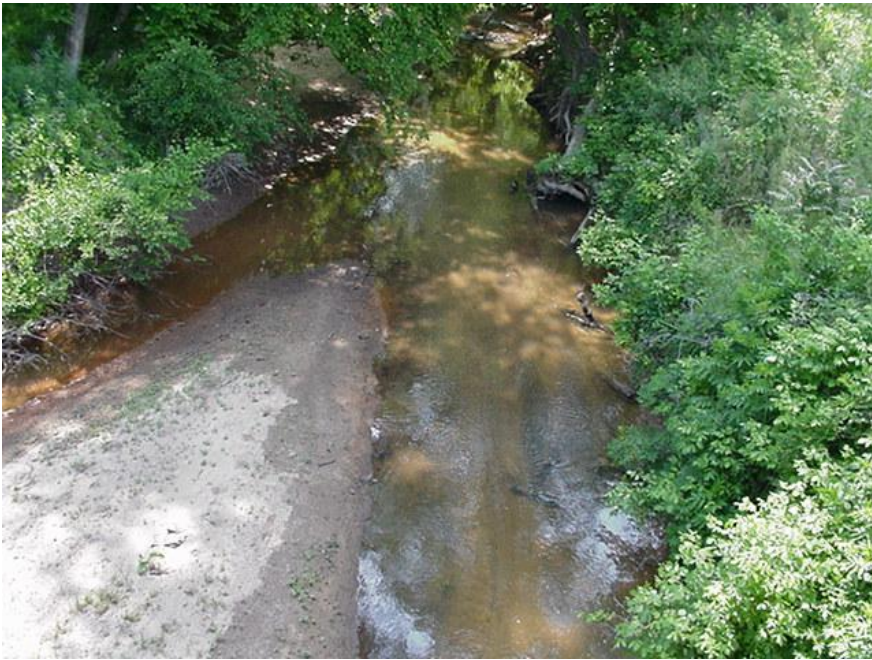
Station FR4: South Flat River at Hwy 157 (downstream view)

The South Flat River watershed was surveyed on May 13, 2004. A map of the watershed is attached in Appendix 1 and photographs of each of the sampling stations are attached at the end of this report. Many agricultural fields were observed throughout the small watershed located near the headwaters. Some of these fields were freshly planted with crops, especially tobacco. Some houses and farms were also observed in this area as well as numerous small farm ponds. There were a few horses in pastures, as well as some areas where logging had been performed and some forested areas. The South Flat River was narrow and very shallow (just a few inches deep) at all of the upstream stations. The water at these upstream stations appeared muddy although low flow conditions were present. The water was especially muddy at the historical biologically impaired station, South Flat River at SR 1109 (station FR1). Water clarity was much better at the most downstream station, the South Flat River at Hwy 157 (station FR4) where the river was much wider due to the confluence of Bushy Fork Creek upstream. The stream bottom at all stations appeared to be a mixture of gravel, mud, sand and rocks. A large sandbar was present at the South Flat River at Hwy 157 (station FR4). Periphyton was observed on the rocks at all stations except the most downstream station, South Flat River at Hwy 157 (station FR4). Fish were observed swimming in the South Flat River at Hwy 157 (station FR4).

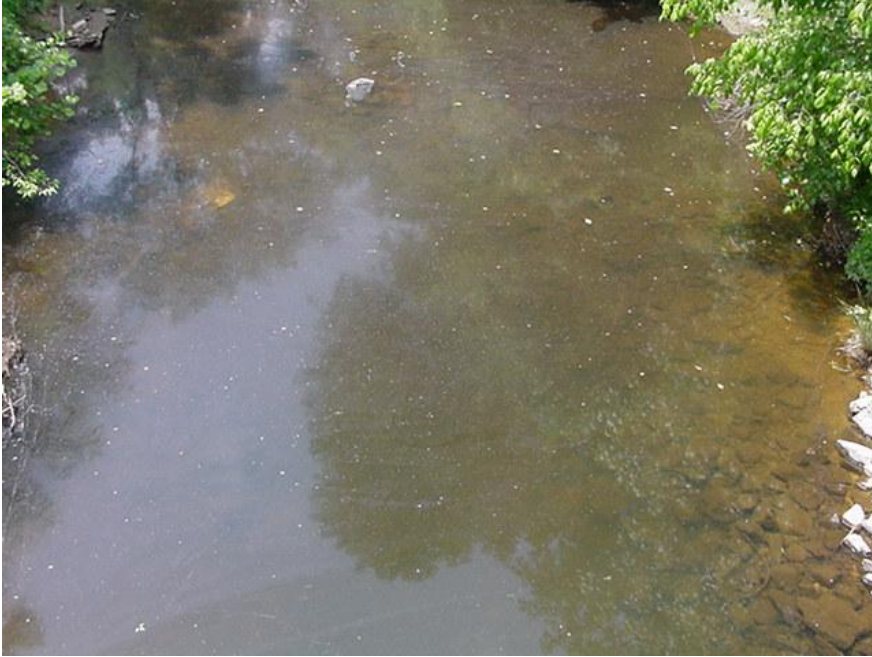
Station KR1: Knap of Reeds Creek at SR 1121 (downstream view)

Physical measurements were collected at each of the sampling stations and are included in Appendix 2. These measurements indicated low dissolved oxygen at Knap of Reeds Creek at SR 1121 (station KR1), Knap of Reeds Creek at SR 1120 (station KR4), and Knap of Reeds Creek 100 feet upstream of the John Umstead WWTP outfall (station KR6). The dissolved oxygen values found at stations KR4 and KR6 (3.0 mg/L and 2.7 mg/L respectively) were below the state surface water quality standard for dissolved oxygen. This standard reads that dissolved oxygen shall not be less than an instantaneous value of 4.0 mg/L. The low dissolved oxygen values were probably due to the low flow and stagnant conditions noticed at these stations because of a lack of recent rainfall and the dams of Holt Reservoir and the waterfowl impoundment. Conductivity values were very high (547 umhos/cm) at Knap of Reeds Creek 450 feet downstream of the John Umstead WWTP (station KR 7) probably because of the wastewater discharge. Upstream of the wastewater discharge at stations KR4 and KR6, conductivity was somewhat high probably due to the stagnant, low flow conditions present. Conductivity values were also very high (333 umhos/cm) at Picture Creek at SR 1239 (station KR2). The most likely cause of this high conductivity was materials leaching out of a now closed landfill located upstream near one of the tributaries to Picture Creek. Conductivity in this tributary (unnamed tributary to Picture Creek at SR 1112) was 621 umhos/cm. The conductivity value further away from the landfill at Picture Creek at SR 1112 was also high (360 umhos/com) and possibly indicated groundwater contamination in this area by the landfill. In a conversation with Larry Rose of the N.C. Division of Waste Management, Solid Waste Section, it was learned that this landfill is unlined. Mr. Rose also mentioned that surface water monitoring performed in the creek

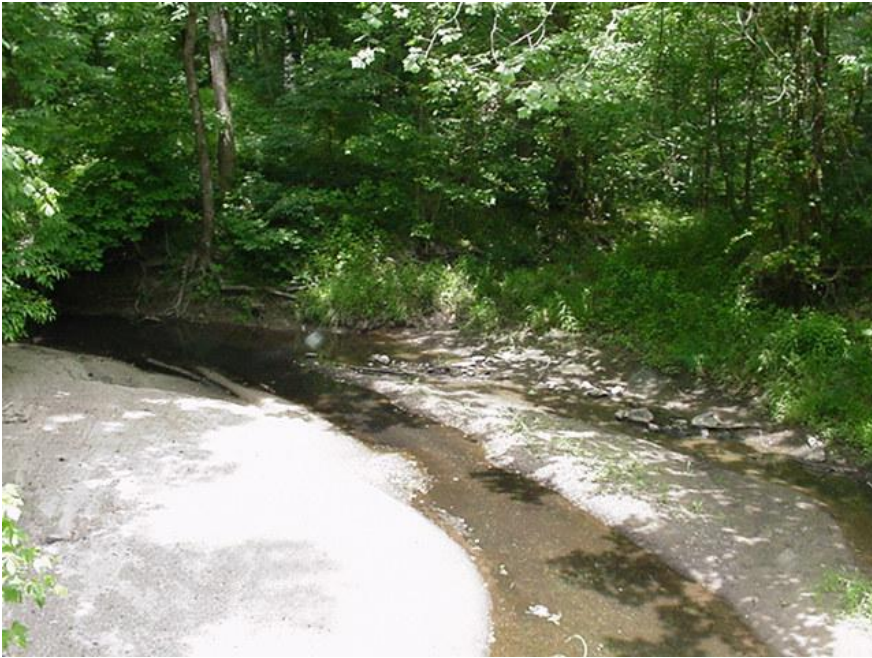
Station KR2: Picture Creek at SR 1239 (downstream view)

Water column metals samples taken at Picture Creek at SR 1239 (station KR2) and Knap of Reeds Creek downstream of the WWTP outfall (station KR7) indicated high values for aluminum, iron, and manganese due to naturally occurring high levels of these metals in local soil types. Copper and zinc were also detected downstream of the WWTP (station KR7) probably due to industrial dischargers to the WWTP although levels found were within water quality standards action levels. A sediment metals sample taken downstream of the WWTP outfall (station KR7) also indicated high aluminum, iron, and manganese because of high naturally occurring levels of these metals in the local soils. With the exception of chromium, the sediment metals found were consistent with historic values found in sediment metals analyses performed on samples collected throughout the state (Roy Byrd, NC DWQ Laboratory Section, Chemistry Laboratory, personal communication). According to Mr. Byrd, the sediment chromium value of 46 mg/kg was much higher than sediment chromium values usually found. The high sediment chromium value may have been due to the discharge of the John Umstead WWTP upstream and metal plating industrial components of this discharge. None of the sediment metals values found at station KR7 were above the EPA hazardous waste site screening values. A sediment pesticides and organics sample taken at Knap of Reeds Creek downstream of the WWTP (station KR7) indicated 3 unidentified pesticide peaks. Unidentified peaks are compounds that are detected in the pesticides and organics sample that are not present in the laboratory sample library of approximately 125 pesticides and organics. Microtoxicity sediment samples were collected at station KR7 and will be discussed in a later memorandum from Sandy Mort of the Aquatic Toxicology Unit. A review of compliance and enforcement records for the John Umstead WWTP revealed that there have been numerous historic permit limit violations for chlorine and the Town of Butner has been repeatedly fined by the Division of Water Quality for these violations.

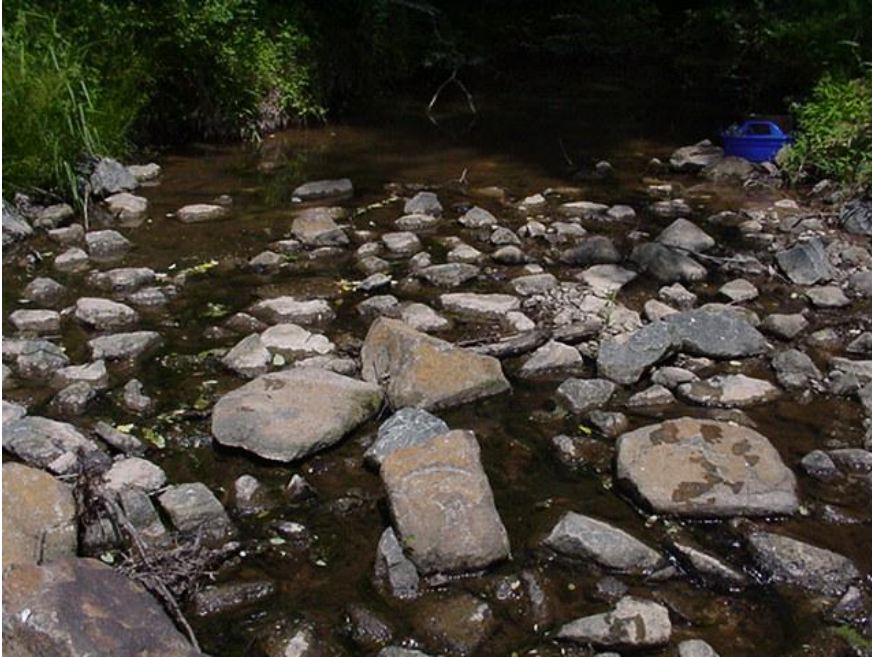
Station KR3: Upstream Unnamed Tributary to Knap of Reeds Creek at SR 1004 (upstream view)

near the landfill has not indicated any problems but that groundwater contamination, especially with volatile organics, is present in the area due to the landfill. Monitoring is continuing and additional groundwater monitoring wells are being installed. A low pH value was found at the upstream unnamed tributary to Knap of Reeds Creek at SR 1004 (station KR3). This value (5.9 s.u.) was slightly outside of the surface water quality standard of a range between 6.0 s.u. and 9.0 s.u. for pH.

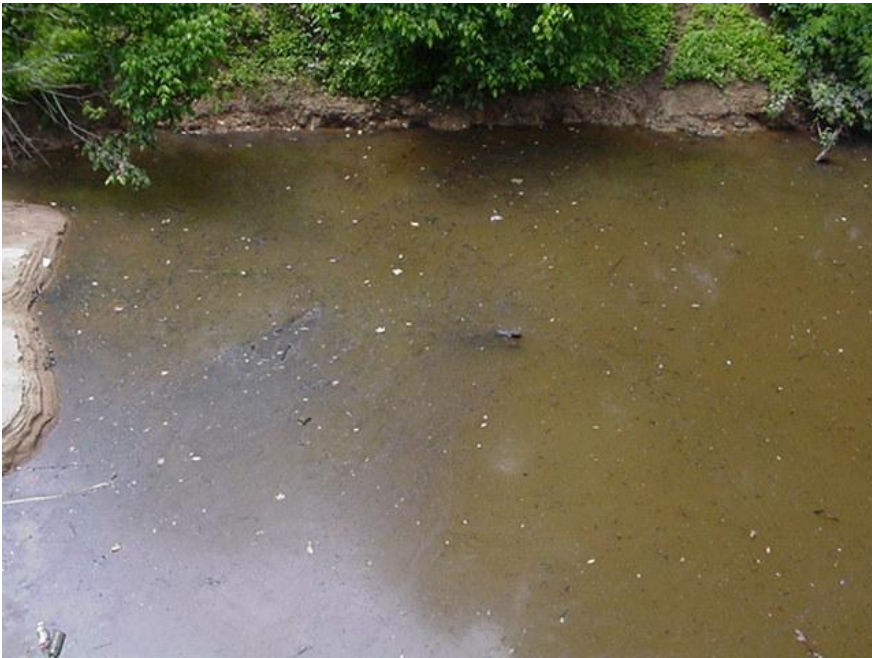
Station KR4: Knap of Reeds Creek at SR 1120 (downstream side of bridge)

Chemical samples were collected at several stations in the watershed and results are included in Appendix 3. Nutrient samples were taken at several stations in the Knap of Reeds Creek watershed. Results indicated nutrient enrichment at Knap of Reeds Creek at SR 1120 (station KR4) and Knap of Reeds Creek 450 feet downstream of the John Umstead WWTP outfall (station KR7). As mentioned previously, stagnant conditions and a large amount of surface debris were present at Knap of Reeds Creek at SR 1120 (station KR4) which could explain the high nutrient levels present. Nutrient levels were very high at station KR7 due to the wastewater discharge immediately upstream. A review of the wastewater treatment plant self-monitoring effluent nutrients data collected on May 18, 2004 (the day before the stressor study was conducted) indicated very high total nitrogen and total phosphorus values of 12.0 mg/L and 1.73 mg/L respectively. A biochemical oxygen demand sample taken at Knap of Reeds Creek downstream of the WWTP (station KR7) indicated a low BOD value with no cause for concern.
