Hunting Creek Watershed Plan

Burke County, NC

February 2011

Prepared by Equinox Environmental Consultation & Design, Inc.
37 Haywood Street, Suite 100
Asheville, NC 28801

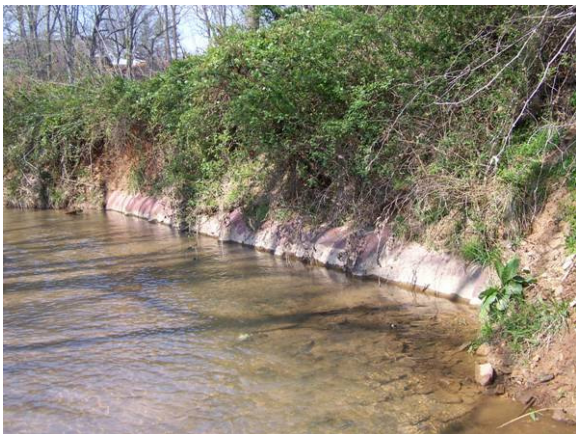
Where utilities occur along the floodplain, stream bank, or stream bottom of Hunting Creek, their location was recorded during the stream walk. The types of utilities included electric power lines, sewer lines, gas lines, and unknown pipes. The condition of the observed utility was noted as well as potential concerns, if applicable. Several utilities were observed to be contributing to some degree of erosion where it crossed the stream corridor. Exposed pipes crossing the stream were also noted as being susceptible to damage during high flow events.

Pipe utility parallel to Hunting Creek along stream bottom.

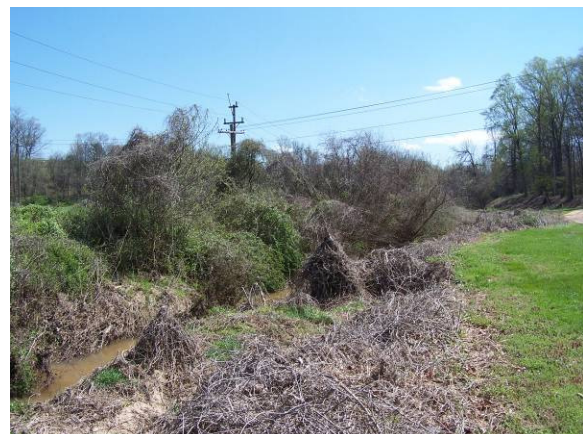
Power lines crossing Hunting Creek overhead.

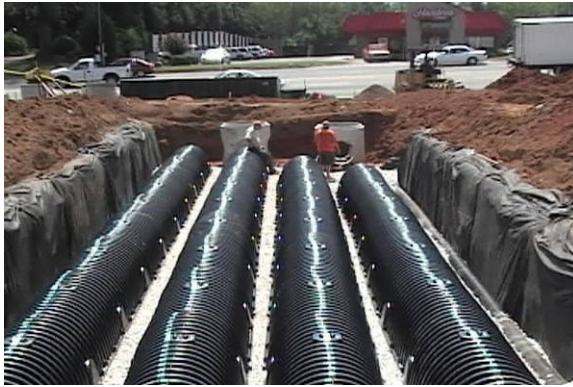
Filtration, another type of structural BMP, can be as simple as filters in storm grates or as complex as large chambers with multiple filters that serve to remove pollutants. Another common structural stormwater BMP is pervious pavement, which allows stormwater to infiltrate into the ground rather than runoff into the stormwater conveyance system.

Filtration chambers are installed during construction of the Bojangles parking lot in Morganton (outside the Hunting Creek Watershed). The chambers will capture stormwater and filter it through a sand and stone medium before releasing it to a nearby stream.

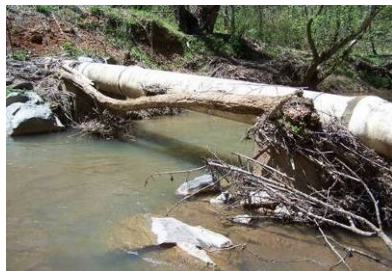
Pipe utility crossing Hunting Creek above stream with debris pile behind pipe. Also note erosion along stream bank
