# WATERSHED ASSESSMENT REPORT

September, 2015

## Little Lick Creek Watershed Improvement Plan

Durham, North Carolina

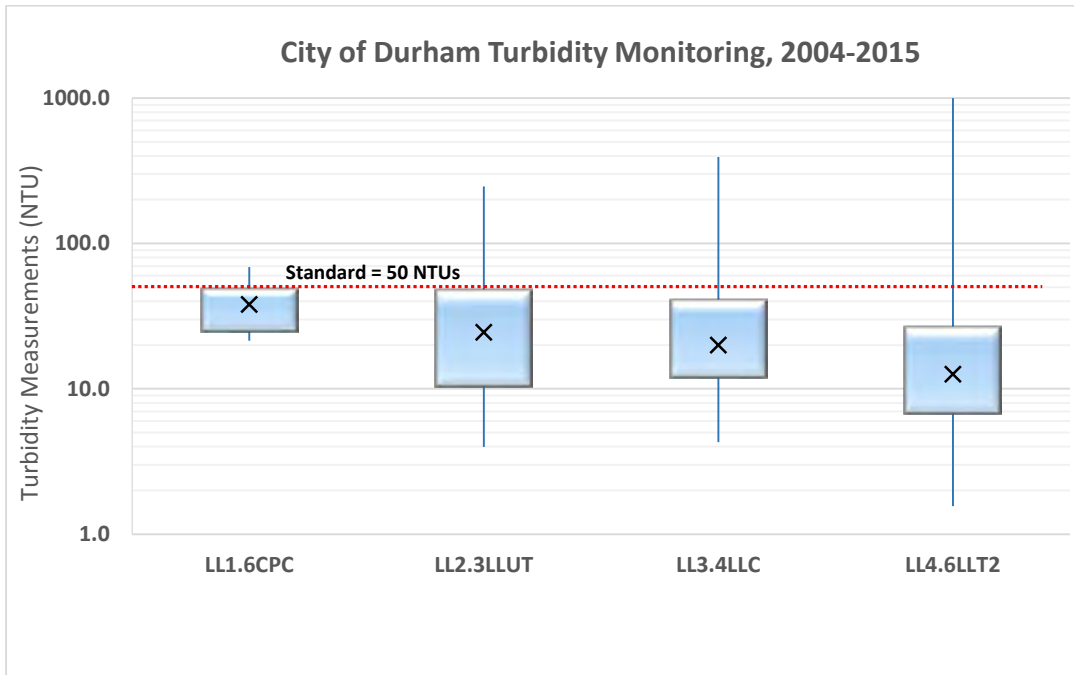
**Plot 7. Statistical Analysis of Turbidity Measurements at Durham Stations**

Turbidity, which in general terms describes the clarity of water, has typically been monitored monthly at all three Durham stations. As shown below on Plots 7 and 8, turbidity concentrations at the three Durham stations are normally below the water quality standard of 50 NTUs for the protection of aquatic life. The 25<sup>th</sup>, median, and 75<sup>th</sup> percentiles at all three stations are below this standard, with the median values between 12 and 25 NTUs. However, instantaneous measurements of turbidity above the standard have been observed at all three stations, as shown on Plot 8. Of the 299 individual observations, turbidity has been measured above the standard in 54 samples (18%). This indicates that although high turbidity levels have been observed in Little Lick Creek, it is not a common occurrence.

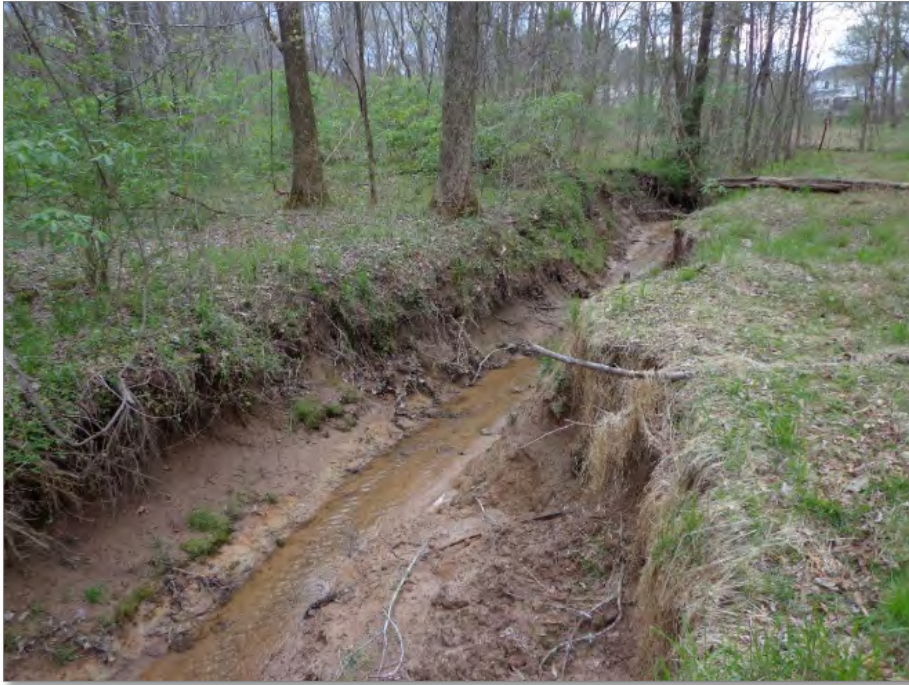
**Photo 1.** *Example of Poor Overall Stream Condition*

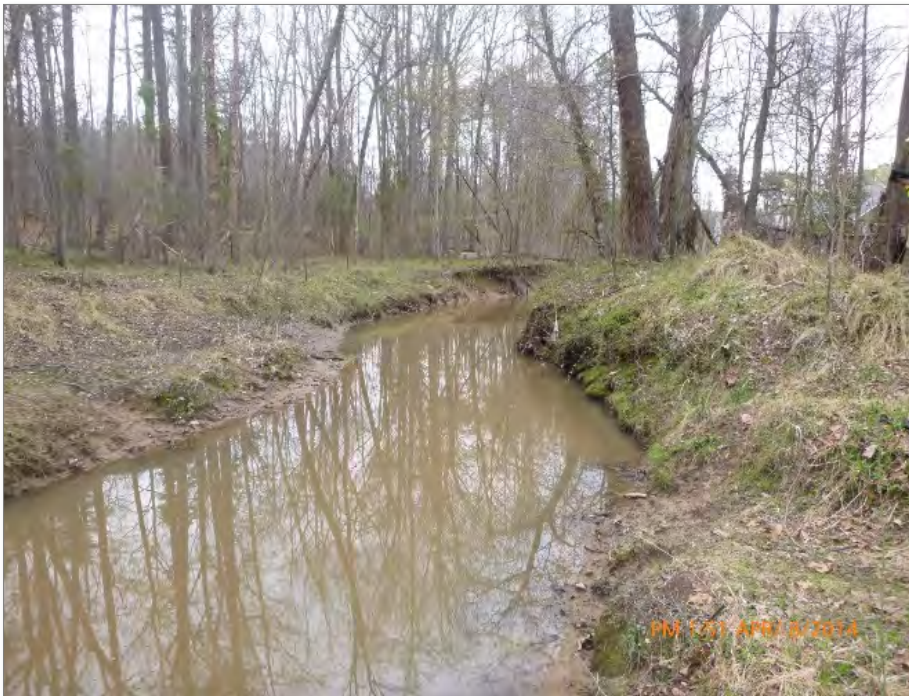
**Photo 2.** *Example of Fair Overall Stream Condition*

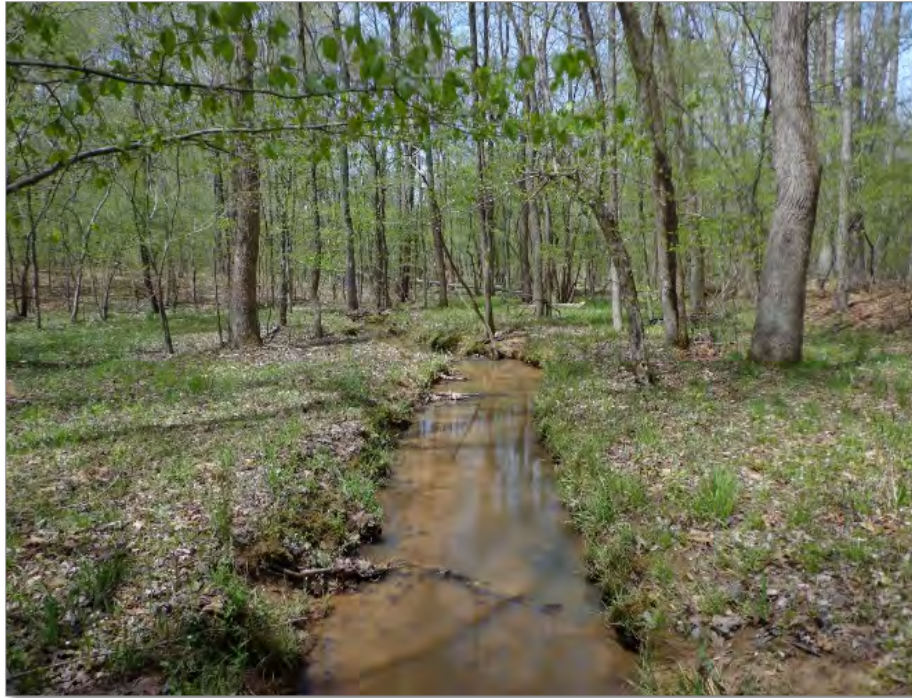
**Photo 3.** Example of Good Overall Stream Condition

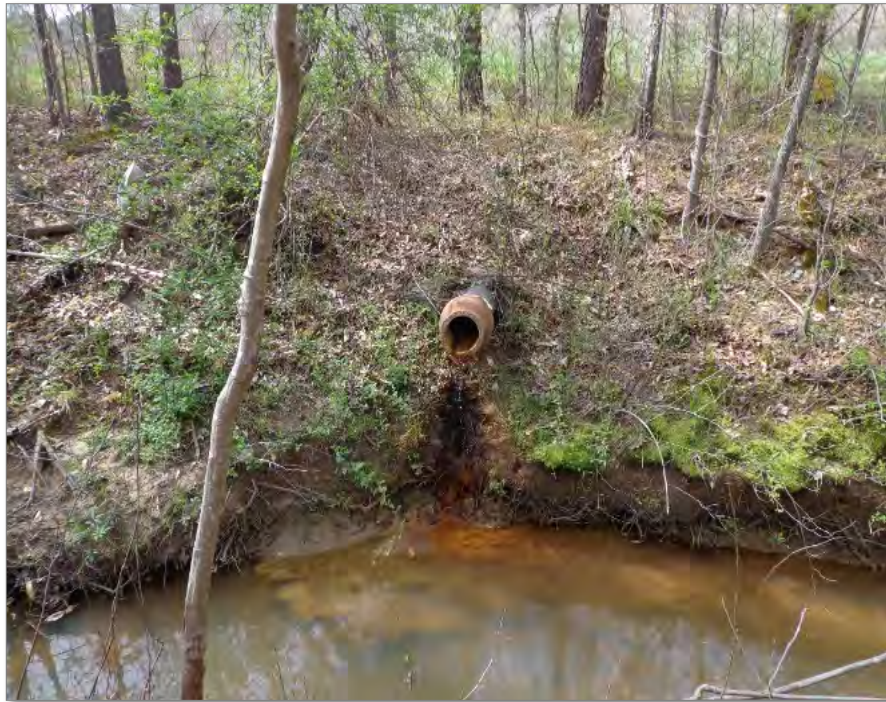
Potential water quality concerns that were identified by field teams during the Level 1 stream assessments were located with GPS (Figure 12). The most frequently observed issues were dumping of garbage and debris in or adjacent to streams, unidentified pipes discharging to streams (see Photo 4), debris or beaver dams creating backwater conditions, and potential sources of excess sediment. Table 16 includes a summary of the types of potential issues observed. Potential water quality issues related to utility crossings are addressed separately in Section 3.5.4.

**Photo 4.** *Example of Pipe Discharging to Stream from Unknown Source*

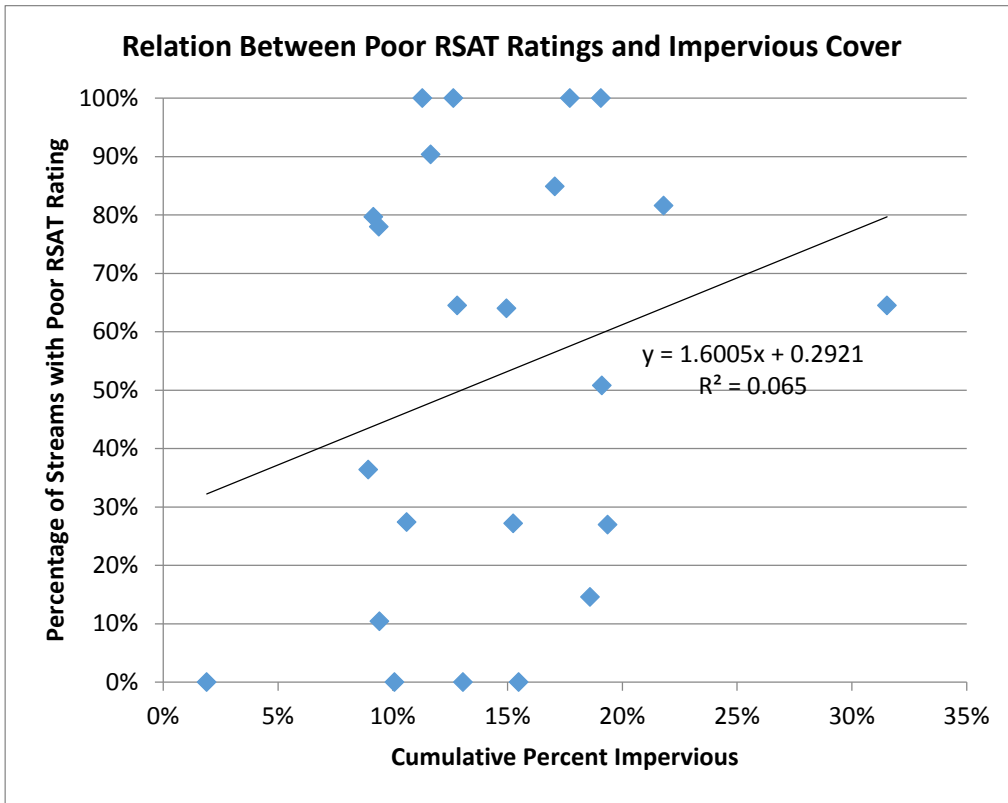
Plot 9. Correlation between Cumulative Impervious % and Poor Stream Quality

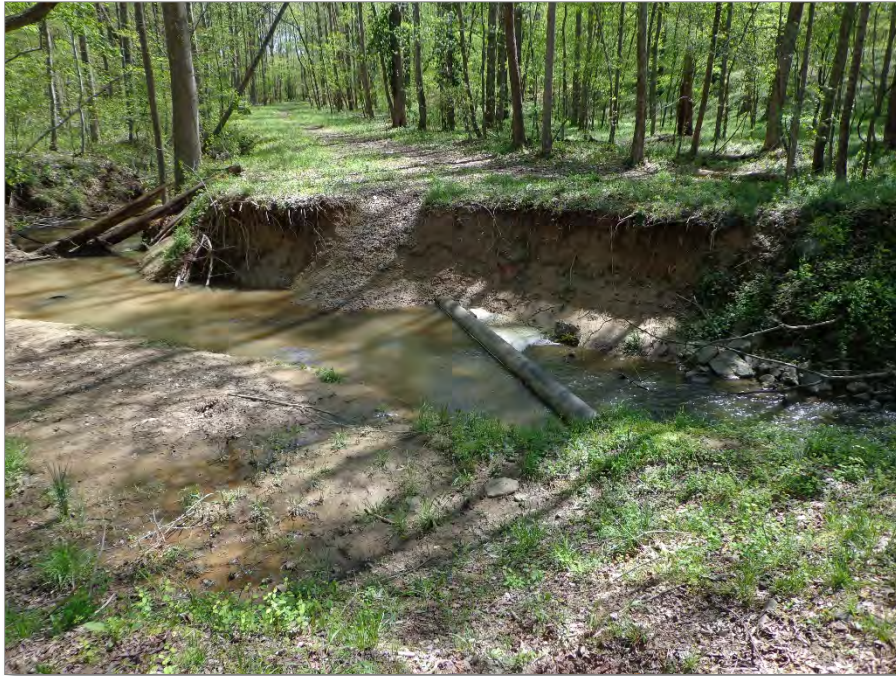
Though many occurrences of utilities crossing or running adjacent to streams were inspected, none had obvious signs of leaking. At several locations, utility lines are exposed or unstable due to stream bed and bank erosion that has occurred since the original installation of the utility (Photo 6). In several locations, these newly-exposed sewer lines were temporarily protected with riprap, but a permanent solution had not been implemented. Table 20 summarizes the utilities that are currently exposed or vulnerable to due erosion. During the field inspection, no signs of leaks were reported by field crews, therefore, no additional contribution to the annual nutrient load will be assigned to exposed utilities. To prevent potential water quality impacts, this information has been submitted to the City's Water Management Department to investigate potential stabilization measures that could be undertaken at each location.

**Photo 6.** Exposed sanitary sewer line due to bed and bank erosion.

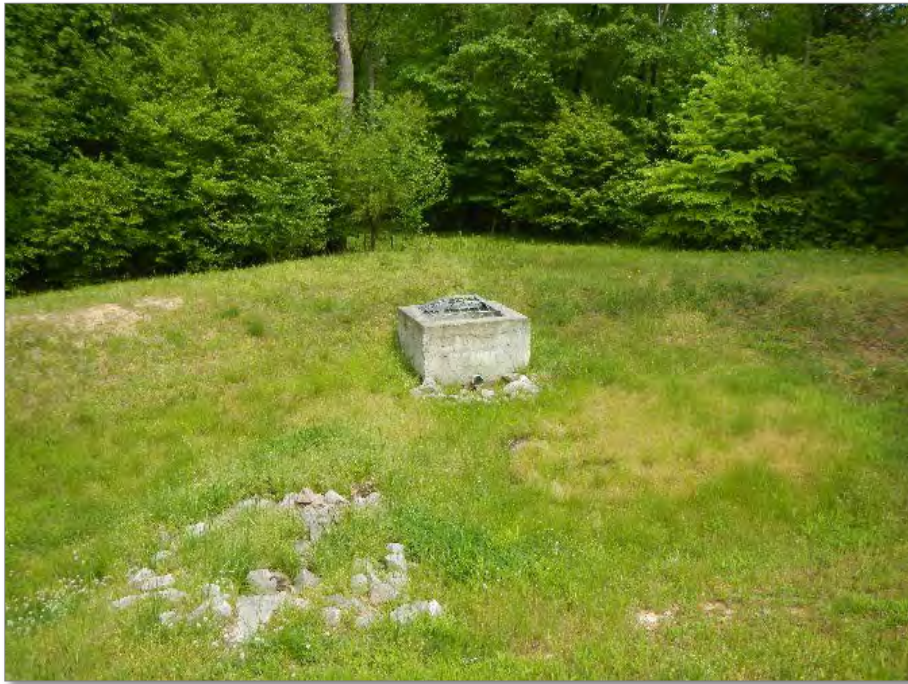
**Photo 7.** *Typical small dry pond in Ridgefield subdivision*

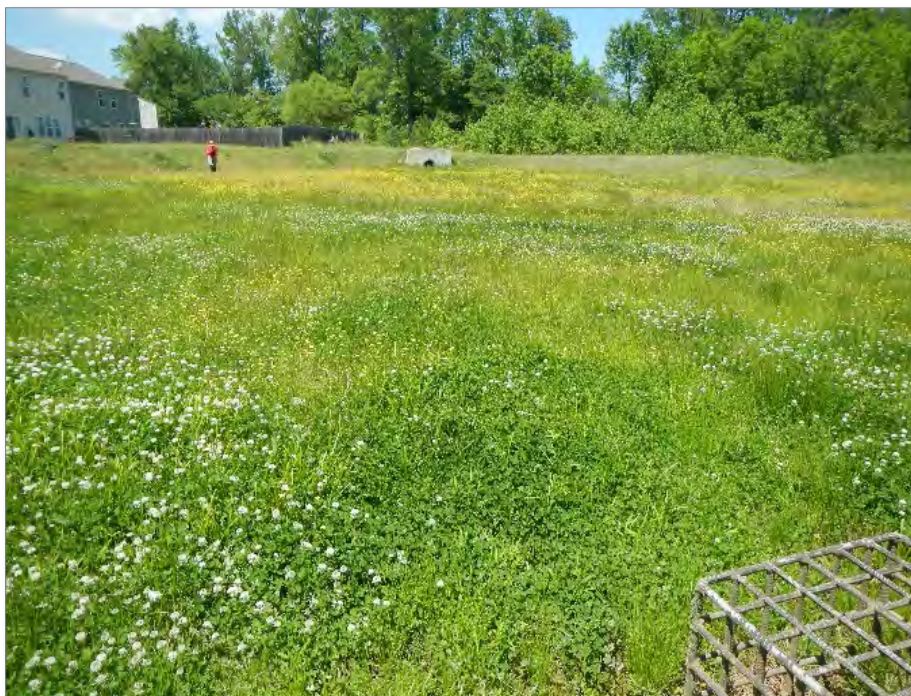
**Photo 8.** *Large scale dry pond in Ganyard Farms subdivision*

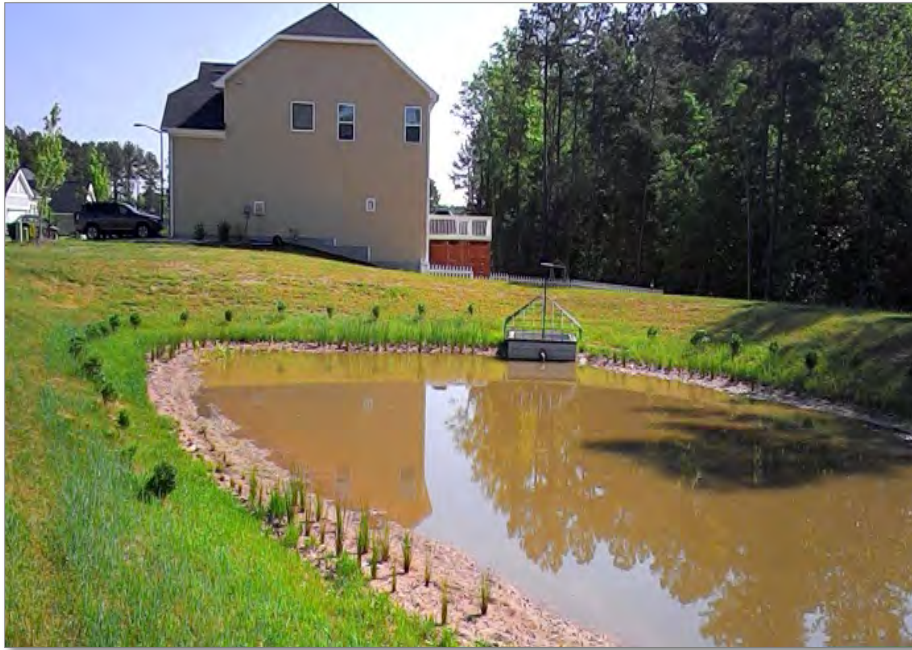
**Photo 9.** *Wet pond in Ashton Hall subdivision*

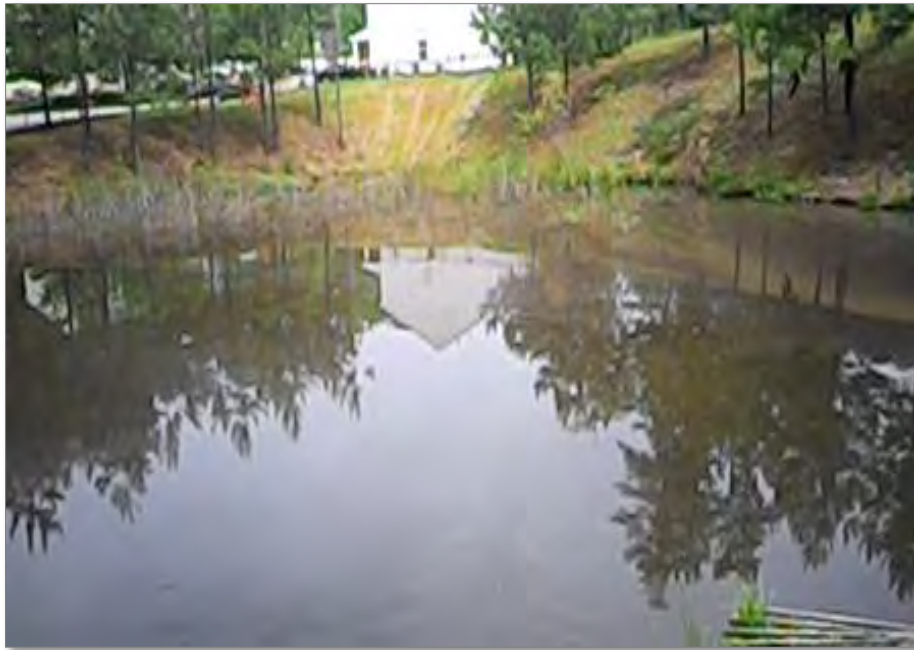
**Photo 10.** *Large wet pond in Lynn Hollow subdivision*

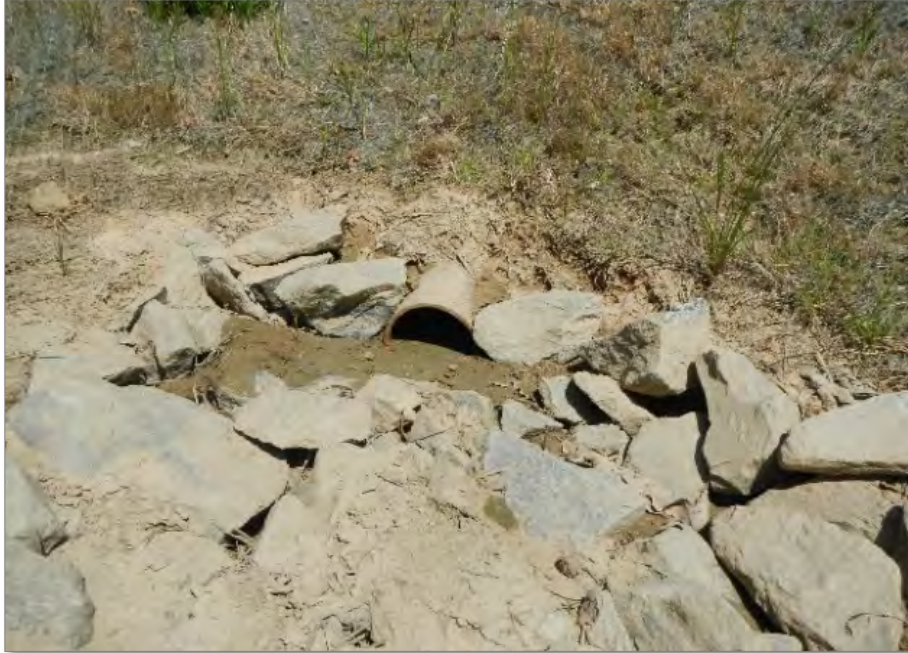
Clogged orifices on riser structures from sedimentation and leaf litter was the leading maintenance issue. Blockages of lower orifices on riser structures are problematic because they raise the normal pool elevation, thereby lowering the storage volume during storm events. This results in reduced residence time of water within the SCM and decreases the water quality performance of the SCM at retaining sediment and nutrients. The inability of level spreaders to reduce flow velocity at the inlet and outlet of several ponds was observed due to sediment buildup that reduces the size of the forebay and the performance of the level spreader. Overgrown vegetation in the footprint of an SCM was also a commonly observed issue with maintenance. Vegetation that isn't properly maintained can lower the storage capacity of an SCM and the root systems can damage infrastructure or weaken an embankment of a pond. Photos 11, 12, and 13 below depict some of the conditions at locations of poorly functioning SCMs.

**Photo 11.** *SCM 00777 – Inlet pipe to level spreader clogged with 2" sediment*

Owners of the facilities' will be notified to take corrective action as part the City's Inspection and Maintenance Certification which is required to be submitted to the City on an annual basis for each facility (<http://durhamnc.gov/695/BCE-As-Built-BCM-Maintenance-Programs>). Erosion and sediment control issues will be reported to Durham County Sediment and Erosion control. Durham County implements the sediment and erosion control program for the City.

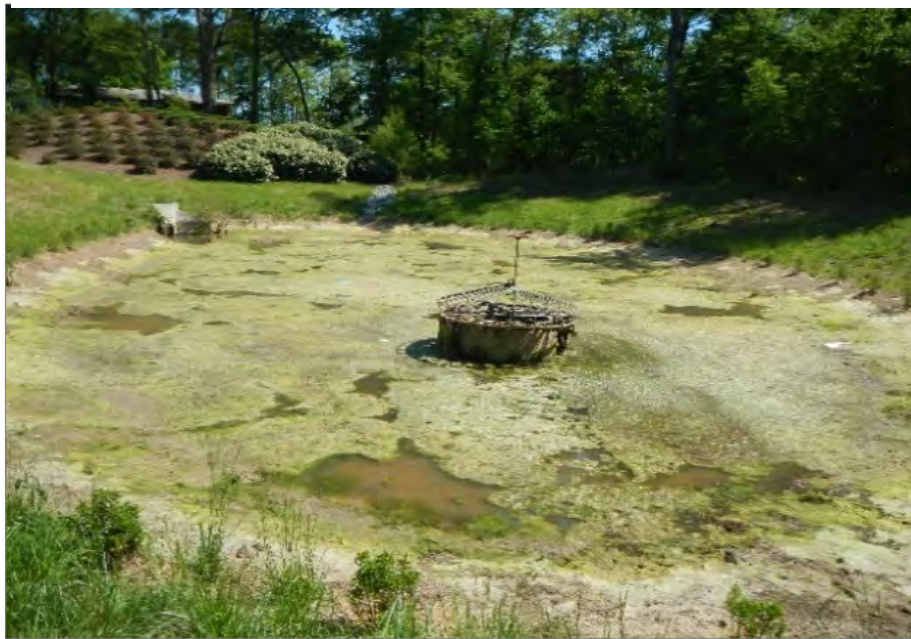
**Photo 12.** *SCM 00390 – Clogged riser orifice leading to heavy algae growth and limited capacity*

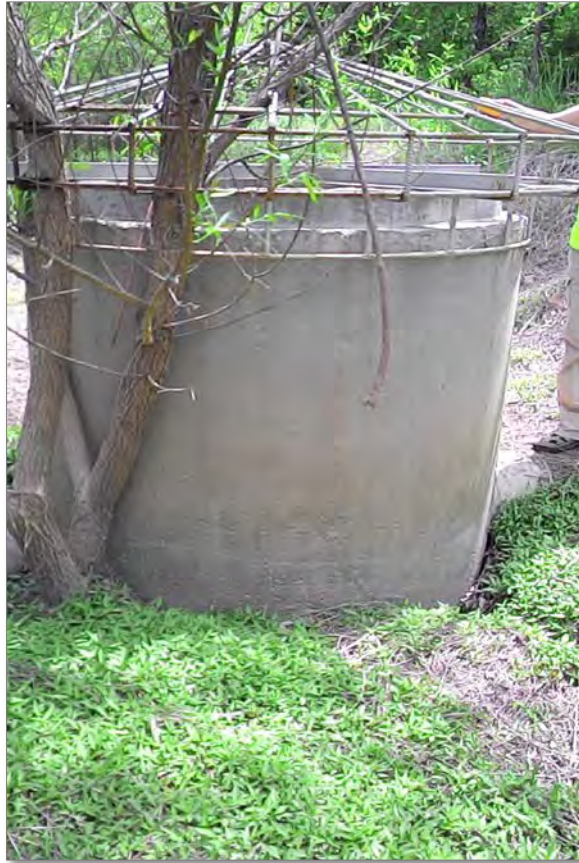
**Photo 13.** *SCM 00420 – Woody vegetation growing in footprint and endangering riser structure*

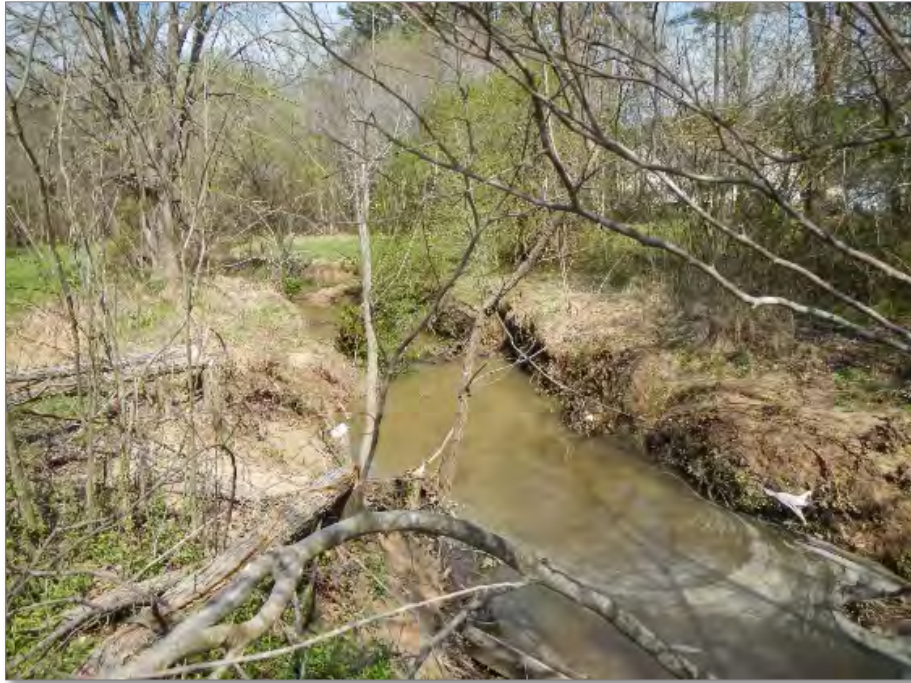
- Stream reach scored “fair” or “poor” on the overall RSAT assessment
- Evidence of active erosion was observed
- Adequate space is available to reconstruct a meandering stream through the floodplain without removing existing infrastructure or other obstacles
- Opportunity exists to raise the existing stream bed without increasing flood risk to surrounding property
- No significant utility conflicts
- Reasonable access for construction and maintenance

**Photo 14.** *Potential Stream Enhancement Reach*

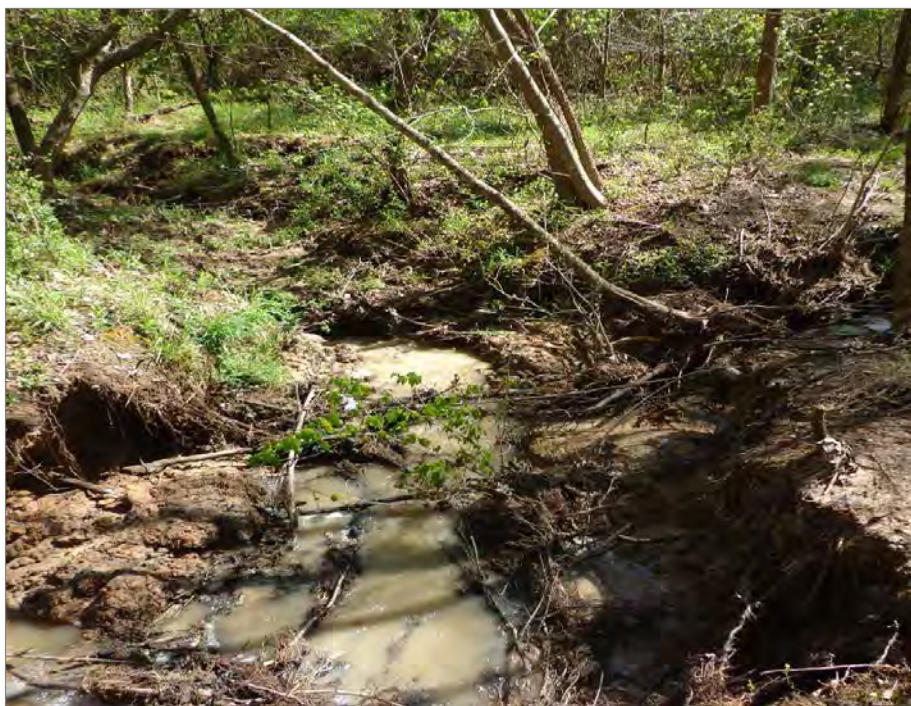
Reaches that were determined to be unsuitable for restoration were then considered for enhancement (Photo 15). *Stream enhancement* refers to “activities undertaken to improve water quality or ecological function of a fluvial system” but fall short of full restoration (USACE, 2003). Stream enhancement includes

**Photo 15.** *Potential Stream Restoration Reach*

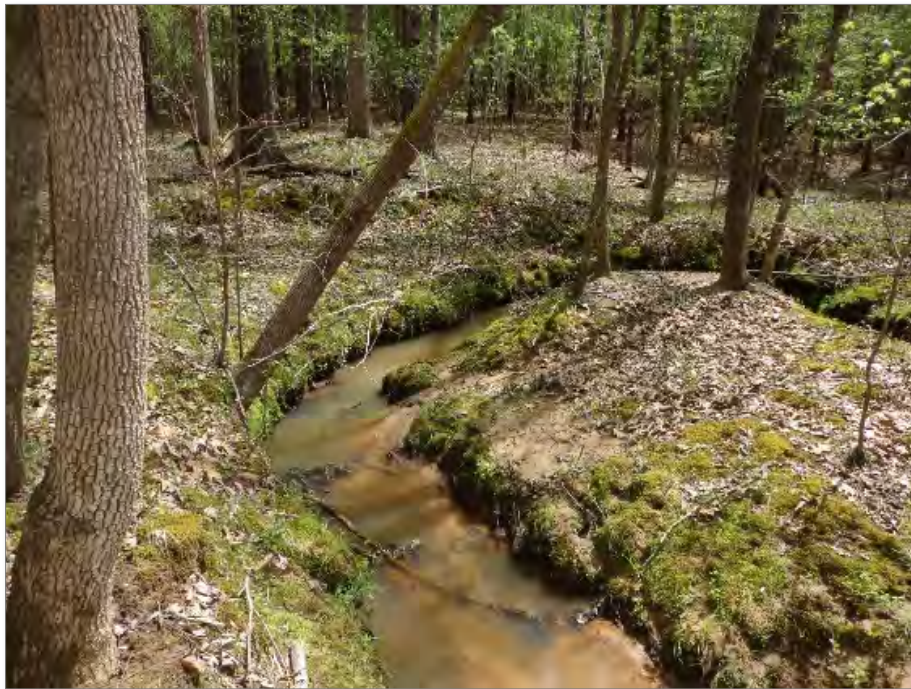
Any stream reaches that received a "good" overall RSAT rating (no reaches were rated "excellent"), have an intact riparian buffer of mature trees on both sides of the channel, and were not observed to be actively eroding were considered for recommendation for stream preservation (Photo 16). *Stream preservation* generally involves placing a conservation easement on the stream and riparian zone to preserve it in its current condition and prevent encroachment or alteration by future development.

**Photo 16.** *Potential Stream Preservation Reach*

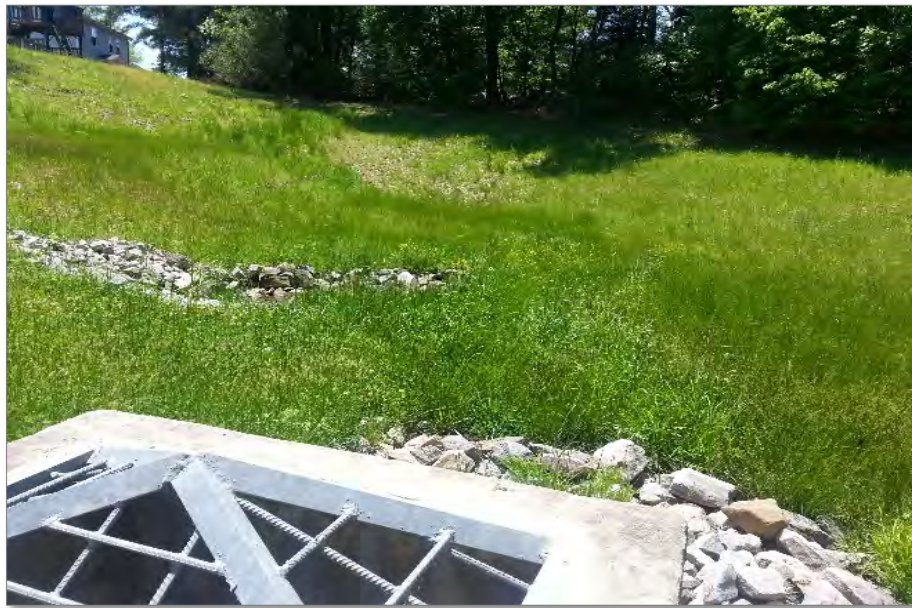
**Photo 17.** *SCM 00161 – Example of a potential volume and structural retrofit combination that would increase SCM volume and treatment time*

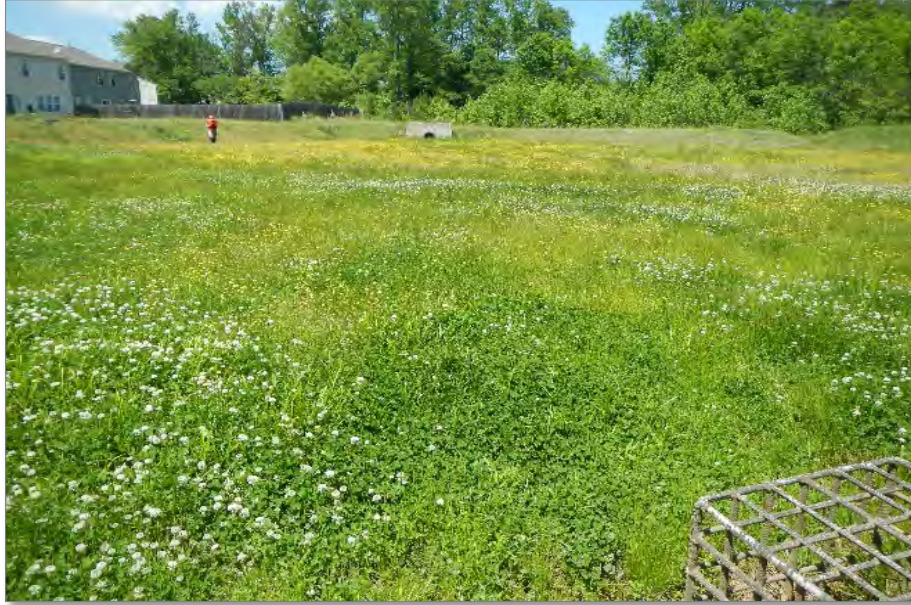
Of the 52 sites evaluated, 16 are candidates for retrofits to improve their water quality benefits. One example of a potential retrofit is SCM 236 (Photo 17), where a structural retrofit would allow a very large dry pond to be converted to a wet pond, thereby increasing nutrient removing capabilities. Another example is SCM 149 (Photo 18), which is an example of a volume and structural retrofit combination. By reconstructing the pond’s embankment downstream and adjusting the orifice on the control structure, SCM 149 could be converted to a stormwater wetland which would increase its nutrient removal capabilities. The specific retrofit opportunity for each of the 16 SCMs is presented in Table 25. The remaining 36 existing SCMs are not good candidates for retrofits, primarily since many have been installed within the past several years and meet current water quality design standards. The location of the existing SCMs that are candidates for retrofit are shown on Figure 20.

**Photo 18.** *SCM 00236 – Example of dry pond that could be converted to a stormwater wetland with a simple structural retrofit*

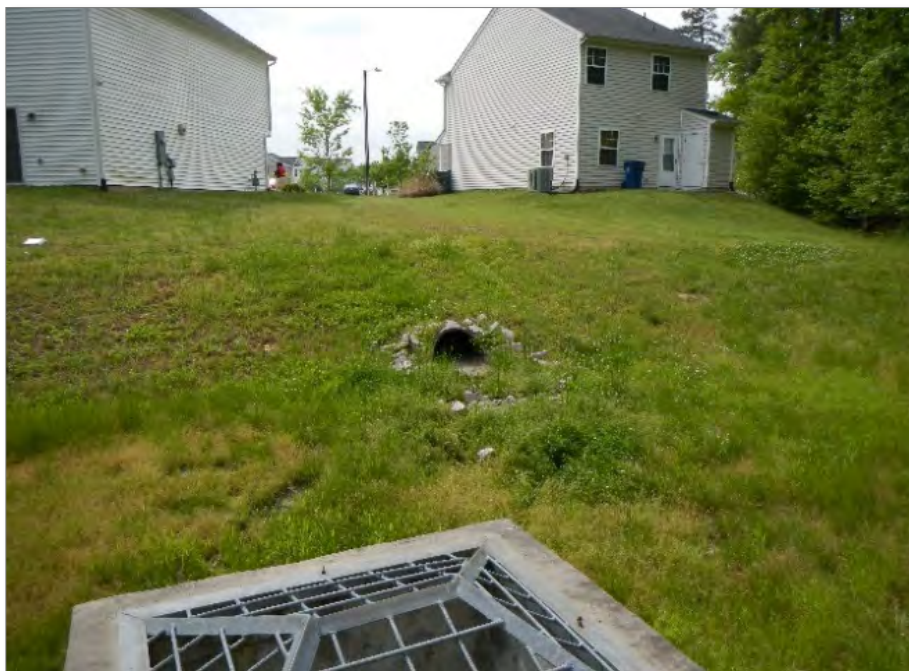
**Photo 19.** *SCM 00354 – Example of a short circuited flow path with inlet directly across from outlet*
