# **LOWER CREEK**

# WATERSHED MANAGEMENT PLAN

# CATAWBA RIVER BASIN CALDWELL AND BURKE COUNTIES NORTH CAROLINA

# **JULY 2006**

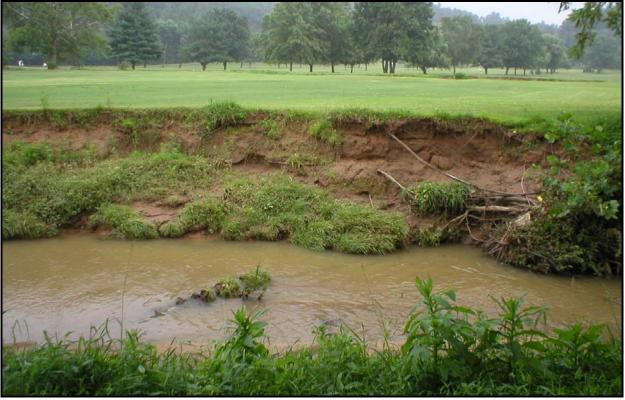
During field reconnaissance efforts, stream channel incision (Figure 6) and widening processes (Figure 7) were observed throughout the watershed. These processes were primarily noted along streams that lacked riparian buffers (i.e., minimal root mass stabilization) and along channels in urbanized areas (e.g., stormwater conveyances). Evidence of significant streambank erosion and downstream sedimentation (aggradation) was also observed at various locations in the watershed. Impacts from construction activities, agriculture, and new development (e.g., residential and commercial) may be contributing to this hydrologic impairment (Figure 8).

Figure 6: Stream down-cutting (incision) along Lower Creek at golf course, 07/31/03 (UL09)

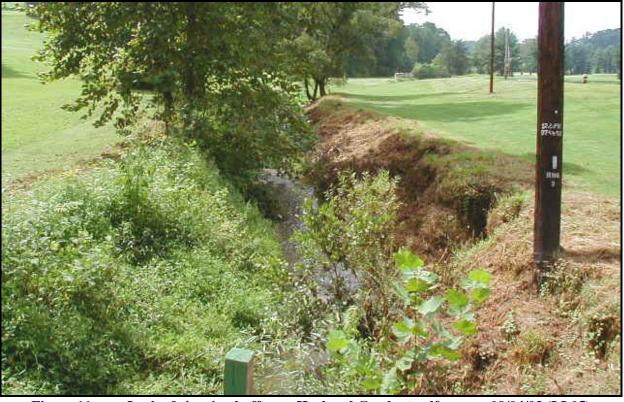
As noted by the DWQ, riparian buffers are absent along many streams in the Lower Creek Watershed. Without such forested buffers, there is only limited filtering of stormwater/NPS pollutants before they reach adjacent stream channels. Forested riparian buffers provide a vegetated transition zone between surface waters and human land uses. During visual assessment efforts in the Lower Creek Watershed, riparian buffers were typically found to be either sparse or entirely absent along many stream channels. This was particularly evident along Zacks Fork, Lower Creek, and an unnamed tributary to Husband Creek (Figure 11 and Figure 12).

Figure 11: Lack of riparian buffer on Husband Creek at golf course, 09/04/03 (LL05)

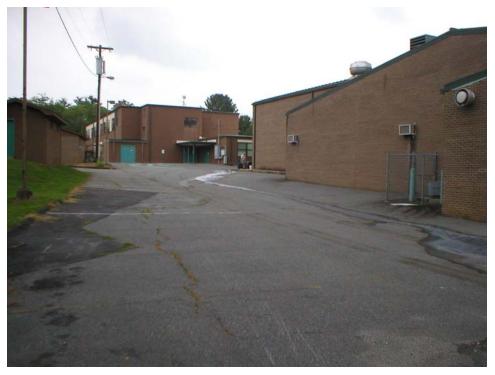
Impervious Cover and Runoff at Gamewell School #319 Site

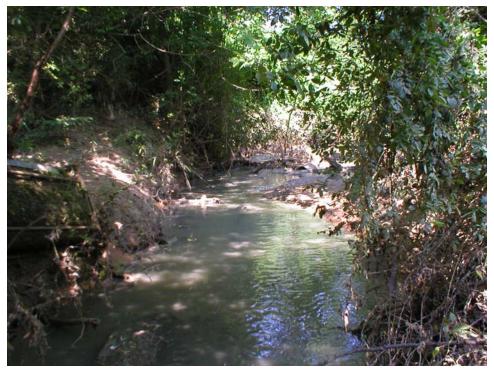
*DWQ monitoring*. Benthic monitoring revealed a highly degraded benthic community in lower Zacks Fork (ZF03), but a community that was much more diverse and healthy above the urbanized area of the mega-subwatershed. Fecal coliform bacteria levels exceeded the NC standard in baseflow and stormflow. High metal levels were found in stormflows. ZF03 was rated NF for DWQ benthic and physical/chemical monitoring.

Sewage in Zacks Fork Creek at Harper Morganton Site

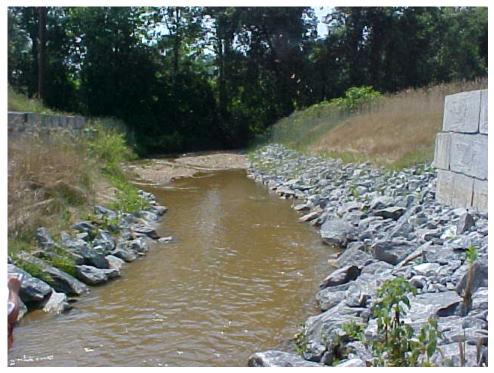
DWQ (2005) indicated that bank erosion was severe; in particular the stream reach from Meadow Lane to the confluence with Blair Fork Creek where several structures were in danger of being lost.

Hard Bank Stabilization along Stream at Main Street #109 Site
