Naked Creek Watershed Plan

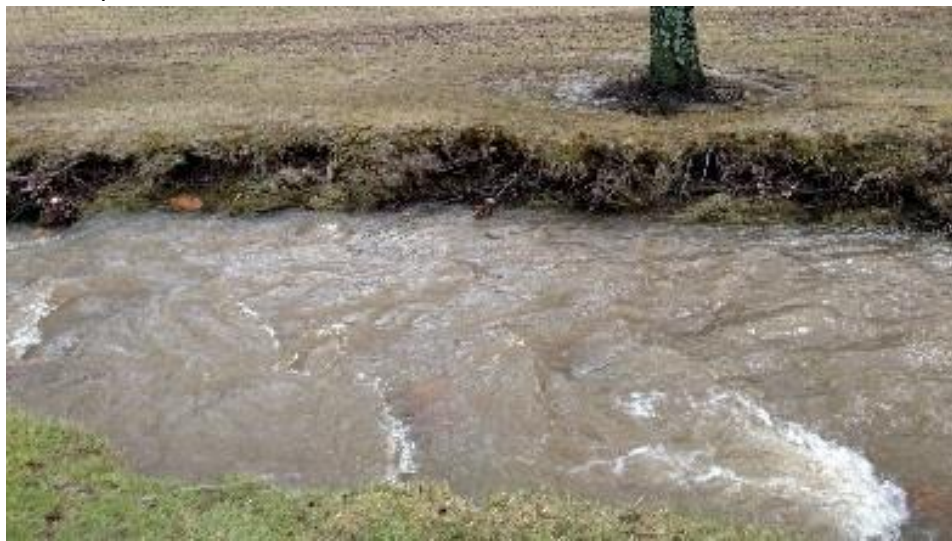
- Mowing to edge and removing any native trees and shrubs destabilizes the bank. This is a common practice for most of the creek and its tributaries.

Figure 8. The picture above, taken at Foster Tyson Park, is an example of a destabilized bank.

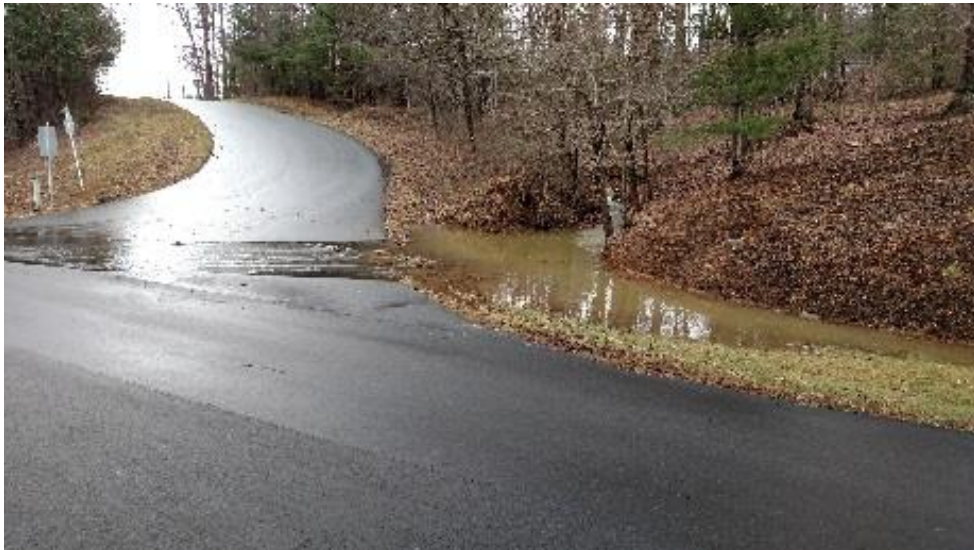
- Straightening the channel cause the creek to flow more rapidly. This can increase soil erosion. Similarly, fast flows eventually reach choke points resulting in floods. Furthermore, studies point to declines in fish populations in channelized rivers. Fish and invertebrates require “natural pools” as habitat.
- Dredging the creek can cause additional sedimentation and erosion. The increased turbidity may influence aquatic metabolism and spawning success.

Figure 8. The picture above is an example of a destabilized bank.
